## North Coast Regional Water Quality Control Board

**Subject: Notice of Violation, Directive to Obtain Regulatory Coverage for Cannabis Cultivation, and Transmittal of Inspection Report for July 8, 2021 Inspection of Mendocino County Assessor's Parcels 154-140-02 and 154-130-02**

**FACILITIES INSPECTION REPORT**

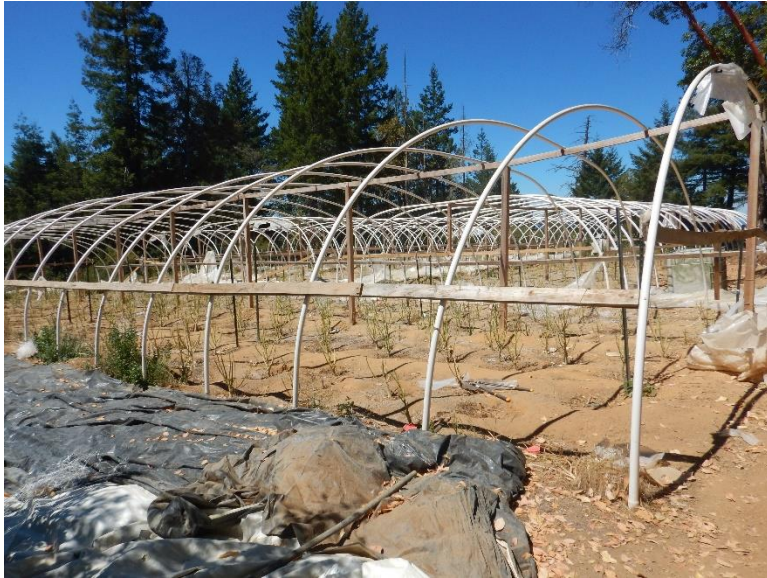
Photo 1: Inactive cultivation:  
Four hoop houses with  
cannabis plants already  
harvested

1. If the property owner and/or tenant(s) plan to continue cultivating cannabis on the Property, enroll for coverage under the State Water Board’s Order WQ 2019-0001-DWQ, General Waste Discharge Requirements and Waiver of Waste Discharge Requirements for Discharges of Waste Associated with Cannabis Cultivation Activities here: <https://public2.waterboards.ca.gov/cgo>

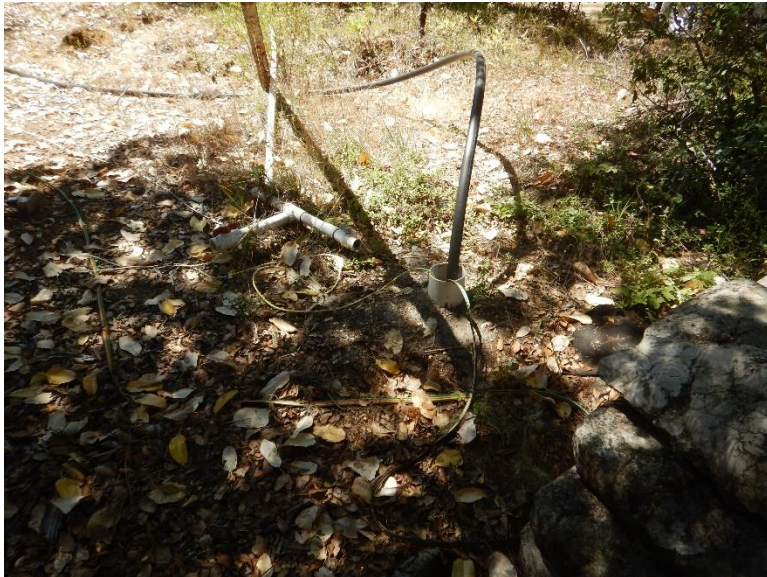
Photo 2: Well: Unsealed  
groundwater well

4. Adhere to Bulletin 74: California Well Standards as required by the Department of Water Resources (<https://water.ca.gov/well-standards>) and enforced by Mendocino County for installation, maintenance, and destruction of wells.

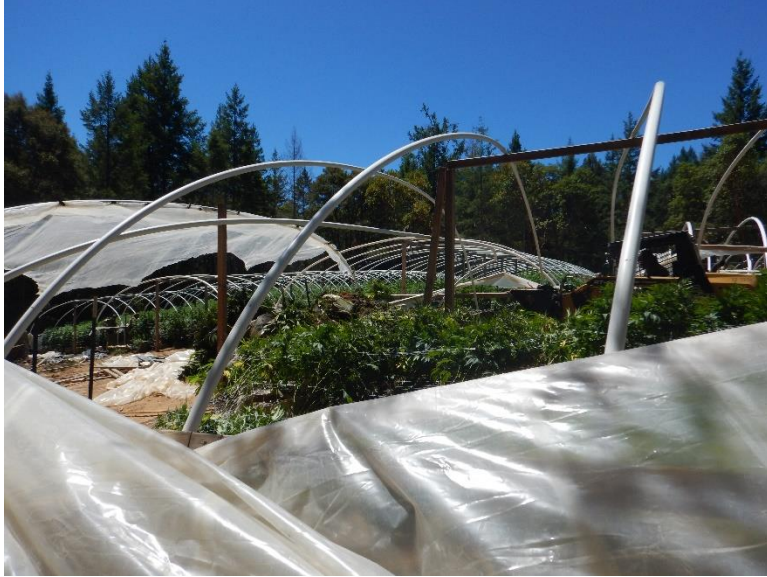
Photo 3: Active cultivation: Ten hoop houses with active cannabis cultivation

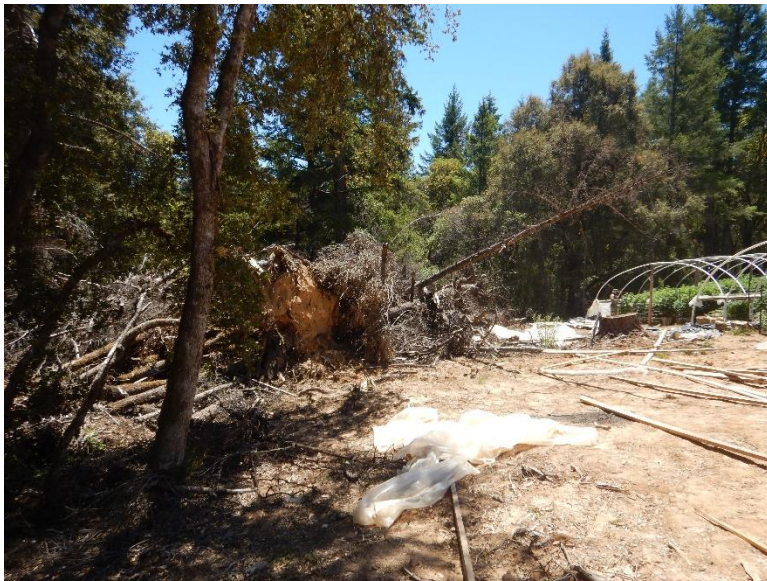
Photo 4: Active cultivation: Slash and cultivation related waste around active cannabis cultivation area

2. Store and contain all potting soil, cultivation-related waste, and chemicals, including pesticides and petroleum products, properly to prevent spillage and potential for migration/transport into receiving waters. Storage areas shall comply with the riparian setbacks and have secondary containment as necessary.

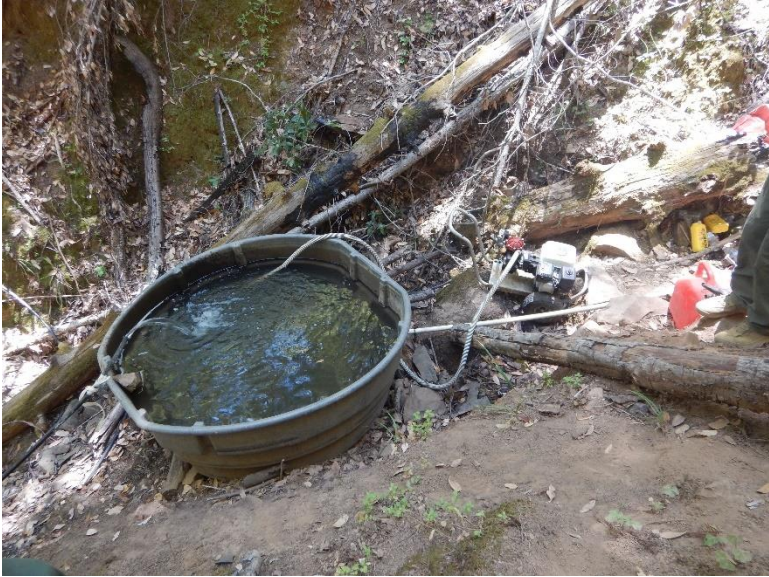
Observations cont.  
 Watercourse: In a Class III watercourse at 39.1586, -123.3836 Decimal Degrees, I observed an open plastic reservoir attached to a pump. I also observed gasoline and oil canisters in the watercourse.

Photo 5: Watercourse:  
Reservoir, pump, and gasoline  
and oil canisters in a Class III  
watercourse

3. Remove the reservoir, pump, and canisters from the watercourse as soon as possible, prior to November 15, 2021. Use erosion control measures to stabilize the disturbed area and replant with native vegetation. Relocate all cannabis related infrastructure and waste at least 50 feet away from the watercourse.
