## North Coast Regional Water Quality Control Board

**Subject: Notice of Violation and Transmittal of Inspection Report for July 20, 2021 Inspection of Humboldt County Assessor's Parcel Number (APN) 216-244-001-000 and Directive to Respond within 30 days**

**FACILITIES INSPECTION REPORT**

**Inspection Maps and Photolog for inspection conducted, July 20, 2021**

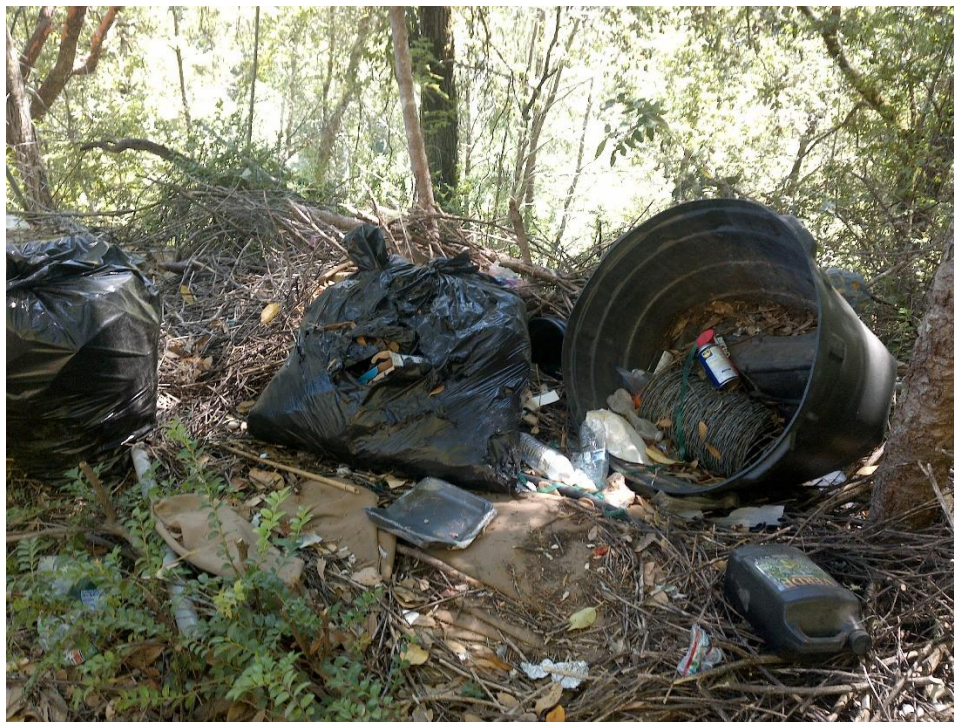
Photo 1—Looking east at cultivation waste located at WQ1. Waste is uncontained and perched above a steep hillside where it threatens to disperse offsite.

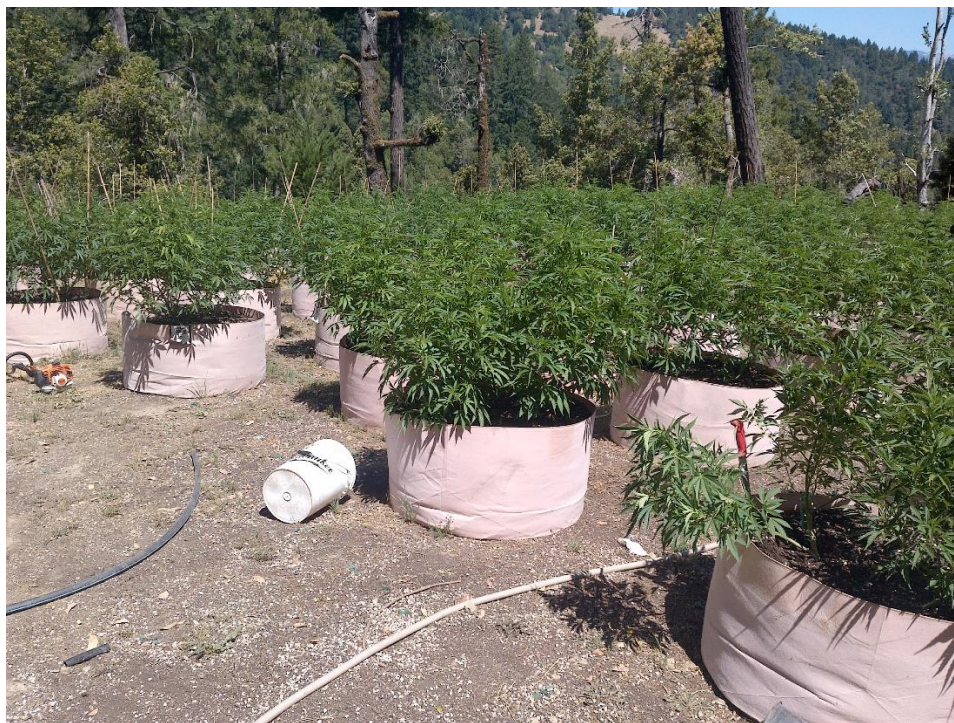
I accessed the property on foot from the south along a road west of Powers Creek. I observed an approximate 15,000 square foot disturbed area with outdoor cannabis cultivation north of WQ2 and east of WQ3. I observed waste cannabis stalks in a plant drying area at WQ4.

Photo 2—Outdoor cannabis cultivation in this vicinity of WQ2.

1. Prior to cultivating cannabis or developing the property for cannabis cultivation, obtain required authorizations.
2. Engage a qualified professional to develop and submit a work plan to correct the roads and crossings on the Property to conform with the Cannabis Policy.
3. Submit application for and obtain 401 WQC from Water Board before performing any instream work associated with Recommendation 2 above.

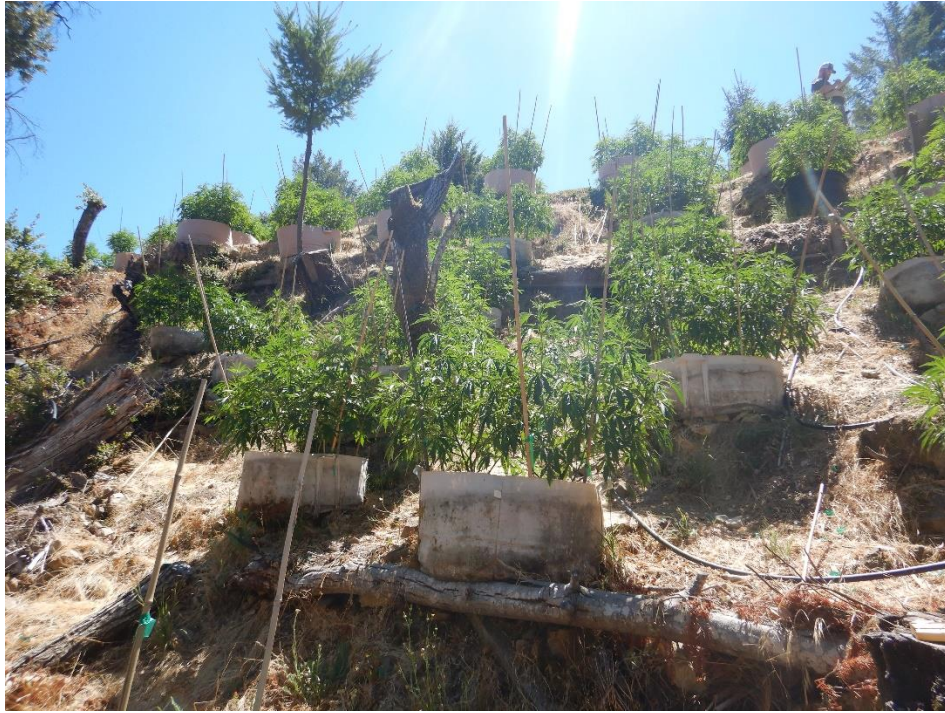
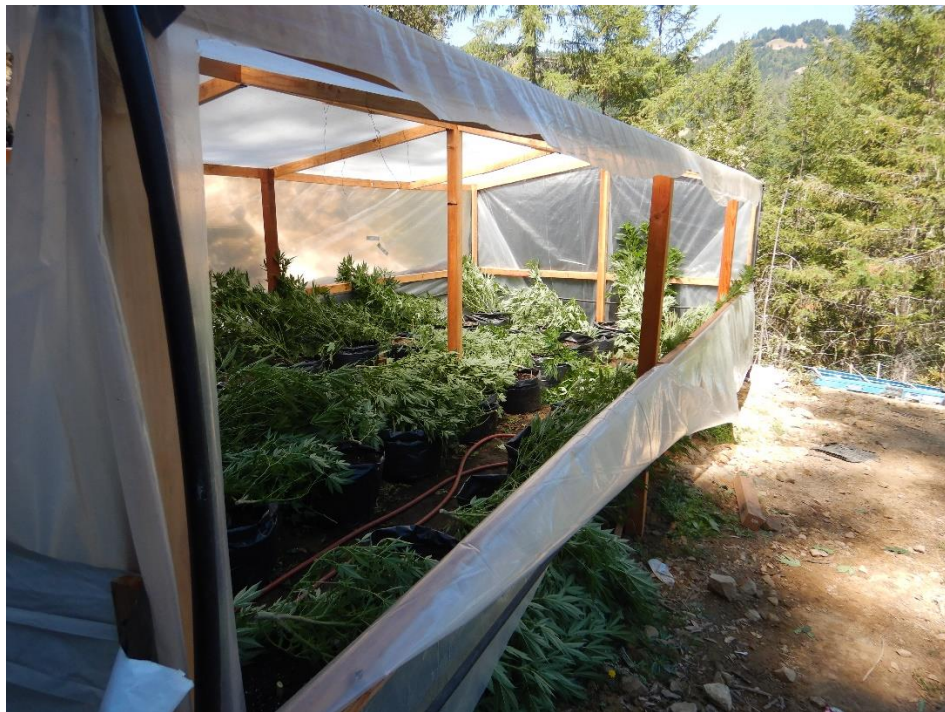
Photo 3—Outdoor cannabis cultivation in this vicinity of WQ3.

Photo 4—Outdoor cannabis cultivation in this vicinity of WQ3.

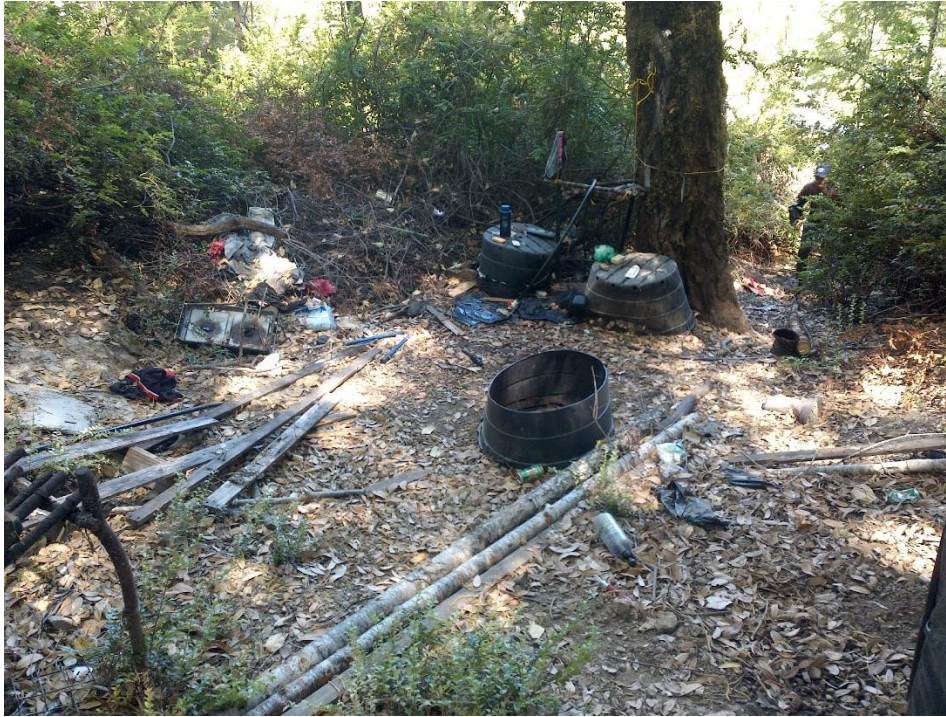
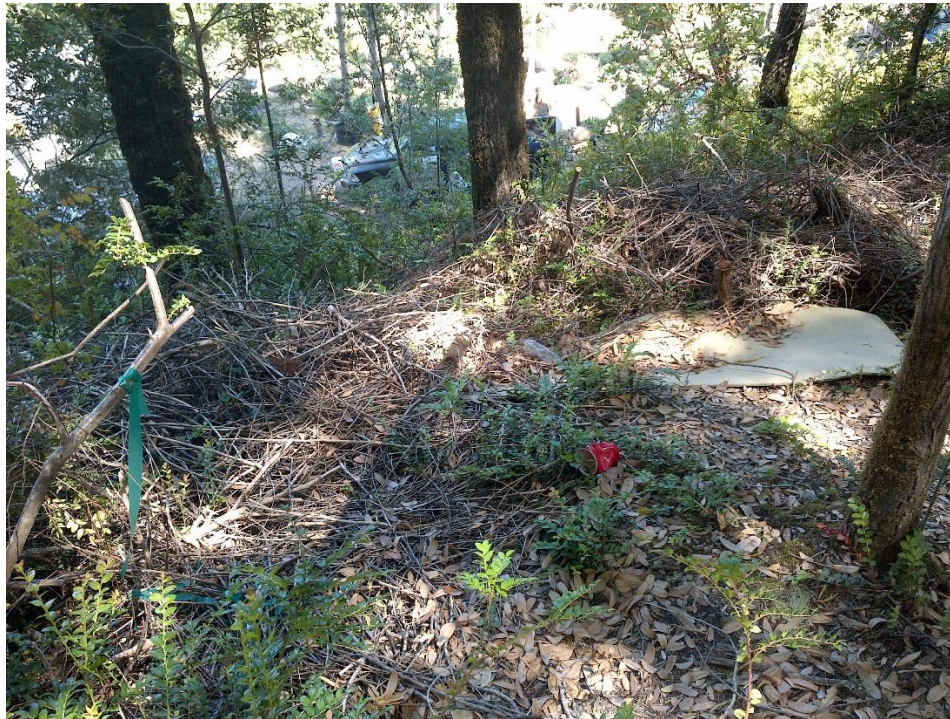
Photo 5—Cannabis cultivation waste in plant drying area located at WQ4.

Photo 6—Cannabis cultivation waste in plant drying area located at WQ4.

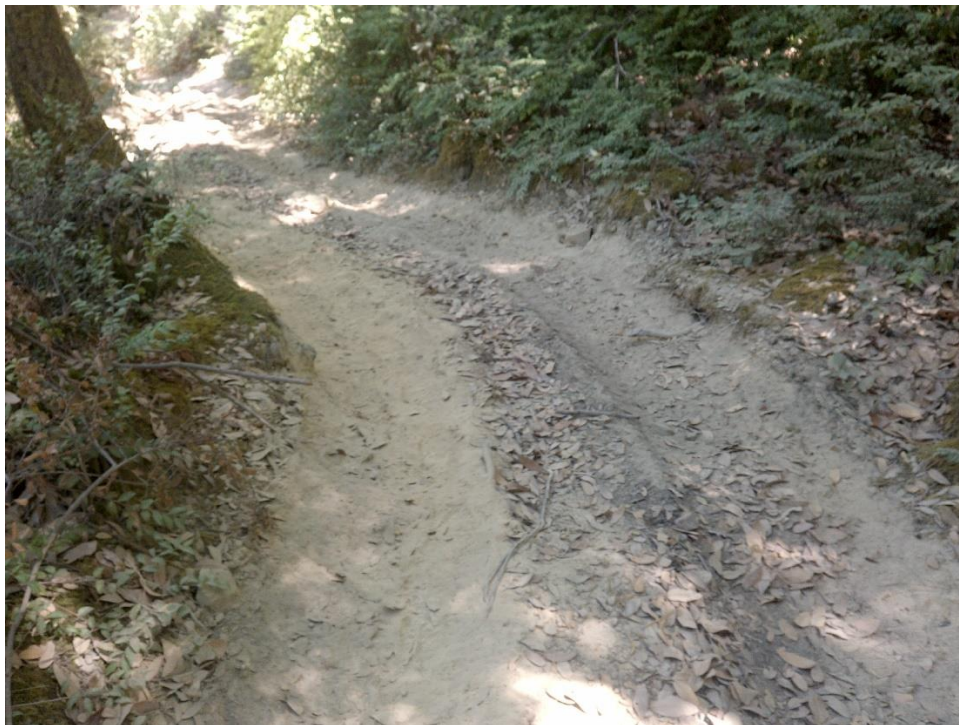
I walked along a dirt road north of WQ3 then west towards WQ5. The road leads west of the mapped parcel lines, but I am not aware of the actual parcel boundary. The road ends at a cannabis cultivation site at WQ6, and the only associated human habitation area is in the vicinity of WQ4, leading me to conclude that the two cultivations areas are part of the same operation and may be on the same Property. The dirt road was steep, unarmored and vulnerable to erosion from stormwater.

Photo 8— Road north of WQ3. The road is steep, rutted and lacks features to prevent stormwater from eroding the road surface.

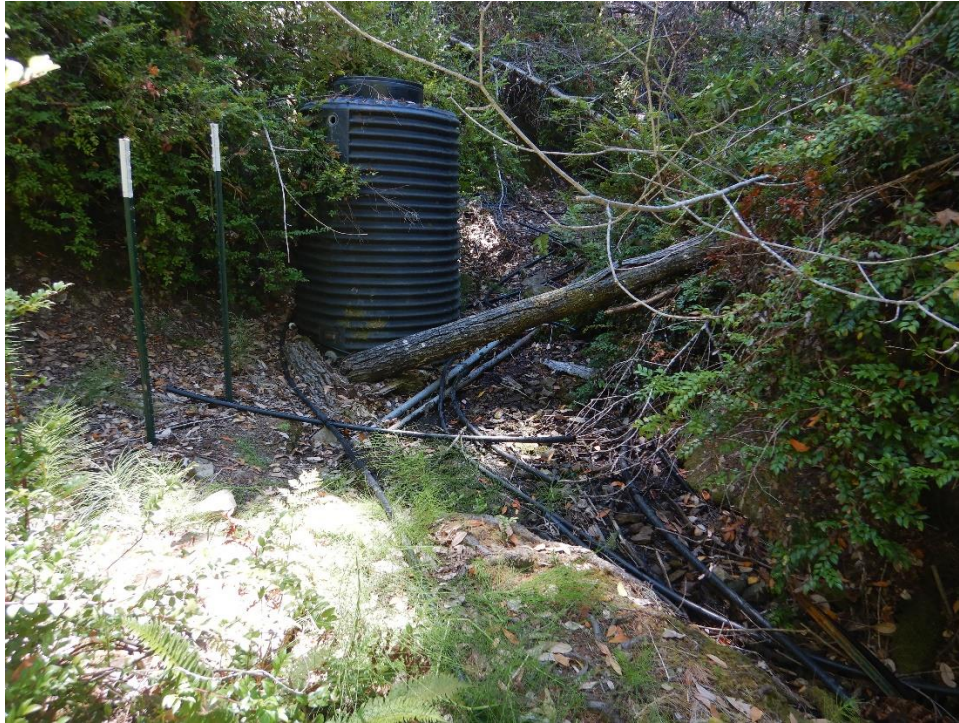
I observed a water tank and plastic pipes within the banks of a watercourse at WQ5 and observed that the watercourse was obstructed by the dirt road to the north. At WQ6, I observed an above ground pool with fertilizers, pesticides, petroleum products and other wastes uncontained on the bare ground where they threatened to discharge to Steelhead Creek to the north. At WQ 7, I observed abandoned bags of imported potting soil threatening to discharge to Steelhead Creek to the north.

Photo 9—Watercourse located at WQ5. Water tank is visible within the banks of the watercourse, and several black plastic pipes run along the channel.

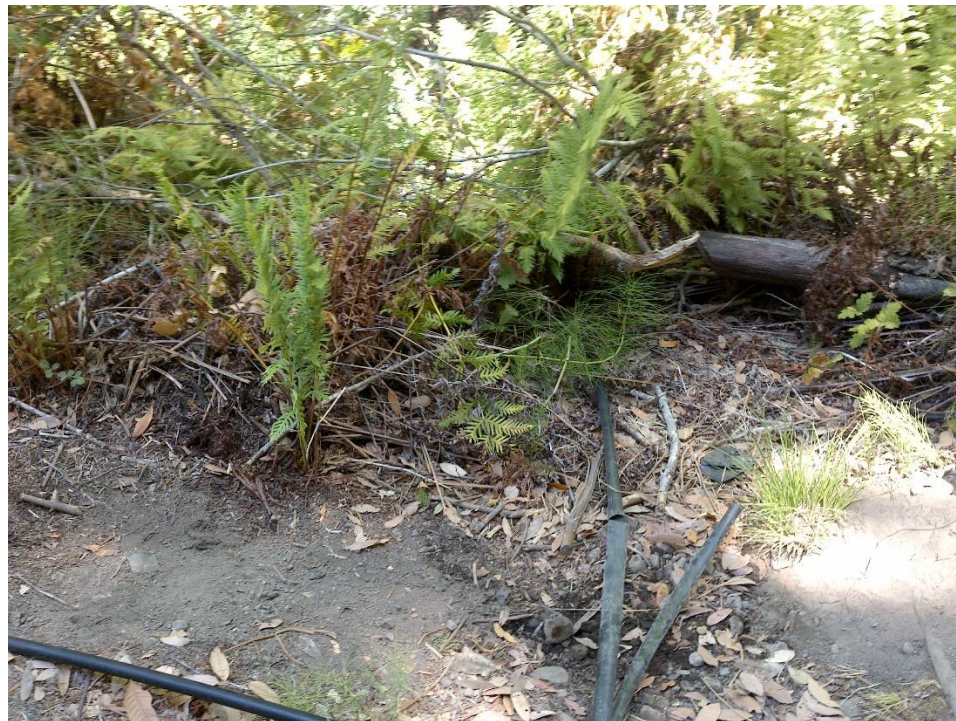
Photo 10—Watercourse in previous image crossing over the road surface north of WQ5.

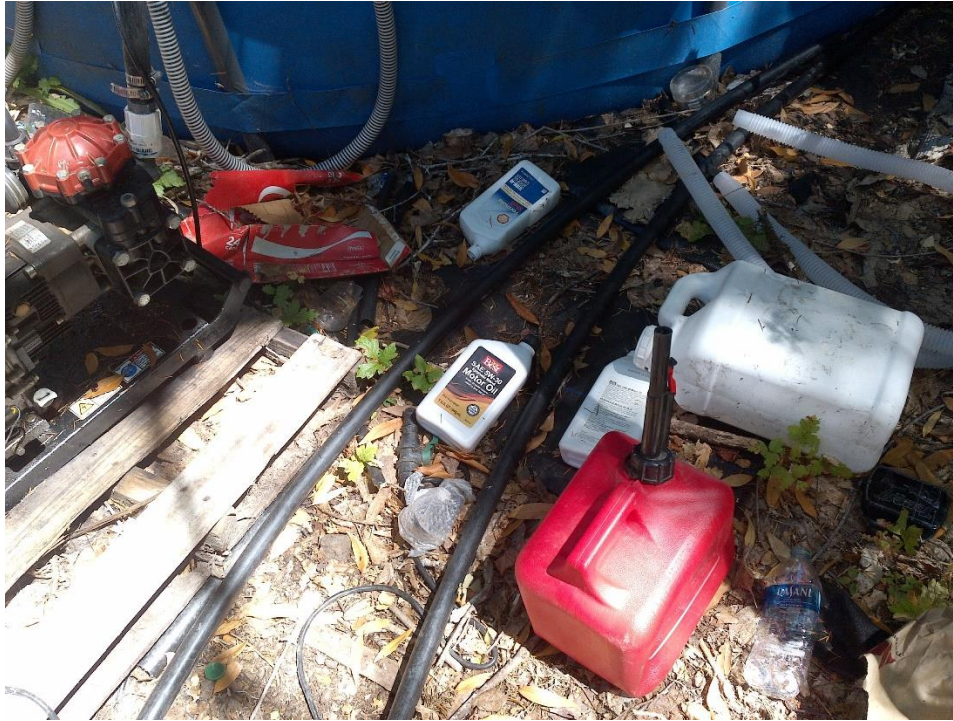
*Photo 11—Above ground pool located at WQ6, used to store water for cannabis cultivation to the west. Waste pesticides, petroleum products and fertilizer containers litter the ground surrounding the pool.*

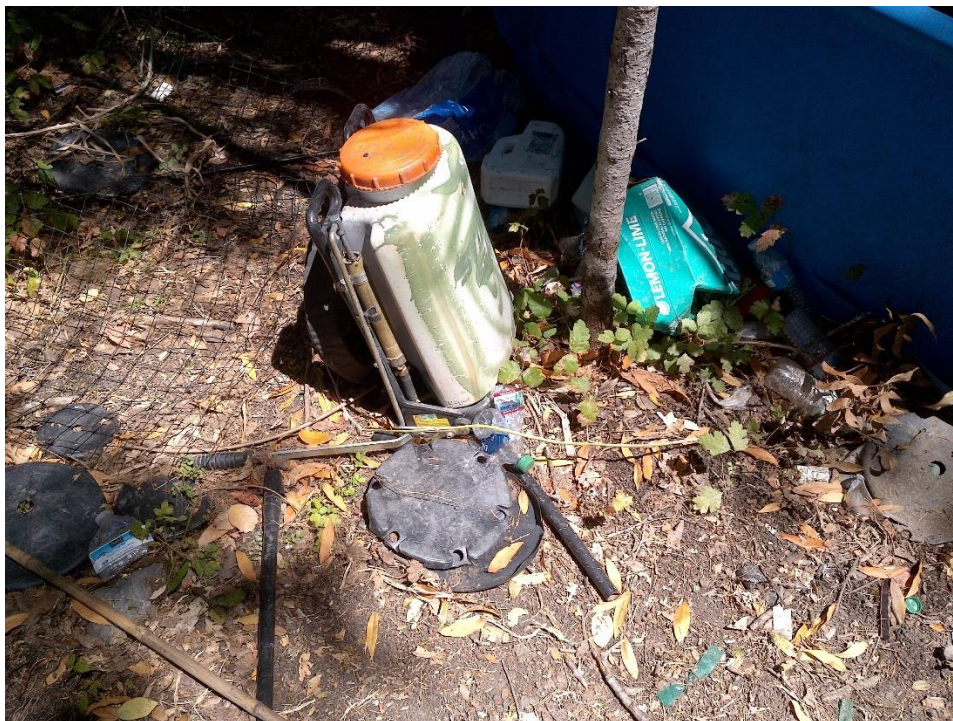
*Photo 12—Backpack sprayer with unknown contents adjacent to pool at WQ6.*

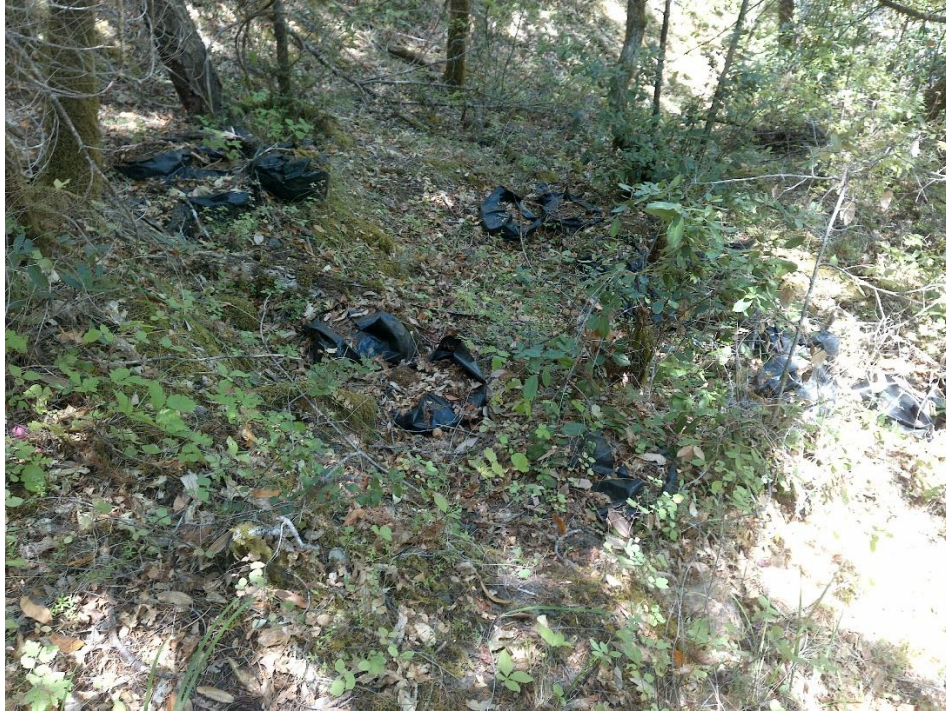
*Photo 13—Waste black plastic bags with imported potting soils abandoned at WQ7.*
