North Coast Regional Water Quality Control Board

Subject: Notice of Violation, Directive to Obtain Regulatory Coverage for Cannabis Cultivation, and Transmittal of Inspection Report for May 24, 2021 Inspection of Mendocino County Assessor's Parcels 108-192-11-00 and 108-191-11-00

FACILITIES INSPECTION REPORT

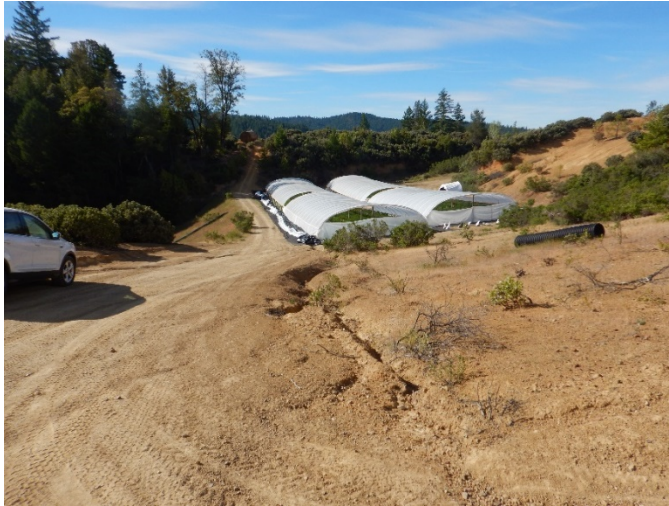
I observed a steep access road with a large rut leading to cultivation area 1. I observed a trench around the four hoop houses that discharges to a plastic culvert. The plastic culvert extends downhill, discharging road and irrigation runoff to a Class III watercourse. I observed a pile of spent grow bags at inactive cultivation area 2. At cultivation area 3, on a conservation easement, I observed stems with green plastic pieces thrown over a fence, and cannabis plants in grow bags.

Photo 1 - Cultivation Area 1: Rut on steep dirt access road to four hoop houses

3. Improve access road alignment, surfacing, and drainage to minimize erosion and sediment transport. Remove culvert that is directing irrigation and road runoff into the Class III watercourse. Do not discharge irrigation runoff or road runoff to surface waters.

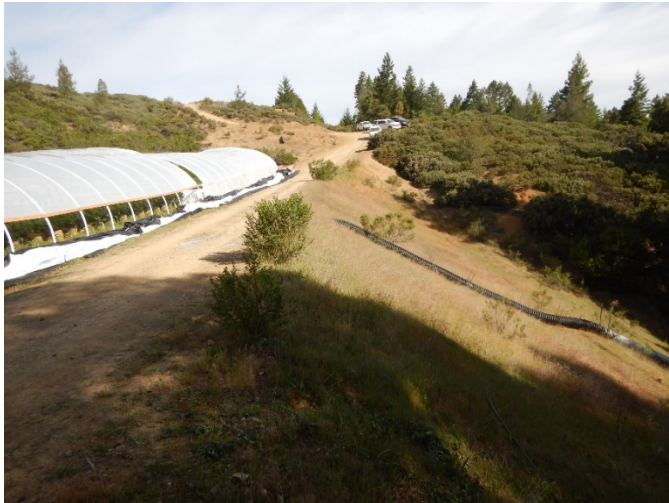
Photo 2 - Cultivation Area 1: Culvert directs irrigation and road runoff downhill

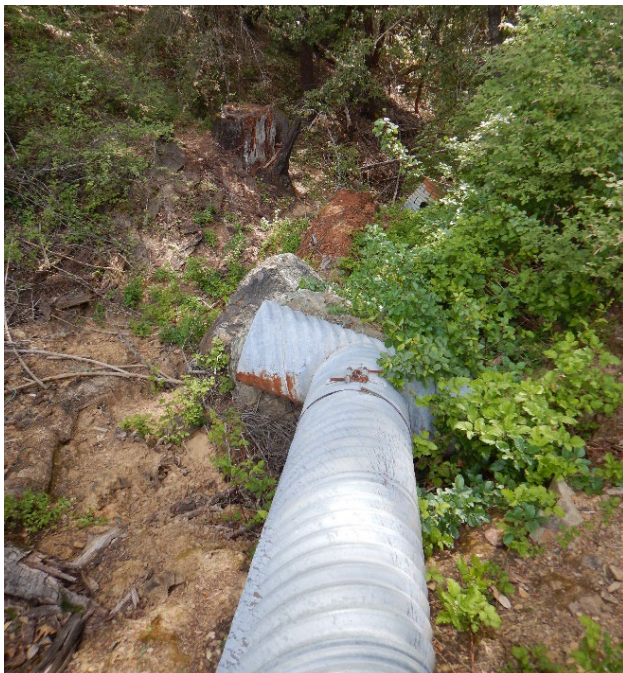
Photo 3 - Cultivation Area 1: Culvert discharges to head of Class III watercourse. Fine sediment is visible around the culvert outlet

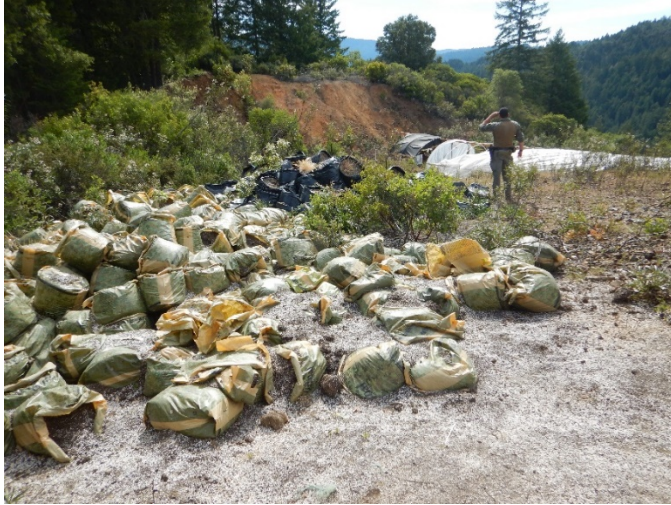
Photo 4 – Cultivation Area 2: Spilt, used grow bags with hoop house in background

2. Contain and properly dispose of excess soil and trash associated with cannabis cultivation activities to prevent discharge to waters of the state. Use erosion control techniques, as needed, for any reused or stored spent growth medium to prevent polluted runoff.

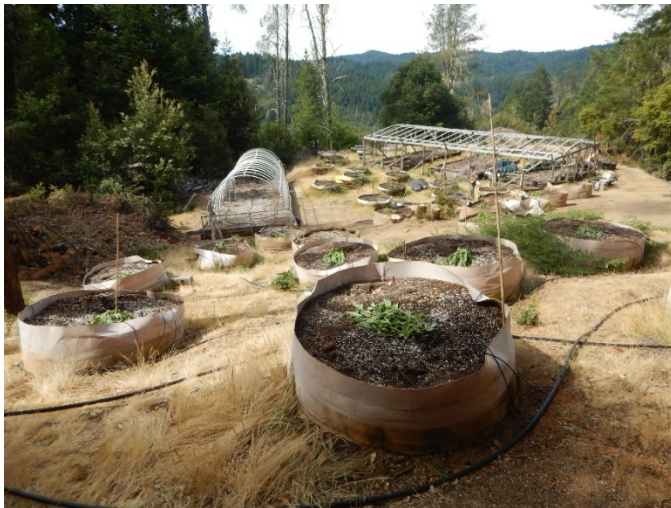
Photo 5 – Cultivation Area 3: Hoop houses and grow bags
