Subject: Notice of Violation, Directive to Obtain Regulatory Coverage for Cannabis Cultivation, and Transmittal of Inspection Report for July 8, 2021 Inspection of Mendocino County Assessor's Parcels 154-150-12-00 and 154-150-13-00

FACILITIES INSPECTION REPORT

Grazing Land Conservancy July 8, 2021 Inspection Photo Log
Photos Taken by Kate Hawken

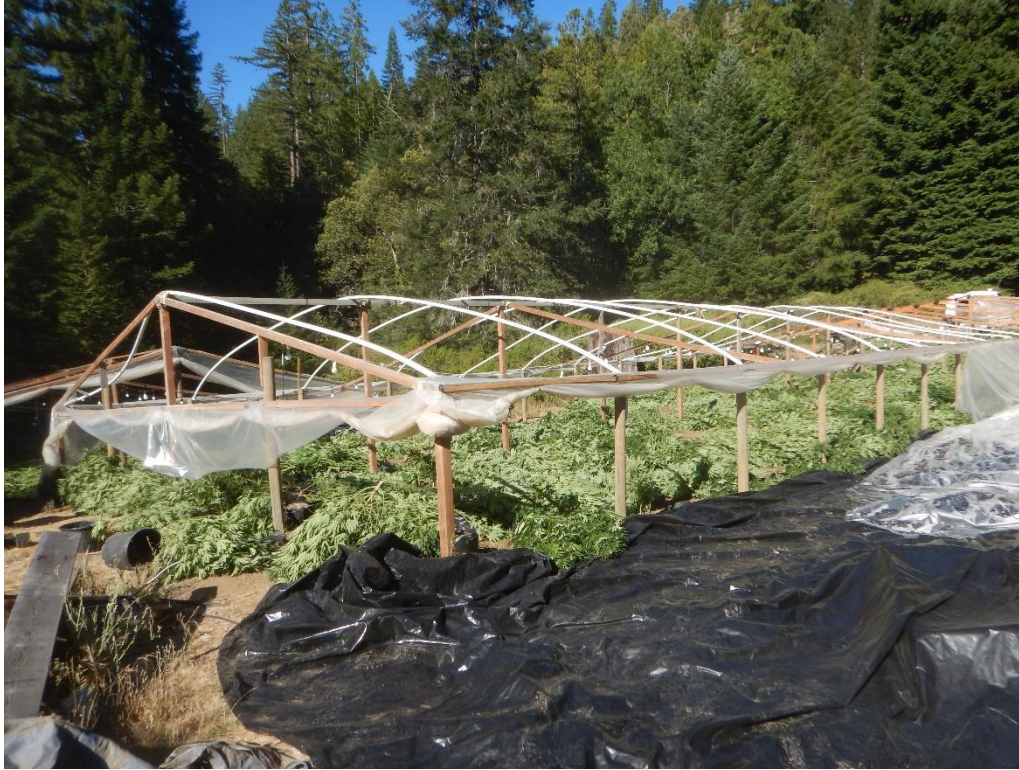
On parcel 154-150-12-00, I observed an outdoor cultivation area with multiple hoop houses full of cannabis plants in pots (Photo 1). Throughout the cultivation area, I observed fertilizer containers, mixing tanks, and cannabis plant waste. I observed one water storage tank, pump, fuel can, and generator located near the head of a Class III watercourse (Photo 2).

Photo 1:
Lower
outdoor
cultivation
area with
cannabis
plants in pots

1. If the property owner and/or tenant(s) plan to continue cultivating cannabis on the Property, enroll for coverage under the State Water Board’s Order WQ 2019-0001-DWQ, General Waste Discharge Requirements and Waiver of Waste Discharge Requirements for Discharges of Waste Associated with Cannabis Cultivation Activities here: <https://public2.waterboards.ca.gov/cgo>

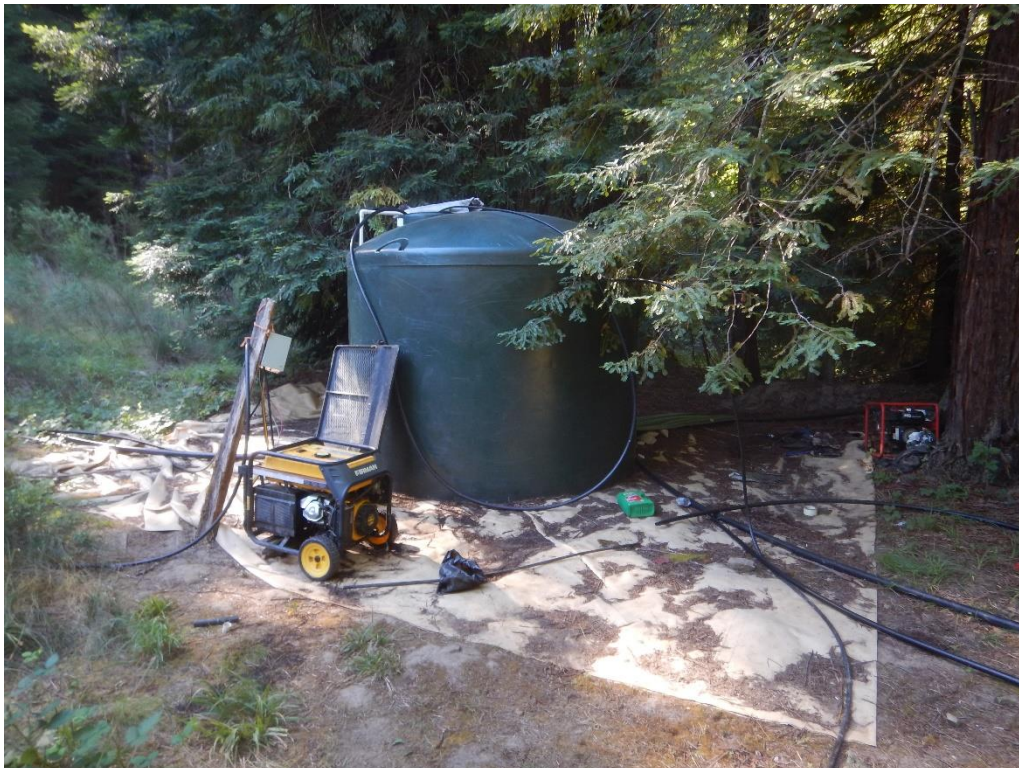
Photo 2:
Tank, pump,
and generator
near head of
Class III
watercourse

3. Relocate the tank, pump, generator, and fuel container at the lower cultivation area at least 50 feet away from the Class III watercourse.
4. Store and contain all potting soil, cultivation-related waste, and chemicals, including pesticides and petroleum products, properly to prevent spillage and potential for migration/transport into receiving waters. Storage areas shall comply with the riparian setbacks and have secondary containment as necessary.

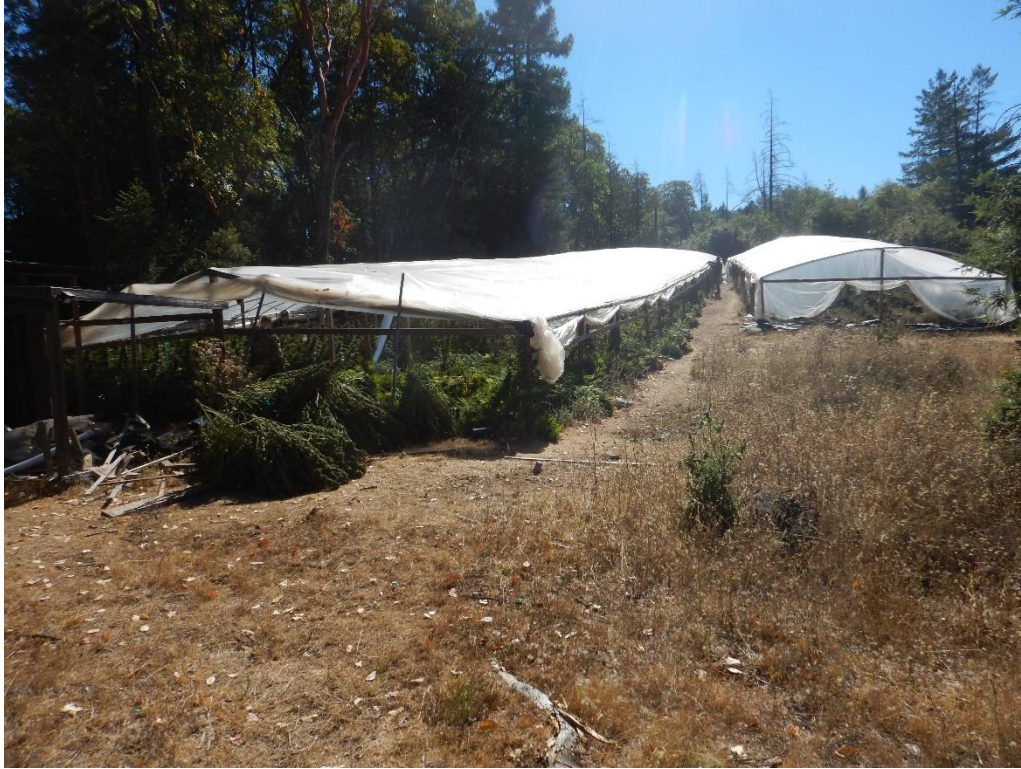
On parcel 154-150-13-00, I observed another outdoor cannabis cultivation area with multiple hoop houses (Photo 3). This cultivation area was located on the top of a ridge. The dirt access road up to the cultivation area had rill erosion (Photo 4). Continuing along the access road to the east I observed a pond receiving flow from a watercourse (Photo 5). The pond had an outlet culvert high in the berm. I observed an eroded channel below the pond outlet, that eventually connected to a roadside ditch (Photo 6). The roadside ditch continued off the parcel boundary to the east.

Photo 3:
Upper
outdoor
cannabis
cultivation
area on top of
ridge

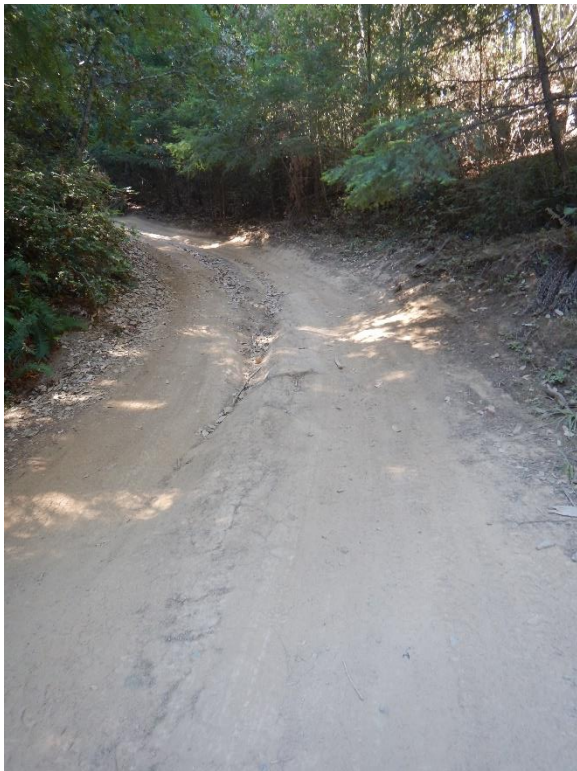
Photo 4: Access road with surface erosion

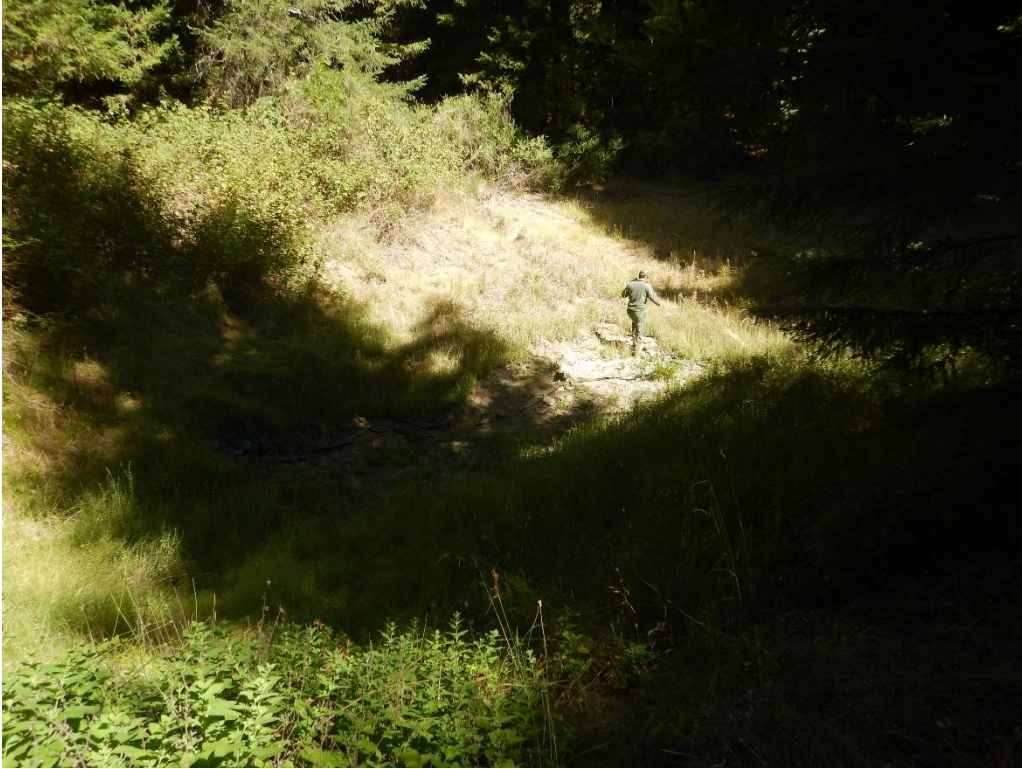
Photo 5:
Onstream
pond

2. Retain a licensed professional to assess the pond and restore the watercourse channel and riparian areas as necessary. Work with the California Department of Fish and Wildlife and the State Water Board Division of Water Rights on permitting options for the instream impoundment.

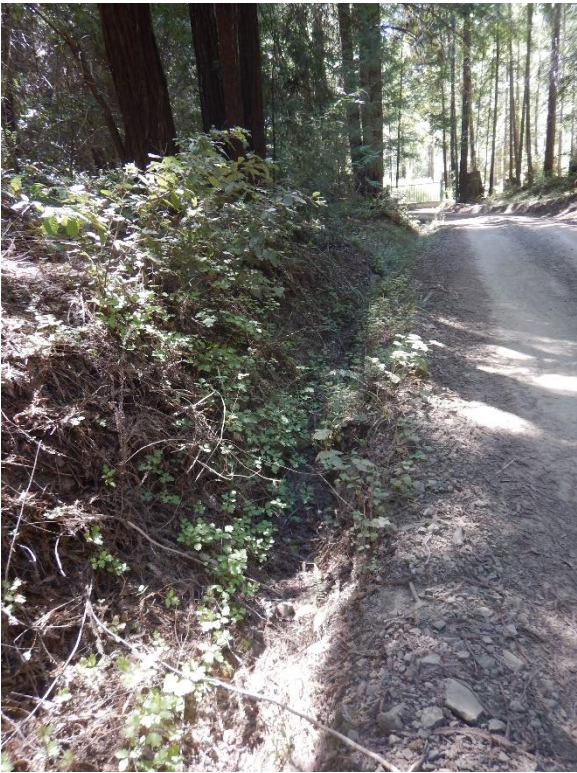
Photo 6: Diverted stream/
roadside ditch
