North Coast Regional Water Quality Control Board

Subject: Notice of Violation and Transmittal of Inspection Report for April 29, 2021 Inspection of Mendocino County Assessor's Parcel Number (APN) 031-020-29-01

FACILITIES INSPECTION REPORT

Inspection Maps and Photolog for inspection conducted April 29, 2021

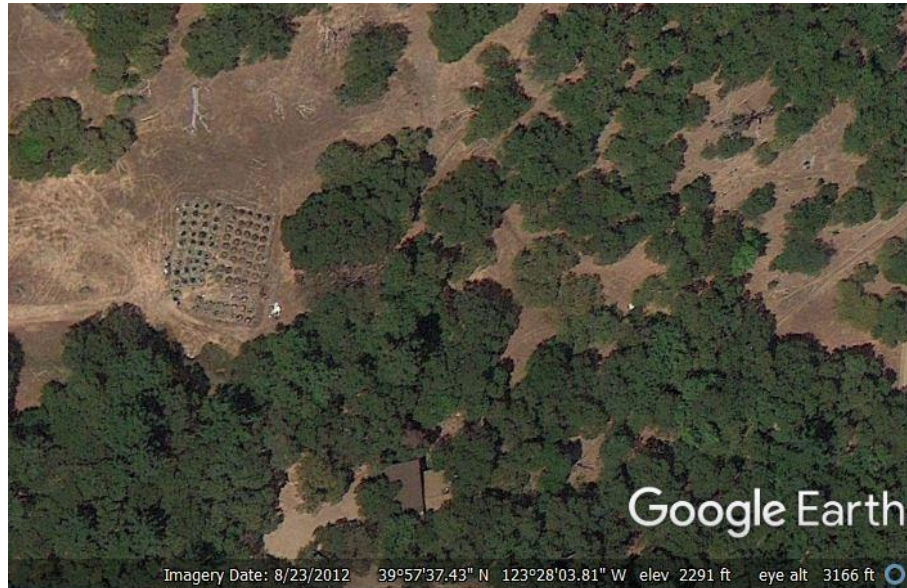
Aerial Image 1—Dated August 23, 2012 and accessed with Google Earth. The image shows the south western corner of the property. An outdoor cultivation area is visible in the left of the image and a house is visible in the bottom of the image.

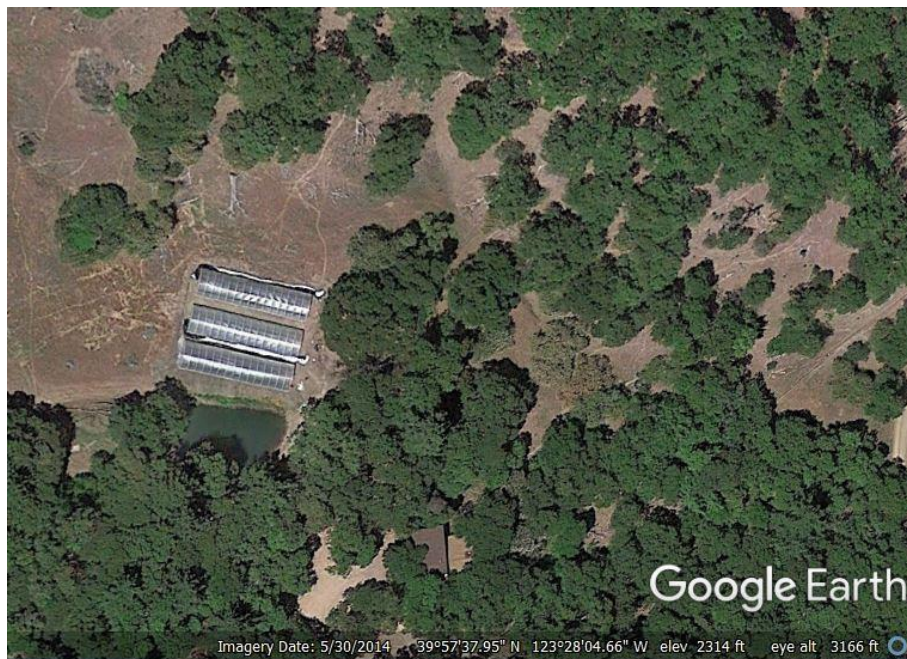
Aerial Image 2—Dated May 30, 2014 and accessed with Google Earth. The image shows the same area as pictured above. The outdoor cultivation area has been replaced with hoop-type greenhouses and a reservoir has been constructed below the cultivation area.

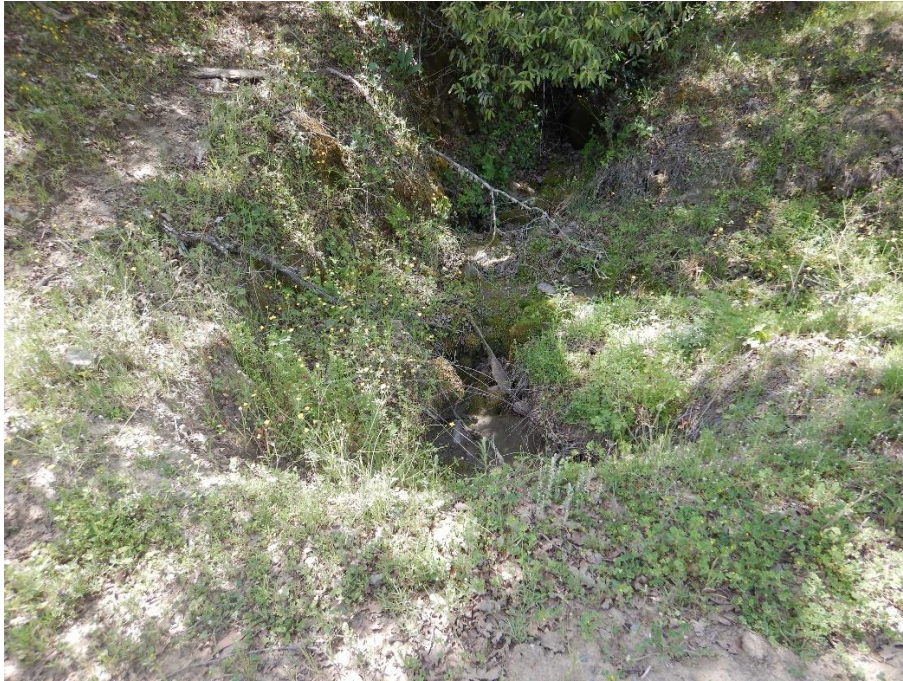
At WQ1, I observed an undersized and perched culverted watercourse crossing. I followed a steep and rutted road west to a cultivation area and observed a trailer encroaching on a watercourse at WQ2. I observed cultivation waste within the banks of the watercourse at WQ2. I walked north to another cultivation area at WQ3. I observed an intermittent watercourse passing along the southwestern edge of the cultivation area and another watercourse, with more clearly defined banks, passing along the northeastern edge of the cultivation pad. I observed a gully eroding into the fill on the southeastern edge of the cultivation pad and a swale connecting the gully to the watercourse leading to WQ1.

Photo 1—Looking west at watercourse upstream from culvert crossing at WQ1. Staff estimated that the active channel is four-feet wide. A roadside ditch discharges to the culvert inlet from the road to the north as well.

1. Enroll in the Cannabis General Order, address the water quality-related impacts from recent development & ensure future development and uses for cannabis are in conformance with current regulations.
2. Engage a qualified professional to develop and submit a work plan to address the threatened and actual discharges of waste associated with cannabis operations on the property.
3. Submit application for and obtain 401 WQC from Water Board before performing any instream work.

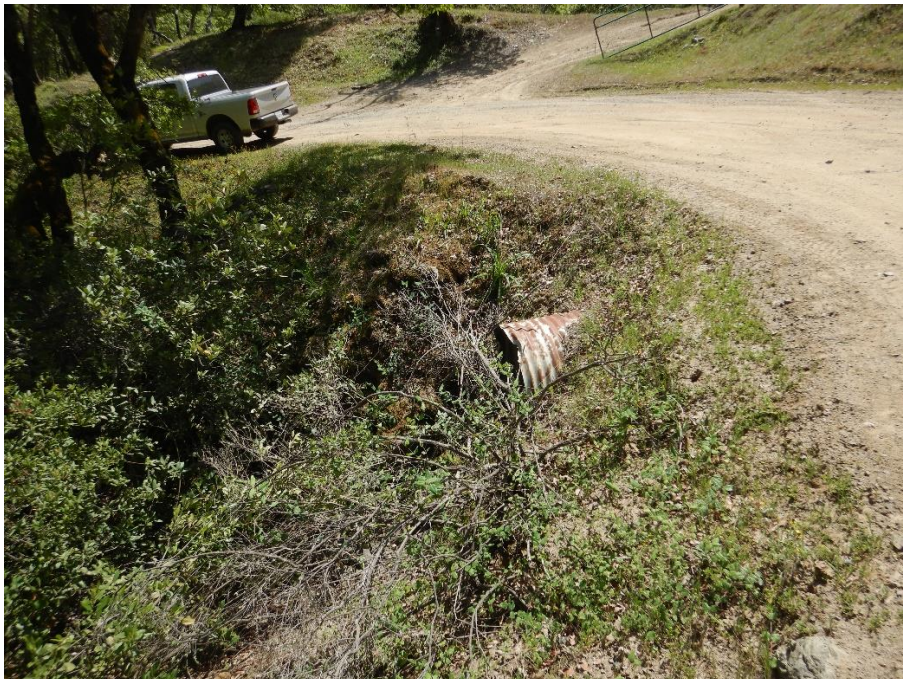
Photo 2— Looking south at 28-inch diameter culvert outlet located at WQ1.

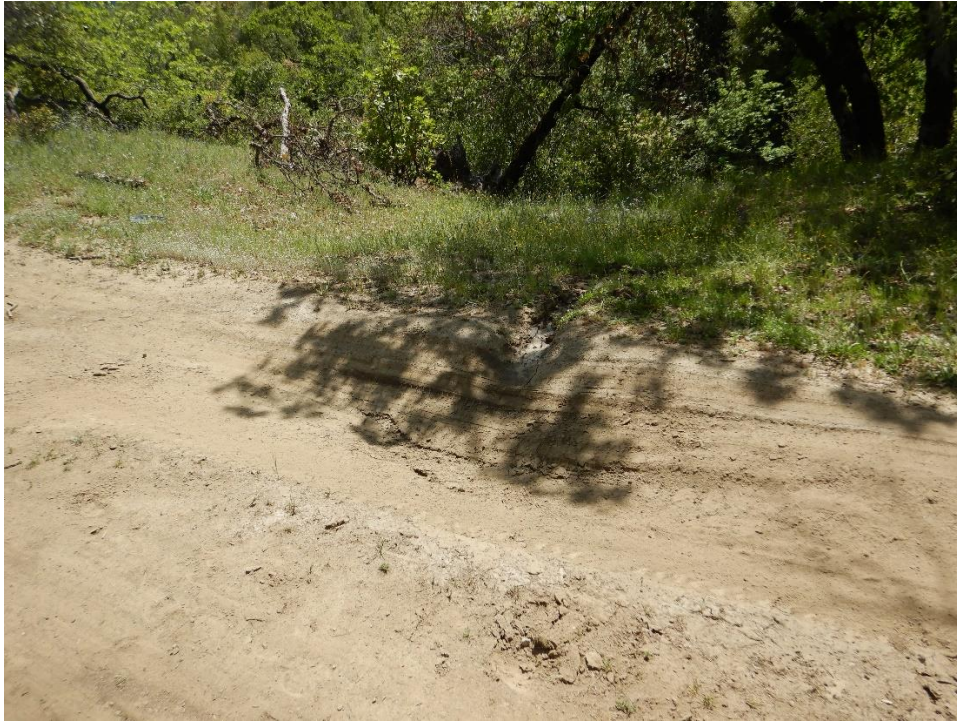
Photo 3—Looking north at scour marks on the edge of road west of WQ1. The watercourse leading to WQ1 is out of view in the background of the image.

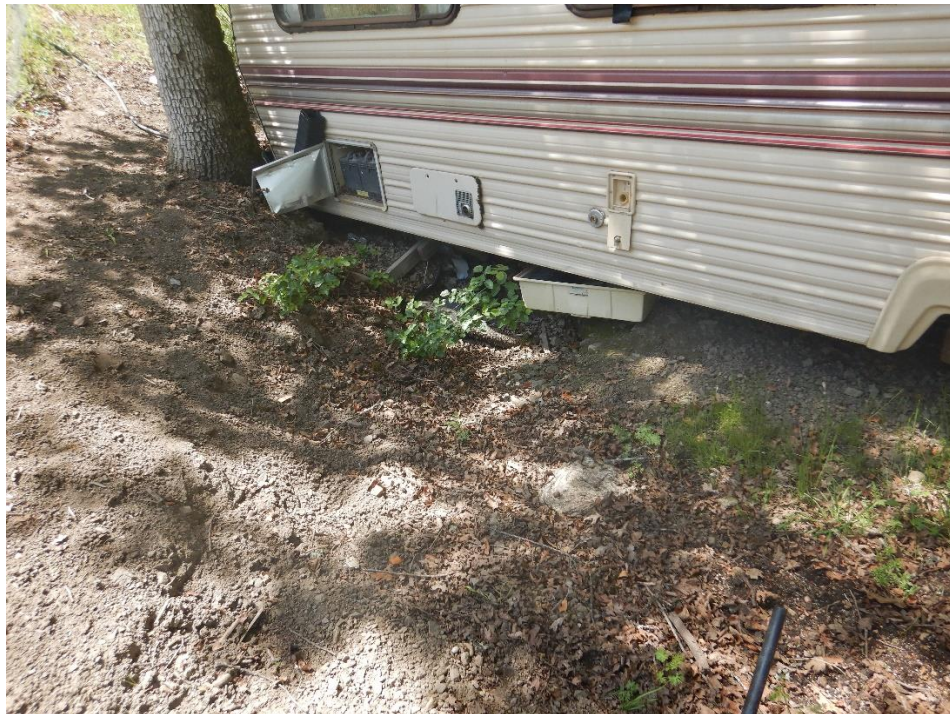
Photo 4—Looking west at trailer parked on top of a watercourse at WQ2.

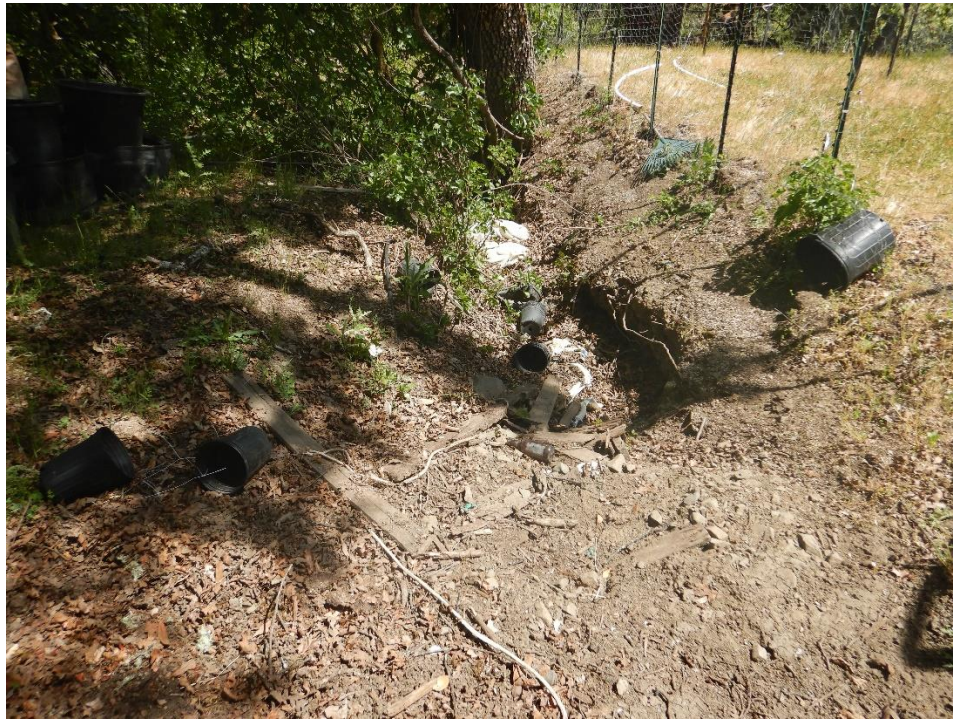
Photo 5—Looking east and downstream from same photo location as previous image. Cultivation waste including soil bags and pots are visible within the channel banks.

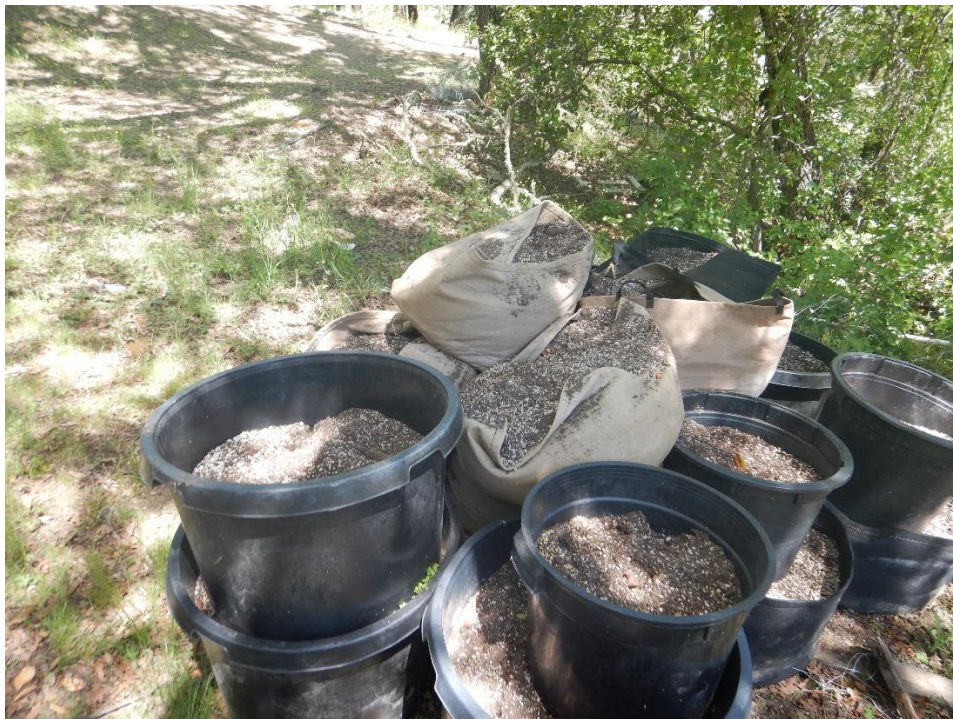
Photo 6—Looking east at pots filled with imported potting soils at WQ2. Watercourse pictured in previous photo is out of view to the right of the image.

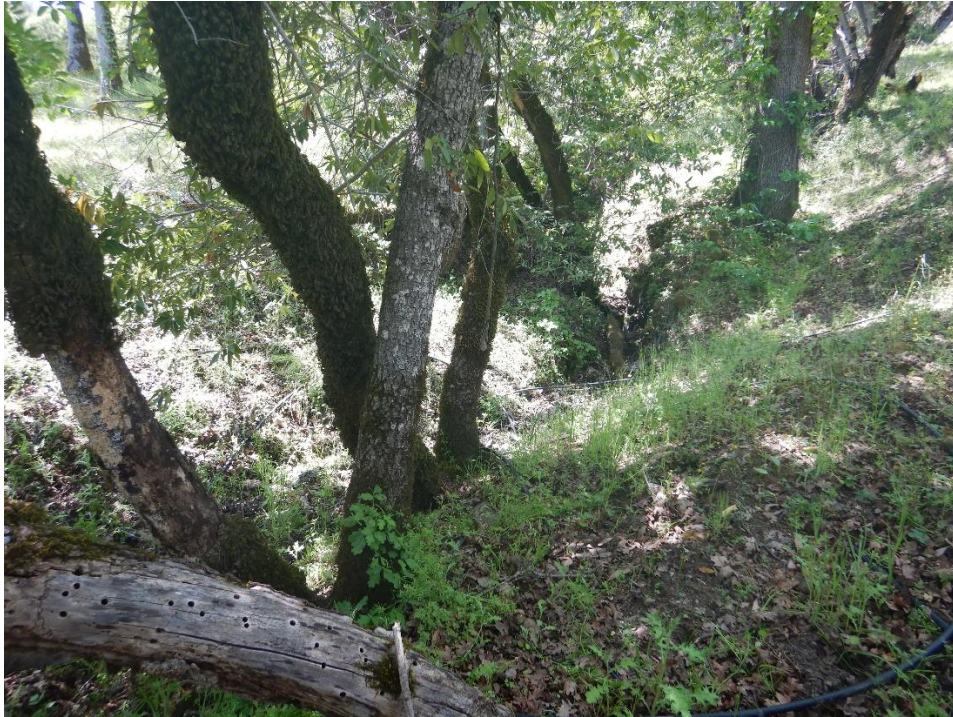
Photo 7—Looking west at watercourse upstream from WQ2.

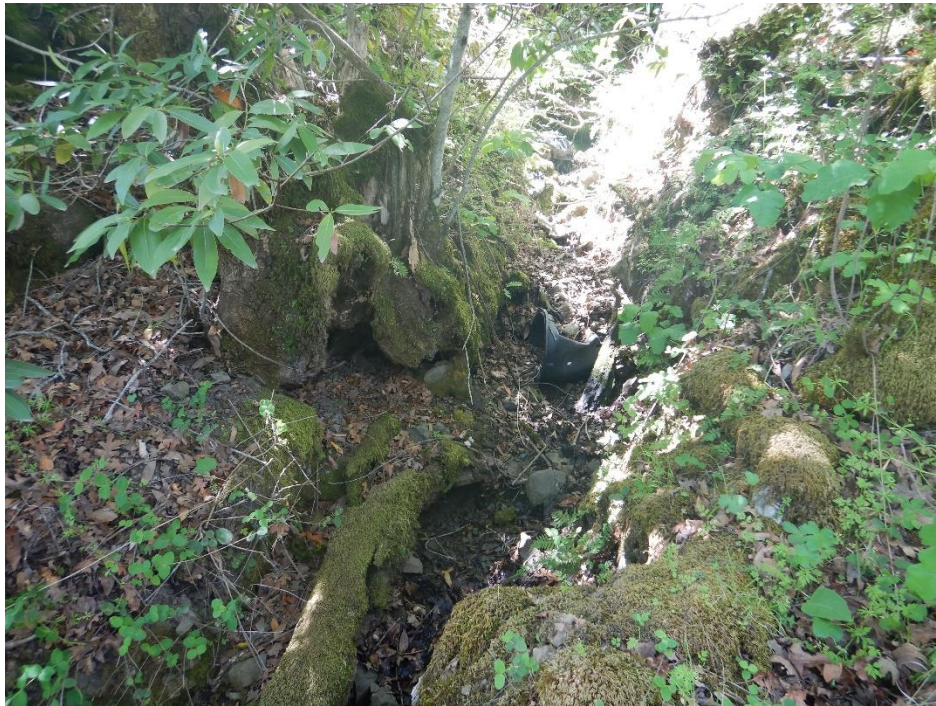
Photo 8—Looking west at watercourse upstream from WQ2. A plant pot is visible within the channel banks in the middle of the image.

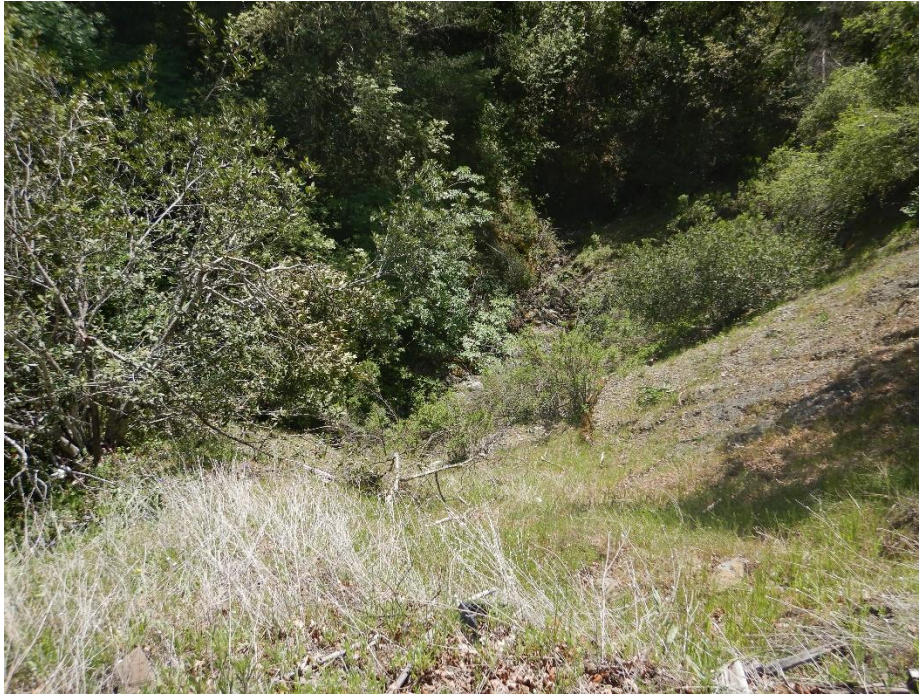
Photo 9—Looking south towards a blue-line stream tributary to the Eel River.

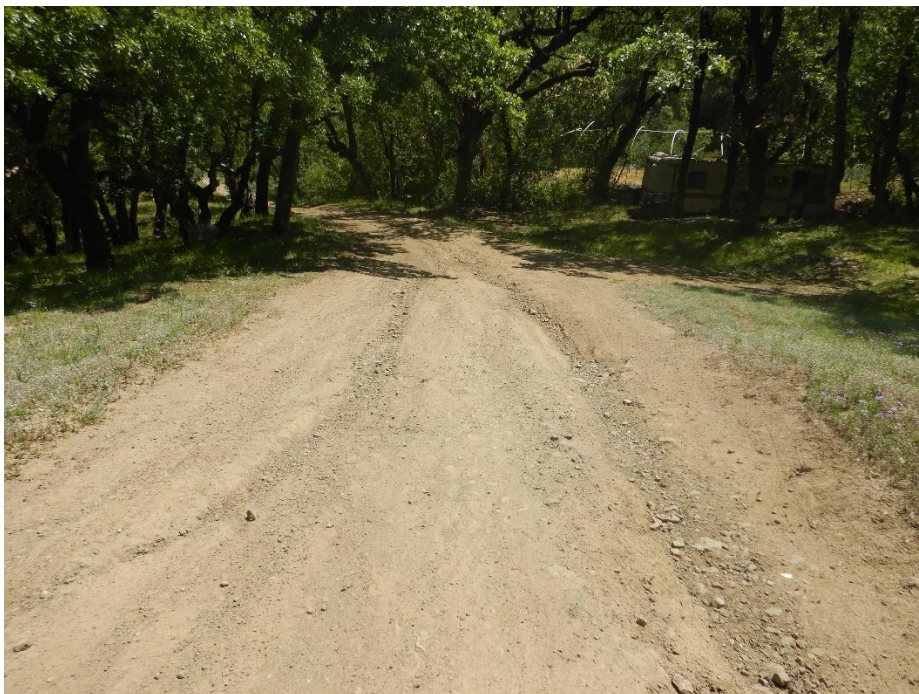
Photo 10—Looking south along a rutted road. Trailer at WQ2 is in the back right of the image.

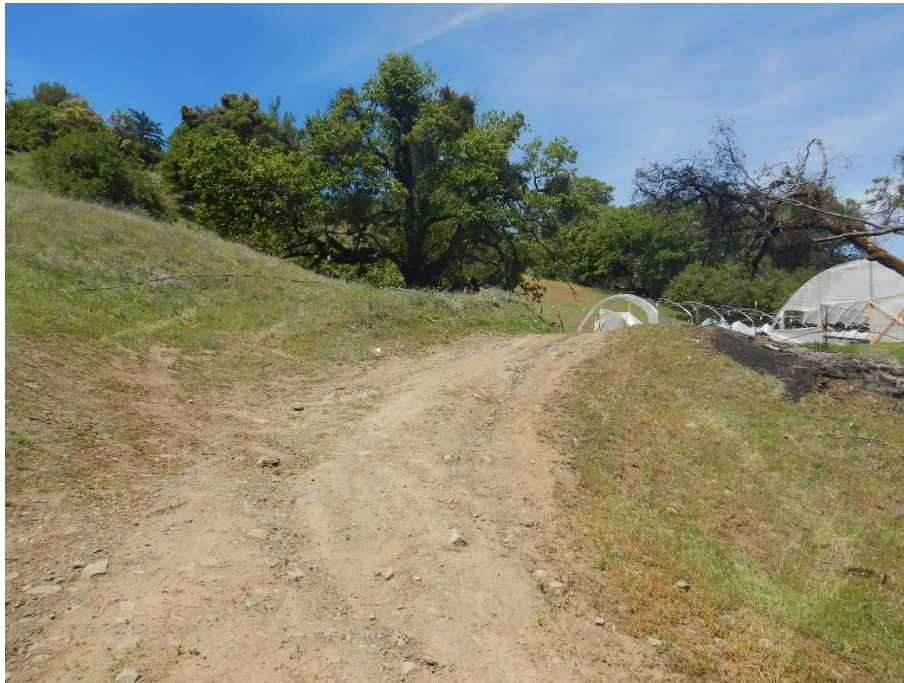
Photo 11—Looking north toward cultivation area at WQ3 from the same photo location as the previous image. The large oak tree in the top middle of the image is pictured in the following photo.

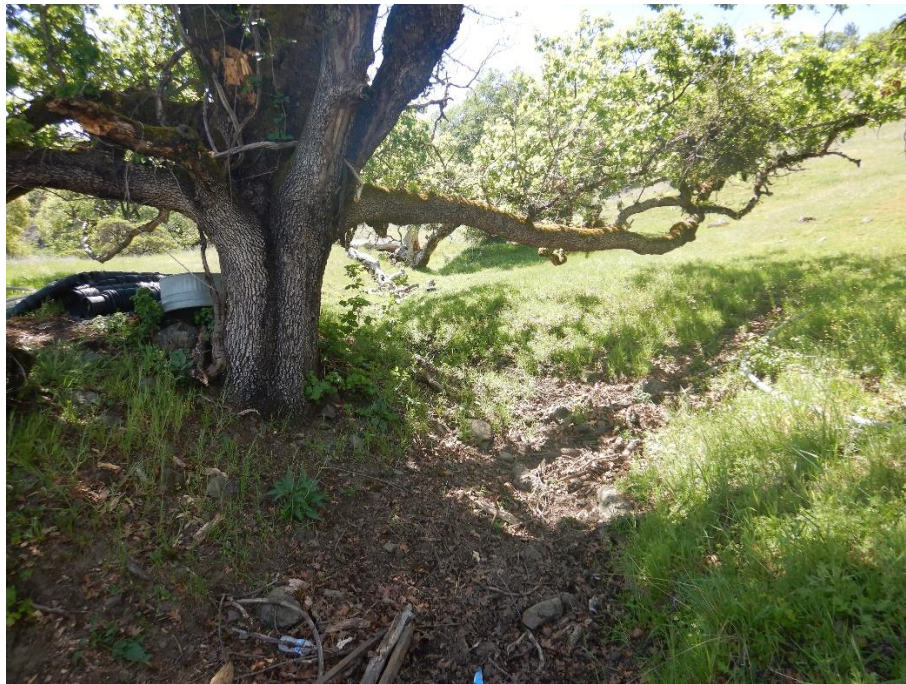
Photo 12—Looking northwest at intermittent watercourse upslope from WQ3.

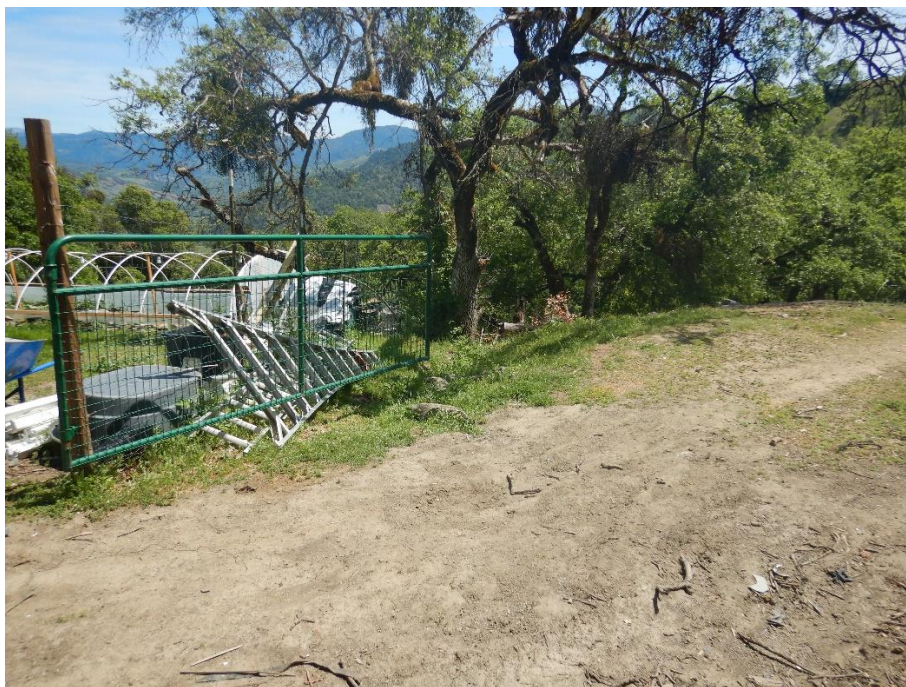
Photo 13— Looking southeast from the same location as the previous image. An intermittent watercourse is visible next to the tree in the top middle of the image.

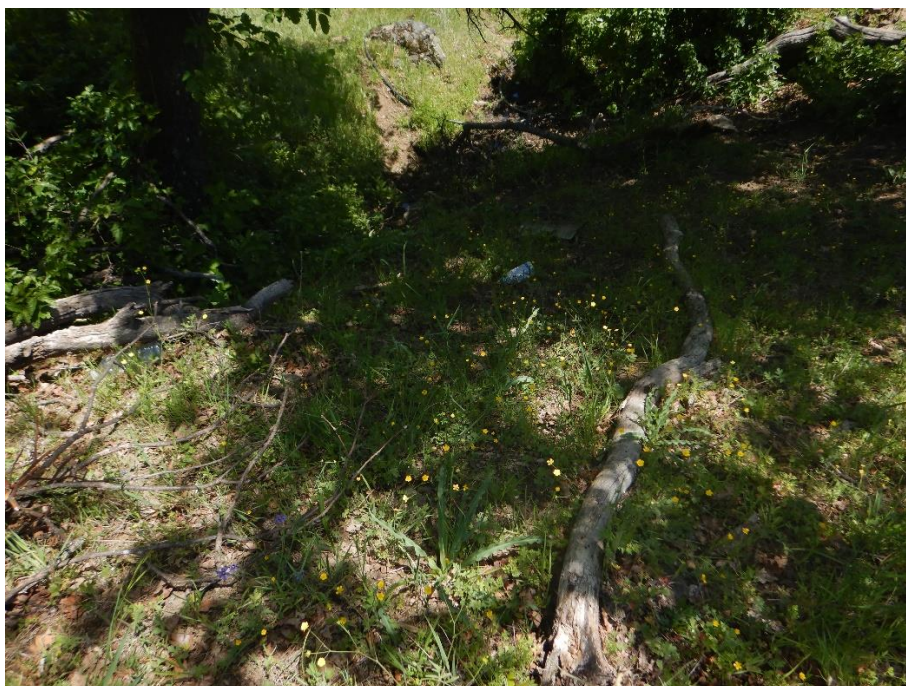
Photo 14— Looking southeast and downslope from the previous image. The intermittent watercourse has more clearly defined banks than upstream. The channel continues east to WQ1.

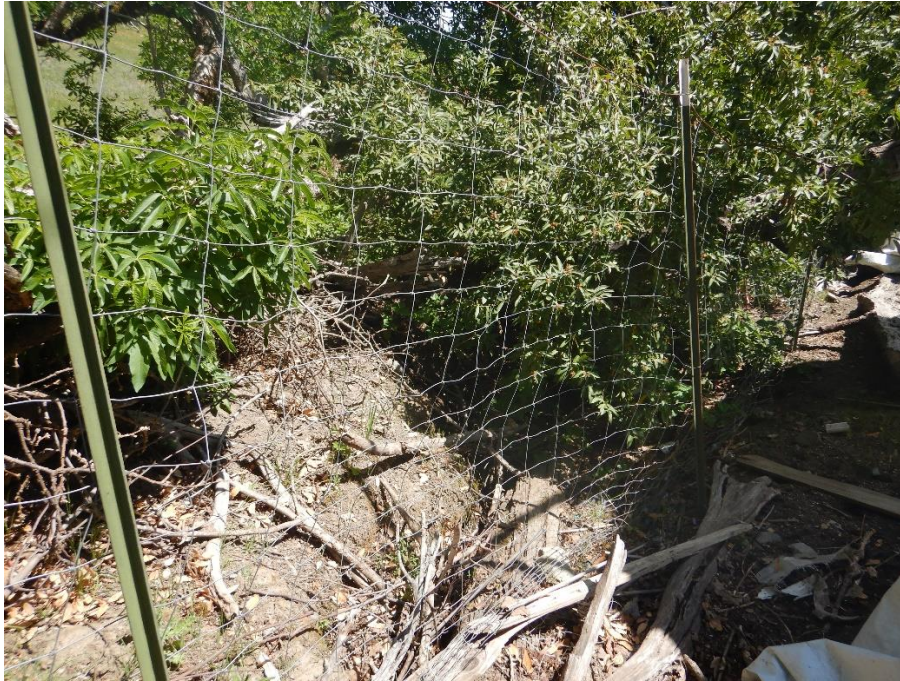
Photo 15—Looking northeast through fence at the northeastern edge of cultivation area located at WQ3. Piles of earth and slash are perched above watercourse obscured by shadows in the background of the image.

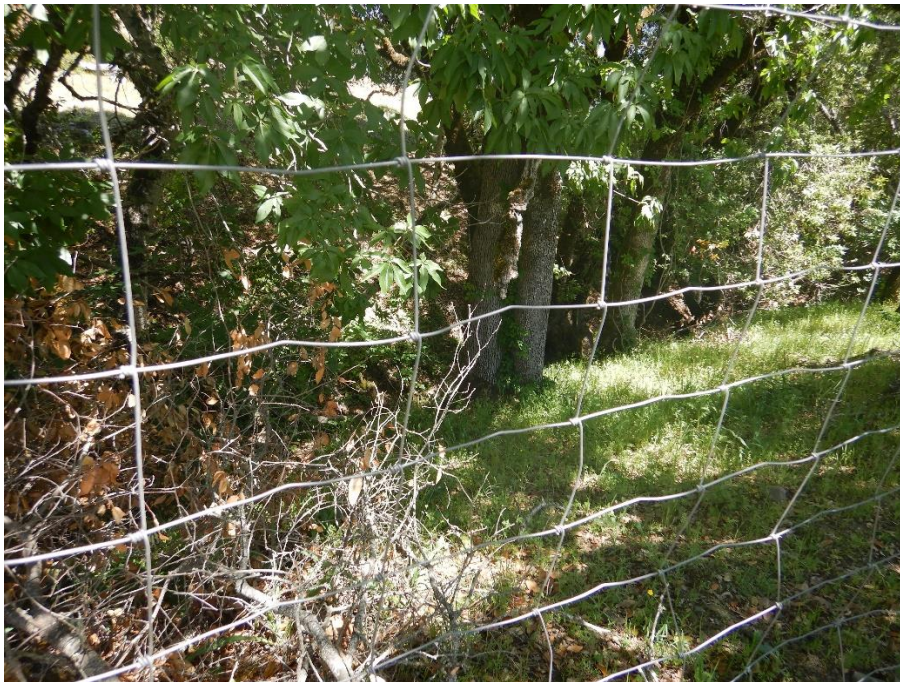
Photo 16— Looking northeast through fence, farther downslope from area pictured in previous photo. A dry watercourse, obscured by shadows, follows a line of riparian trees in the middle of the image.

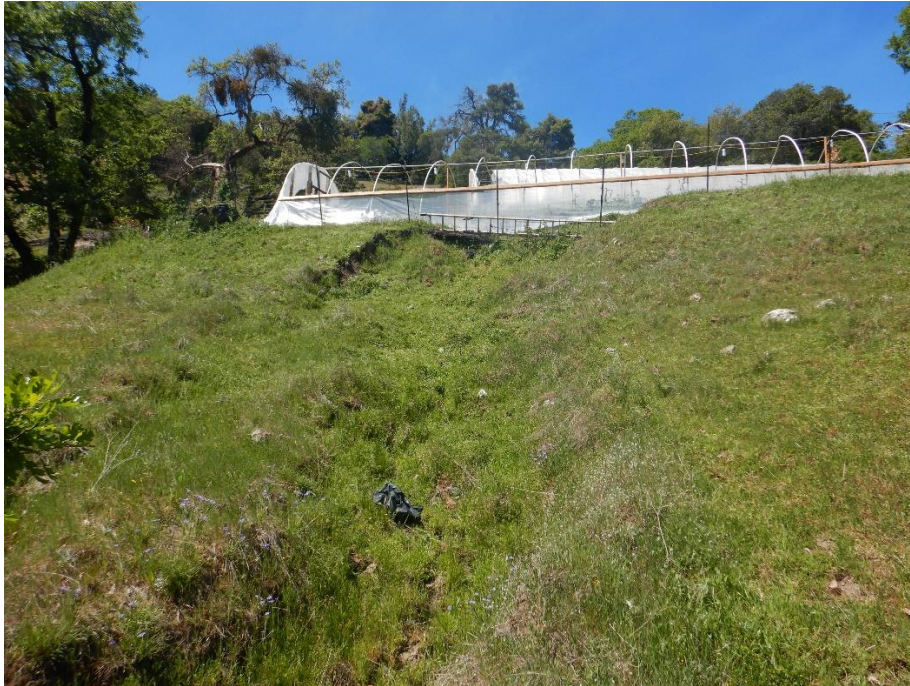
Photo 17—Looking northwest at eroded gully extending into the edge of the cultivation pad.

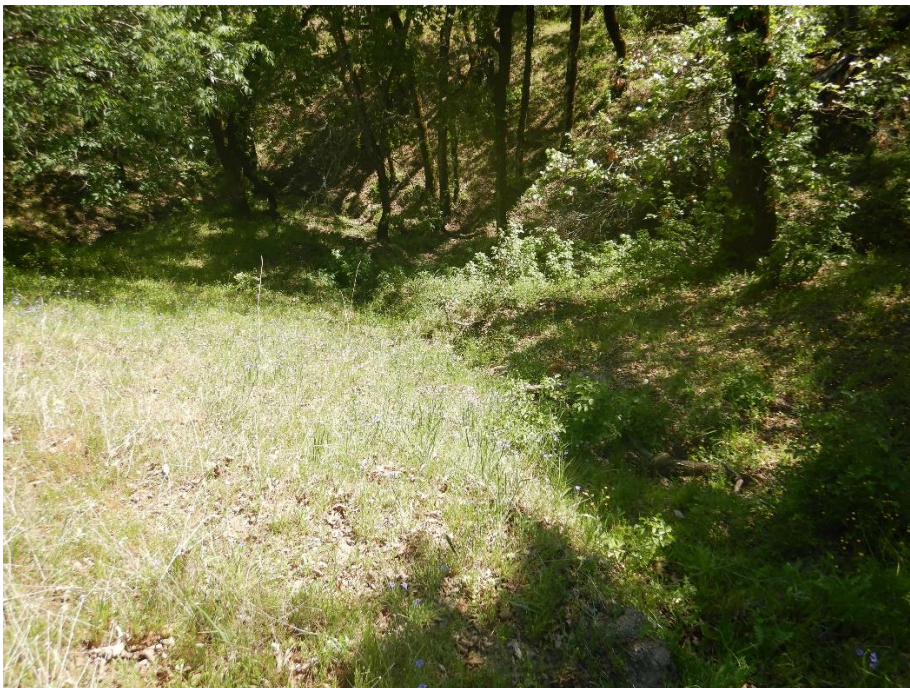
Photo 18—Looking south along swale/watercourse connecting gully in previous photo to watercourse partly obscured by tree shadows in the background of the image which flows toward WQ1.

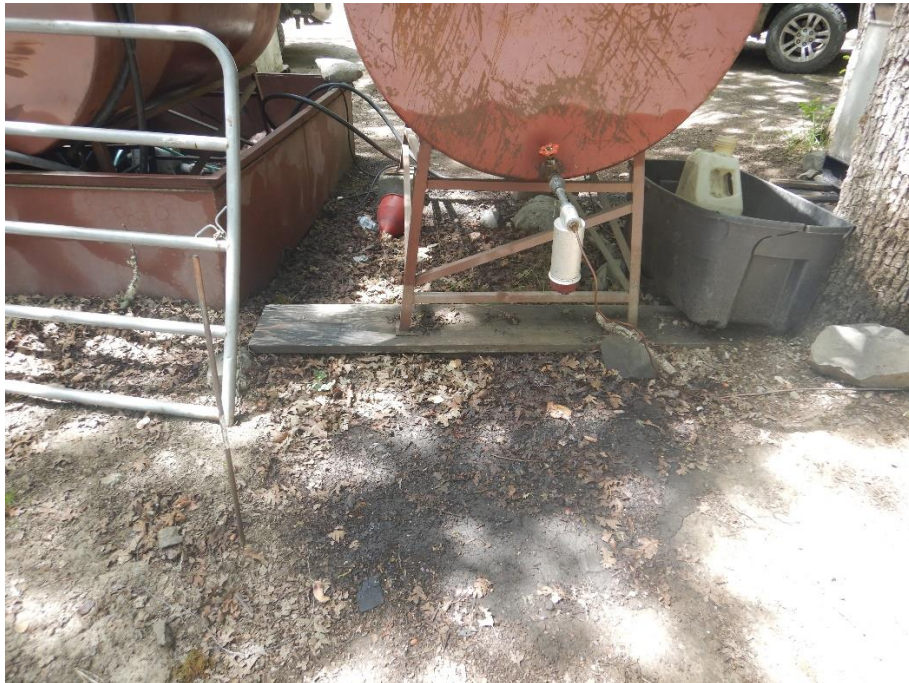
At WQ4 I observed diesel fuel had spilled to the earthen ground below a diesel tank without secondary containment and motor oil had spilled to the earthen ground below a diesel generator. I observed a spring at WQ5, that is hydrologically connected to a watercourse supplying a reservoir. I observed the reservoir outlet pipe discharging to a broad vegetated swale that passes a residence with an outhouse toilet discharging to the ground. The attached map shows the watercourse is tributary to the Eel River.

Photo 19—Diesel storage tank without secondary containment at WQ4. Patch of dark earth below the tank identifies the location of a fuel spill.

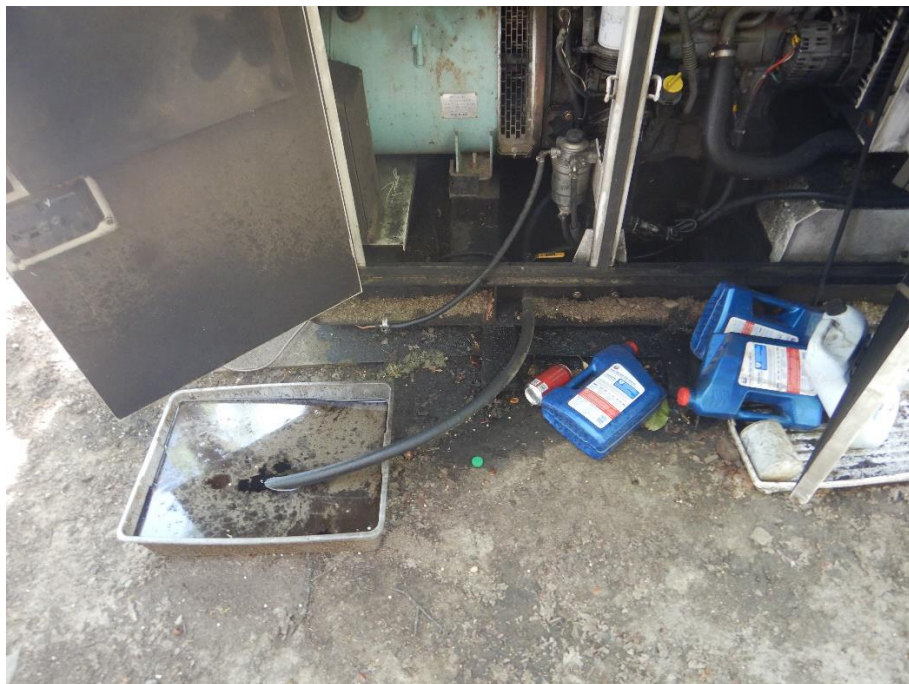
Photo 20—Motor oil leaking out of diesel generator at WQ4. Patch of dark earth below the generator identifies the location of an oil spill.

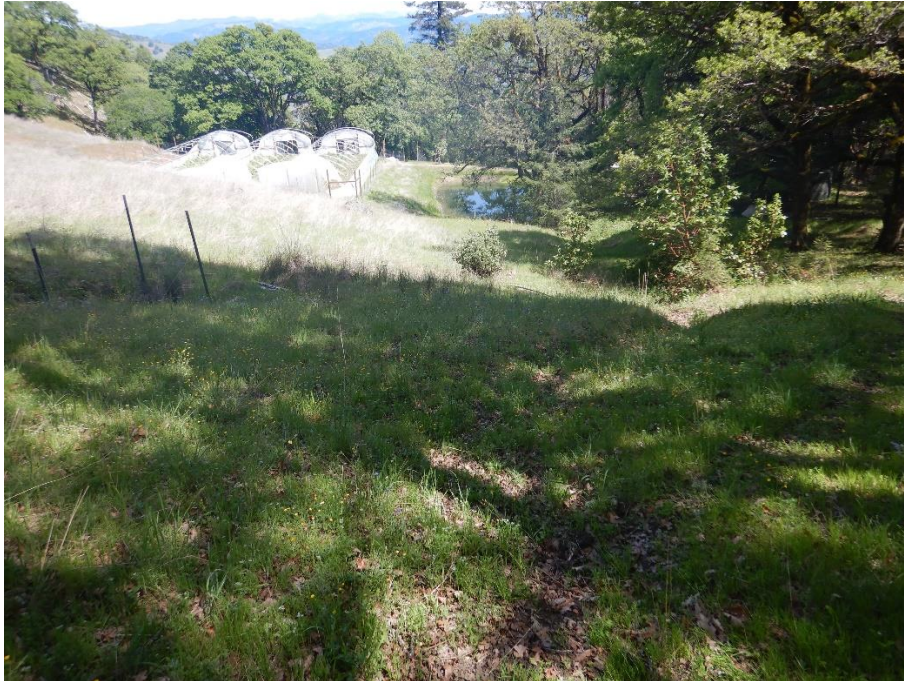
Photo 21—Looking east from WQ5. A spring, located at stakes in the middle left of the image and pictured in the following photo, is connected by a line of unique vegetation to an intermittent watercourse, marked by a madrone sapling in the middle right. The intermittent watercourse drains towards the reservoir in the background of the image.

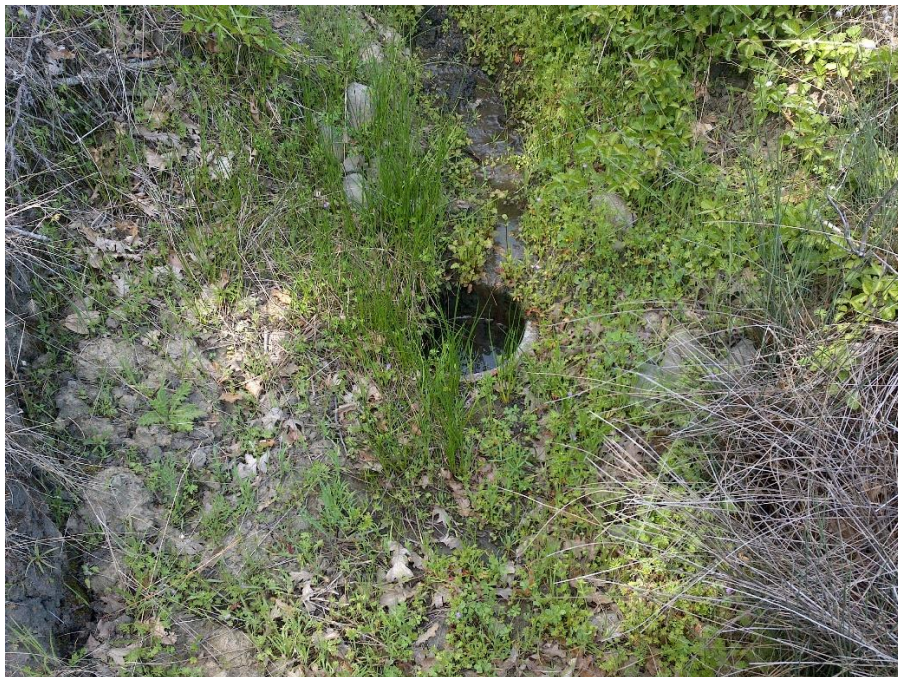
Photo 22—Spring located in the vicinity of WQ5.

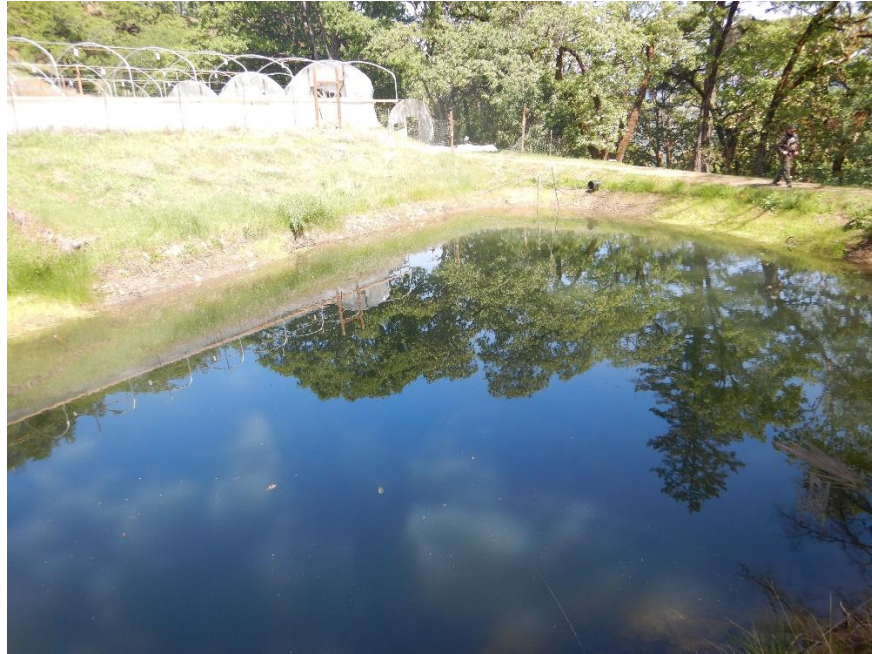
Photo 23—Looking east toward WQ 6. The reservoir outlet pipe is visible in the upper right of the image.

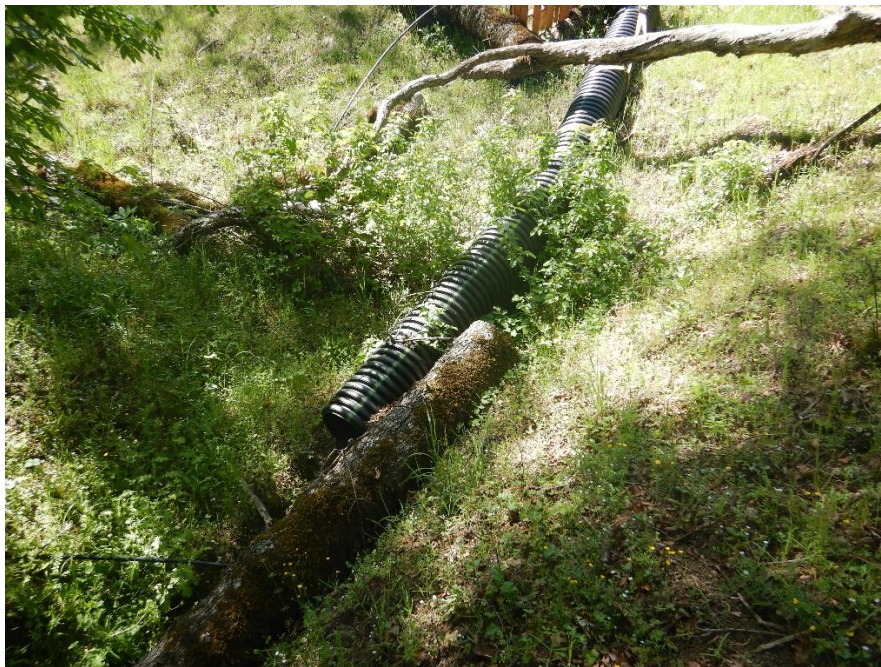
Photo 24—Looking west at the reservoir outlet pipe. The pipe is resting on a cut and fallen tree.

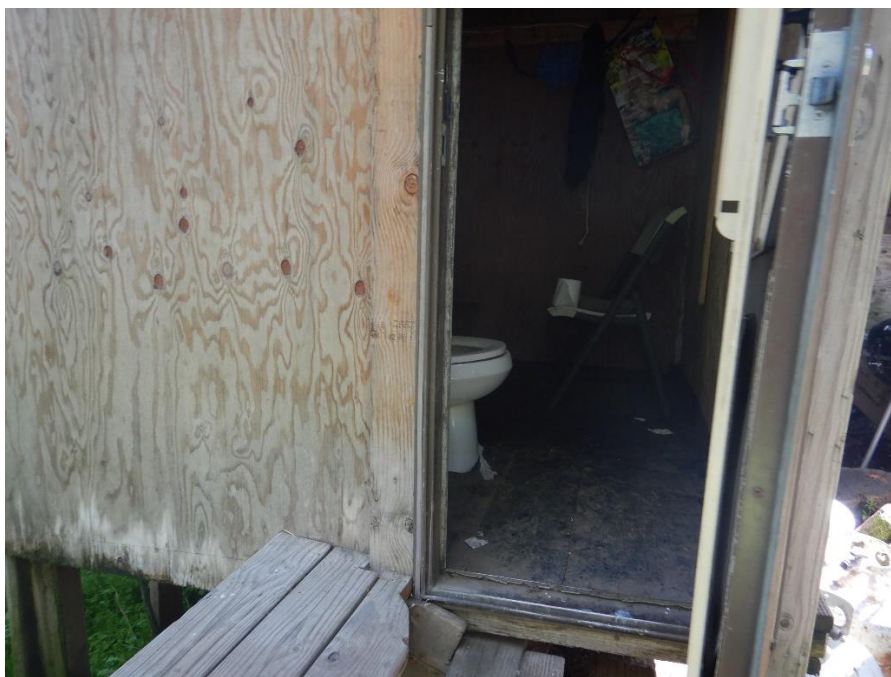
Photo 26—Toilet discharging to ground adjacent to watercourse east of WQ6.

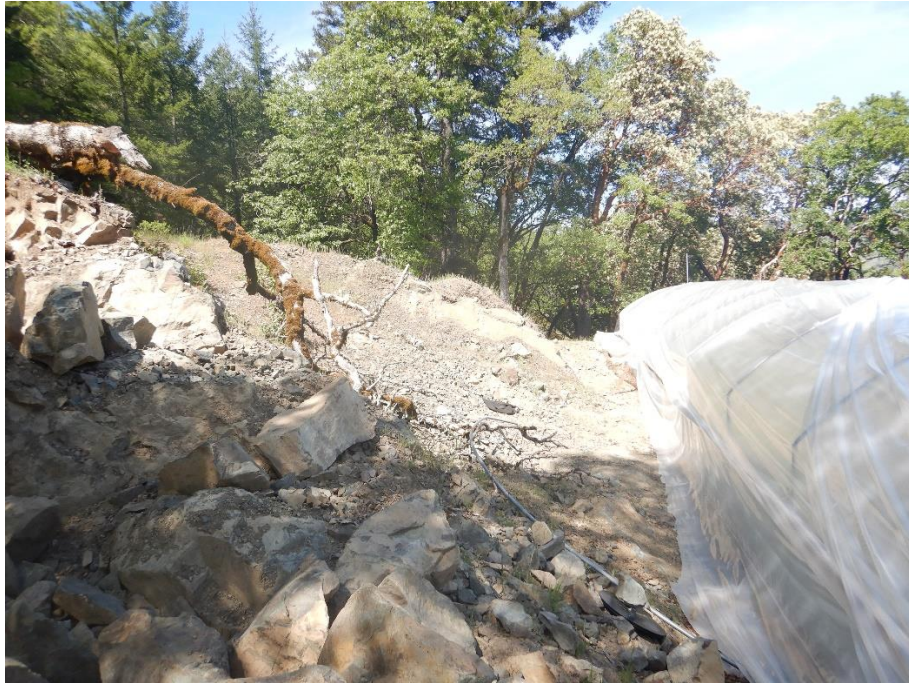
Photo 27—Looking north along cultivation pad located at WQ7.

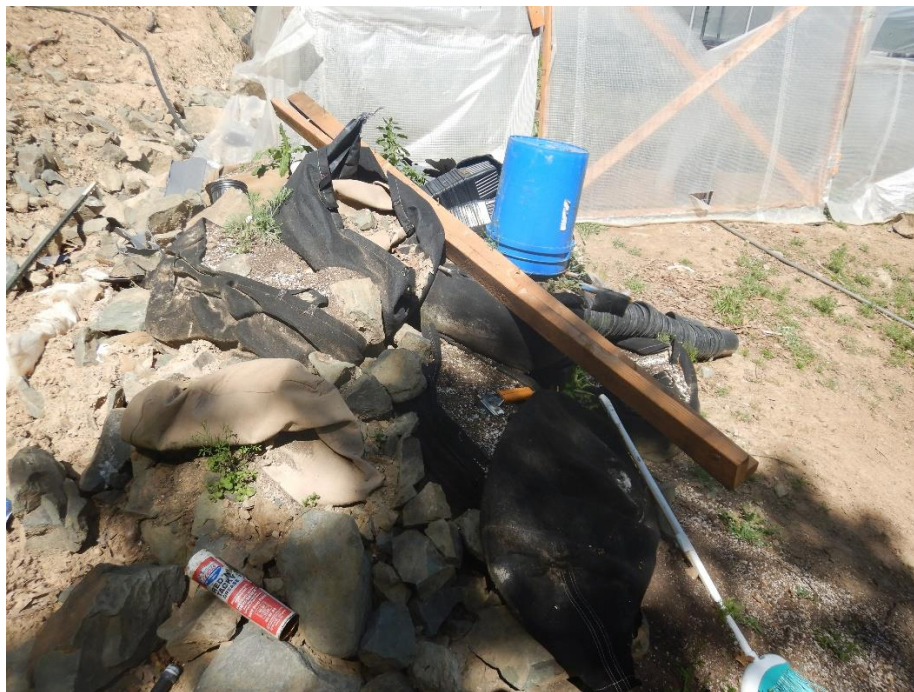
Northeast of WQ6, I observed a cultivation area at WQ7, with uncontained cannabis cultivation and construction waste. Farther northeast, I observed a well at WQ8.

Photo 28—Waste potting soils and construction debris at WQ7.

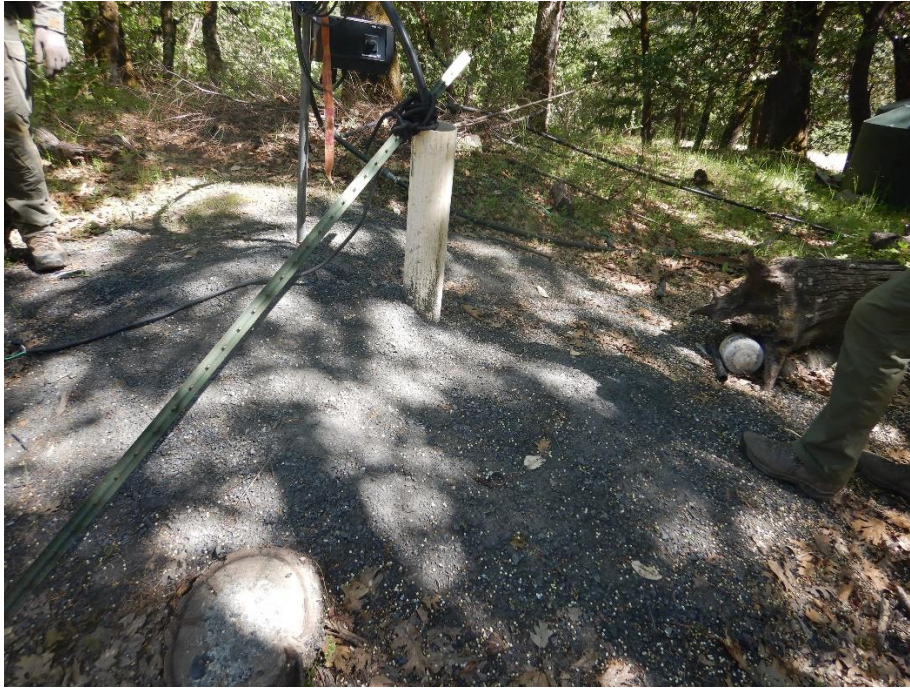
Photo 29—Groundwater well located at WQ8.
