**FACILITIES INSPECTION REPORT**

Travis Farm Photo Log  
May 11, 2021 Inspection

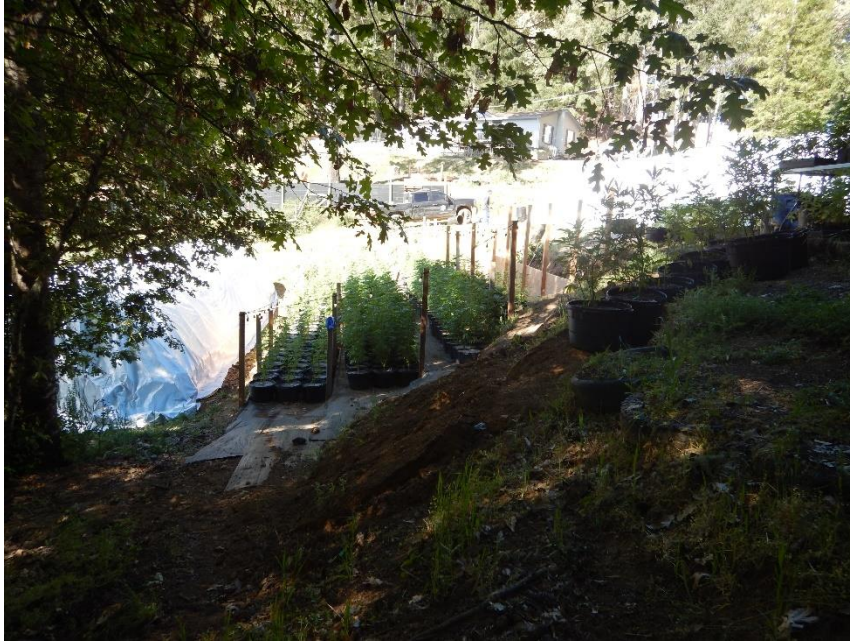
Photo 1 - Upper cultivation area: Cannabis plants in pots and in white tarped hoop houses on terraced hillside

2. Remove all cannabis cultivation related infrastructure including pots, grow bags, soil bags, metal fencing, fertilizer, etc. from the riparian setback. The setback is 50 feet for Class III watercourses.

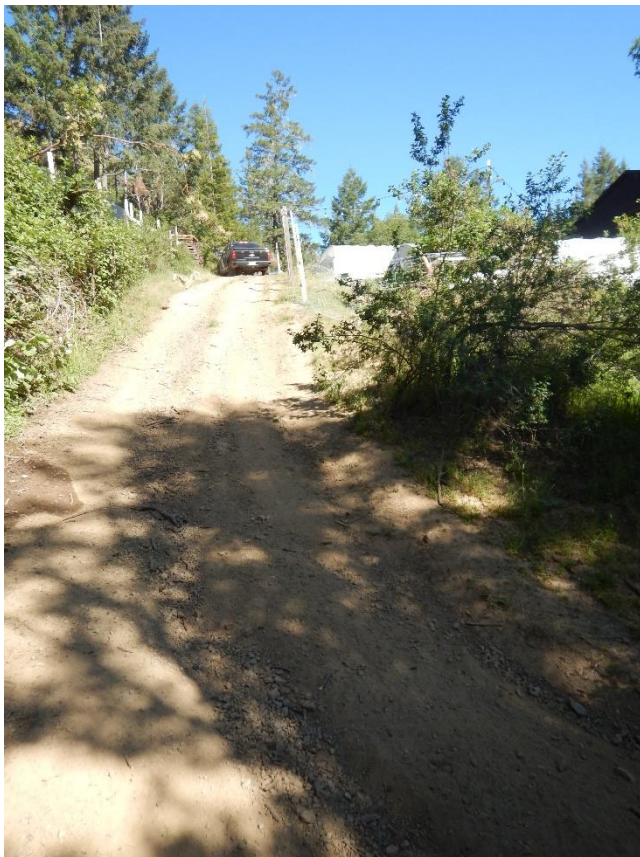
Photo 2 - Access road: Steep access road with tire ruts

4. Improve access road alignment, surfacing, and drainage to minimize erosion and sediment transport. Hydrologically disconnect access roads and road ditches from watercourses.

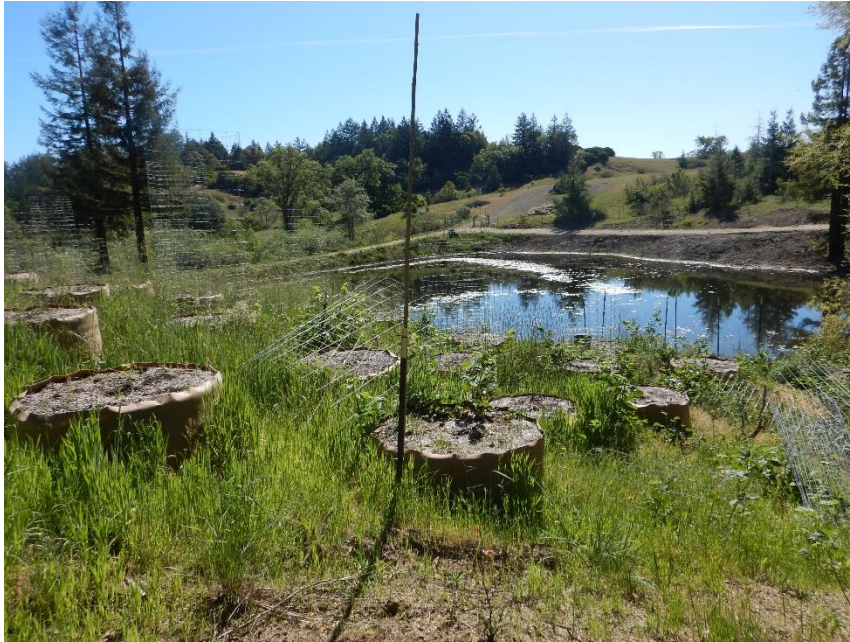
Photo 3 – Pond: Pond with fencing and grow bags on near bank, and disturbed area with vegetation removed on far bank

3. Work with the State Water Board Division of Water Rights (DIV) and the California Department of Fish and Wildlife (CDFW) to assess the environmental impact of the onstream pond. Hire a qualified professional to develop a plan to either stabilize and revegetate the pond, or remove the pond and recontour and revegetate the watercourses, depending on agency input.

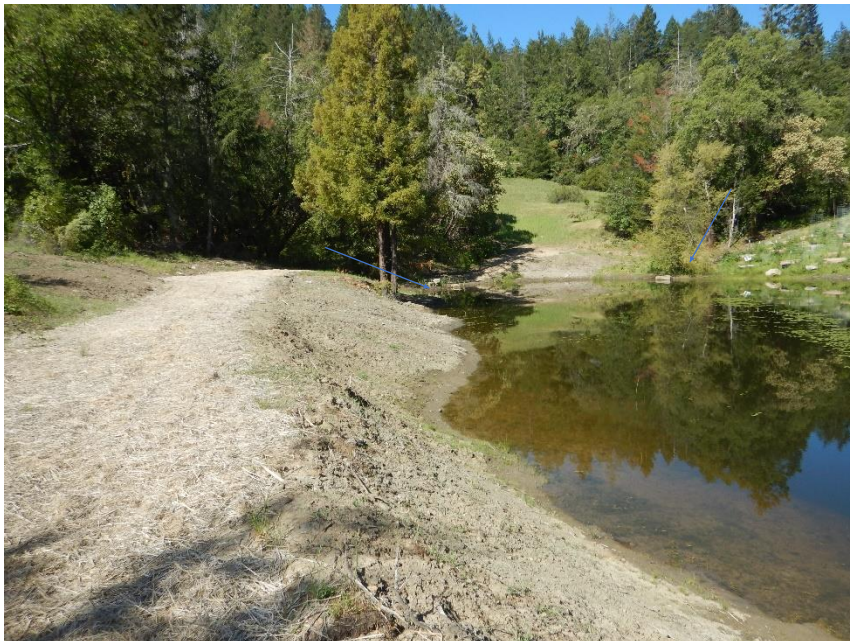
Photo 4 – Pond: Disturbed area on pond bank. The approximate locations of Class III watercourses entering the pond are marked by blue arrows

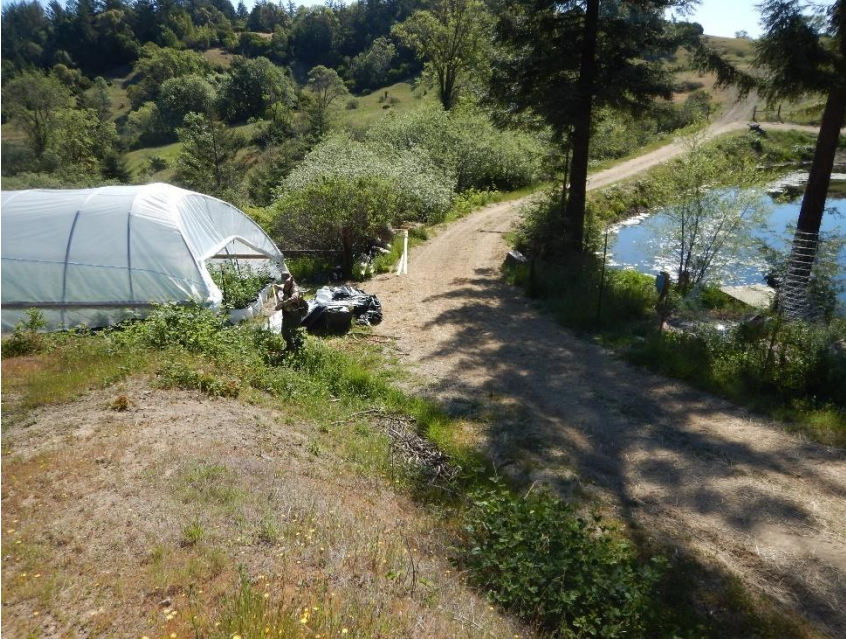
Photo 5 – Lower cultivation area: Hoop house with cannabis cultivation approximately 20 feet away from onstream pond. Road drainage/ watercourse runs in culvert under hoop house

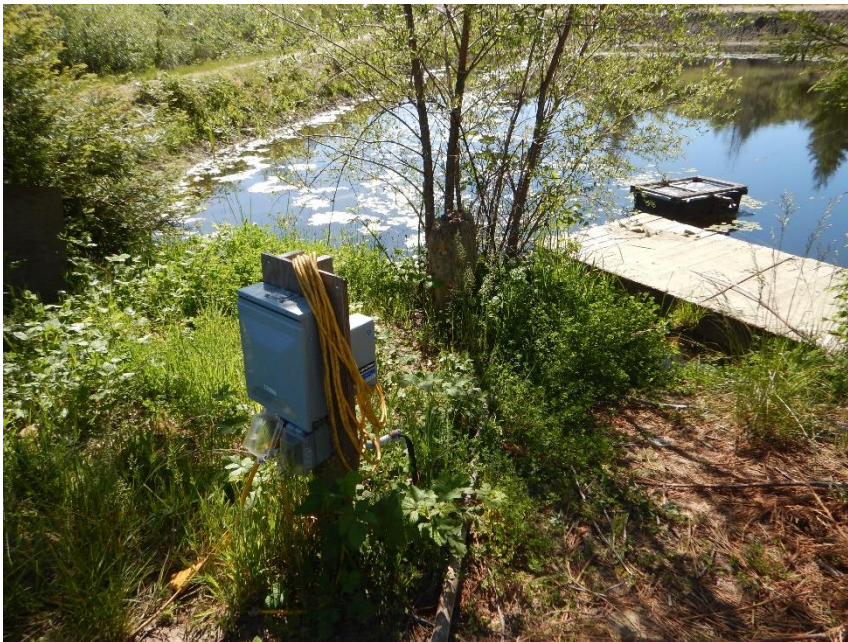
Photo 6 – Pond: Water diversion infrastructure in and adjacent to onstream pond

6. Work with CDFW and DIV to determine and secure any applicable permits or licensing required for surface water diversion from the pond if it is to be kept, and water storage and use on the site.
