Subject: Notice of Violation and Transmittal of Inspection Report for July 20, 2021 Inspection of Humboldt County Assessor's Parcel APN 216-381-016, and Directive to Respond within 30 days

FACILITIES INSPECTION REPORT

Lope Map and Photo Appendix
 July 20, 2021 Rancho Sequoia Inspection
 CIWQS Inspection ID 44858862

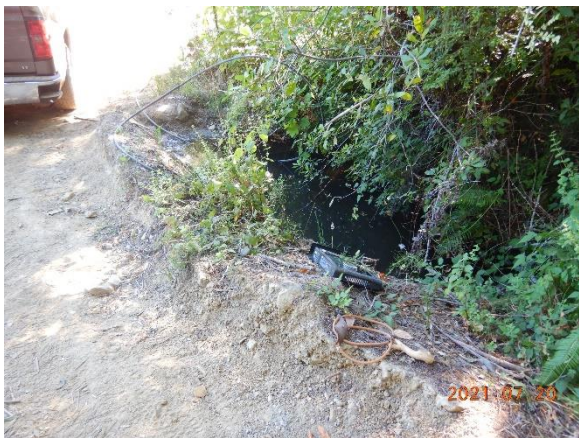
Figure 3. An exposed seep along a cutbank of driveway is used for diversion.

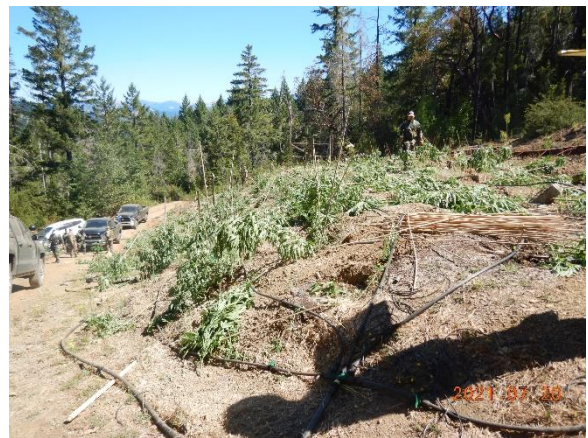
Figure 4. An outdoor cultivation area is located above and below the driveway.

1. Don't cultivate without proper authorizations.
2. Clean up, haul away, and properly dispose of refuse.
3. Hire a professional to evaluate roads and crossing (WQ1) for drainage and adequate sizing and installation, and to provide recommendations to stabilize and replant disturbed area adjacent to watercourse (WQ2), to ensure sediment and other waste is not discharged to watercourse. Develop and submit a plan for approval, obtain permits, and conduct work.

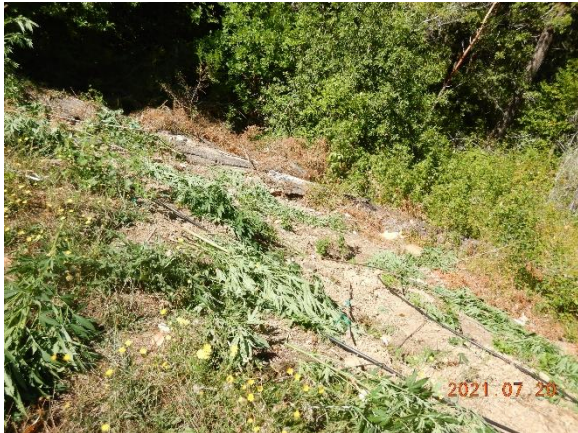
Figure 5. Outdoor cultivation.

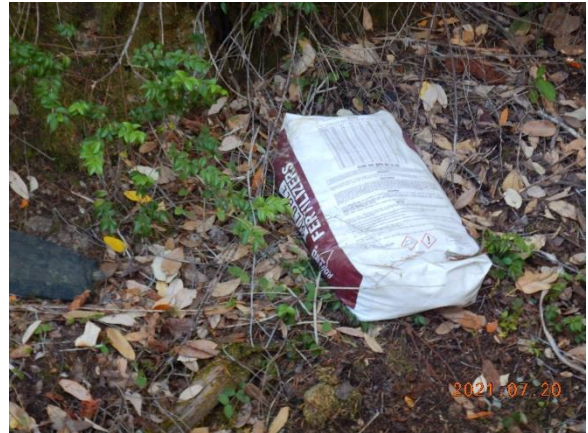
Figure 7. High concentration water soluble fertilizer on ground.

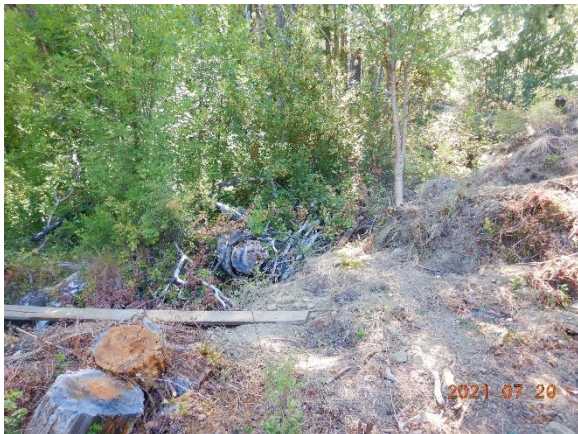
Figure 6. The cultivation area extends within 10 feet of watercourse and debris is pushed toward watercourse. The watercourse is located along the northern boundary of the parcel, shown here on left.

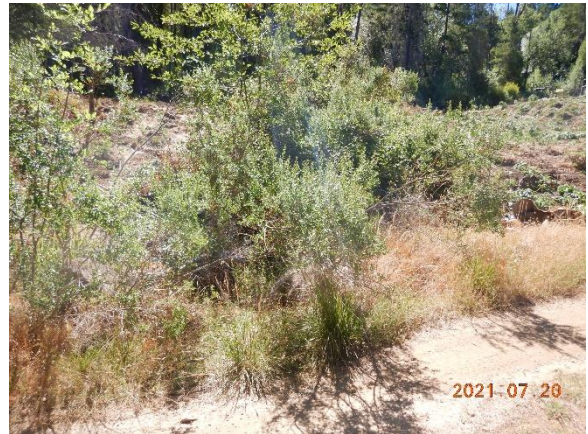
The Property is located in Rancho Sequoia and I inspected it associated with a search warrant executed by the Humboldt County Sheriff's Office, along with Ca Dept of Fish and Wildlife (CDFW) and Division of Water Rights (DIV). The east side is the upper portion of the parcel and is cleared of trees, with the driveway built through it north to south. The driveway crosses a class III watercourse. Cannabis cultivation was occurring above and below the driveway; water for irrigation appeared to come from a point of diversion on an upper parcel. CDFW and DIV assessed and documented the surface water and use and will make separate contact. Above the crossing (WQ1), cultivation was on both sides of the watercourse, with disturbed area within ten feet of its stream banks (WQ2). The stream crossing is a 24" corrugated metal pipe. I observed cultivation-related refuse throughout the Property.

Figure 8. A class watercourse is crossed by the driveway and has a 24" corrugated metal pipe for a culvert. The cultivation is within ten feet of the watercourse on either side.
