North Coast Regional Water Quality Control Board

Subject: Notice of Violation and Transmittal of Inspection Report for March 23, 2021 Inspection of Humboldt County Assessor's Parcel 271-217-002

FACILITIES INSPECTION REPORT

Maps and Photolog for Inspection of Humboldt APN 217-271-002 (Prop B) on March 23, 2021. WDID 1_12CC419772, CIWQS Inspection ID 43510635.

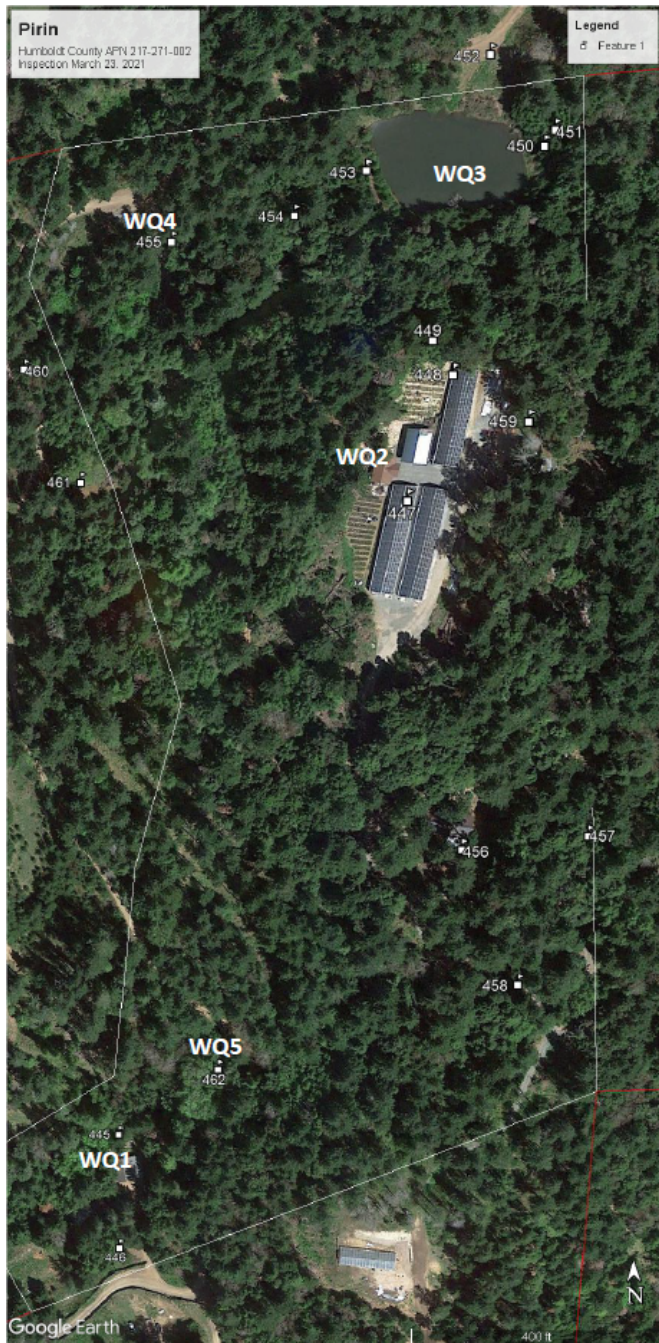
Figure 1. Inspection map including, Google Earth 2019 aerial imagery, GPS locations of field identified features, and water quality locations of concern WQ1-WQ5.

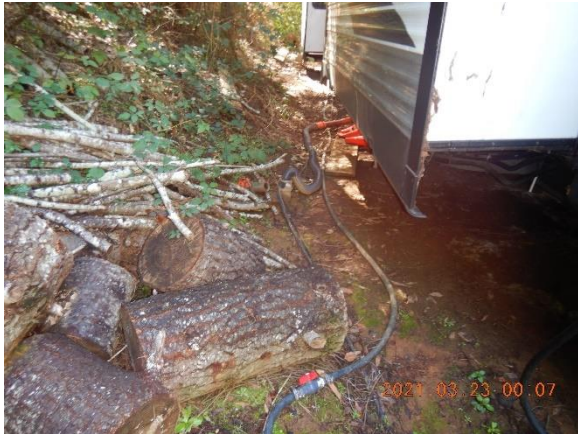
Figure 3. Trailer with waste line presumably to onsite septic system.

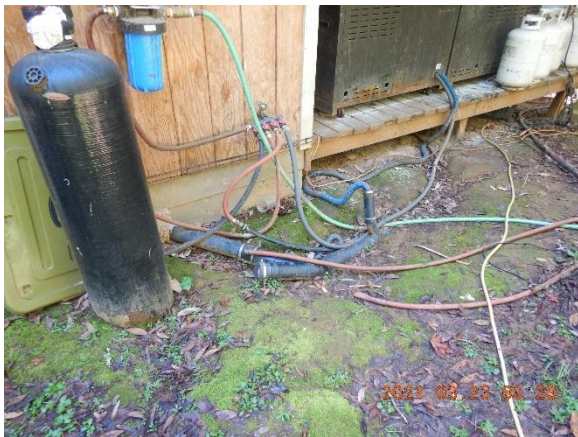
WQ1 - Residential Area adjacent to and uses encroaching on riparian setback of Class II watercourse; appears to be on septic. Behind structures is old road, that does not appear to be in use, with an undersized stream crossing. The culvert was not included in LSAA and appears appropriate for decommissioning. Water pump with lines through culvert. Generator with small spill, assessed by HazMat

Figure 4. Primary residential facility with waste lines, located within approximately 50 feet of Class II watercourse.

1. Submit SMP, including all stream crossings, pond at WQ3, and uses at WQ1 in riparian
2. Prior to additional instream work, obtain water quality certification.
3. Improve road drainage and hydrologic disconnections to prevent sediment discharge
4. Consult Water Rights on pond at WQ3 and associated water diversion and use for conformance with Cannabis Policy.
5. Implement measures to ensure that there is no threat of waste discharge from WQ2 to pond & surface waters

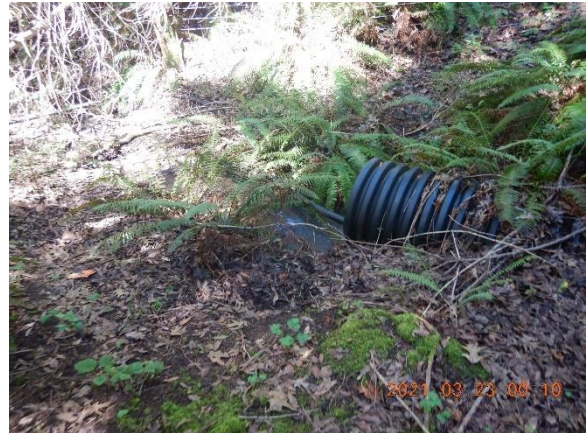
Figure 5. GPS point 445, inlet of 24" which is misaligned located on a Class II watercourse, on a road behind residence, road does not appear to be in use. The culvert was not disclosed in LSA.

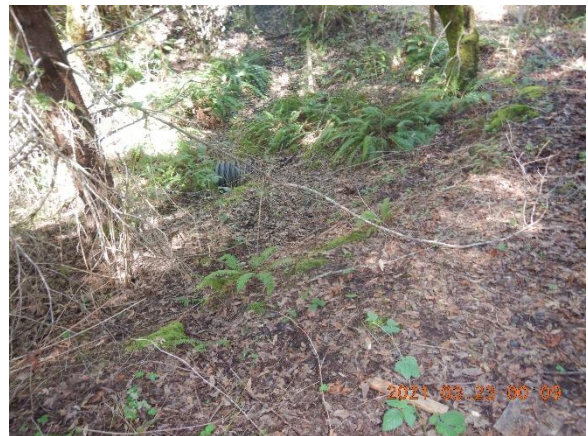
Figure 6. Outlet of culvert at GPS Point 445.

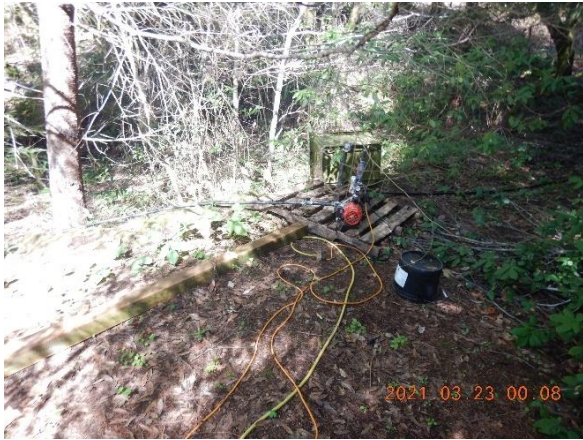
Figure 7. Water pump connected to waterlines running through culvert at GPS point 445.

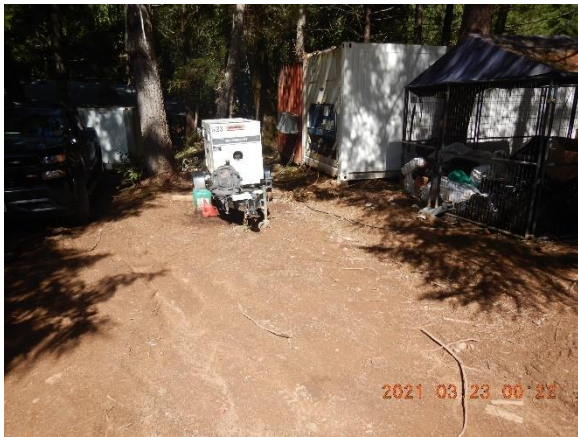
Figure 8. GPS point 446, Generator with evidence of small spill, assessed by Humboldt County HazMat.

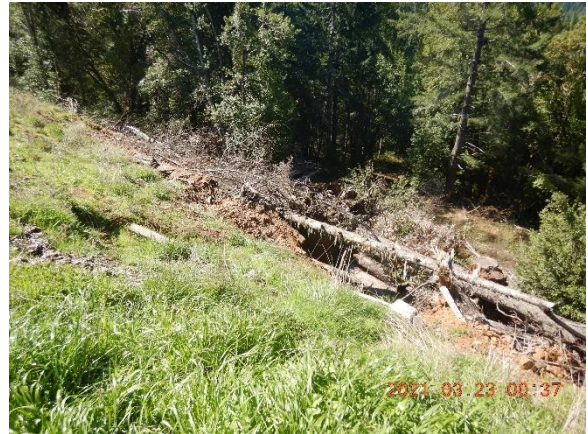
Figure 9. Upper graded flat, near GPS Point 447, slash at toe of fill slope.

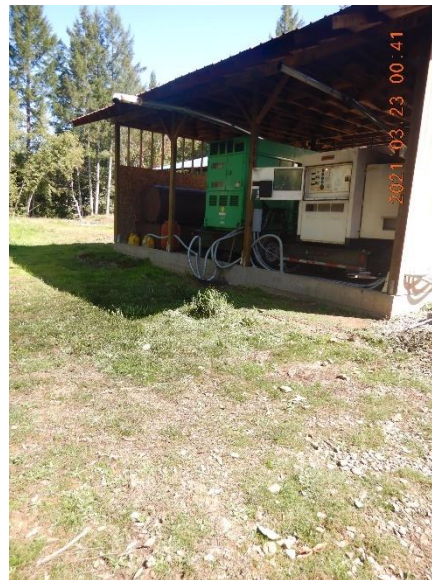
Figure 10. Generator at GPS location 447.

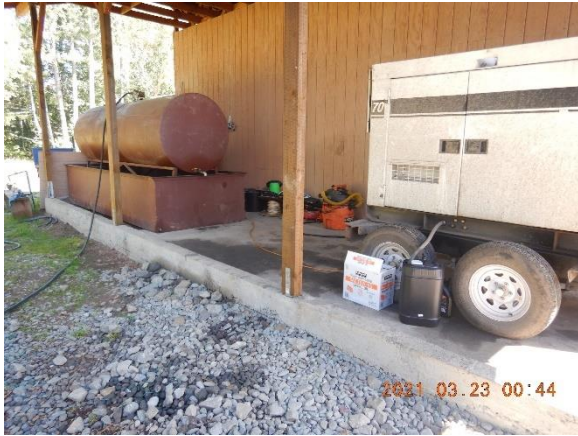
Figure 11. GPS location 447. A large generator powers the three large greenhouses. Indications of numerous small spills, as assessed by HumCo HazMat.

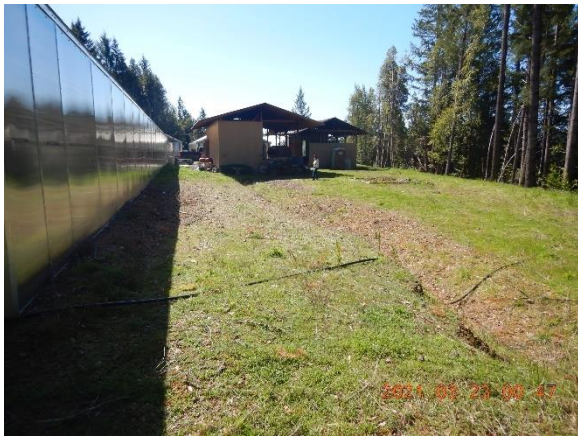
WQ2 - Upper graded flat with runoff from approximately 1 acre, including greenhouse roof catchment and ground surface near generator and fuel storage, is directed to a drain-pipe which discharges to steep hillside, approx. 160 feet above pond.

Figure 12. GPS location 448. Gutters catch approx. 12,000 sq ft of greenhouse roof runoff and route it to a trench, located on back side of fuel storage and generator area shown in previous figure. Runoff from the generator area could transport to the trench.

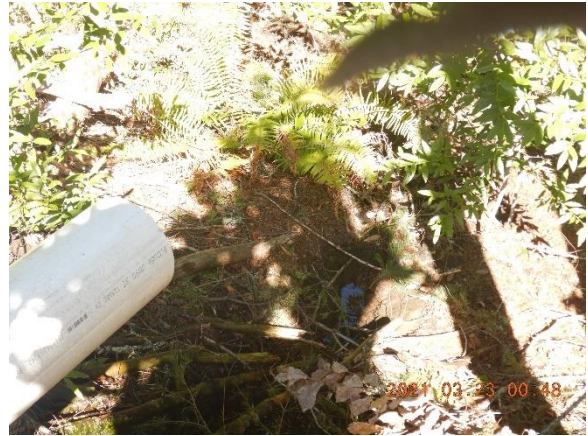
Figure 13. GPS location 449. Trench in previous figure outlets to a pipe that discharges over slope above pond; trench and pipe have potential to carry pollutants to the pond, which provides aquatic habitat and discharges to surface waters.

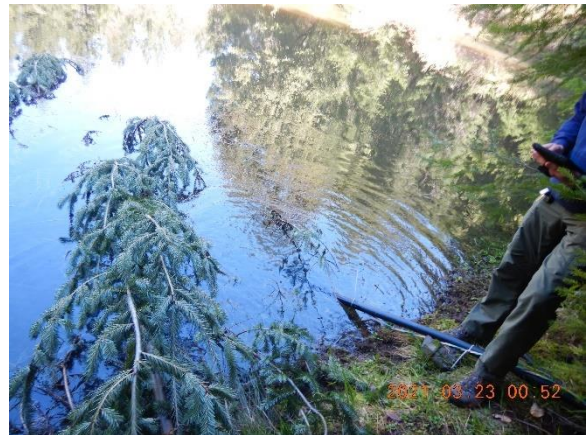
Figure 14. Water diversion from pond.

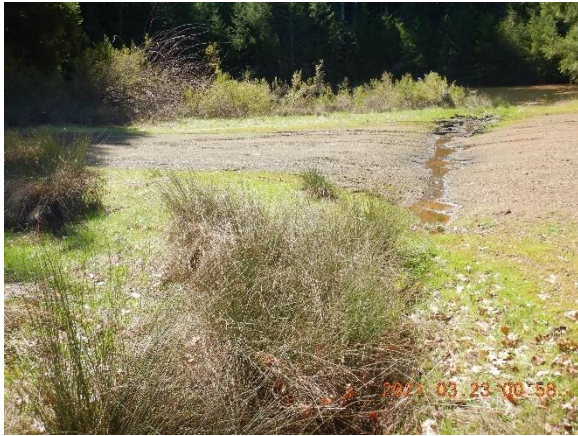
Figure 15. Class IV watercourse along road ditch where it drains to pond, with some wetland vegetation and flowing water.

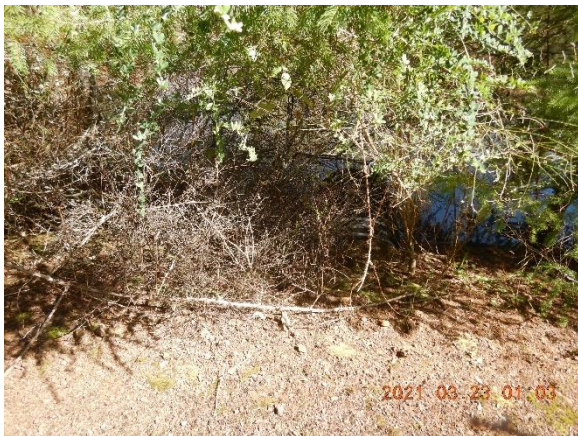
Figure 16. GPS location 454. Top of berm where the outlets to watercourse via two parallel pipes, with 45s and downspouts over the rocked fill face.

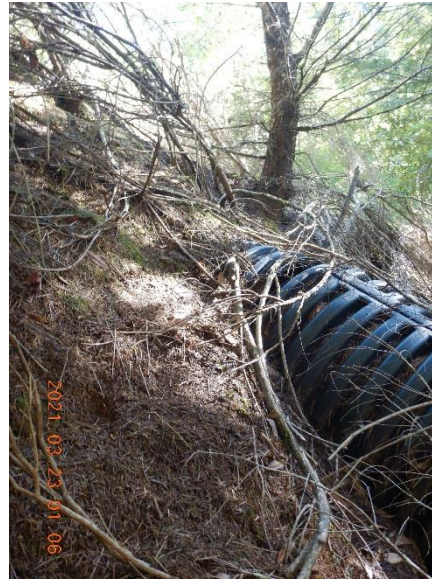
WQ3 - An approx. 0.66 acre pond constructed with discharges via two corrugated plastic outlet pipes over fillslope to watercourse; one pipe collar has separated at the top of the berm. Draining into pond, I observed a class IV road ditch with surface flow and small swales with minor scour. Point of diversion up to tank at WQ2.

Figure 17. GPS point 454. One of the pond outlet pipes is separated at the 45, near the top of the berm

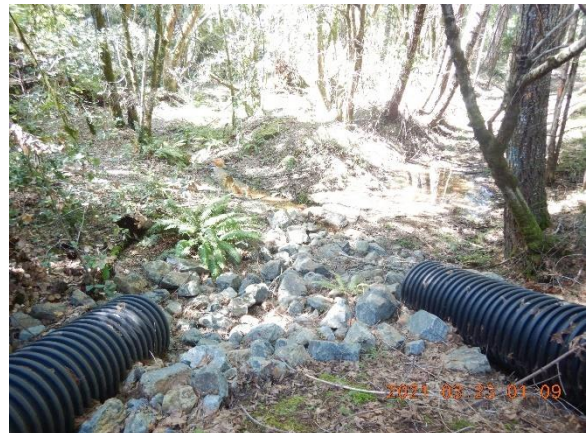
Figure 18. At base of pond berm, outlet pipes drain to watercourse. The LSA included the rock placement.

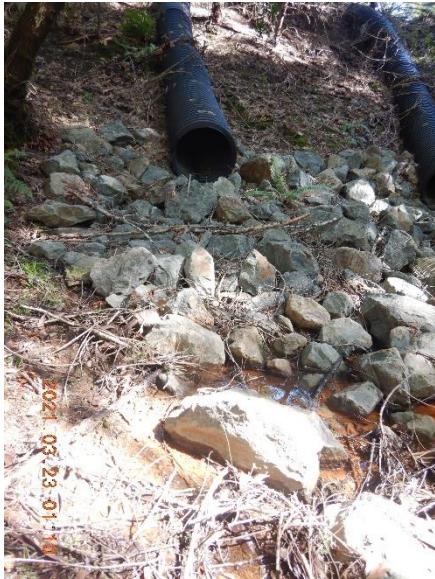
Figure 19. The separated pipe was not flowing water but I observed water between the rip rap at the outlet, indicating seepage at pipe separation or berm seepage.

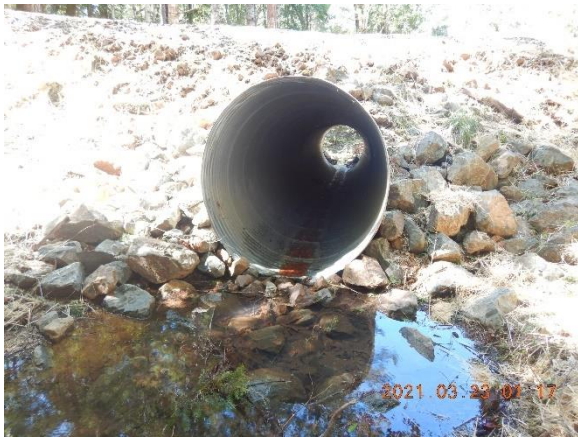
WQ4 - Crossing 3 inlet was high and not set to grade.

Figure 20. GPS location 455, LSA Crossing 3. Downstream of pond, the stream crossing Culvert was upgraded in ~2018, while enrolled in cannabis general order, without first obtaining authorization for instream work from the Regional Water Board. The inlet is a bit

high and there appears to be seepage underneath.

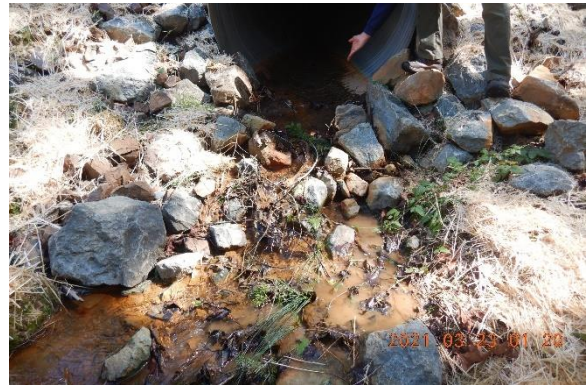
Figure 21. GPS location 455. Outlet of Crossing 3 with evidence of sediment deposits in downstream channel. According to CDFW, the erosion control measures weren't installed at the time of there inspection in December 2020.

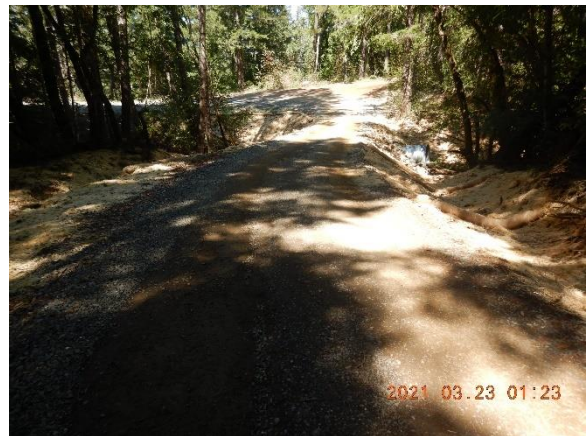
Figure 22. GPS location 455. Looking downslope along road approach to Crossing 3.

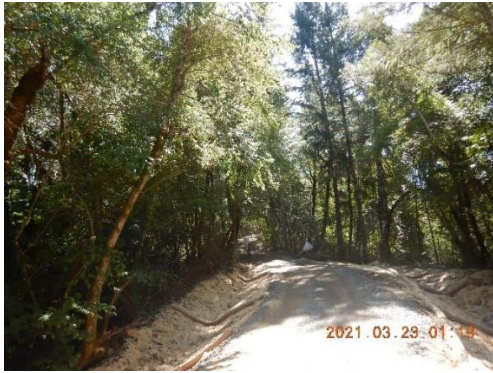
A December 2020 CDFW inspection identified road-related discharges associated with failure to install hydrologic disconnections and erosion control measures. Since then, rock armoring and straw had been added. I observed that the roads remain hydrologically connected at most stream crossings due to lack of treatments to road approaches and inboard ditches.

Figure 23. GPS location 455. The road approach to Crossing 3 lacks hydrologic disconnects.

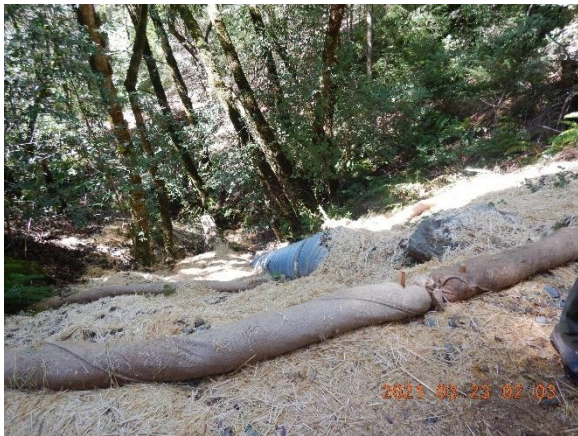
Figure 24. GPS location 462. Crossing 1. Downspout was included in the LSAA but was added during installation of the 36" culvert.

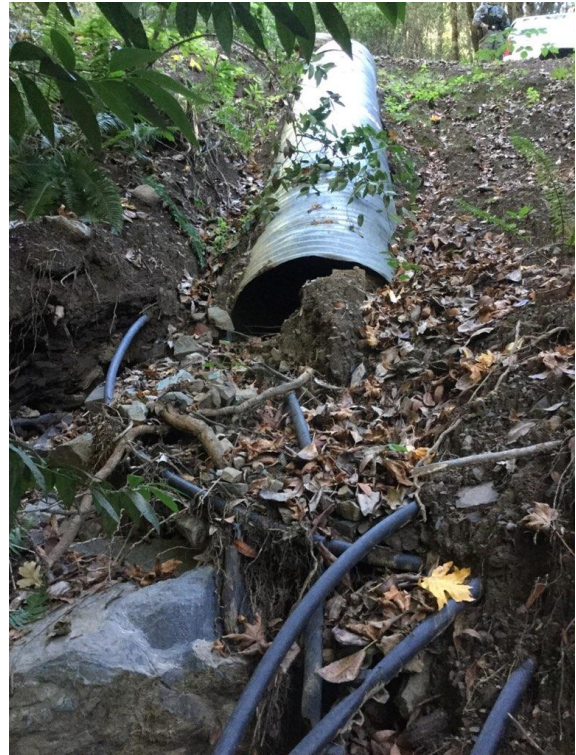
WQ5 - Crossing 1 had sediment discharges following upgrade due to inadequate alignment and grade, armoring, and erosion control measures.

Figure 25. Photo of Crossing 1, by Ryan Bourque of CDFW taken on December 7, 2020 inspection. Photo shows lack of erosion control and erosion and sediment transport to the watercourse at the outlet of the downspout.

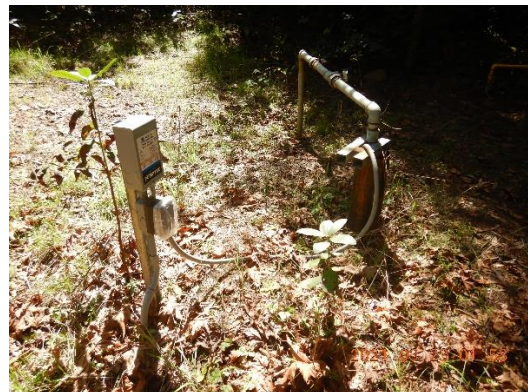
Figure 26. GPS location 461. Well without proper cap.
