## North Coast Regional Water Quality Control Board

**Subject: Notice of Violation and Transmittal of Inspection Report for March 24, 2021 Inspection of Humboldt County Assessor's Parcel 212-263-042**

## FACILITIES INSPECTION REPORT

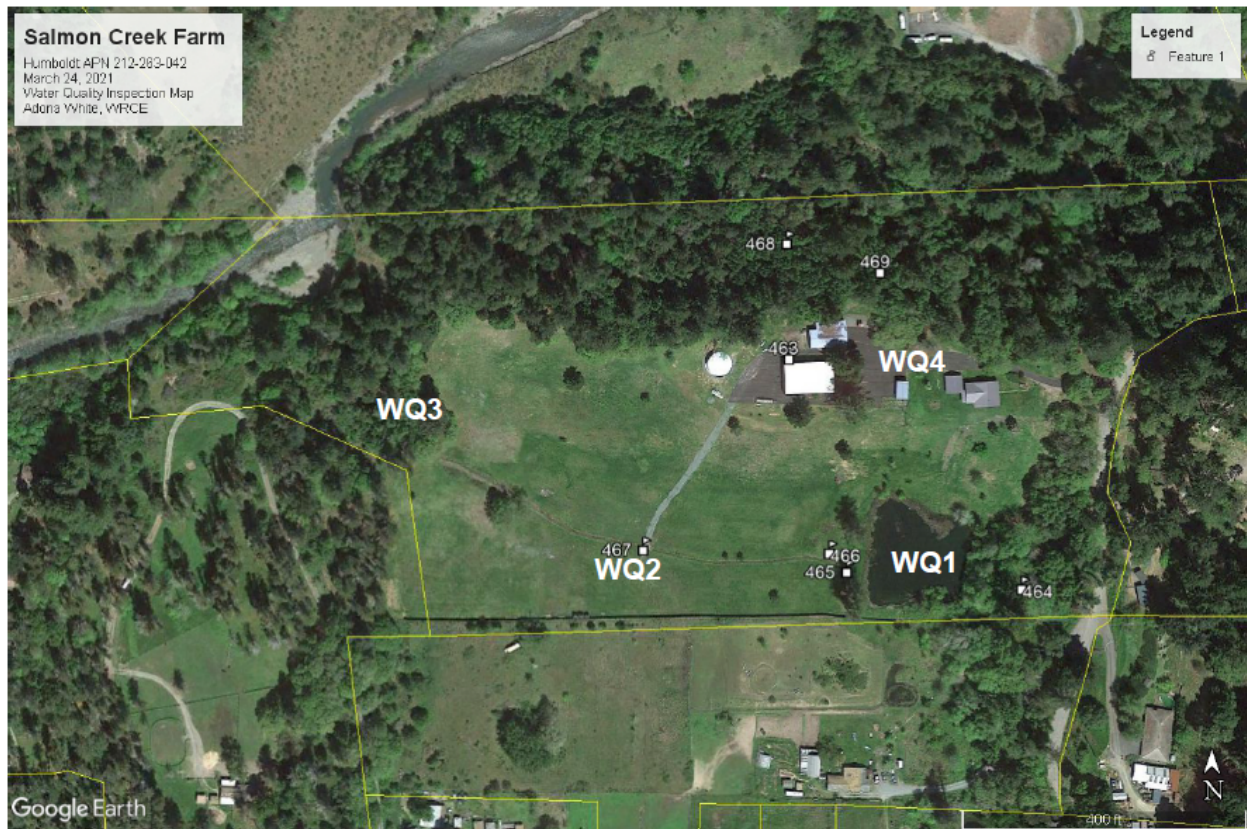
Figure 1 shows locations of features described below.  
 -Enrolled in CANGO, Tier 1 Low risk.  
 -No outdoor cultivation. Indoor cultivation on PGE and Septic.  
 -WQ1 is unlined, seemingly stable, onstream pond, fed by surface water spring (GPS point 464) with irrigation line to exterior of cultivation building. The pond diversion infrastructure is buried. The pond outlet (GPS point 465) drains to a Class IV watercourse through a flat field.  
 -WQ2 is at GPS Point 467 and is 12-inch culvert. At the edge of the field, the Class IV delivers to a larger, much steeper natural topographic drainage which appears relatively stable.  
 WQ3 is adjacent to the natural channel, where slash and refuse has been pushed to the break in slope and is being held back by small trees. This material could deliver to natural watercourse.  
 At WQ4, I observed an uncontained pile of soil near the buildings.

Figure 1. Inspection map of APN 212-263-042 with aerial imagery (GoogleEarth, 2019), Humboldt County parcel boundaries (shown in yellow), GPS locations of inspection observations as 463-469, and locations of water quality-related concerns shown as WQ1-WQ4.

Recommendations:  
 WQ1: Work with CDFW and the State Water Resources Control Board’s Division of Water Rights (DIV) to determine and secure any applicable permits or licensing required for surface water diversion, storage, and use on the Property.  
 WQ2: Submit Site Management Plan (SMP), including assessment of crossing.  
 WQ3: Move slash placed near watercourse.  
 WQ4: Store and contain all potting soil properly to prevent spillage and potential for migration/transport into
