North Coast Regional Water Quality Control Board

Subject: Notice of Violation, Transmittal of Inspection Report for July 20, 2021 Inspection of Humboldt County Assessor's Parcel Number (APN) 216-244-002-000, and Directive to Respond within 30 days

FACILITIES INSPECTION REPORT

Inspection Maps and Photolog for inspection conducted, July 20, 2021

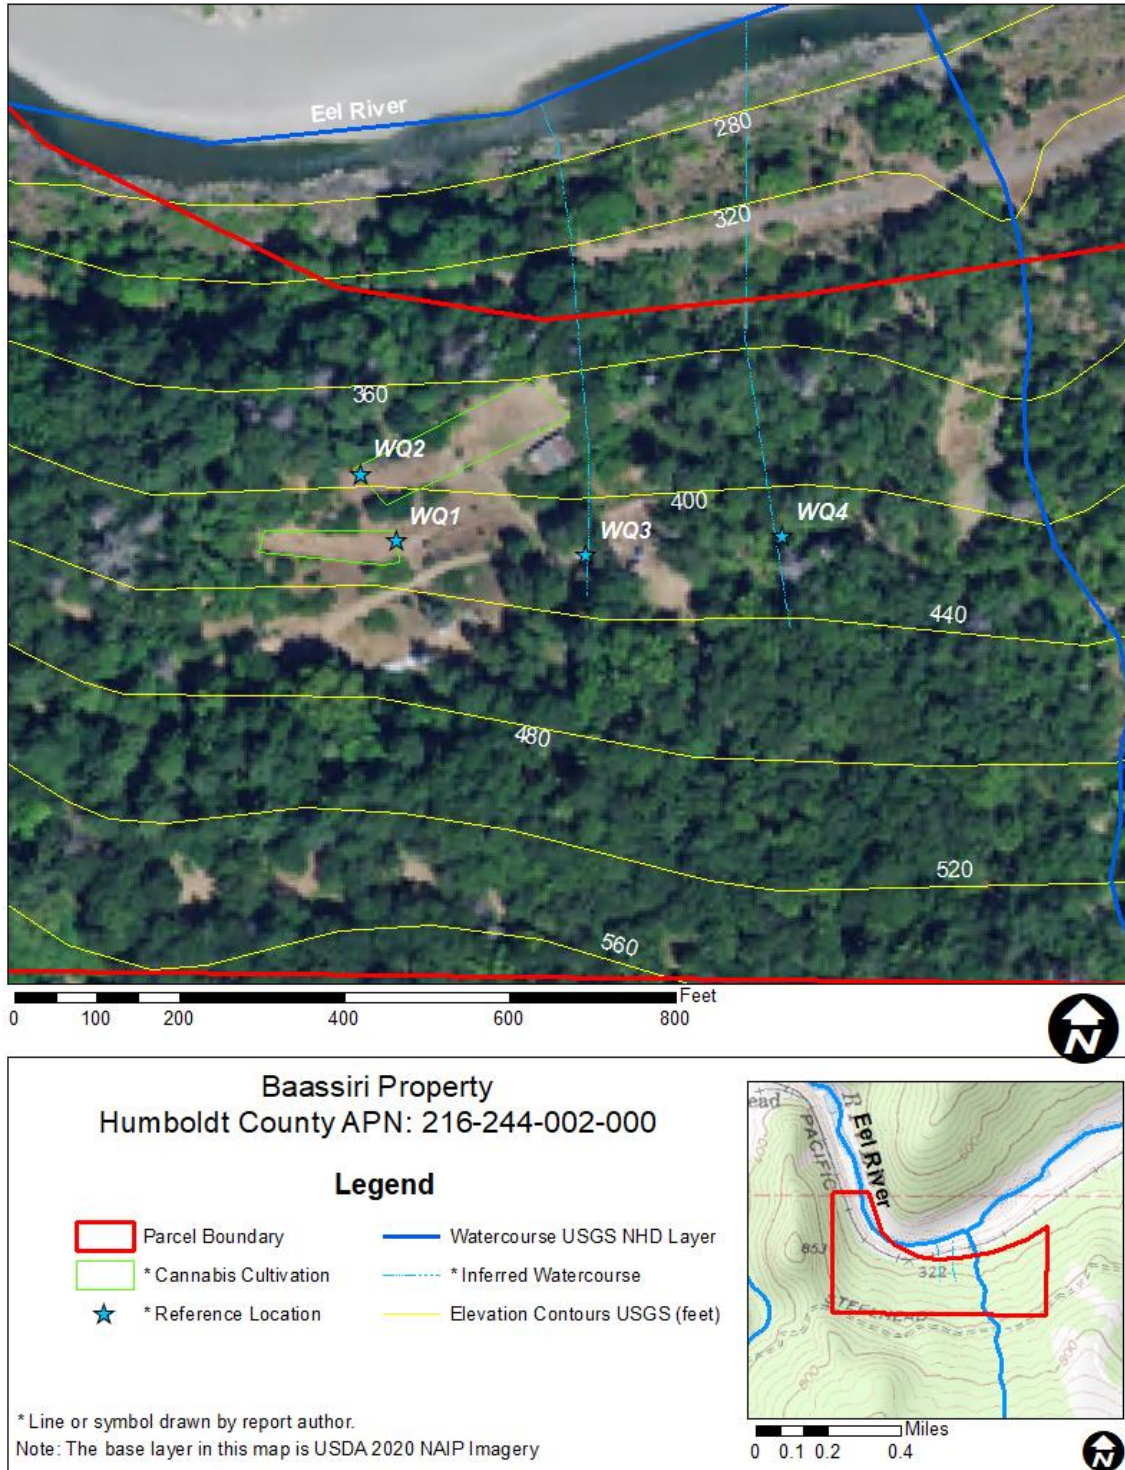
Figure 1: Map of Property, including inspection points of interest.

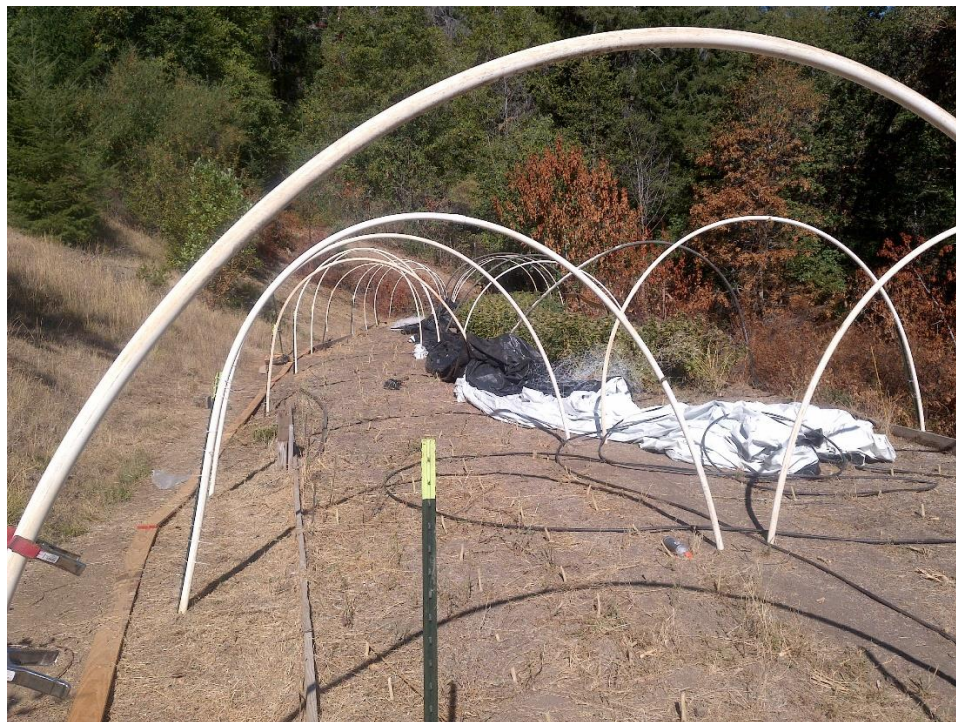
At WQ1, I observed a historical cultivation area. I walked north and observed active cannabis cultivation, with an associated disturbed area exceeding 5,000 square feet extending east from WQ2. The cultivation pad extends to the west into the topographic form of a watercourse, which originates approximately 50 feet upslope from WQ2 dissipates north of WQ2 where the topography steepens significantly. There are burned trees in the channel and the ground appears charred suggesting a fire had occurred since the last wet weather period.

Photo 1—Looking west at a historical cultivation area located at WQ1.

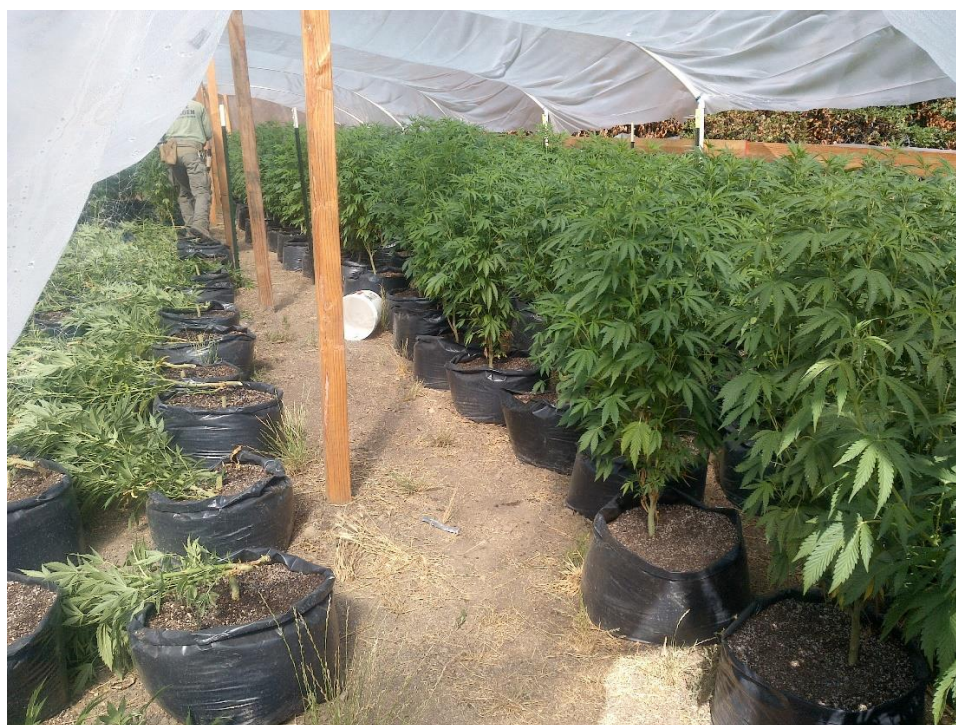
As documented in the July 20, 2021 inspection report, Regional Water Board staff observed violations of the California Water Code 13260 and 13264 at Property location identified in the inspection report as WQ2, and Basin Plan Section 4.2.1, Prohibition 2 for threatened discharges of fine sediment associated with the stream crossing at WQ3.

Photo 2—Looking west, toward WQ 2, at outdoor cannabis cultivation.

Recommendations:
 1. Prior to cultivating cannabis or developing the property for cannabis cultivation, obtain required authorizations.
 2. Engage a qualified professional to develop and submit a work plan to correct the roads and crossings on the Property to conform with the Cannabis Policy.
 3. Submit application for and obtain 401 WQC from Water Board before performing any instream work associated with Recommendation 2 above.

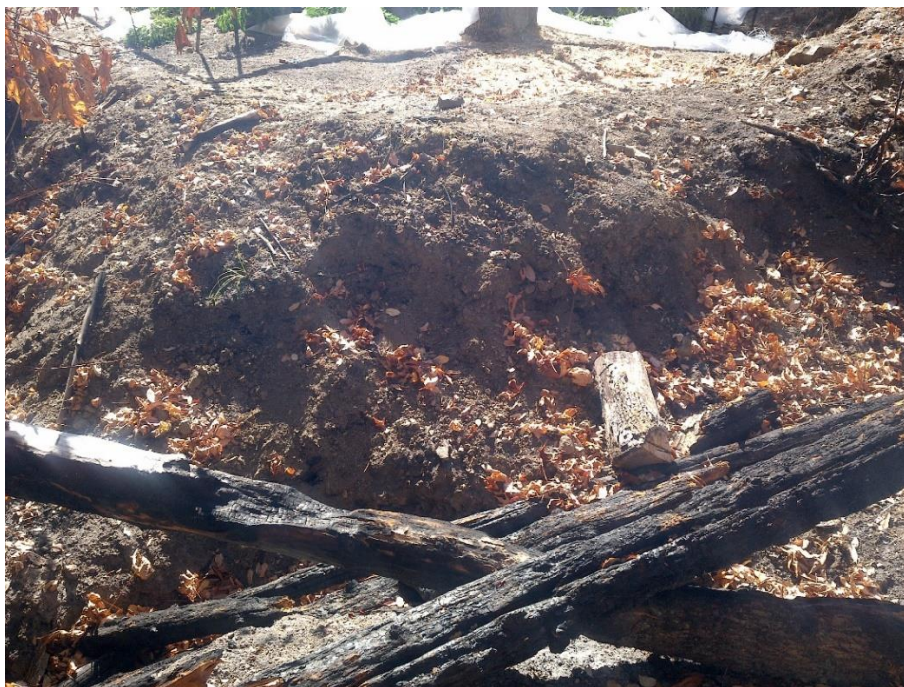
Photo 3—Looking east toward WQ2 from local topographic channel. Cultivation pad is visible in the top of the image. The topographic form of the channel stops approximately 50 feet upslope to the right of the image.

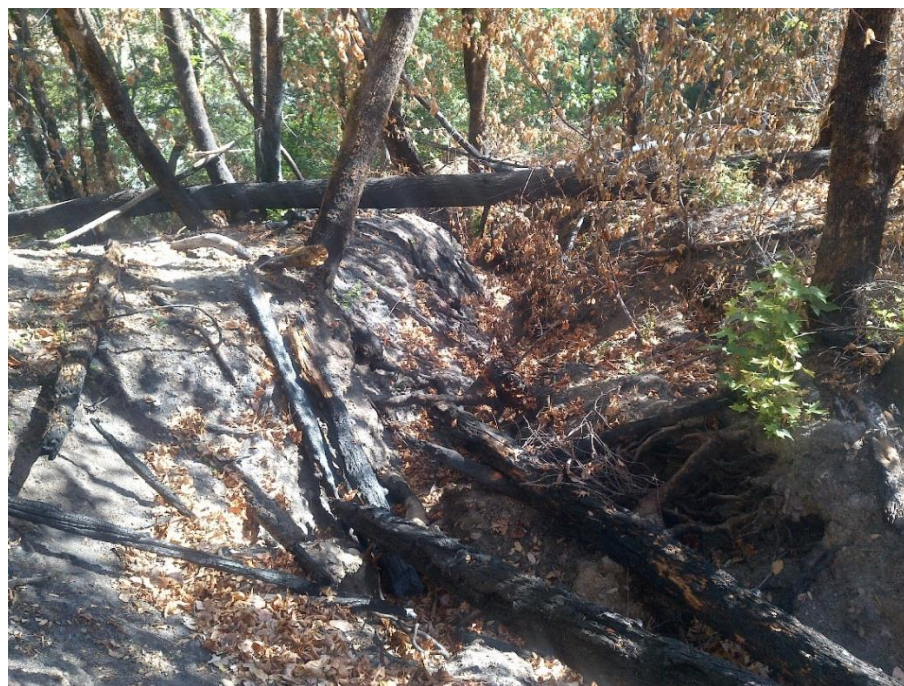
Photo 4—Looking north and downstream along local topographic channel. Recently burned trees are lying in the middle of the channel.

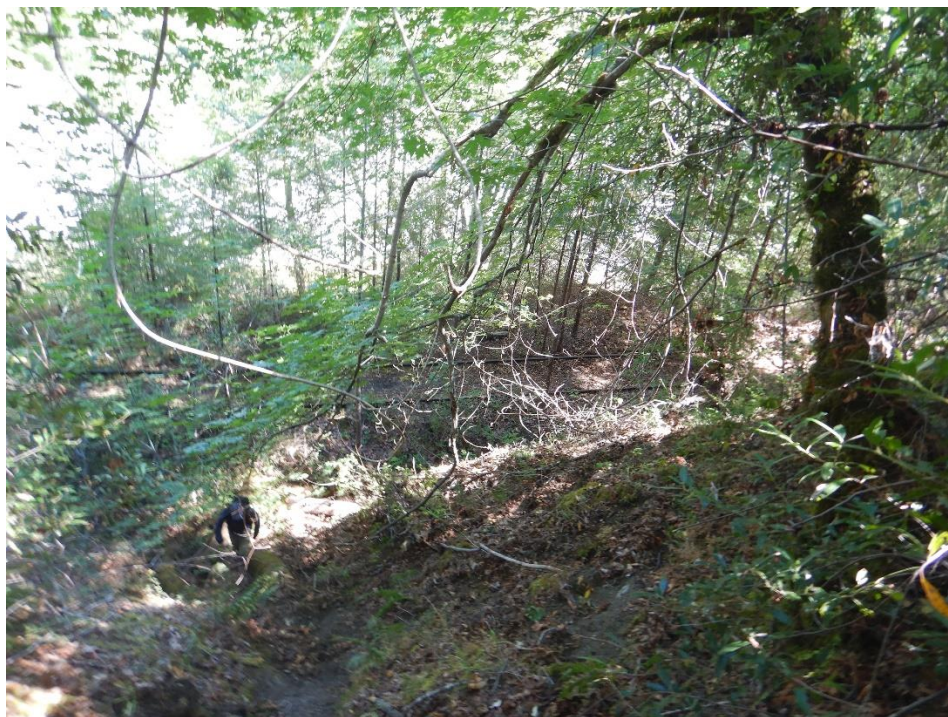
Photo 5—Looking north along flow path of channel pictured in previous image. A channel is not visible.

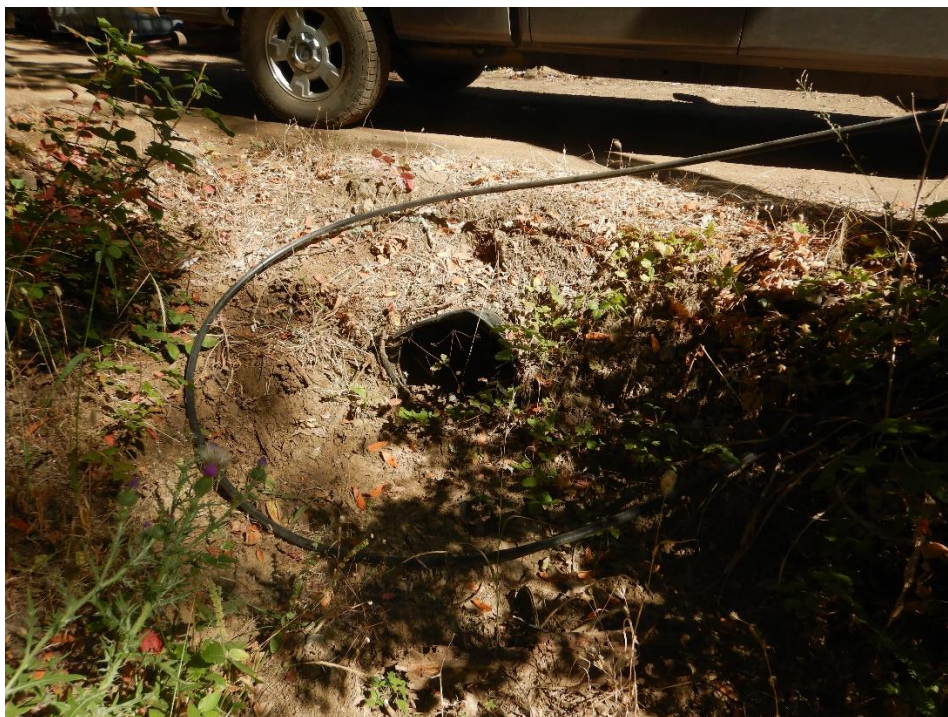
I walked east and observed a crushed culvert at WQ 3 with sediment aggrading at the inlet. I looked for the outlet from the road, but it was obscured by vegetation. I observed waste associated with cannabis cultivation in the vicinity of where I anticipated finding the culvert outlet.

Photo 6—Looking north at partially crushed culvert inlet located at WQ3.

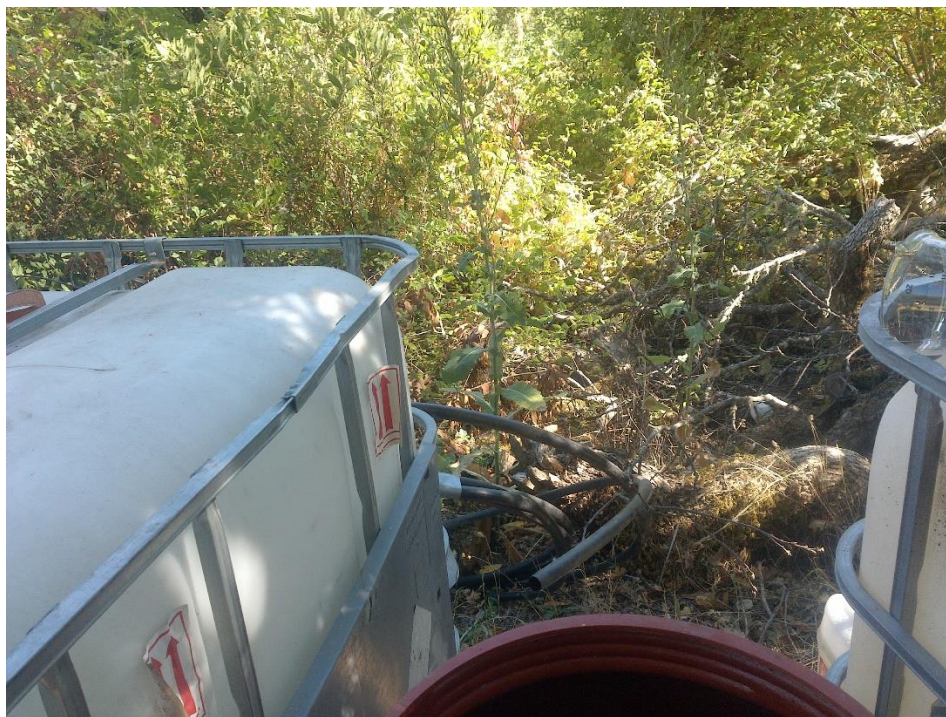
Photo 7—Looking north at cannabis nutrients and waste pipe in the vicinity of anticipated outlet for culvert pictured in previous image.

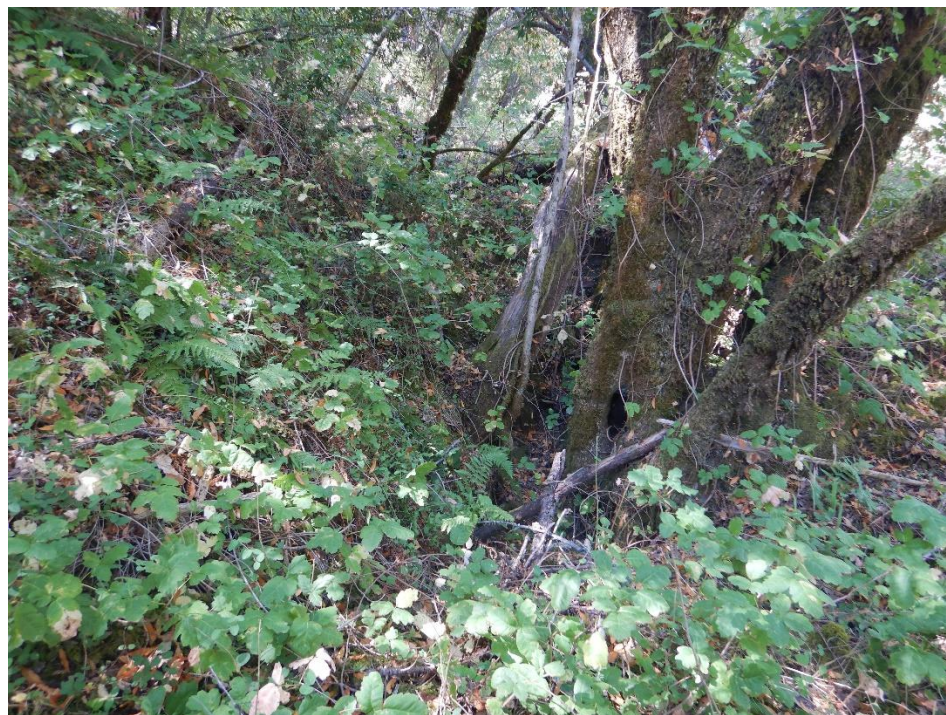
I walked east and observed the road crossing a watercourse at WQ4. The culvert at this location was appropriately aligned with the channel bed and I did not observe any evidence of watercourse scour associated with the culvert.

Photo 8—Looking south and upstream from culvert crossing at WQ4.

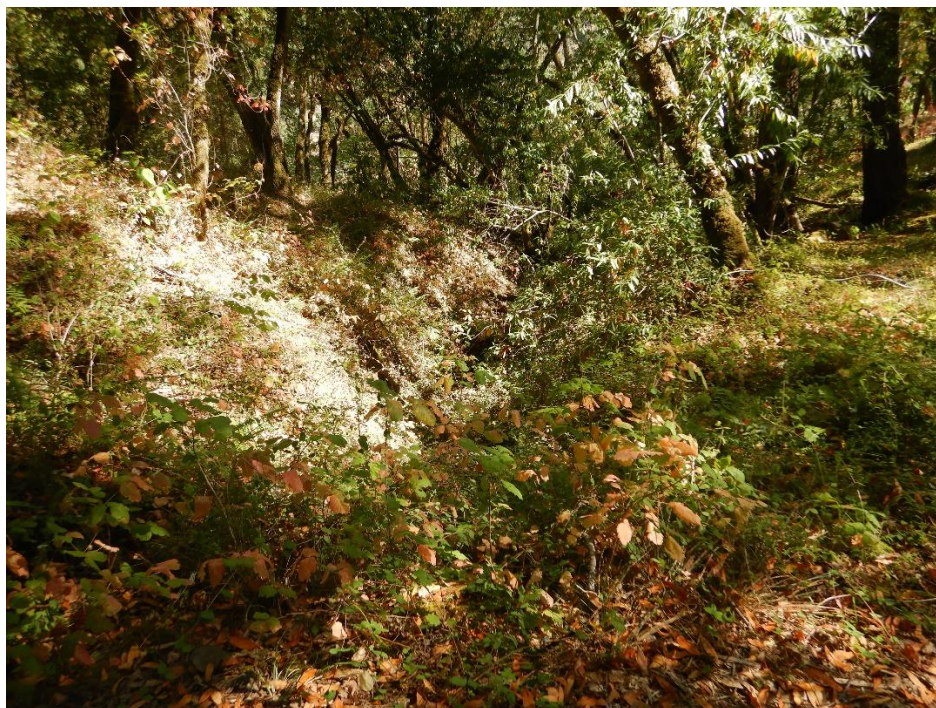
Photo 9—Looking north and downstream at culverted watercourse at WQ4.

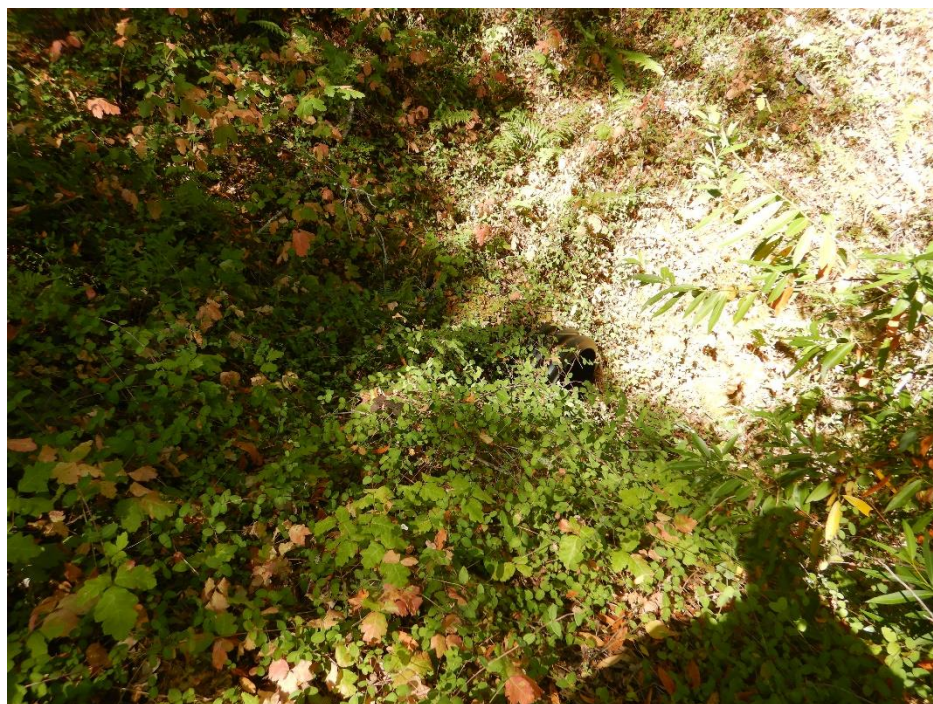
Photo 10—Looking west at culvert located at WQ4. The culvert is a corrugated plastic pipe, less than 10 years old, approximately two feet in diameter and well aligned with the channel bed.
