**CALIFORNIA REGIONAL WATER QUALITY CONTROL BOARD
NORTH COAST REGION**

Cleanup and Abatement and 13267 Order No. R1-2021-0056

**Justin Baldwin and Mia Baldwin as Trustees of the Baldwin J and M Trust
Assessor's Parcel Number 222-071-030-000**

Aerial Images of Humboldt County Assessor's parcel number (APN) 222-071-030

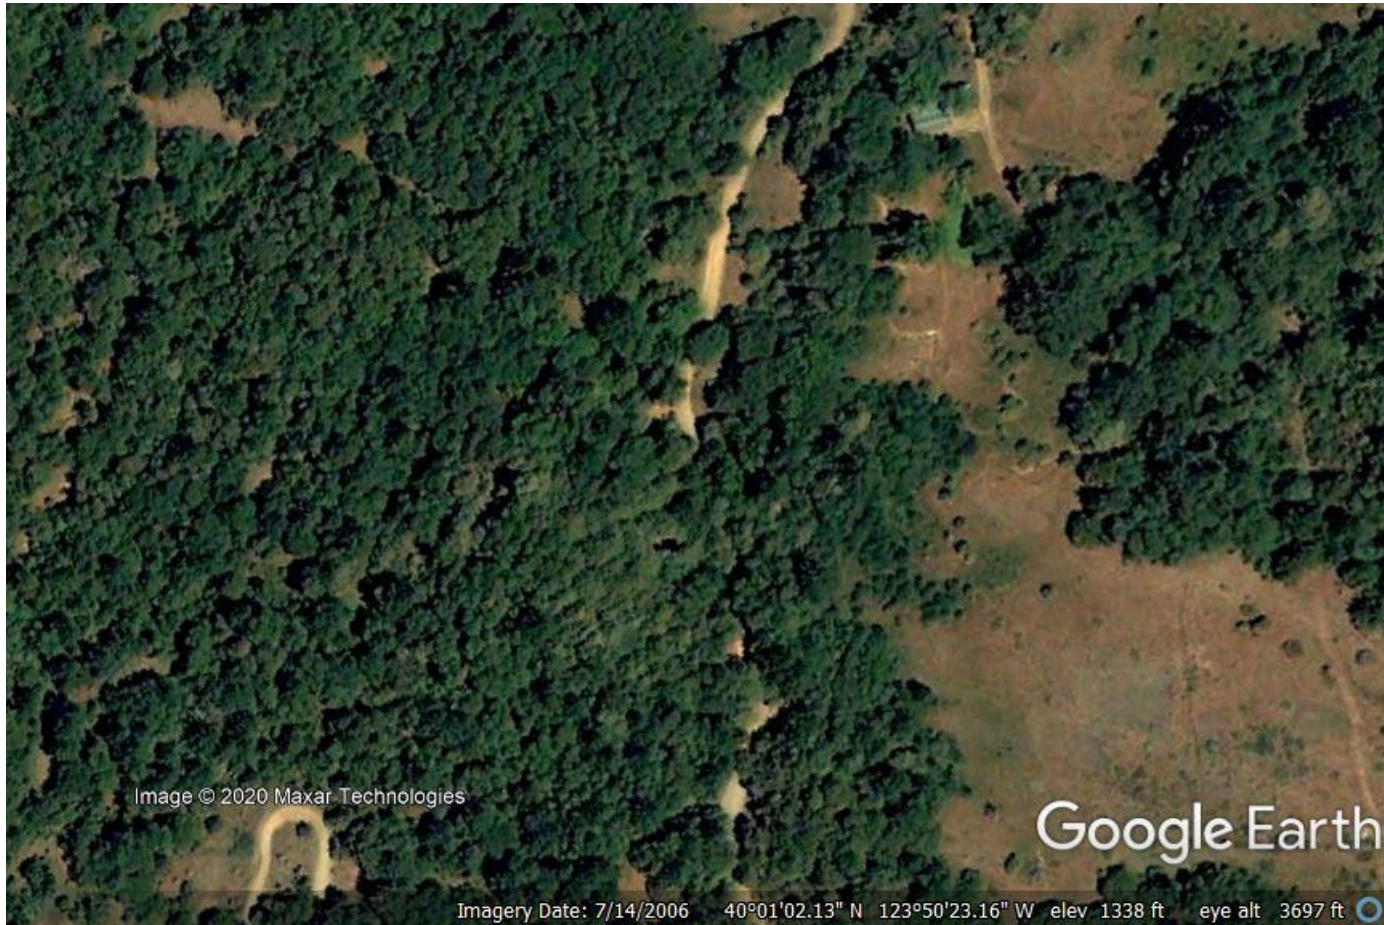
Image dated July 14, 2006, accessed with Google Earth

aerial image 1 – Shows middle-southern portion of property before being developed for cannabis cultivation.

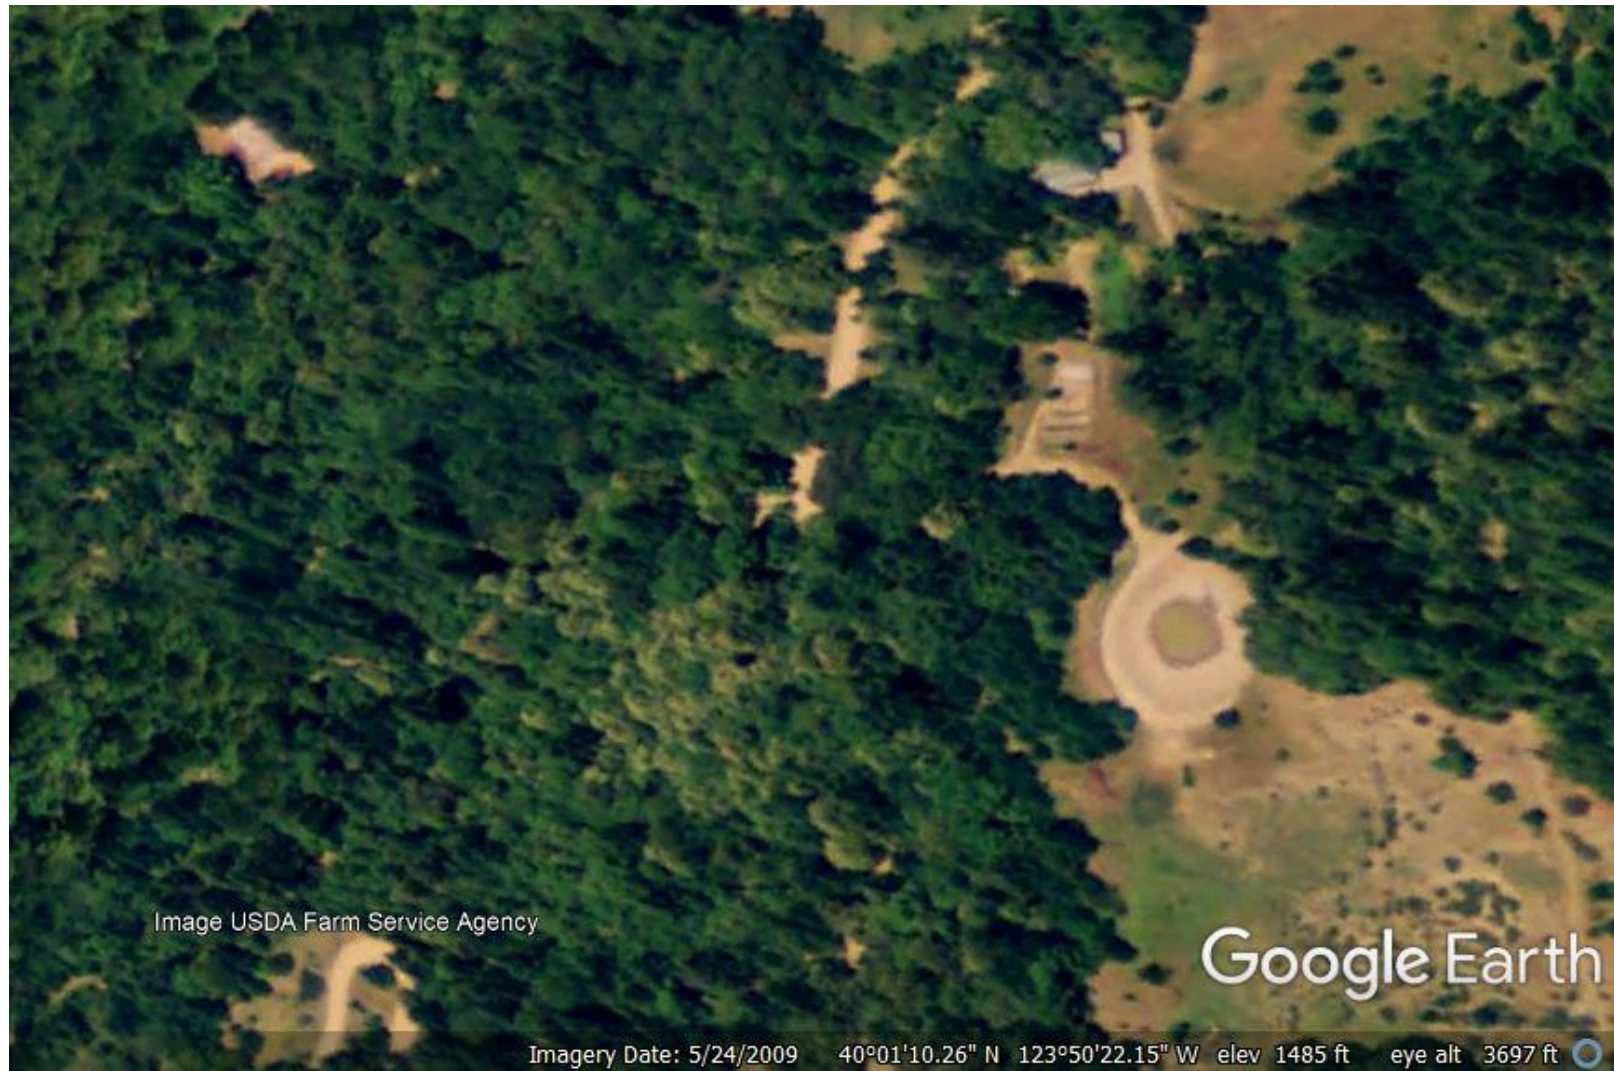
Image dated May 24, 2009, accessed with Google Earth

aerial image 2 – Shows reservoir constructed in middle right of image.

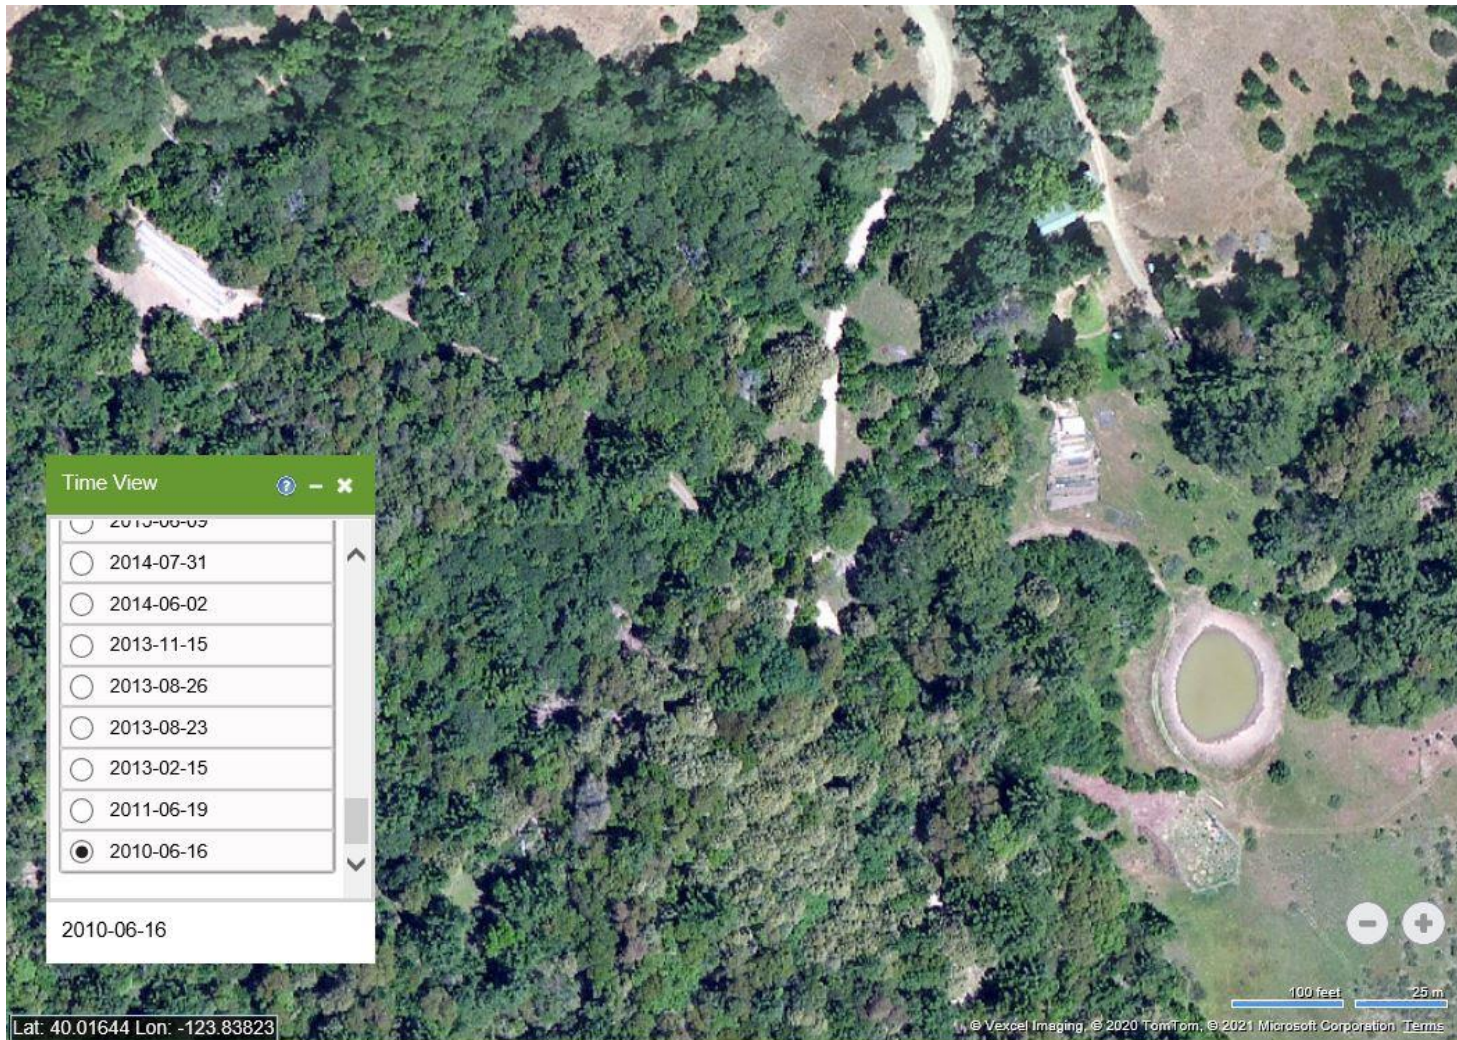
Image dated June 16, 2010, accessed with Digital Map Products' Land Vision service

aerial image 3 – Shows hoop-house construction in the top left of the image and some land disturbance south of the reservoir in the bottom right of the image.

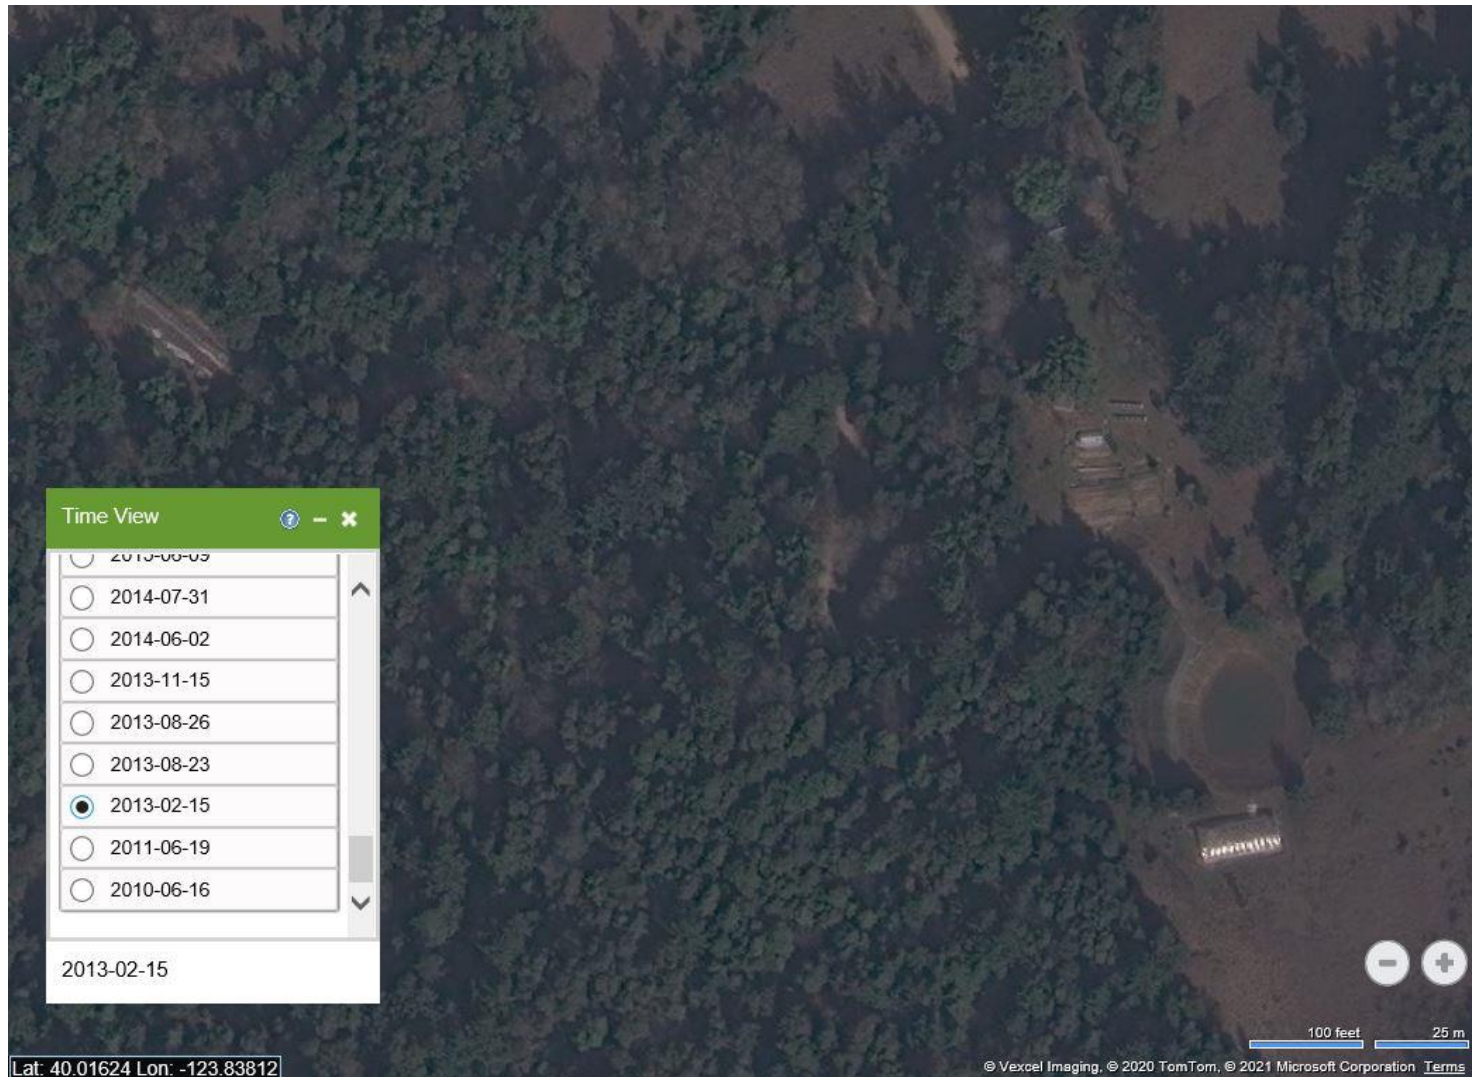
Image dated February 15, 2013, accessed with Digital Map Products' Land Vision service

aerial image 4 – Shows a greenhouse constructed south of the reservoir in the bottom right of the image.

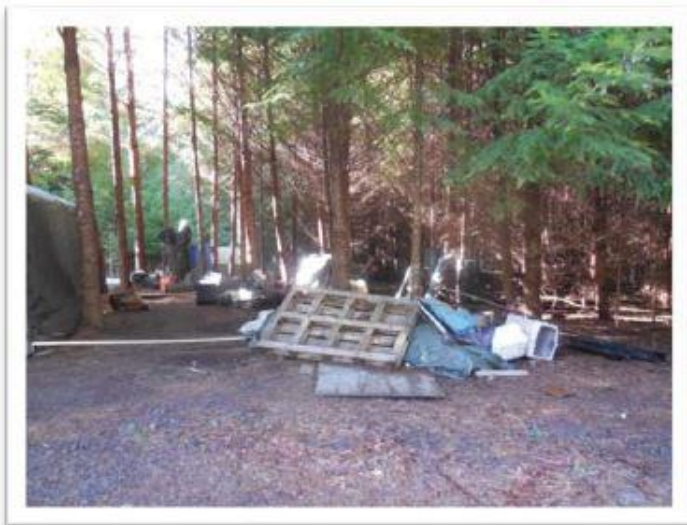
Miscellaneous storage west of pond R1

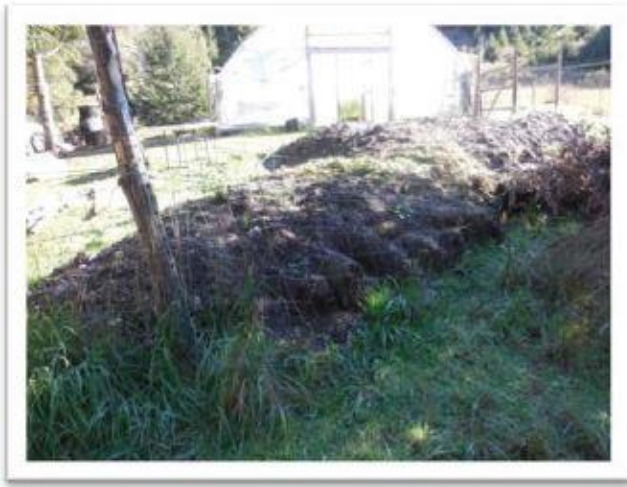
- Greenhouse G8: The greenhouse is sited on a flat area with a fenced grassy area just to the south. There were several small piles of potting soil to the west of greenhouse. The roadway between the greenhouse and the pond was very soft and muddy, and with many tire tracks. Housekeeping and drainage improvements may be warranted in this area.

Greenhouse G8, stockpiled potting soil to the south, muddy road to the west

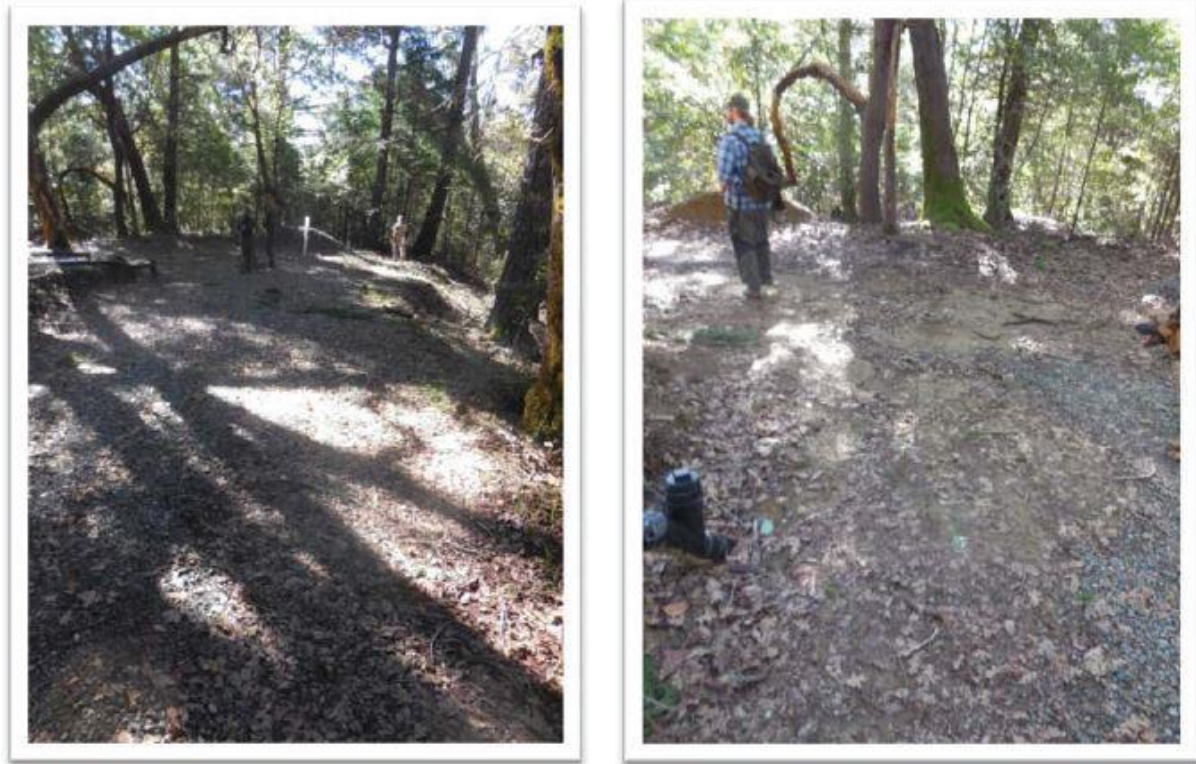
The feature identified as ST3 is a travel trailer located on an access road/driveway that widens out around the trailer and continues south to the outdoor grow area shown as Map Point OG3. Terrain slopes roughly north to south in this area, and we saw evidence of sediment movement, rilling, and gullying as we travelled from feature ST3 to feature OG3 and on downslope toward the property line.

Signs of erosion on the driveway between features ST3 and OG3

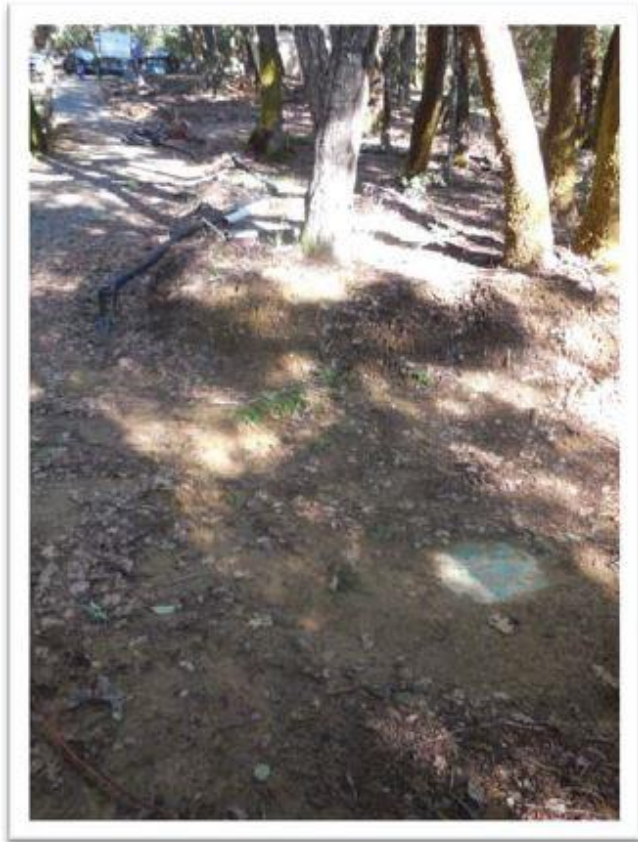
At map point ST3, we observed a travel trailer that appears to be inhabited, another trailer, an ATV, and miscellaneous items including buckets, propane tanks, pipes, materials and equipment, toys, fuel containers, refuse, etc. The team observed a ~4-inch plastic corrugated hose running from the trailer downhill toward feature OG3, connecting to black plastic sewer pipe with a cleanout stub, and just downslope of this, we observed what appears to be the lid of a buried holding tank. This domestic wastewater disposal system may not meet County standards.

Hose leading from the trailer southward to the buried container; lower picture shows the round green container lid.

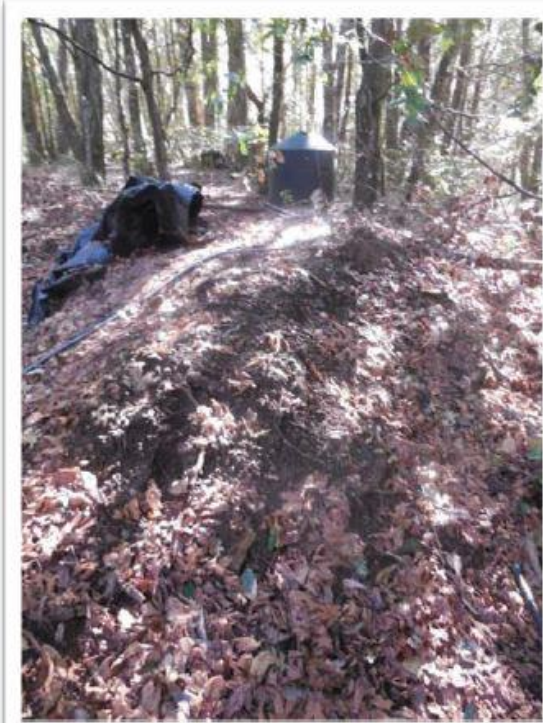
The remaining features on the parcel are located along either side of Sproul Creek. We observed tanks, water bladders, and what appeared intended to be a small lined impoundment, all in the vicinity of ST2, a tarped/poled structure.

Tank and plastic liner near ST2

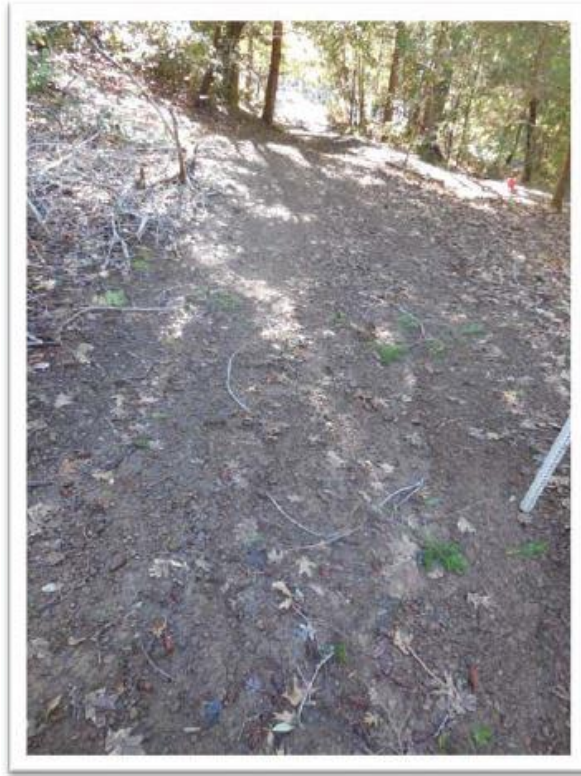
Following waterlines down the access road to the feature at Map Point G1, we observed signs of road surface erosion, rilling, gullying, and sediment transport.

On the roadway between ST2 and G1

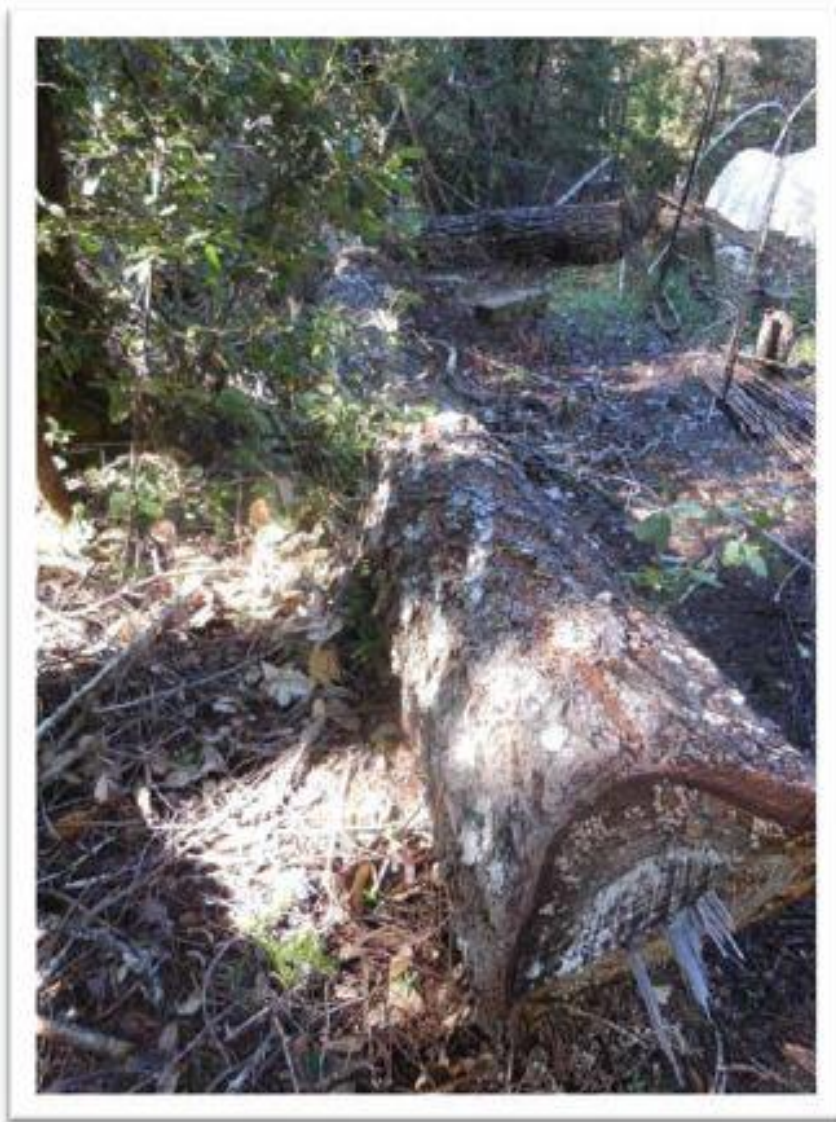
A short distance to the south and east of this feature, we found additional small outdoor growing areas and piles of empty plant containers, and miscellaneous waste materials associated with plant cultivation. Ground cover and vegetation was in fairly good condition in this area, so the potential for sediment delivery to receiving waters from the cultivation areas appears fairly low at this time, although piled vegetation, trees, and soil adjacent to the large grow area at G1 suggests that development of this feature involved a significant amount of vegetation removal and soil disturbance.

Piled soil and slash along the edge of the G1 clearing

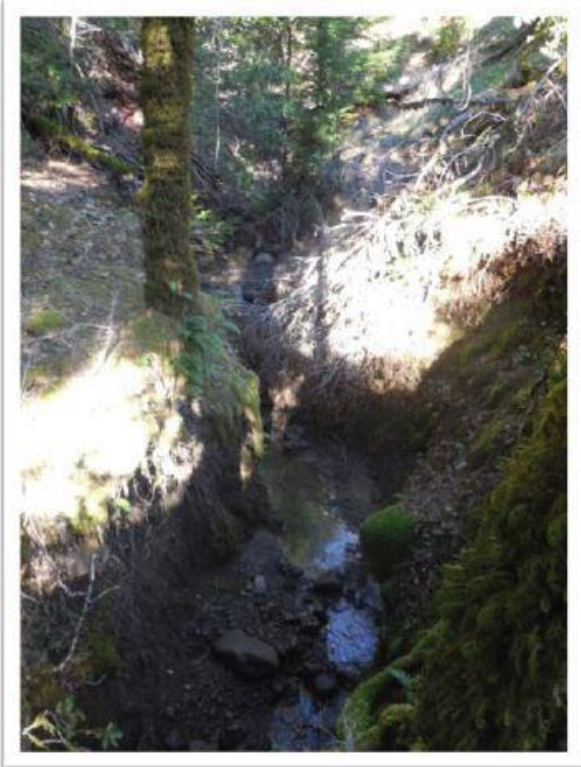
Stream channel alongside OG1

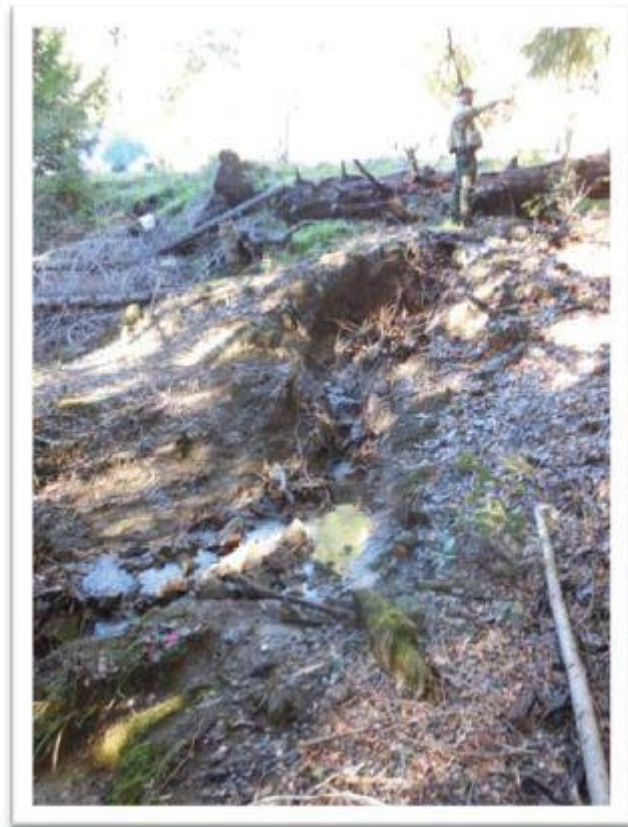
Walking north from Feature OG1 to Feature G5, we observed that the instream channel conditions were extremely poor, with extensive erosion and sediment deposition. [At this point, part of the inspection team split off to inspect the remaining features towards the south edge of the property line (Features identified as I and K, and Ponds 2 and 3 on Figure 2), while the remainder of the team, including Water Quality staff, continued to investigate instream conditions and to head toward Feature G5.]

It appears the stream channel may have been moved or may have diverted in the vicinity of development at and around Feature G5.

Stream channel just south of G5

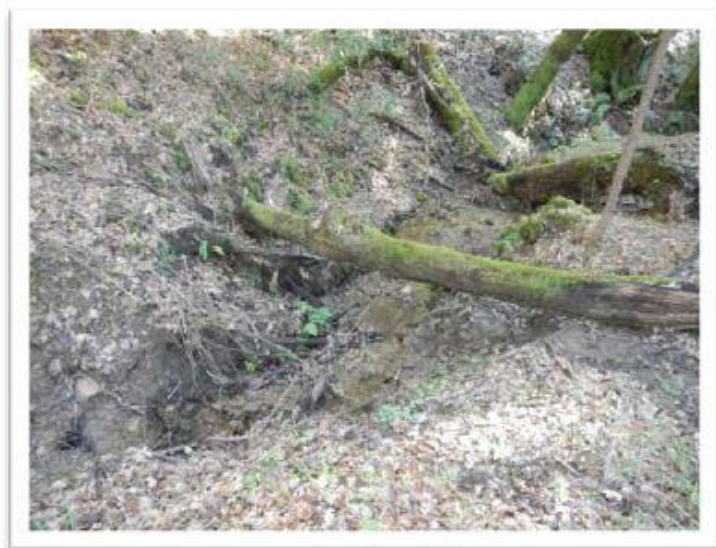
movement, deposition, and discharge into the watercourse. A culvert crossing in this area (C4) also appears to be undersized and silting-in, and shows signs of erosion around the outlet.

Culvert C4 inlet and channel below outlet (photos taken by DFW)

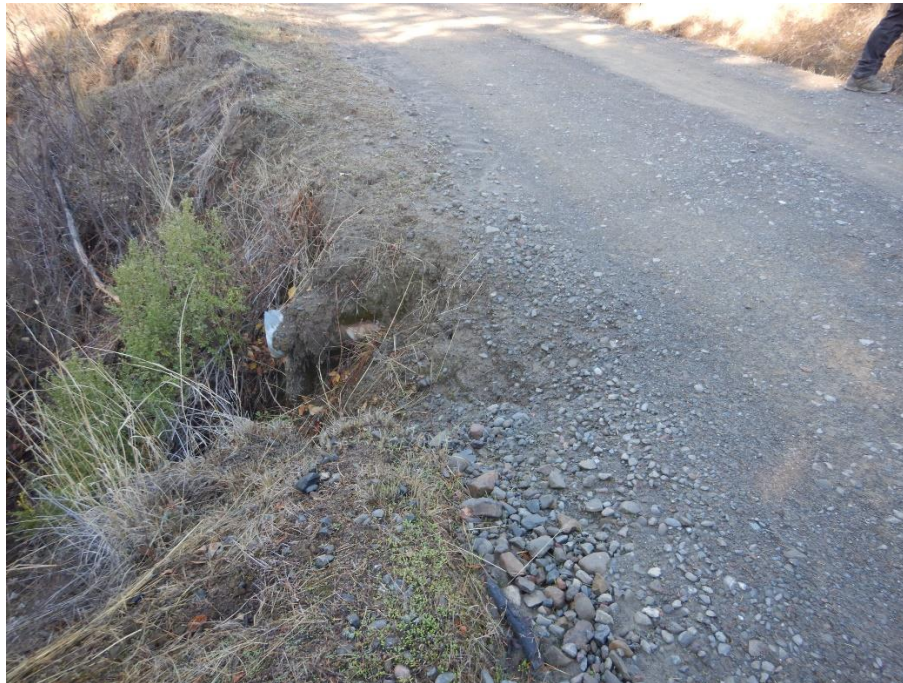
Photo 3—Looking west at culvert outlet located at WQ 3. The culvert is perched, and the channel has incised below the outlet.

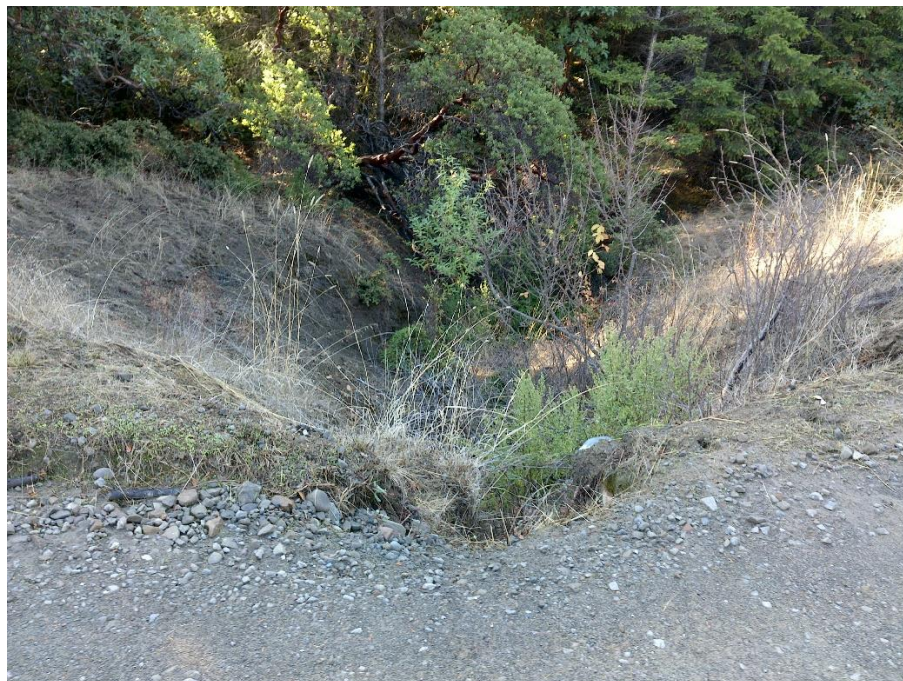
Photo 4—Looking south and downhill at culvert outlet located at WQ 3.

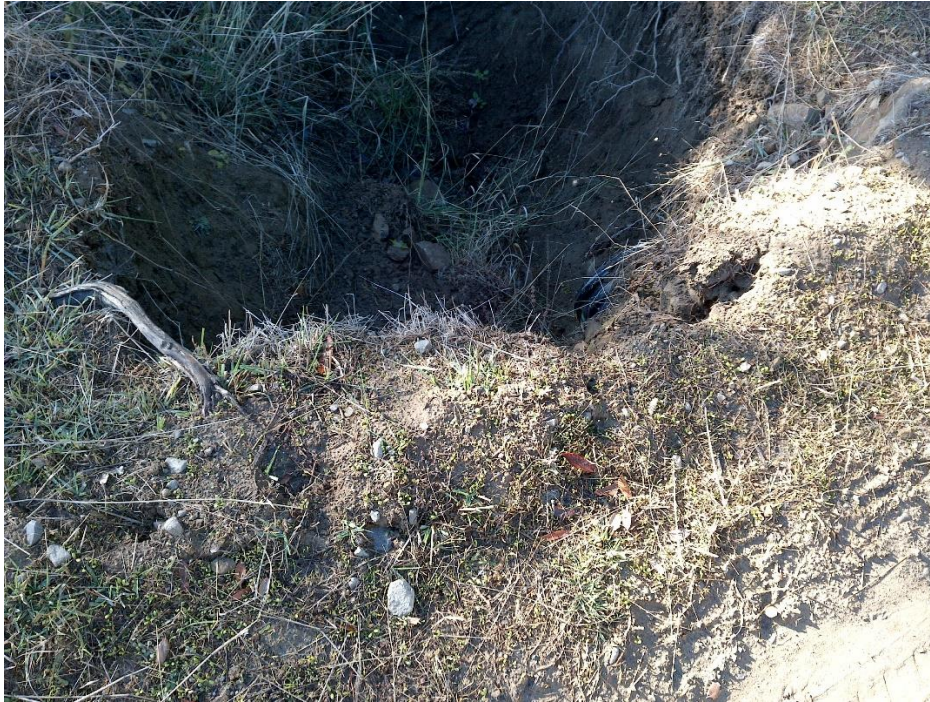
Photo 7—Looking south at culvert outlet at WQ 5. The top of the culvert is visible to the center-right of the image.

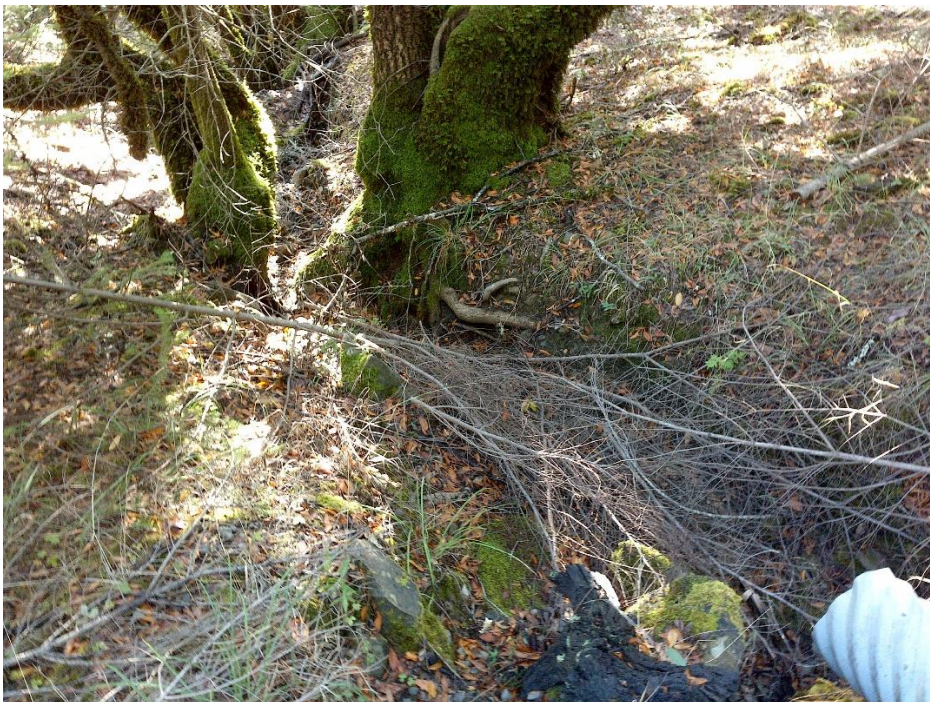
Photo 8—Looking west at culvert outlet at WQ 6.

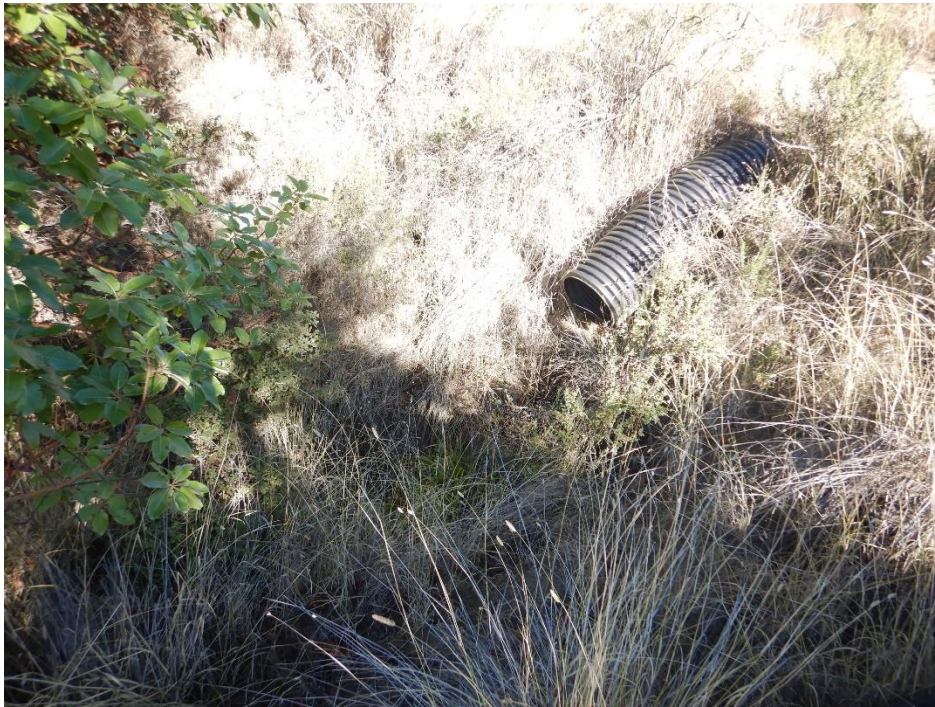
Photo 11—A 24-inch diameter corrugated plastic pipe extending from the road fill at WQ 9.

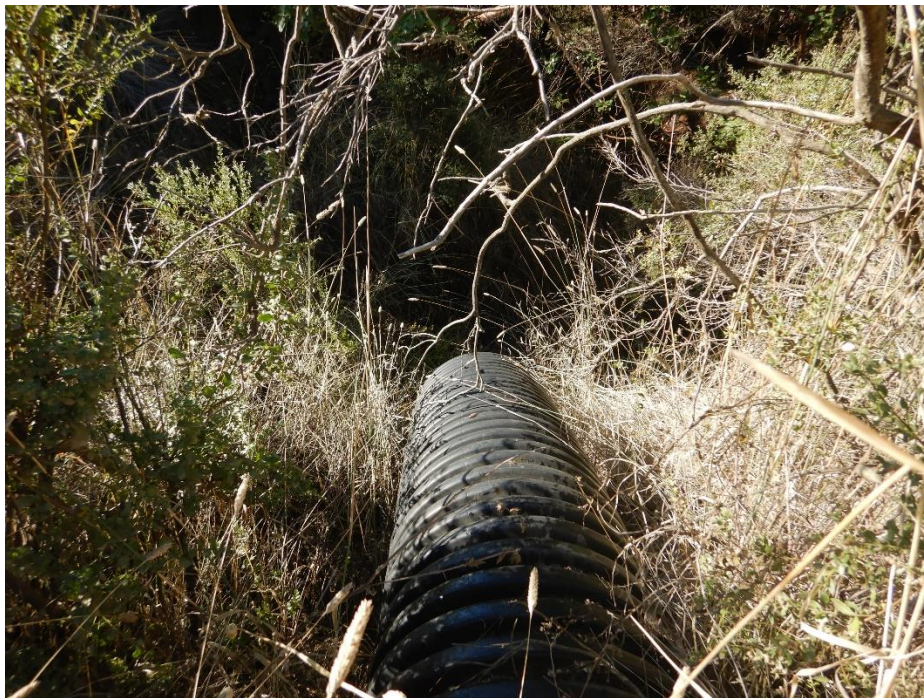
Photo 12 Looking west towards incising watercourse downstream from pipe at WQ 9.

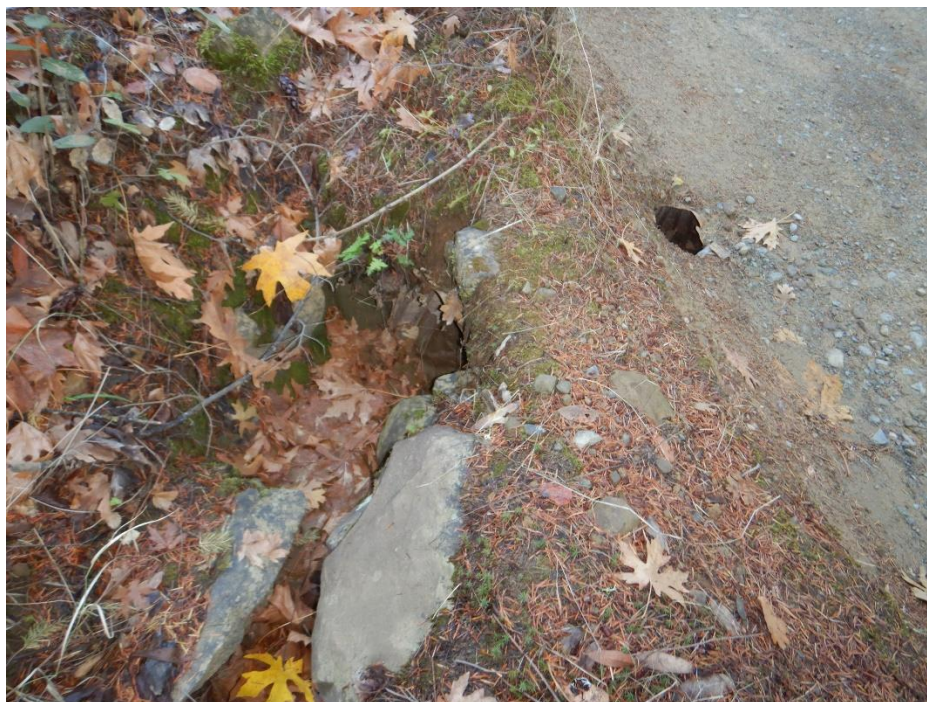
Photo 13—A hole in the road surface connecting to ditch relief culvert below the road located north of WQ 10.

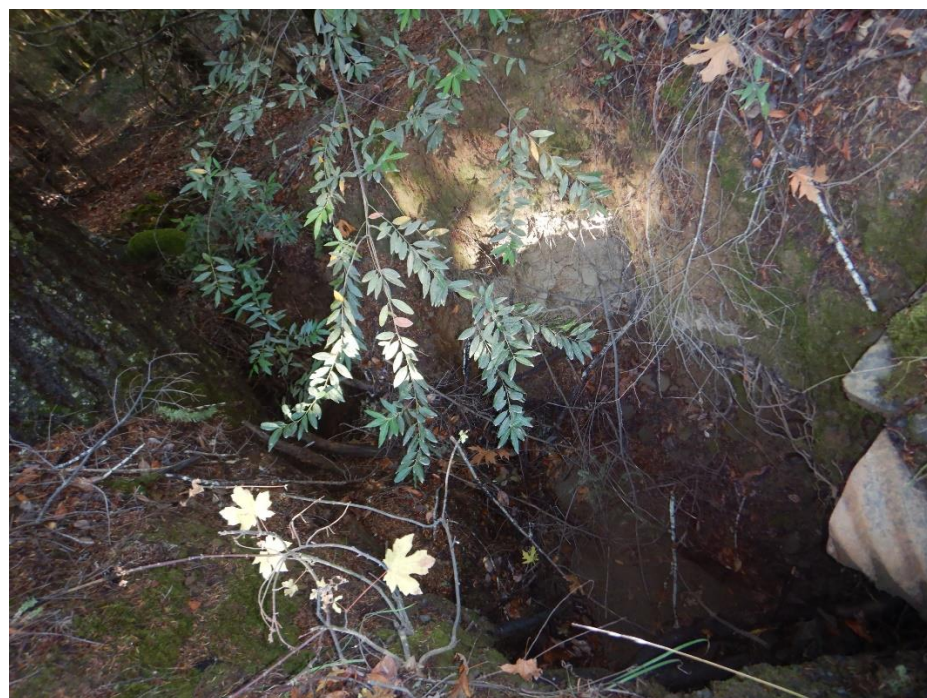
Photo 14—A 12inch diameter culvert perched above a scoured watercourse at WQ10.

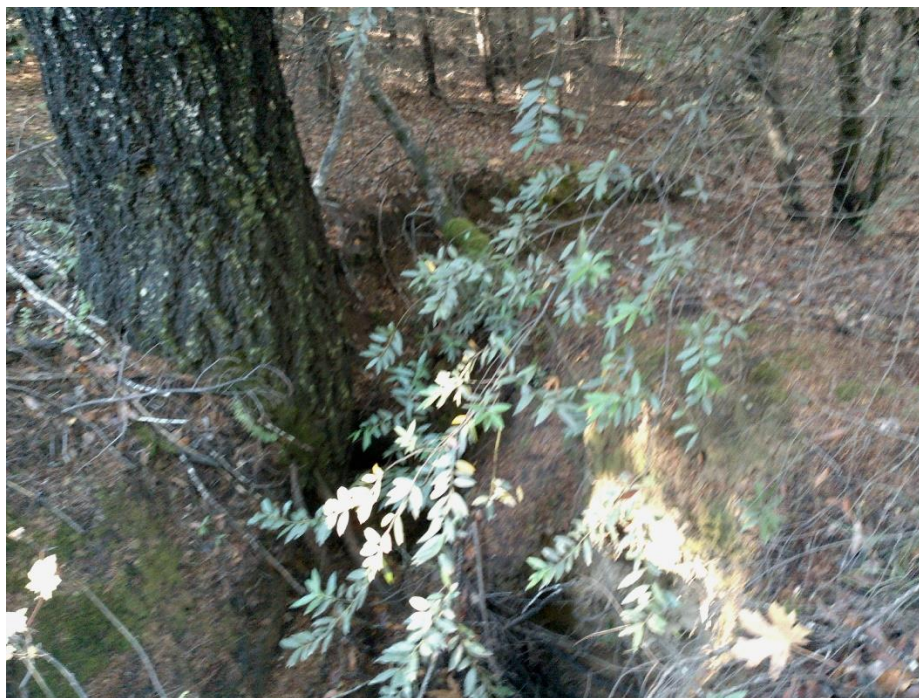
Photo 15—The watercourse downstream from culvert pictured in previous image at WQ 10.

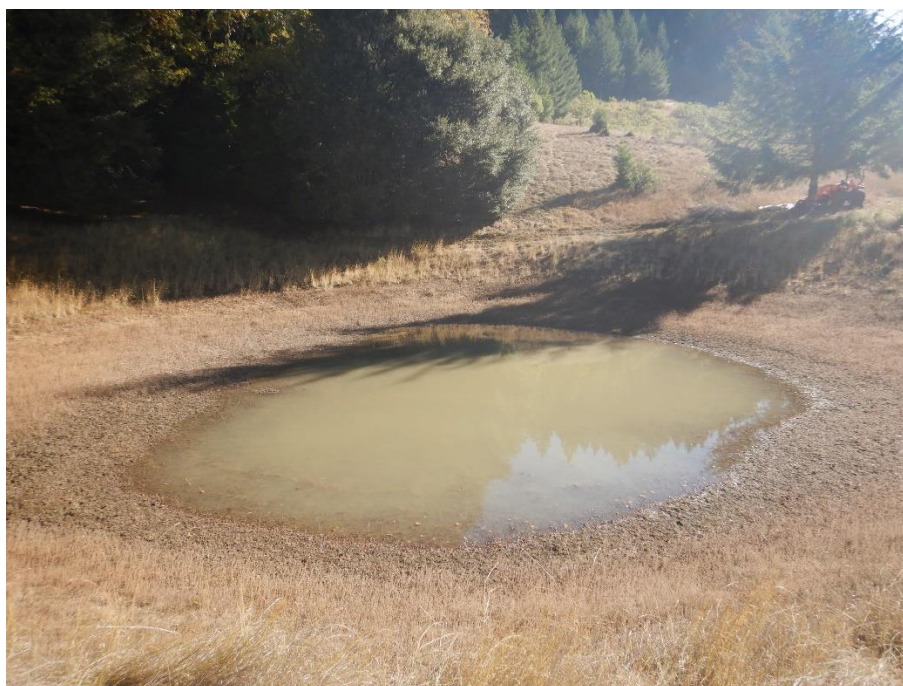
Photo 16—Looking east at the reservoir located at WQ 11.

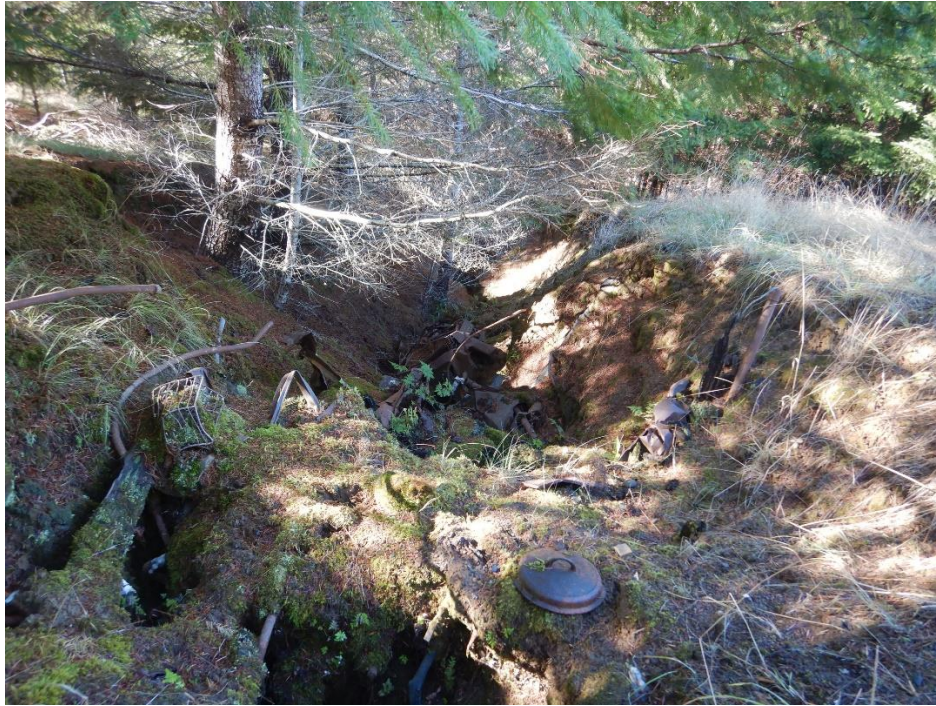
Photo 23— Looking west and downstream at scrap metal in a watercourse at WQ 14.

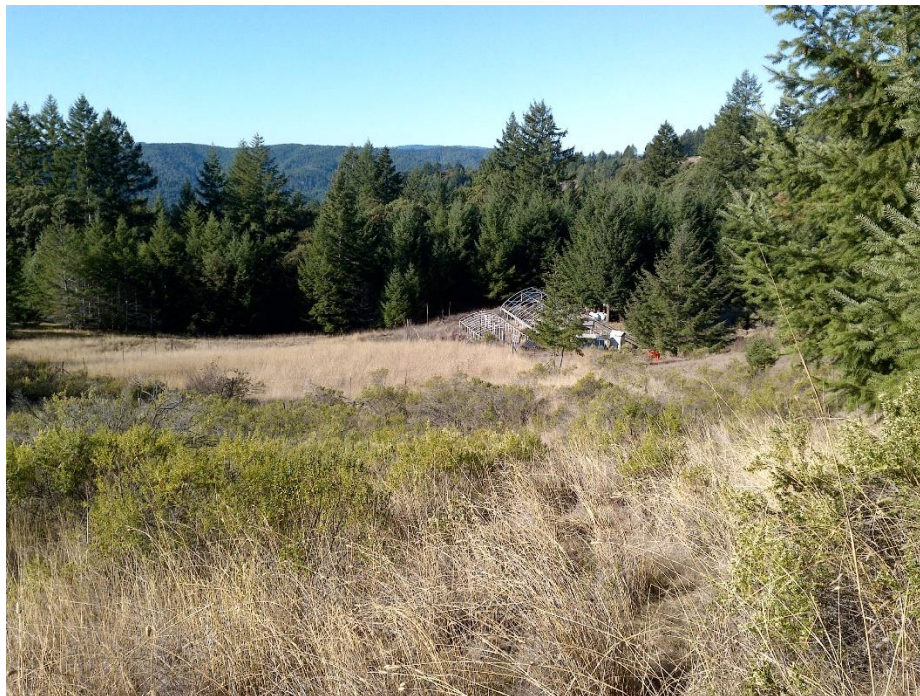
Photo 24— Looking west towards greenhouse located at WQ 15 from legacy road north of WQ 13.

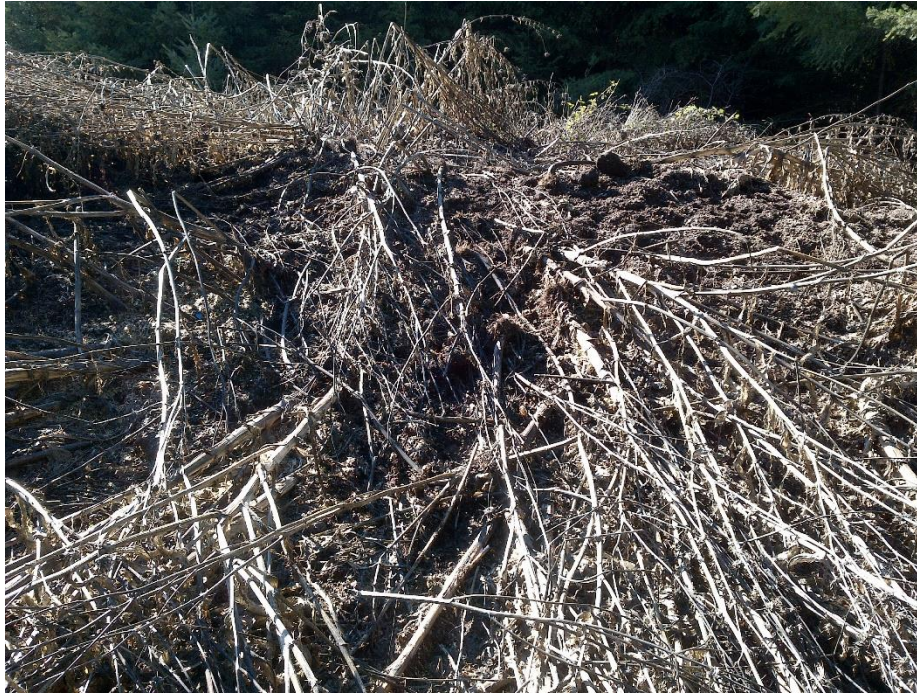
Photo 25—Uncontained potting soils southwest of greenhouse located at WQ 15.

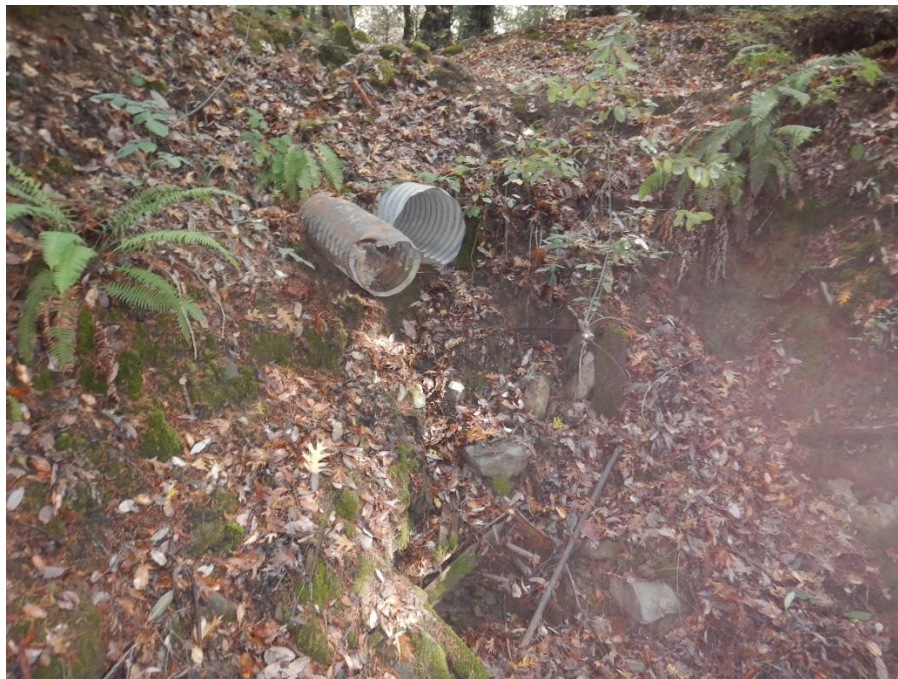
From WQ 14, we walked to the greenhouse located at WQ 15 (Photo 24) and I observed the large pile of potting soils, that is identified in the 2015 Inspection Report, remained behind the greenhouse (Photo 25). We then walked north to the reservoir outlet at WQ 11 and followed the receiving waters west where I observed a perched and undersized culvert conveying the watercourse across Oak Rock Road at WQ 16 (Photo 26 and Photo 27). This culvert, which was identified as C2 in the 2015 Inspection Report, is too small relative to the size of the receiving watercourse and installed shallow in the road fill resulting in a steep drop at the outlet that was scouring the downstream watercourse.

Photo 27—Looking upstream at the two culverts pictured in the previous image perched five feet above the receiving watercourse at WQ 16.

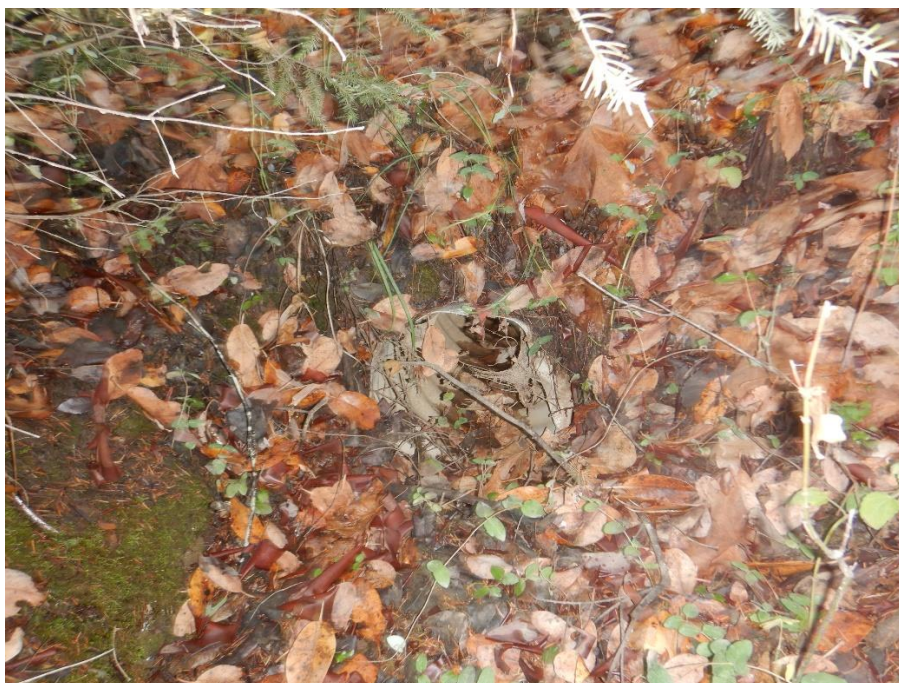
Photo 28—Looking west and downstream at inlet of a 15-inch diameter metal pipe located at WQ 17.
