**CALIFORNIA REGIONAL WATER QUALITY CONTROL BOARD
NORTH COAST REGION**

Cleanup and Abatement and 13267 Order No. R1-2021-0056

**Justin Baldwin and Mia Baldwin as Trustees of the Baldwin J and M Trust
Assessor's Parcel Number 222-071-030-000**

Aerial Images of Humboldt County Assessor's parcel number (APN) 222-071-030

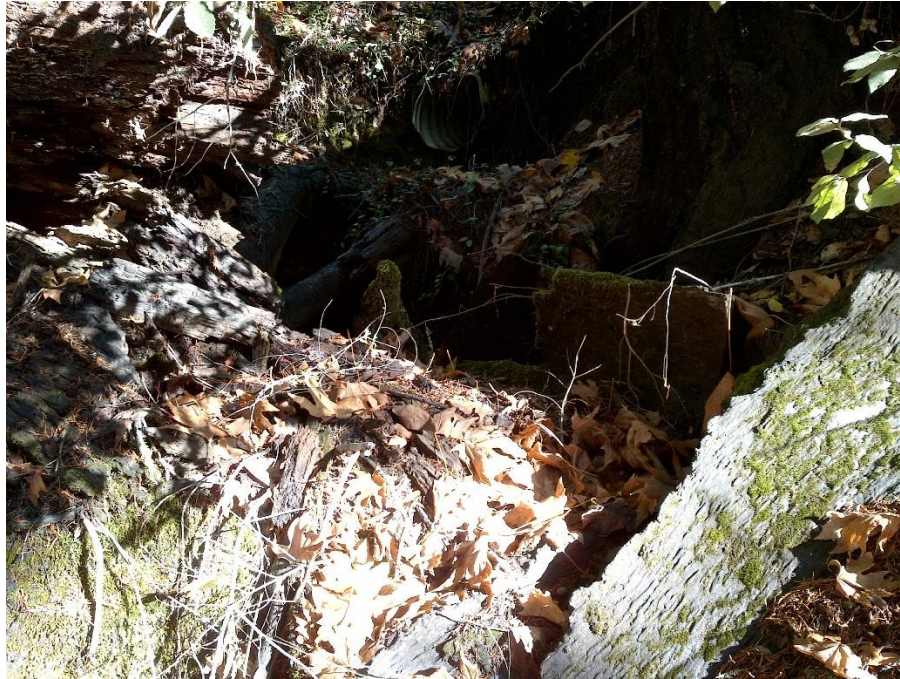
We continued south and I observed two more culverts that appeared undersized at WQ 17 and WQ 18 (Photo 28 thru Photo 31). Further south, Oak Rock Road passes the property boundary and loops back north onto the property. I observed a long section of road from WQ 19, to the north, without drainage before an inboard ditch directs surface water over the road and towards a tributary to Sproul Creek in the vicinity of WQ 20 (Photo 32 and Photo 33).

Photo 29—Looking east and upstream at WQ 17 where culvert discharges into the receiving water. The culvert, visible in the top center of the image is perched several feet above the channel.

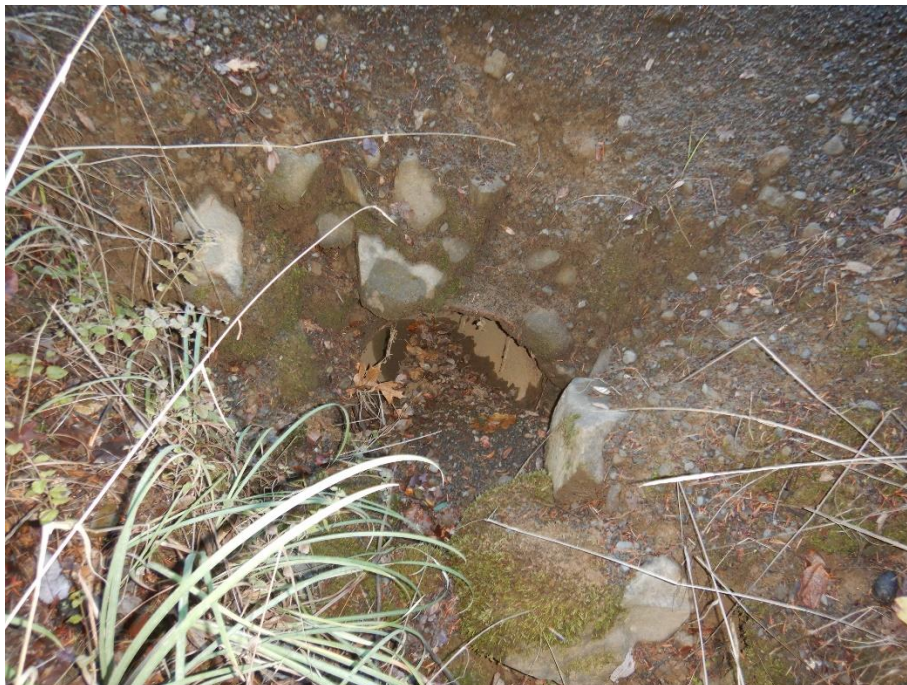
Photo 30—Looking west and downstream at inlet of an 18-inch diameter culvert located at WQ 18.

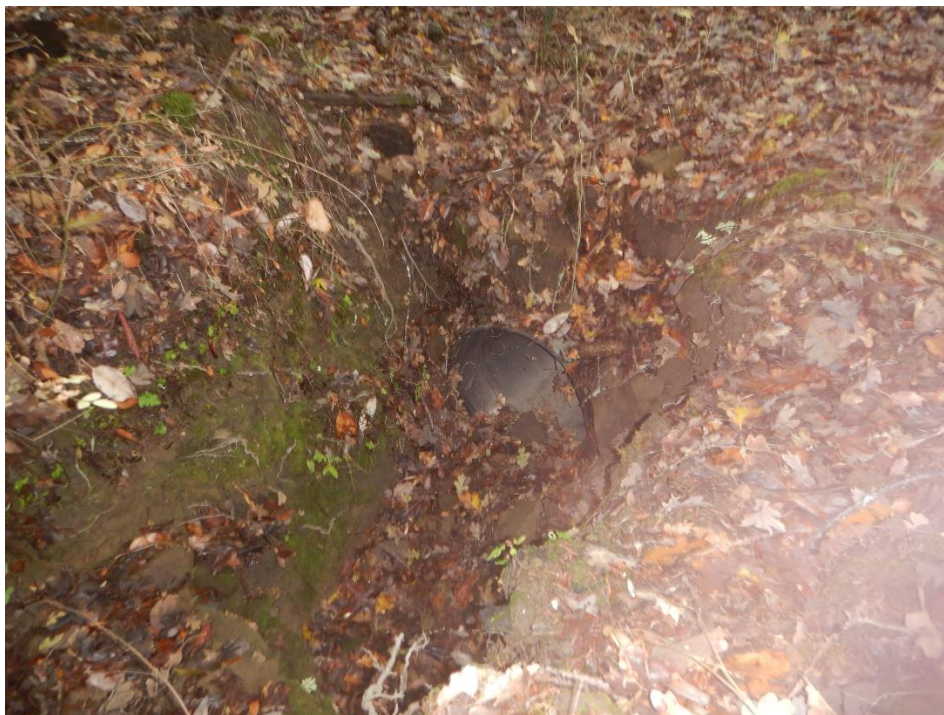
Photo 34—Inlet of an 18-inch diameter culvert at WQ 21.
