North Coast Regional Water Quality Control Board

November 24, 2021

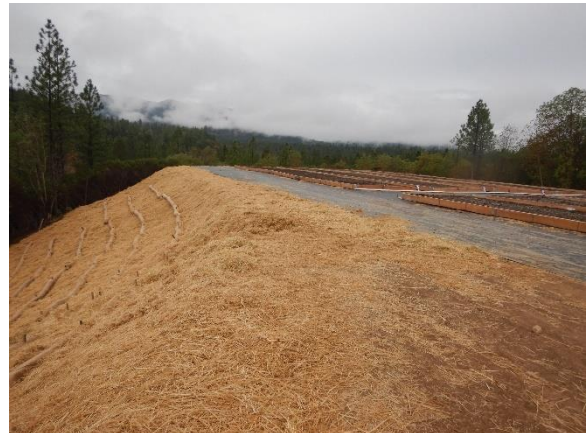
Figure 7. View looking west from top of swale at WQ1, showing from right to left the cultivation beds, the plastic woven fabric underneath, the break in slope, and erosion control measures, including straw and fiber rolls. The slope failure formed a void that now has straw stuffed into and fiber rolls terminate there, leaving the same location vulnerable to reactivation.

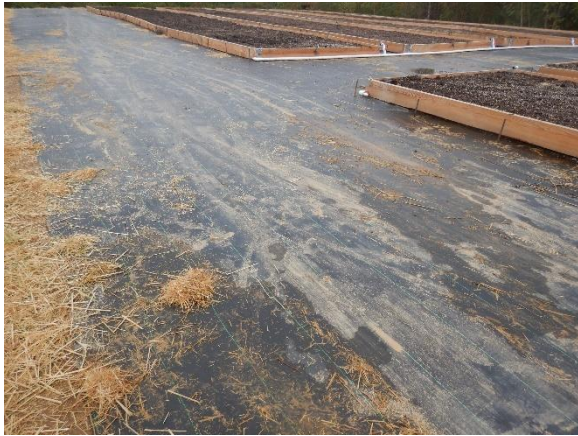
Figure 8. Woven plastic fabric likely holds water which, then drained to initiation point.

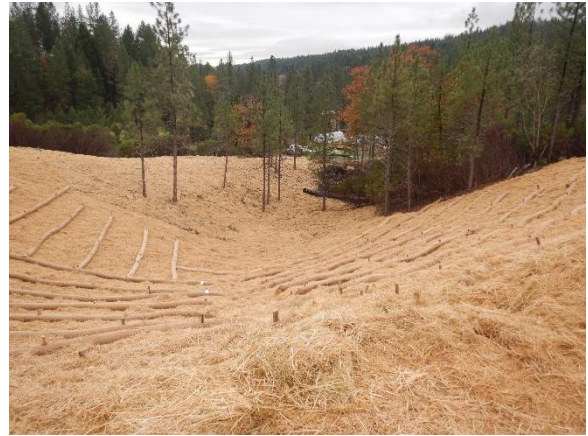
Figure 10. View from top of slope at WQ1. On right top is the location where concentrated water spilled over edge and caused erosion and transport of the recently graded slope material.

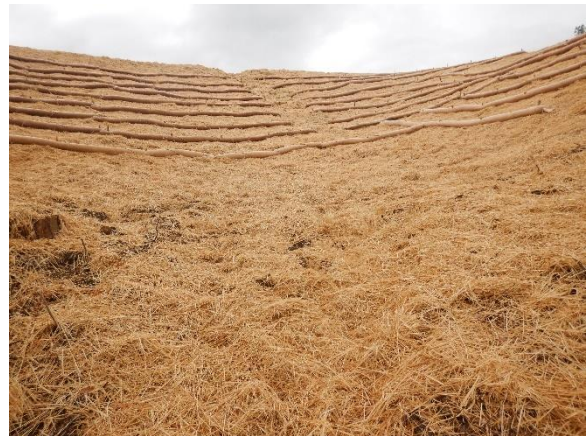
Figure 11. View looking up at slope. The location where the fiber rolls are separated is where concentrated water came down the slope. Straw was pushed in void.

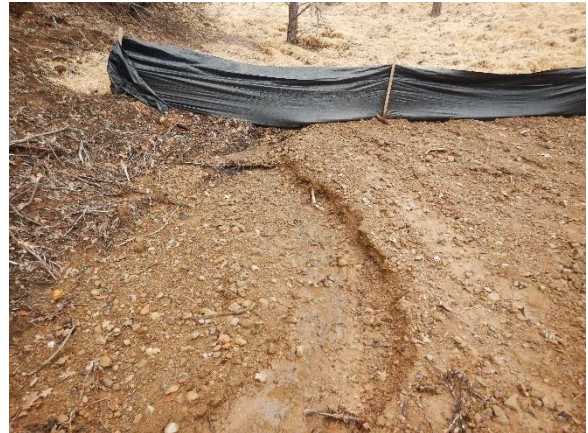
Figure 14. Looking up at the silt fence and settled sediment from the slope failure. Note light color of the fresh deposits.

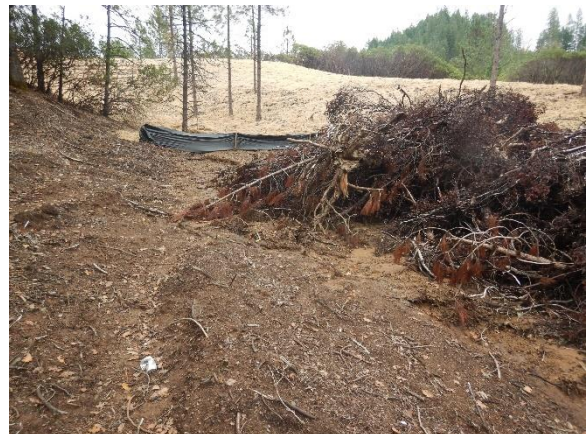
Figure 15. View from swale, looking upslope, with silt fence, brush pile, new deposits and natural hillslope.

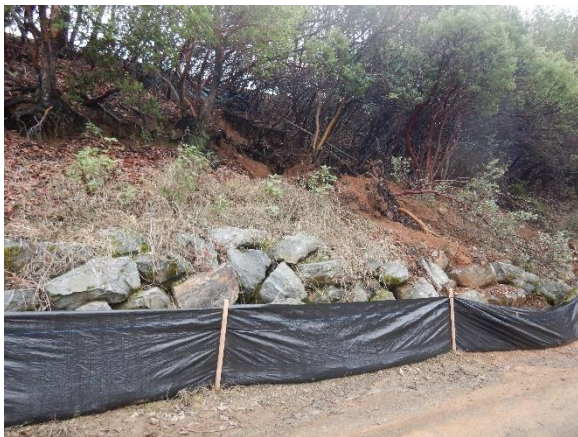
Figure 21. Along the cut bank of the driveway, rip-rap had been placed, according to the landowner prior to his purchase of the Property. Above the riprap is the cleared flat. Runoff from the cleared flat caused fill erosion at the rip rap

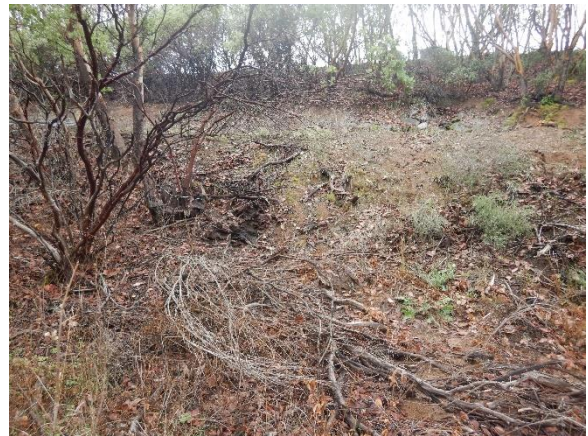
Figure 23. Slope below road at runoff point is sparsely vegetated.
