Subject: Notice of Violation, Transmittal of Inspection Report for the October 11, 2021 Inspection of Mendocino County Assessor's Parcel 037-580-01-00, and Directive to Respond within 30 days

FACILITIES INSPECTION REPORT

Inspection Maps and Photolog for inspection conducted, October 11, 2021

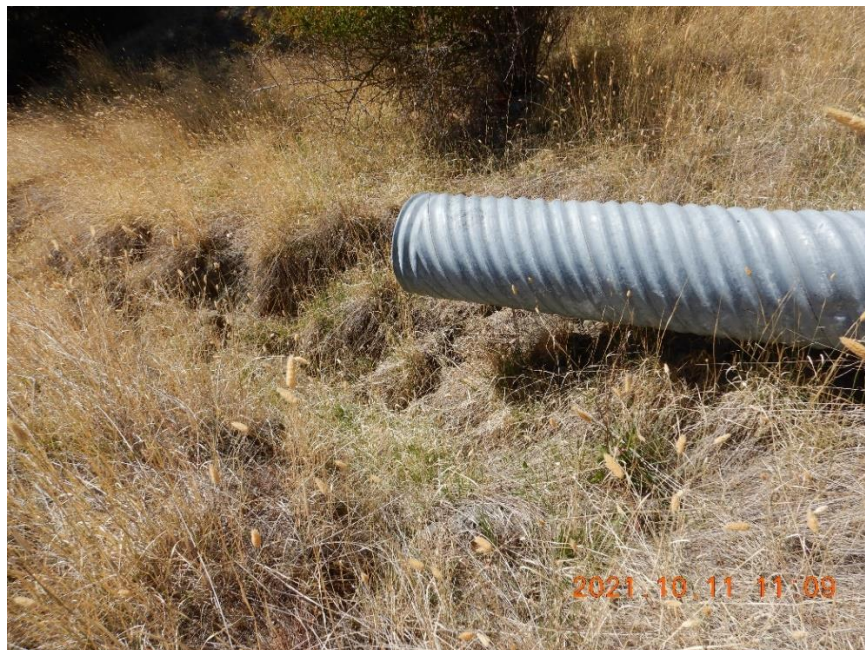
I parked near the northern boundary of the Property and walked west to a reservoir. I inspected the reservoir outlet at WQ1 and observed that it was perched 3.5 feet above a scoured bed. I observed dry grasses vegetating the channel banks. I followed the watercourse that received the reservoir outflow where it crossed a road through a 36-inch diameter plastic pipe that appeared adequately aligned with the channel-bed and close to the same width as the channel upstream.

Photo 1—Looking south at reservoir outlet located at WQ1. The pipe is 18 inches in diameter and perched 3.5 feet above the locally scoured channel. The scoured channel is vegetated and appears to have stabilized given the age of the culvert.

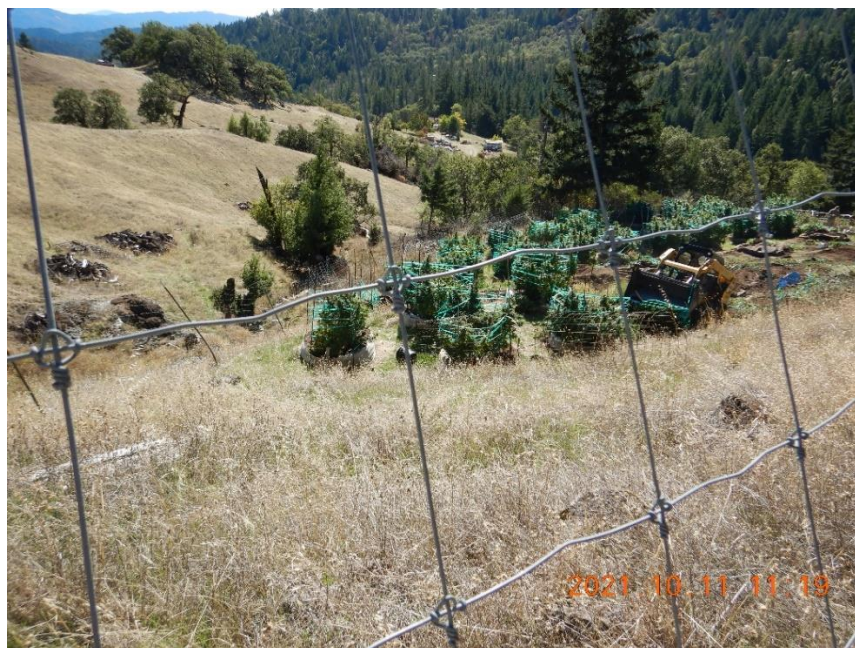
I followed the road to a cultivation area west of WQ2. I observed that the disturbed area associated with cannabis cultivation was less than 50 feet from the watercourse at WQ2. At WQ3 I observed fuel tanks connected to a generator. The fuel tanks did not have secondary containment.

Photo 2—Looking southeast toward WQ2. The topographic form of an ephemeral watercourse is visible in the middle back of the image with a cannabis cultivation area less than 50 feet from the watercourse.

1. Enroll in the Cannabis General Order.
2. Provide secondary containment for all petroleum products.
3. Engage a qualified professional to develop and submit a work plan to restore disturbed areas bordering watercourse at WQ2, and correct/decommission roads and watercourse crossings at WQ4, WQ5 and WQ6 to conform with the Cannabis Policy.
4. Submit application for and obtain 401 WQC from Water Board before performing any instream work.

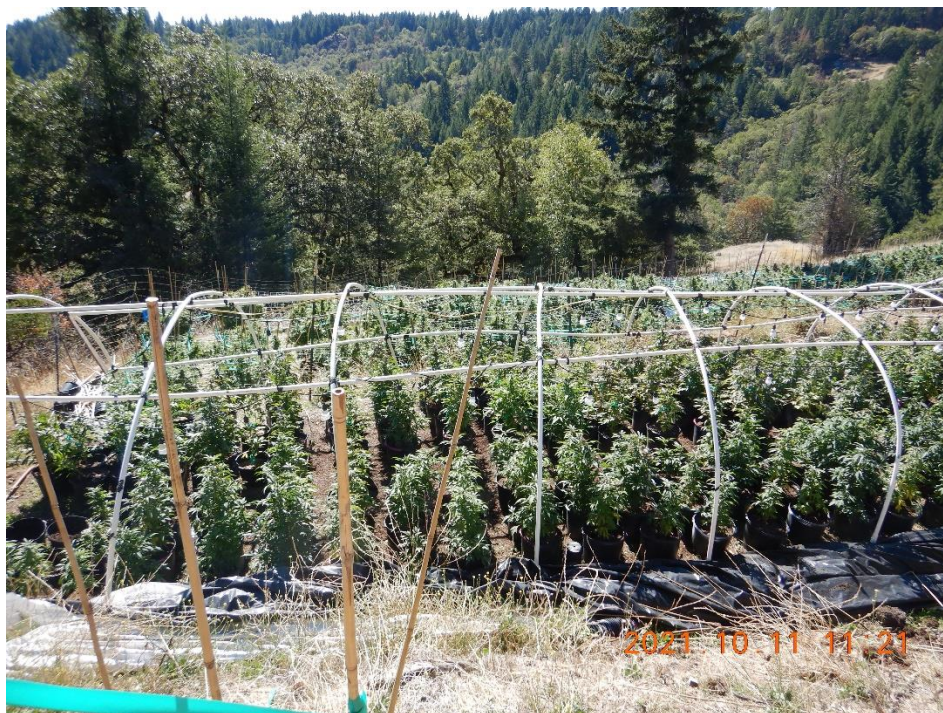
Photo 3—Hoop-type greenhouses with cannabis plants immediately south of cannabis cultivation pictured in the previous image.

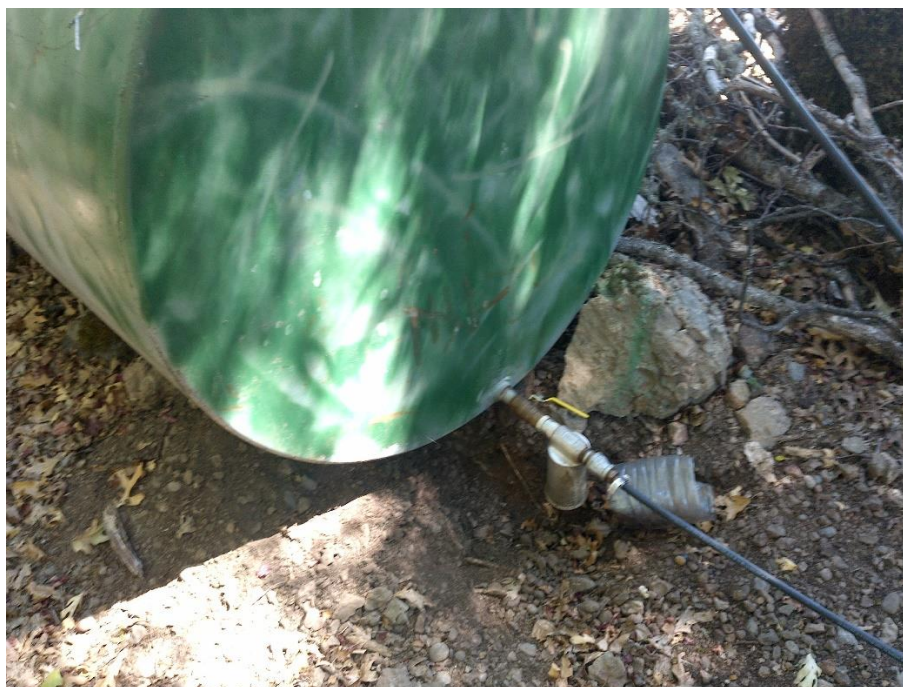
Photo 4—Diesel tanks without secondary containment in the vicinity of WQ3.

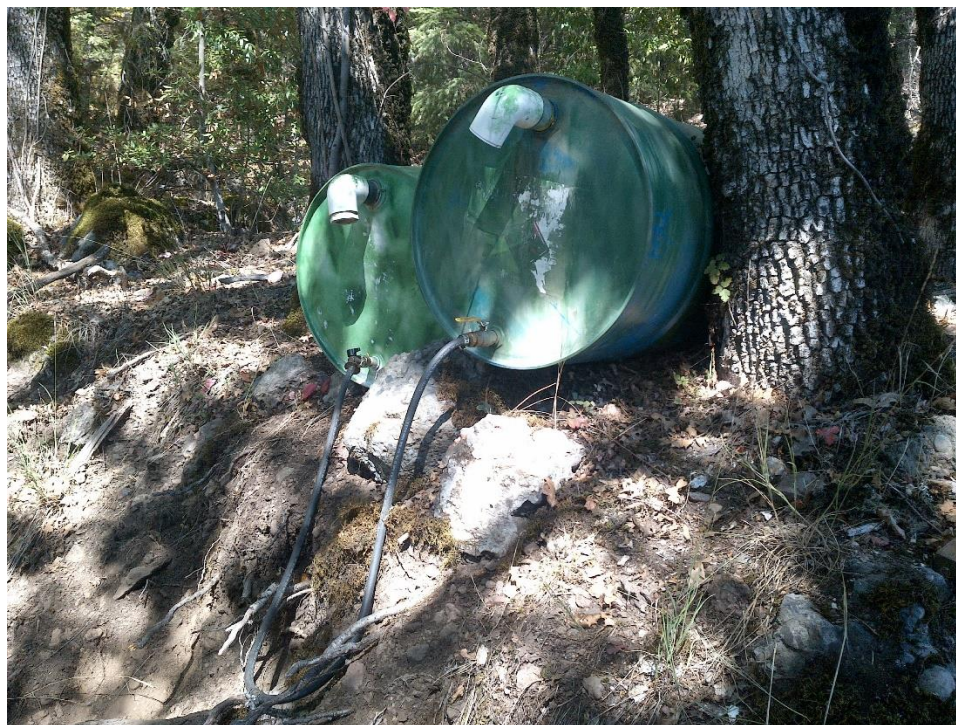
Photo 5—Diesel tanks without secondary containment in the vicinity of WQ3.

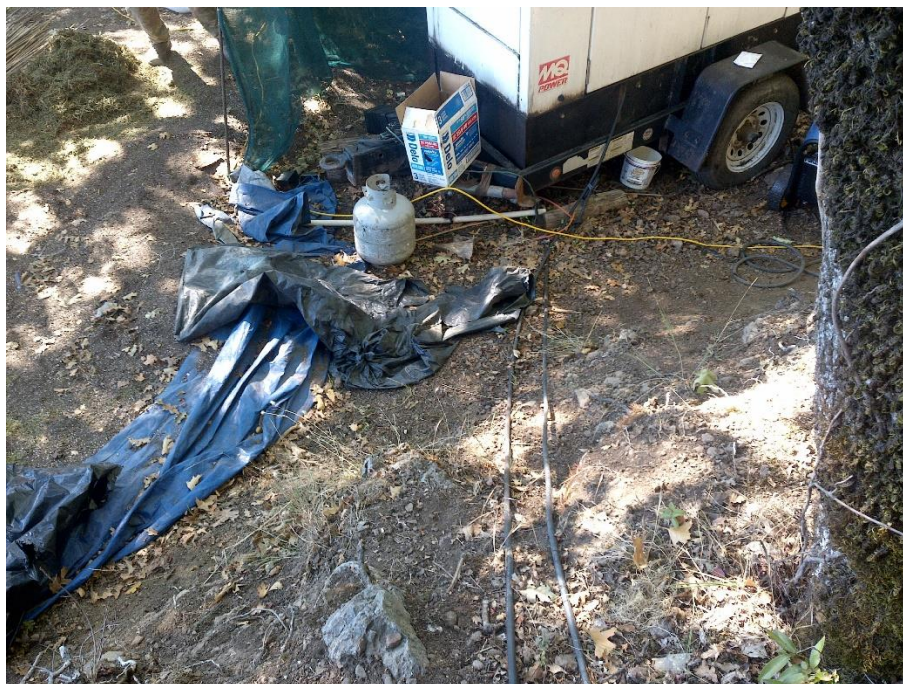
Photo 6—Fuel lines from tanks in two previous images connected to a diesel powered generator in the vicinity of WQ3.

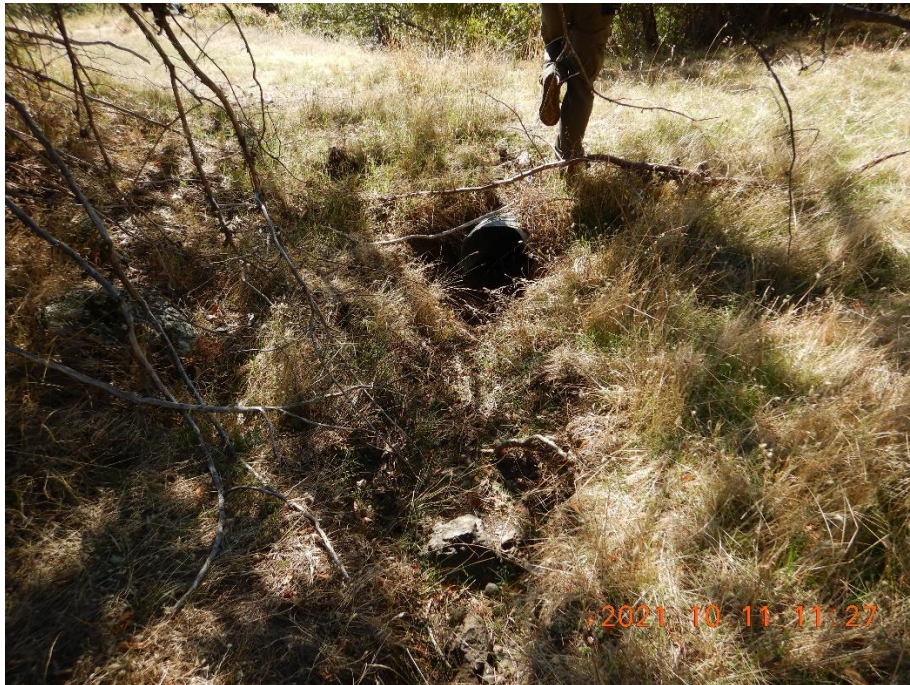
I walked south along the road and observed the road surface was vegetated with dry grasses. At WQ4 I observed an undersized culvert with perched outlet. I observed a one-foot deep scour hole on the road-surface at WQ5 where stormwater had concentrated before discharging to a watercourse crossing the road at WQ6. I observed that the culvert crossing at WQ6 was shallowly buried, narrow relative to the width of the watercourse upstream and perched at the outlet.

Photo 7—Culvert inlet at watercourse crossing located at WQ4. The culvert is 18 inches in diameter.

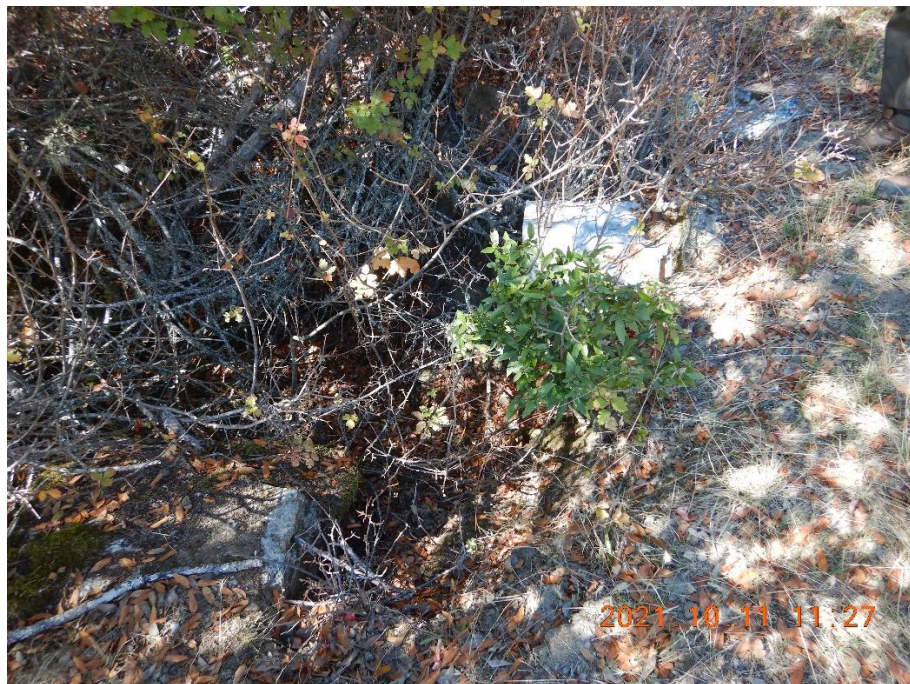
Photo 8—Culvert outlet perched 3.5 feet above the receiving watercourse's bed at WQ4.

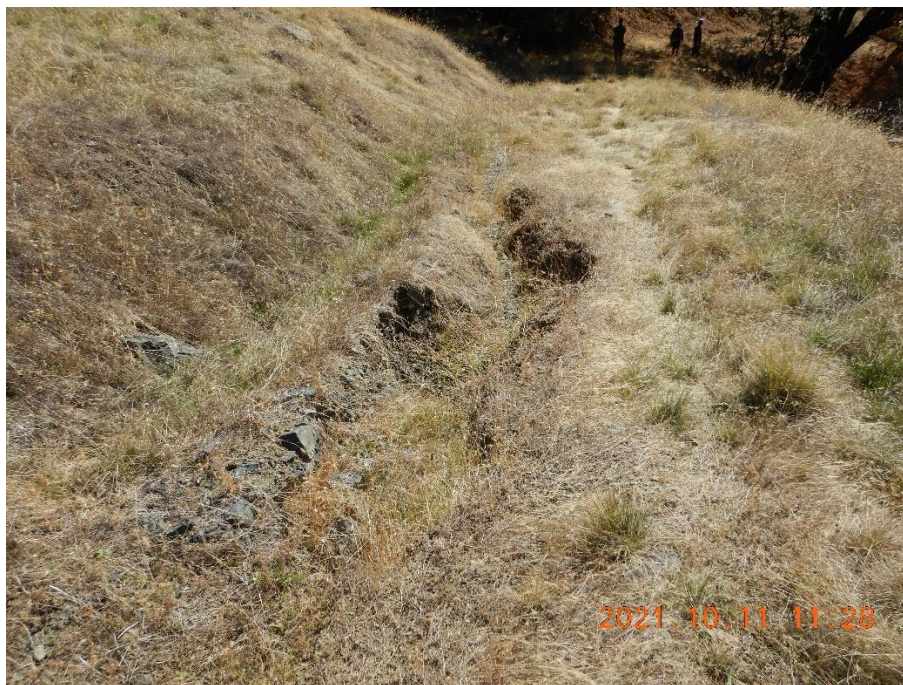
Photo 9—Looking south east at a one-foot deep scour hole on the road-surface at WQ5 where stormwater concentrates before discharging to the watercourse crossing the road at WQ6.

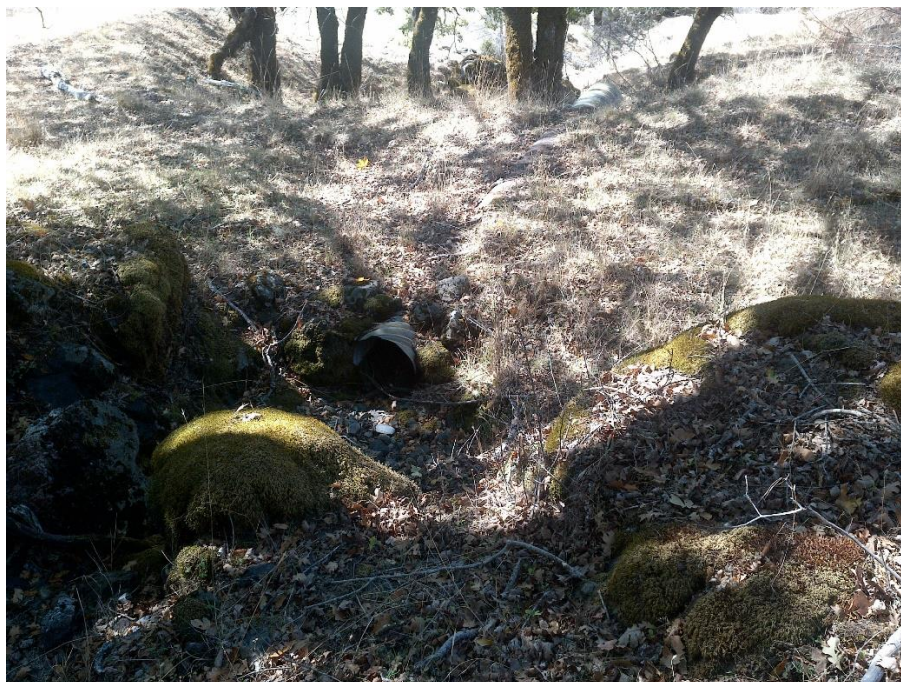
Photo 10—Looking south at a shallowly buried, 18-inch diameter corrugate metal pipe culverting a watercourse across the road at WQ6. The watercourse upslope has a four to 6-foot bank-full width and a substrate consisting of small boulder steps and pools. The culvert outlet is perched two feet above the channel bed.
