North Coast Regional Water Quality Control Board

Subject: **Notice of Violation and Transmittal of Inspection Report for October 11, 2021 Inspection of Mendocino County Assessor's Parcel Number 037-560-08-00**

FACILITIES INSPECTION REPORT

Inspection Maps and Photolog for inspection conducted, October 11, 2021

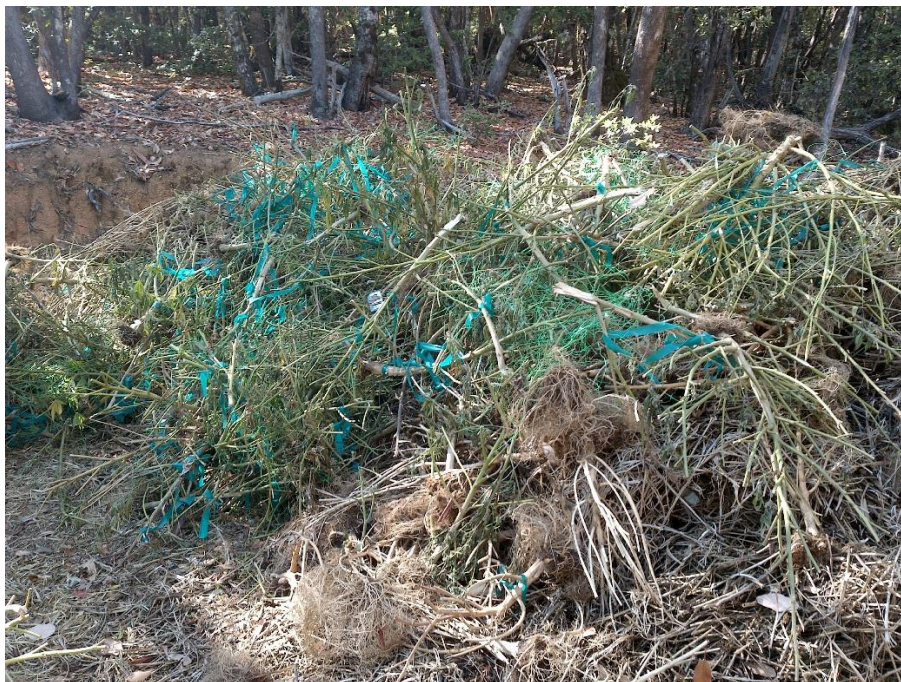
My inspection was associated with a criminal search warrant and I viewed only portions of the Property. See the attached map and photos for locations and details about features of concern to water quality. I accessed the Property from the northwest and parked at WQ1. At this location, I observed a large pile of waste cannabis stalks. I walked along a road to the south and observed a roadside trench cut at the base of a hillslope and the earthen spoils placed on the opposite side of the road. The spoils lacked any cover or BMP to prevent their transport from stormwater.

Photo 1—Pile of waste cannabis stalks and plastic netting at WQ1.

1. Engage a qualified professional to: a) accurately determine the cultivation and disturbed areas on the Property and reassess the Property's Tier level; correct features on the Property to be consistent with Requirements of the Cannabis General Order; and complete and submit a Site Management Plan.
2. Implement Best Management Practices (BMP) to limit erosion of excavated spoils from stormwater and clean up, haul away, and properly dispose of refuse and cultivation waste.

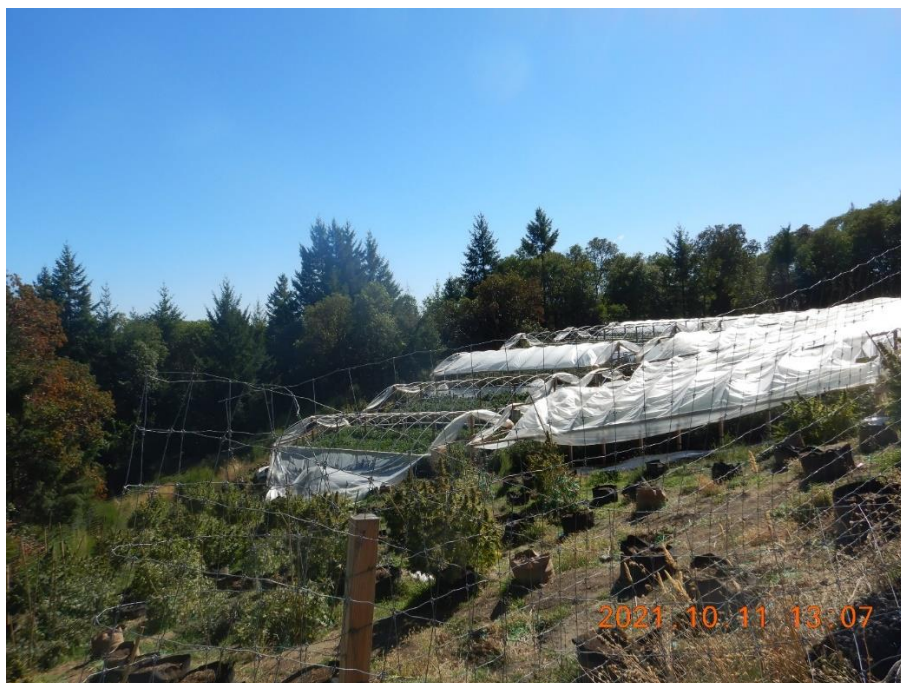
I observed a large outdoor cultivation area on the opposite side of the road that has an approximate one-acre disturbed area. I followed the road south to WQ3 where I observed fuel and other chemicals stored without secondary containment or adequate cover from weather. I observed a large amount of refuse both in and outside of black plastic bags without a clear location for collecting waste. I observed locations for bathing and cooking but did not observe an appropriate location for collecting human waste.

Photo 2—Looking south from WQ2 at outdoor cannabis cultivation area.

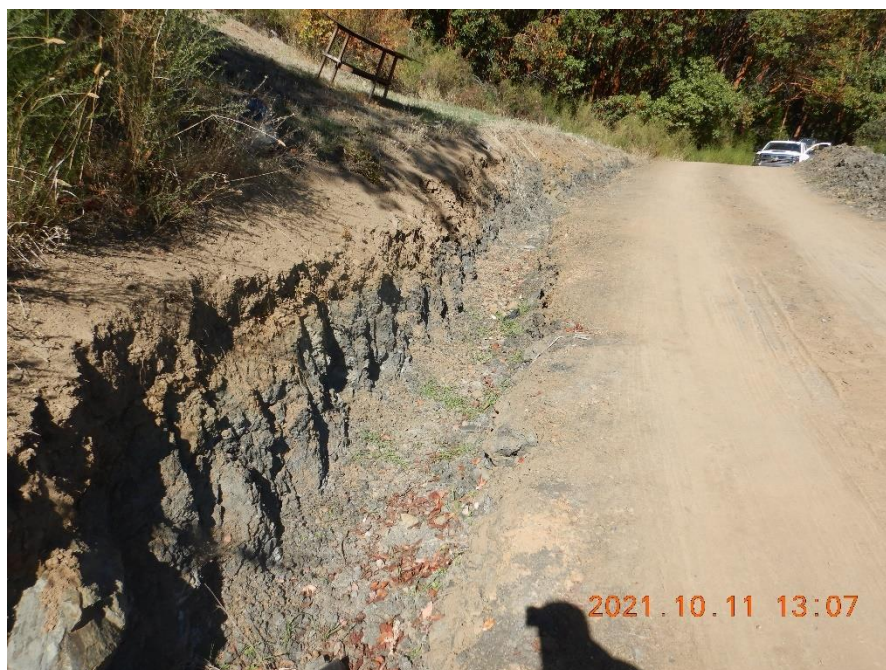
Photo 3—Looking north at excavated roadside ditch in the vicinity of WQ2.

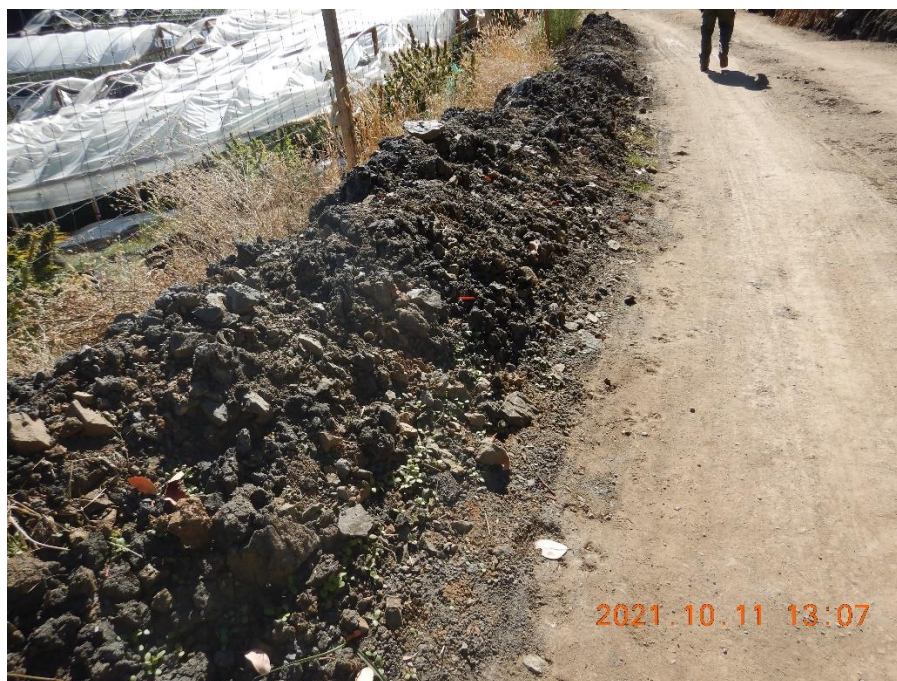
Photo 4—Looking south, in the vicinity of WQ2, where earthen spoils from excavation in previous image were placed. The spoils have not been covered or protected from stormwater.

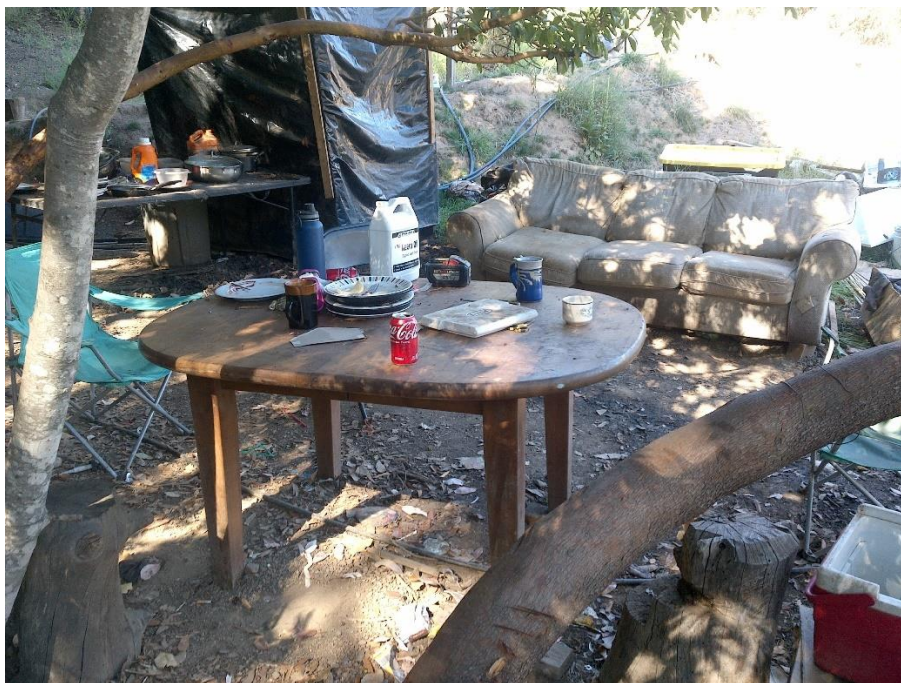
Photo 5—Food preparation area at WQ3. A gallon jug of neem oil is visible in the eating area.

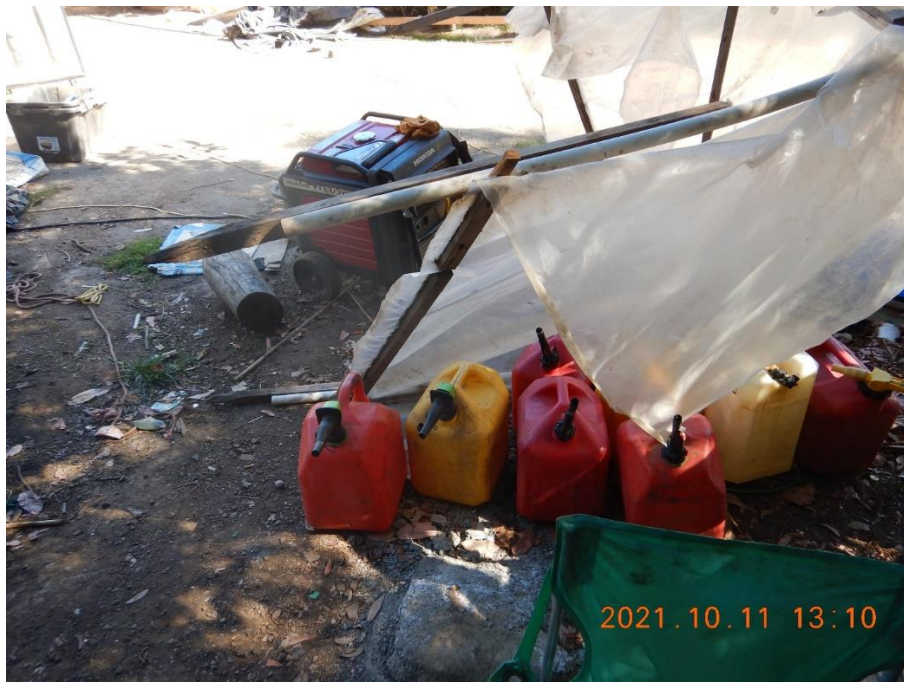
Photo 6—Fuel containers stored at WQ3 without secondary containment.

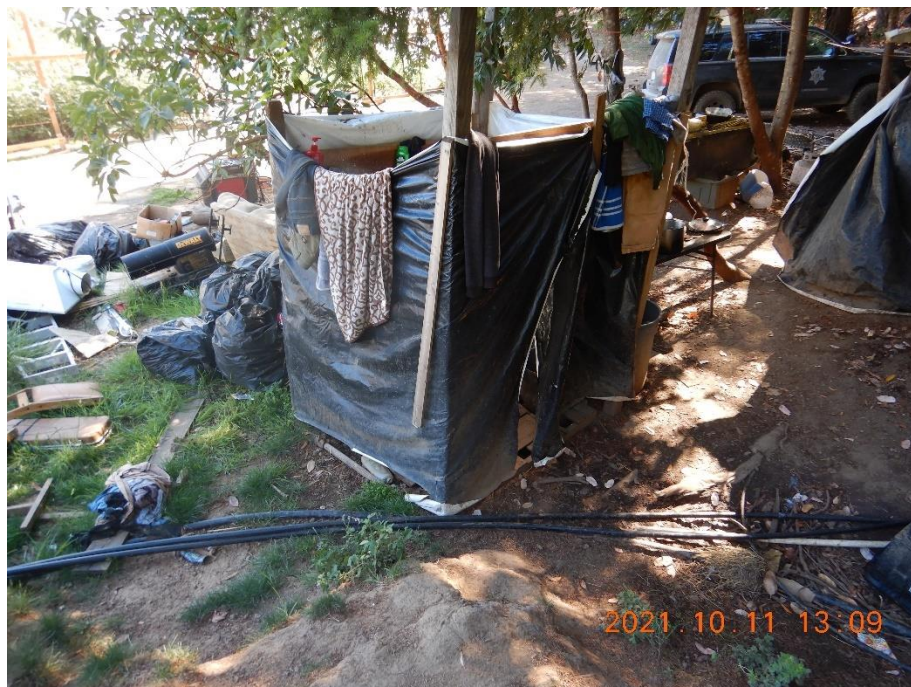
Photo 7—Refuse in black plastic bags surrounding a shower area in the vicinity of WQ3.

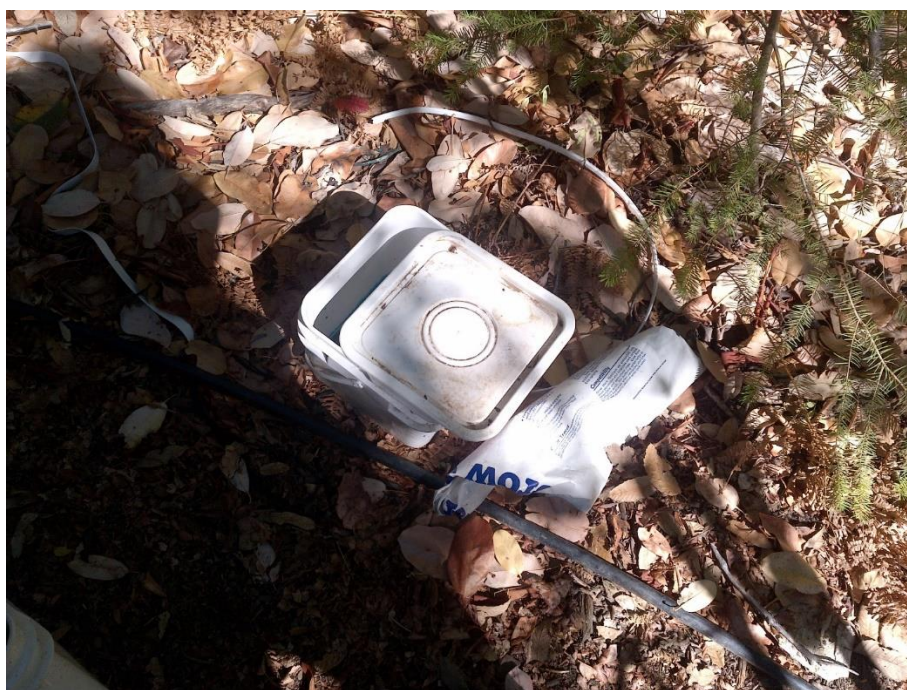
I continued walking south and observed fertilizers and nutrients at WQ4 where they are susceptible to being mixed with and transported by stormwater. At WQ5, I observed the frame of a hoop-type greenhouse and associated disturbed area approximating 5,000 square feet in size. I walked back north and observed a well at WQ6.

Photo 8—Chemical fertilizers uncovered at WQ4 where they are susceptible to being transported by stormwater.

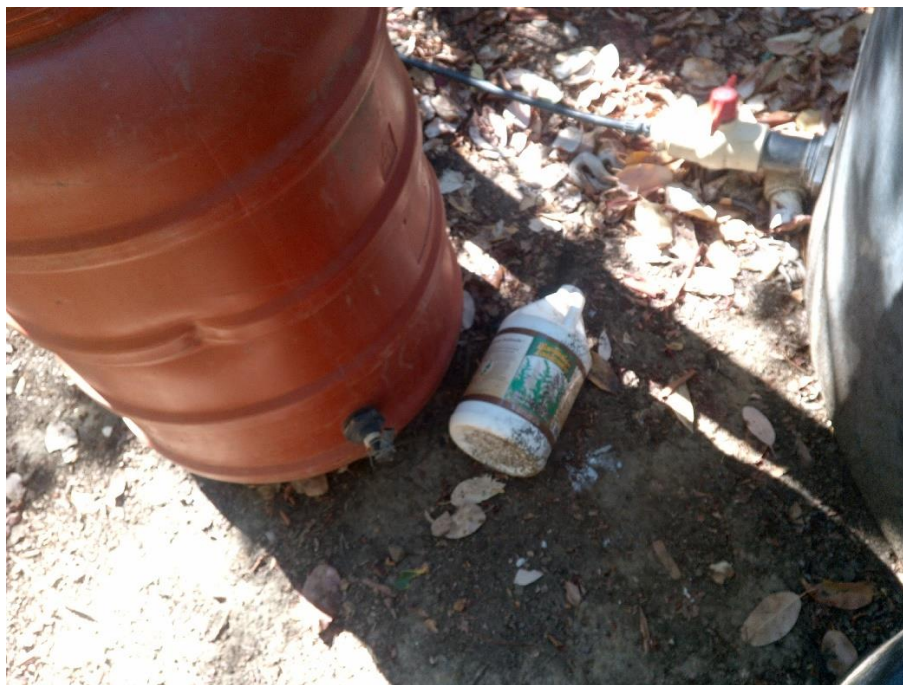
Photo 9— Chemical fertilizer container open and on its side at WQ4 where it is susceptible to being transported by stormwater.

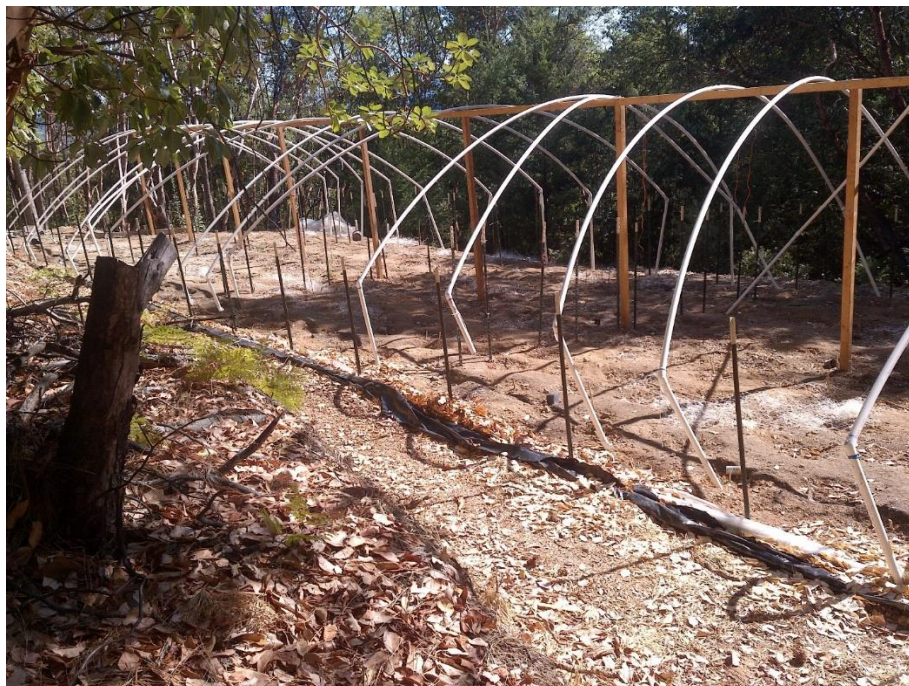
Photo 10—Outdoor cannabis cultivation area without plants or grow medium present. Clumps of plastic netting are visible uncontained within the frame of the hoop-type greenhouse.
