Subject: **Notice of Violation, Transmittal of Inspection Report for November 30, 2021 Inspection of Trinity County Assessor's Parcel 024-680-032-000**

File: Cannabis Program Inspections, Trinity County, November 30, 2021,
CIWQS Place ID 828365

FACILITIES INSPECTION REPORT

Hurst Photo Log – Attachment C
November 30, 2021 Inspection
Photos taken by Kate Hawken

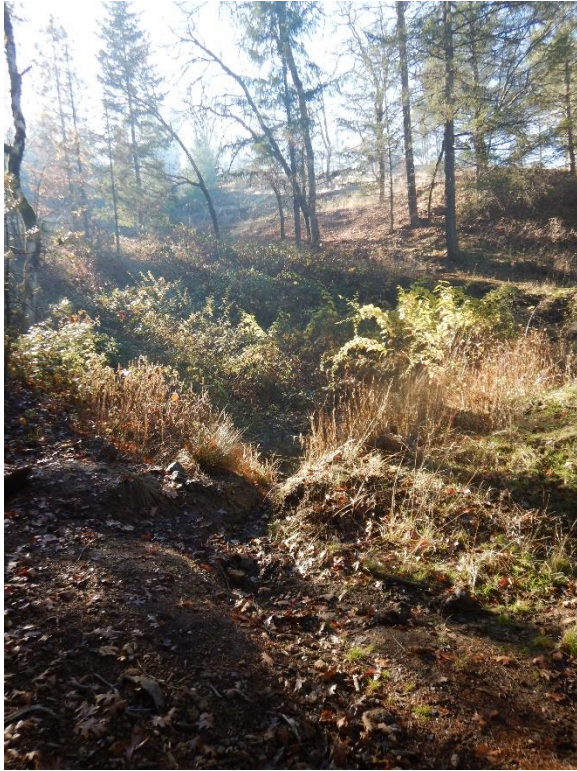
Pond: I observed a small onstream pond at the base of a hill (Photo 1). The pond was blocked from discharging to the downhill channel by a road. The landowner’s proposal is to install a rolling dip and rocked ford to decommission the pond and reconnect the watercourse channel.

Photo 1, Pond: small onstream pond with evidence of overflow across road

2. Submit additional information to complete the 401 Water Quality Certification application prior to starting work in the onstream pond.
3. Improve road surfacing and add drainage structures such as water bars, rolling dips, and/or ditch relief culverts to reduce erosion and to prevent transport of sediment from the road.

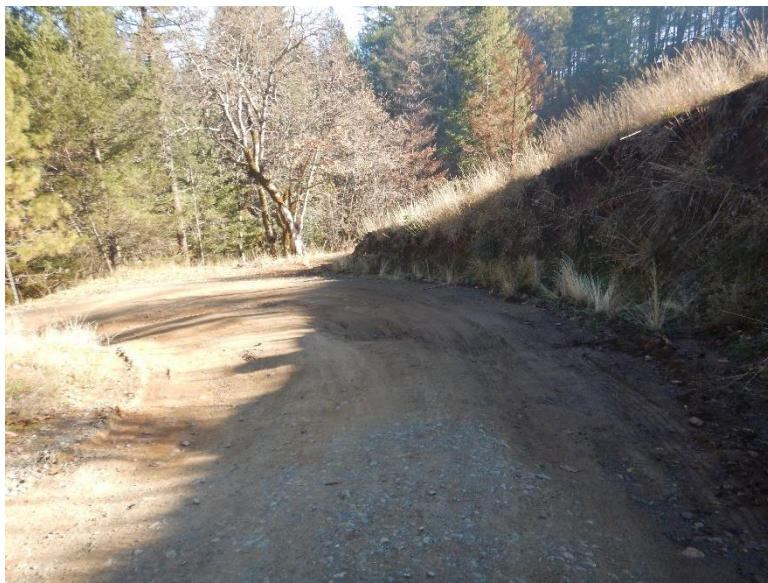
Access Road: I observed surface erosion and rut formation near the top of the access road (Photo 2). Walking down the road I observed a widening inboard ditch with no drainage relief structures.

Photo 2, Access Road: Rut across road surface

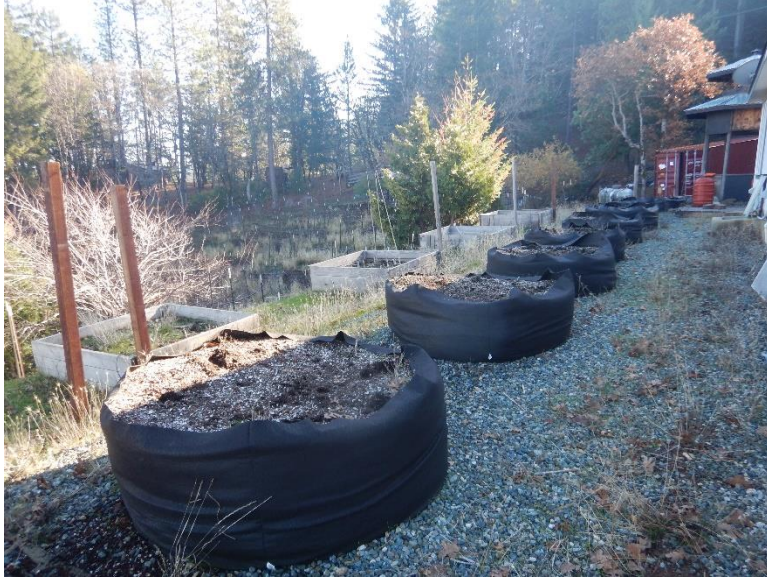
Cultivation Area: I observed pots, raised beds, soil, irrigation lines, stakes, and fencing on a steep hillside (Photo 3). I observed bare soil walkways around the pots and raised beds. I observed a watercourse through the cultivation area, described in more detail below.

Photo 3, Cultivation Area: Pots, soil, stakes, and fencing on steep hillside near residence

1. Submit a Disturbed Area Stabilization Plan detailing removal of cultivation infrastructure including but not limited to pots, raised beds, soil, irrigation lines, stakes, and fencing; and provide a plan to revegetate all disturbed area within riparian setbacks. Do not use heavy machinery in, or stockpile material in or adjacent to the watercourse in the cultivation area.

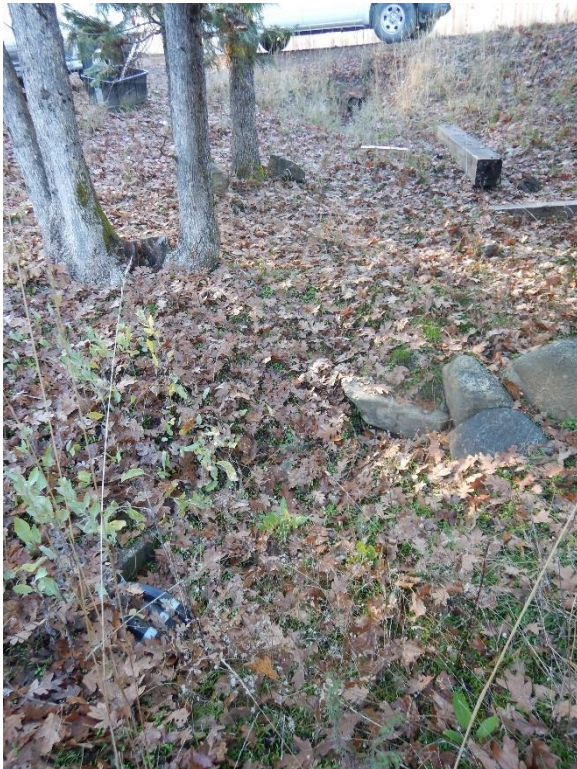
Culverts: I observed a culvert stream crossing under the access road discharging to a vegetated area (Photo 4). Approximately 20 feet downhill I observed another culvert stream crossing discharging to the cultivation area, with a defined channel extending down the hillside through the cultivation area (Photo 5). The culvert outlet was occluded with sediment and trash. The cultivation area was located within riparian setbacks required by the Cannabis General Order.

Photo 4, Culverts: Black plastic culvert outlet under access road in background, and black plastic culvert inlet in foreground

4. Regularly clean out and maintain culverts to prevent occlusion and overtopping.
5. Contain and regularly dispose of domestic and cultivation-related waste to prevent spillage and potential for transport of waste into receiving waters.

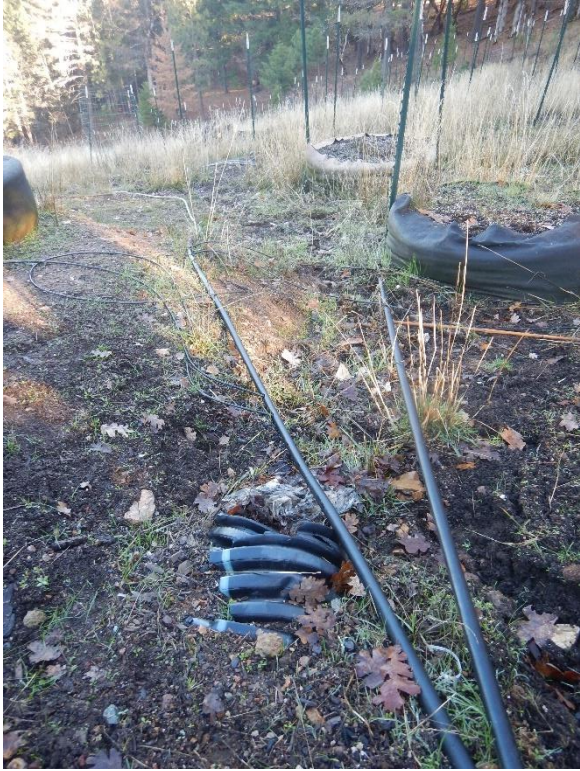
Photo 5, Culvert: Squashed culvert outlet and defined channel below
