## North Coast Regional Water Quality Control Board

**Subject: Notice of Violation and Transmittal of Inspection Report for June 28, 2021 Inspection of Sonoma County Assessor's Parcel Number (APN) 028-130-009-000**

**FACILITIES INSPECTION REPORT**

### Inspection Maps and Photolog for inspection conducted, June 28, 2021

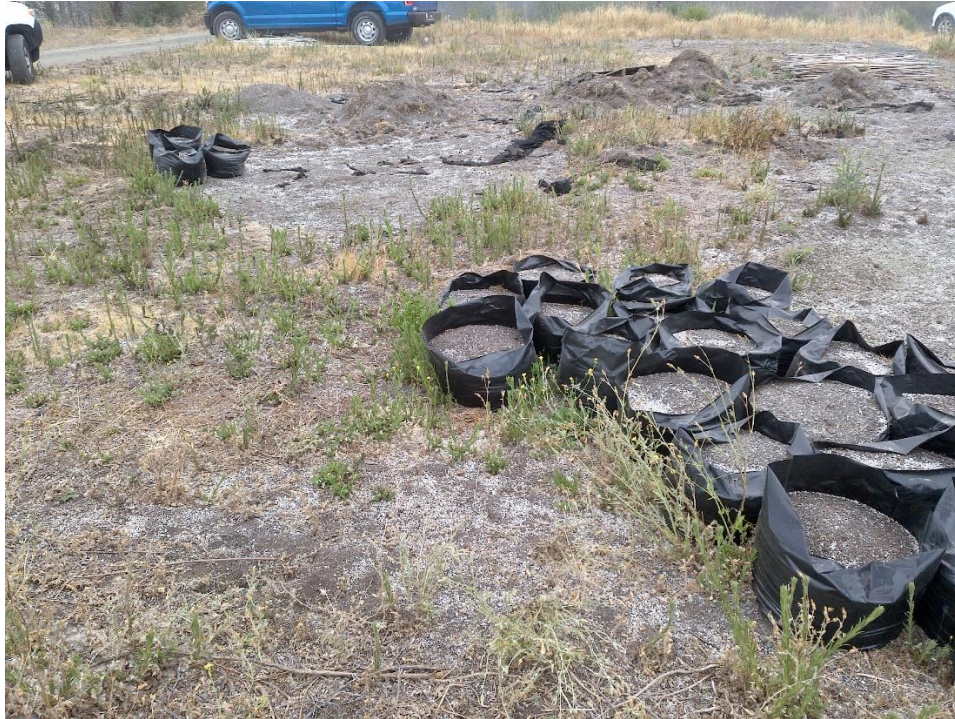
At WQ1, I observed a historical cultivation area with piles of imported potting soils uncontained where they may spread offsite. I walked west along a steep road. The road-surface is composed of fine material and shaped such that stormwater will concentrate and erode the road surface.

*Photo 1—Historical cultivation area at WQ1. Imported potting soils are uncontained.*

1. Enroll in the Cannabis General Order, ensure future development and uses for cannabis are in conformance with current regulations.
2. Engage a qualified professional to develop and submit a work plan to correct the roads and crossings on the Property to conform with the State Water Resources Control Board Cannabis Policy.
3. Submit application for and obtain a 401 Water Quality Certification from the Regional Water Board before performing any instream work.

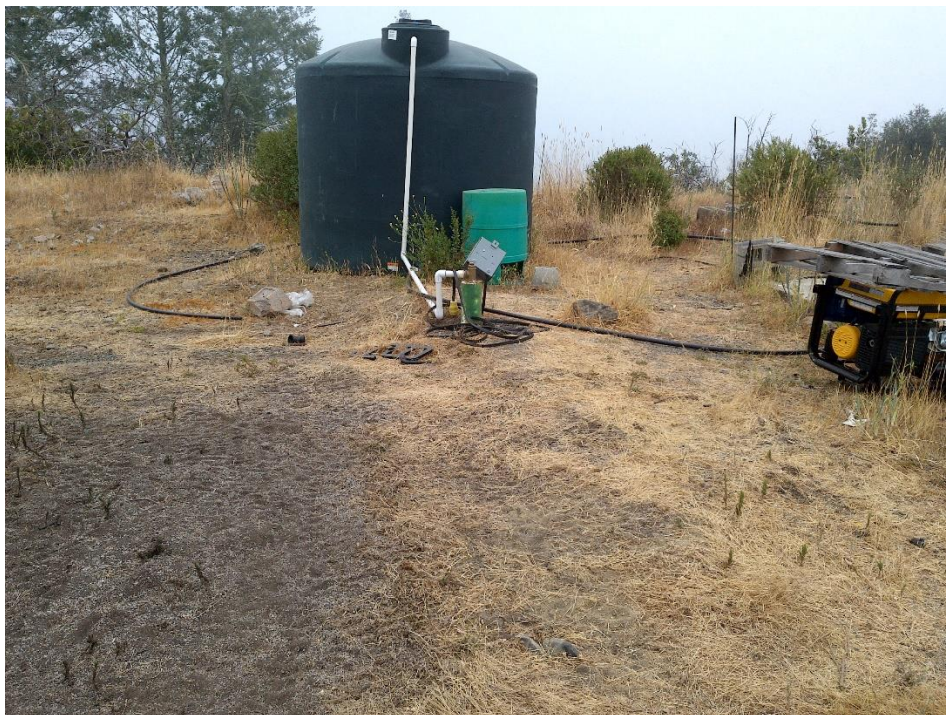
*Photo 2—Well located at WQ1.*

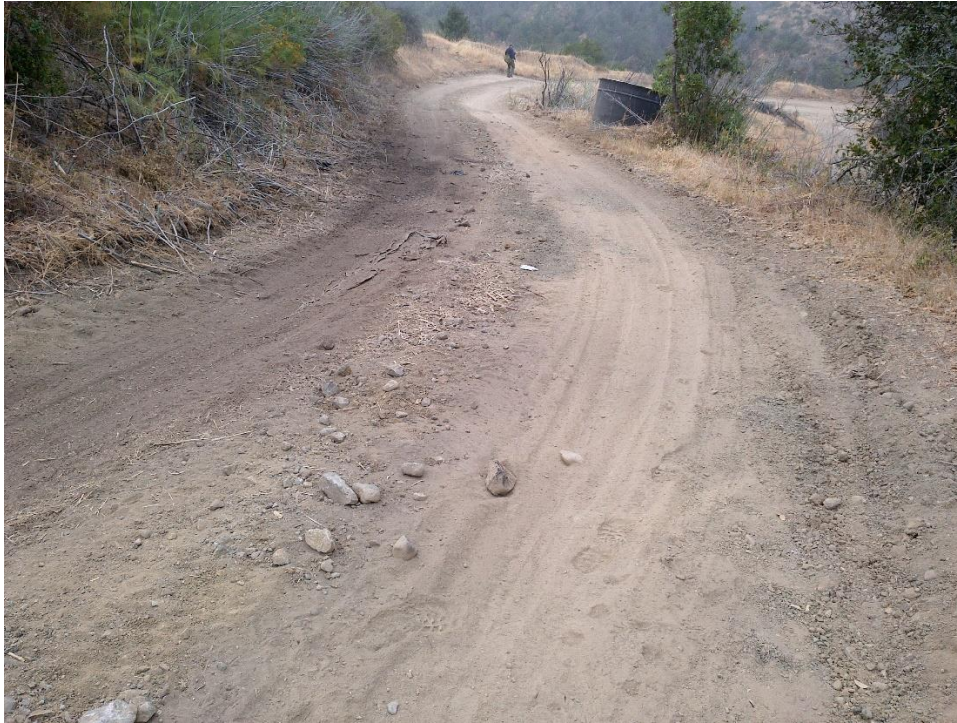
*Photo 3—Looking south on road west of WQ1. The road is steep with a surface of fine material.*

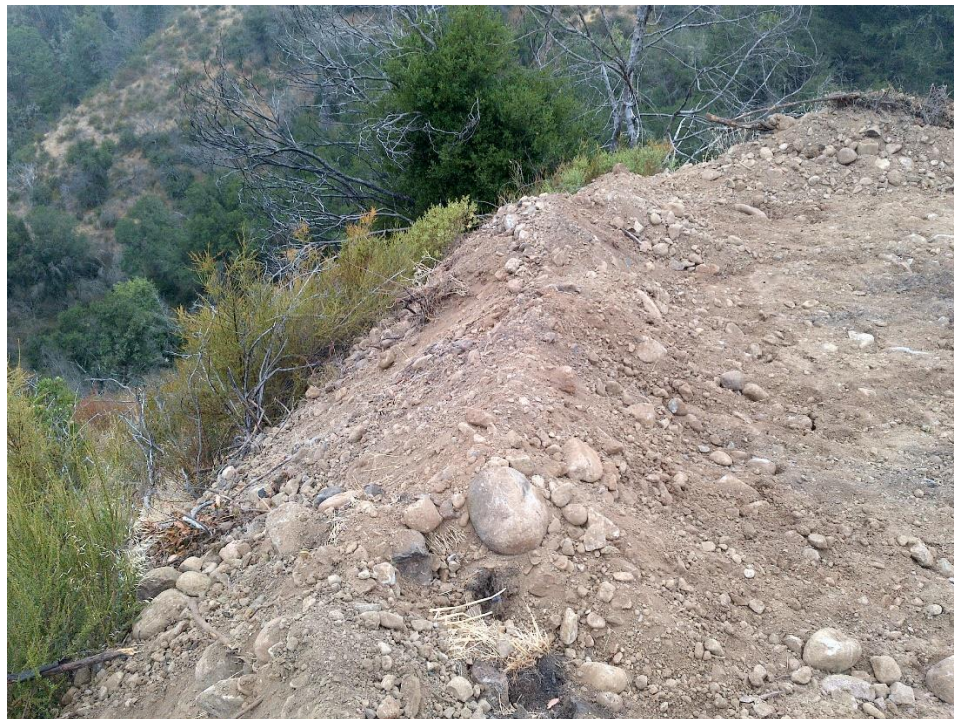
At WQ2 I observed earthen spoils, perched ~400 feet upslope from a tributary to Humbug Creek. Farther north along the road, at WQ3, I observed a culvert worn through the top in the middle of the road. I was unable to see a watercourse through the dense vegetation on either side of the road at WQ2.

*Photo 4—Earthen spoils at the edge of the road at WQ2.*

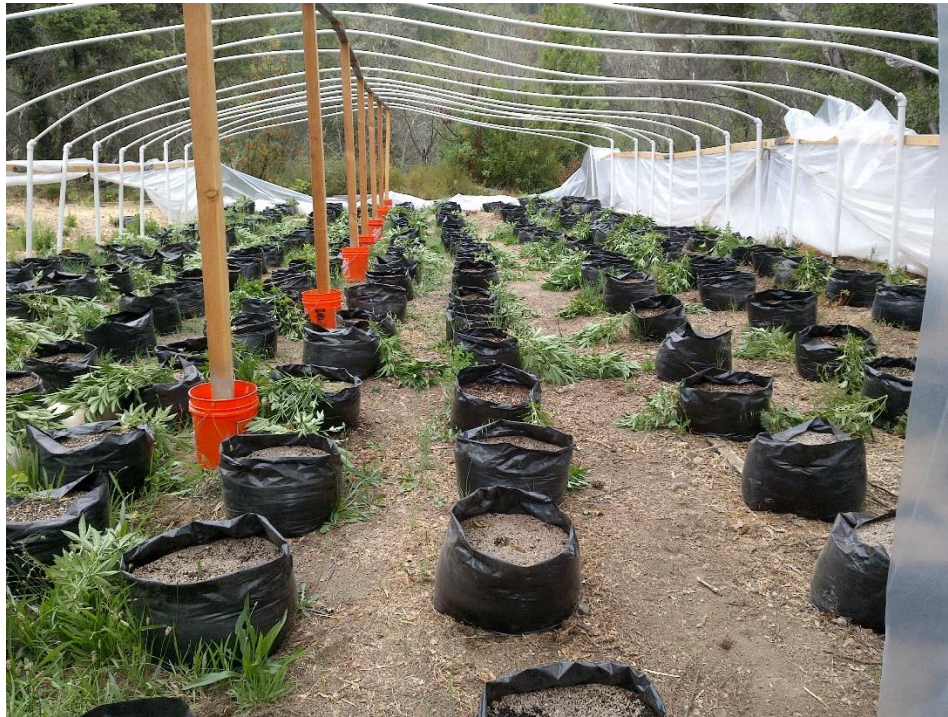
*Photo 5—Active outdoor cultivation area at WQ4.*

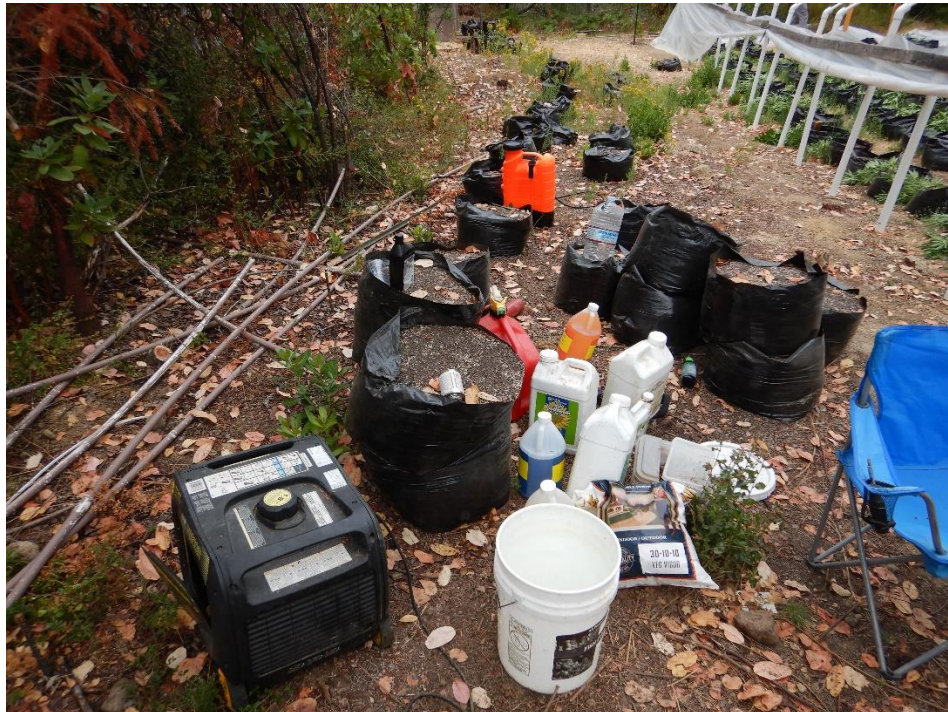
I observed an active cannabis cultivation site at WQ4 with petroleum products and other chemicals improperly stored. I observed earthen spoils on the road east of WQ4 on the downslope side of the road where it threatens to discharge to an onstream reservoir to the north. Farther east, at WQ5, I observed a recently installed culvert with earthen spoils at the outlet. I observed a reservoir downslope from the culvert at WQ5 and a watercourse downslope from the reservoir at WQ6. North of WQ5, I observed a steep road hydrologically connected to the reservoir. Farther north, I observed a bridge had been installed at WQ7 with earthen spoils from the work in the watercourse and perched on where they threatened to discharge to the watercourse.

*Photo 6—Fuel and fertilizer located at WQ4.*

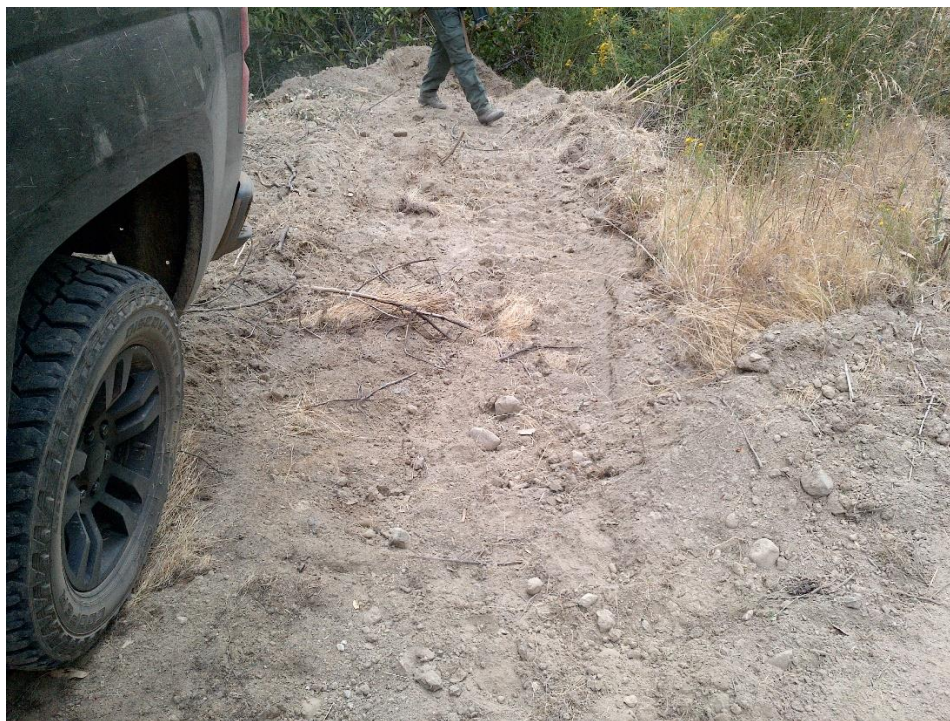
*Photo 7—Looking north at earthen spoils east of WQ4. The reservoir pictured in later photos is out of view in the background of the image.*

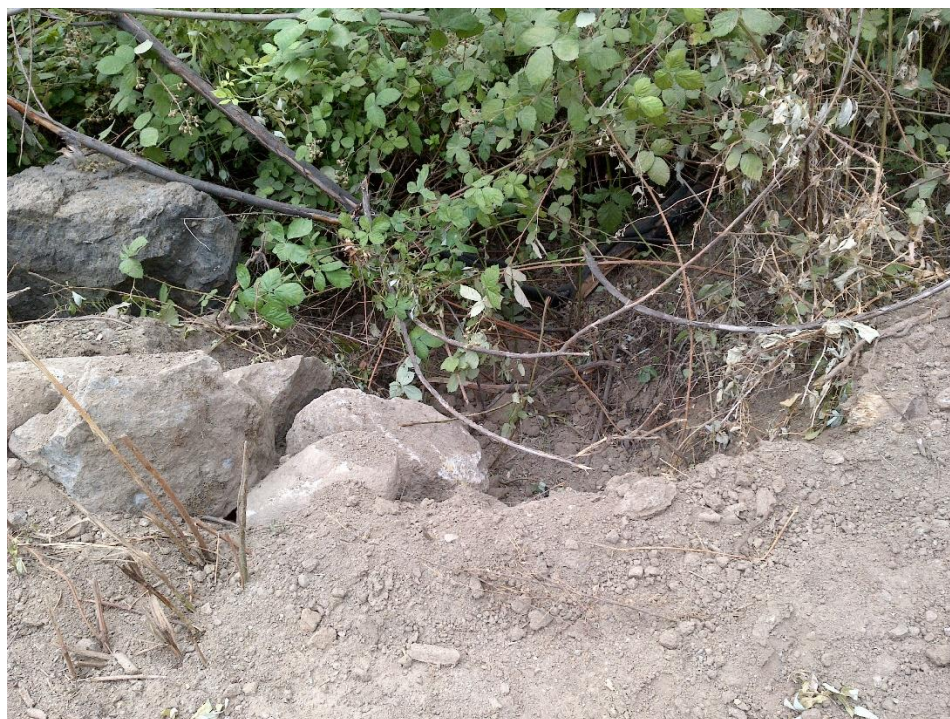
*Photo 8—Looking east and upstream at culvert inlet located at WQ5. The watercourse upstream is not visible behind dense vegetation.*

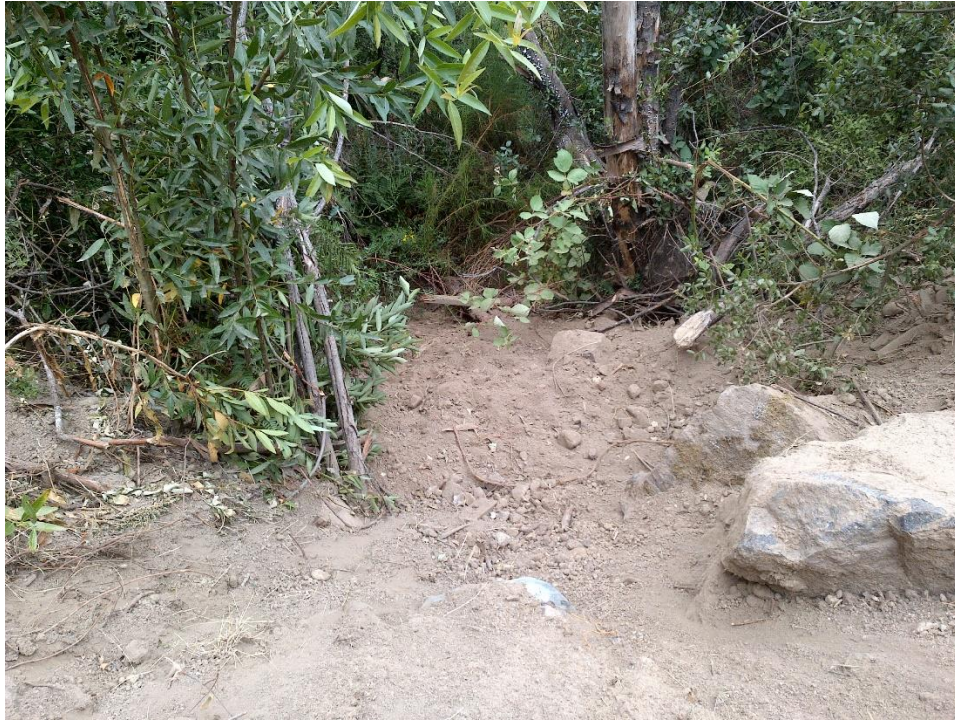
*Photo 9—Looking west and downstream at culvert outlet located at WQ5. Earthen spoils cover the ground from the culvert outlet to the line of dense vegetation.*

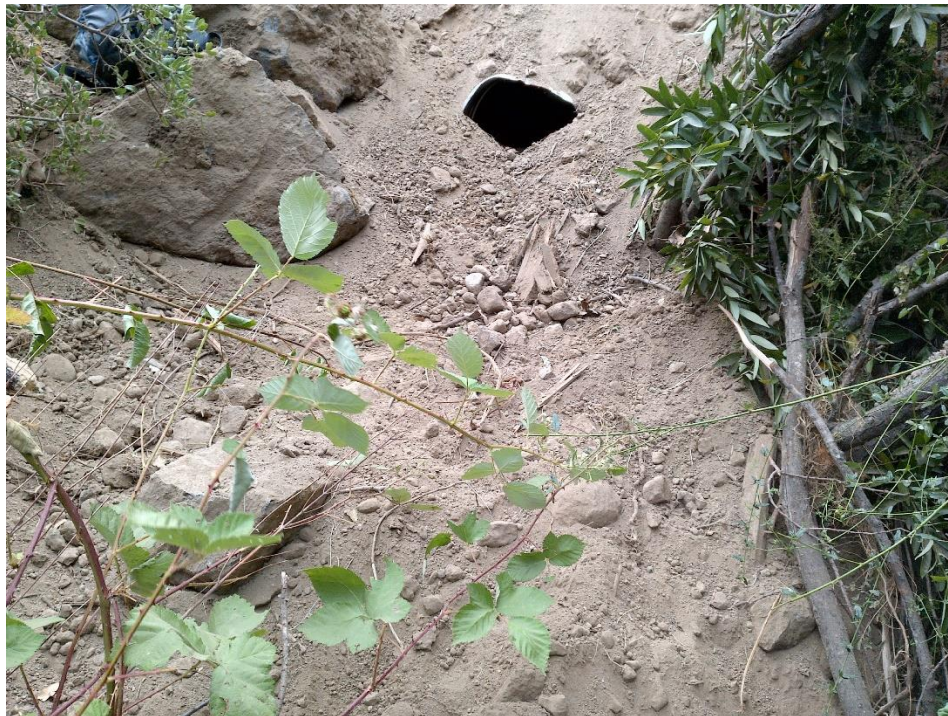
*Photo 10—Looking east and upslope at culvert outlet located at WQ5.*

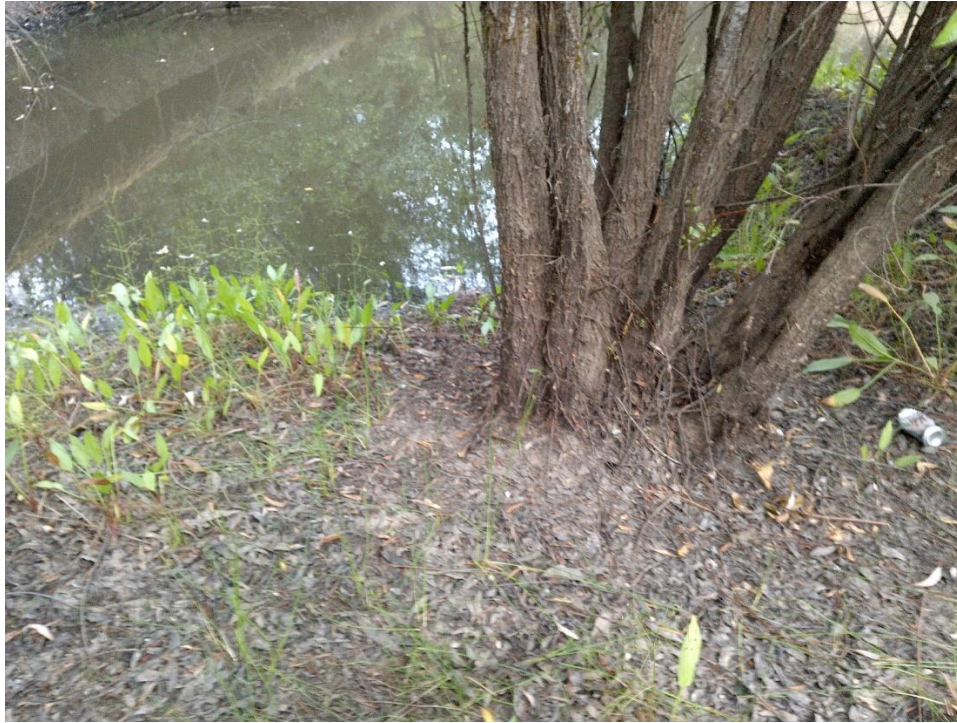
*Photo 11—Looking west and downstream where water from the culvert at WQ5 would flow into the reservoir in the background of the image.*

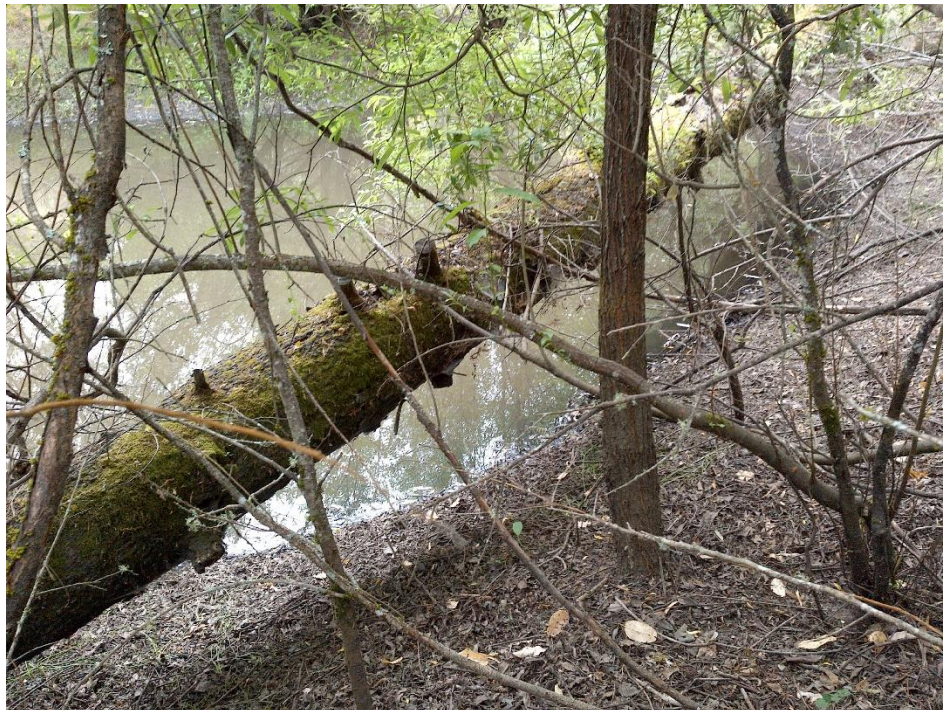
*Photo 12—Reservoir that is also pictured in the previous image.*

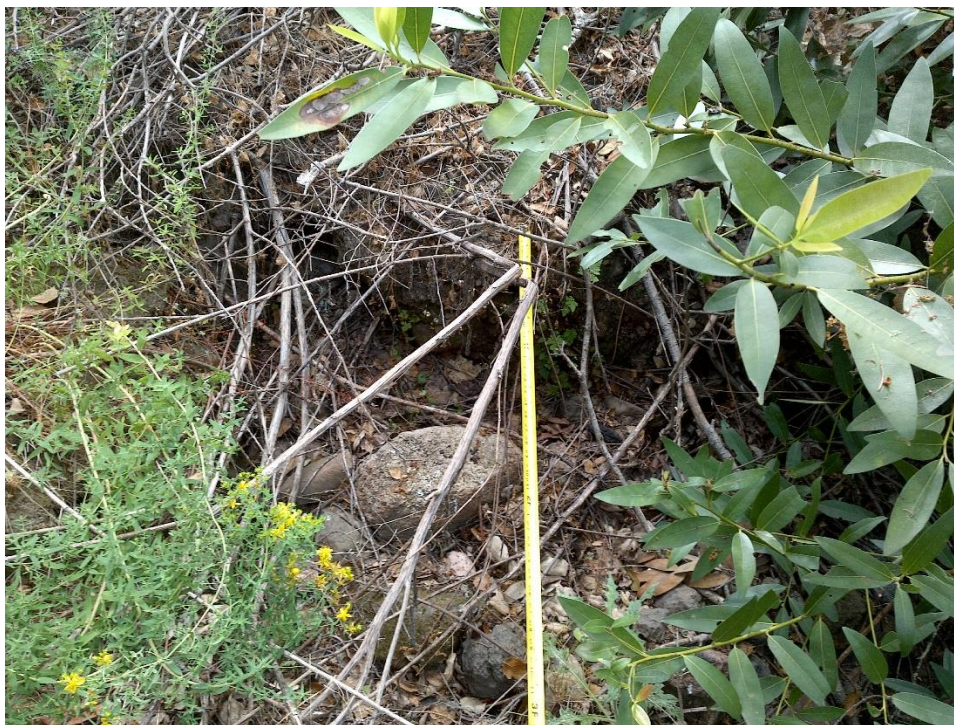
*Photo 13—Looking west at cobble bedded channel with defined banks at WQ6. The channel is immediately downslope from the reservoir's impounding berm.*

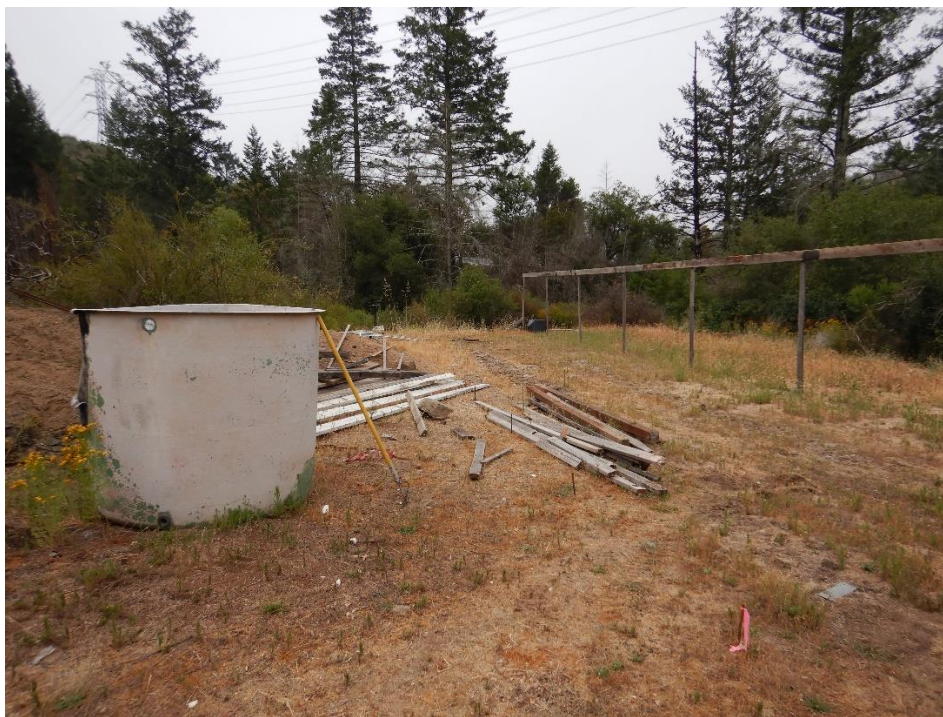
*Photo 14—Historical cultivation area at WQ7.*

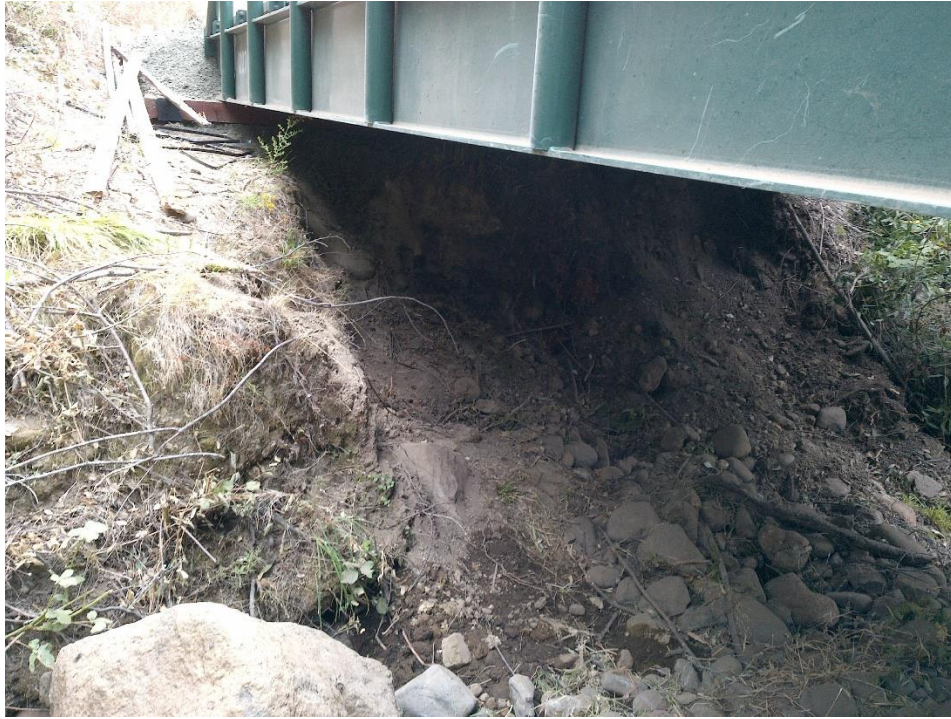
*Photo 15—Looking east at the left embankment of a recently installed bridge at WQ8.*

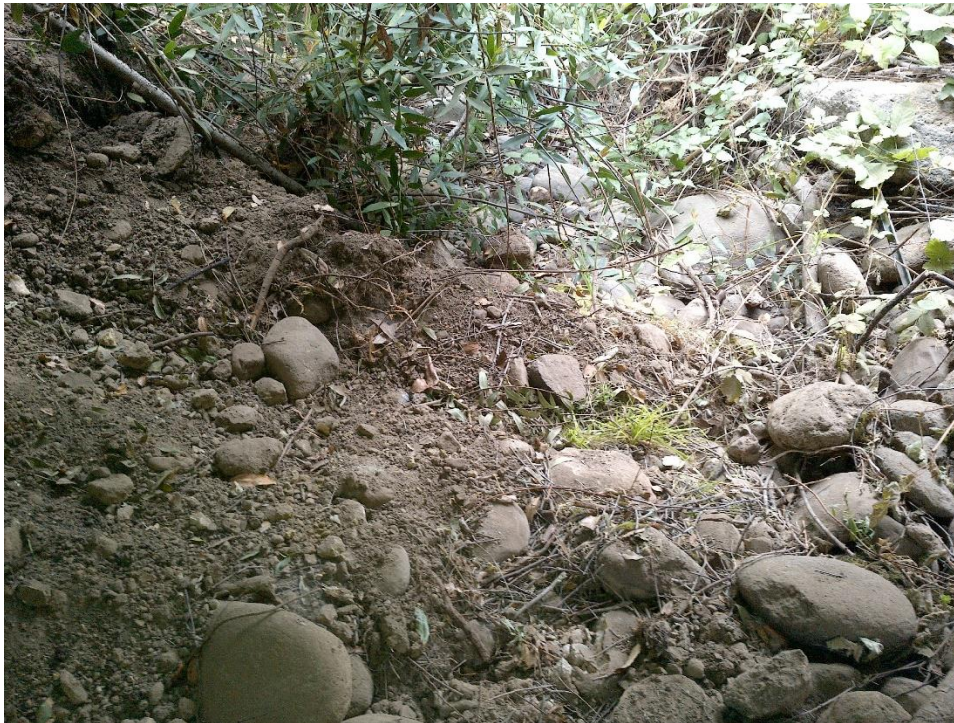
*Photo 16—Looking downstream below recently installed bridge at WQ8. Finer earthen material from the left bank is overlying the cobble bedded substrate of the channel.*

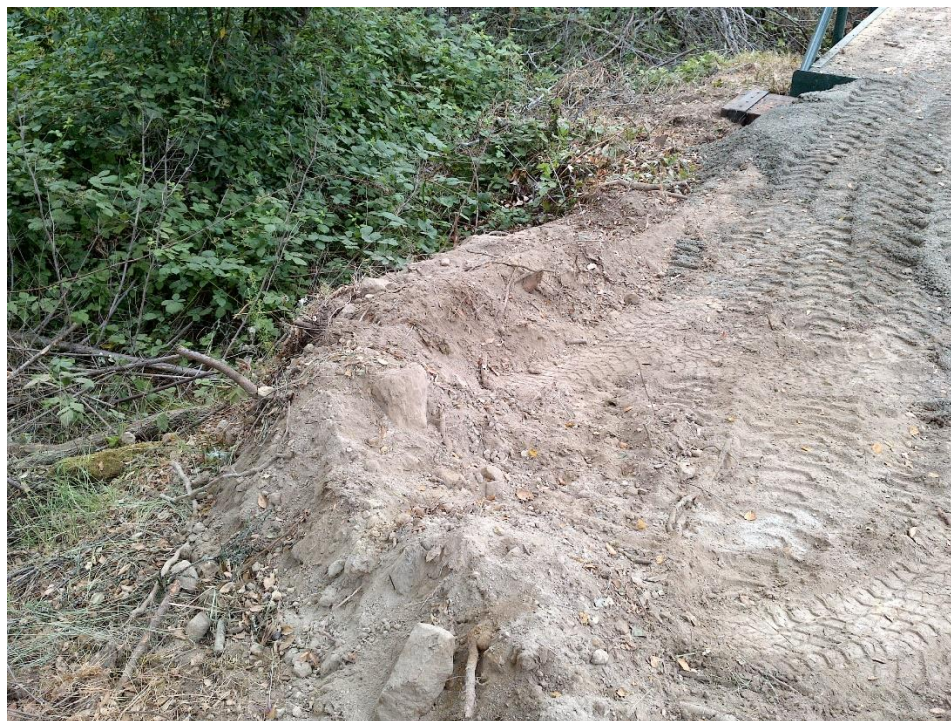
*Photo 17—Earthen spoils on the road approaching the recently installed bridge from the west.*

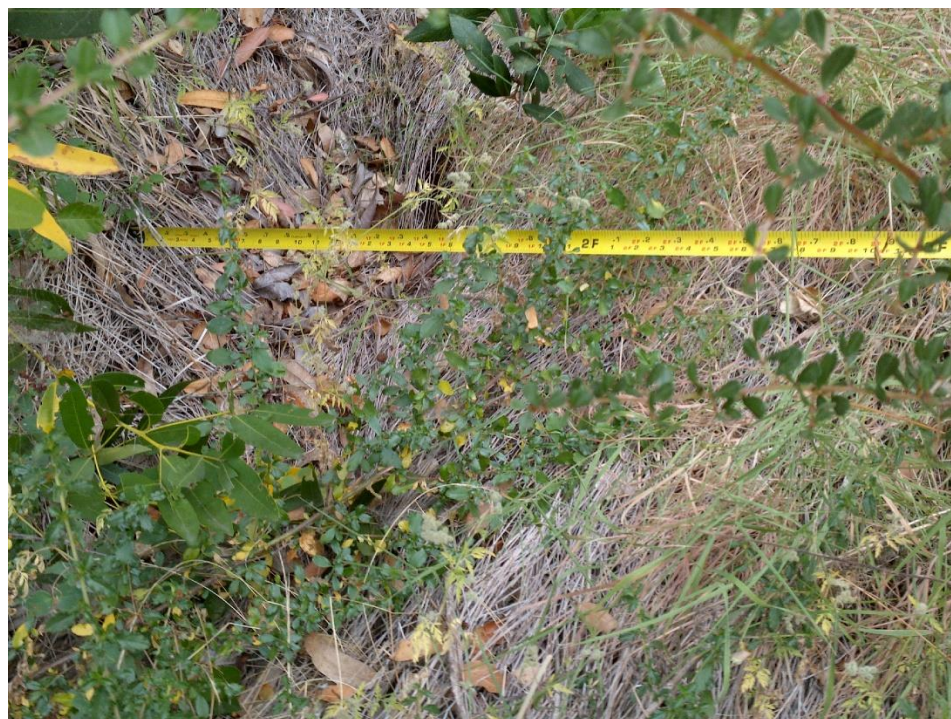
*Photo 18—Channelized watercourse, approximately two feet wide upstream from recently installed culvert at WQ9.*

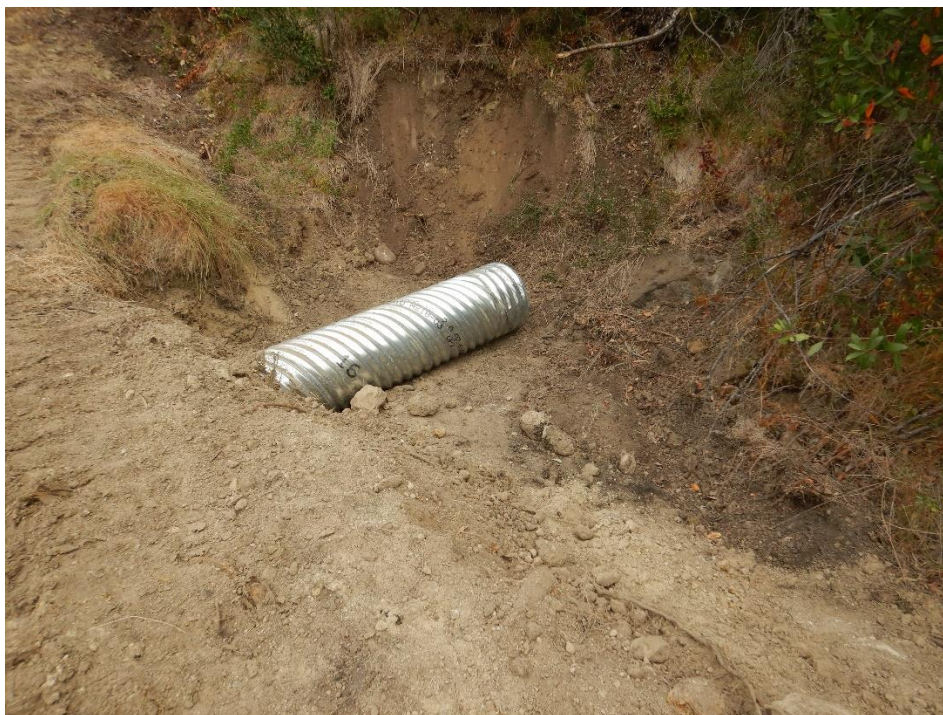
I observed a culvert installed at WQ9. Ms. Foreman from PG&E was onsite and explained they had installed the culverts and bridge. Ms. Foremen said she did not think permits were required because they were replacing like for like in the burn area. I explained that Permits are required from the Regional Water Board and that the work did not meet requirements for size and alignment. I advised they stop work until they obtained permits.

*Photo 19—Looking west at upstream end of recently installed culvert at WQ9. The culvert is eighteen inches in diameter.*

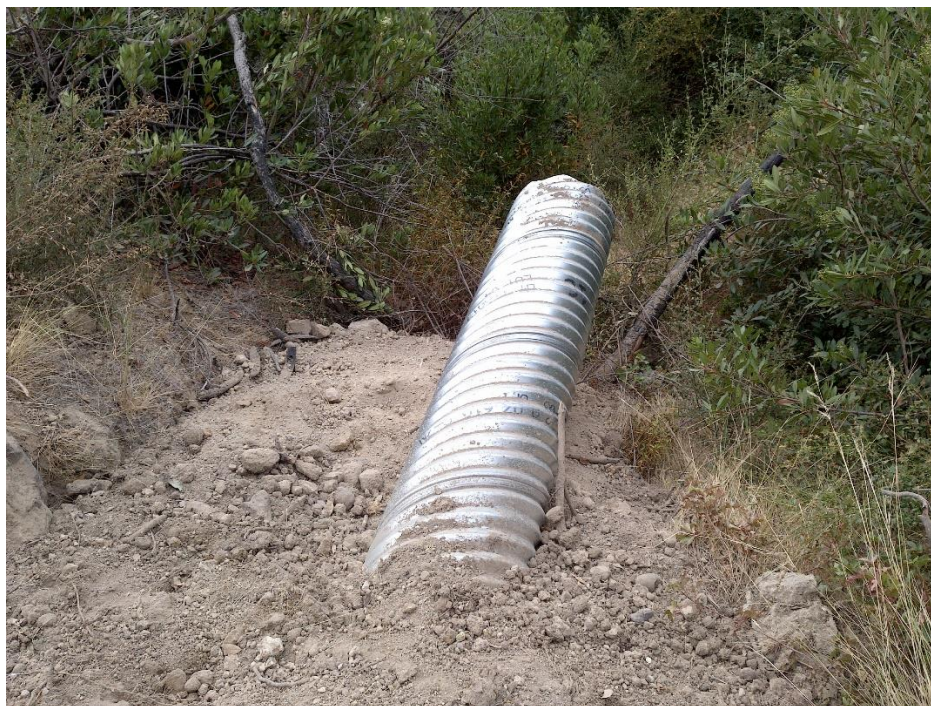
*Photo 20—Looking south and downstream at recently installed culvert at WQ9. The culvert outlet is perched five feet above the watercourse downstream.*
