Subject: Notice of Violation and transmittal of Site Inspection Memo, Deixler Property, 43050 Little Lake Road, Mendocino

File: Avram Deixler, 43050 Little Lake Road, Mendocino,
CW-872226, WDID No. 1B21207WNME

Subject: Site Inspection Memo, Deixler Property, 43050 Little Lake Road, Mendocino

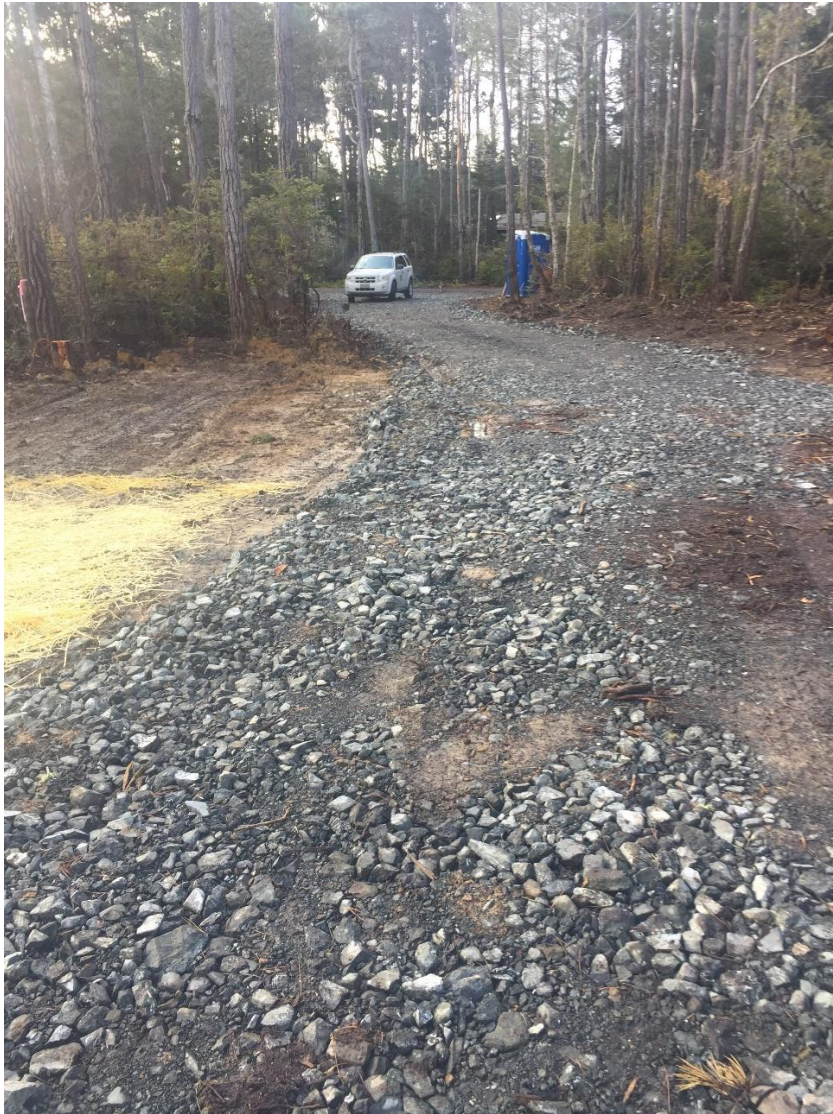
Photo 1: Rocked driveway looking south

A driveway path near the southwestern corner of the property appeared to have been recently cleared of vegetation and rocked (Photo 1). A cleared area directly east of the driveway was very wet and muddy at the time of the inspection; a portion of this area was covered with straw with standing water visible underneath the straw (Photo 2). Mr. Deixler stated that he thinks the wet area at the driveway site is being caused by a new culvert installed adjacent to his property by a neighbor, which he said is concentrating flow onto his property (Photo 9).

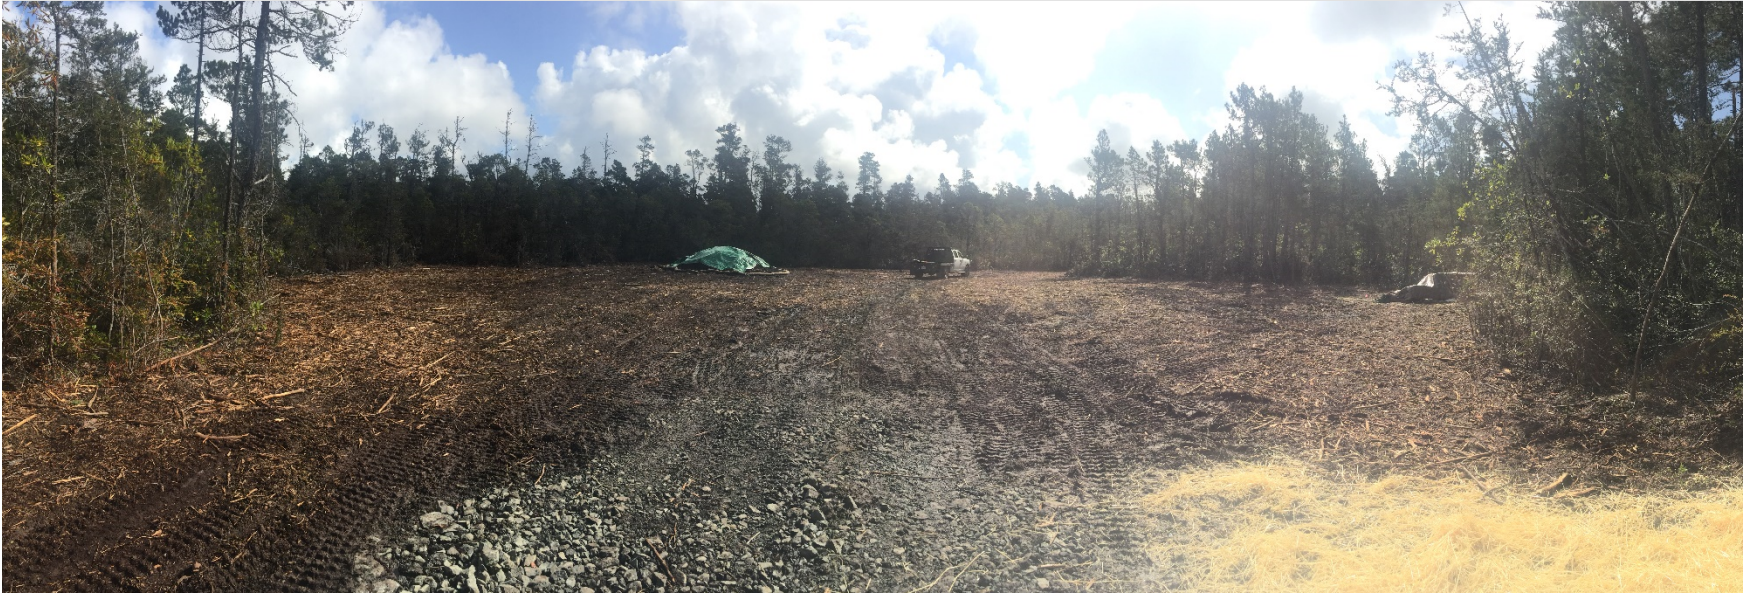
Photo 3: Cleared Area #1 in central portion of southern half of property (end of rocked driveway visible in foreground)

We observed three cleared forested areas on the property, including Mendocino cypress forest and other vegetation. Cleared Area #1 was the largest and was located east of the driveway, in the central portion of the southern half of the property (Photo 3). Bare soil visible in Cleared Area #1 was muddy at the time of the inspection.

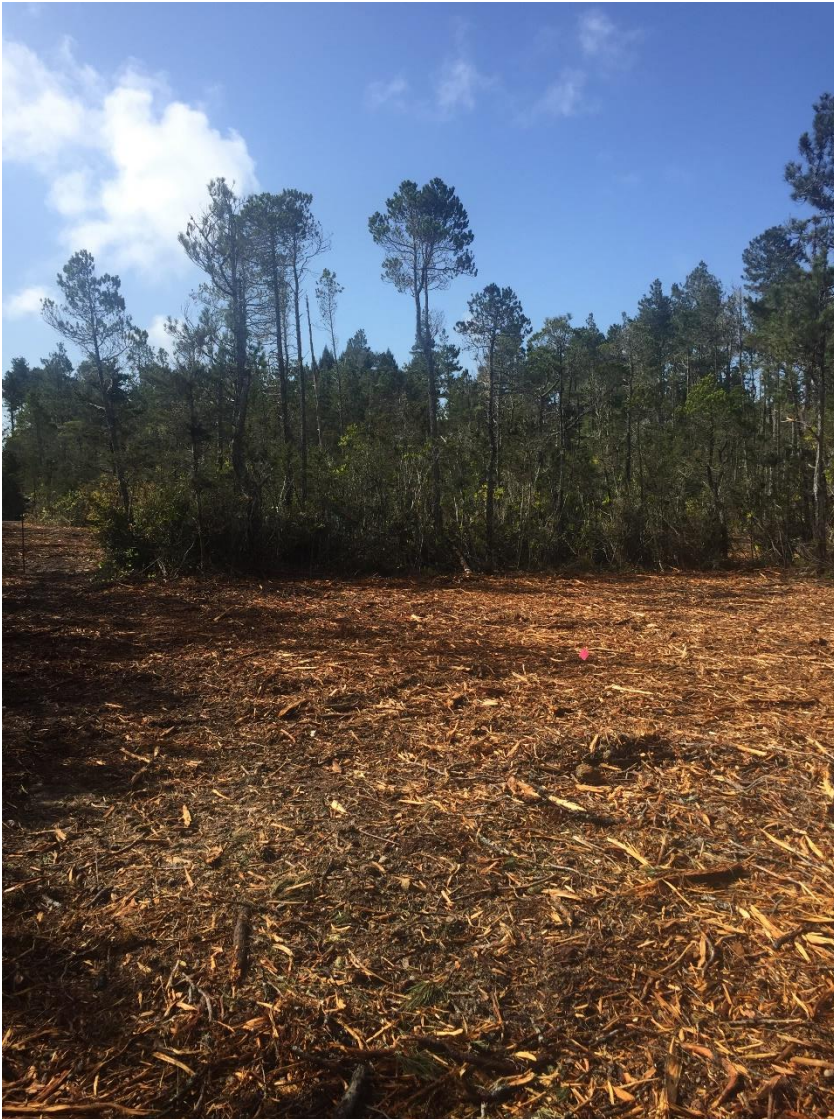
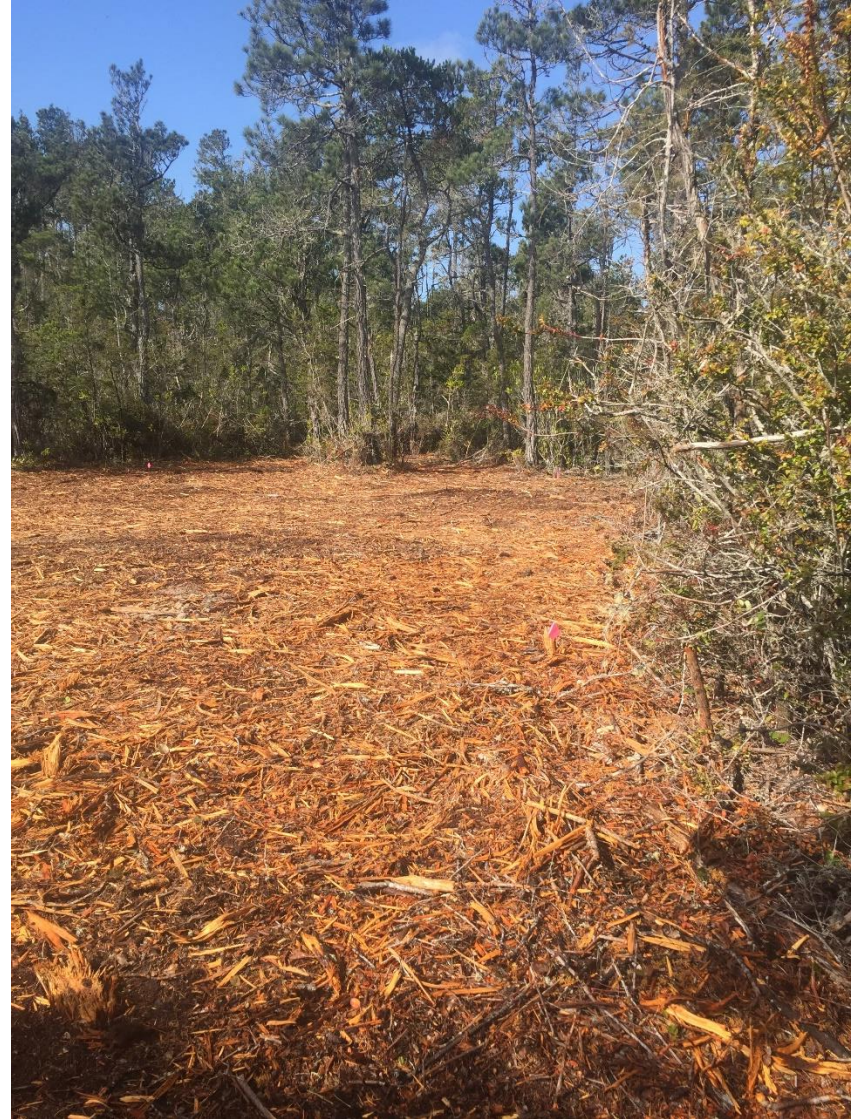
Photos 4 & 5: Cleared Area #2, north of Cleared Area #1

Cleared Area #2 was smaller and was located directly north of Cleared Area #1 (Photos #4 and 5). Cleared Areas #1 and 2 were connected by a cleared path, one of several paths cleared throughout the property (Photo #6).

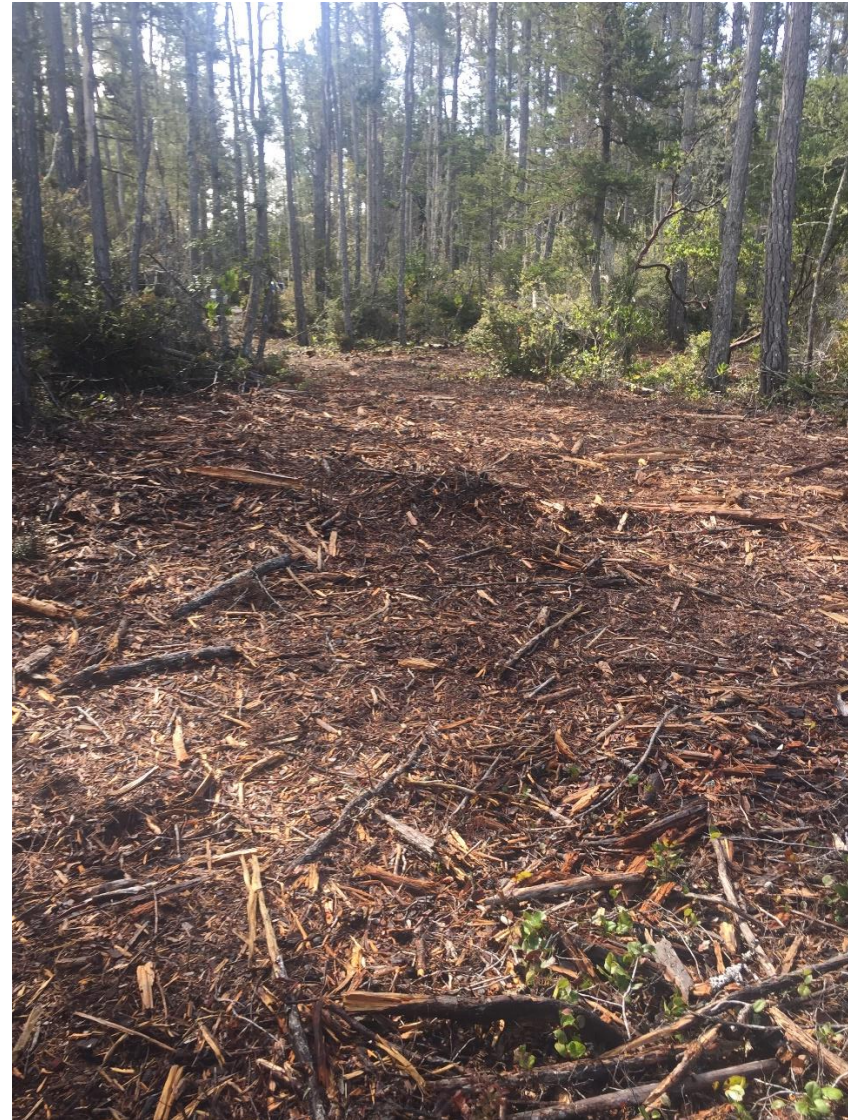
Photo 7: Cleared Area #3, west of Cleared Area #2

Cleared Area #3 was the smallest, located west of Cleared Area #2 (Photo 7). Cleared Area #3 was connected to Cleared Area #2 and to the driveway by two cleared paths. We observed a wetland plant (Western Labrador Tea, *Rhododendron columbianum*; a wetland indicator species [OBL]) growing on both sides of the cleared path between Cleared Areas #2 and 3 (Photo 8).

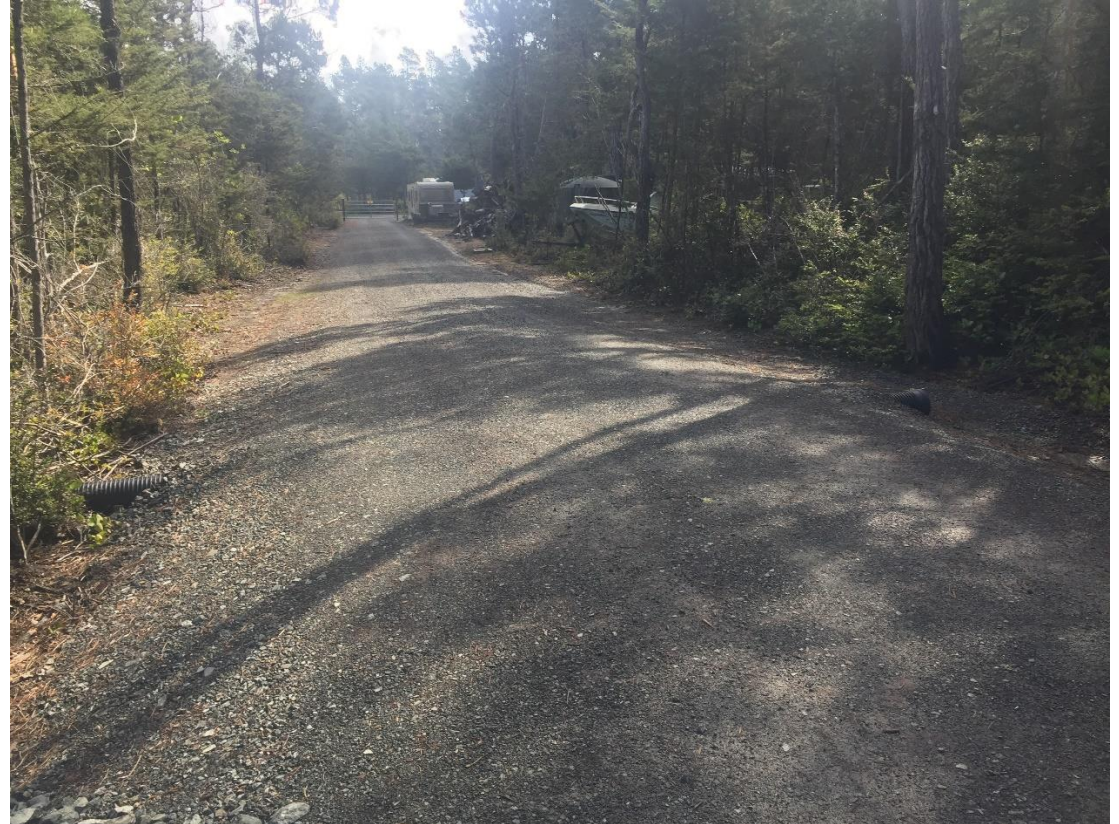
Photo 9: New culvert installed on gravel access road near Deixler property.
The culvert appears to outlet toward Deixler property (left side of photo).
