Subject: Notice of Violation and transmittal of Site Inspection Memo, Thompson Property, 9000 Mill Station Road, Sebastopol

Inspection Memo

Subject: September 13, 2021, inspection of 9000 Mill Station Road, Sebastopol.

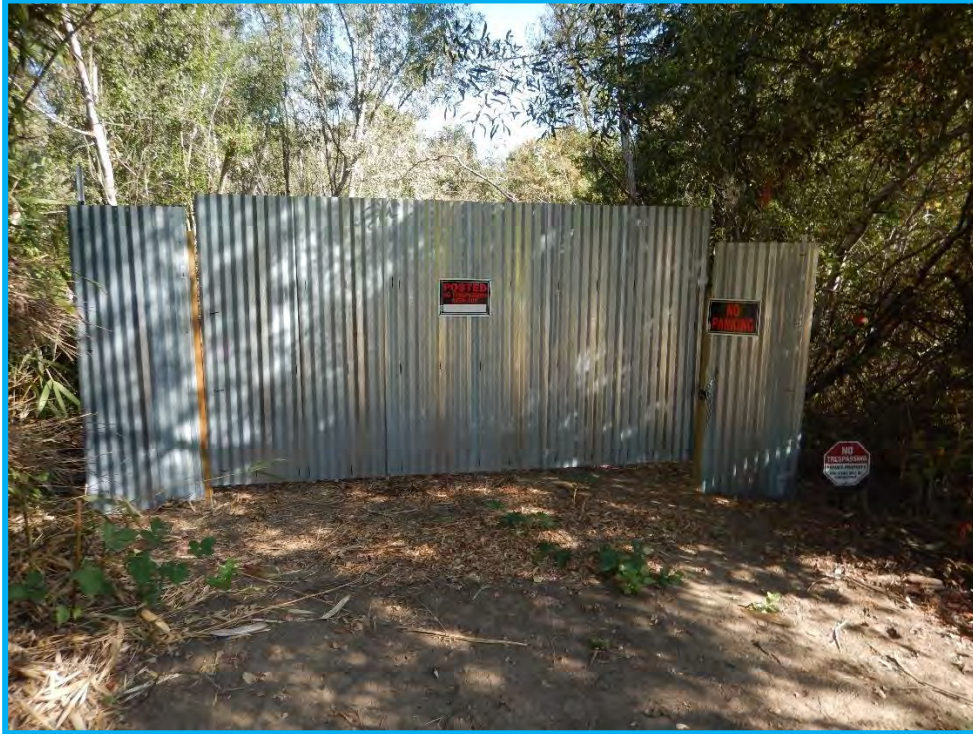
On September 13, 2021, at 1000 hours, Mr. Falcone and I met with Ms. Thompson, the property owner and Tony Cohen at 9000 Mill Station Road in Sebastopol, APN 142-005-000 (Site). A new corrugated metal fence and gate had been installed at the property entrance since my July 27, 2021 inspection (Photograph 1). Ms. Thompson verbally granted Mr. Falcone and me permission to access the property and take photographs. The inspection started at the property entrance above the floodplain and descended onto the floodplain and into the riparian forest.

Photograph 1. New corrugated metal fence and gate installed at 9000 Mill Station Road, Sebastopol.

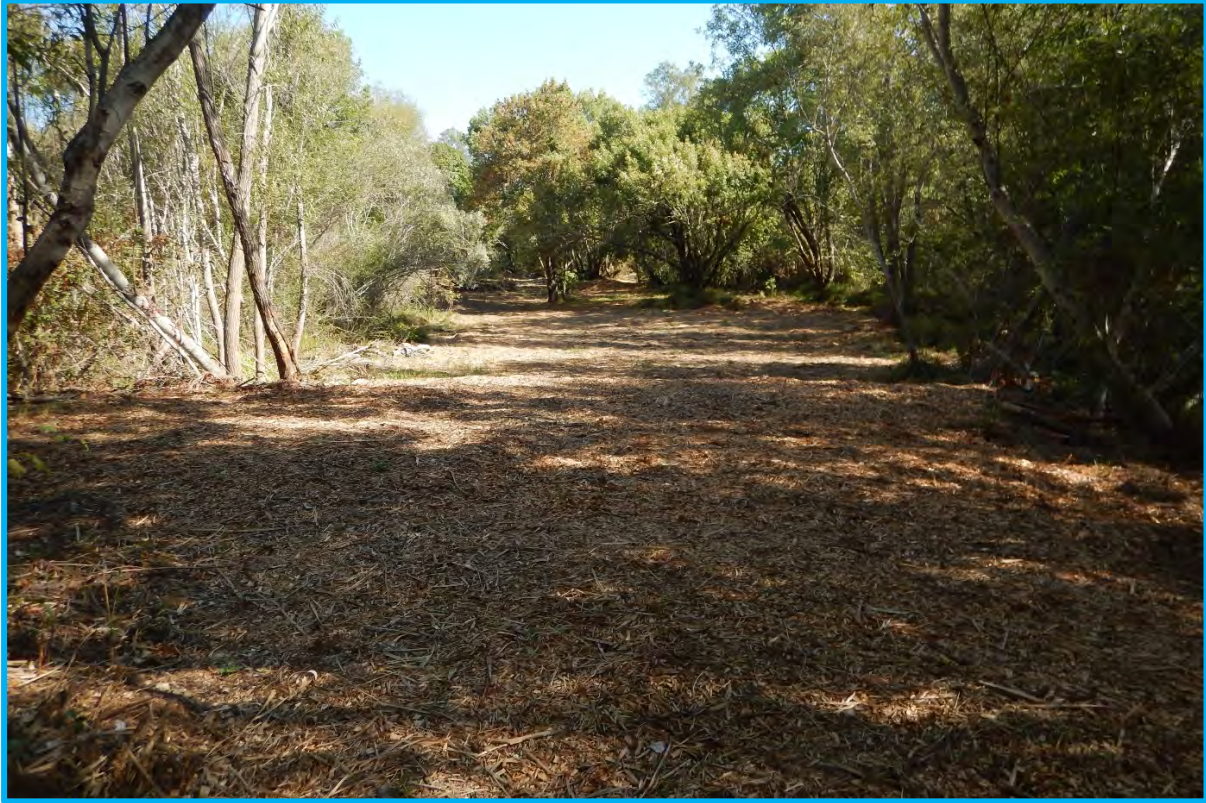
Photograph 2. Photographer is standing on the “upland” located at the Site entrance and looking north down a cleared corridor and into the Atascadero Creek floodplain and designated wetlands. Chipped vegetation has been spread on exposed soils disturbed using heavy equipment. Trees include willows, cottonwood, and Oregon ash, wetland and riparian species.

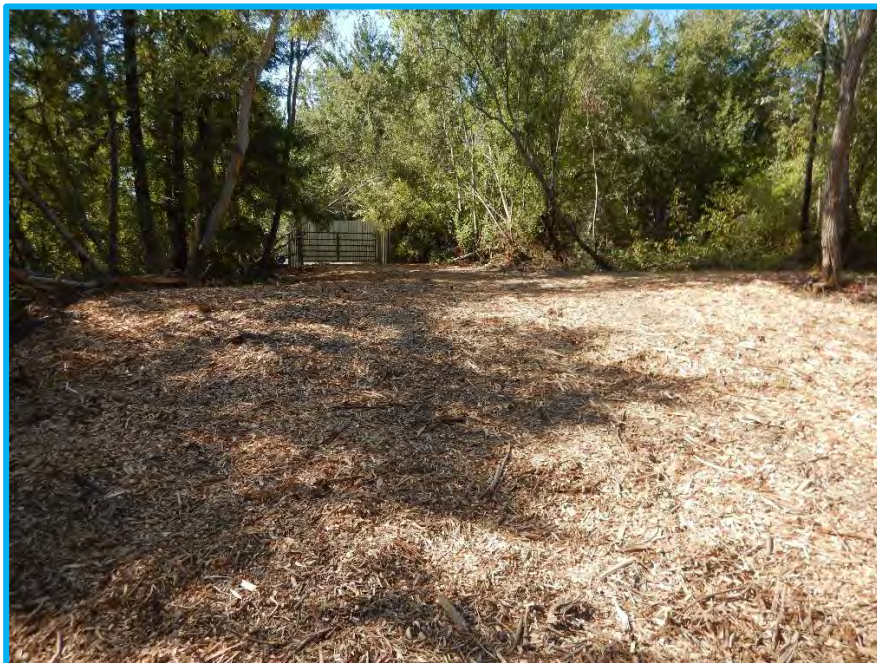
The inspection team proceeded to walk the Site by descending 4.5 to 5 feet from the Site entrance uplands and down onto the floodplain and delineated wetlands (Photographs 2, 3, and 4). Once onto the floodplain and mapped wetland area, it appeared vegetation clearing was performed using chainsaws and heavy equipment. Generally, vegetation was dropped using chainsaws and then cleared either by pushing the slash into the riparian forest or by chipping and spreading. Vegetation on the west side of the Site included an abundance of sedges (*Carex sp.*) indicative of wetlands (Photographs 5, 6, and 7). Areas cleared of vegetation using heavy equipment and later covered in chipped vegetation had sedges resprouting from their underground root system indicating the cleared area is a wetland.

Photograph 3. The photographer is standing on the floodplain and looking south to the “upland” located at the Site entrance. The corrugated metal fence and entrance gate can be seen in the distance.

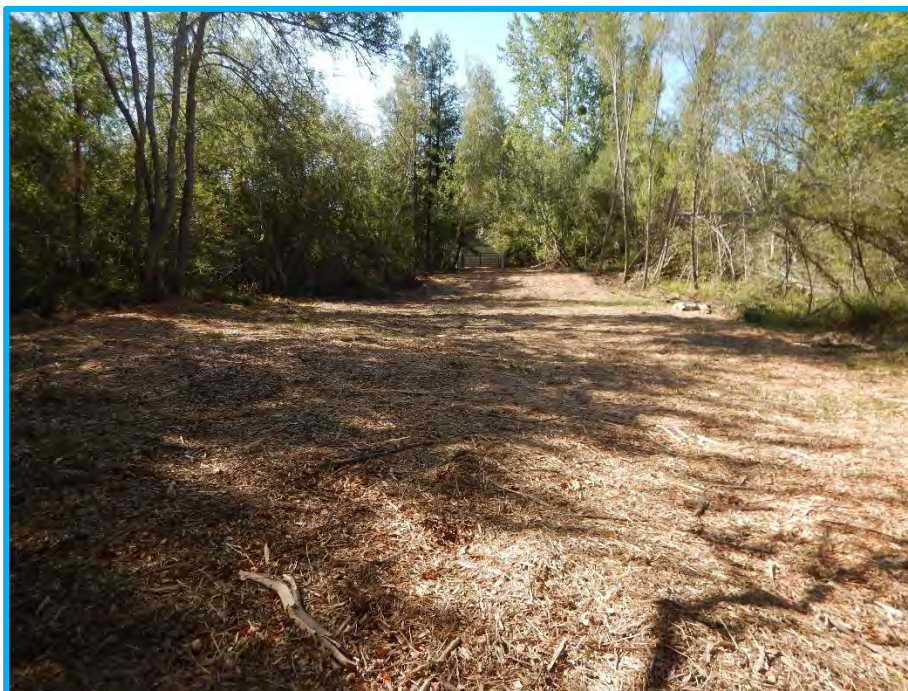
Photograph 4. The photographer is standing on the floodplain in the Site interior and looking south to the “upland” located at the Site entrance.

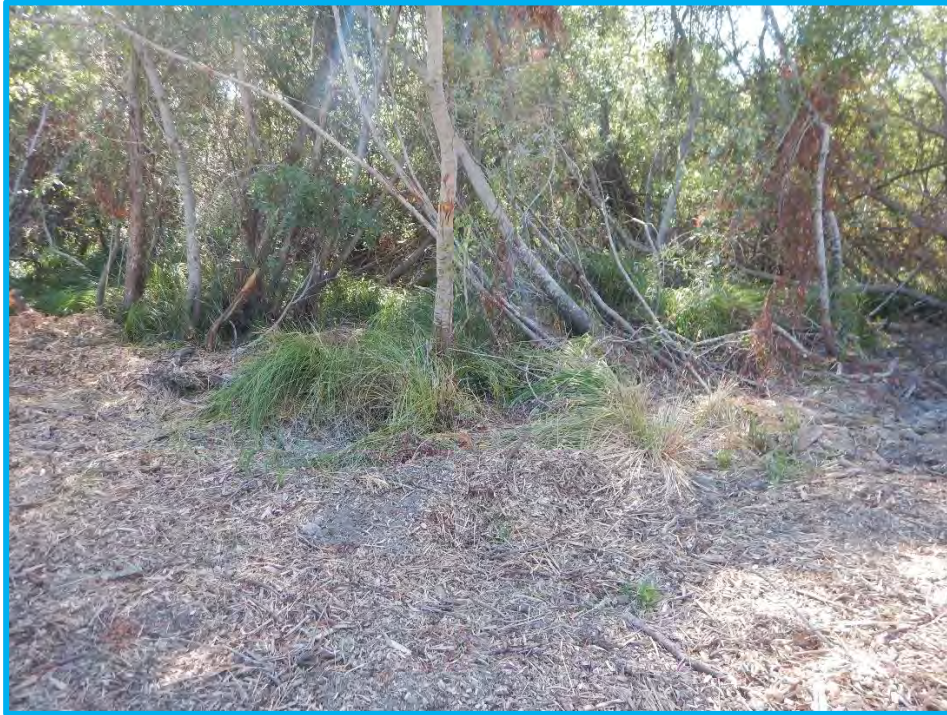
Photograph 5. Close to the western property line and looking west, chipped vegetation has been spread on soils disturbed by heavy equipment. Grass-like wetland vegetation seen are sedges and the trees are willows.

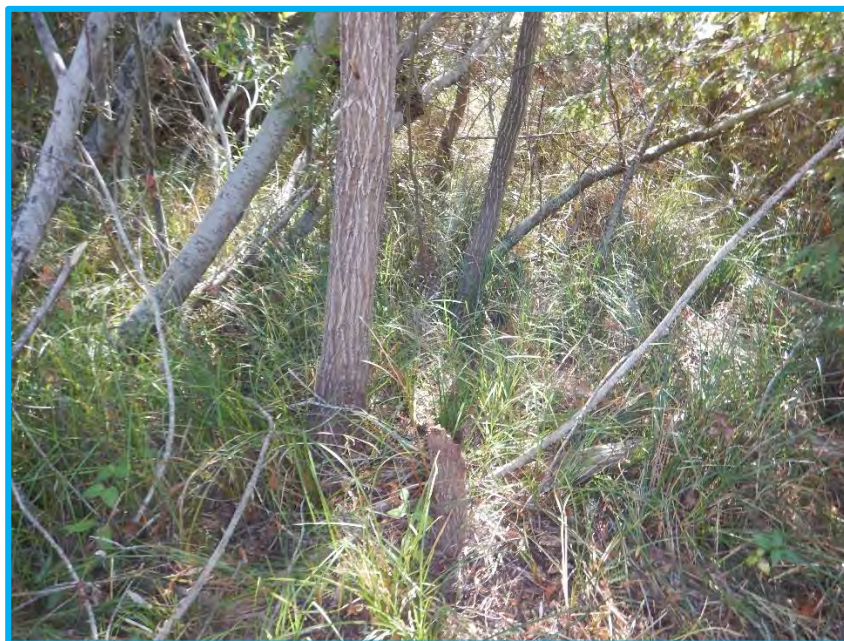
Photograph 6. This photograph shows undisturbed riparian forest and sedge growing west of the of the cleared riparian forest.

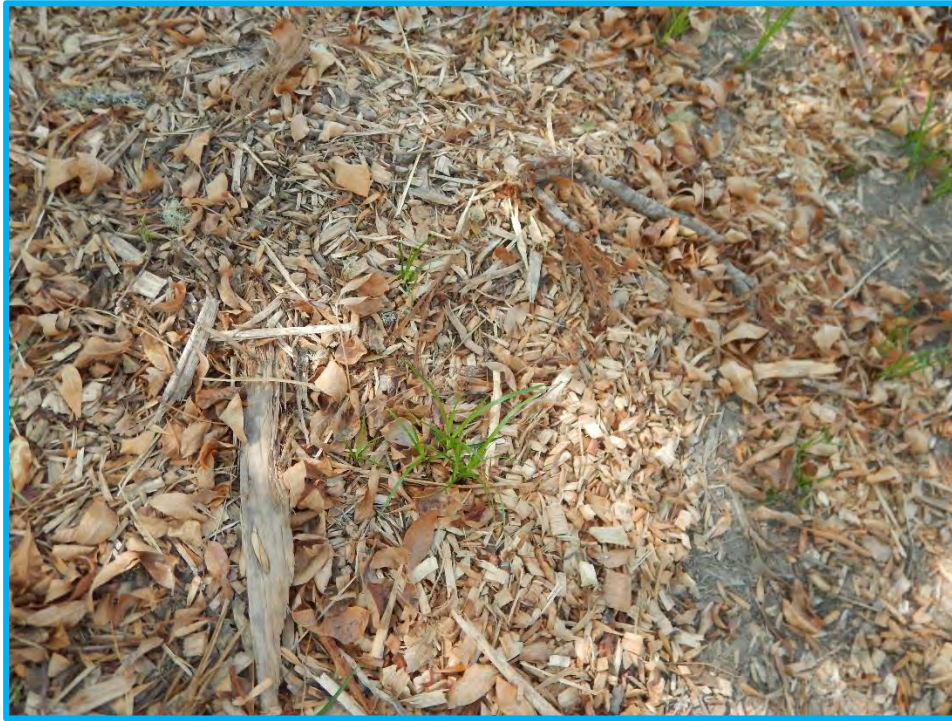
Photograph 7. Sedge cleared by heavy equipment are re-sprouting from its underground root system indicating the cleared area is a wetland.

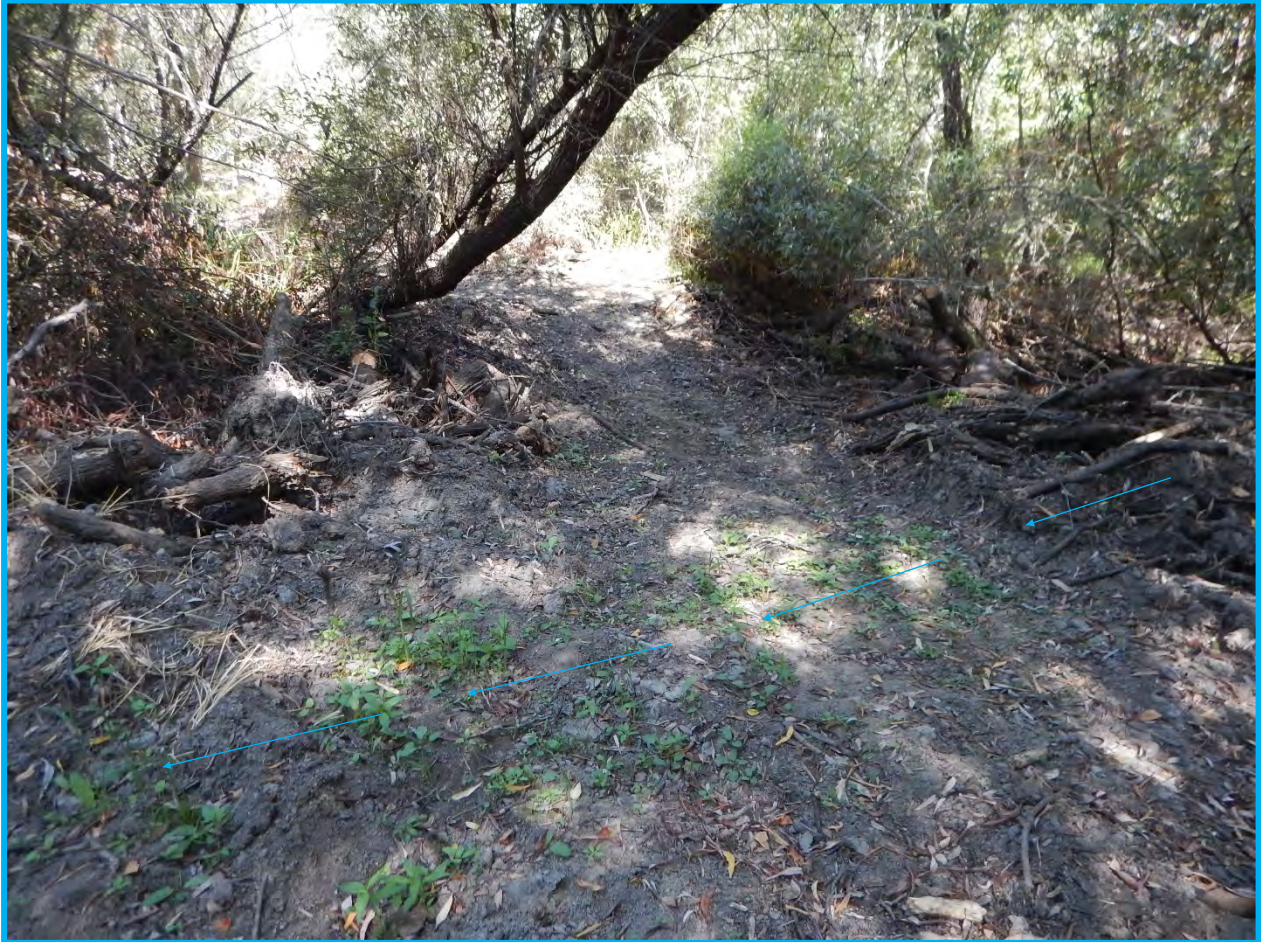
Photograph 8. The road crossed a major overflow channel as it headed towards Atascadero Creek. Riparian trees were felled using chainsaws and heavy equipment pushed the fallen trees into the riparian forest. Fill consisting of fallen and cut trees, understory vegetation, and soil had been placed in the overflow channel. Blue arrows show flow direction during high water.

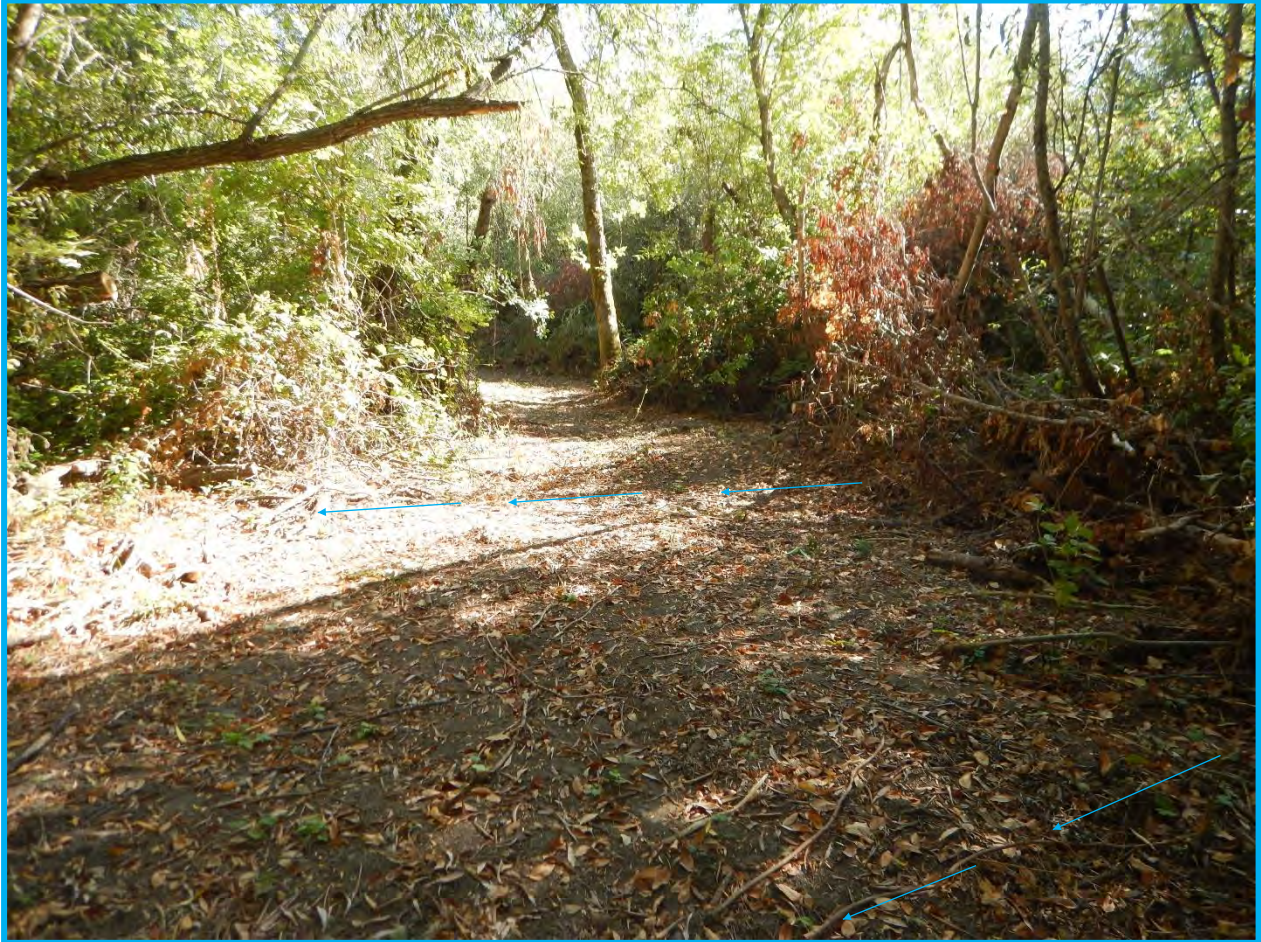
Photograph 9. The road crossed several smaller overflow channels and small clearings where vegetation was pushed into the riparian forest. Blue arrows show flow direction during high water.

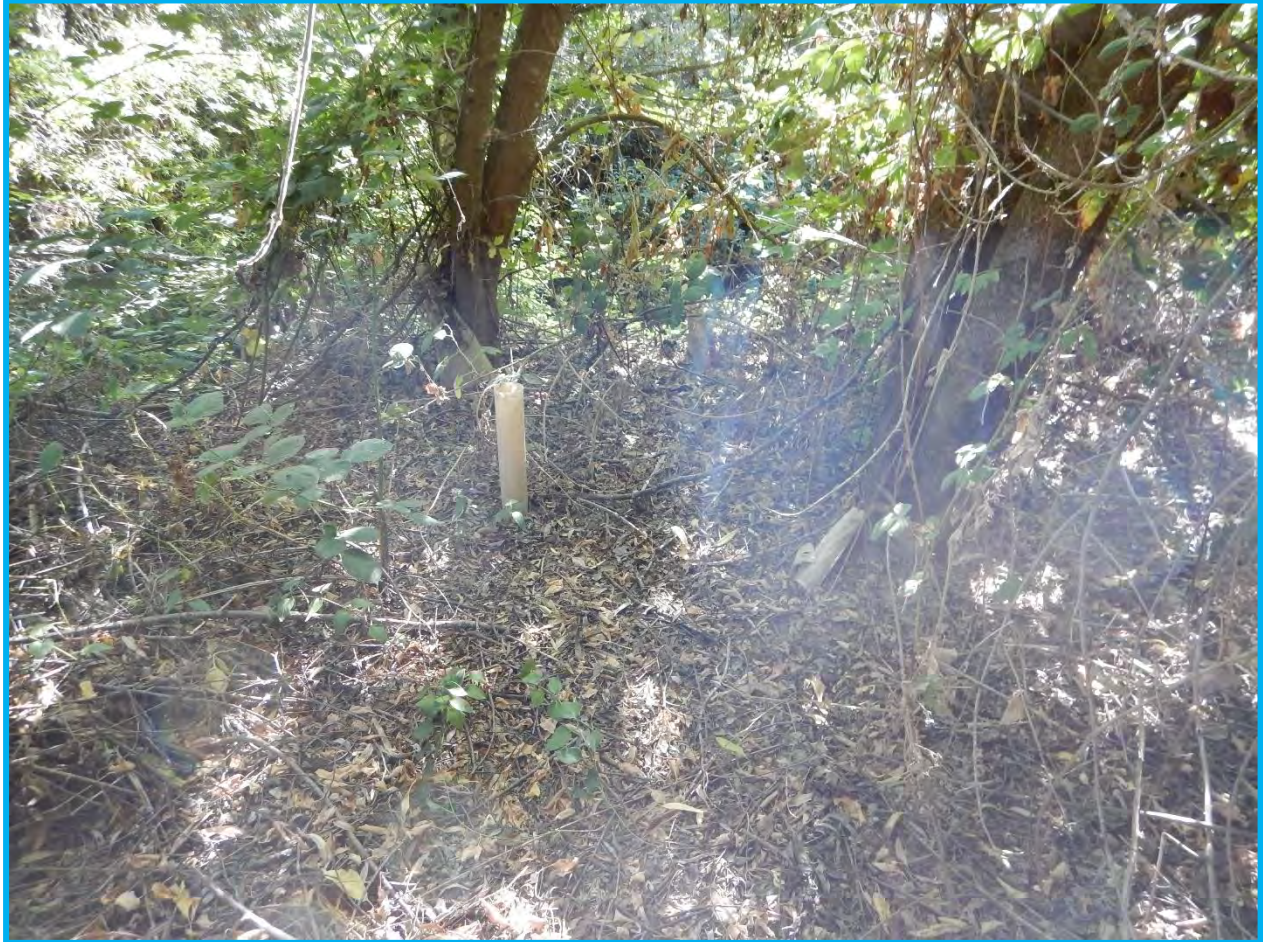
Photograph 10. Along the perimeter of a small clearing near the road termination, several white translucent grow tubes 12 to 18 inches tall were seen in the forest. Mr. Falcone and I presumed this area was cleared in 2002 by the previous owner and the grow tubes were for vegetation restoration. This area has been cleared of replanted riparian vegetation.

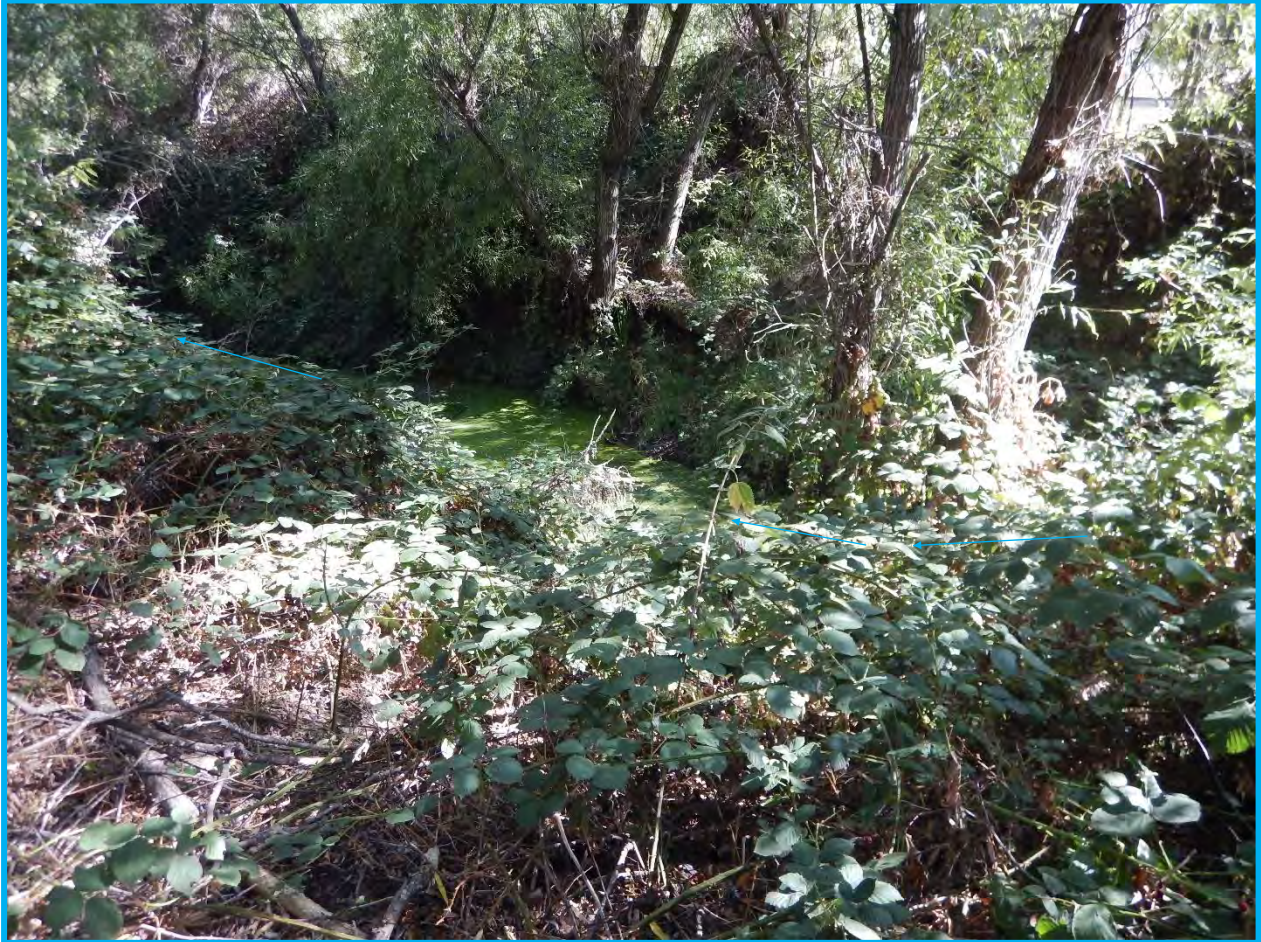
Photograph 11. The photographer is standing on the edge of a small clearing where the road terminates, and an estimated 25 feet from the top-of-bank of Atascadero Creek. Atascadero Creek can be seen in the center of the photograph covered with bright green algae or duck weed. Blue arrows show flow direction.

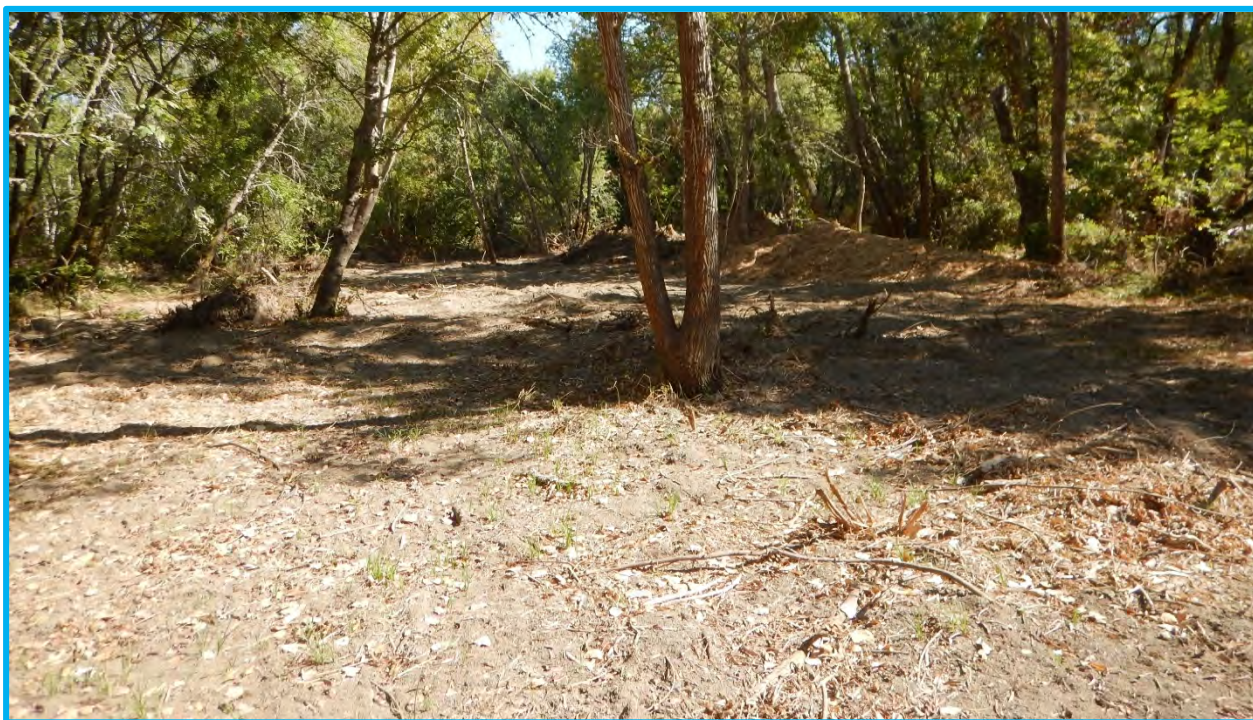
Photograph 13. Farther to the north, again, vegetation clearing was extensive, the soil surface was scrapped of all vegetation and the riparian trees were chipped with large piles of woodchips remaining on the eastern side of the clearing (right side of the photograph).

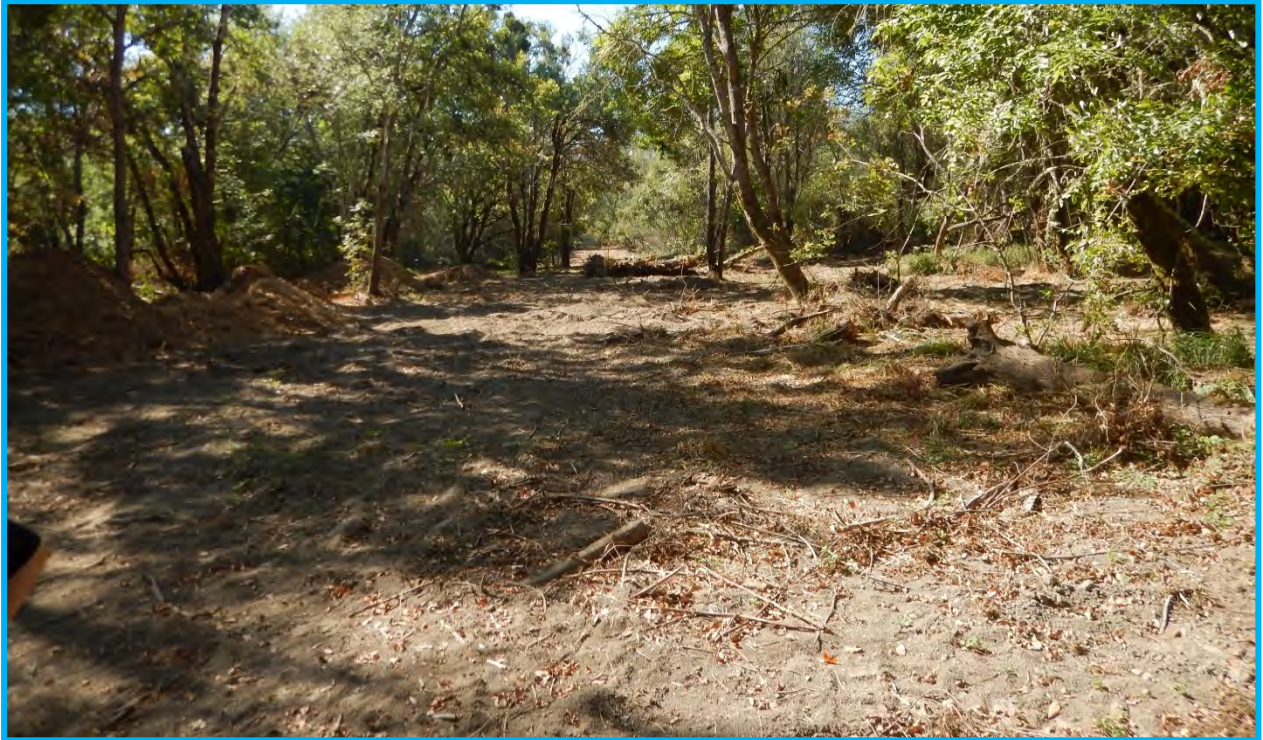
Photograph 14. Looking south, the western edge of the clearing (right side of the photograph) is densely covered in sedge. The soil has been heavily disturbed by heavy equipment.

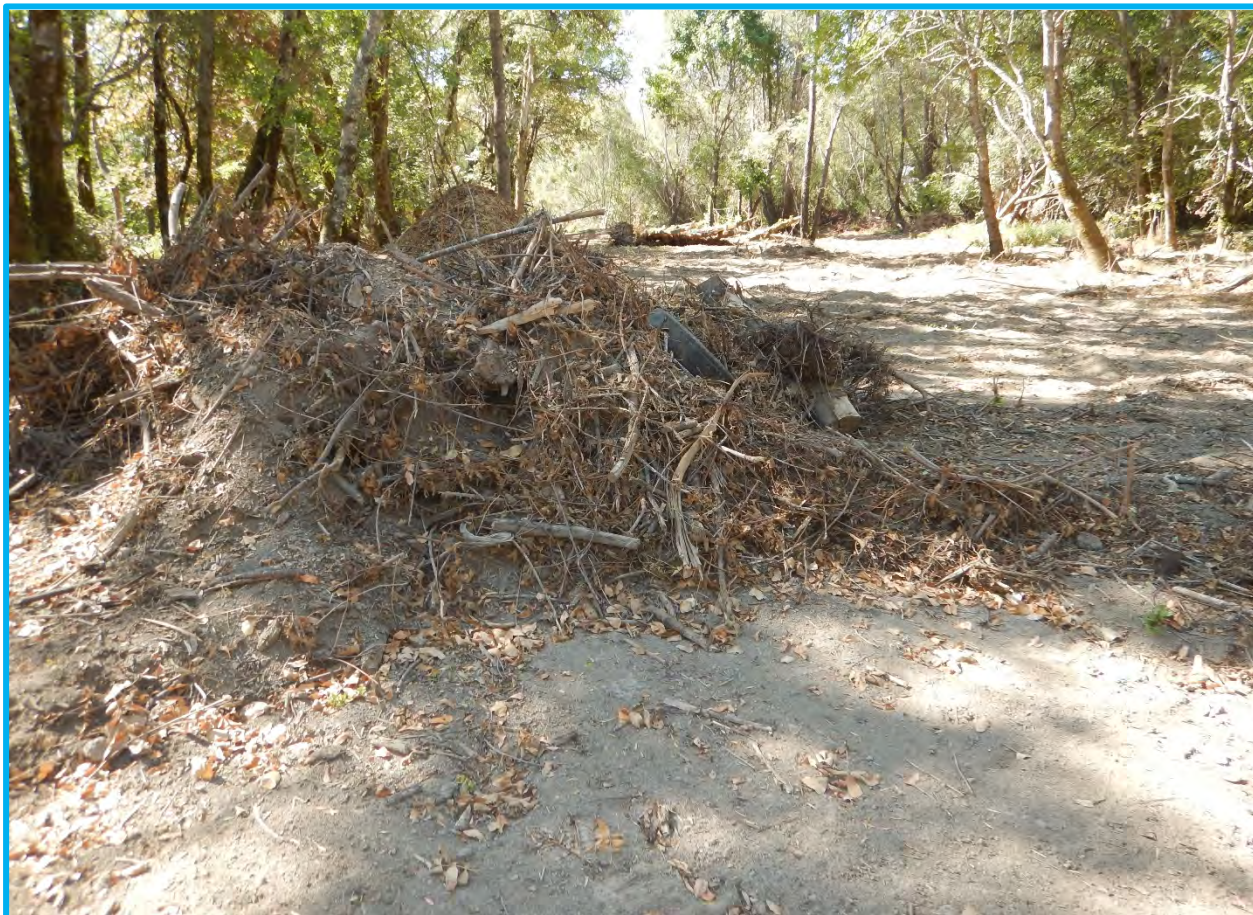
Photograph 15. Several large piles of scraped riparian vegetation and soil were left in piles along the eastern perimeter of the central clearing.

Heavy equipment has pushed cut trees and riparian vegetation into large piles and into the riparian forest. Large piles of chipped trees are onsite, in other areas the chips have been spread, and other areas the ground has been left highly disturbed and exposed. Clearing and road construction has occurred in overflow channels with fill placed in currently dry channels. The disturbed soil material consists primarily of fine sandy loam Gold Ridge soils that are easily erodible. It appeared the area of impact is over approximately 1-acre.

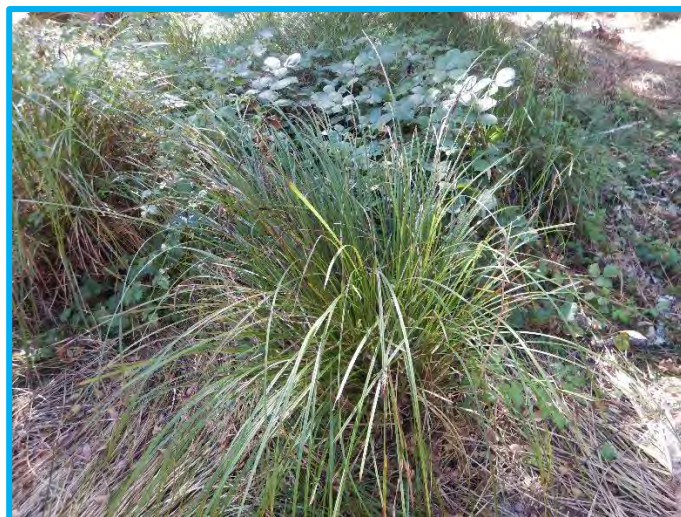
Photograph 16. Thickly growing sedge was observed on the western side of the clearing with some individual plants becoming quite large. This plant was located near the northern property boundary.

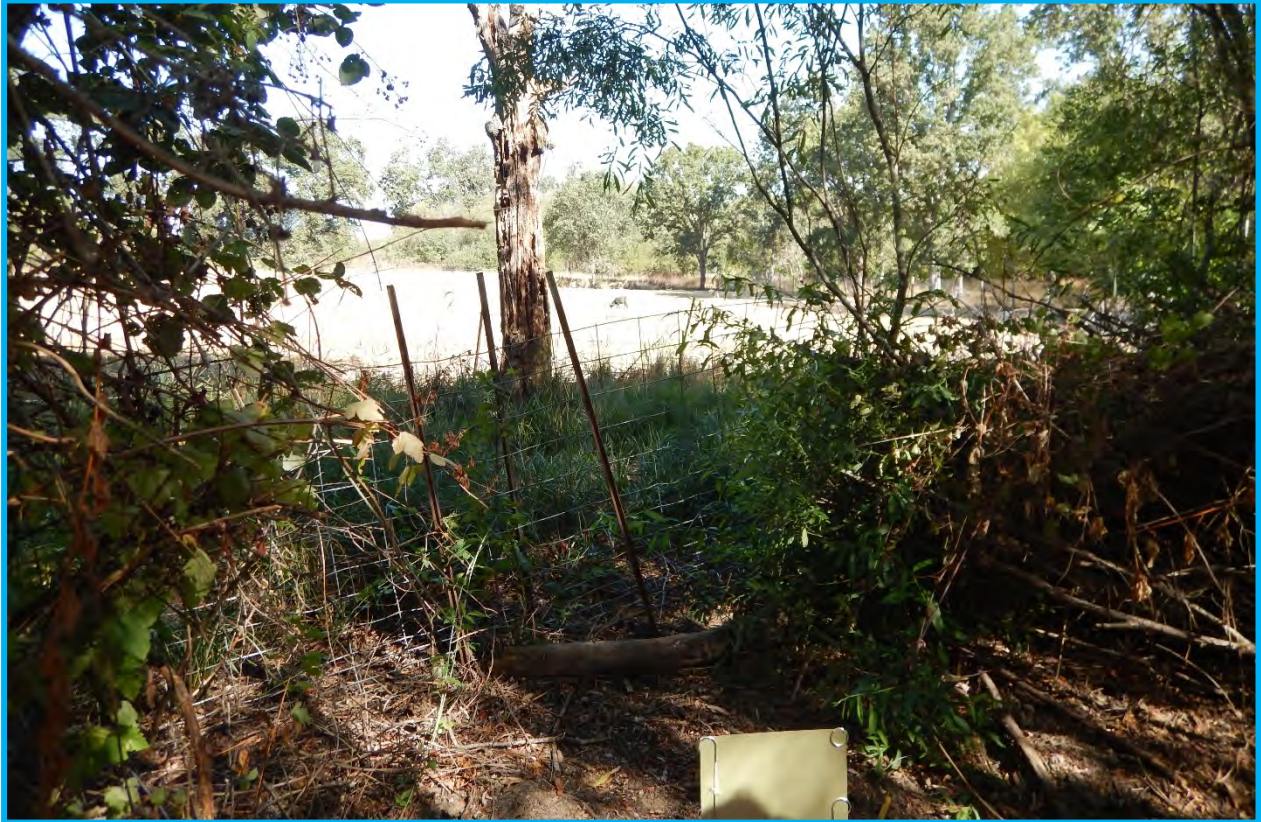
Photograph 17. A short, cleared length of road extended to the northern property line where a “no trespassing” sign was posted. The neighboring property was historically cleared and is currently used for livestock grazing.

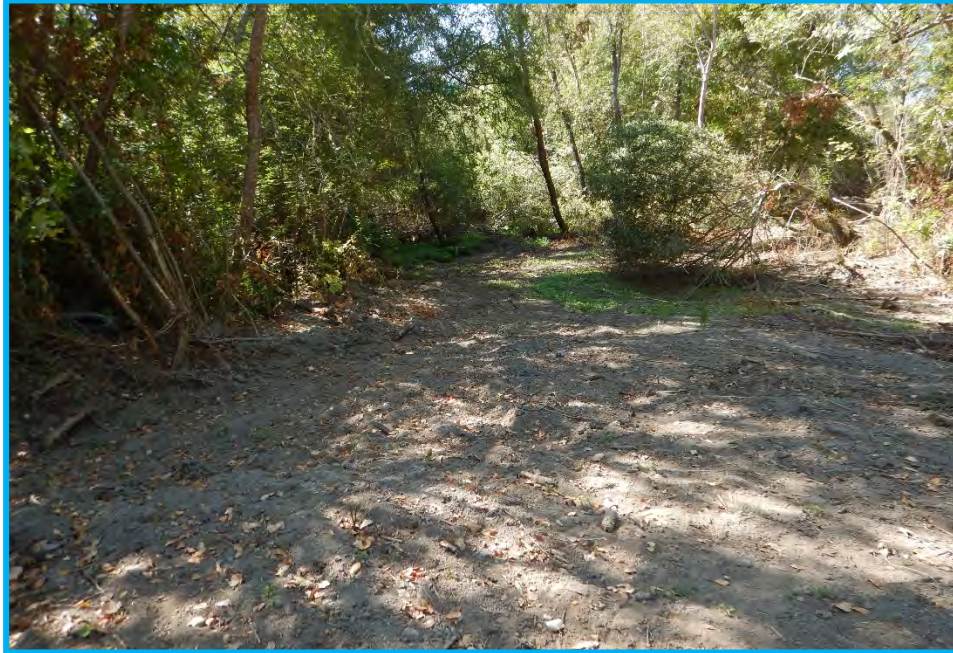
Photograph 18. Photographer is looking east, and the photograph shows a segment of the northern perimeter riparian vegetation clearing.

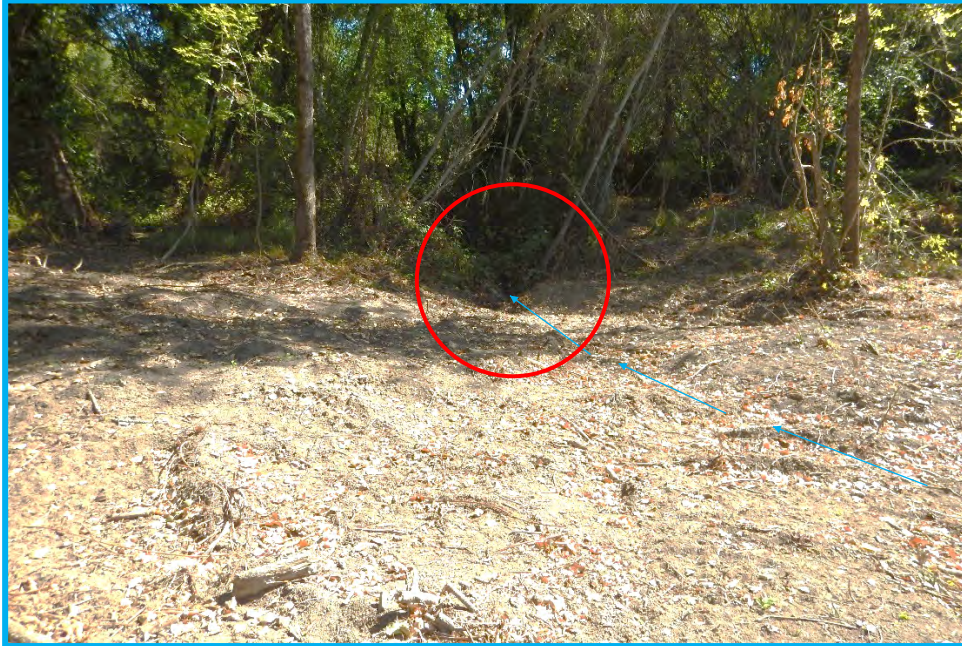
The northernmost portion of the riparian clearing had the same features as the previous areas (Photograph 19). Riparian vegetation clearing and soil disturbance extended into a large overflow channel that significantly deepened and widened to the north (Photographs 20 and 21). Sonoma County LIDAR Imagery of 9000 Mill Station Road, Sebastopol, shows the large overflow channel to merge with Atascadero Creek near the northeastern property boundary (Figure 3). In addition, a network of small overflow channels had been cleared of riparian vegetation with fill deposited in them (Photographs 22, 23, and 24).

Photograph 19. Clearing and soil disturbance along the northern perimeter extended into a large overflow channel that significantly deepened and widened to the north. Sonoma County LIDAR Imagery shows the large overflow channel to merge with Atascadero Creek. The photo has been lightened to show the overflow channel and the channel circled in red. Blue arrows show flow direction during high water.

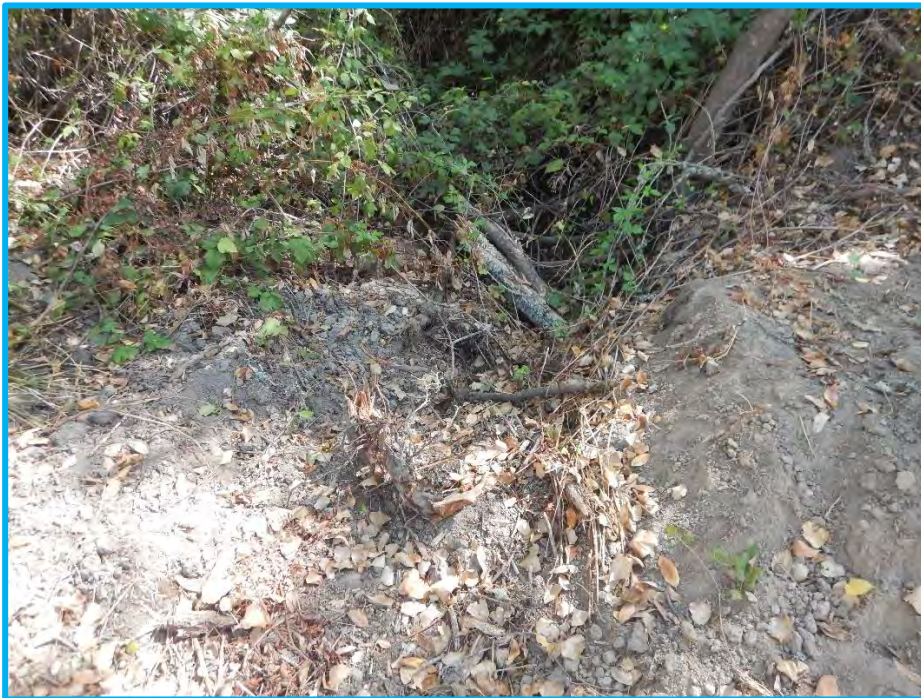
Photograph 20. Closeup photograph of the overflow channel immediately before it dramatically deepens to the north. Heavy equipment has placed disturbed fill in the channel.

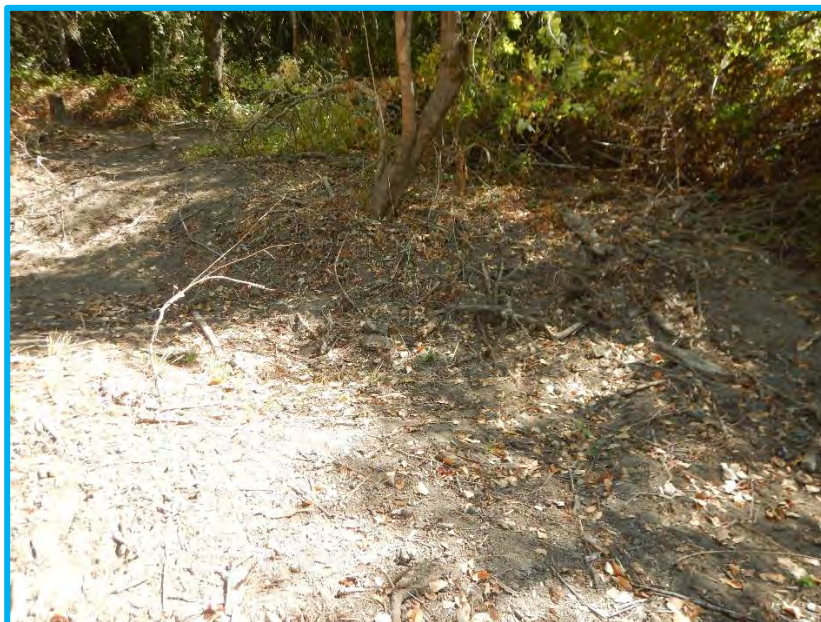
Photograph 21. Photograph shows an overflow channel that had been cleared of riparian vegetation and surface soil highly disturbed.

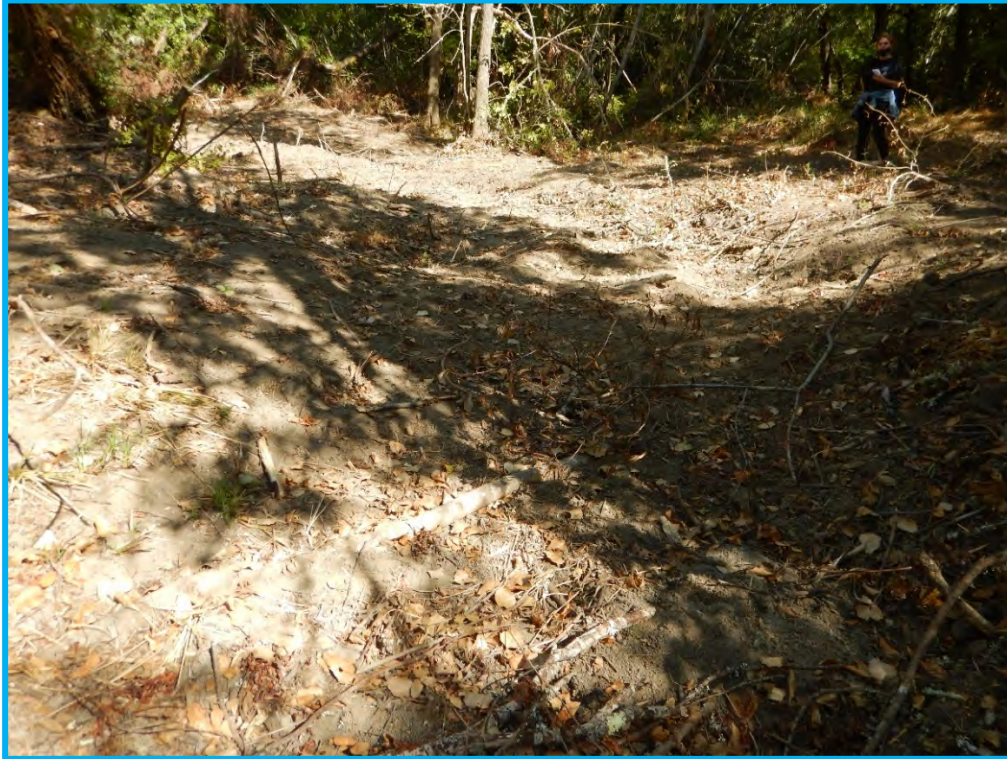
Photograph 23. Photograph is looking south and shows an overflow channel cleared of riparian vegetation with fill deposited in it. A cleared road continues to the east (upper left side of the photograph) and ends on the top-of-bank of Atascadero Creek.

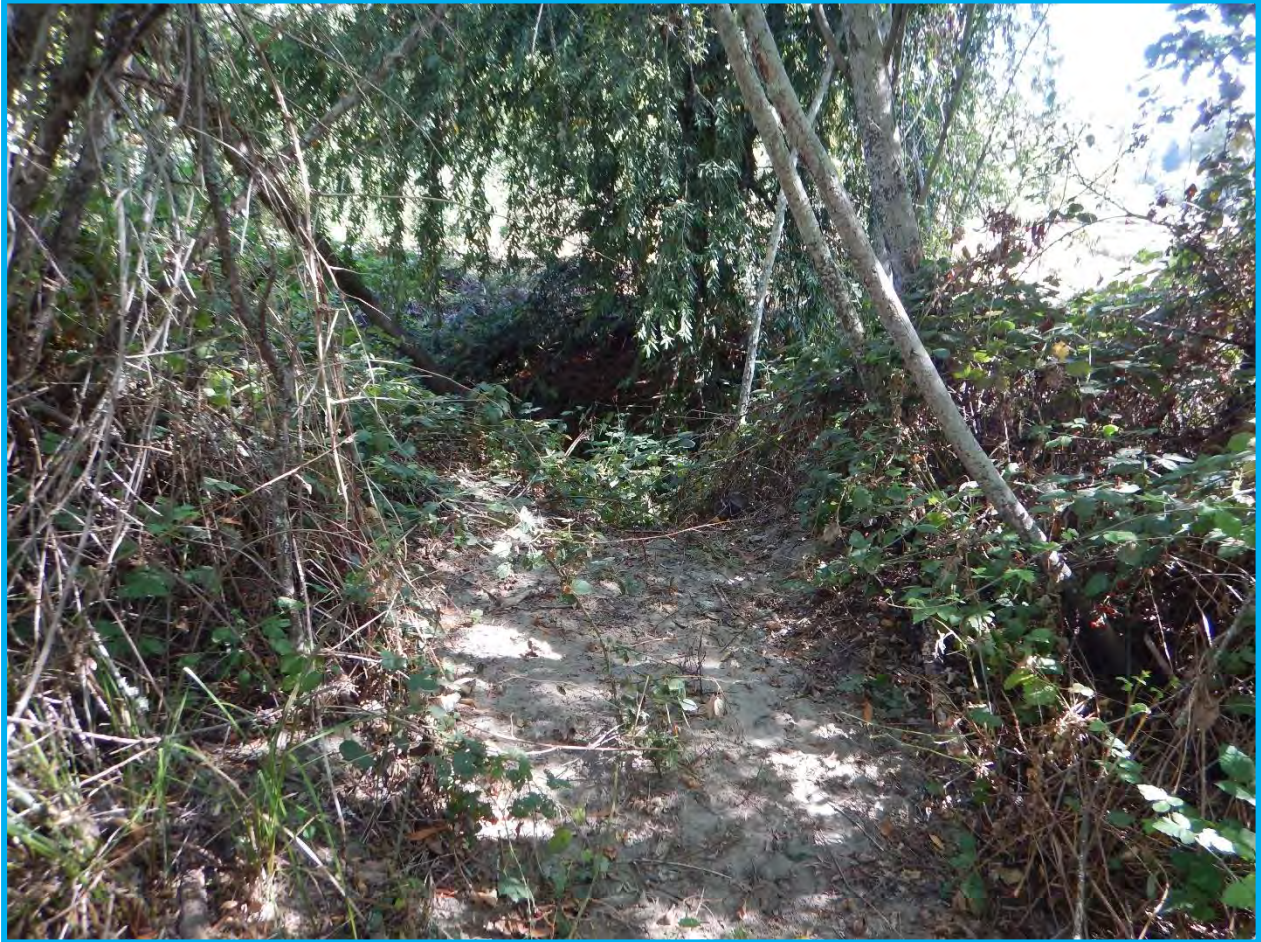
Photograph 24. The cleared road ended at the top-of-bank of Atascadero Creek. Appropriate setback from the creek was not followed.
