Subject: **Notice of Violation Associated with Bridge Installation and Culvert Replacement Activities at 3157 Calistoga Road, Santa Rosa**

Exhibit B: August 11, 2021 Inspection Report

SUBJECT: Inspection of Unpermitted Stream Crossing Replacement

LOCATION: 3157 Calistoga Road, Santa Rosa (APN 028-130-009)

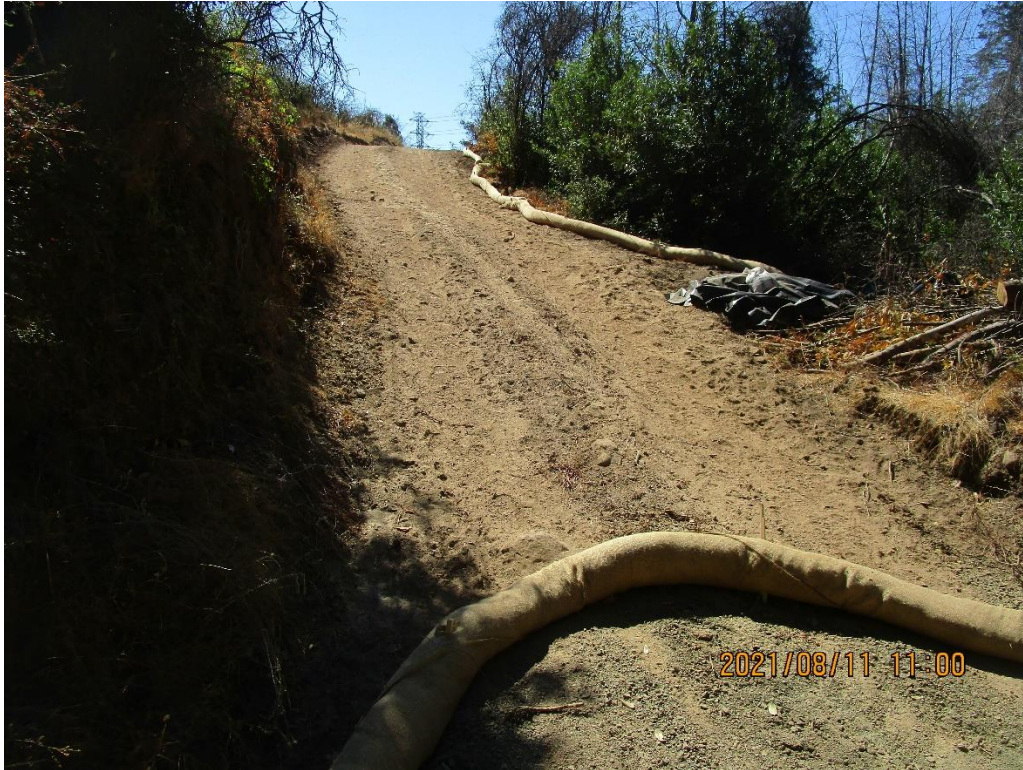
PG&E suspended work on the project and conditions observed on August 11 appeared unchanged compared to conditions observed and documented in the June 28, 2021 inspection report except for the addition of straw wattles. Straw wattles appeared to be placed without an erosion control plan. The straw wattles were not installed properly, lacked adequate staking to the ground, and did not appear adequately distributed to effectively control potential sediment discharges from the fine material on the roadbed and disturbed soil around stream crossings in the event of a storm event. Based on conversations with PG&E representatives during the inspection, PG&E conducted all recent and observed road grading, culvert replacement at reference locations (Figure 1) WQ5 and WQ9, and bridge installation at WQ8.

Photo 1. Road segment south of WQ5 with representative example of straw wattle installation.

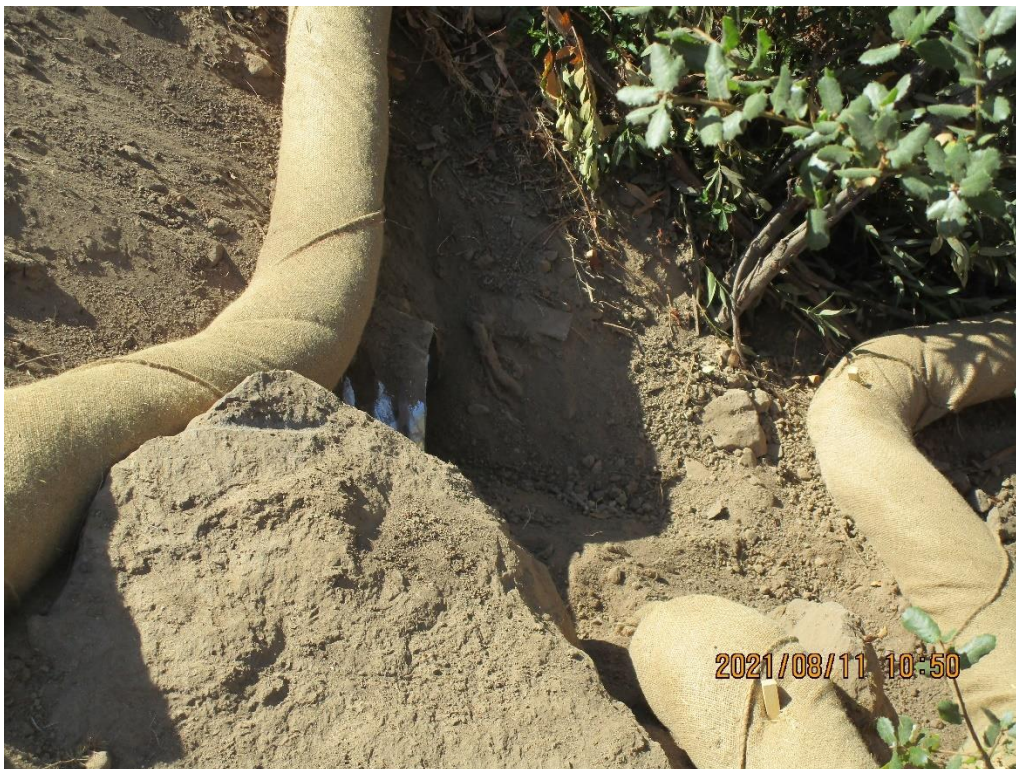
During the inspection a discussion occurred regarding the poor condition of the road surface, the lack of road drainage, and the amount of fine material on the road surface and inlet and outlet of the new metal culverts. PG&E representatives indicated the type of work is messy and they had not completed the work due to suspending the project. PG&E representatives indicated they planned to add rock riprap at culvert inlets and outlets. When asked whether the road surface would be rocked as part of the project PG&E representative Jason Warshawer stated that PG&E does not rock the surface of utility access roads on private property where they only need the road access a couple times per year.

Photo 2. Outlet of new unauthorized culvert, wattles, and fine sediment at WQ5.

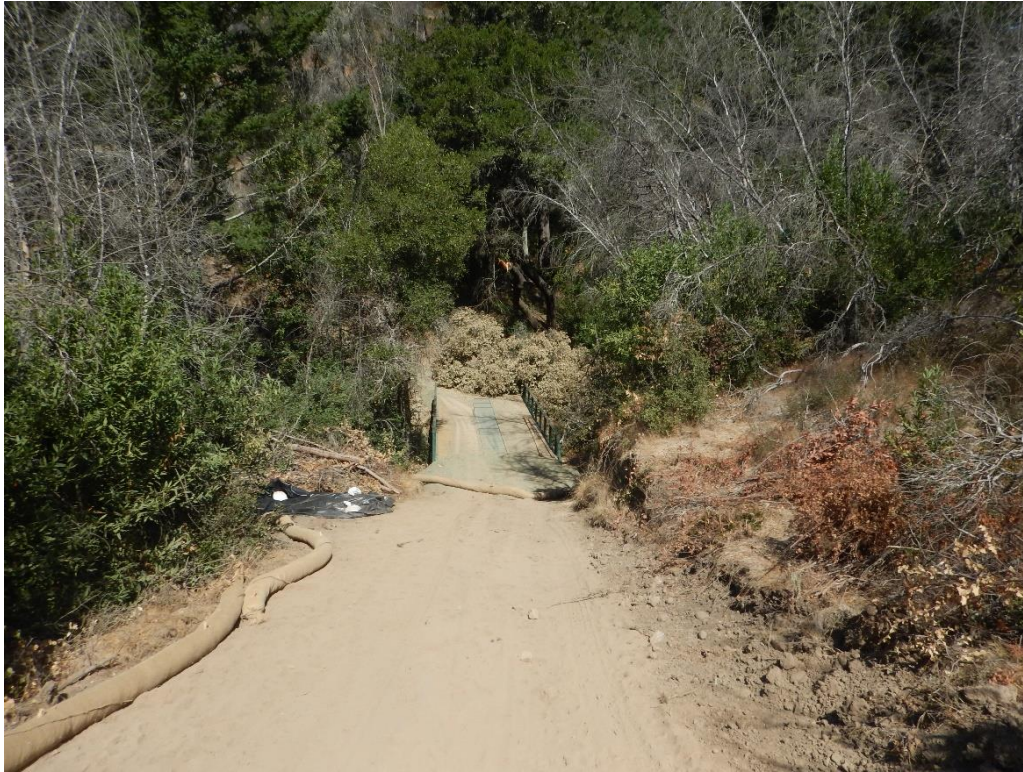
PG&E representatives indicated the road work and replacement of burned out plastic culverts with permanent metal culverts was a necessary aspect of a utility hardening project. Since PG&E representatives referred to the new bridge as temporary, RWQCB staff inquired as to why permanent culverted stream crossings were necessary on either

side of the bridge if the bridge was temporary. PG&E representatives clarified there was no plan to remove the bridge and their use of the term “temporary bridge” only meant that the new bridge could be removed and relocated if needed at another location. RWQCB staff explained that our permitting approach for a “temporary” bridge installation involves ongoing permit coverage during the period of use of the bridge and a “permanent” bridge would be permitted for the bridge installation with permit coverage typically terminating following bridge installation.

Photo 3. Recently installed bridge at WQ8 and opposite direction view of road and wattles in Photo 1.

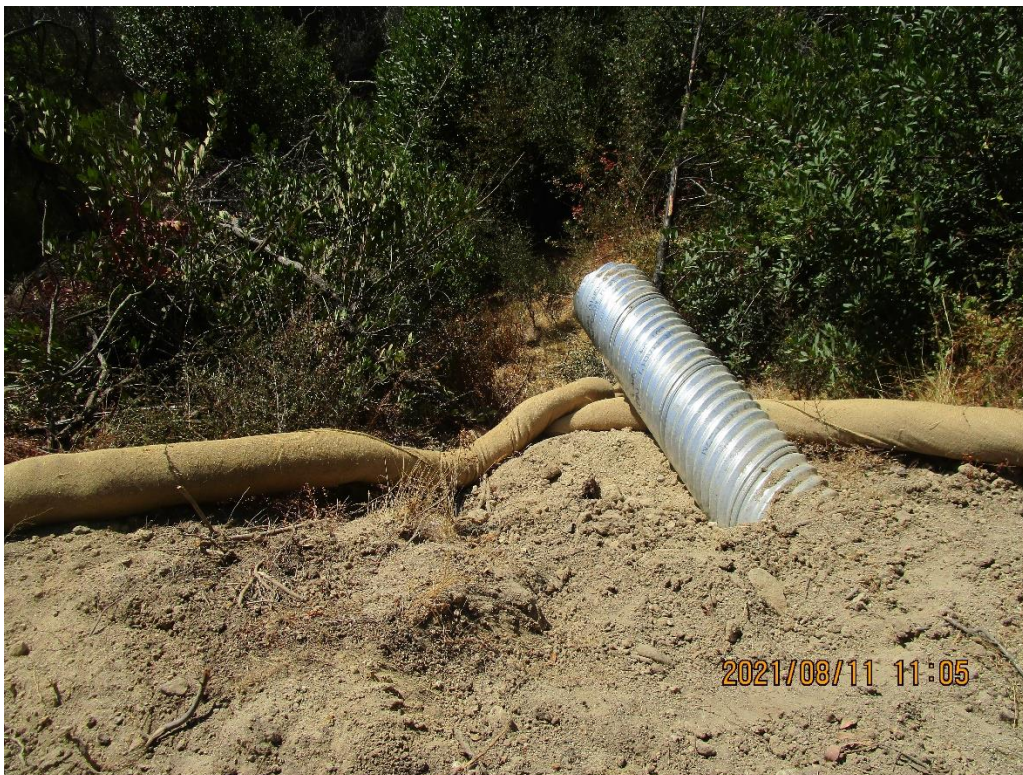
Photos taken on August 11 of reference point locations WQ5, WQ8, WQ9 are attached (Attachment 1) below. Locations of additional fire damaged watercourse crossings where PG&E is proposing additional culvert replacements were also observed to the west of WQ9 along the same access road. All of the proposed additional culvert replacements were located on ephemeral channels no larger than the channels located at WQ5 and WQ9. PG&E representatives noted that the installation of the culvert at WQ9 would likely need to be reinstalled to place the culvert on grade and in-line with the channel. Photo 4 below shows the culvert at WQ9 is clearly perched and not installed appropriately to current standards.

Photo 4. Outlet of recently installed culvert at WQ9.

By no later than **September 24, 2021**, we request that PG&E submit a complete *Notice of Intent (NOI) to Enroll Under and Comply with the Terms of Water Quality Order No. 2004-004-DWQ (General WDRs), Statewide General Waste Discharge Requirements for Dredged or Fill Discharges to Waters Deemed by the U.S. Army Corps of Engineers to be Outside of Federal Jurisdiction* including details for stream crossing design, calculations to demonstrate proposed crossings are adequately sized to pass flows

associated with a 100-year flood event, and details of Best Management Practices to be employed to control pollutant discharges from the reconstructed access road and associated stream crossings during and after construction to prevent project related sediment and disturbed soil from entering streams. A copy of the NOI and General WDR can be found on our website here:
