North Coast Regional Water Quality Control Board

Subject: Notice of Violation and Transmittal of Inspection Report for June 24, 2021 Inspection of Mendocino County Assessor's Parcel Number (APN) 148-070-02-00

FACILITIES INSPECTION REPORT

Inspection Maps and Photolog for inspection conducted, June 24, 2021

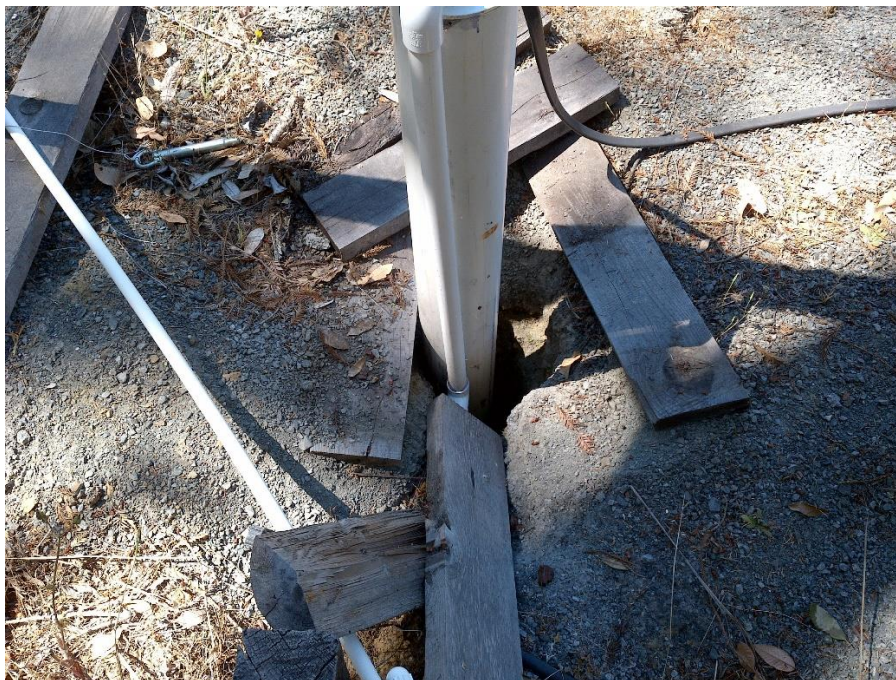
At WQ1, I observed a well that was being used to irrigate cannabis cultivation. The wellhead was not properly developed and provides a pathway for pollutants to contaminate groundwater. I observed cannabis cultivation occurring at WQ2 without coverage under the Statewide Cannabis General Order. I followed a recently created road from WQ2, and past WQ3 that threatens to discharge waste sediment to the tributary to Johnson creek at WQ4.

Photo 1—Groundwater well located at WQ1. Cavity where the well protrudes from the ground may allow pollutants from the service to pollute groundwater.

1. Enroll the Property in the Cannabis General Order.
2. Engage a qualified professional to assess the recently constructed roads on the Property & ensure future development and uses for cannabis are in conformance with current regulations.
3. Engage a qualified professional to assess the wellhead at WQ1 and ensure the wellhead meets Mendocino

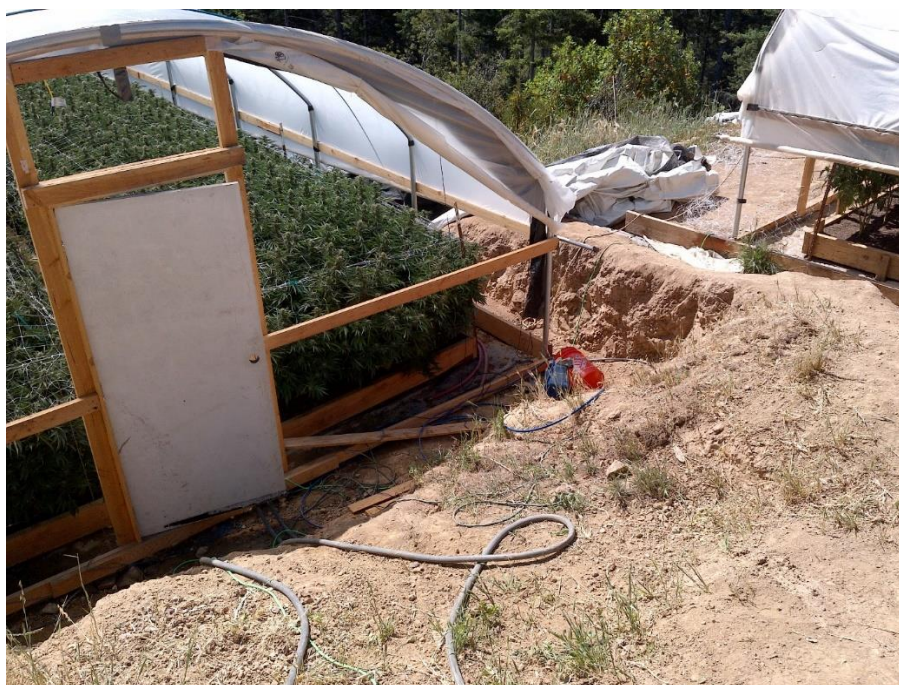
Photo 2—Looking south between two hoop-type greenhouses with growing cannabis plants at WQ2.

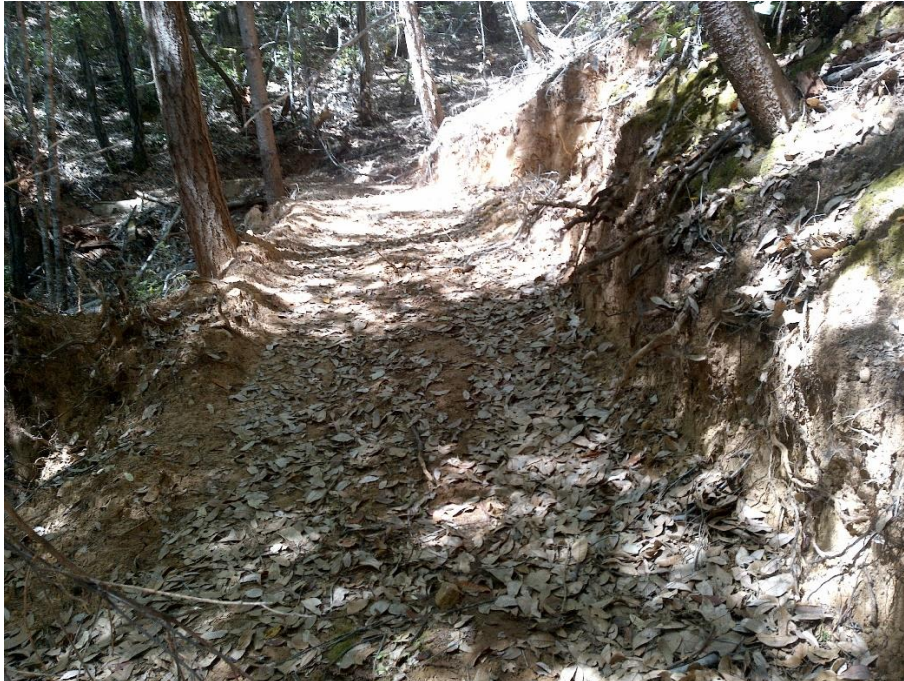
Photo 3—Looking west along road in the vicinity of WQ3. The road is six feet wide and the catface on the opposite side of the road averages three feet high. A berm of earthen spoils borders the out-slope edge of the road, which will concentrate stormwater and erode the road surface.

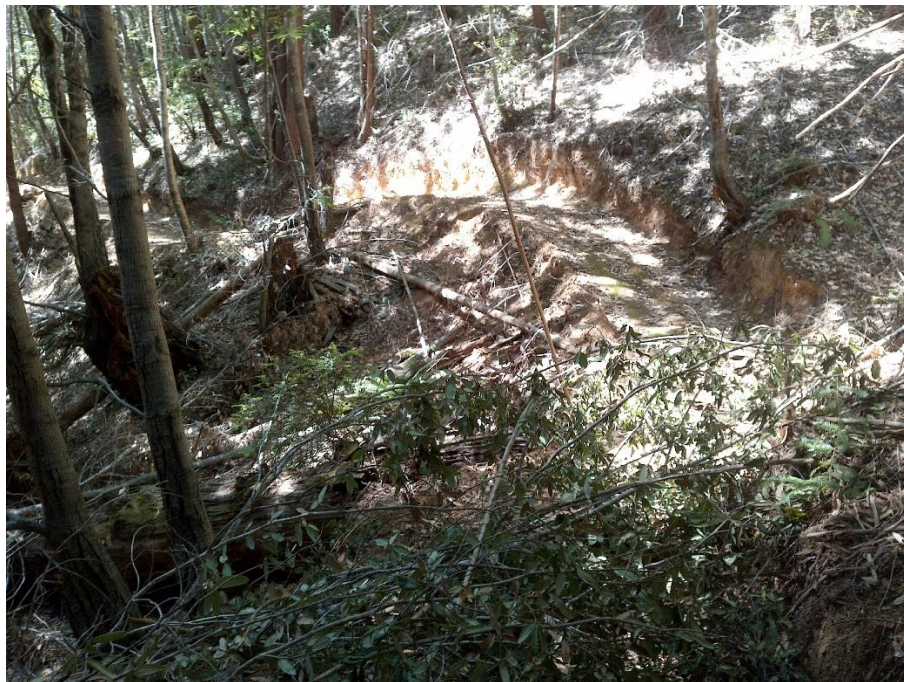
Photo 4—Looking west along road in the vicinity of WQ3.

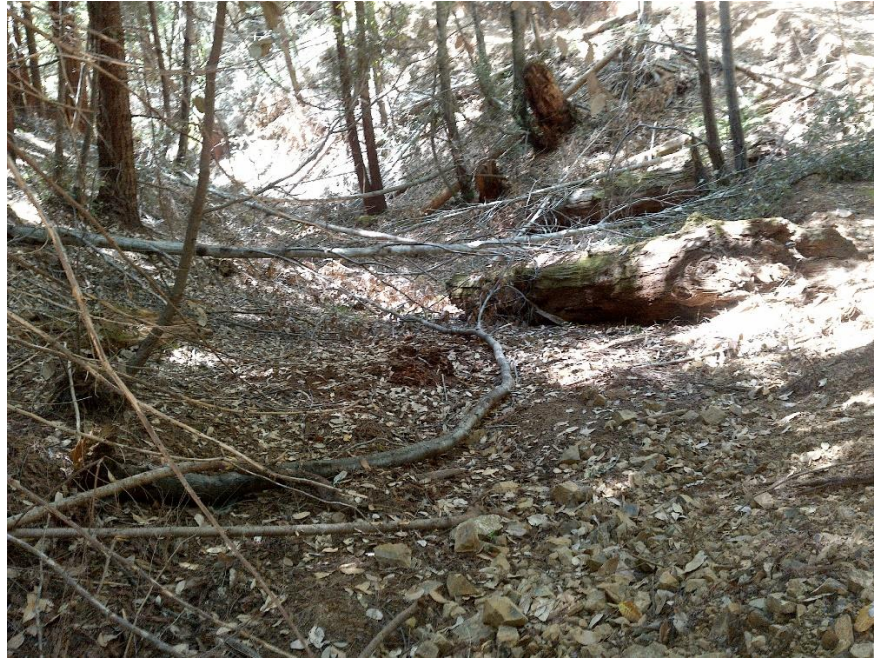
Photo 5—Looking south east from the road pictured in the previous image. Cobbles from creating the road are in the foreground of the image. A channelized channel, that is pictured in the following image, is visible in the middle back of this photo.

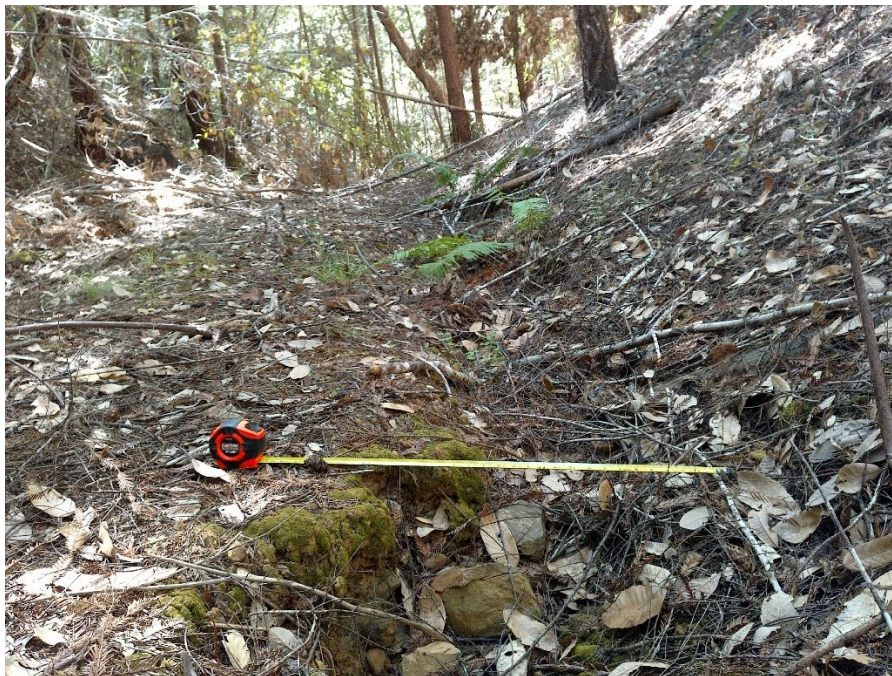
Photo 6—Channelized watercourse located, at WQ4, in the topographic swale pictured in the previous image. The watercourse is the upstream extent of the tributary to Johnson Creek Mapped as a blueline stream in the USGS National Hydrography Dataset.

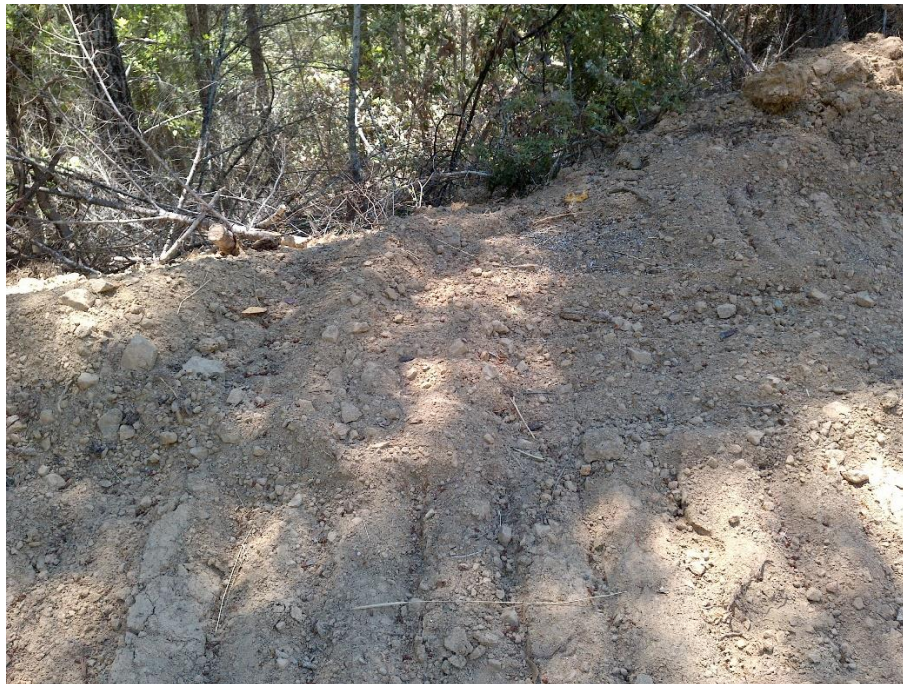
Photo 8—Earthen spoils on the downslope edge of the road in the vicinity of WQ5.

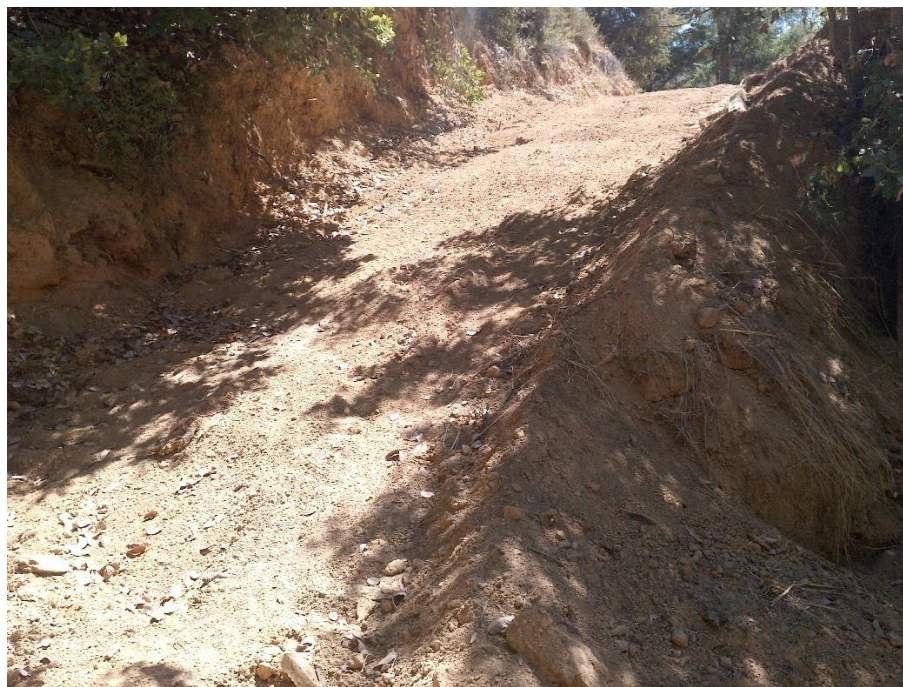
At WQ5 I observed domestic wastewater had recently been discharged to the ground behind a residence. At WQ6 I observed a road segment had been recently tracked by heavy equipment. The Road leads to, but does not cross, a watercourse at WQ7. I observed sediment transported by surface water at WQ8. The sediment appeared to originate from the road segment to the west. The roads passing WQ3, WQ5, WQ6 and WQ8 are not designed or maintained according to the standards of the Rural and Ranch Roads Handbook.

Photo 9—Looking east at earthen spoils on the downslope edge of the road in the vicinity of WQ6.

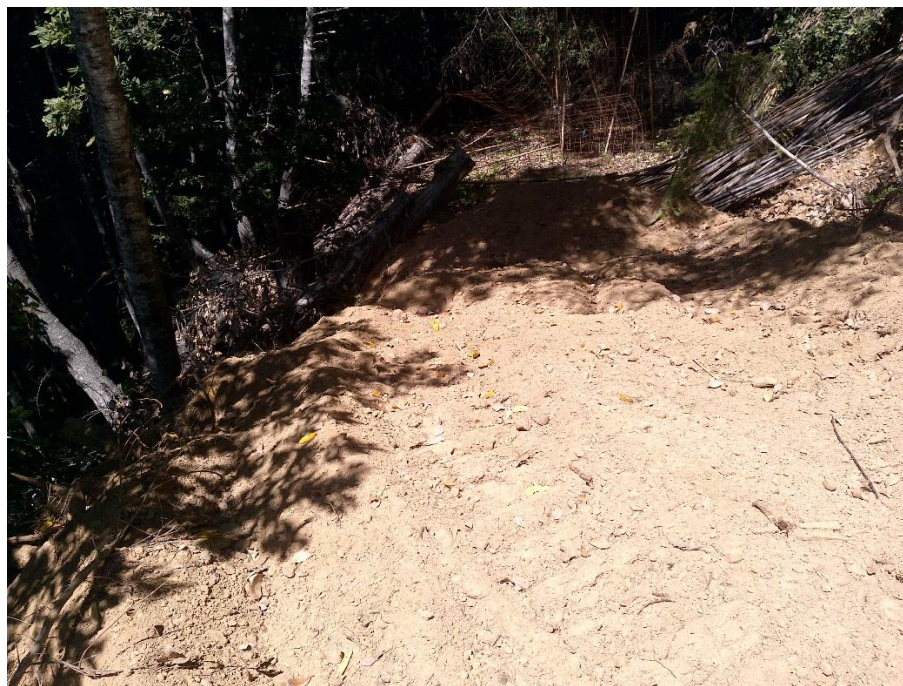
Photo 10—Looking west at earthen spoils on the road in the vicinity of WQ6.

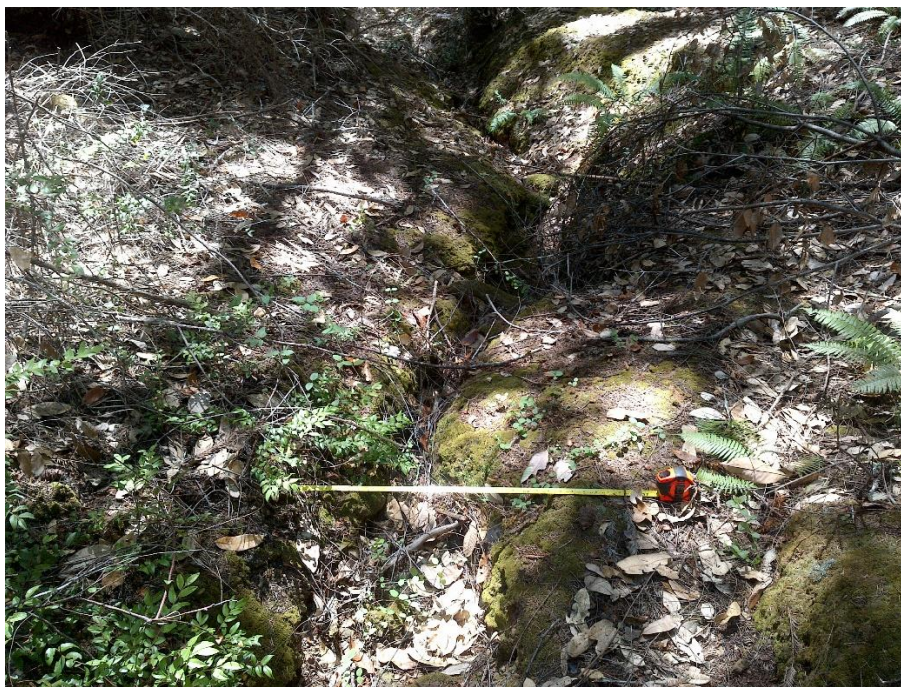
Photo 11—Watercourse at the end of the road at WQ7. The road did not cross the watercourse.

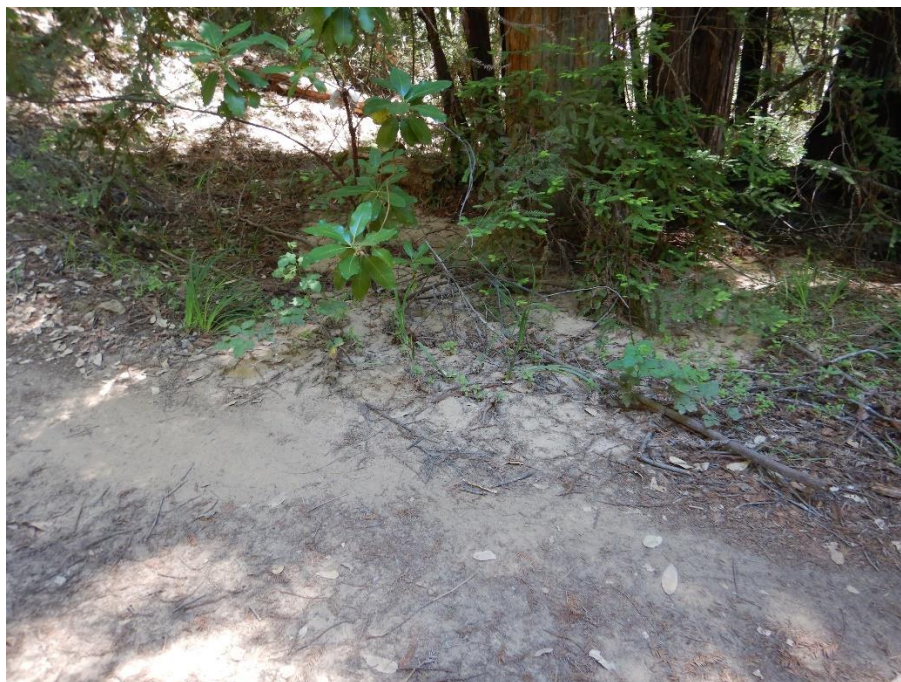
Photo 12—Fine sediment uniformly deposited on out-slope edge of the road at WQ8.

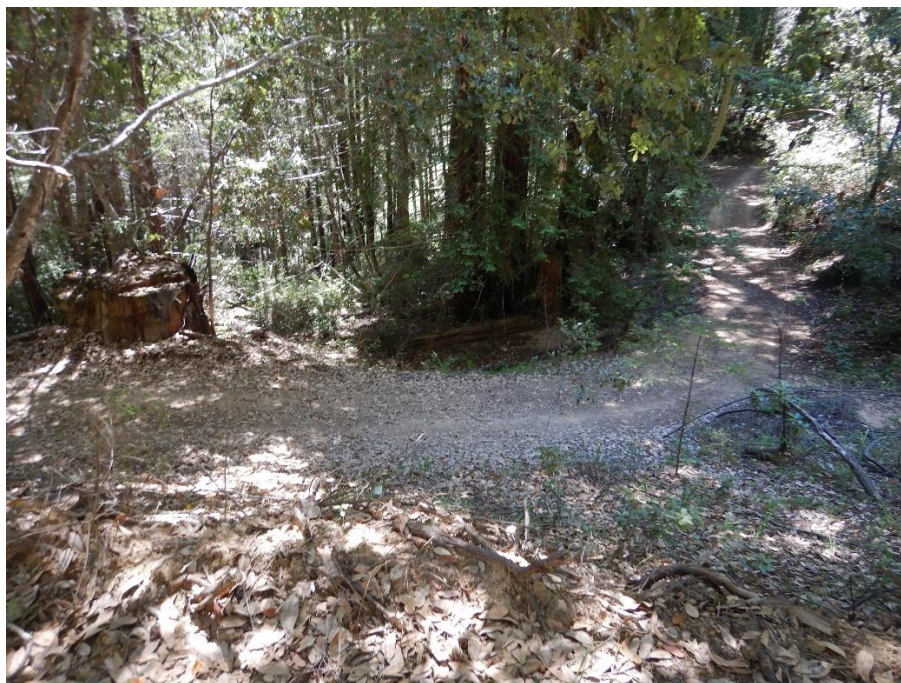
Photo 13—Looking east from northern fork of road towards WQ8 in the center of the image. The road to the west is shaped such that it will collect stormwater for a long distance and direct it to a topographic swale in the right of the image.

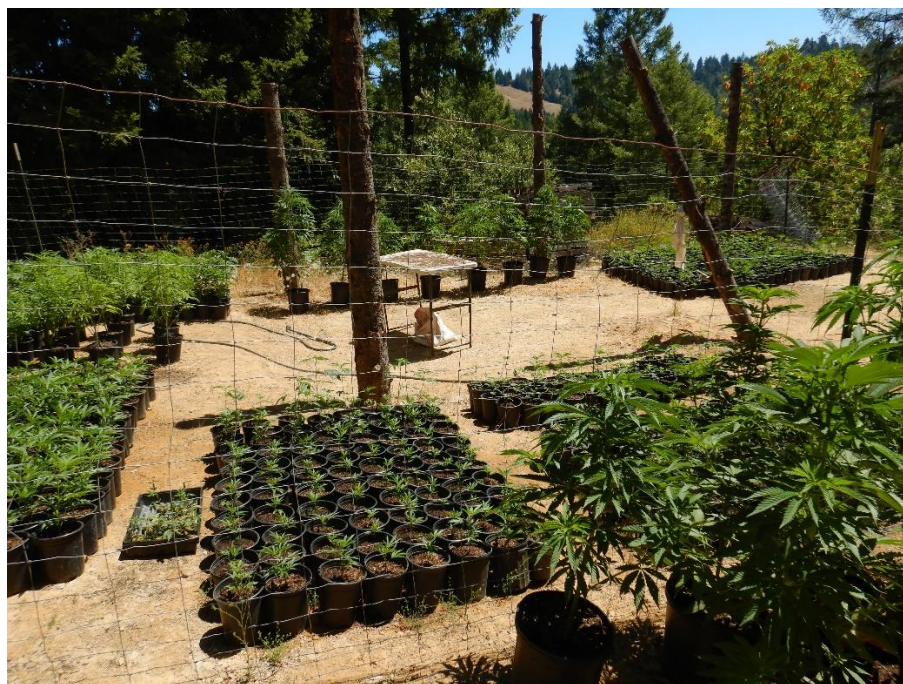
At WQ9 I observed cannabis cultivation occurring without coverage under the Statewide Cannabis General Order.

Photo 14—Outdoor cultivation area located at WQ9
