## North Coast Regional Water Quality Control Board

**Subject: Notice of Violation, Transmittal of Reports for July 13, 2022 and October 26, 2022 Inspections of Mendocino County Assessor's Parcel Number 013-490-30-00**

**Attachment B –Report of July 13, 2022 Inspection**

**Attachment C –Report of October 26, 2022 Inspection**

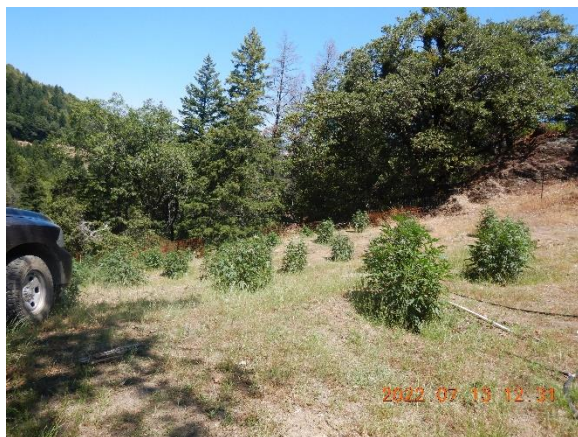
Way Point (WP)789, CA1: Cultivation area on ridge, outdoor and hoop house

Figure 2. WP789, CA1, outdoor cultivation on ridgetop.

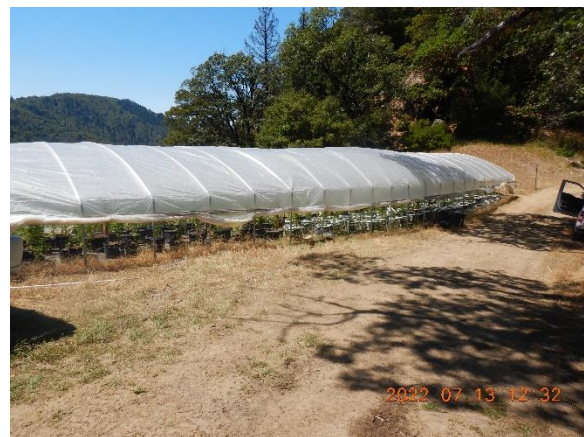
Figure 3. WP789, CA1, hoop house cultivation on ridgetop.

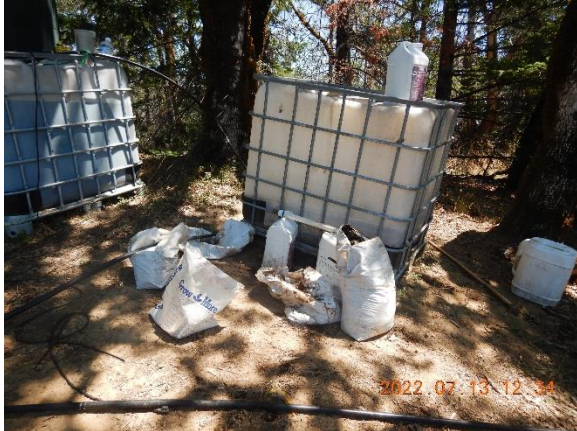
Figure 4. Feed tanks and fertilizer at CA1.

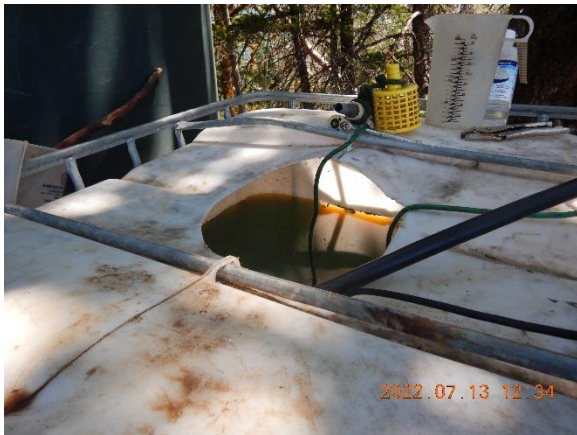
Figure 5. Open top of feed tank at CA1.

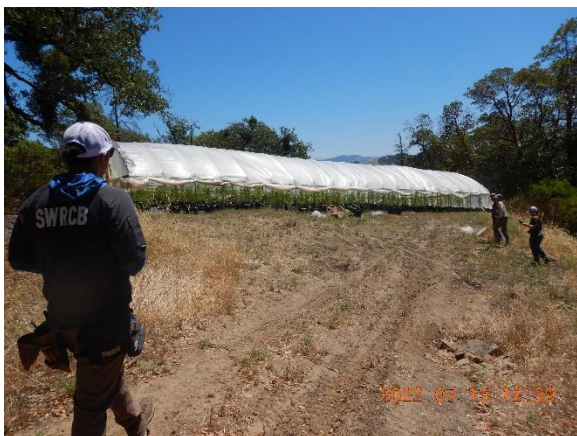
WP790, CA2: Cultivation area on ridge, outdoor and hoop house (83'x25')

Figure 6. WP790, CA2, hoop house cultivation on ridgetop.

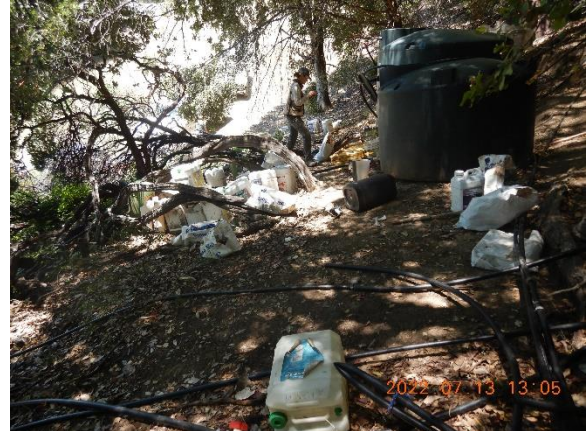
WP791, Tanks: Chased lines from CA1/CA2 to tanks located upslope of bigger cultivation area. Some tanks have open tops. Lots of fertilizer and spent containers accumulated.

Figure 7. WP791, Tanks. We followed water lines from CA1 and CA2 to tanks located upslope of larger cultivation area. Some tanks have open tops. Lots of fertilizer and spent containers accumulated.

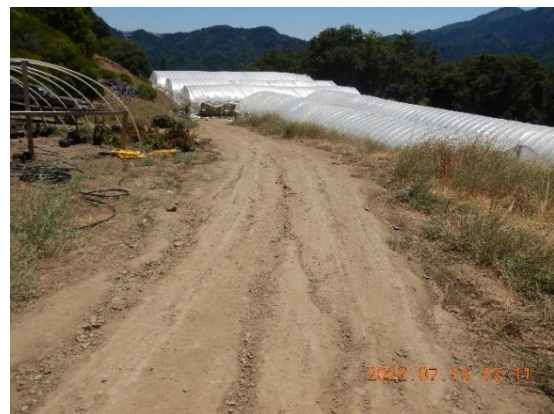
Figure 9. WQ1. CA3 and rilled access road.

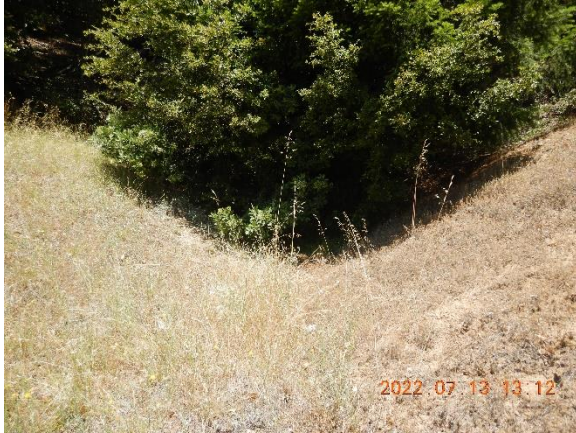
*Figure 10. Swale above road at CA3, looking upslope.*

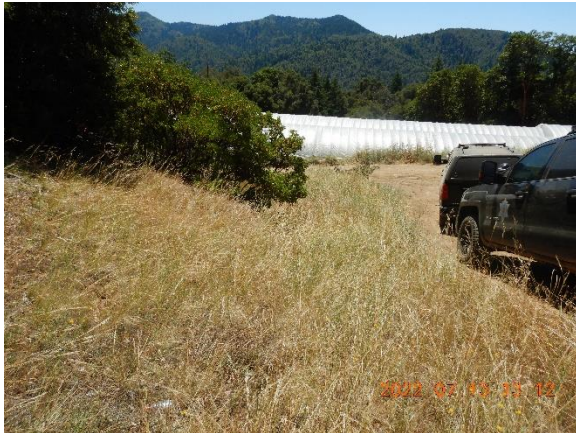
*Figure 11. Swale above road at CA3, looking downslope.*

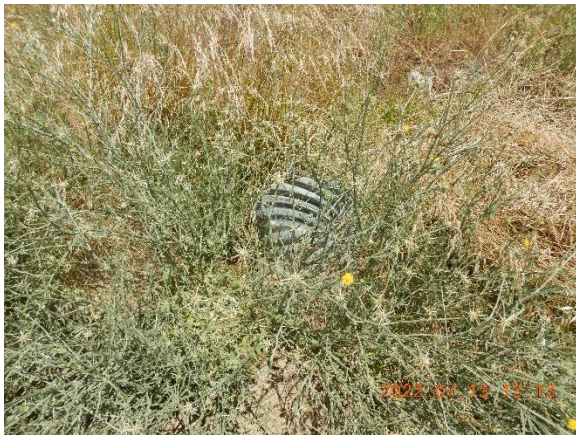
WQ1, WP793, Drop inlet: Corrugated metal drop inlet installed along swale/small Class III watercourse where rutted road leads to large cultivation area (CA3).

*Figure 12. WQ1. Drop inlet upslope of access road to CA3.*

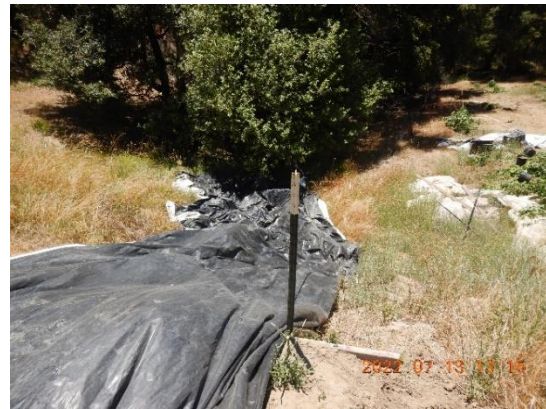
WP795: A corrugated plastic pipe protrudes from fill slope associated with constructed flat used for cultivation (CA3)

*Figure 14. WQ2. WP795. A corrugated plastic pipe protrudes from fill slope associated with constructed flat used for cultivation (CA3). Photo shows plastic sheeting over the culvert outlet and fillslope, down to watercourse channel.*

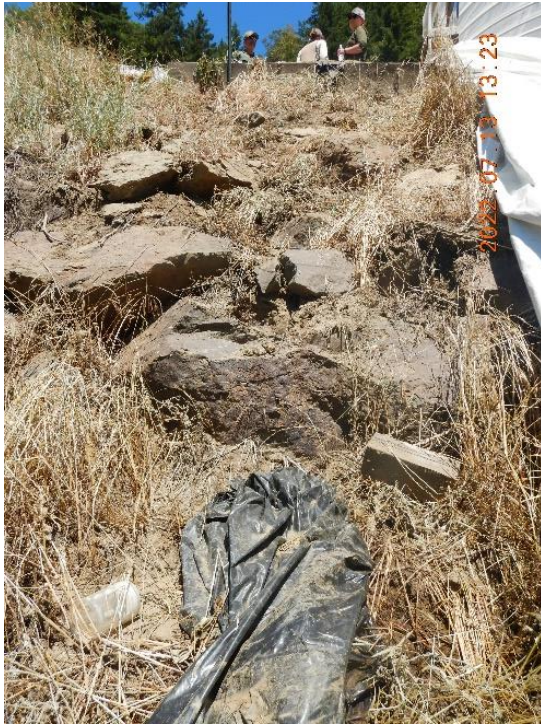
*Figure 15. Rock on fillslope upslope of culvert outlet.*

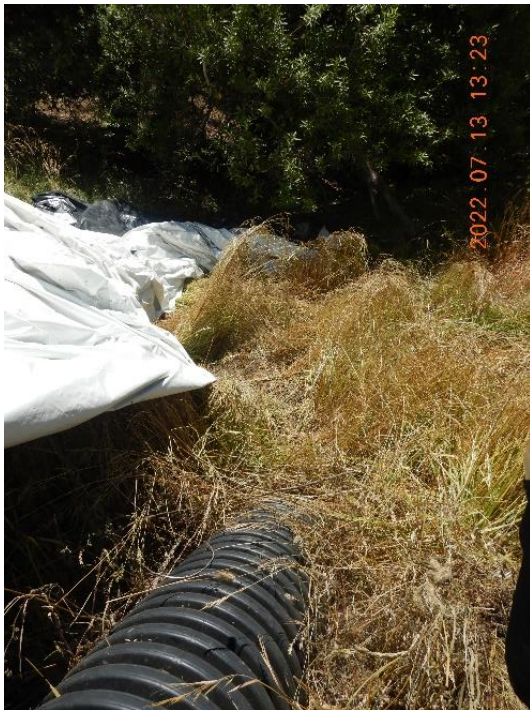
*Figure 16. Outlet of culvert discharges onto fillslope of CA3 graded flat.*

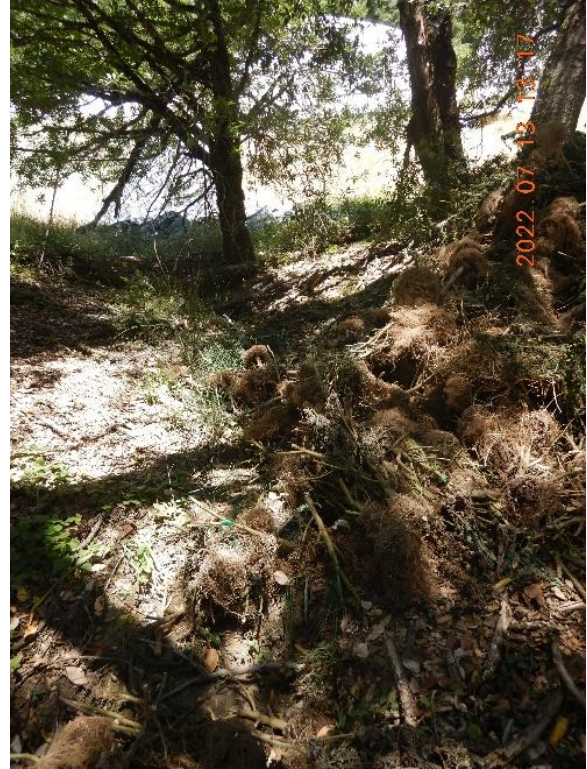
WQ2, WP794, Below the cultivation flat, in line with swale and drop inlet, is a well-defined Class III watercourse with cultivation waste and refuse in the channel.

*Figure 17. WQ2, WP794. Watercourse below CA3, with discarded root wads and attached potting soil into channel, looking upslope.*

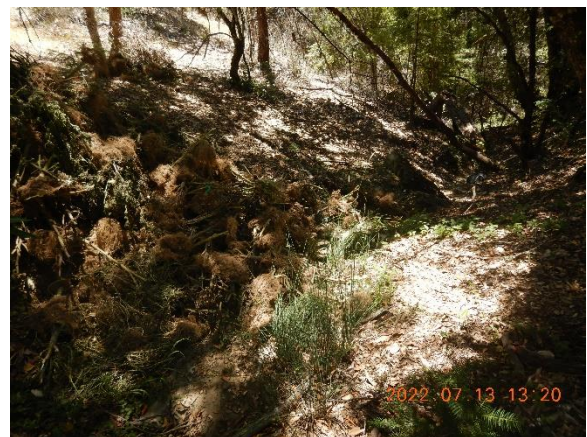
*Figure 18. WQ2, WP794. Receiving watercourse channel below fillslope at CA3, looking downslope.*

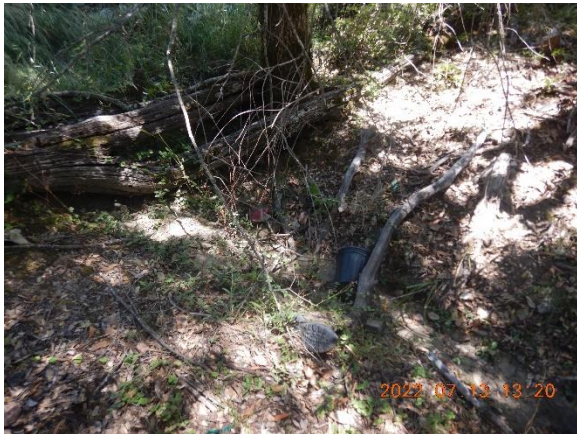
*Figure 19. WQ2, Watercourse below CA3, WP794. with refuse in channel, view looking downslope.*

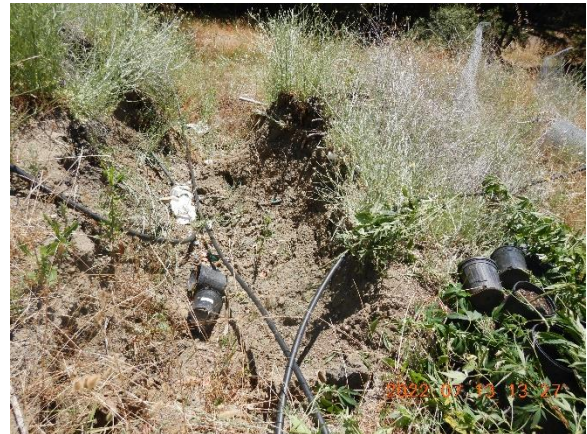
*Figure 22. WQ4, WP797. Gully with delivery to same channel head identified at WP796 is 2-3' deep x 25' long x 3' wide.*

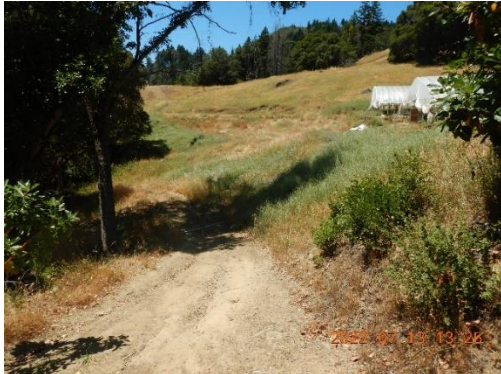
*Figure 20. WQ3, WP 796. Road below CA3 with sediment delivery to a Class III channel.*

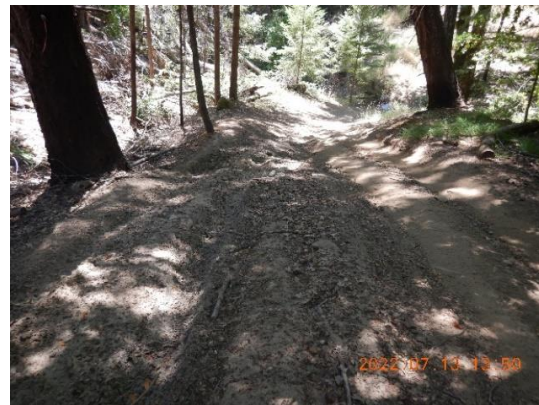
*Figure 23. WQ5, WP803. Upslope of Stream Crossing 2, the steep rutted road surface is hydrologically connected to the stream crossing for 170 feet.*

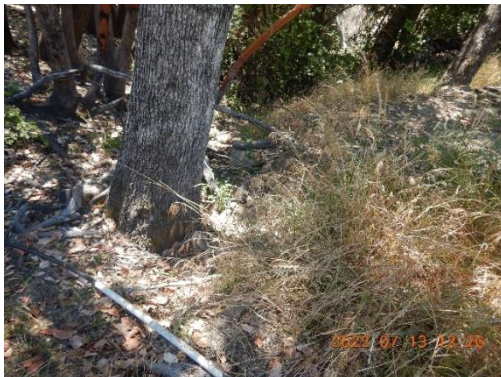
*Figure 21. WQ3, WP796. Class III channel below that receives runoff from the road below CA3.*

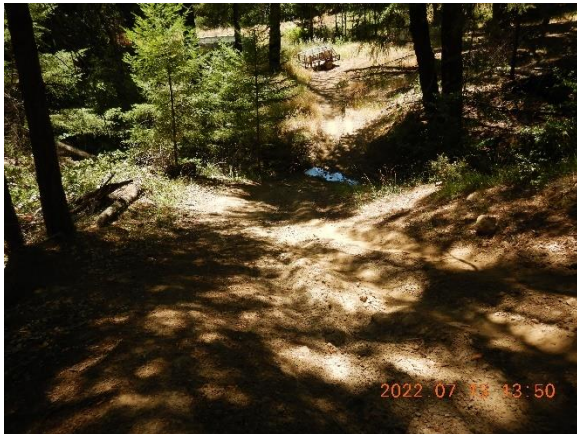
*Figure 24. WQ5, WP803. Stream Crossing 2 is a wet ford on a Class II watercourse, with direct delivery from the road surface.*

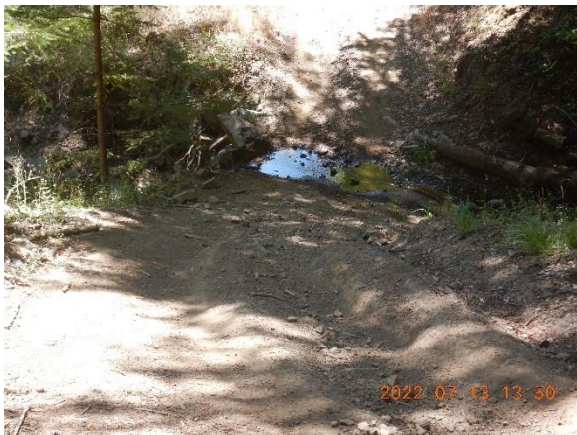
*Figure 25. WQ5, WP803, Stream Crossing 2.*

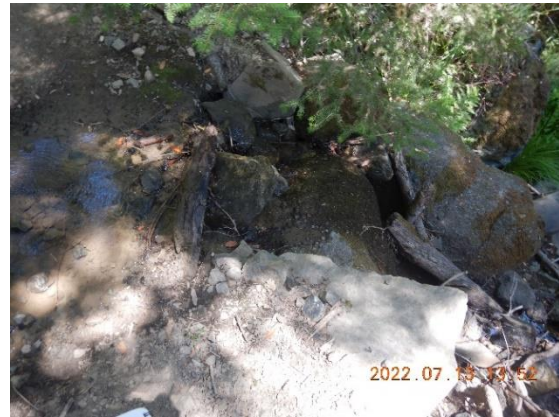
*Figure 26. WQ5, WP803. The crossing consists of large rocks used to level the road surface, and a wet ford across the stream.*

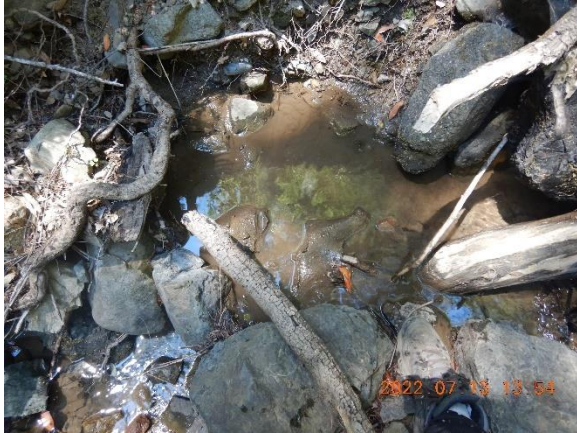
*Figure 28. WQ5, WP803, Crossing 2 contributes fine sediment in pools.*

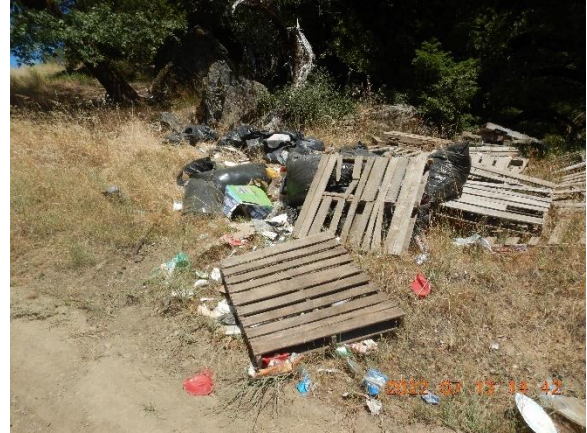
*Figure 30. Trash accumulation.*

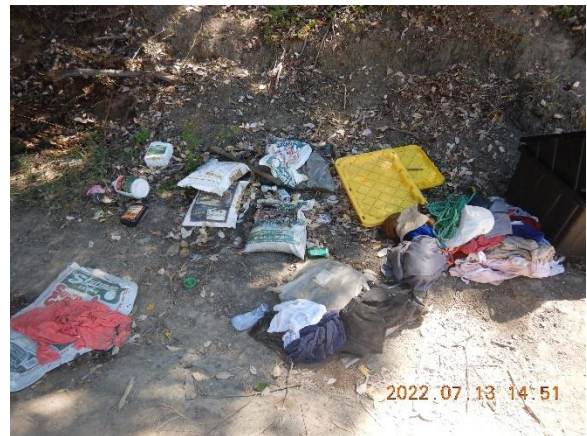
*Figure 31. Inadequate containment of refuse and amendments, including high concentration, water soluble fertilizer.*

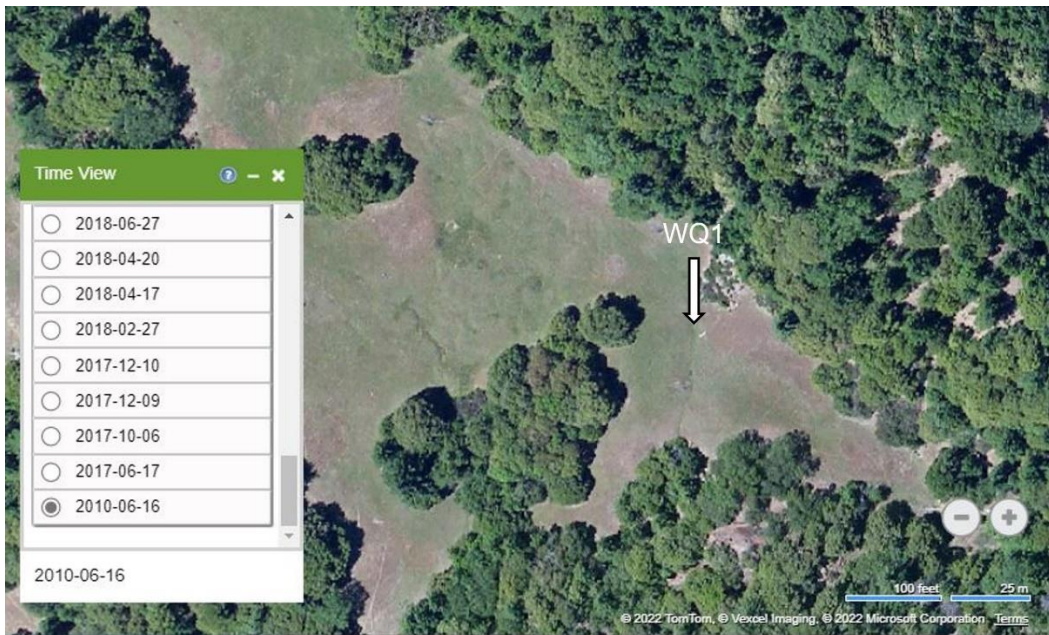
*Figure 2—Aerial image taken on June 16, 2010, obtained from Land Vision services. The area shown in the image has not yet been developed and a watercourse, tributary to Tenmile Creek, is visible at WQ1.*

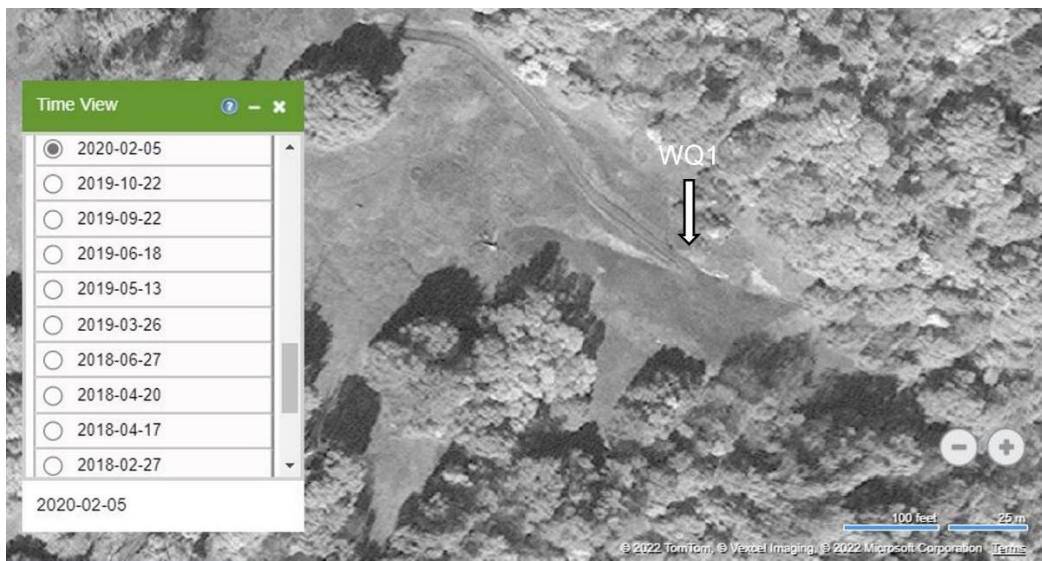
*Figure 3—Aerial image taken on February 5, 2020, obtained from Land Vision services. A road is visible approaching WQ1 from the northwest (top left) of the image, but there is no other apparent development.*

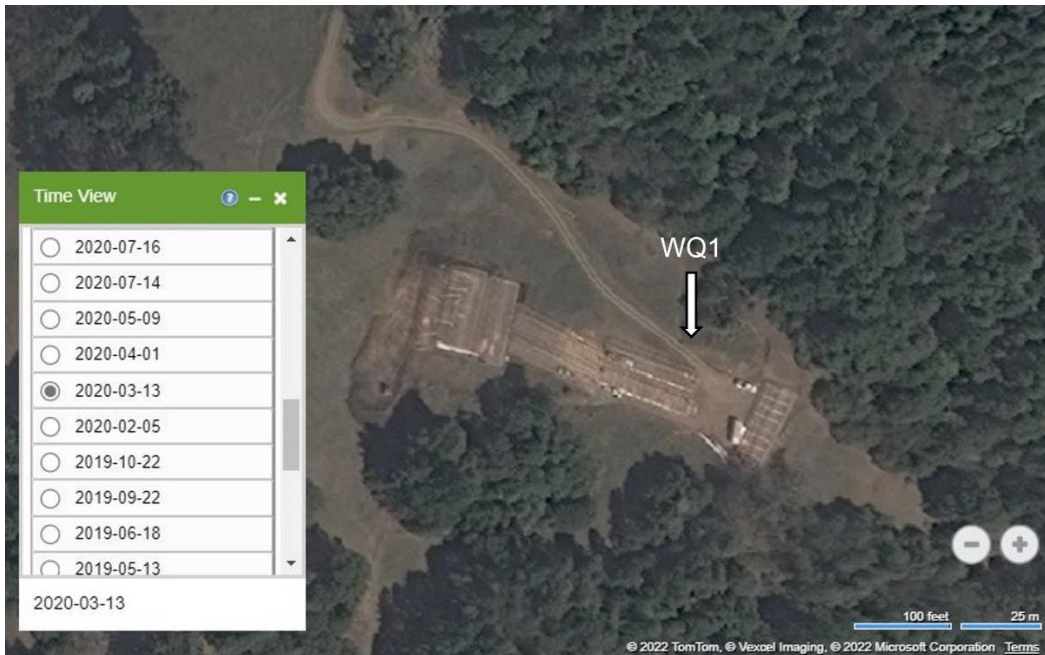
*Figure 4 Aerial image taken on March 13, 2020, obtained from Land Vision services. Image shows greenhouses being constructed south of WQ1 where they impact a tributary to Tenmile Creek.*

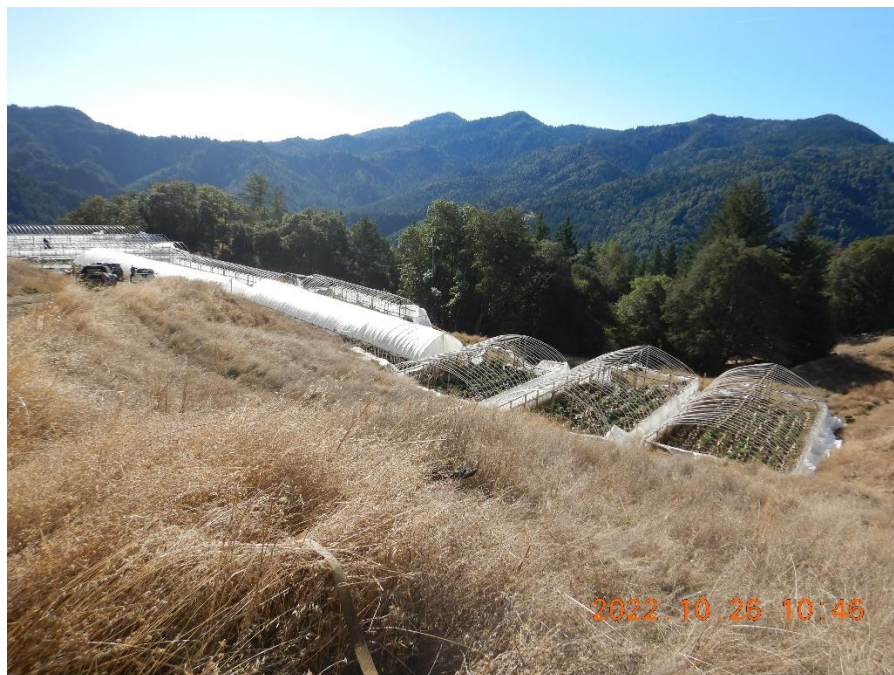
*Figure 6—Looking southeast towards greenhouses covering an area of approximately 30,000 square feet in the vicinity of WQ1.*

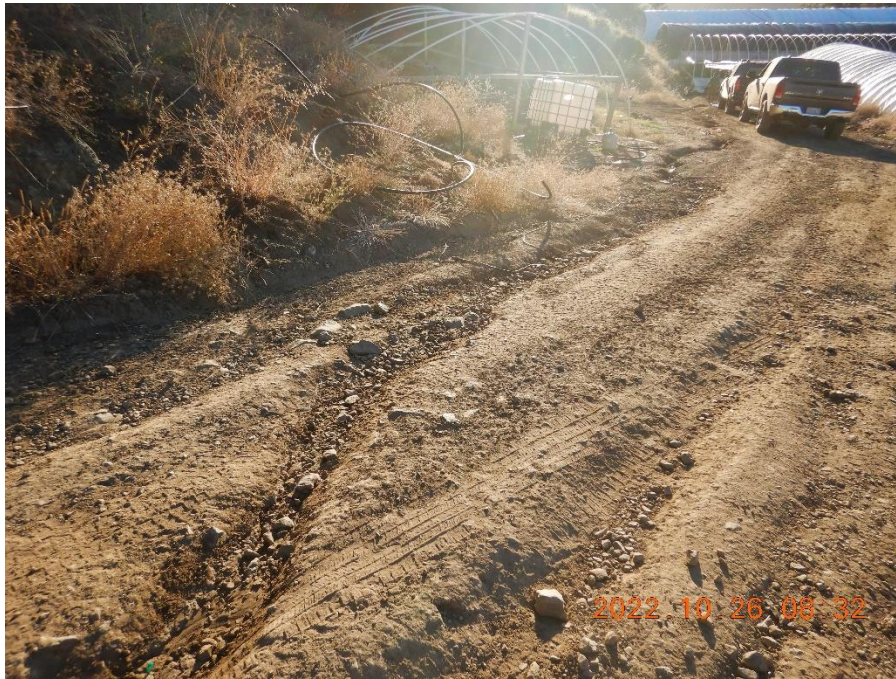
*Figure 8—Looking east in the vicinity of WQ1. Wheel ruts on the road surface are visible in the middle of the image.*

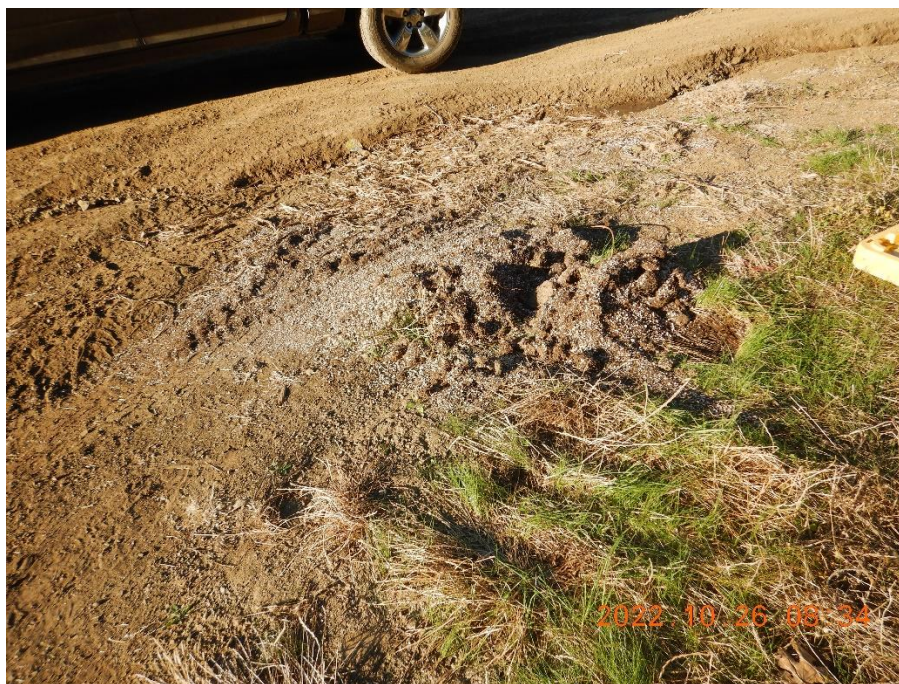
*Figure 9—Pile of imported potting soils on the edge of the road in the vicinity of WQ1.*

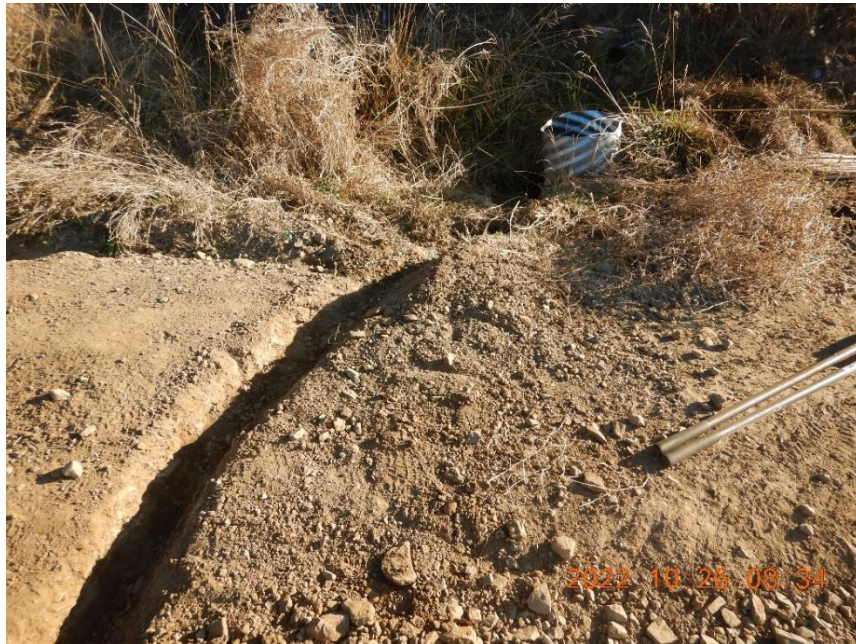
The inspection was associated with a criminal search warrant, and I viewed only portions of the Property. See the above Inspection Map and below Photo Appendix for locations and details about features of concern to water quality. I entered the northern portion of Property from the north and observed a row of hoop-type greenhouses on a constructed pad in the vicinity of WQ1. I observed ruts on the dirt road leading to the cultivation area at WQ1, and a watercourse upslope from the road at WQ1. I observed a vertically oriented culvert and I measured with a tape measure: a pipe diameter of 18 inches; a depth of seven feet from the top of the pipe; and a distance of three feet below the top of the pipe to a slot that would allow flow to enter from the side. I also observed a trench crossing the road that was shaped such that stormwater collected by the road would be directed into the pipe.

*Figure 10—Looking north at culvert inlet located at WQ1. A trench across the road is shaped such that stormwater collected by the road will be directed into the pipe.*

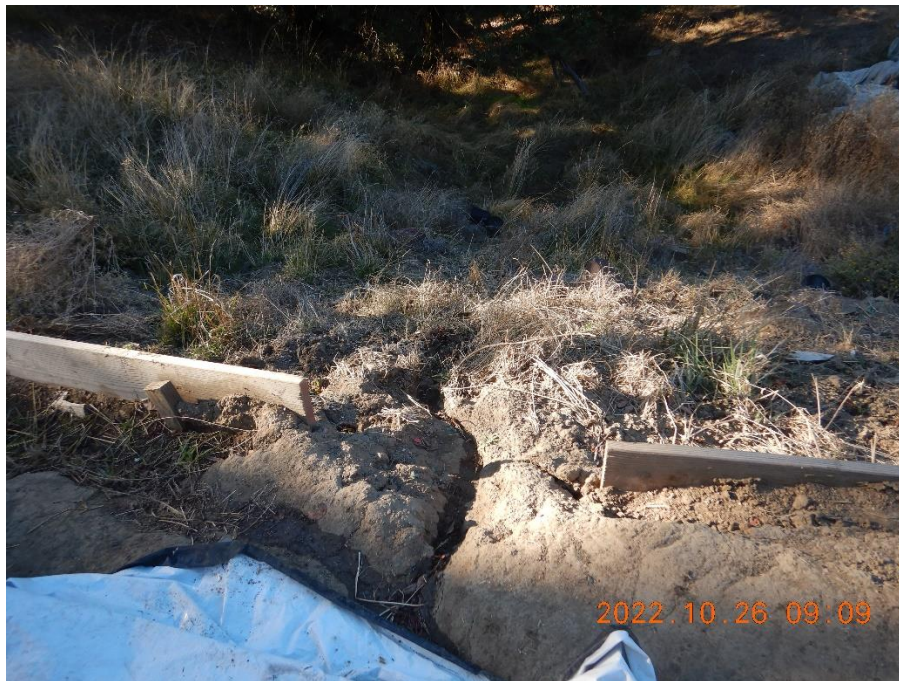
*Figure 11—Looking south in the vicinity of WQ2 where irrigation runoff from the greenhouse to the back of the photographer would flow toward a watercourse located in the top center of the image.*

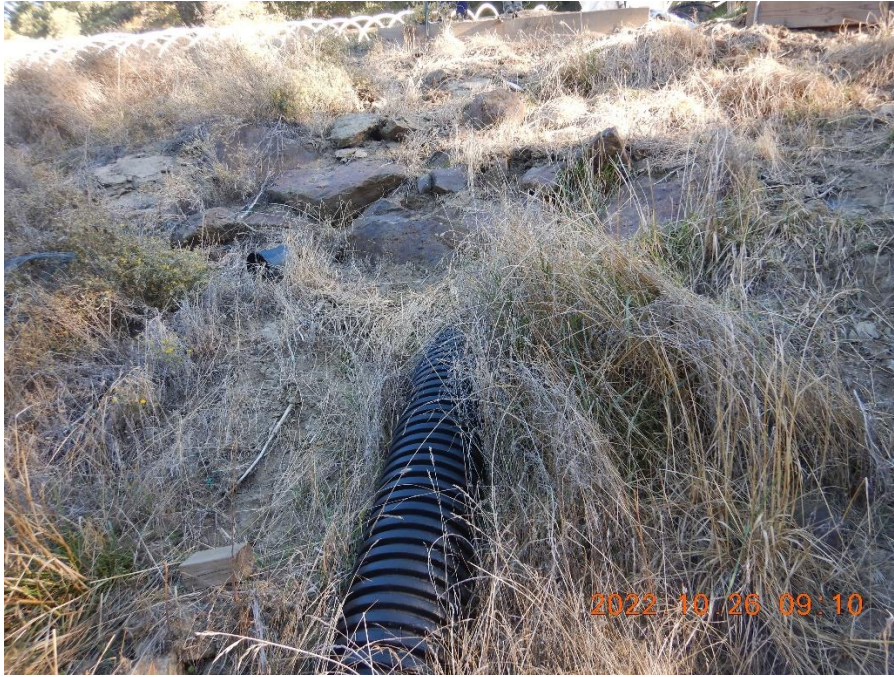
On the opposite side of the cultivation pad from the culvert inlet, I observed scour marks on the outboard edge of the cultivation pad and a corrugated plastic pipe extending from below the pad which I suspect was installed to convey water from WQ1. I observed a watercourse approximately 25 feet downslope from WQ2 and measured an estimated channel bank-full width of between two and four feet. I observed a pile of cannabis cultivation waste 15 feet long and six feet wide, including plant stalks and root-balls extending into the watercourse. I also observed a lens of fine sediment immediately upstream from the waste cannabis material.

*Figure 12—Corrugated plastic pipe located at WQ2. Aerial imagery shown in Figures 2 through 5 above suggests the pad in the background of the image buries a surface watercourse.*

- b. develop a workplan and schedule to implement measures to ensure that all impacted features—including the buried channel between WQ1 and WQ2, the impacted watercourse in the vicinity of WQ7 and any impacted wetlands in the vicinity of WQ10—are restored and that all developed features, roads and watercourse crossings throughout the Property are corrected, restored, and/or maintained in conditions that comply with the Cannabis Cultivation Policy<sup>1</sup>.

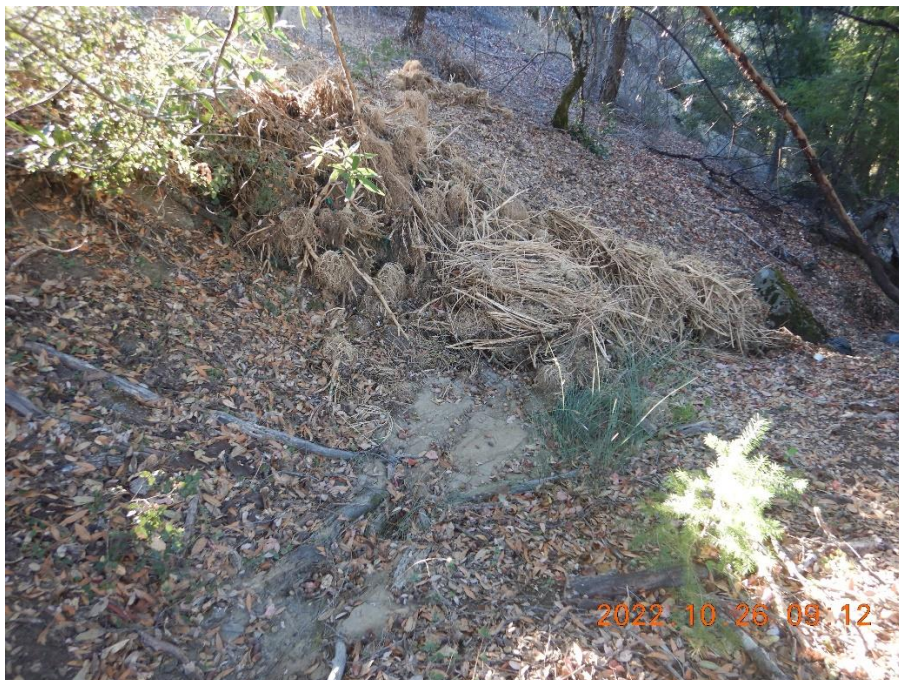
*Figure 13—Looking south and downstream at a watercourse approximately 25 feet downslope from WQ2. A pile of cannabis cultivation waste including plant stalks and root-balls is visible extending over a portion of the channel. A lens of fine sediment is also visible immediately upstream from the waste cannabis material.*

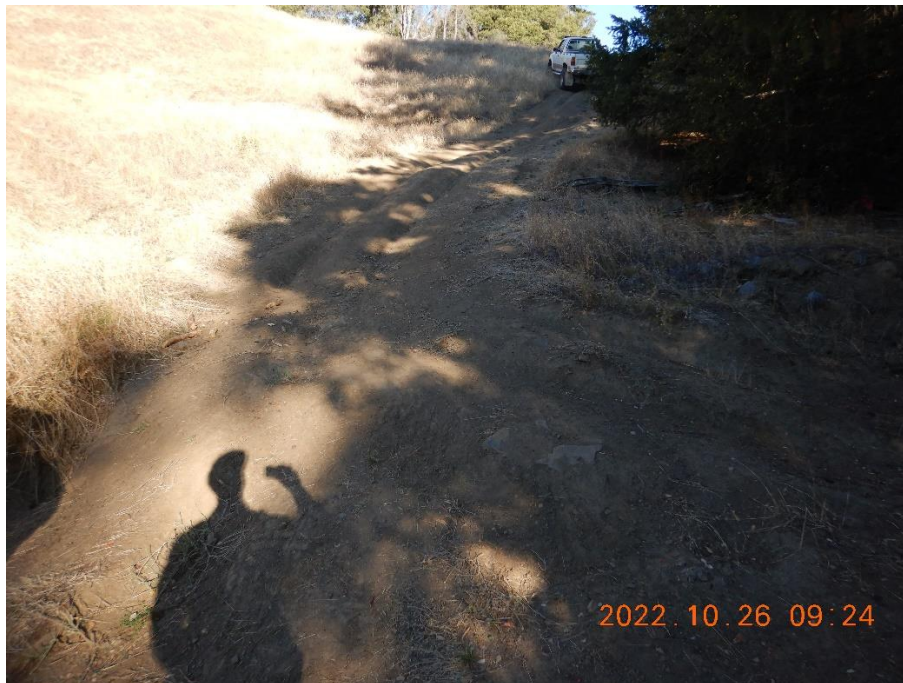
*Figure 14—Looking northwest at a rutted dirt road in the vicinity of WQ12.*

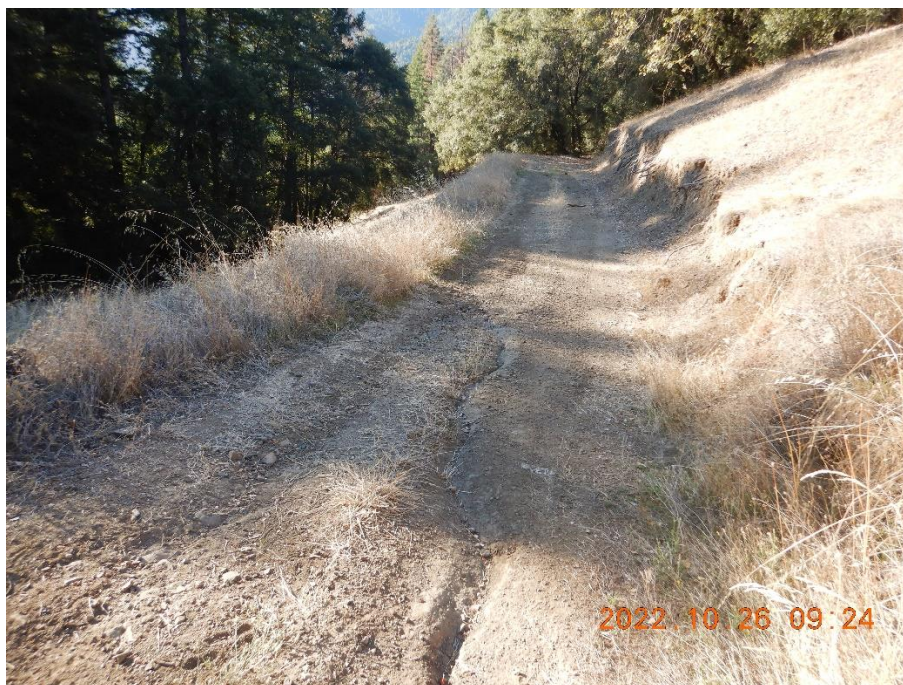
*Figure 15—Looking south along the dirt road in the vicinity of WQ12. A sinuous scour mark is visible on the road's surface.*

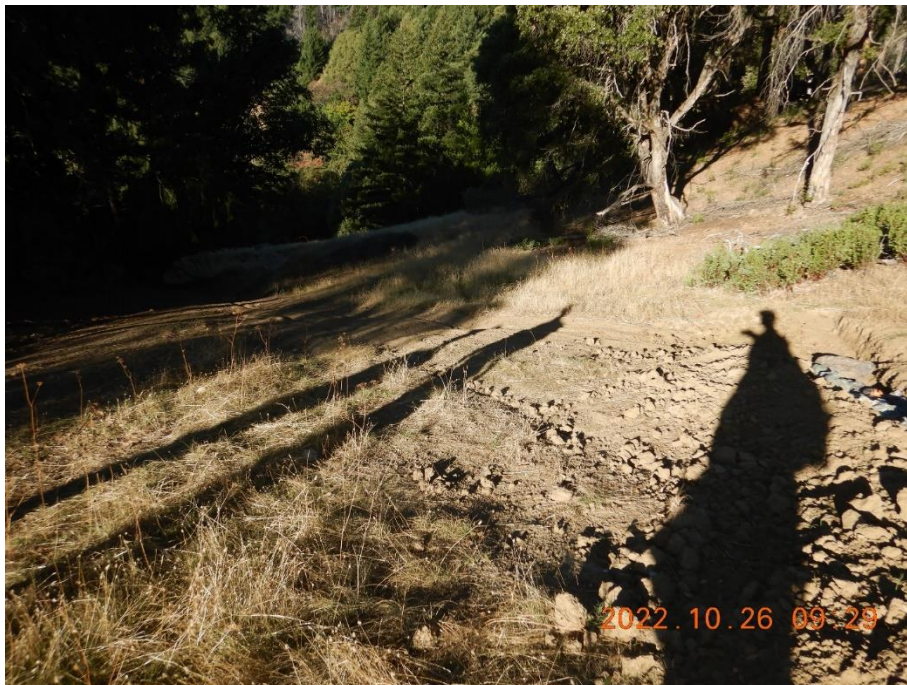
I walked west to WQ12 where I observed another rutted dirt road. I followed the road south to WQ13 where I observed recently constructed rock-filled trenches. The trenches were shaped such that they would locally collect surface water, but they would not always direct the water off the road, instead allowing stormwater to flow through earthen spoils on the downslope side and back onto the road. Additionally, some of the trenches were installed at an insufficient interval to prevent stormwater from collecting on the road and scouring the road surface. I followed the road to WQ5 where I observed the road fording a tributary to Tenmile Creek.

*Figure 16—Looking northwest along dirt road at WQ13. A rock filled trench is visible in the right image, and another rock filled trench is out of view approximately 80 feet down the road to the west.*

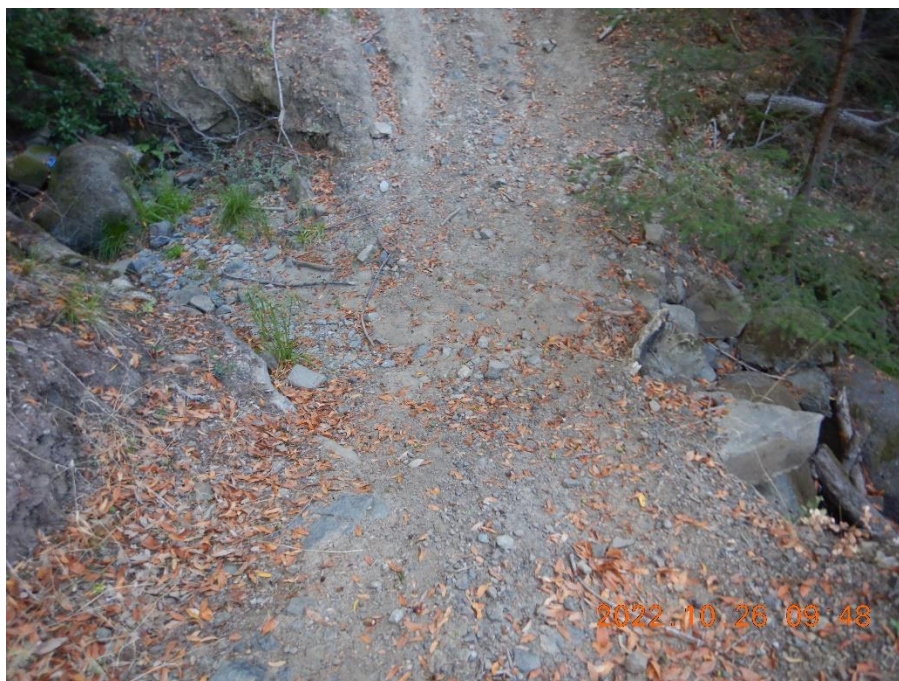
*Figure 17—Road fording watercourse at WQ5.*

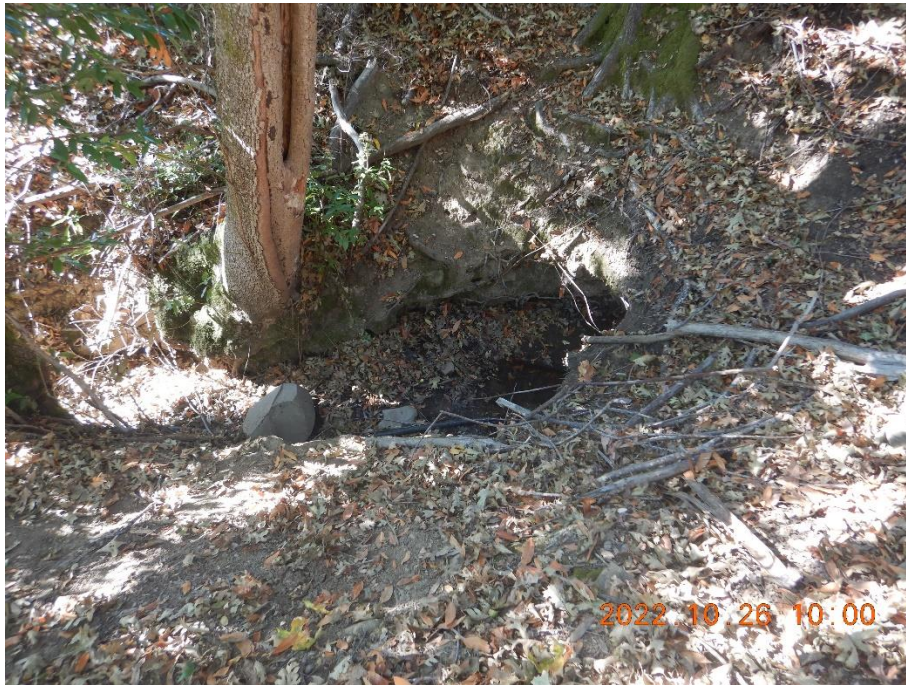
I observed an overflowing water tank west of WQ5 and followed the line that was filling the tank to the point of diversion at WQ6. I walked southeast of WQ6 following the watercourse and observed the form of the watercourse channel diminish as the slope decreased, which also corresponded with the location of a road to access a historical outdoor grow area to the south. I followed the flow path of the watercourse from this point to the east, past two above ground swimming pools and to a point where the slope steepened and the form of a channel reestablished as it approached a tributary to Tenmile Creek, 35 feet downstream from WQ5.

*Figure 18—Watercourse located at WQ6. A black plastic pipe, visible in the channel, was diverting the surface water to a storage tank north of WQ7 to the east.*

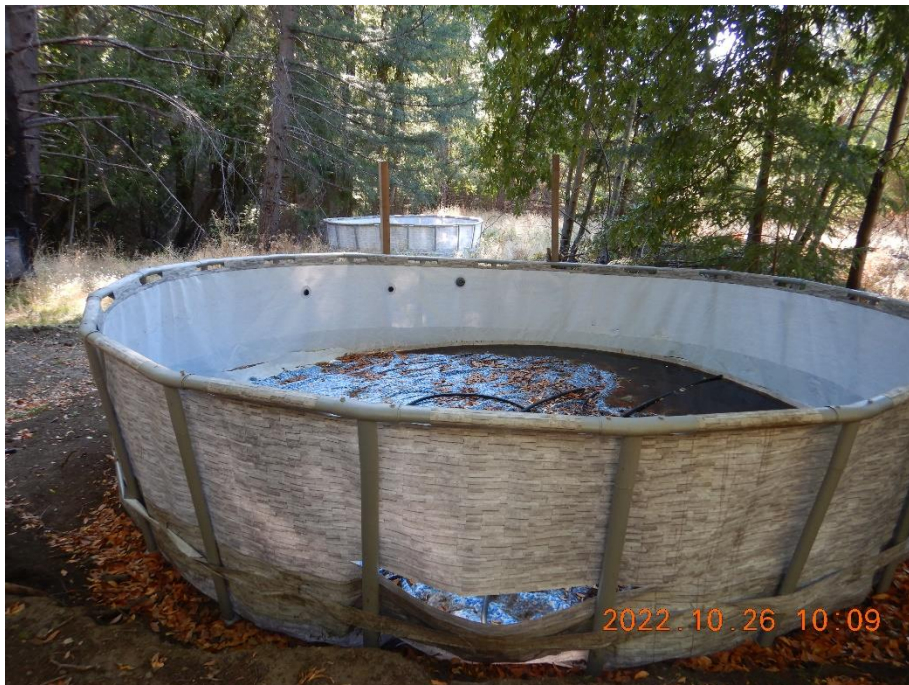
*Figure 19—Looking east in the vicinity of WQ7, past above-ground pools located in the flow path of the watercourse pictured above at WQ6.*

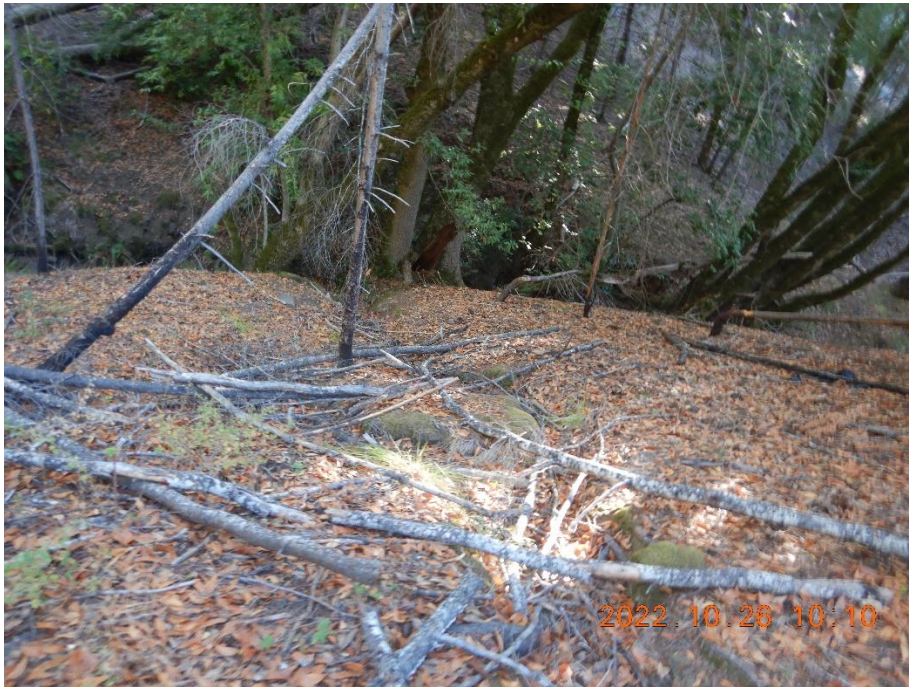
*Figure 20—Looking east with the above ground pools pictured in the previous image to the back of the photographer. The topography is shaped such that it would direct surface water from WQ6 to the receiving watercourse in the middle of the image, approximately 35 feet downstream from WQ5.*

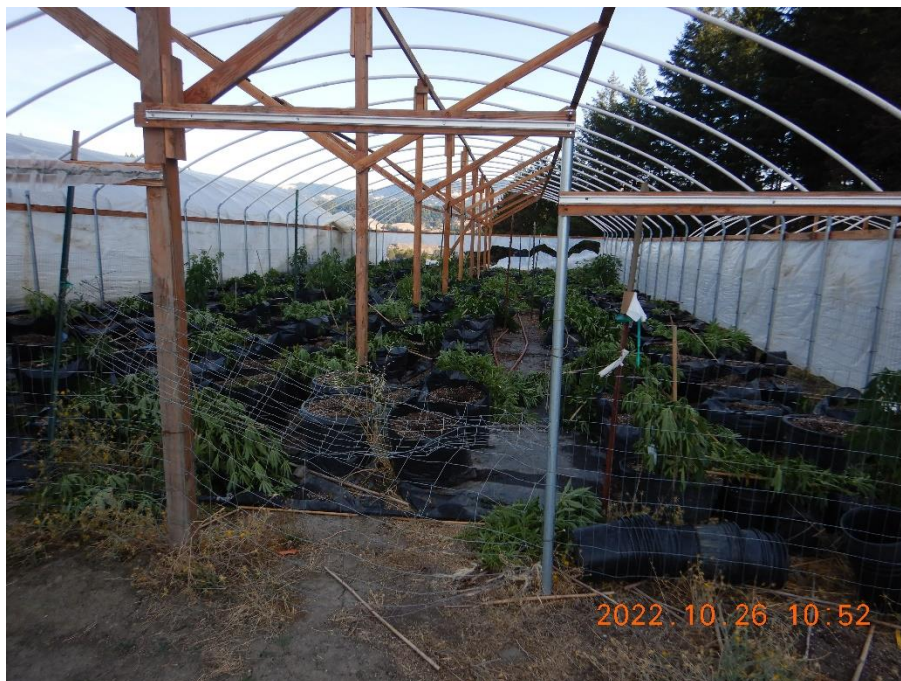
*Figure 21—A hoop-type greenhouse covering approximately 8,000 square feet in the vicinity of WQ8.*

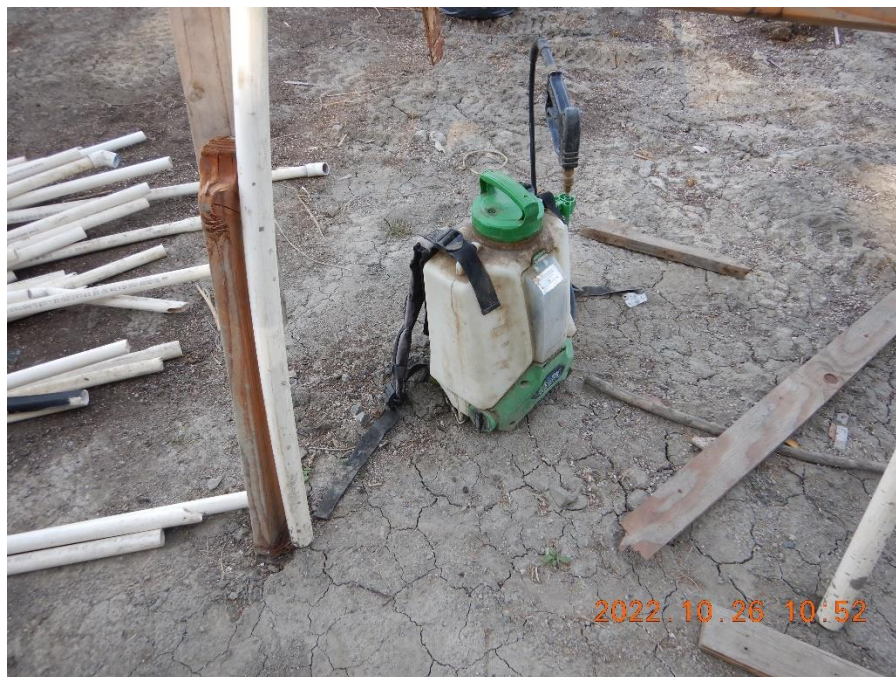
Figure 22—A pesticide sprayer located at WQ8.

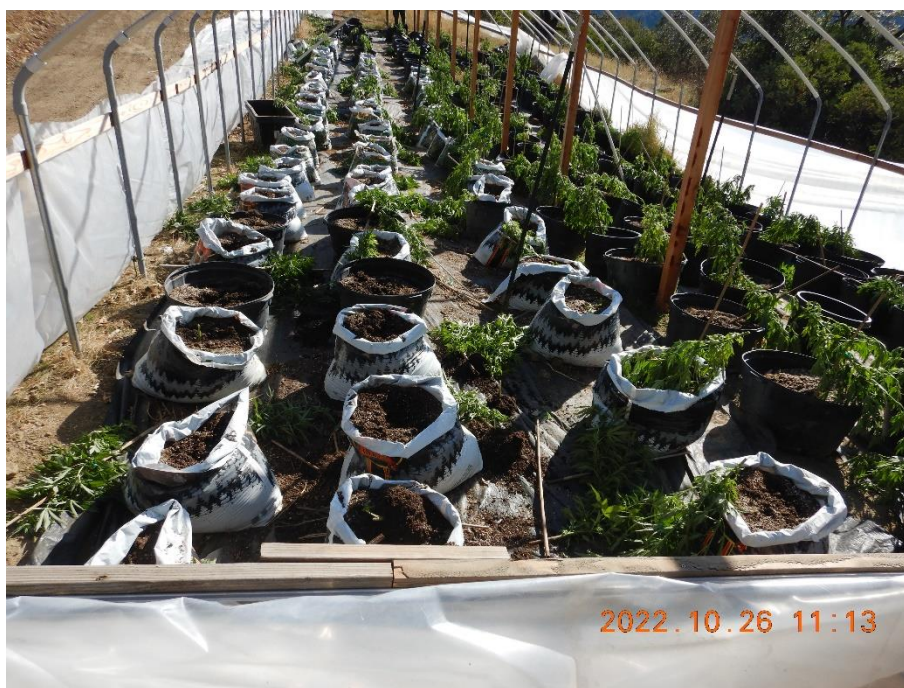
Figure 23—One of two hoop-type greenhouse in the vicinity of WQ9 covering a combined area of approximately 5,000 square feet.

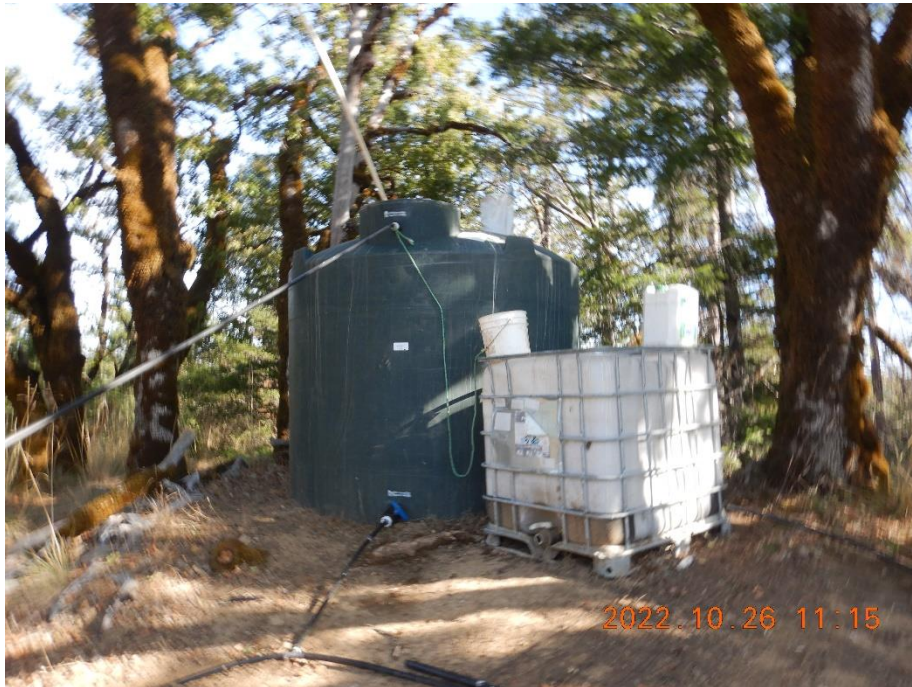
*Figure 24—Nutrient mixing area located at WQ9.*
