## North Coast Regional Water Quality Control Board

**Subject: Notice of Violation, Transmittal of Reports for July 13, 2022 and October 26, 2022 Inspections of Mendocino County Assessor's Parcel Number 013-490-30-00**

**Attachment B –Report of July 13, 2022 Inspection**

**Attachment C –Report of October 26, 2022 Inspection**

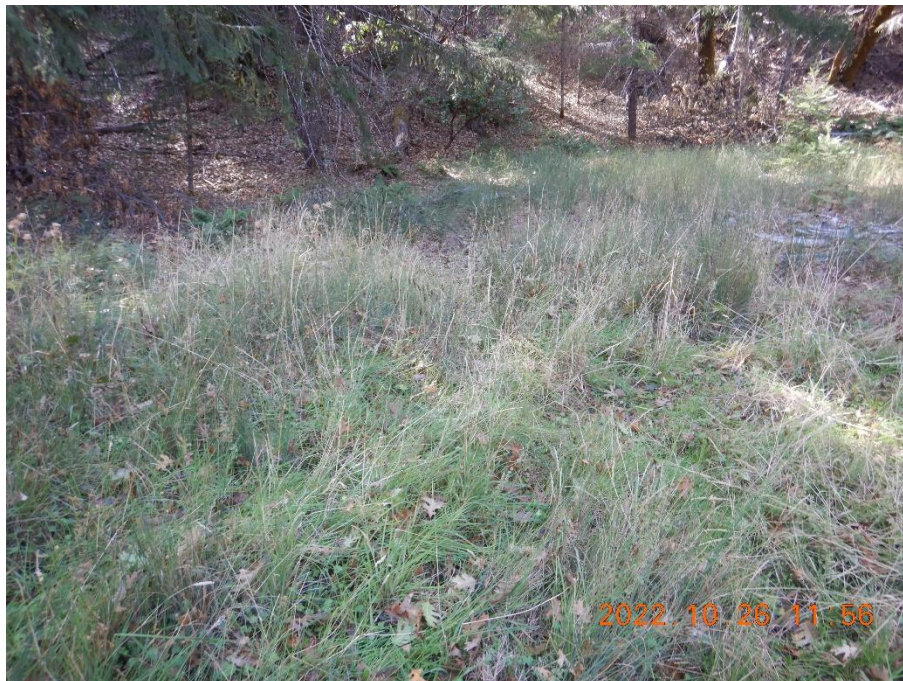
I observed cannabis plants in a hoop-type greenhouse at WQ 8 and WQ9. At WQ10 I observed an area with distinct vegetation including plants from the genus *Juncus*. The area dips gently north towards a watercourse that connects to a tributary to Grub Creek which is tributary to Tenmile Creek.

*Figure 25—Looking south and across an area in the vicinity of WQ10 that is vegetated with juncus and slopes gently to the back of the photographer.*

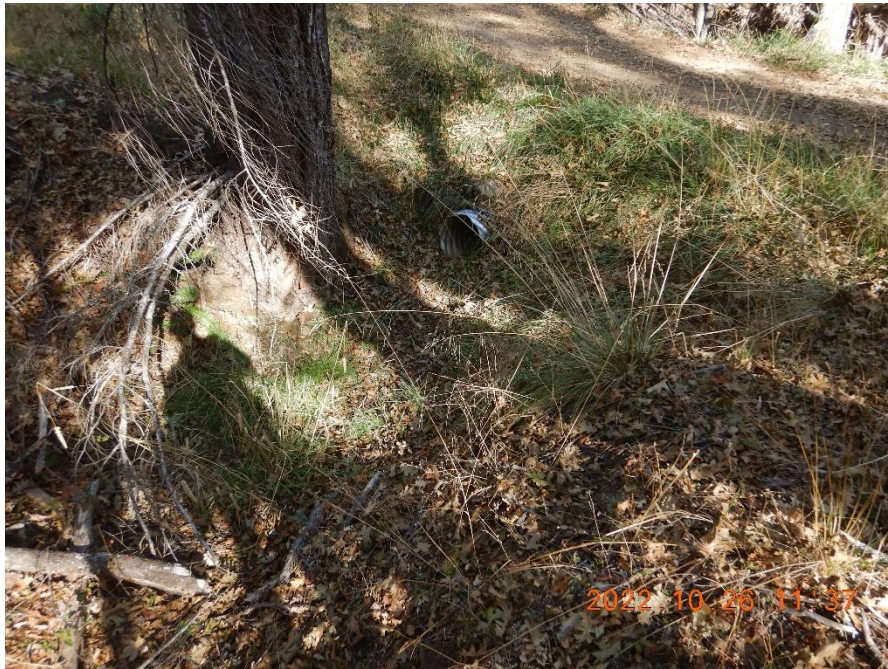
*Figure 26—Looking north where at a culverted road crossing located at WQ10. A suspected wetland, pictured above, is to the back of the photographer. The culverted channel flows north before connecting to a tributary to Grub Creek which is a tributary to Tenmile Creek.*
