North Coast Regional Water Quality Control Board

**Subject: Notice of Violation, Transmittal of Inspection Report for October 12, 2022, Inspection of Del Norte County Assessor's Parcel No. 127-200-020, and Requirement to Respond within 30 days**

## FACILITIES INSPECTION REPORT

Crowley Inspection Photo Log – Attachment C  
Photos taken October 12, 2022, by Katherine Hawken

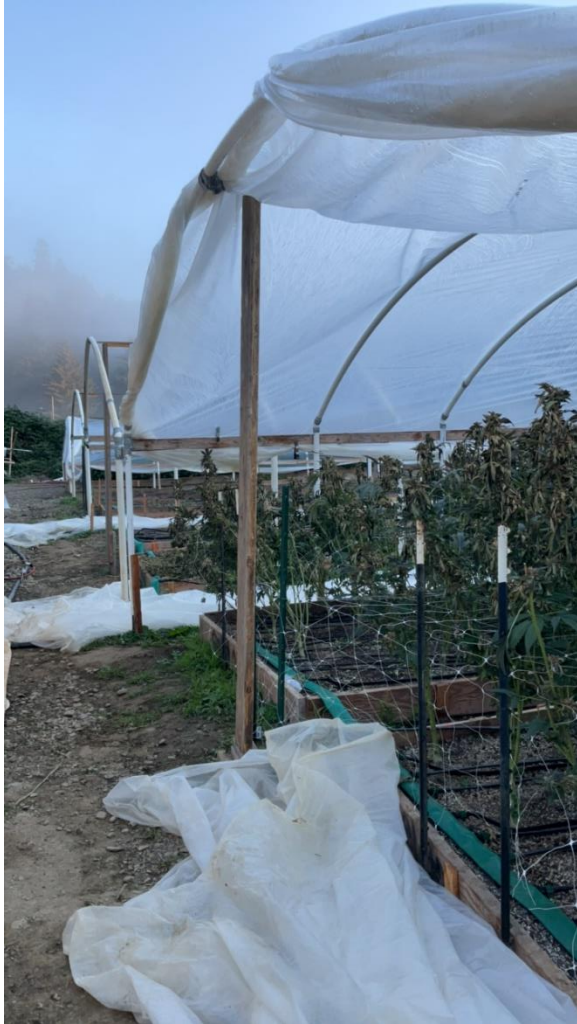
Observations  
 Cultivation Area: I observed three active hoop houses with cannabis plants in raised beds (Photo 1). I observed plastic netting around the plants. I observed potting soil and plant waste piled around the hoop houses (Photo 2).

Photo 1, Cultivation Area: Hoop houses with cannabis plants in raised beds

2. If the owner and/or tenant plan to continue cultivating cannabis, enroll for coverage under the State Water Board’s Order WQ 2019-0023-DWQ, General Waste Discharge Requirements and Waiver of Waste Discharge Requirements for Discharges of Waste Associated with Cannabis Cultivation Activities and take steps to comply with all local and state regulations governing cannabis cultivation.

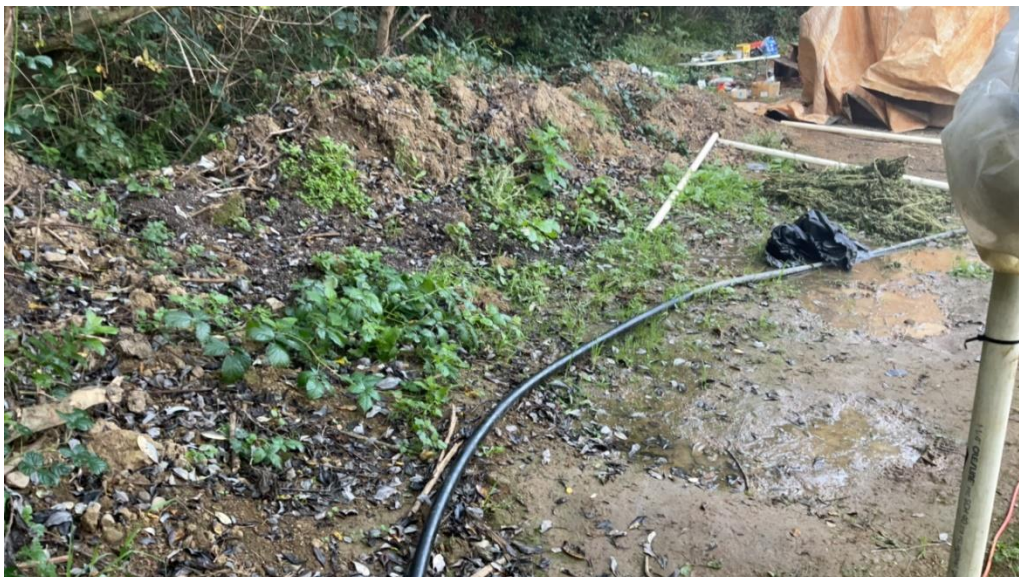
Photo 2, Cultivation Area: Potting soil, plant waste, and trash piled around hoop houses

3. Contain and properly dispose of potting soil, fertilizers, plant waste, petroleum products, and human waste to prevent spillage and transport into receiving waters, and to maintain public health. Relocate materials at least 50 feet away from ephemeral watercourses, and 100 feet away from wetland habitat.

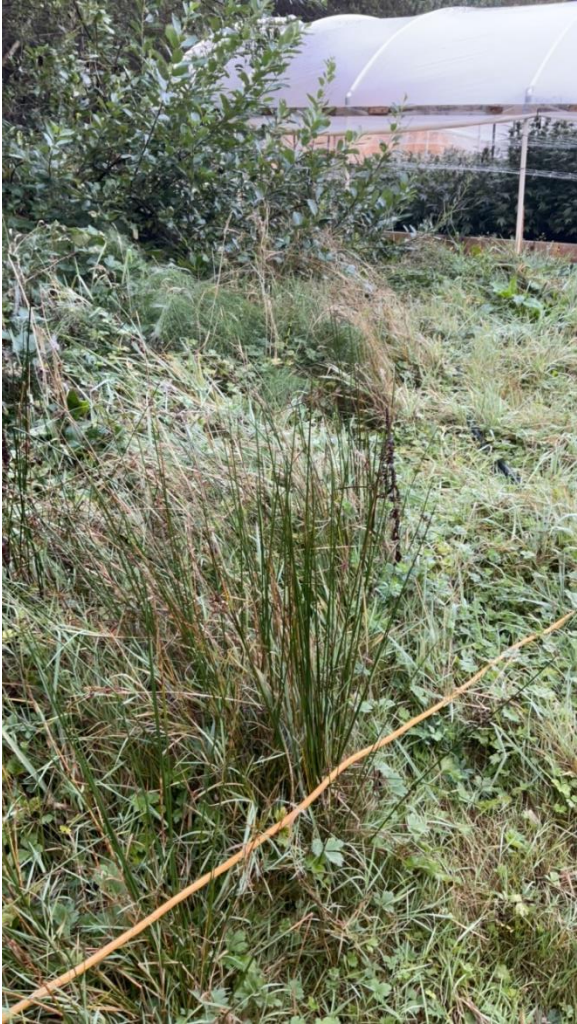
Wetland: Emergent freshwater wetlands are mapped on this Property. I observed hydrophytic plants including willows, alders, skunk cabbage, rushes, and sedges. I observed isolated areas with standing water. I observed grasses growing around the hoop houses, and willows on the edges of the cultivation area (Photo 3).

Photo 3, Wetland: View of hydrophytic plants near the cultivation area

1. Prior to further development of the Property, retain a qualified professional to delineate the extent of the wetlands. Do not operate machinery in, stockpile materials next to, or otherwise threaten discharges of waste to wetlands.

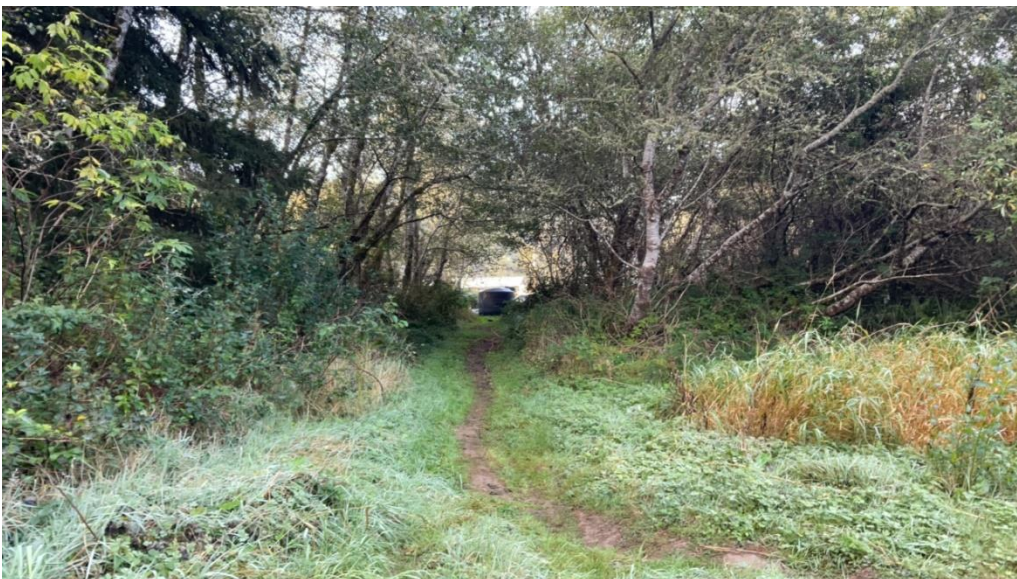
Storage Area: I observed a dirt road from the cultivation area, through wetland habitat, to a materials storage area (Photo 4). I observed water storage tanks, fertilizer containers, petroleum products, and a pump situated atop an ephemeral culvert stream crossing on the dirt road (Photo 5-6). The fertilizers and petroleum products were stored inadequately to protect the adjacent watercourse and wetland complex.

Photo 4, Storage Area: View of road through wetland habitat leading to water storage tanks

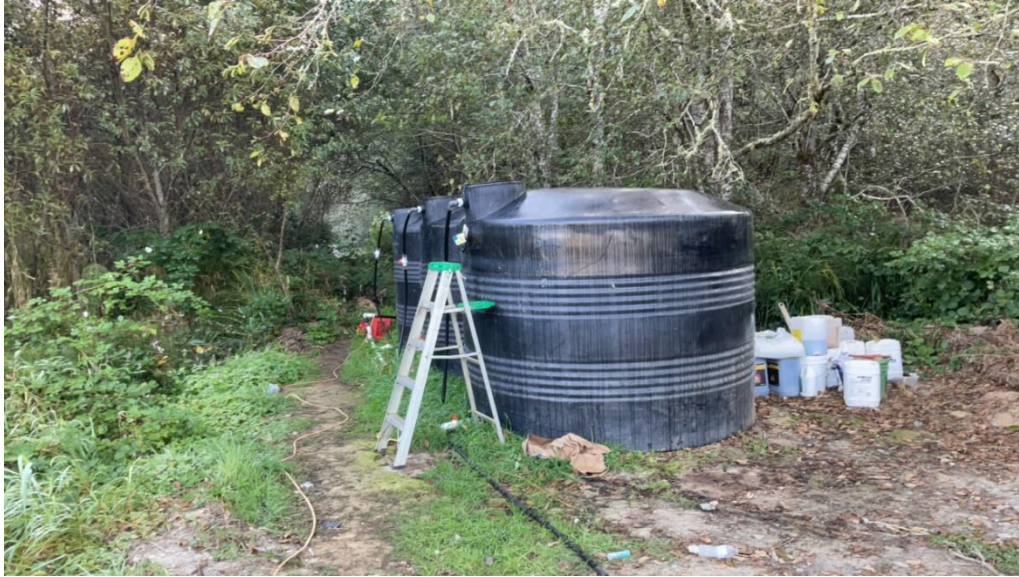
Photo 5,  
Storage Area:  
Water storage  
tanks,  
fertilizers, red  
pump, on dirt  
road surface  
atop culvert  
stream  
crossing

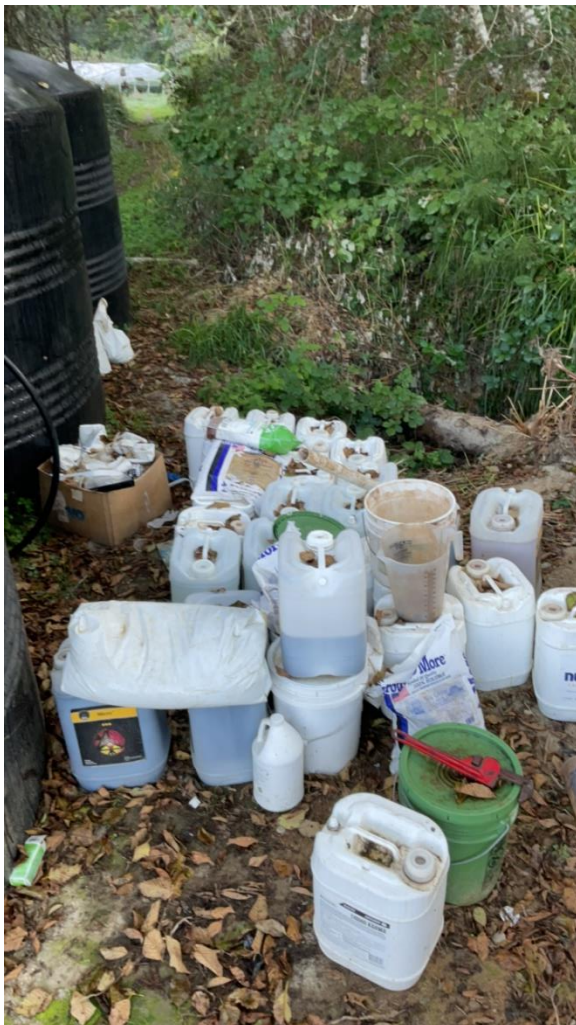
Photo 6, Storage Area: Fertilizer containers  
near ephemeral watercourse culvert inlet.  
View of cultivation area in background

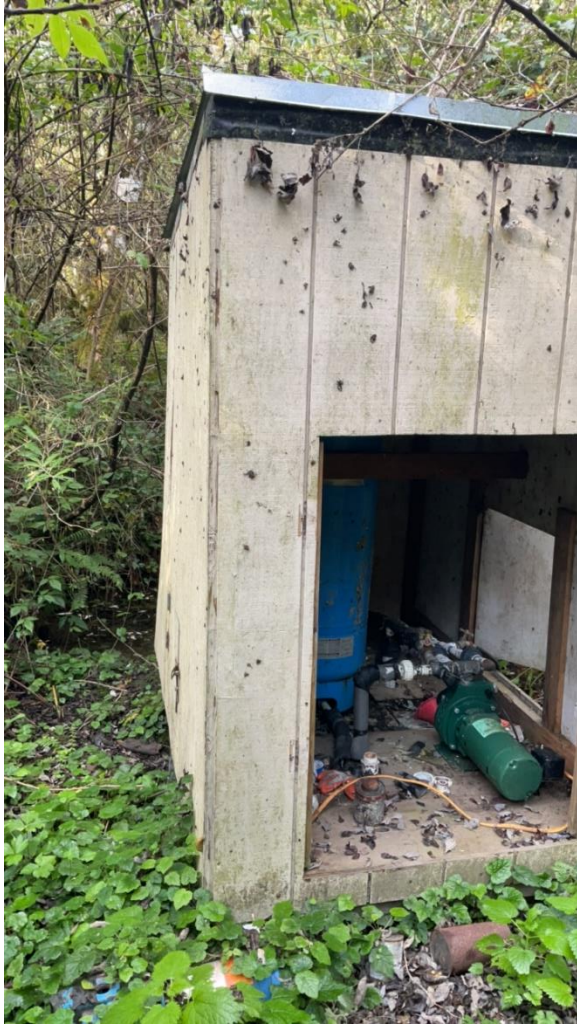
Water Source: I observed a well shed near a pool of standing water in the wetland complex (Photo 7). The water lines connecting to the well shed were buried.

Photo 7, Water Source: Well shed in wetland complex. Pool of standing water visible behind well shed

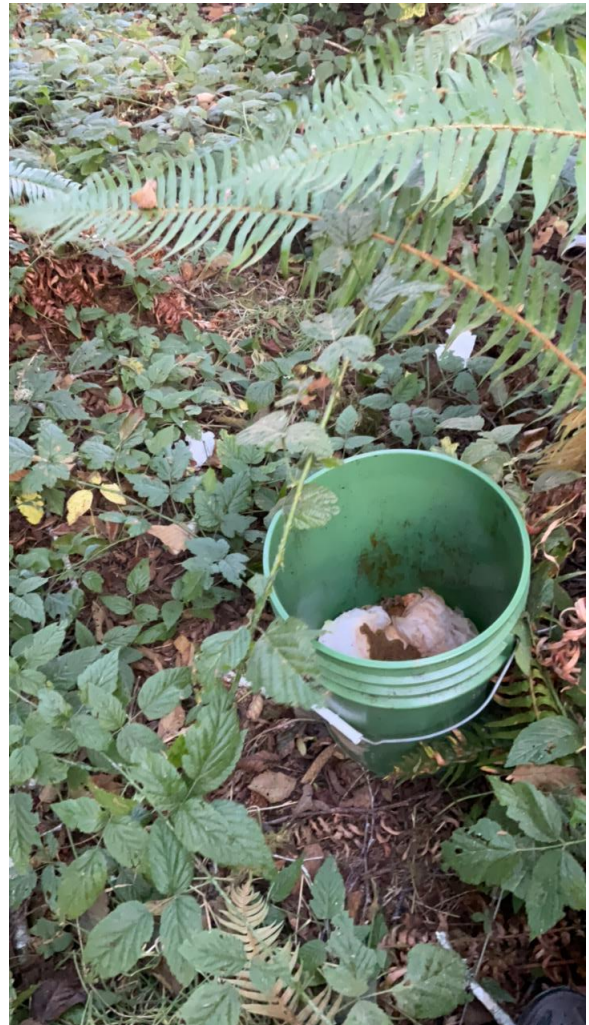
Human Waste: I observed human waste and toilet paper in a bucket and on the ground in the wetland complex (Photo 8).

Photo 8, Human Waste: Bucket with human waste and toilet paper. Waste also visible on ground
