CALIFORNIA REGIONAL WATER QUALITY CONTROL BOARD NORTH COAST REGION

CLEANUP AND ABATEMENT ORDER NO. R1-2022-0009

KEN BAREILLES

Figure 1. 1-20EM-00125-SON Inspection Map

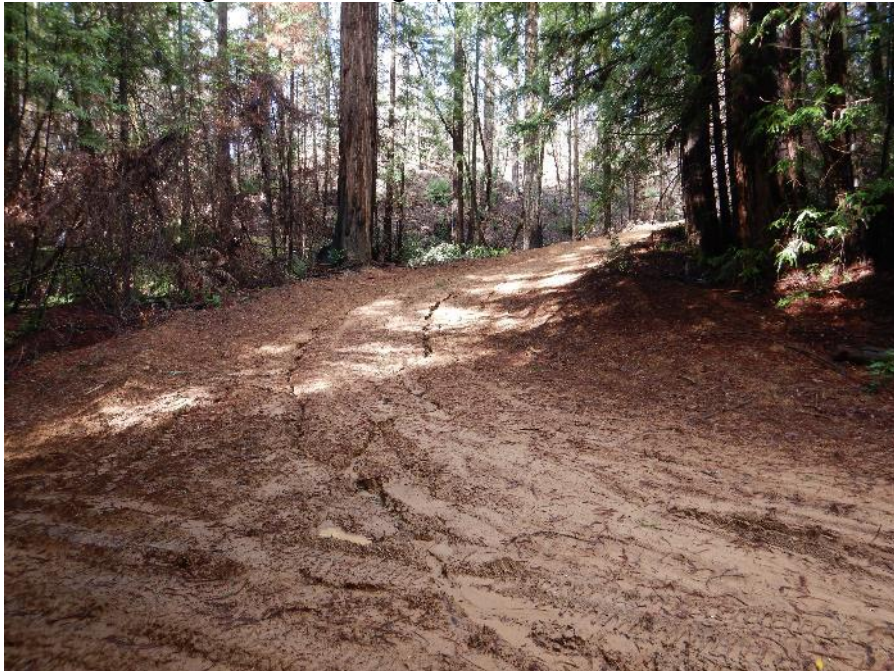
Photo Point 2.1 - Road segment, looking uphill. 11/04/2021

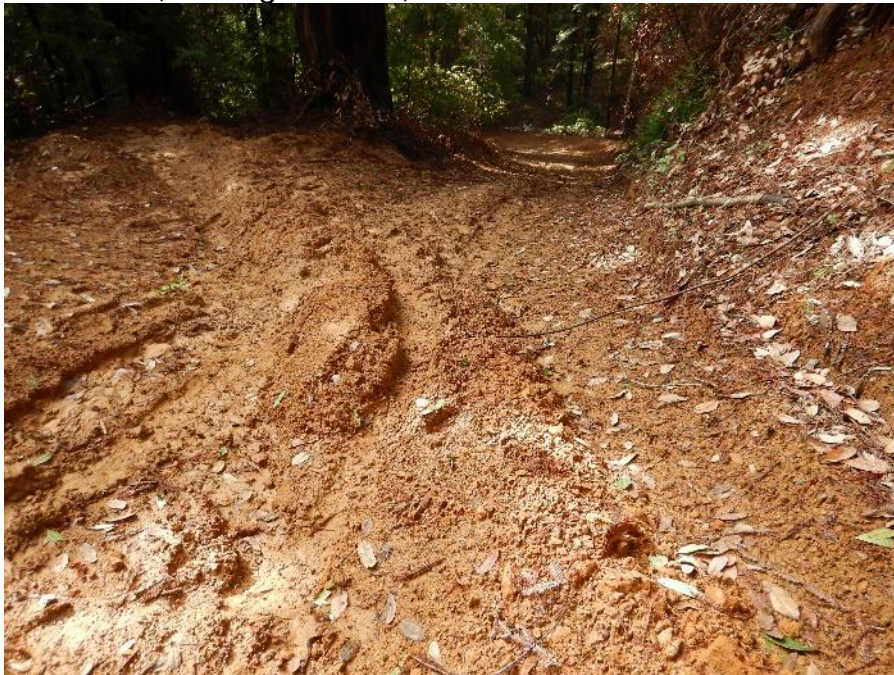
Photo Point 2.2 - Road, looking downhill, from first waterbar. 11/04/2021

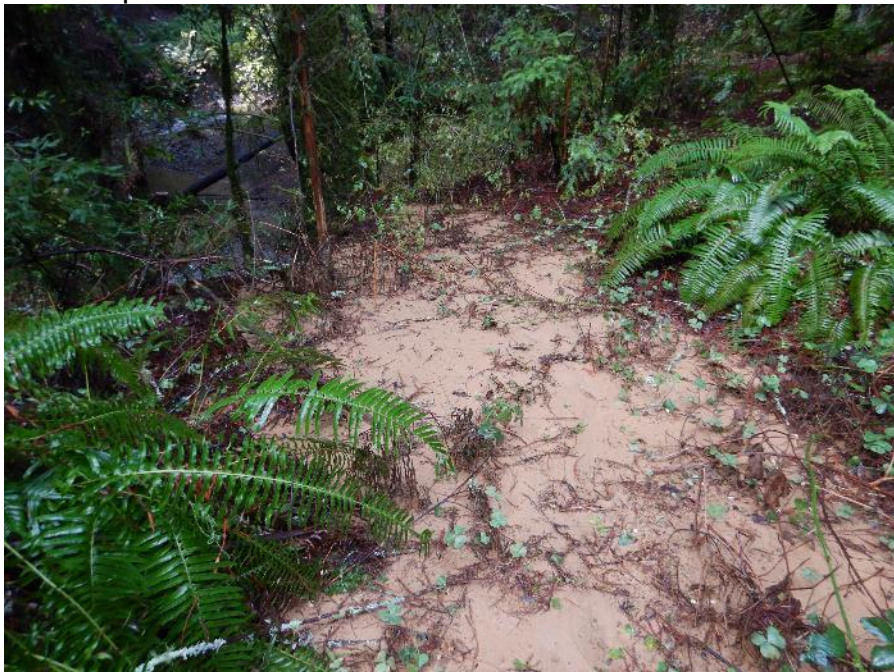
Photo Point 2.3 - Deposited sediment on banks above Felta Creek. 11/04/2021

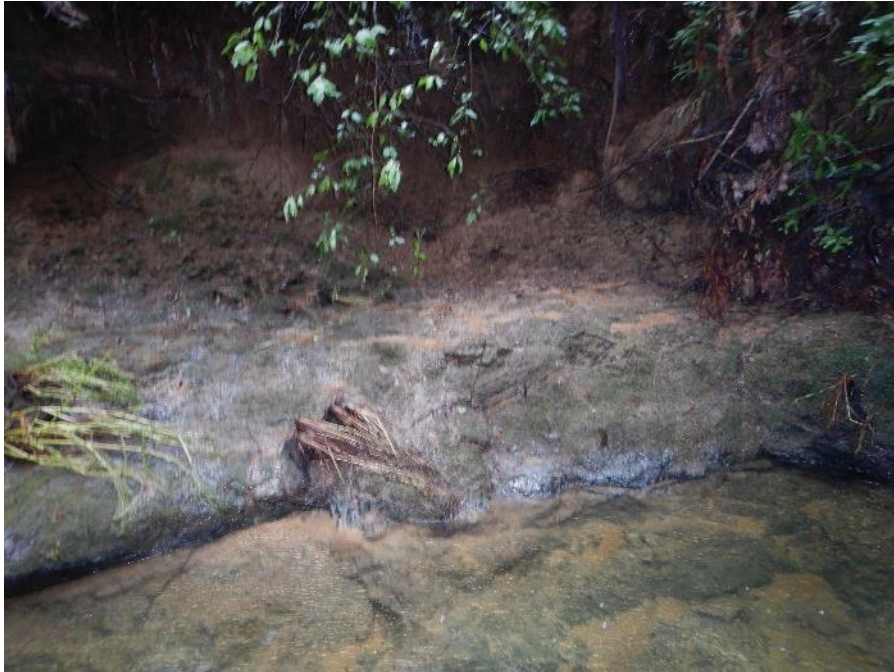
Photo Point 2.4 - Fine sediment deposits on channel bank and leading into channel of Felta Creek. 11/04/2021

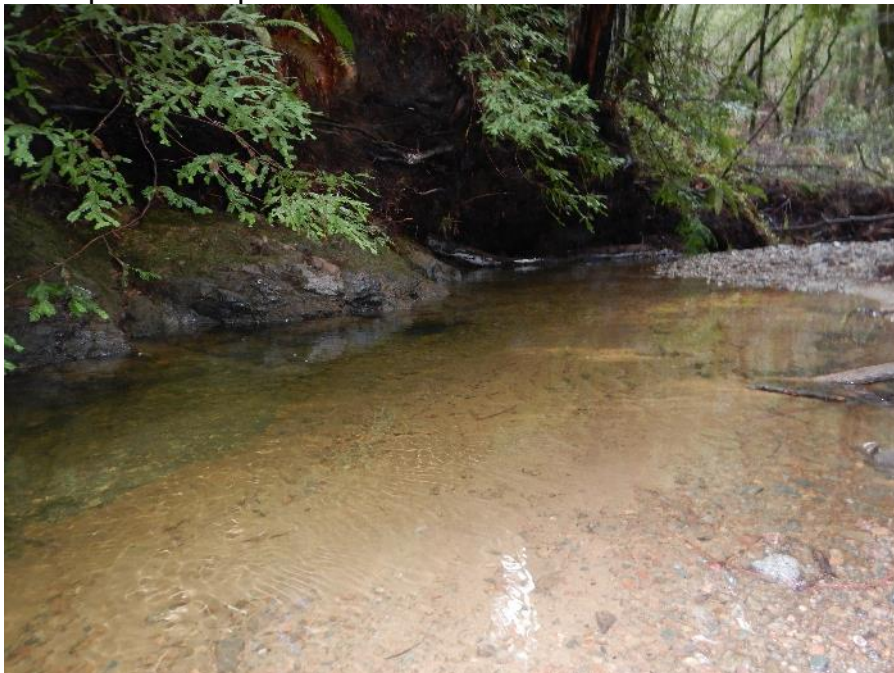
Photo Point 2.5 - Fine sediment deposits in channel of Felta Creek looking downstream from point of deposition. 11/04/2021

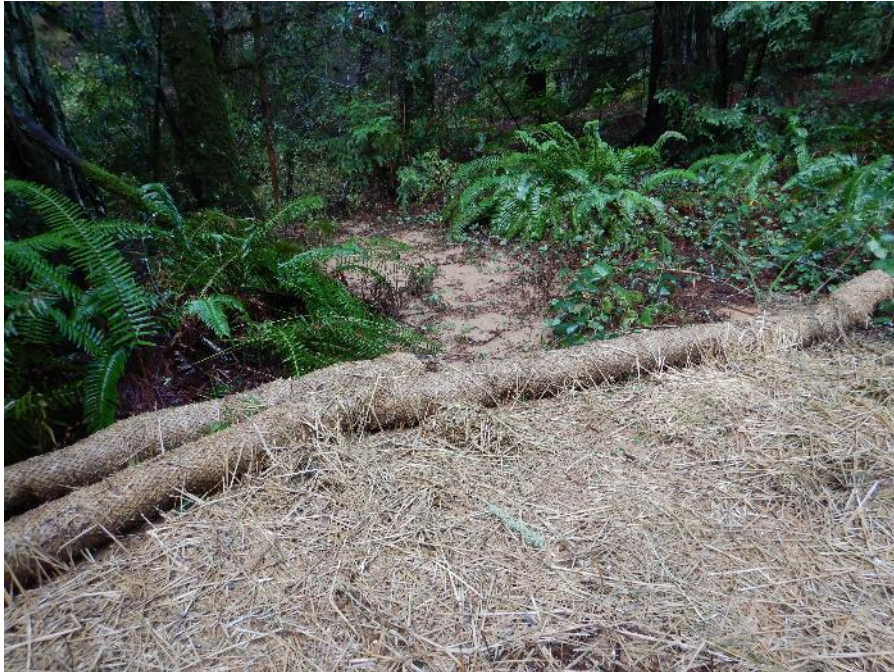
Photo Point 2.6 - Erosion control measures at base of hill, on banks of Felta Creek, installed after storm of October 24, 2021. 11/04/2021

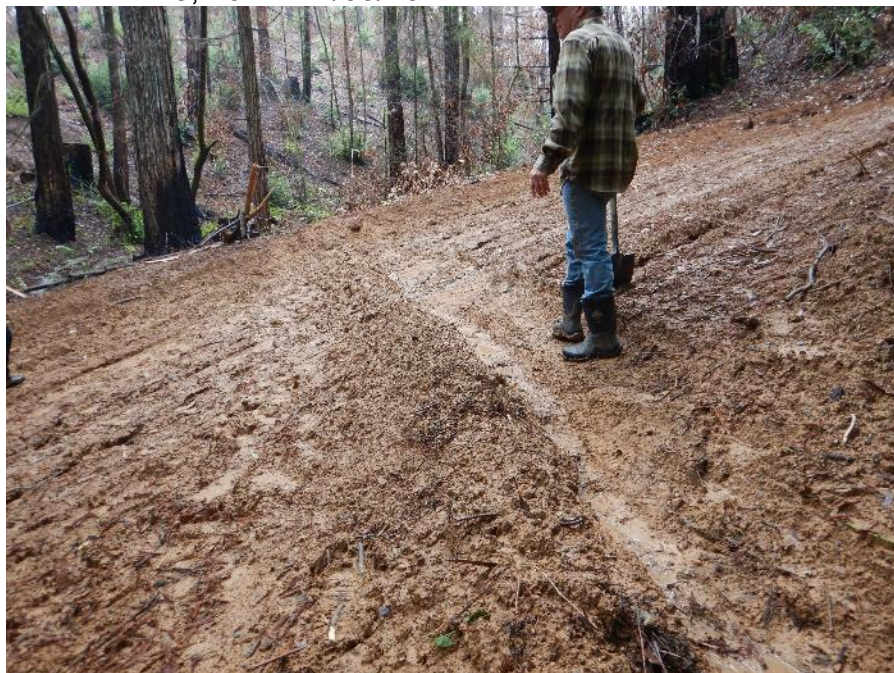
A waterbar was installed on this segment of road at some time between our inspection of November 4, 2021 and the rain event on November 8, 2021 (Photo Point 2.7). Roughly four inches of fresh sediment from the segment of road up to the newly installed waterbar was deposited on the straw mulch from the rain event on November 8, 2021 (Photo Point 2.8). No sediment from this event appears to have discharged to Felta Creek from the road.

Photo Point 2.7 - Waterbar, newly installed between inspection of November 4, 2021 and rains of November 8, 2021. 11/08/2021

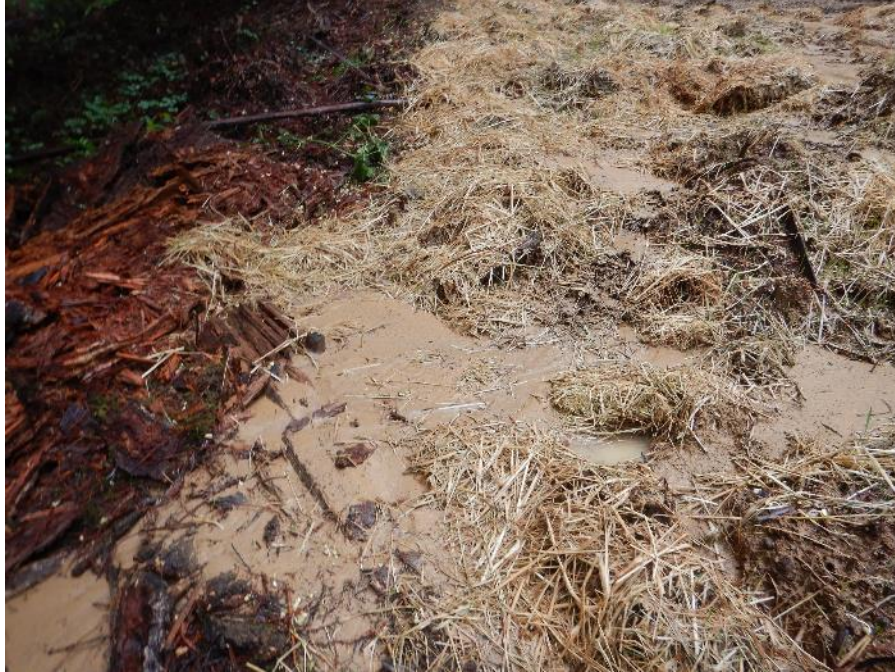
Photo Point 2.8 - Roughly 4" of freshly deposited sediment on top of erosion control straw. 11/08/2021

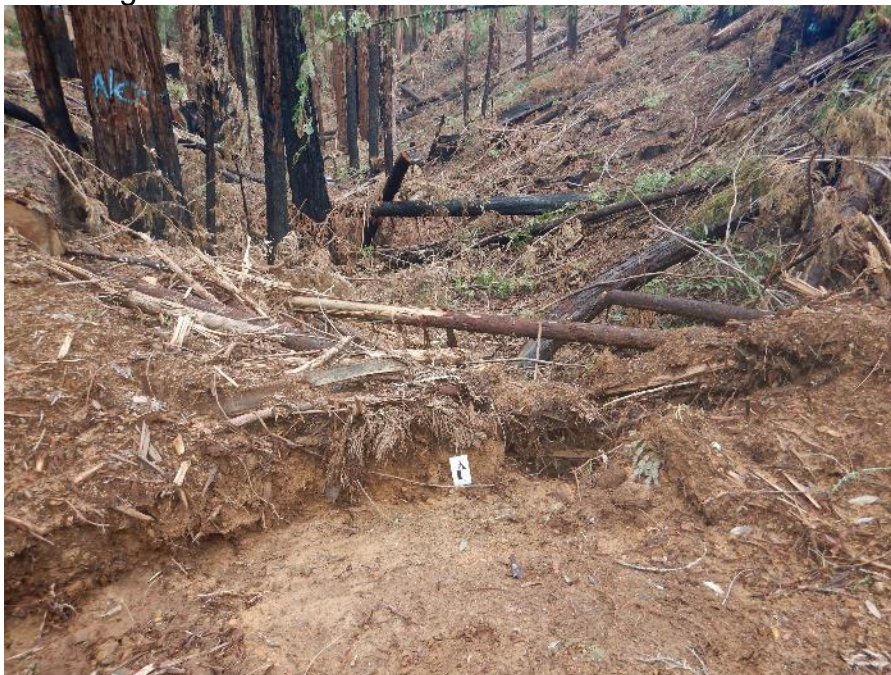
Photo Point 3.1 - Outboard edge of Class III crossing, showing material placed at crossing outlet during road reconstruction. 11/04/2021

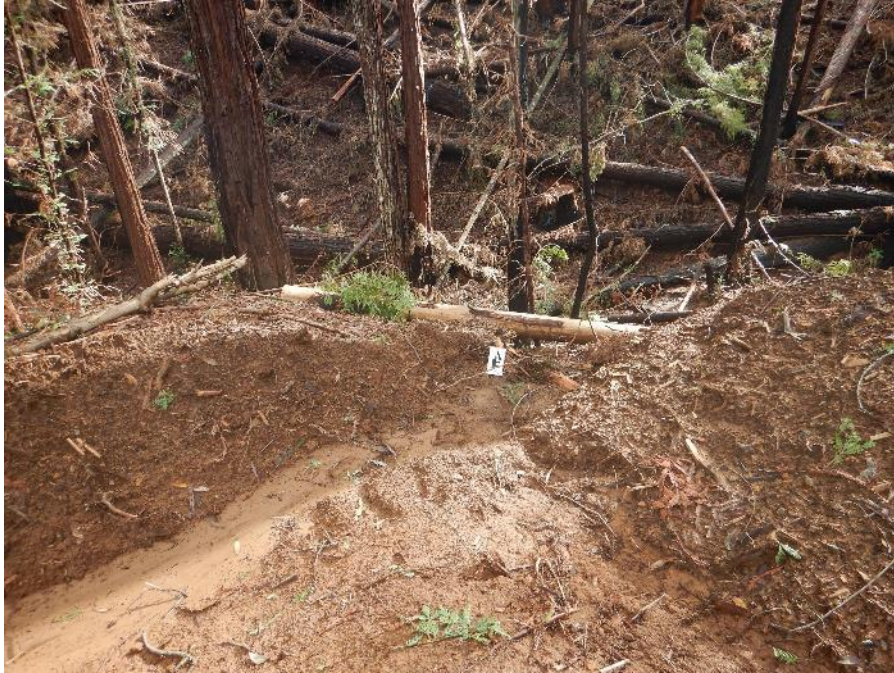
Photo Point 3.2 – Water and sediment reentering Class III watercourse after diverting down road and through sidecast material. 11/04/2021

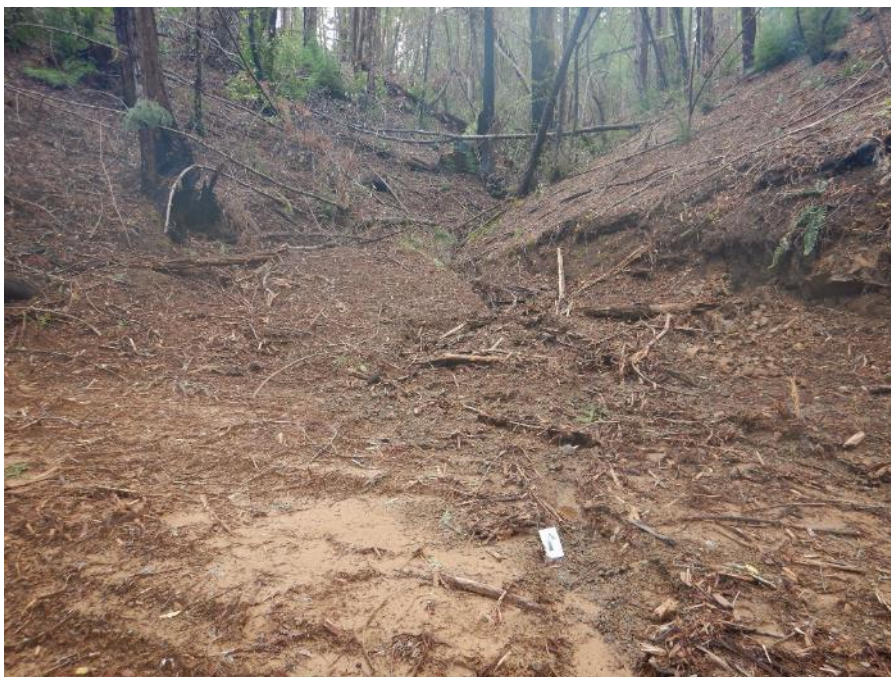
3.3). The 2017 THP identifies this crossing as Map Point 6, stating the streams are eroding the road surface and calls for a 30' culvert, and armoring the inlet, outlet, and inboard ditch. We observed fresh sediment deposits up to approximately 18 inches deep in the channel below this location.

Photo Point 3.3 –Class III watercourse entering road prism before diverting down road and through sidecast material. 11/04/2021

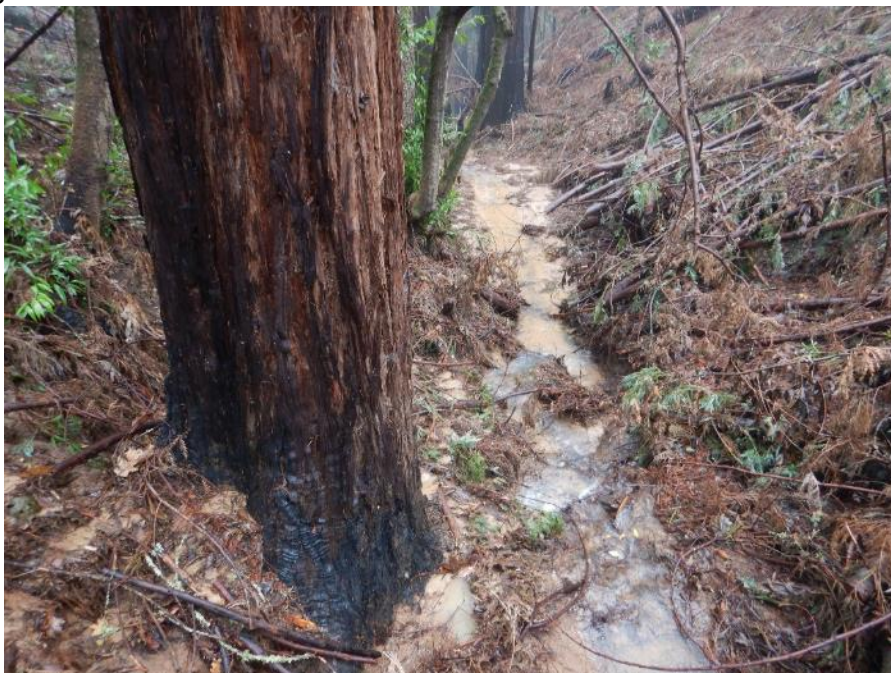
Photo Point 3.4 - Sediment discharge into channel of Class III stream after running over landing and down old skid trail. 11/09/2021

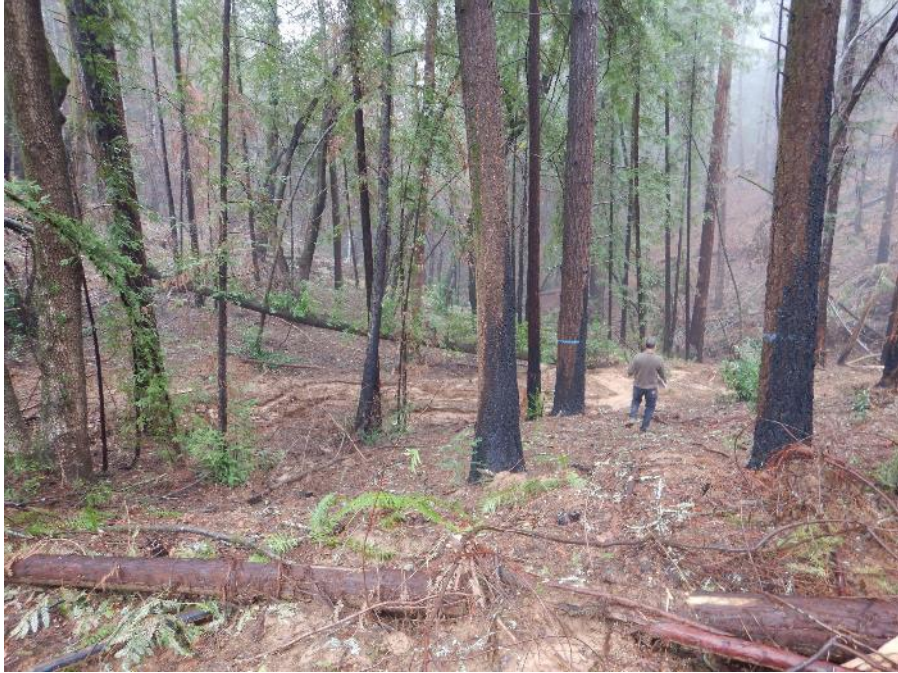
Photo Point 3.5 - Sediment being transported downslope from landing to Class III stream. 11/09/2021

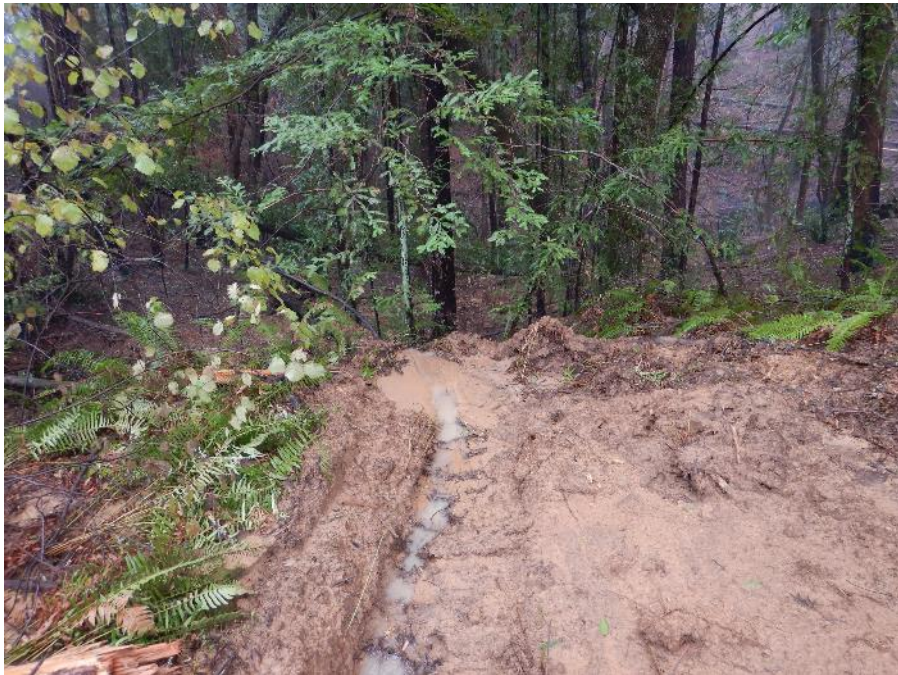
Photo Point 3.6 - Sediment on outboard edge of landing before being delivered downhill to Class III watercourse/ 11/09/2021

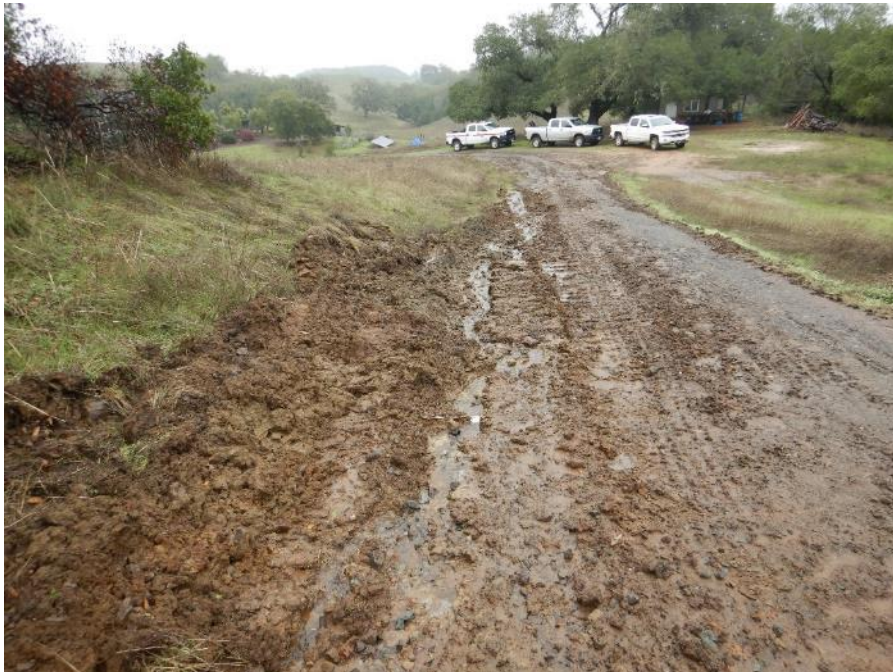
Photo Point 4.1 – Rilling on haul road downhill of newly installed waterbar.
11/09/2021

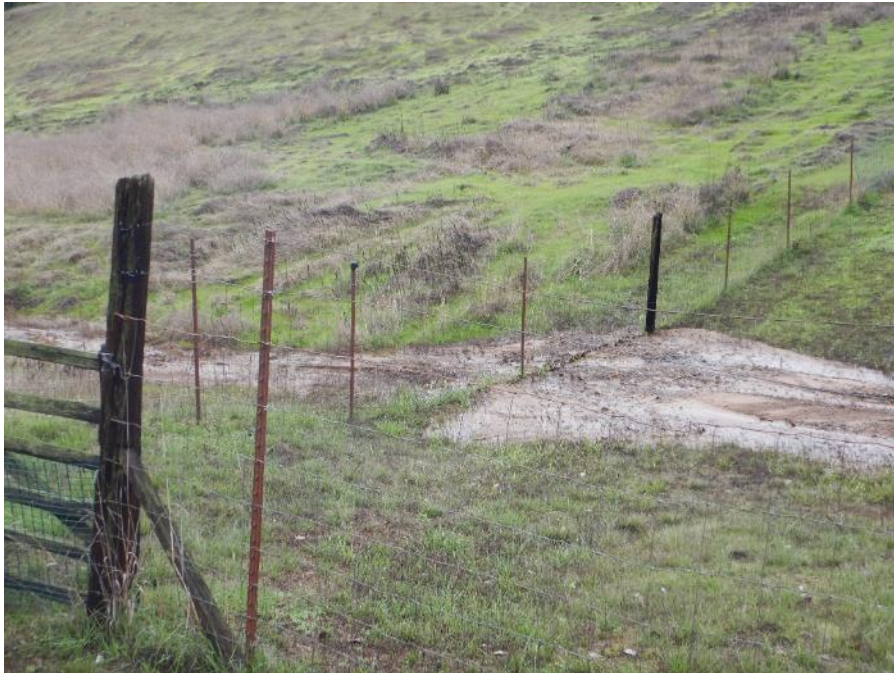
Photo Point 4.2 – Sediment deposition at head of Class III watercourse near haul road junction with Felta Creek Road. 11/09/2021

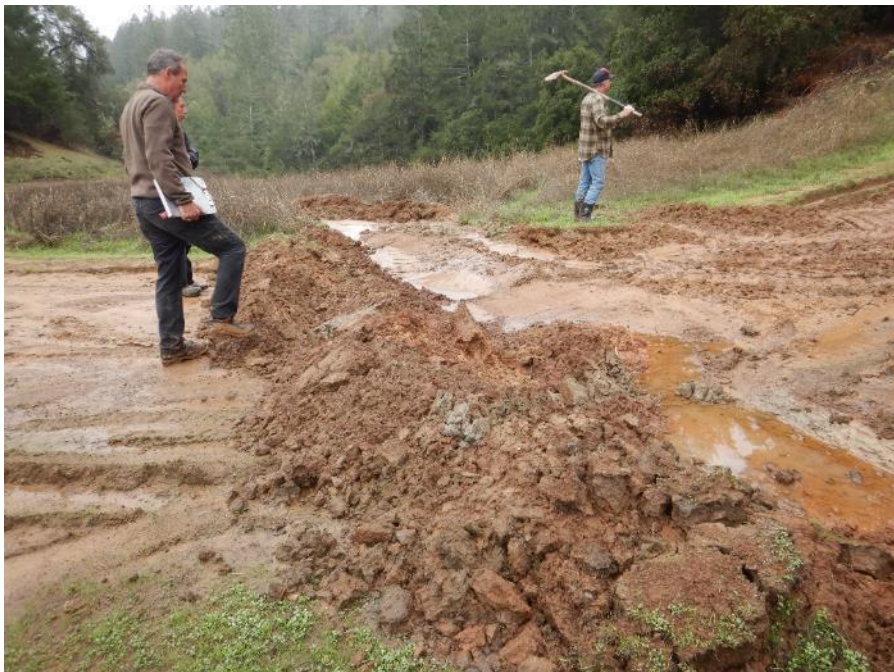
After the storm event of October 24, the landowner installed one waterbar using heavy equipment during saturated soil conditions (Photo Point 4.3).

Photo Point 4.3 – Newly installed waterbar on haul road. Installed during saturated soil conditions. 11/09/2021
