Fw: Bridge on MT-10 road

Subject: RE: Bridge on MT-10 road

Subject: Bridge on MT-10 road

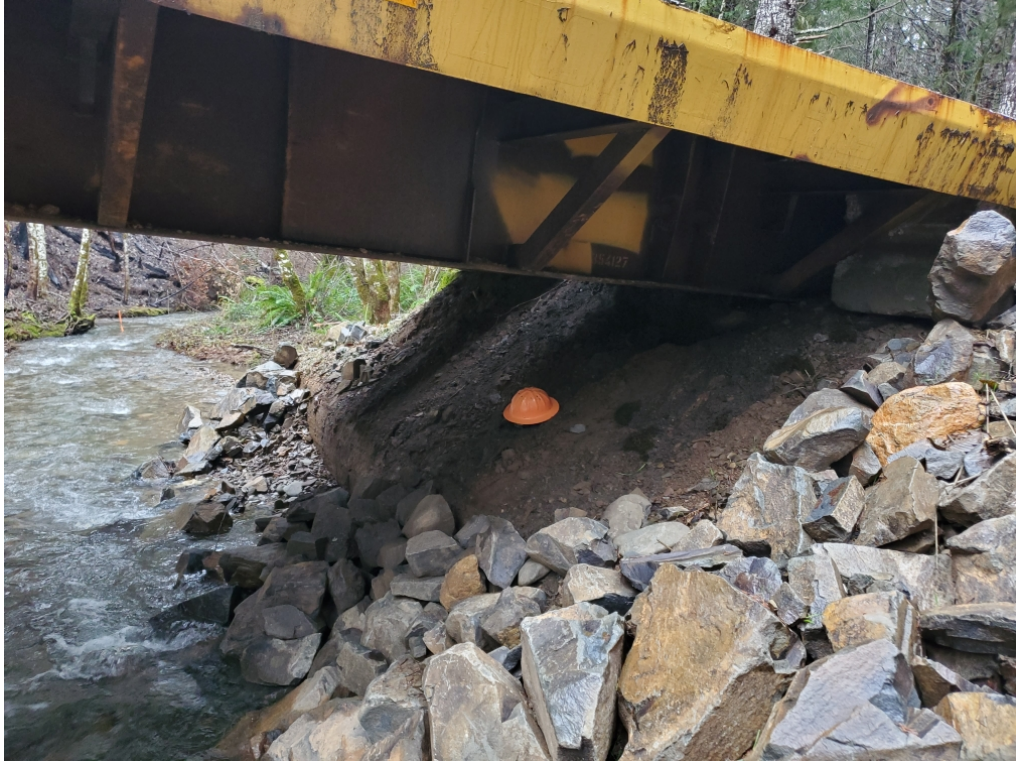
Image 1

On Tuesday, I was able to inspect the recently installed bridge in the Moore Tract on the MT-10 (RP 1). Some rip rap directly under the bridge on the right approach had eroded during recent storm events (see Image 1), which was observed the previous Friday. During my inspection, I saw no other issues with the fill slopes and the abutments appeared stable. The road contractor in the area was able to replace most of the rip rap that had slumped on Sunday, and added additional rip rap to already armored fill slopes as added protection (see Image 2-4). Today, the contractor is finishing rocking the last portion under the bridge which was only accessible by hand, as shown in Image 2. The added rip rap was of greater size and durability of the existing rock. With that, I do not anticipate any future significant issues with the fill slopes or abutments for this bridge.

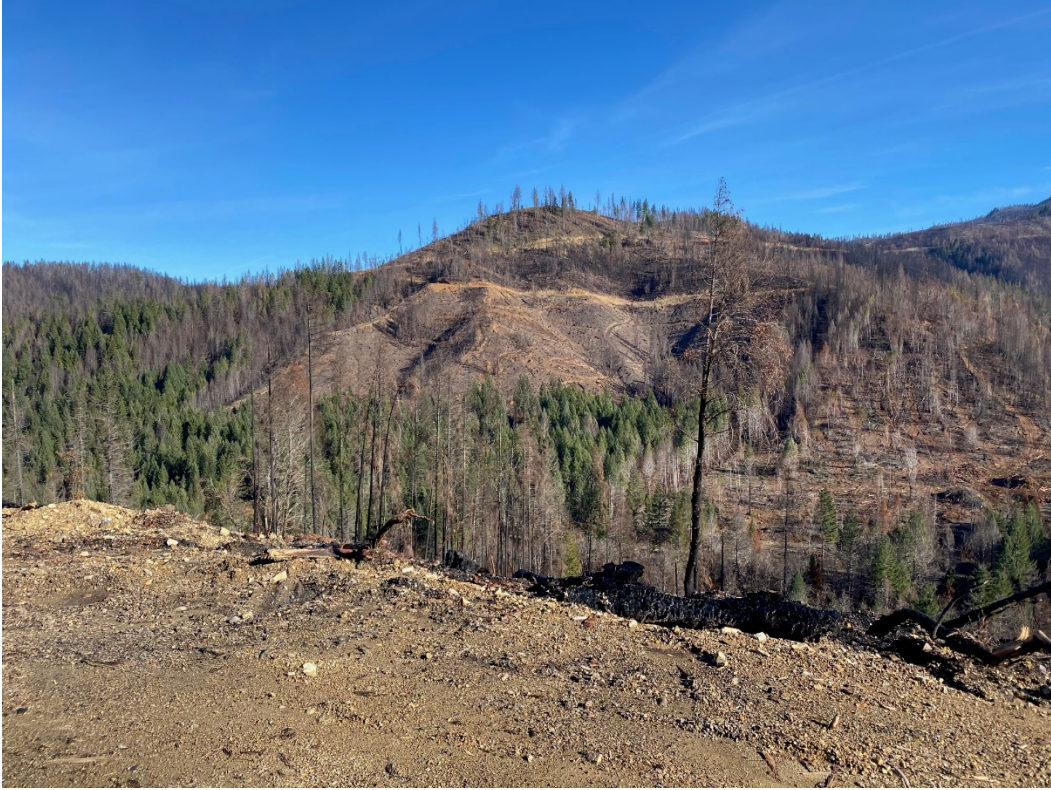
Image 5

I also took some time to inspect the majority of drivable roads in the tract. I saw no evidence of landslides or debris torrents, and all culvert inlets were functional and clear of debris. Additionally, all watercourses were flowing clear (see Images 5-6).
