**Subject Notice of Violation, Transmittal of Inspection Report for July 13, 2022
Inspection of Mendocino County Assessor's Parcel Numbers
013-540-50 and 013-540-51**

Inspection Map and Photo Appendix, ACME Investments Inc Property
CIWQS Inspection ID, July 13, 2022 Inspection, MEN APNs 013-540-50 & 013-540-51

FACILITIES INSPECTION REPORT

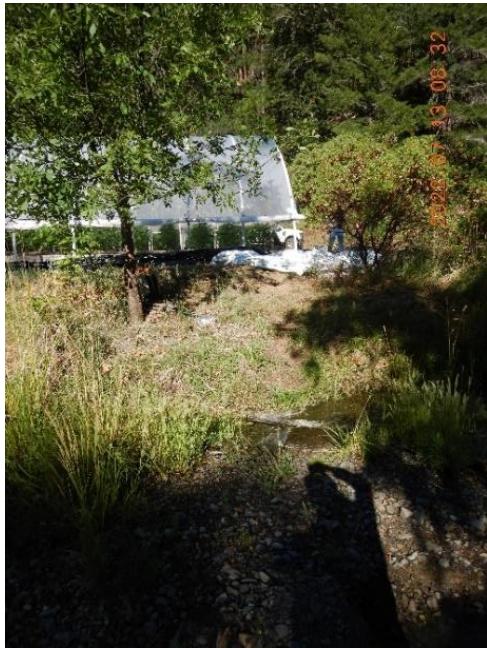
Figure 7. WQ1, WP767, Cultivation Area CA1 as viewed from the watercourse. The north corner of the cultivation area is 15' from top of bank of watercourse at WP768. Dep hoop house, spray tank. Cultivation waste, riparian disturbance.

1. Immediately remove fertilizers, pesticides, and petroleum products and containers from near stream areas, including at WQ1, WQ6, WQ10, WQ13.
2. Remove unpermitted cultivation, related materials, and associated refuse and cultivation waste from WQ1, WQ6, WQ9, WQ12.
3. Hire a qualified professional to conduct and submit a wetland delineation at WQ8. Identify impacts associated with the encroachment on the wetland with fill. Propose a cleanup plan to restore the wetland and associated watercourse to their pre-disturbed conditions.
4. Hire a qualified professional to inventory the Property, and provide treatment plans to protect streams and wetlands from unauthorized discharge of sediment and other waste, including from the access road and crossings. The roads assessment treatment plan should be consistent with the guidance offered in the document found at this link:

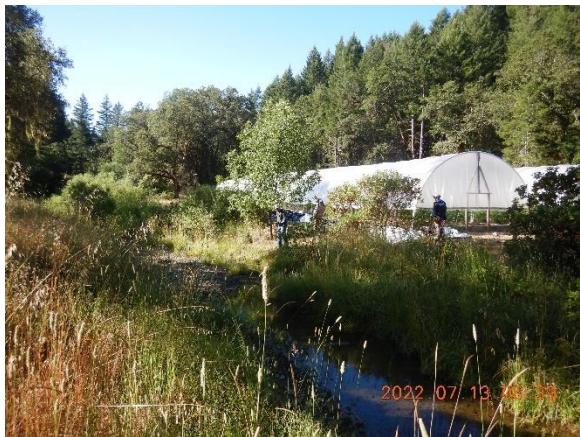
Figure 8. WQ1, WP767. View of CA1 from Grub Creek. The light depreciation hoop house was constructed near the top of the bank, resulting in riparian disturbance.

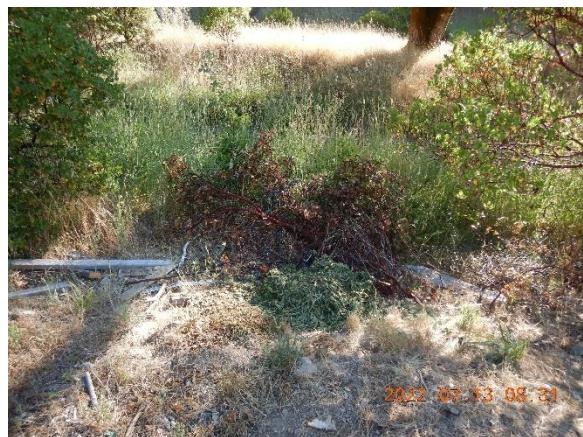
Figure 10. WQ1, CA1. Cultivation waste stored near watercourse.

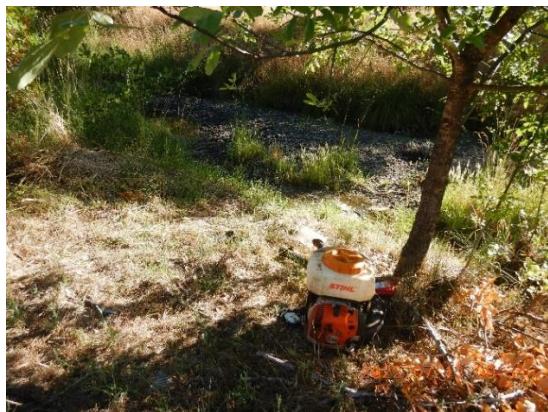
Figure 11. WQ1, WP 767. Backpack sprayer stored at top of bank.

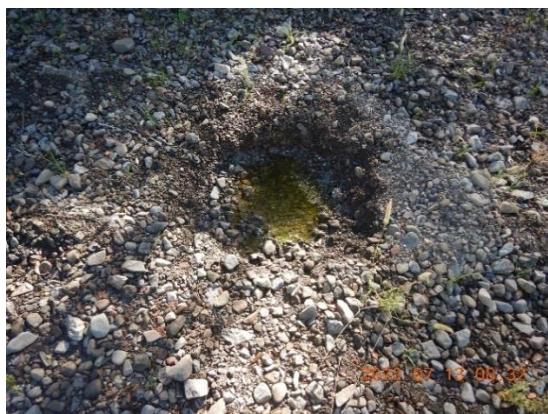
Figure 12. WQ1. WP768. Within less than 20 feet from the backpack sprayer, I observed a hole dug in gravels of Grub Creek, with water on the surface and algae growing.

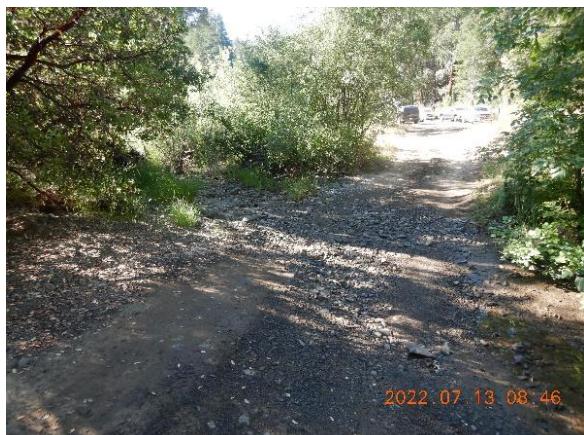
Figure 13. WQ2, WP769, watercourse crossing X1. Ford crossing on Grub

Creek. 30' long x 16' wide. The road approaches are hydrologically connected. Fine sediment is deposited upstream and downstream in the watercourse. Downstream is to the right of photo.

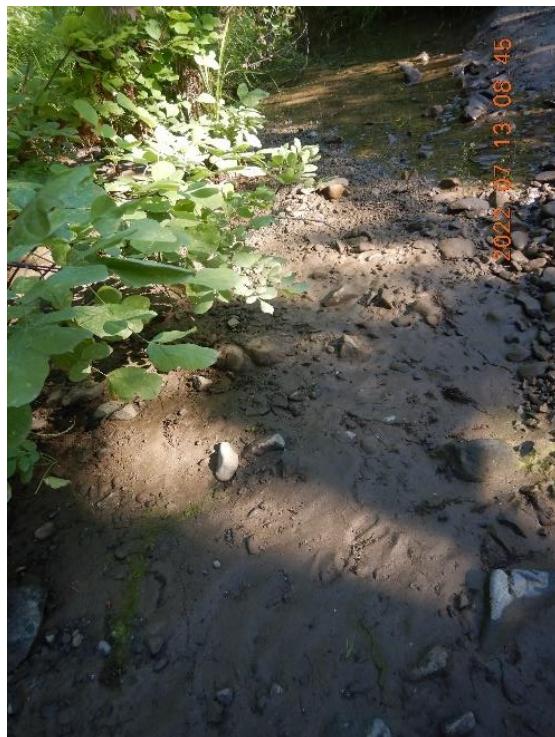
Figure 14. WQ2, WP769, X1. Fine sediment deposited in watercourse immediately downstream of ford crossing from road-related erosion of the crossing and the hydrologically connected road approaches.

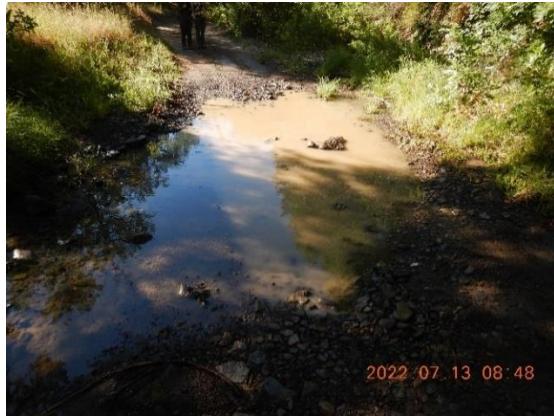
Figure 15. WQ3, WP770, watercourse crossing X2. Ford crossing on Grub Creek. 22' long by 12' wide. Vehicular use of the crossing results in a visible turbid plume downstream.

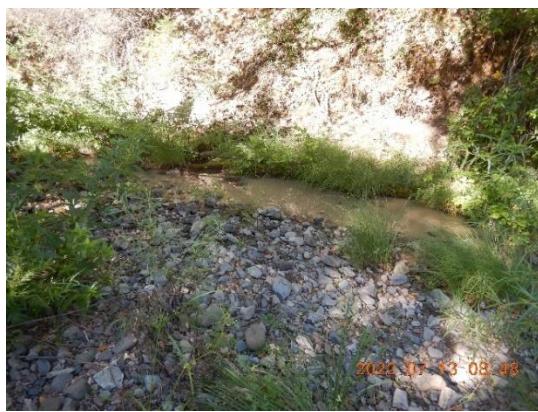
Figure 16. WQ3, WP770. Turbid plume downstream of X2.

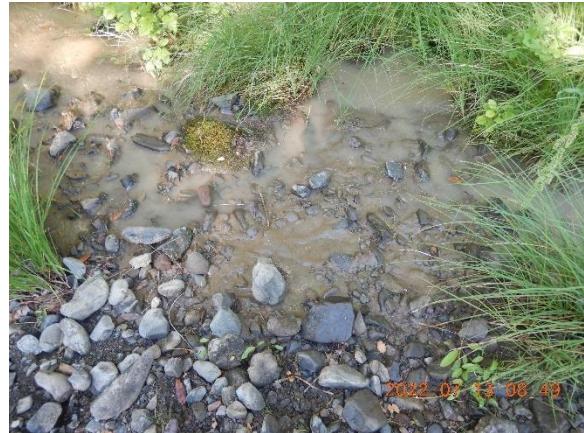
Figure 17. WQ3, WP770. Turbid plume and fine sediment deposition downstream of X2.

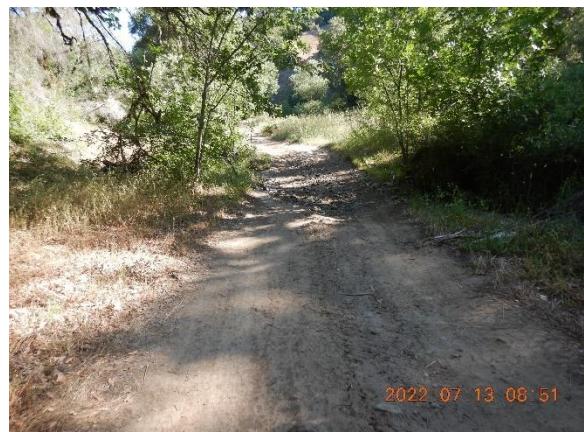
Figure 18. WQ4, WP771, watercourse crossing X3 is a ford crossing on Grub Creek. The unsurfaced road approaches are hydrologically connected to the watercourse. Outside of the crossings, Grub Creek is a free flowing stream.

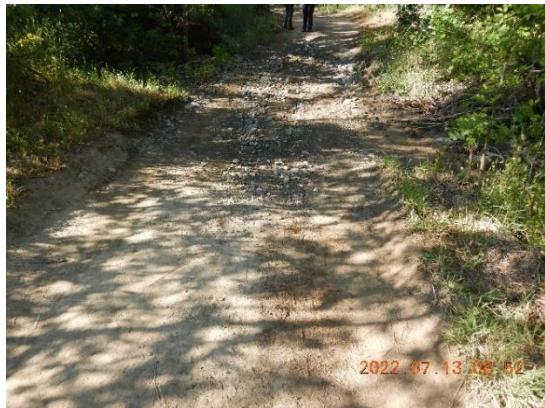
Figure 19. WQ4, WP771, watercourse crossing X3. The ford is 22' long by 8' wide.

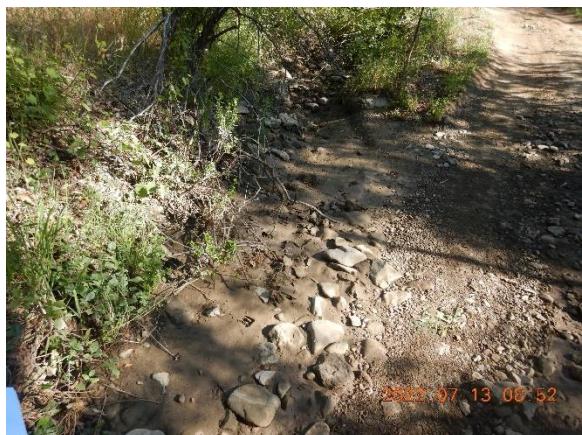
Figure 21. View downstream at WQ4, WP771, X3 with fine sediment deposition.

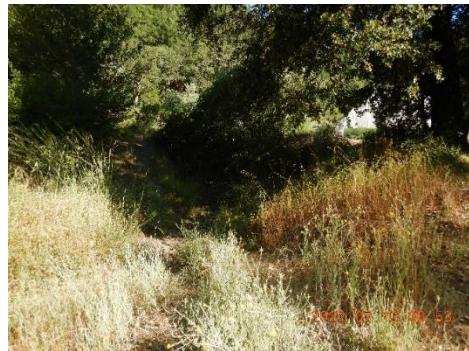
Figure 22. WQ5, WP772, watercourse crossing X4 is a skid trail ford over a Class II tributary to Grub Creek and is a ford crossing that is 14' long x 6' wide.

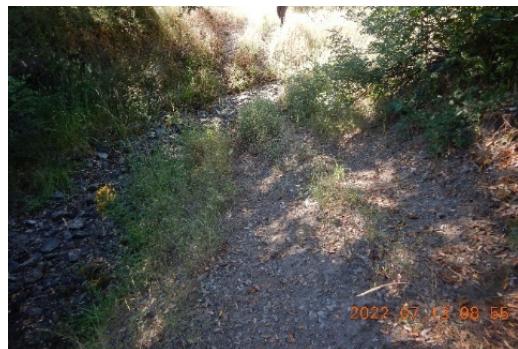
Figure 23. WQ5, WP772, watercourse crossing X4. The road approaches are hydrologically connected to the watercourse.

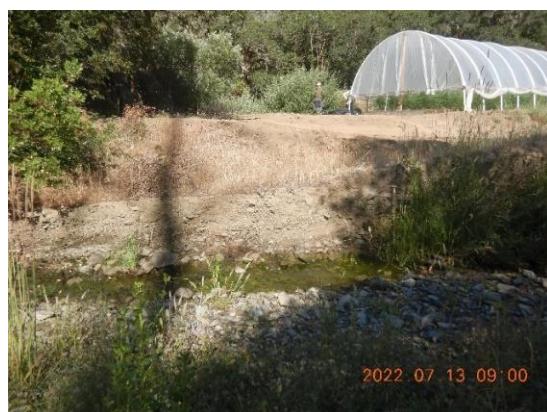
Figure 24. WQ6, WP773, hoop house cultivation area CA2. The area is located adjacent to the watercourse and has been graded associated with the access road and the cultivation area.

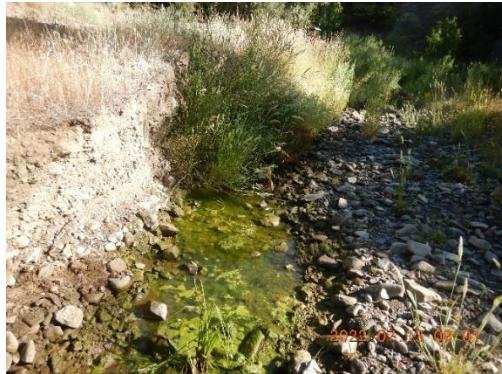
Figure 25. WQ7, WP774. The stream bank is eroded to verticle, and algae is growing in the channel. I observed loose uncompacted fill pushed within 15' of the top of the bank of Grub Creek.

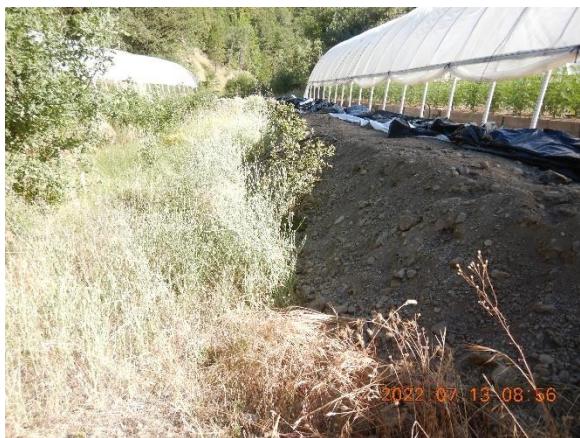
Figure 30. WQ8, WP776. Loose fill associated with the greenhouse pad construction is pushed over the break in slope with the wetland. Looking approximately north.

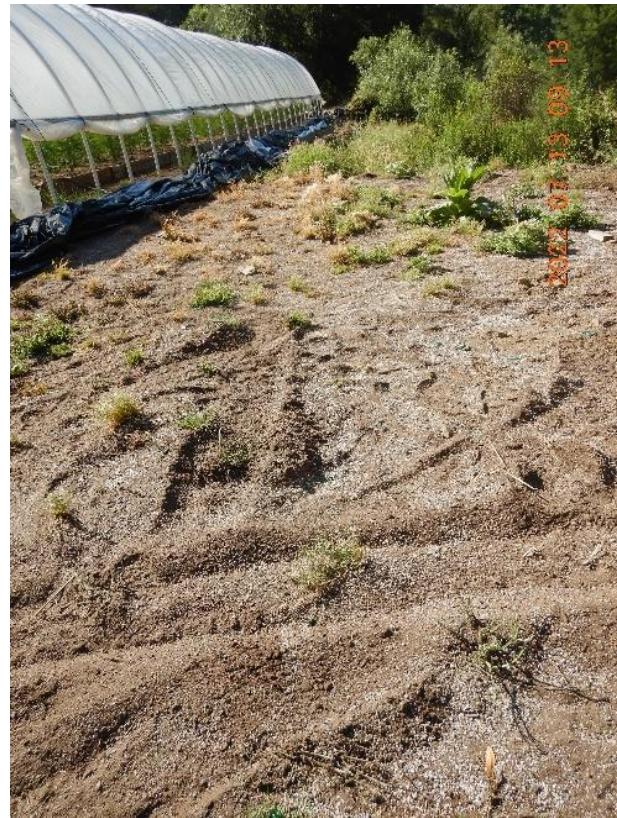
Figure 31. WQ8, WP776. Potting soil and dirt graded adjacent to wetland feature. Looking approximately south.

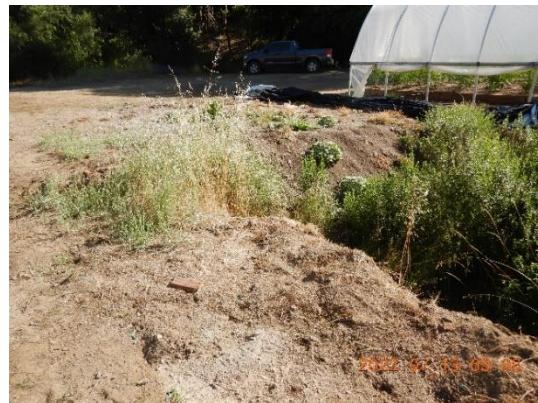
Figure 32. WQ8, WP776. Pushed fill encroaching over slope into wetland feature. Looking approximately north.

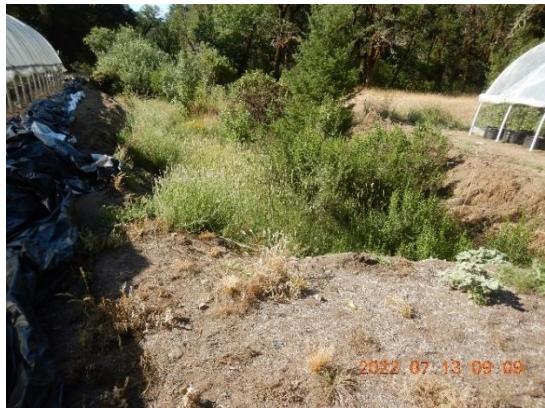
Figure 33. WQ8, WP776. Pushed fill encroaching over slope into wetland feature. Looking approximately south.

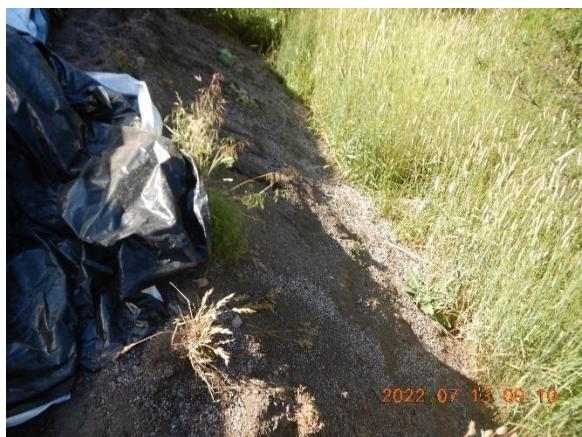
Figure 34. Pushed fill and potting soil encroaching over slope into wetland feature. Looking approximately south.

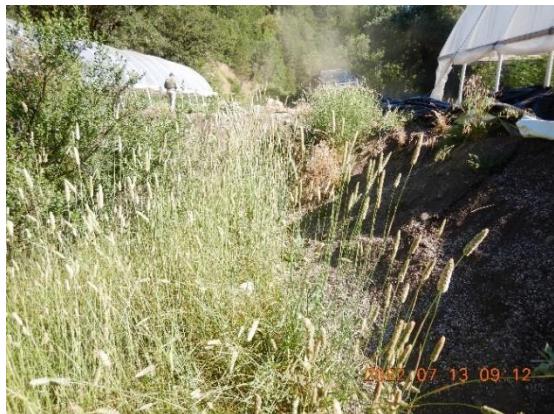
Figure 35. Pushed fill and potting soil encroaching over slope into wetland feature. Looking approximately north.

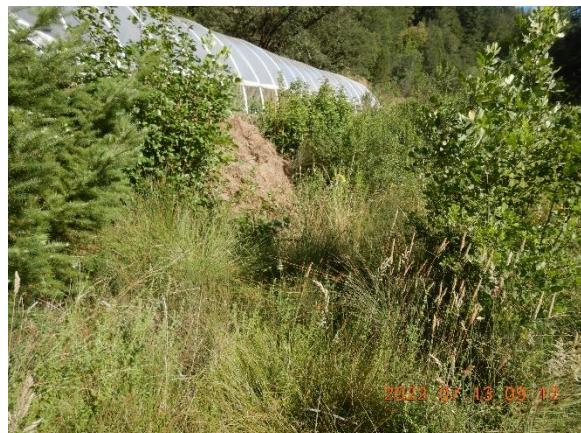
Figure 37. Pushed fill encroaching over slope into wetland feature. Looking approximately east.

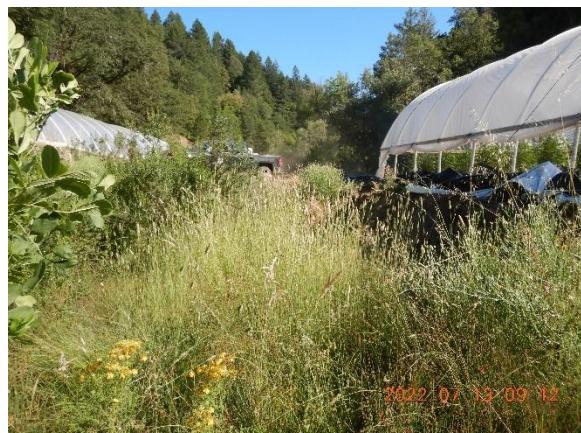
Figure 38. WQ8, WP776. Based on rapid visual observation, and my experience with wetlands in the

northcoast, vegetation associated with wetland feature appears to be dominated by hydrophytic vegetation.

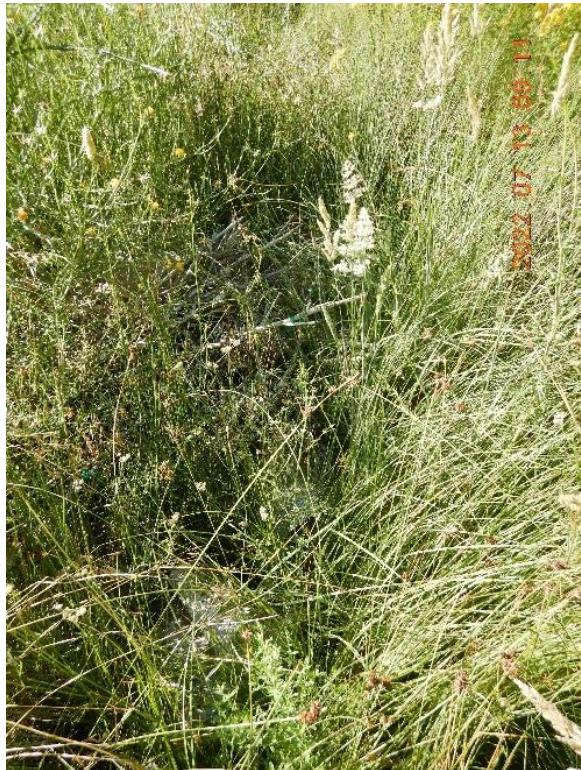
Figure 39. WQ8, WP776. Based on rapid visual observation, and my experience with wetlands in the northcoast, soils within the wetland feature appear to be saturated.

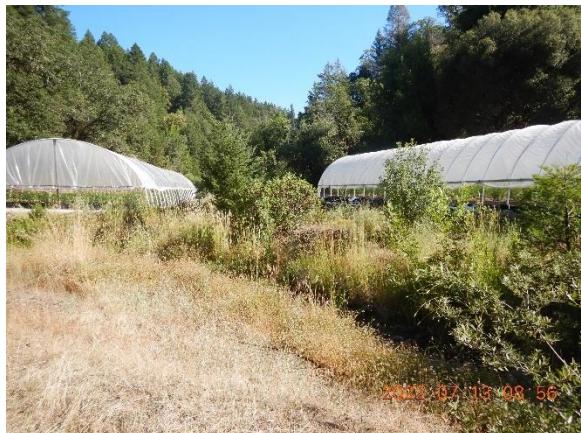
Figure 40. WQ8, WP776. View looking north of watercourse in foreground, and the wetland feature, flanked by

greenhouses. Based on my field observations and evaluation of the terrain, and my experience with wetlands in the northcoast, the hydrology of the the feature is associated with the unnamed Class II tributary to Grub Creek.

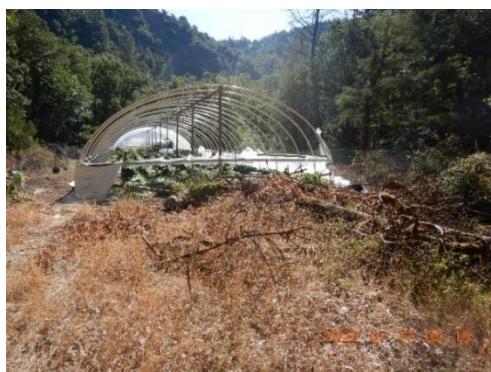
Figure 45. WQ9, WP777, CA3. Riparian trees were cut to facilitate cannabis cultivation.

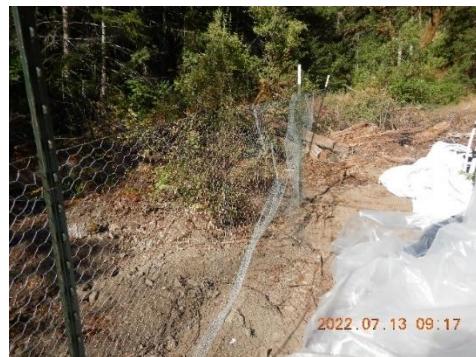
Figure 46. WQ9, WP777, CA3. Removal of riparian trees to facilitate cannabis cultivation allows more sun to reach the watercourse and associated riparian area, potentially increasing water temperatures.

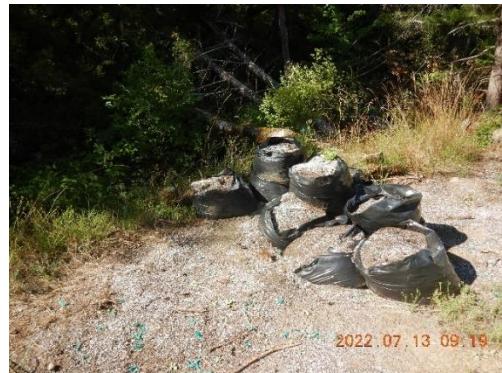
Figure 47. WQ9, WP777. Potting soil is stored uncontained at the top of bank at CA3.

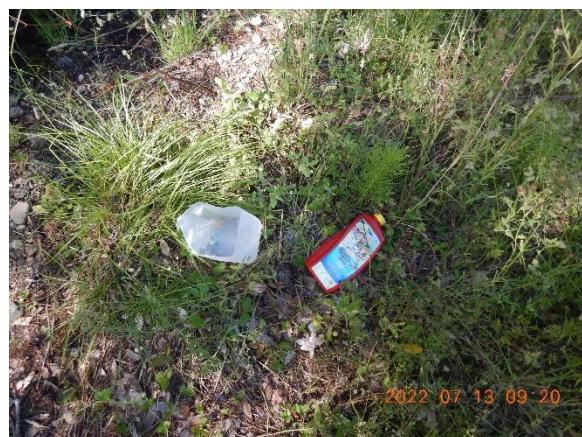
Figure 48. WQ10, WP 778. On the gravels of the stream channel, next to

the flowing surface water of the stream, I observed a pesticide container and jug. According to the safety data sheet for the pesticide, Sevin Insect Killer, it contains active ingredient zeta-cypermethrin, which according to the US EPA label amendment in 2021, the “product is extremely toxic to fish, aquatic invertbrates..”

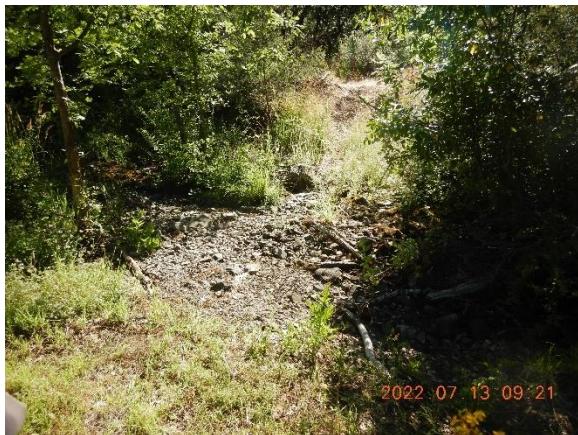
Figure 49. WQ11, WP778, quad trail watercourse crossing X5 over the Class II unnamed tributary. The ford is 12' wide by 6' long and connects to the crossing identified at WQ5, WP772.

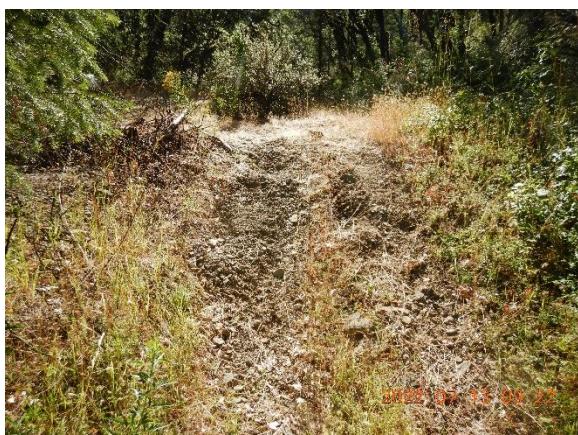
Figure 50. WQ11, WP778, X5, approaches are steep and hydrologically connect to the watercourse.

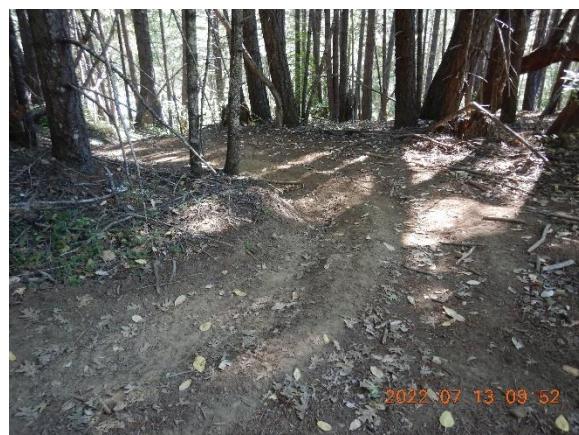
Figure 52. A road up to water tanks is very steep (30-50% slope) with wheel track troughs.

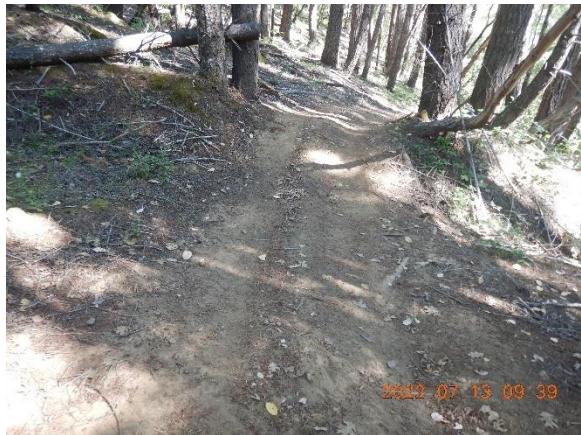
Figure 53. Road surface erosion has transported into swale at WP779 along road to water tanks.

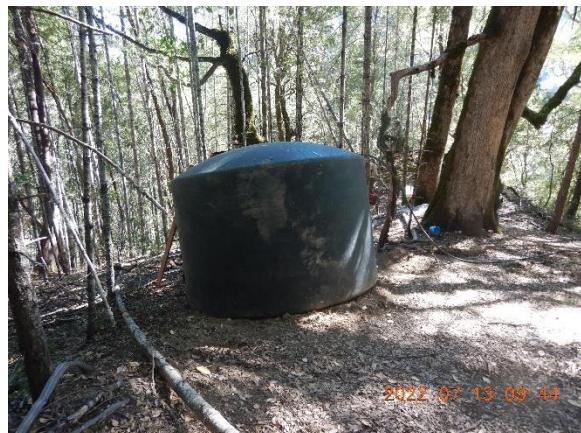
Figure 57. WP780. Water tank is not level.

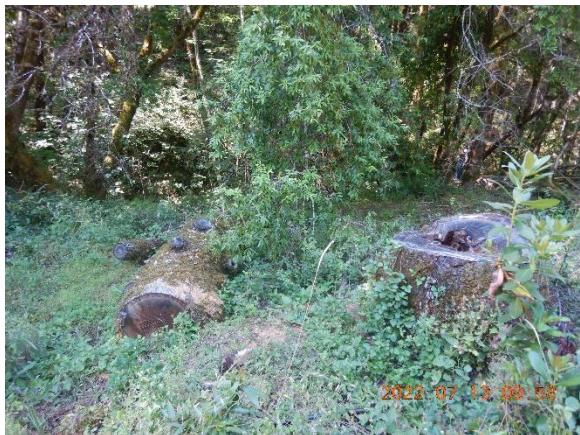
Figure 60. WQ12. Between Cold Creek and the CA4 cultivation area, oaks and firs are cleared. Late afternoon summer shade on big Class II stream could be reduced, potentially elevating air temperatures and water temperatures.

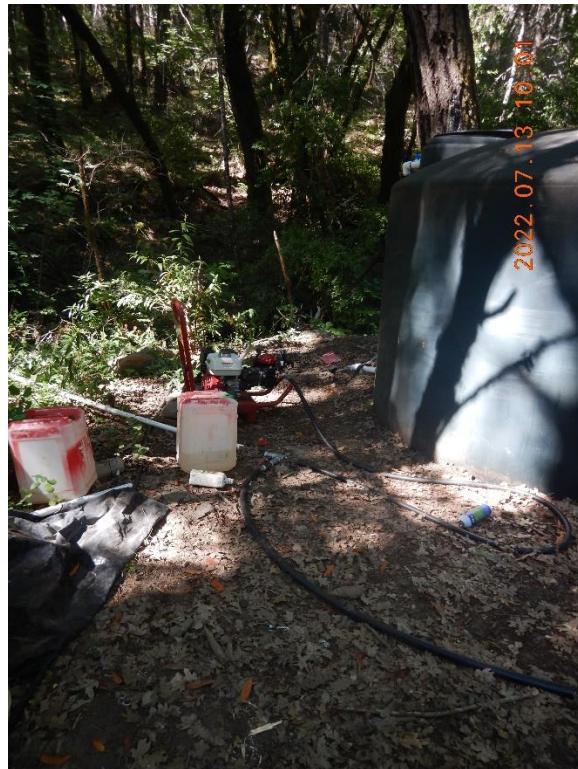
Figure 62. WQ13, WP 782. A streamside landing is being used to facilitate water diversion for the cultivation. Two pumps and a water tank are located on the top of the bank of Cold Creek. There is a diversion into the tank, and out are two pumps, each on separate out lines.

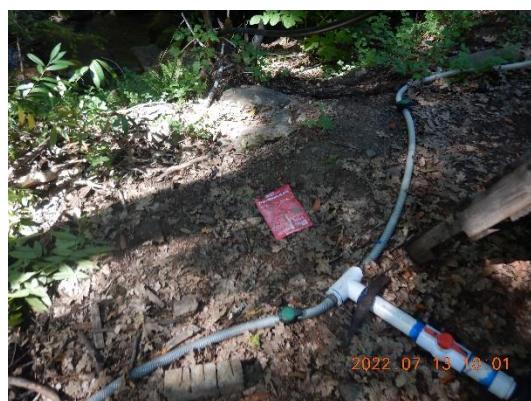
Figure 63. WQ13, WP782. I observed evidence that fertilizer was being used at the top of the streambank.

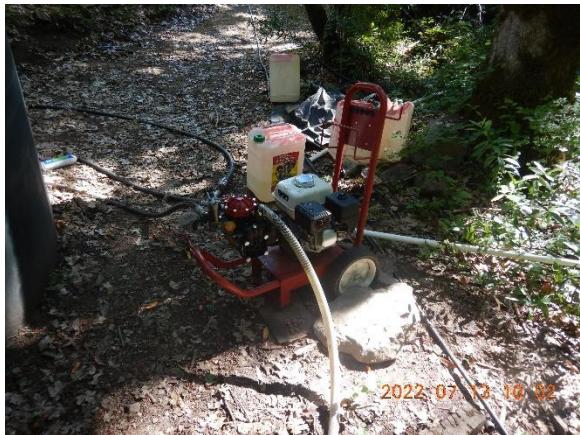
Figure 64. WQ13, WP782. Jugs of fertilizer are located on the streamside landing and water tank.

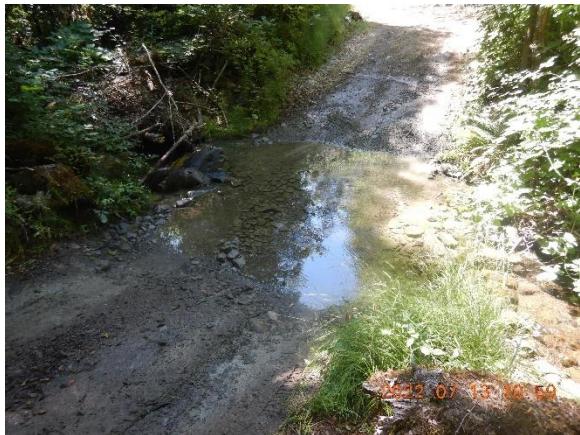
Figure 70. WQ14, WP 784. Ford crossing of Cold Creek. Both road approaches discharge to this stream this stream, shown as a blueline stream on the USGS map in Figure 3. 12' long wet ford built up with rocks in the channel. Lots of fine sediment deposited in channel.

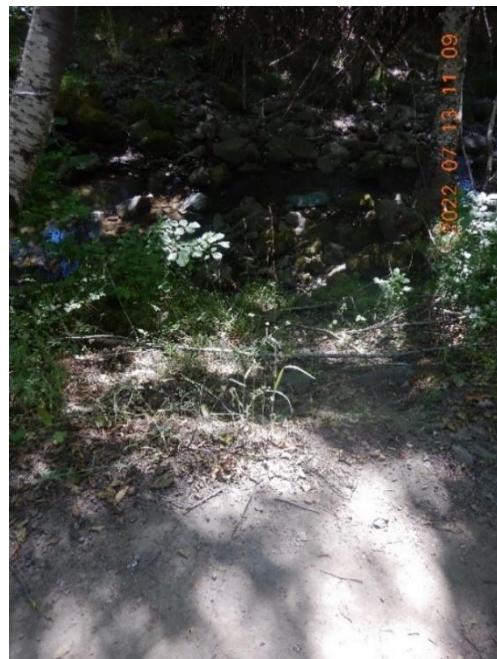
Figure 72. WQ16, WP 786. The access road is located close to Grub Creek, 4' horizontally and 4' vertically. Road surface erosion ready can discharge to the watercourse. I observed fish in this reach.

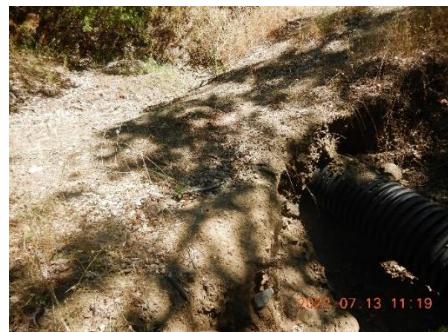
Figure 73. WQ17, WP 787. Misaligned corrugated plastic pipe located on a skid trail with eroded fill on tributary to Grub Creek
