North Coast Regional Water Quality Control Board

August 25, 2022

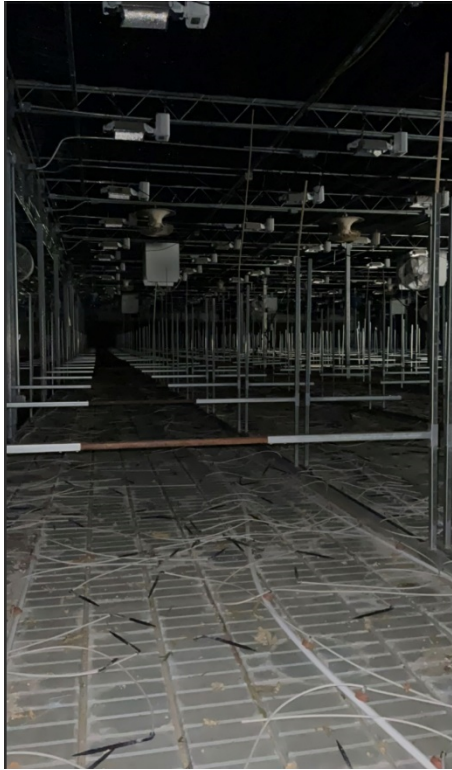
Photo 1: Inactive indoor cultivation setup in building with concrete flooring.

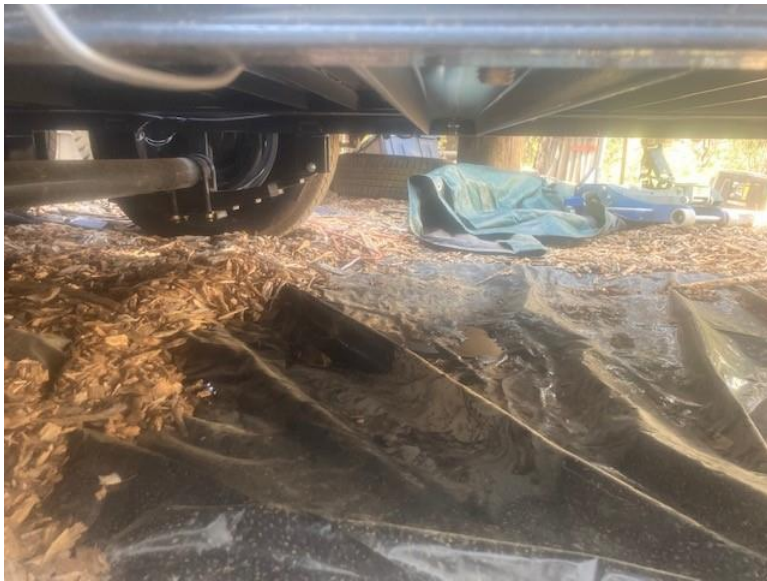
Photo 11 (taken by Helen Bowman): View under generator with inadequate secondary containment and diesel spill evident on tarp.

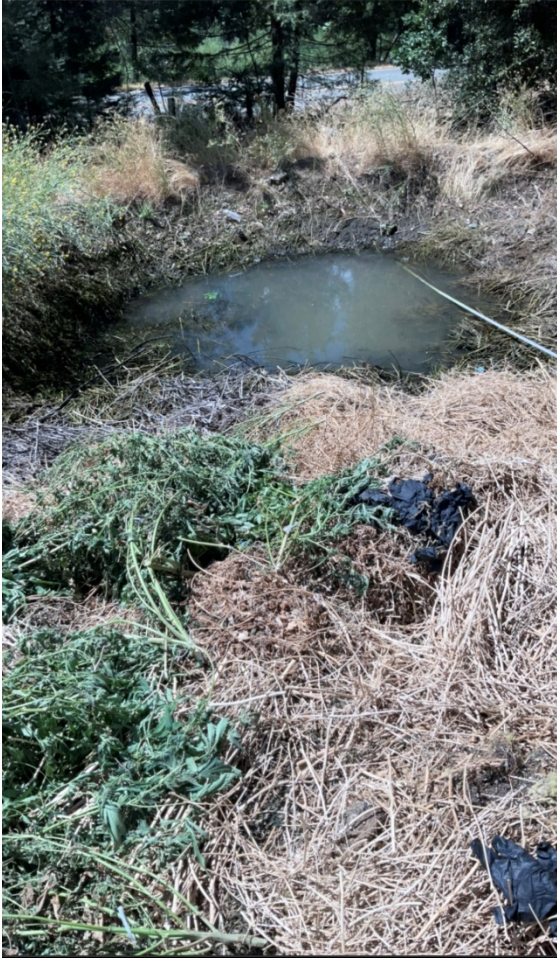
Photo 12: Small man-made reservoir with standing water, cannabis plant waste, and black plastic waste. Hayfork Creek is across the road in the background.
