North Coast Regional Water Quality Control Board

Subject: Notice of Violation, Transmittal of Report for August 23, 2022 Inspection of Trinity County Assessor's Parcel Numbers 022-230-011-000 and 022-230-017-000

**Inspection Report for August 23, 2022 Warrant Inspection,
Trinity County
Assessor's Parcel Numbers (APN) 022-230-011-000 and 022-230-017-000
(the "Property")**

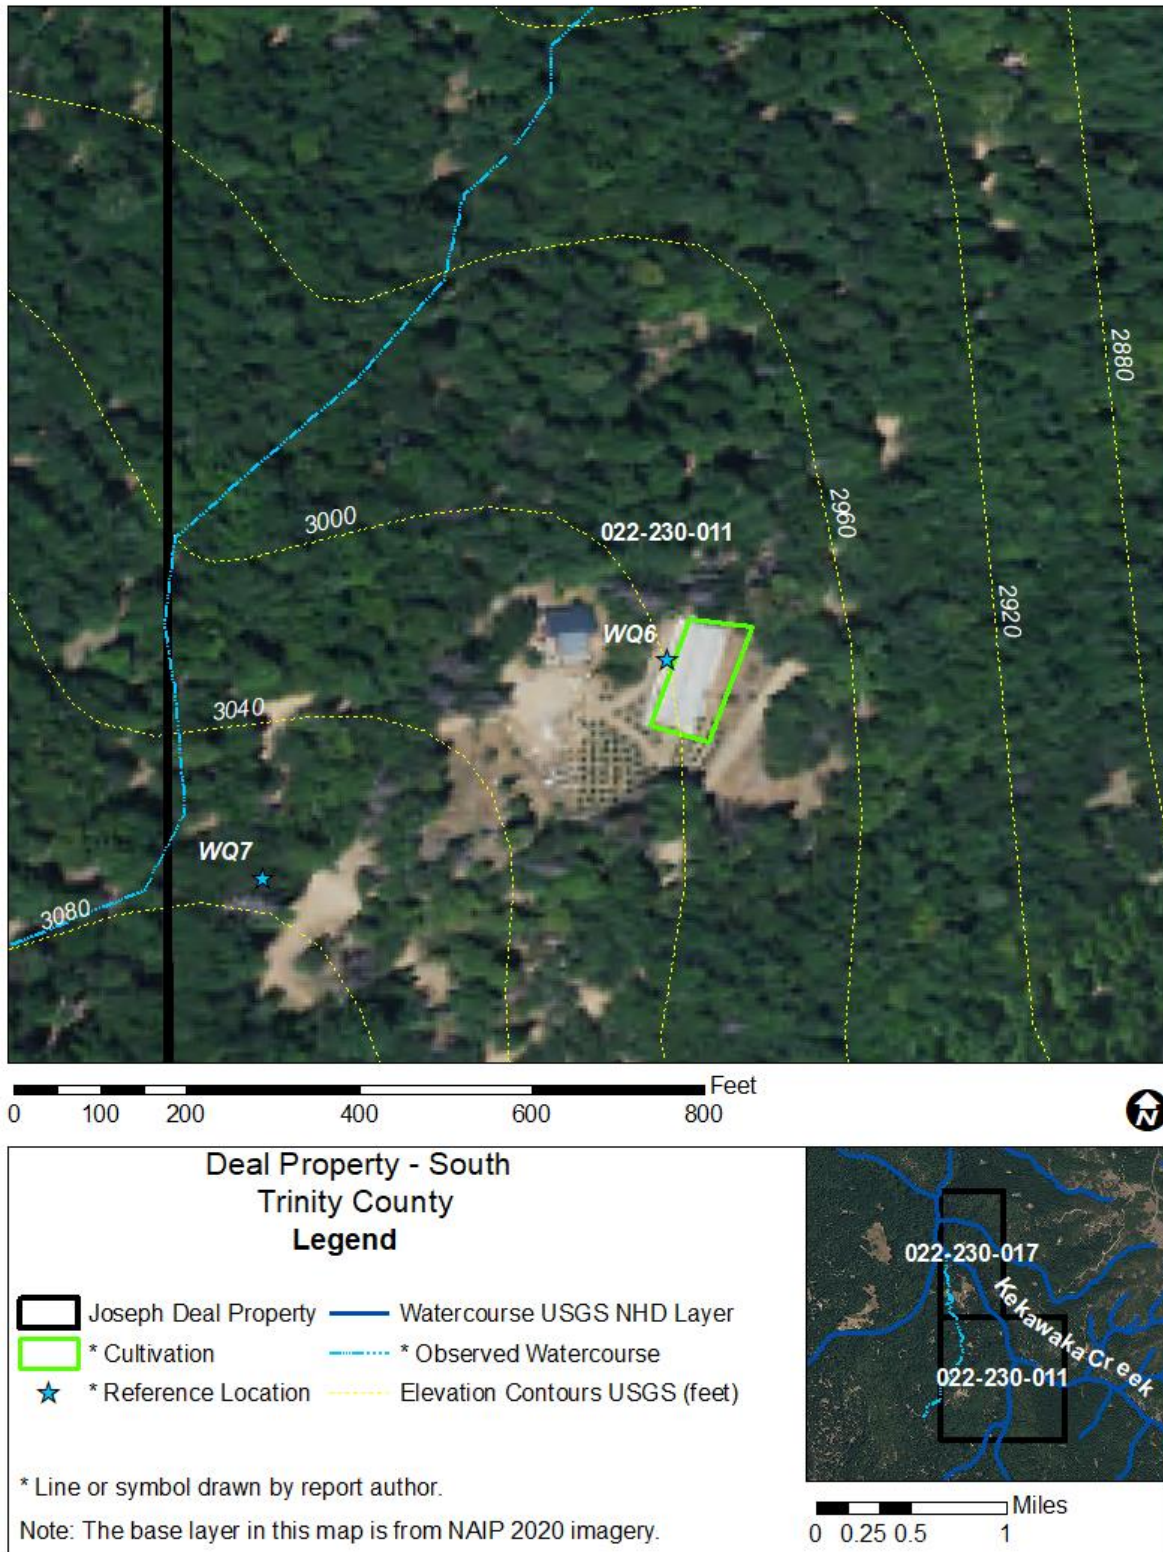
Figure 2: Aerial image/map showing inspection points discussed in this report.

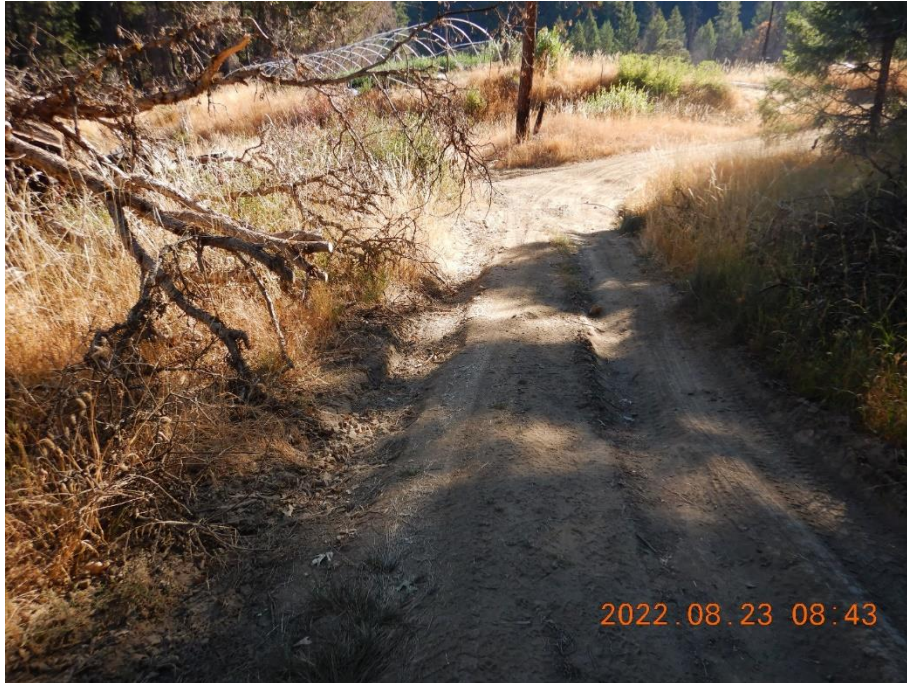
Photo 1— Looking north along a road at WQ1. Wheel ruts are visible on the road's surface. A hoop-type greenhouse is visible in the top of the image.

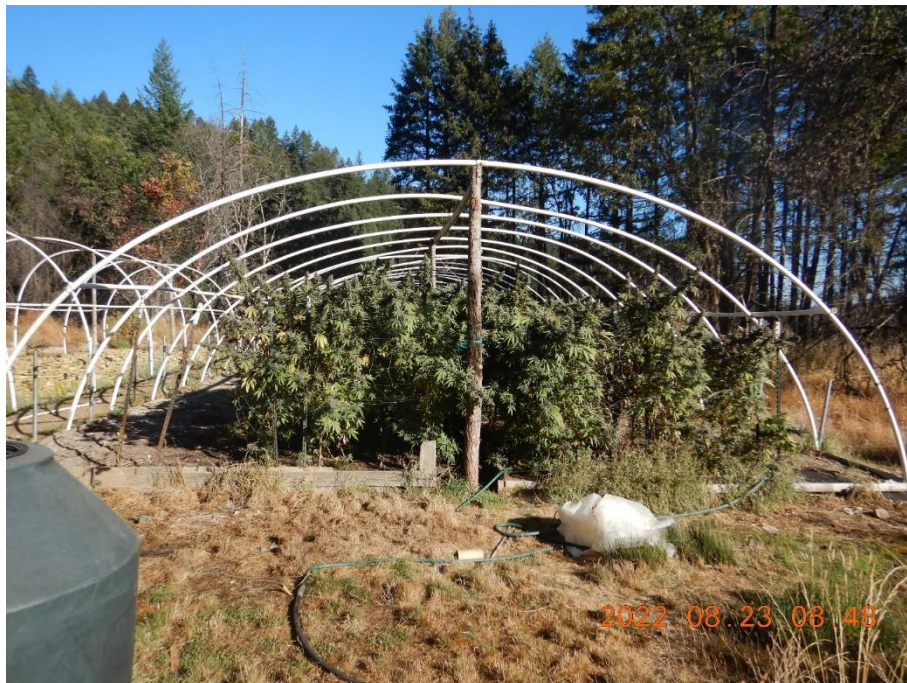
Photo 2—Cannabis plants being grown in a hoop-type greenhouse north of WQ1.

3. Dispose of all development and restoration-related earthen spoils in a manner to prevent/minimize transport and delivery to receiving waters.
4. Prior to cultivating cannabis or developing a property for cannabis cultivation, enroll for coverage under the Cannabis General Order.
5. Prior to conducting work in a water of the state of California, submit the below application and pay the required application fee for a Water Quality Certification/Waste Discharge Requirement:

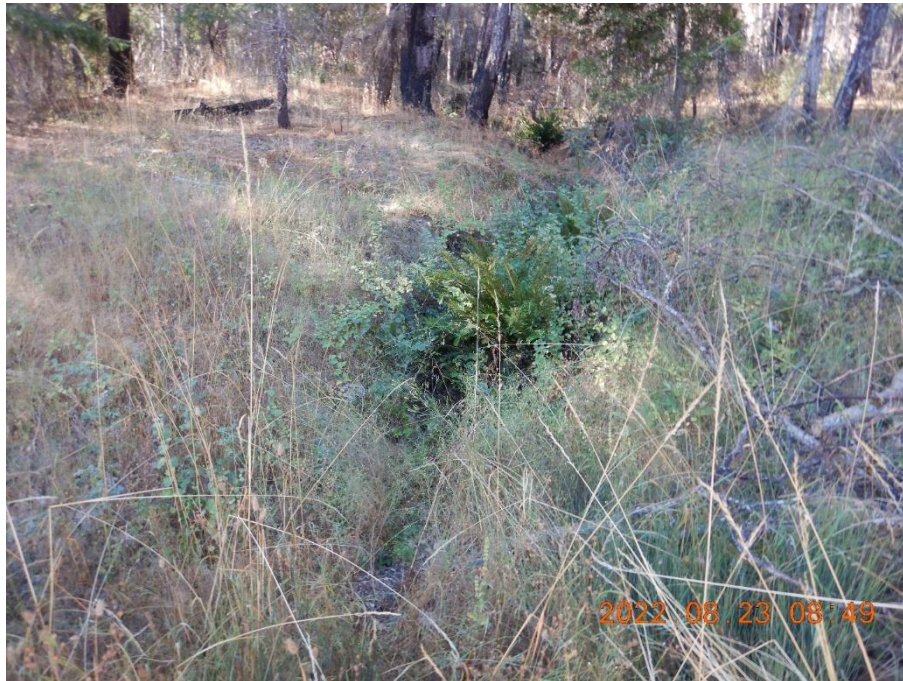
As documented in the report of the August 23, 2022 inspection, Staff observed: violations of the of the Basin Plan Section 4.2.1 Prohibition 2 at locations WQ2 and WQ3 for threatened discharge of sediment to tributaries to Kekawaka Creek; Staff observed large-scale cannabis cultivation and associated activities that were being conducted without first obtaining regulatory coverage for associated waste discharges, in violation of Water Code section 13260; Staff observed violations of the California Water Code section 13264 for unauthorized discharges of cannabis cultivation waste into wetlands that are a water of the state of California at location WQ5. The site conditions at WQ7 also violate the Cannabis Policy.

Photo 3—Looking south and upstream at a watercourse located at WQ2.

1. Immediately collect all petroleum products, other chemicals, refuse and cannabis cultivation wastes on the Property which have discharged and/or threaten to discharge to wetlands and receiving waters and properly dispose of these wastes at licensed waste collection facility.
2. Retain a licensed professional to delineate all watercourses and wetlands that are waters of the state of California on the Property, and to develop a workplan and schedule to implement measures to ensure that all developed features, roads and watercourse crossings throughout the Property are corrected, restored, and/or maintained in conditions that prevent or minimize erosion, sediment transport/delivery, and adverse impacts to water quality and beneficial uses.

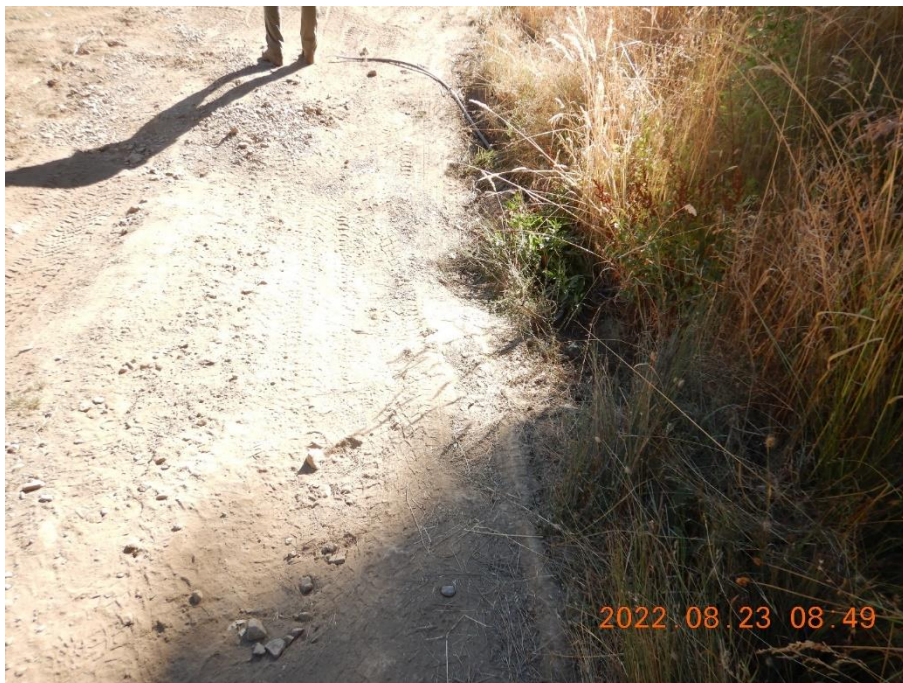
Photo 4—Looking east where a road fords the watercourse at WQ2.

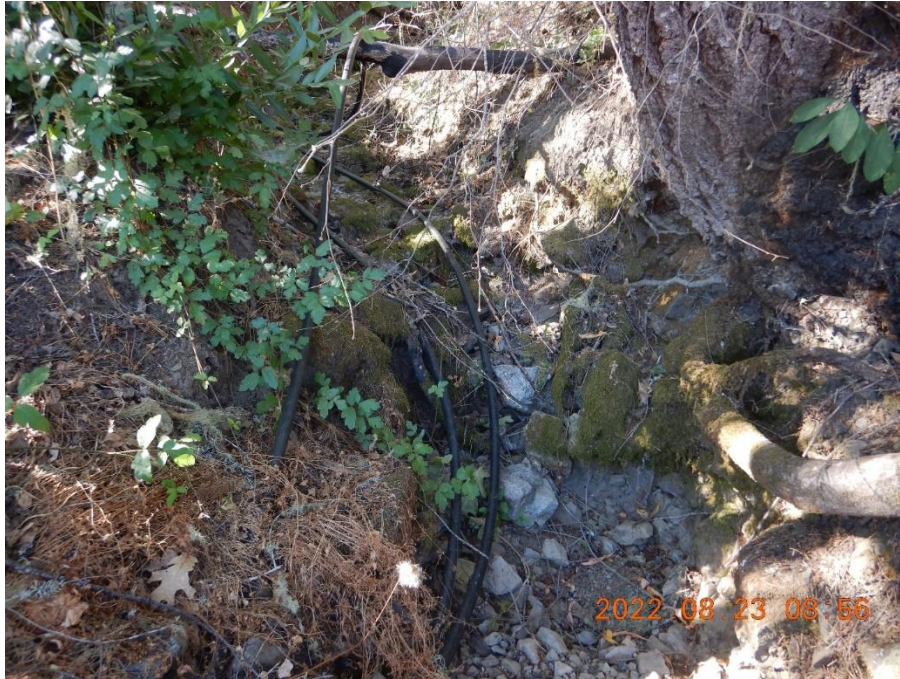
Photo 5— Looking south and upstream at the watercourse located at WQ3.

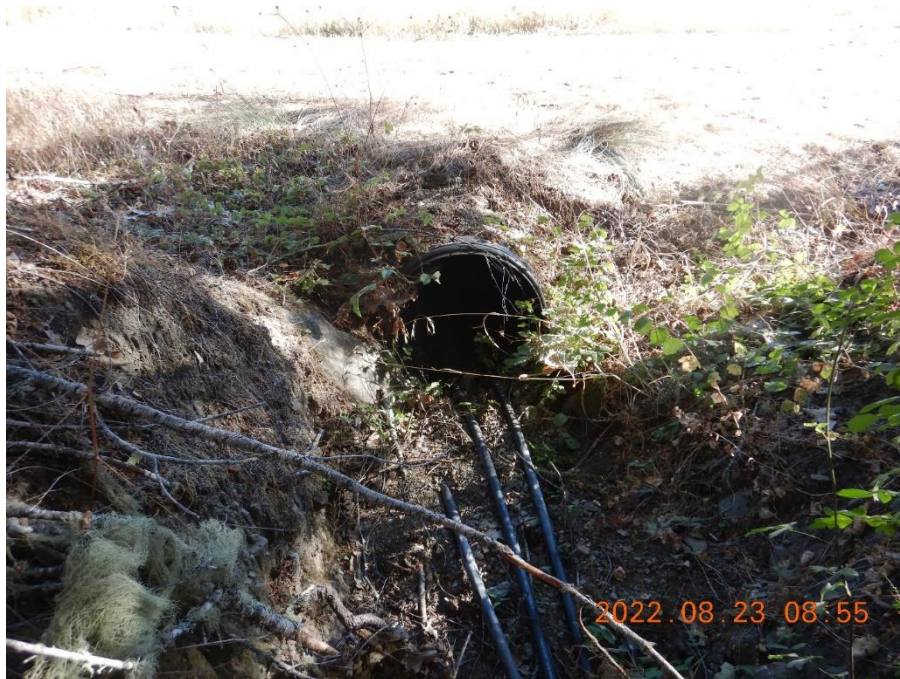
Photo 6— Looking north at the culvert inlet located at WQ3

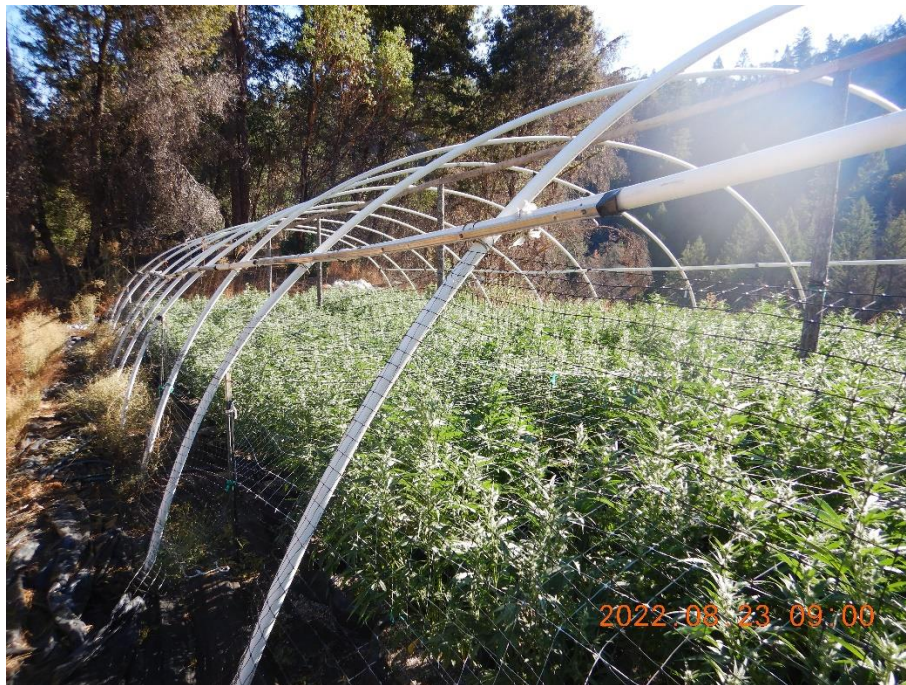
The inspection was associated with a criminal search warrant, and I viewed only portions of the Property. See the above Inspection Maps and below Photo Appendix for locations and details about features of concern to water quality. I entered the Property from the west and drove to the northern of the two parcels (Figure 1). I observed a segment of road with wheel ruts at WQ1 (Photo 1). I observed cannabis plants growing in hoop-type greenhouses covering an approximate 4,000 square foot area north of WQ1 (Photo 2). I observed a road fording a watercourse at WQ2 (Photo 3 and Photo 4). I observed a culverted stream crossing at WQ3, where the culvert diameter was less than half of the watercourse's upstream bank full width (Photo 5 and Photo 6). I observed cannabis plants growing in a hoop-type greenhouse covering an approximate 4,000 square foot area north of WQ3 (Photo 7).

Photo 7— Cannabis plants being grown in a hoop-type greenhouse north of WQ3.

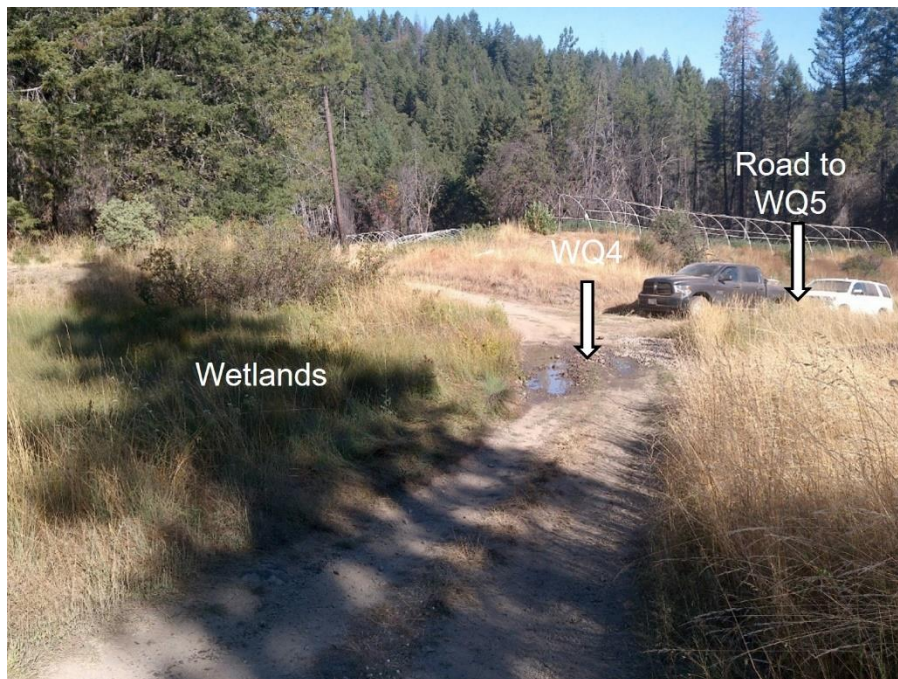
I observed pooled water on a dirt road at WQ4. The water appeared to be emanating from the saturated ground in the area immediately upslope and south of the road, and I observed the plant genus *Juncus* growing in this area (Photo 8). I observed a channelized feature on a road leading from WQ4 to WQ5 (Photo 9). I observed a pile of waste cannabis stalks at WQ5 (Photo 10 and Photo 11) and the plant genus *Juncus* growing in this area which is labeled as "Wetlands" in Photo 10. I observed cannabis plants growing in hoop-type greenhouses covering an approximate 4,000 square foot area east of WQ5 (Photo 12), and the plant genus *Juncus* growing in this area (Photo 13).

Photo 8—Looking north along a road that leads to the southern parcel. Staff observed the plant genus *Juncus* growing in the area pictured to the left of the road. Pooled water is visible on the road in the center of the image which is marked as WQ4 on Figure 1

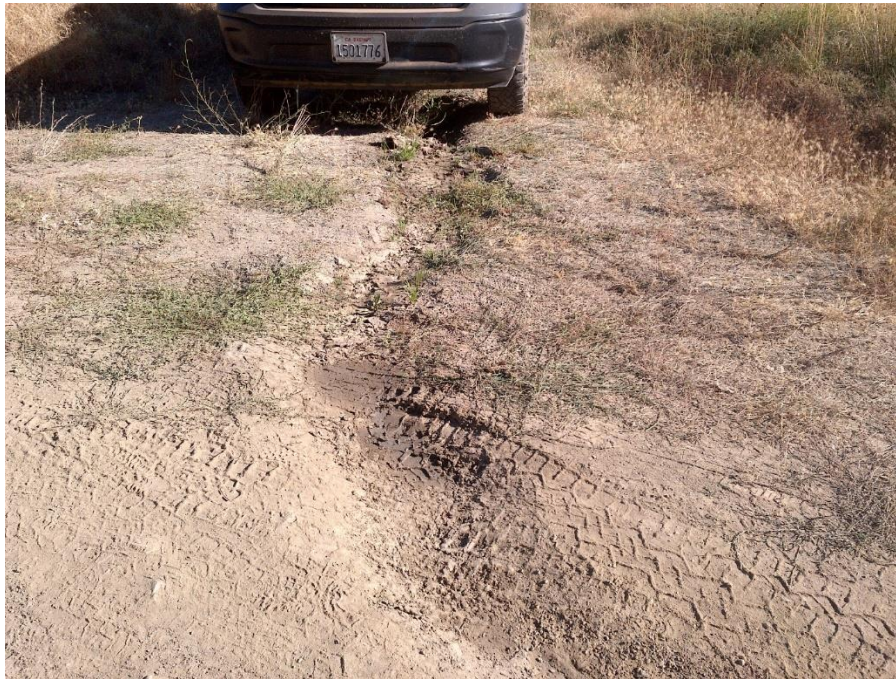
Photo 9—A channel eroded in the road surface by flowing water at WQ4.

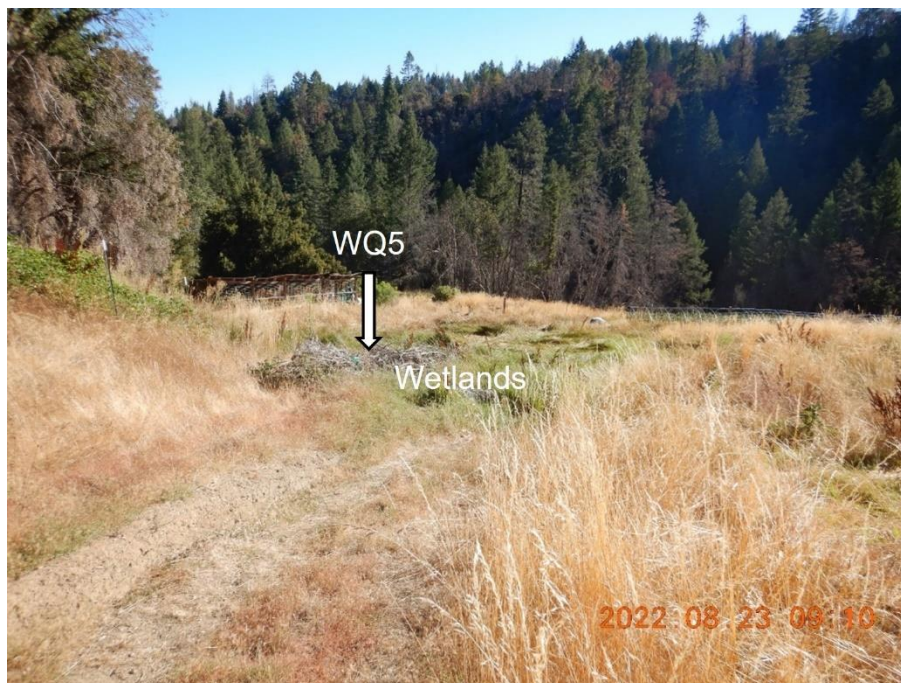
*Photo 10—Looking north toward a pile of waste cannabis stalks, identified as WQ5 in Figure 1, and visible in the middle of the image. Also visible is a patch of greener vegetation in the middle of the image where staff observed the plant genus *Juncus*..*

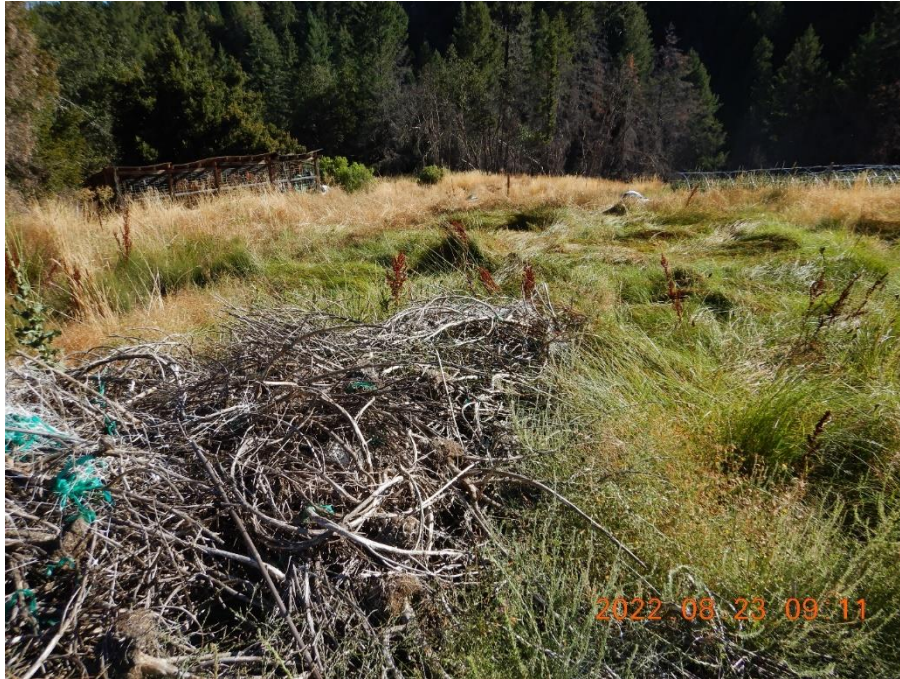
*Photo 11—A closer view of the waste cannabis stalks at WQ5. The vegetation in this area includes plants from the genus *Juncus*.*

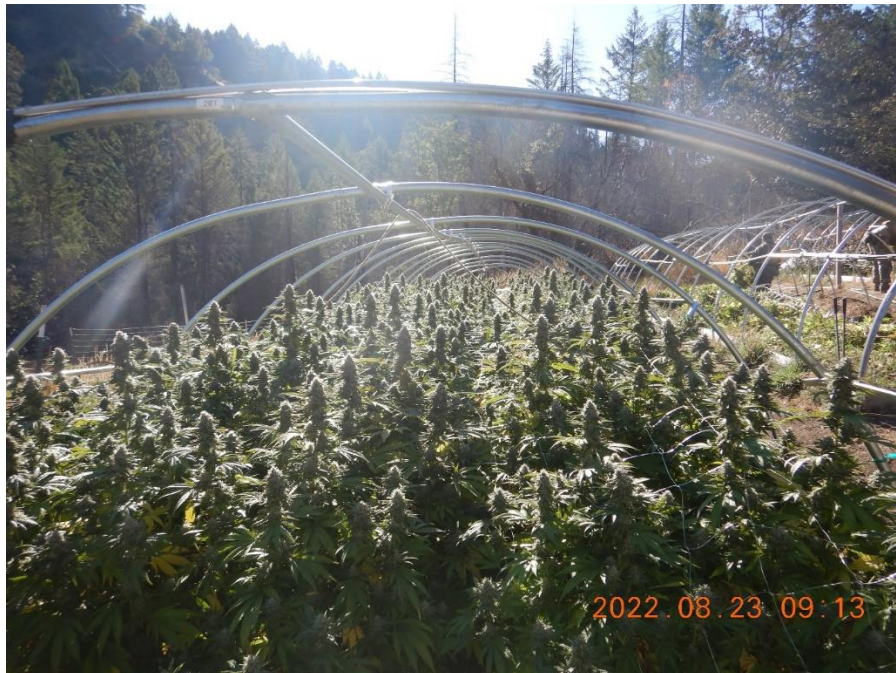
Land Vision records show that Joseph Deal purchased the Property on August 20, 2009. According to review by Staff on September 20, 2022, of aerial imagery available from Google Earth, the greenhouses identified in the inspection report east of WQ5 were constructed between May 24, 2009 and April 24, 2010. Order No. R1-2015-0023 (the Regional Cannabis Order) was in effect from August 2015 through adoption of the Cannabis General Order, and required cannabis cultivators within the North Coast Region to enroll and implement water quality protection measures. The Property was never enrolled under the Regional Cannabis Order.

Photo 12— Cannabis plants being grown in a hoop-type greenhouse east of WQ5.

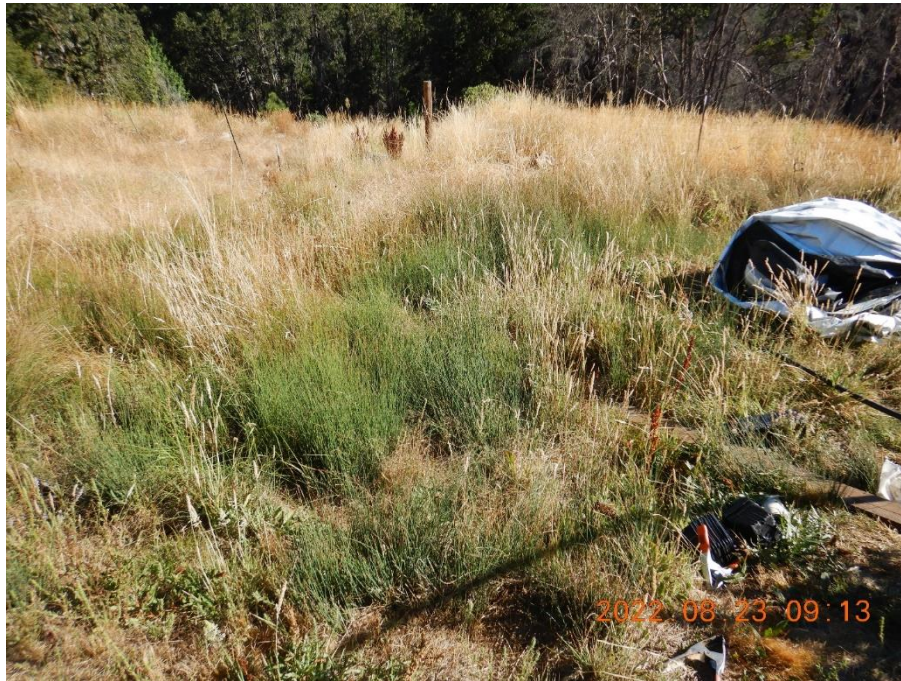
Photo 13—Area north of greenhouse pictured in previous image. The shadow of the the greenhouse hoops is visible in the bottom right of the image.Plants from the genus Juncus are visible in the middle of the image.

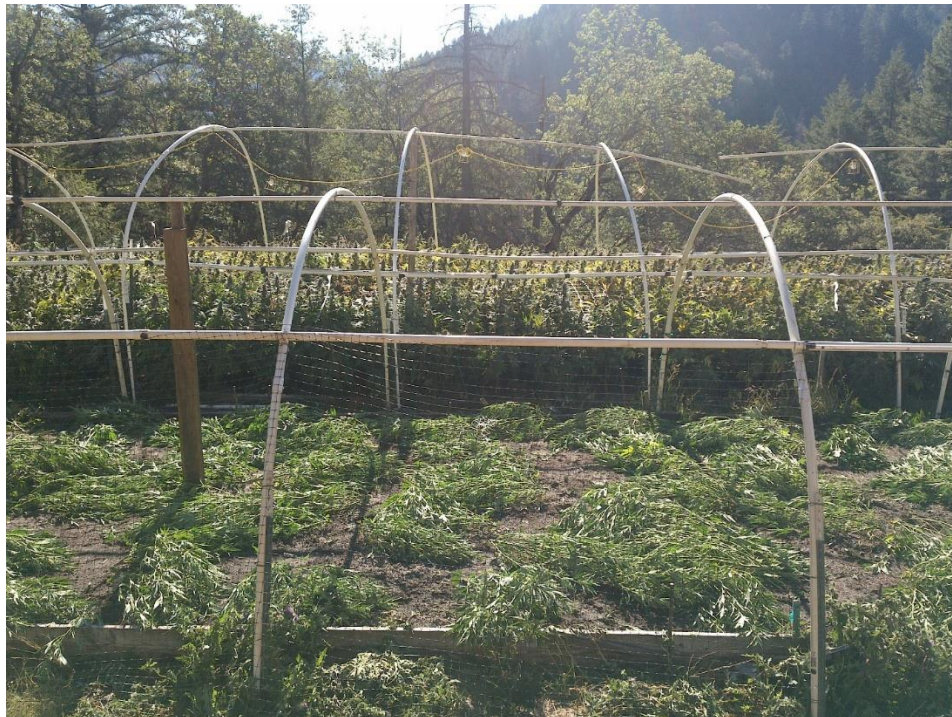
I then drove south along the road passing WQ4, to the area on the southern parcel shown in Figure 2. I observed cannabis plants growing in hoop-type greenhouses covering an approximate 5,000 square foot area at WQ6 (Photo 14). I observed fuels stored in metal 55-gallon drums and smaller plastic containers. I observed these fuel containers within and adjacent to an intermittent watercourse at WQ7 (Photo 15 and Photo 16). I followed the flow path of the intermittent watercourse to a receiving watercourse approximately 100 feet to the northwest.

Photo 14— Cannabis plants being grown in a hoop-type greenhouse east of WQ6 (see Figure 2).

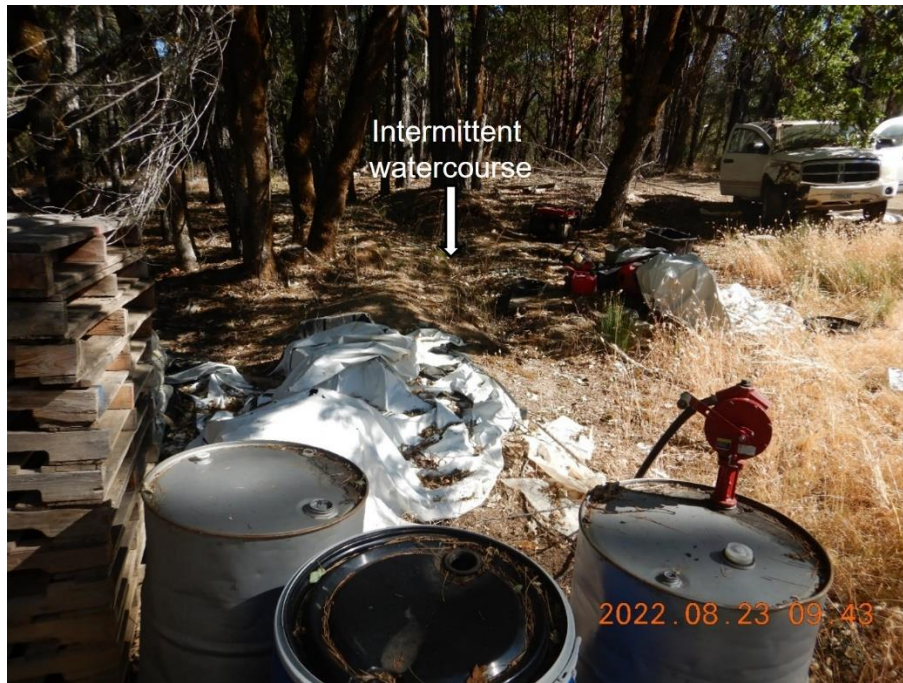
Photo 15—Fuels stored in 55-gallon drums, located adjacent to an intermittent watercourse at WQ7 that is tributary to a receiving watercourse out of view to in the back left of the image, approximately 100 feet to the northwest.

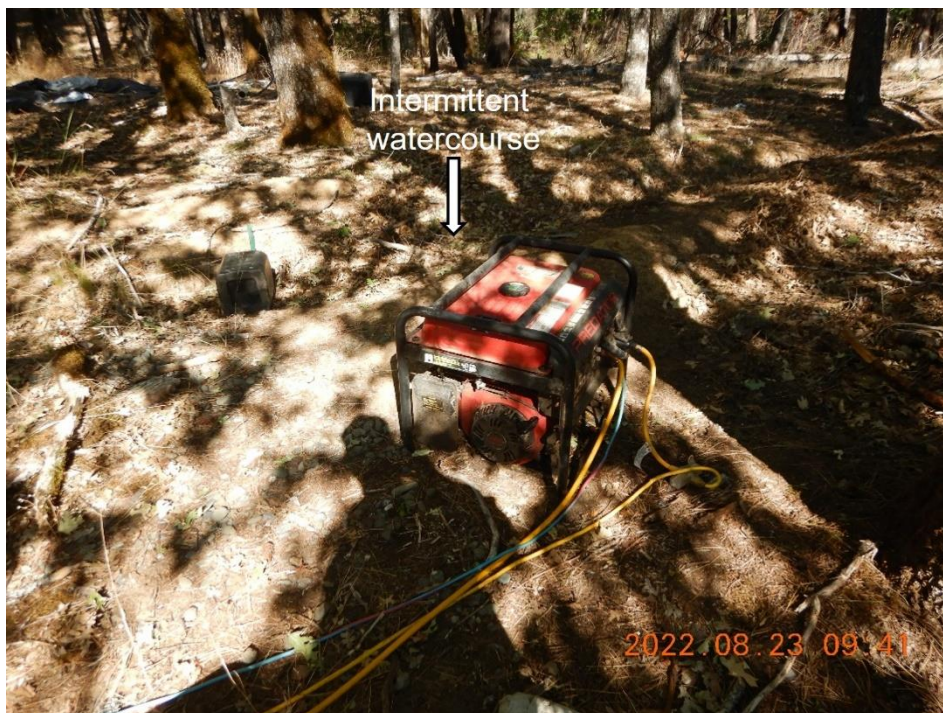
Photo 16—Generator and black plastic container located adjacent to intermittent watercourse in the vicinity of WQ7.
