**Subject: Notice of Violation, Transmittal of Report for April 20, 2022 Inspection of Mendocino County Assessor's Parcel APN 046-310-24-00**

**Inspection Report for April 20, 2022 Warrant Inspection,  
Mendocino County  
Assessor's Parcel Number (APN) 046-310-24-00 (the "Property")**

File: Cannabis Program Inspections, Mendocino County, 2022, Felix,  
CIWQS Place ID 881088

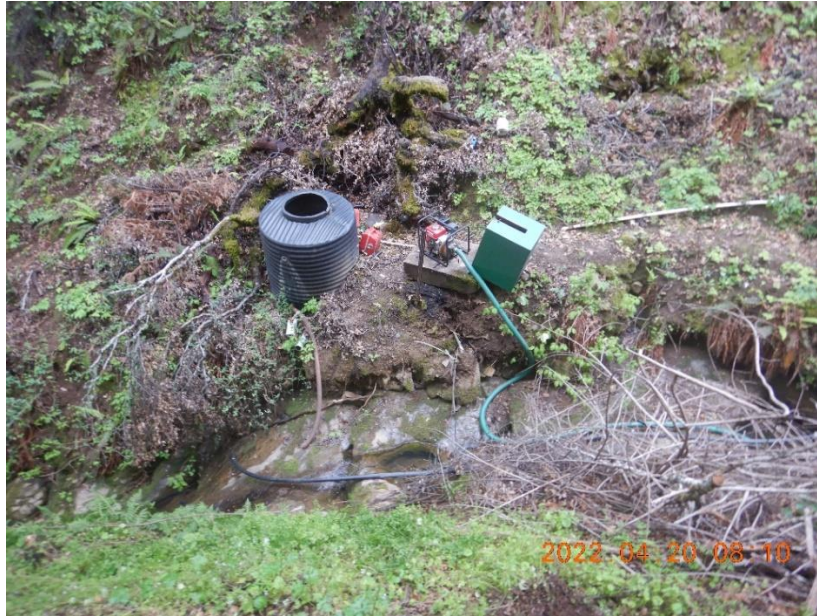
I entered the Property from the east and walked south where I observed water diversion infrastructure on a watercourse at WQ2 (Photo 1 and Photo 2). Behind the active pump, I observed fuel and motor oil containers, and an out of service pump (Photo 3 and Photo 4), that threatened to discharge waste petroleum products to the watercourse at WQ1. I walked northwest along the channel and observed a waste metal drum and tire (Photo 4 and Photo 5) in a tributary to the larger watercourse. I continued walking to WQ3 where I observed a pile of cannabis cultivation waste (Photo 6) that threatened to discharge to the watercourse located less than less than ten feet to the south.

*Photo 1— Looking south toward WQ1. A water tank and gasoline powered pump are installed on the right bank of a watercourse with flowing water. Pipes extending from the pump inlet extend into the watercourse.*

3. Dispose of all development and restoration-related earthen spoils in a manner to prevent/minimize transport and delivery to receiving waters.
4. Comply with requirements/directives from CDFW and the Division of Water Rights with respect to appropriate permitting/licensing for the water diversion and infrastructure and ensure that water diversion features are modified/maintained so

as to minimize the potential for adverse impacts to water quality and beneficial uses.

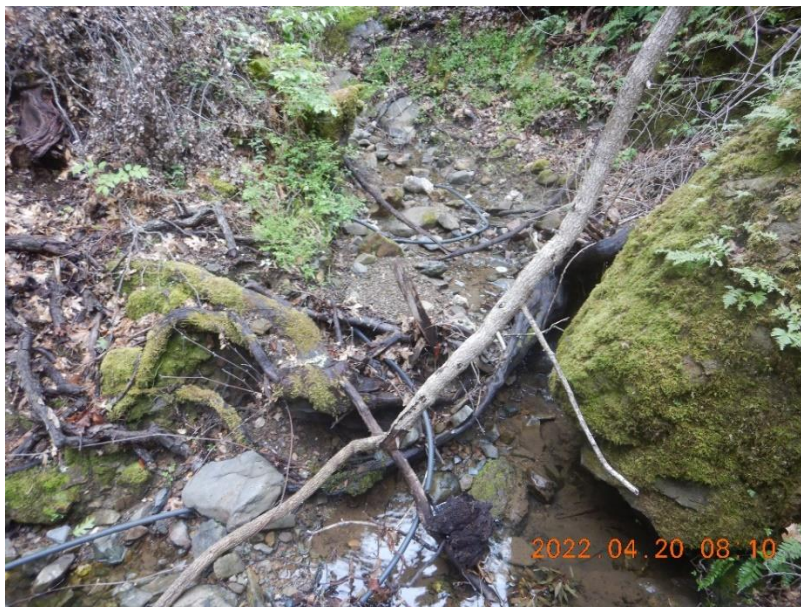
*Photo 2— Looking at watercourse in the vicinity of WQ1. Plastic pipes are visible within the channel banks.*

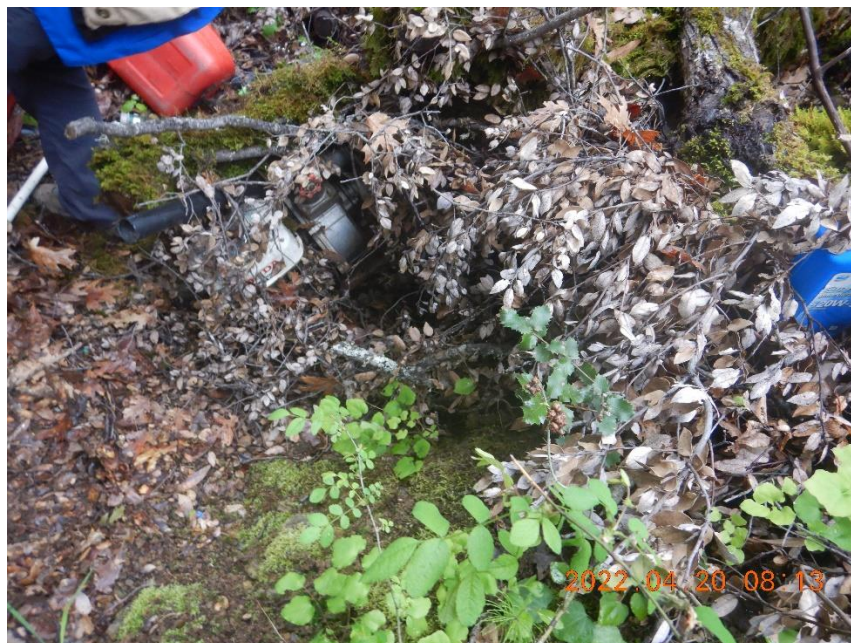
*Photo 3— Gasoline powered pump, fuel can and motor oil container on right bank of watercourse at WQ1*

1. Immediately collect all refuse and cannabis cultivation wastes which have discharged and/or threaten to discharge to receiving waters and which can be collected by hand. You are not authorized to use heavy equipment in a water of the state or modify the bed bank or channel of a water of the state without a permit from the Regional Water Board (see recommendation 6 below). Properly dispose of these wastes at a licensed waste collection facility.

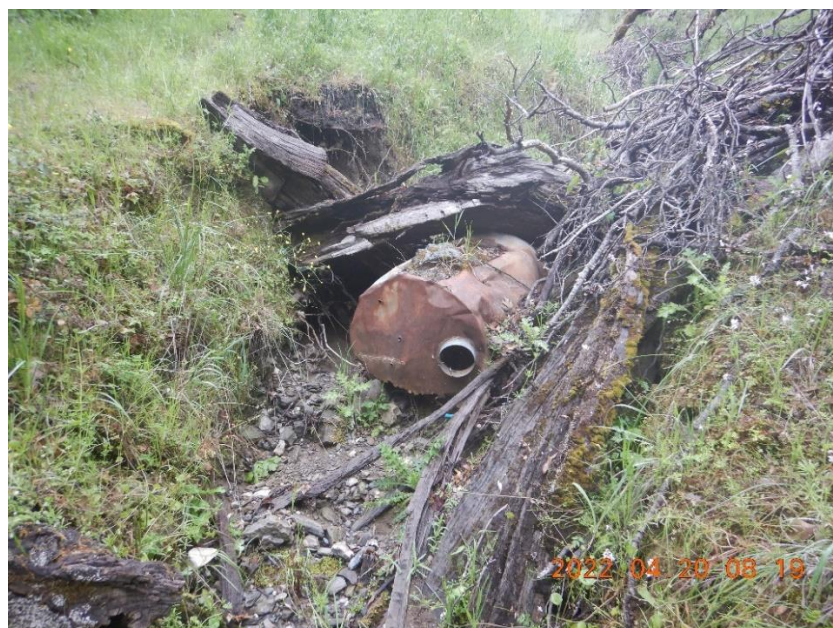
*Photo 4— Looking north at a waste metal drum in tributary at WQ2.*

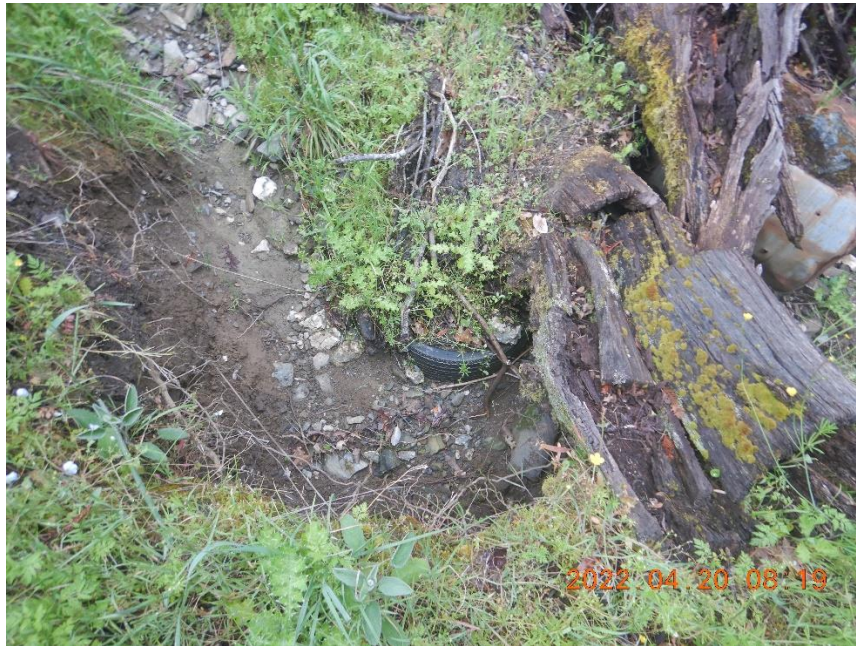
*Photo 5— A waste tire partially buried in sediment in the tributary located at WQ2.*

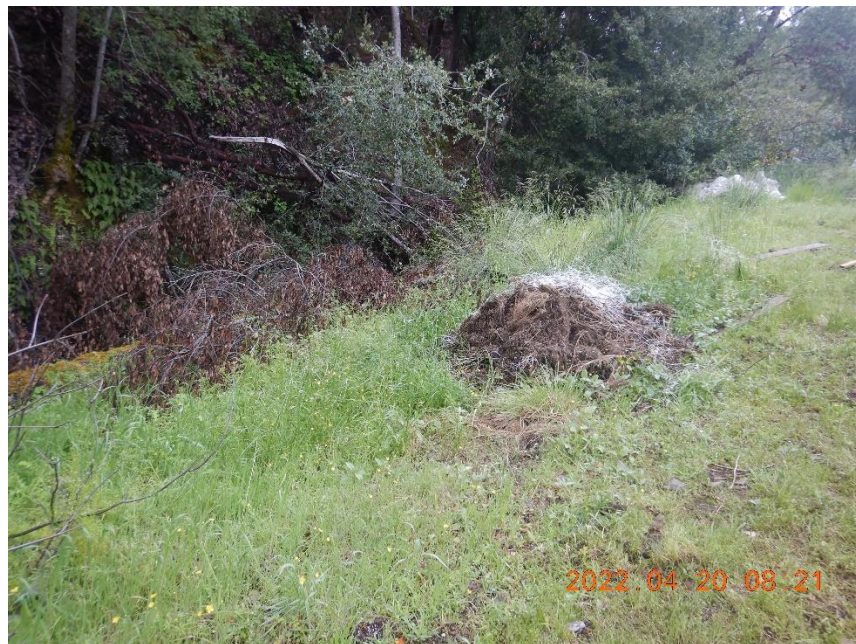
*Photo 6— Looking west at WQ3. A pile of cultivation waste approximately six feet square containing cannabis stalks, root balls, and plastic netting is located 10 feet from the watercourse which is visible in the back of the image.*

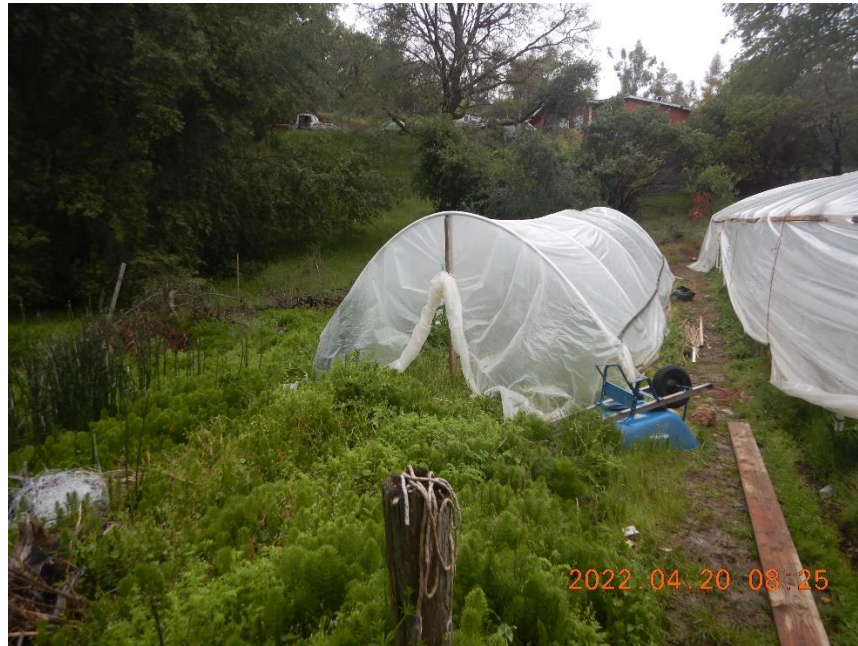
I continued walking northwest and observed an area at WQ4 with equisetum and other vegetation distinct from elsewhere on the Property (Photo 7 and Photo 8). This vegetation is indicative of wetland conditions. I walked north to a footpath fording a watercourse at WQ5 where I observed cannabis cultivation in the watercourse (Photo 9 through Photo 11). I walked upstream to WQ6 and I observed a culvert that had rusted through the bottom (Photo 12 through Photo 14).

*Photo 7— Looking west in the vicinity of WQ4. Greenhouses and plastic netting are visible surrounded by plants from the genera Equisetum.*

2. Retain a qualified professional to inventory and assess all aquatic resources including watercourses and wetlands that are waters of the State of California on the Property, and to develop a workplan and schedule to implement measures to ensure that all developed features, roads and watercourse crossings throughout the Property are corrected, restored, and/or maintained in conditions that prevent or minimize erosion, sediment transport/delivery, and adverse impacts to water quality and beneficial uses.

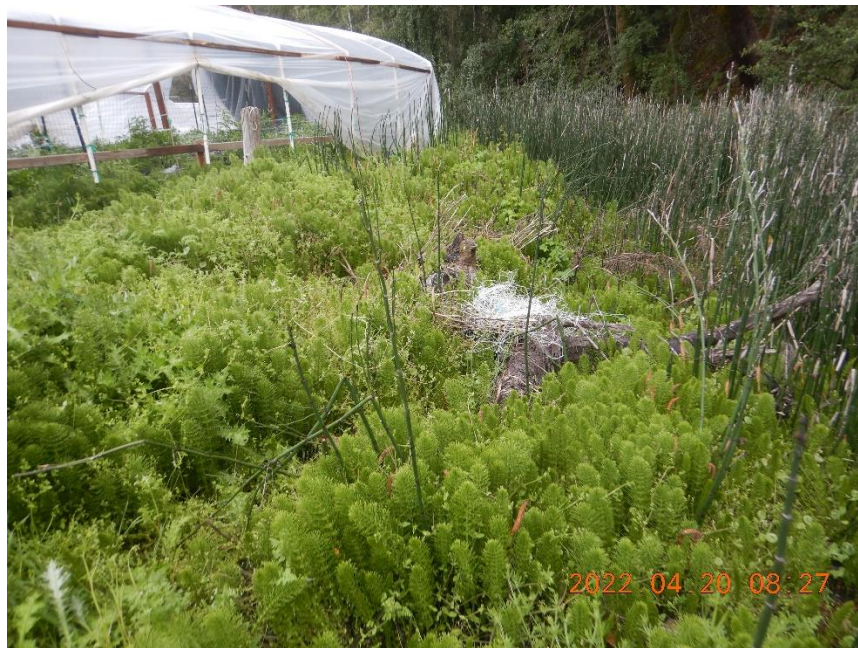
*Photo 8— Looking east in the vicinity of WQ4. A greenhouse and plastic netting are visible surrounded by plants from the genera Equisetum.*

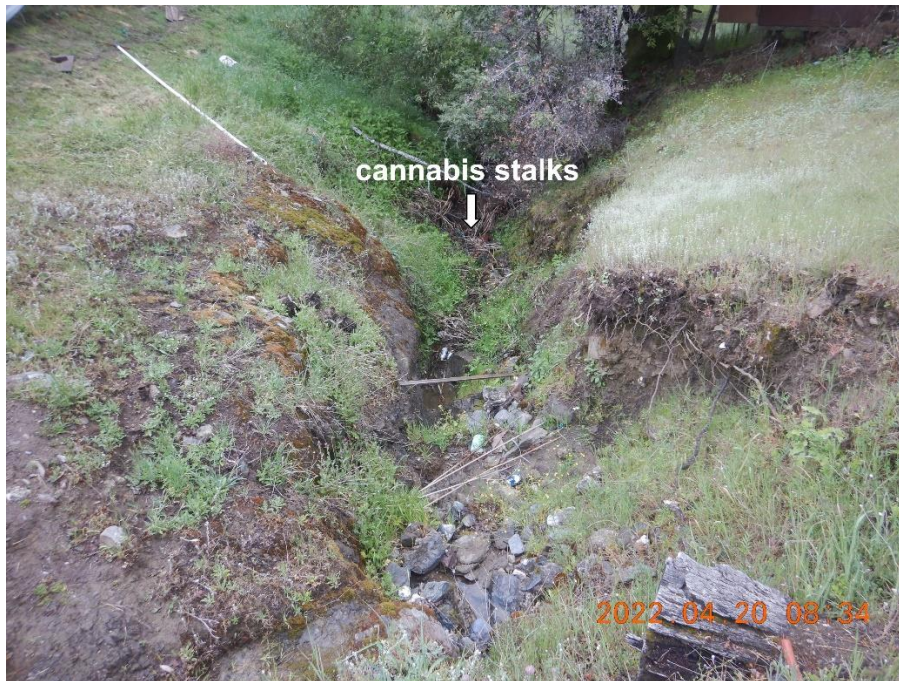
*Photo 9— Looking southeast and downstream from a footpath fording a watercourse at WQ5. Waste cannabis stalks are visible filling the channel in the middle back of the image.*

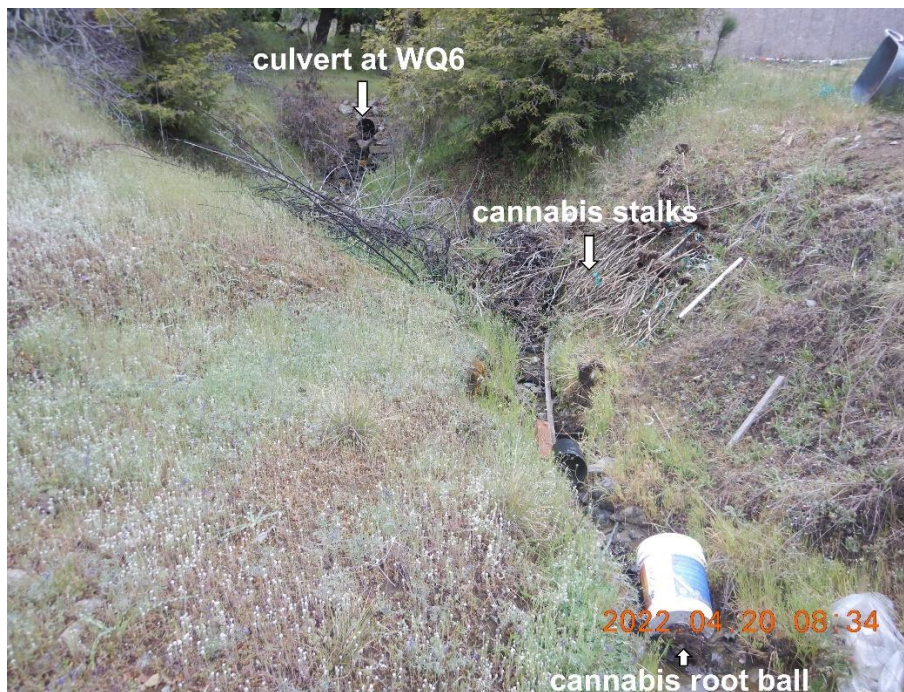
*Photo 10— Looking southeast and downstream from a footpath fording a watercourse at WQ5. Plastic waste, cannabis stalks and cannabis root balls are visible within the watercourse banks.*

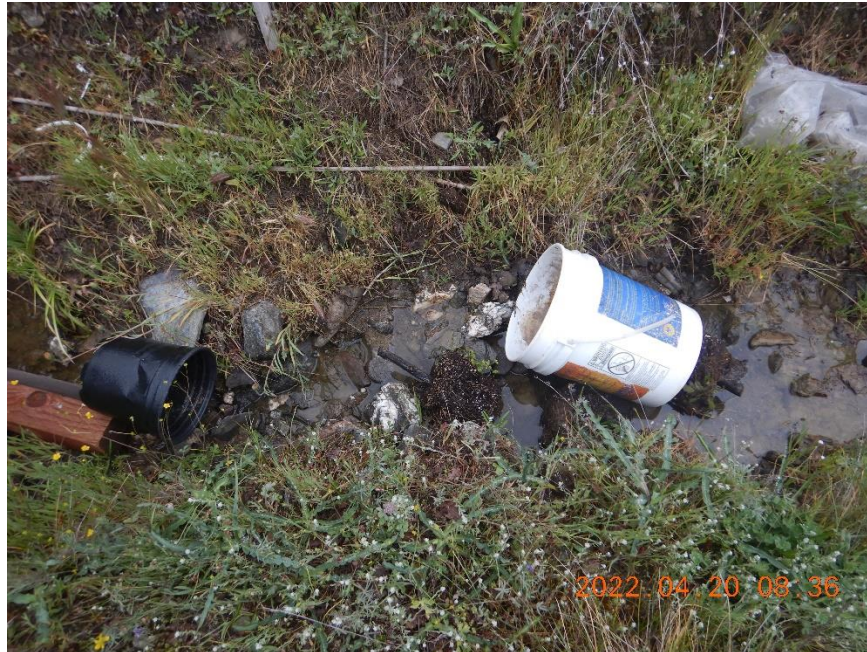
*Photo 11— Close-up view of cannabis root balls identified in the previous image. The watercourse has water in it and white speckles in the root balls identify the presence of perlite which is contained in imported potting soils.*

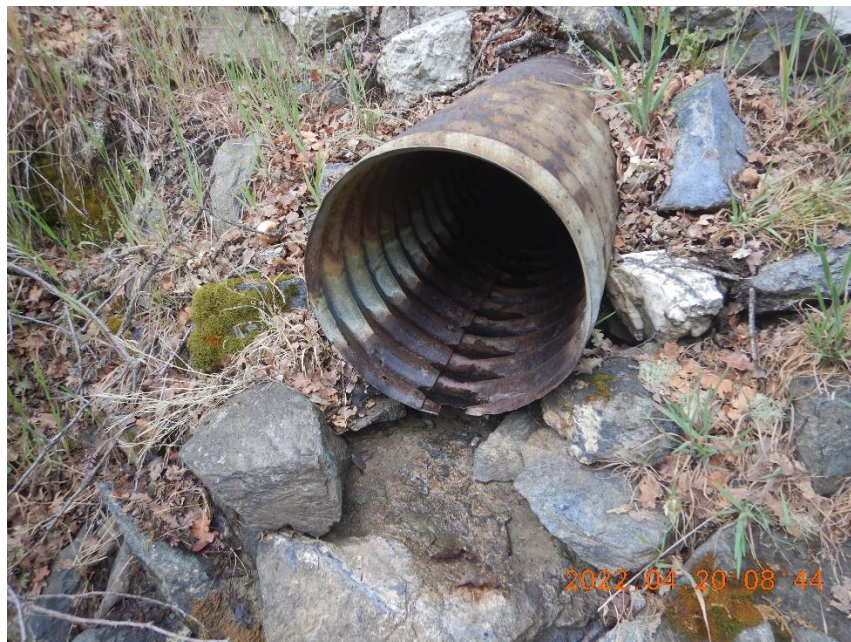
*Photo 12— The outlet of the culvert located at WQ6. The pipe is 15 inches in diameter, and 20 feet long. Holes have rusted through the bottom of the metal pipe allowing water to flow below the pipe.*

5. Prior to cultivating cannabis or developing a property for cannabis cultivation, enroll for coverage under the Cannabis General Order.
6. Prior to conducting work in a water of the state, submit the below application and pay the required application fee for a Water Quality Certification/Waste Discharge Requirement:

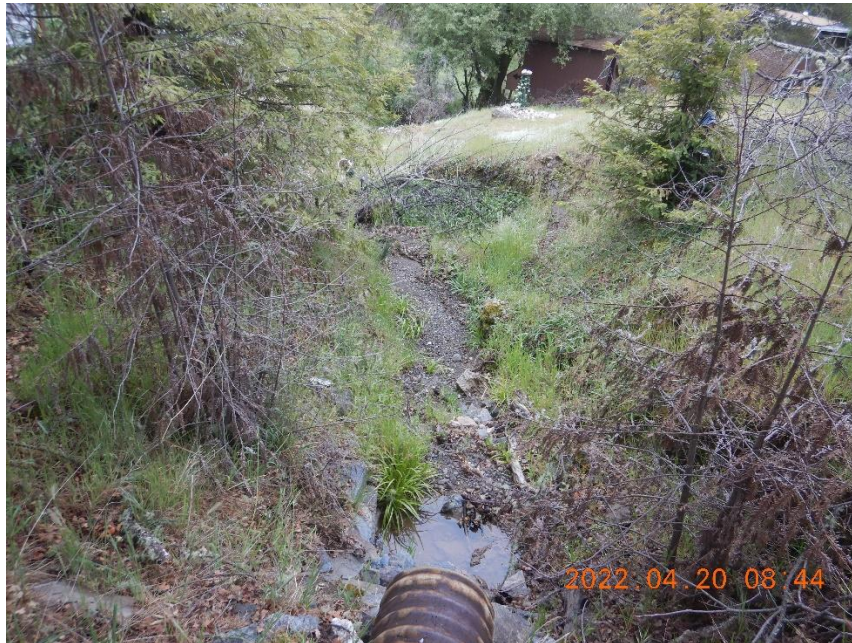
*Photo 13— Looking southeast and downstream from the culvert at WQ6. The culvert is perched several feet above the channel bed.*

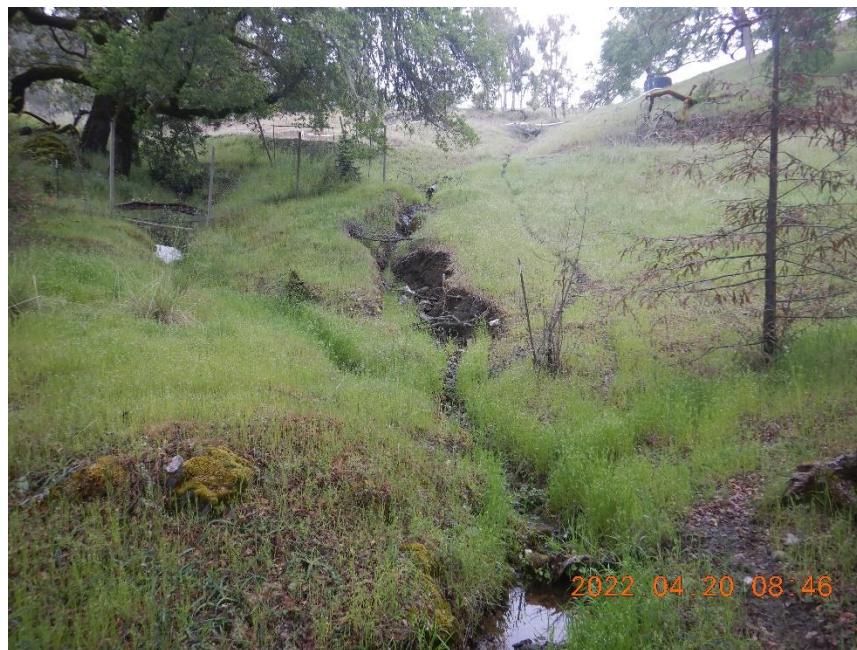
*Photo 14— Looking northwest and upstream from the culvert at WQ6. The watercourse width upstream averages between 2 and 3 feet wide.*
