North Coast Regional Water Quality Control Board

Subject: Notice of Violation, Transmittal of Inspection Report for January 16, 2022 Inspection of Trinity County Assessor's Parcel APN 022-080-025

FACILITIES INSPECTION REPORT

Alicia Garcia Property Inspection Map and Photographs CIWQS Inspection ID 47096964

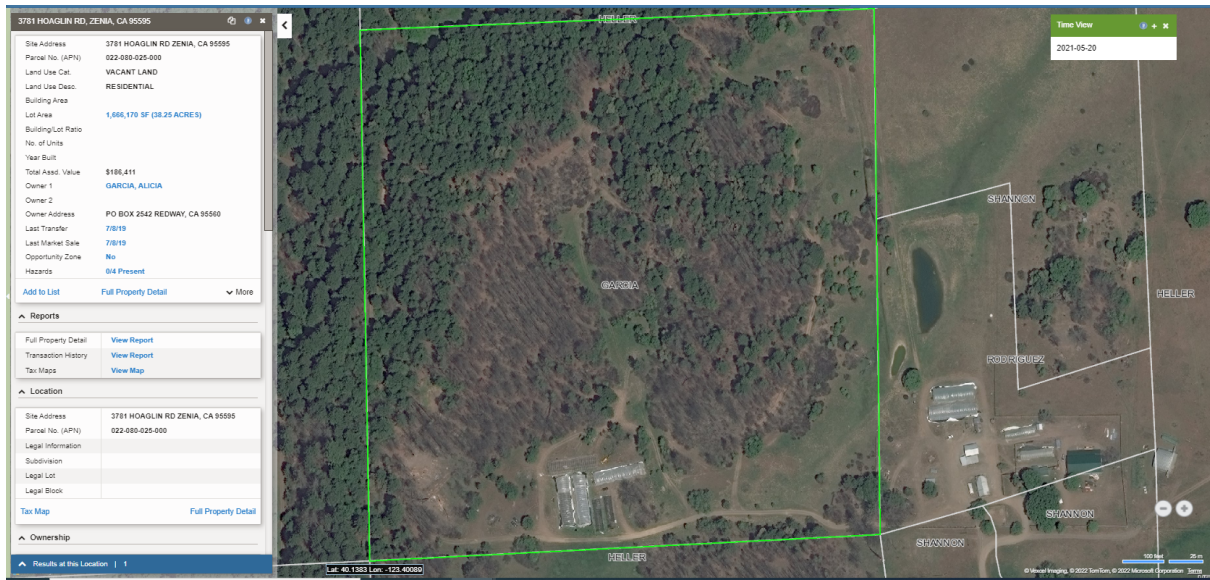
Figure 1. Ownership information of Trinity County APN 022-080-025 (the Property) and adjacent parcels. Imagery represents May 20, 2021. Note plastic on greenhouses on Property not visible in the next figure, thus suggesting they were used for cultivation in 2020.

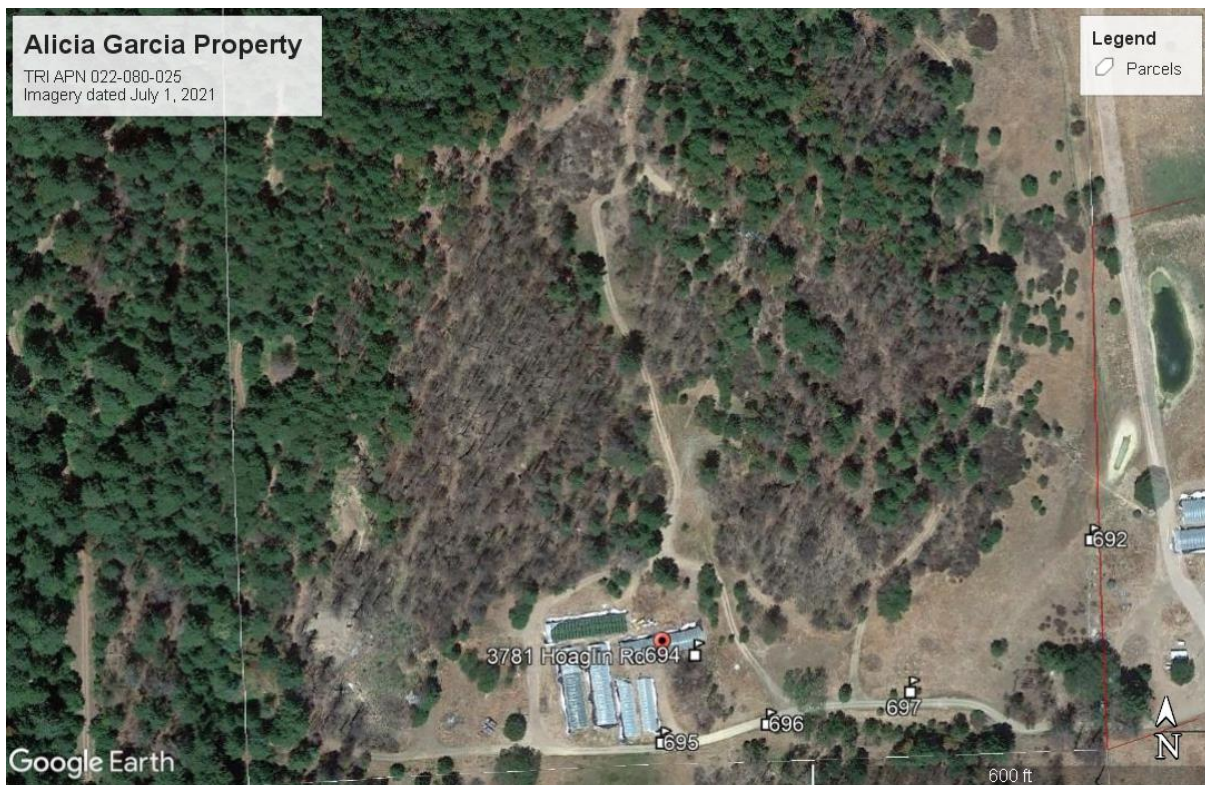
Locations discussed are shown on Figure 2.

Figure 2. Inspection map, showing locations of GPS Way Points discussed in this inspection report.

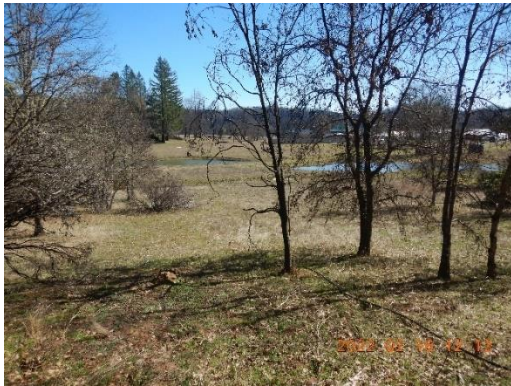
At WP 692, I observed a water line from the adjacent parcel (APN 022-080-034) to the Property, suggesting an affiliation.

Figure 3. View from eastern Property boundary at WP 692 looking east at pond and water line from adjacent parcel, APN 022-080-034, running to the Property.

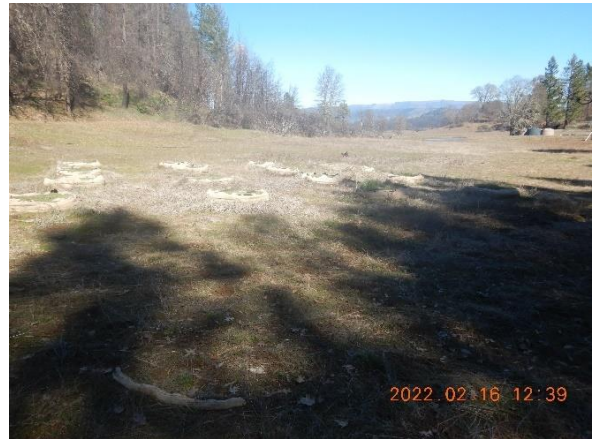
At WQ 697 I observed an area of older outdoor cultivation pots.

Figure 5. Older outdoor cultivation area on the Property, with pond on adjacent parcel in background.

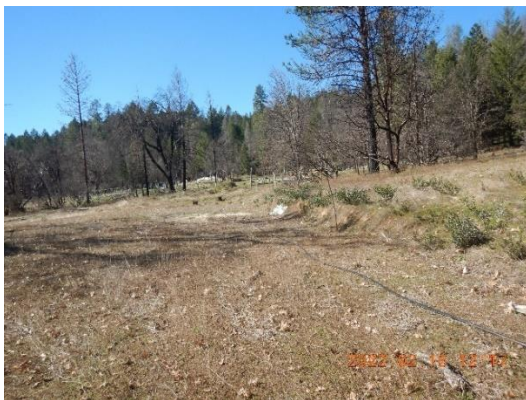
Figure 4. View from eastern Property boundary at WP 692 looking west at Property and waterline from APN 022-080-034 running to the Property, with view of greenhouse frame and cultivation beds in distance.

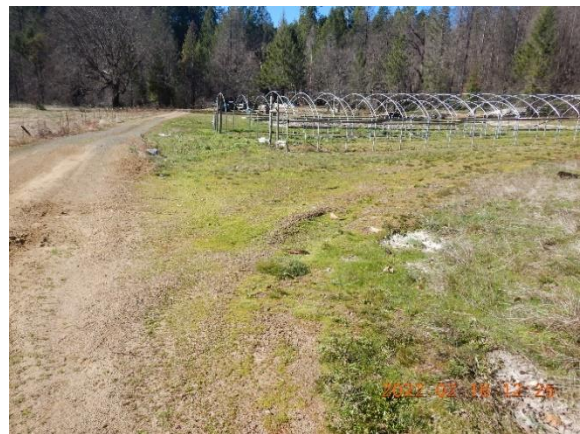
Figure 6. Greenhouse frames, with algae growth visible in foreground.

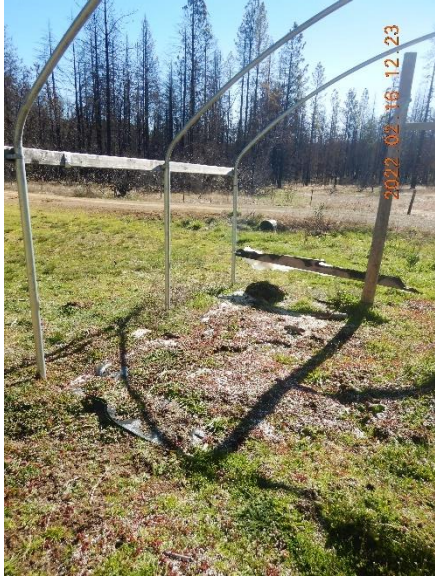
Figure 7. View from within greenhouse frame of access road running along southern Property boundary and inlet of Culvert 2. Vegetation, location, and hydrology suggest potential associated wetland areas.

1. Submit a wetland delineation of wetland features on the Property; describe any impacts to waters of the state from the construction and management of the pond or other cannabis-related infrastructure.
2. Work with CDFW and DIV to determine and secure any applicable permits or licensing required for surface water diversion, storage, and use.
3. Remove cannabis cultivation infrastructure or enroll in the Cannabis General Order and comply with the requirements therein.

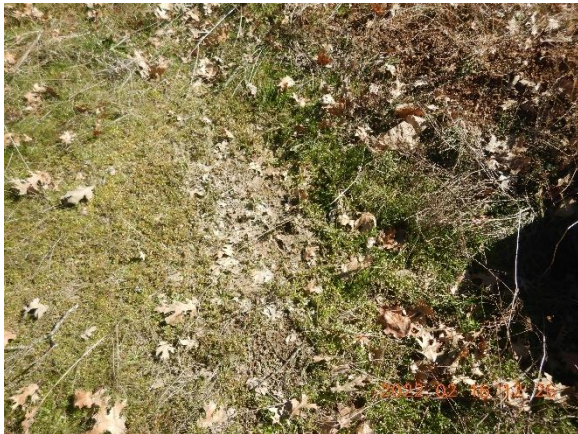
Culvert 2 was located at WP 696.

Figure 8. Culvert 2 inlet with signs of ponding.

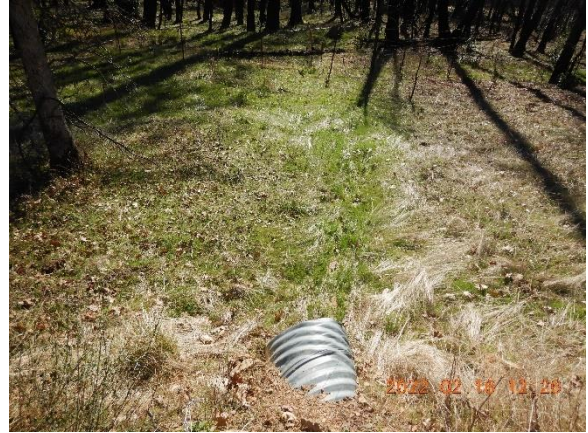
Figure 9. Culvert 1 outlet.

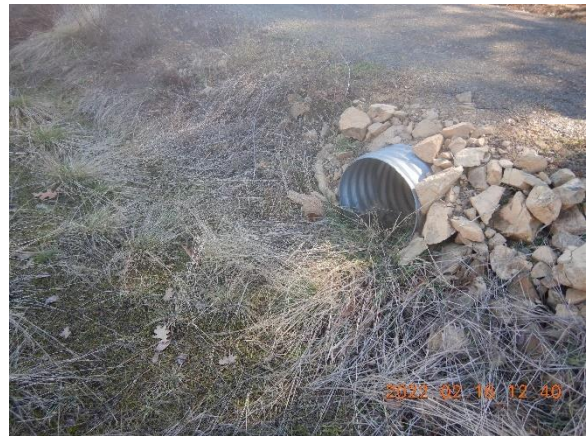
At Way Point (WP 695), I observed the inlet of Culvert 1, and within 15 feet of the inlet, a greenhouse was situated. The area around the inlet looked to have potential wetland characteristics.

Figure 10. Culvert 1 inlet.

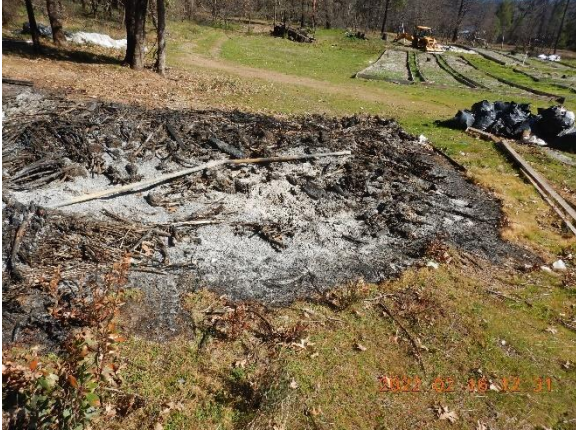
Figure 12. Recent burn pile.

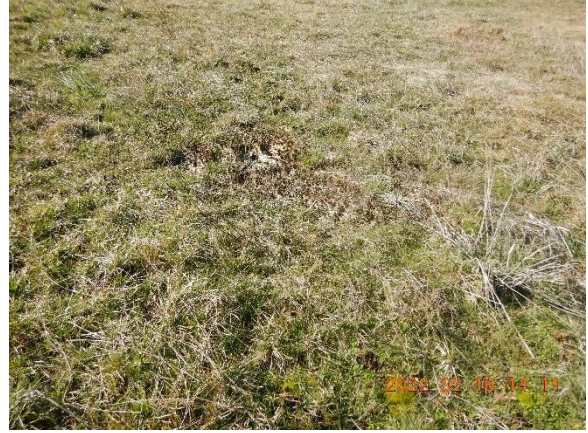
Figure 14. Location, vegetation, and hydrology suggest possible wetlands.
