North Coast Regional Water Quality Control Board

July 12, 2022

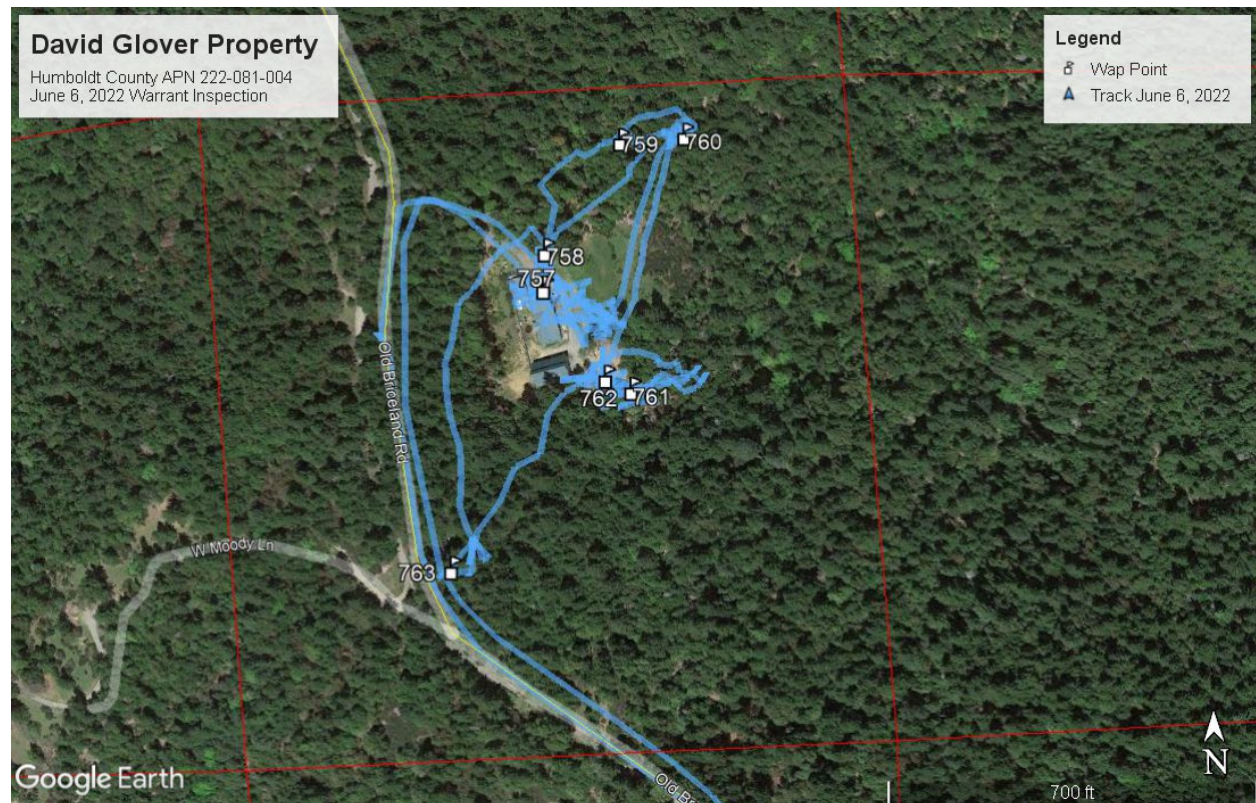
Figure 2. June 2, 2022 Inspection Map of Property conducted associated with criminal search warrant served by the Humboldt County Sheriff's Office. The following features were observed at the locations shown on the map: WP758 - Fuel tank, stain on ground at fuel filter, generator, and soil pile; WP759 - concrete cistern in channel of

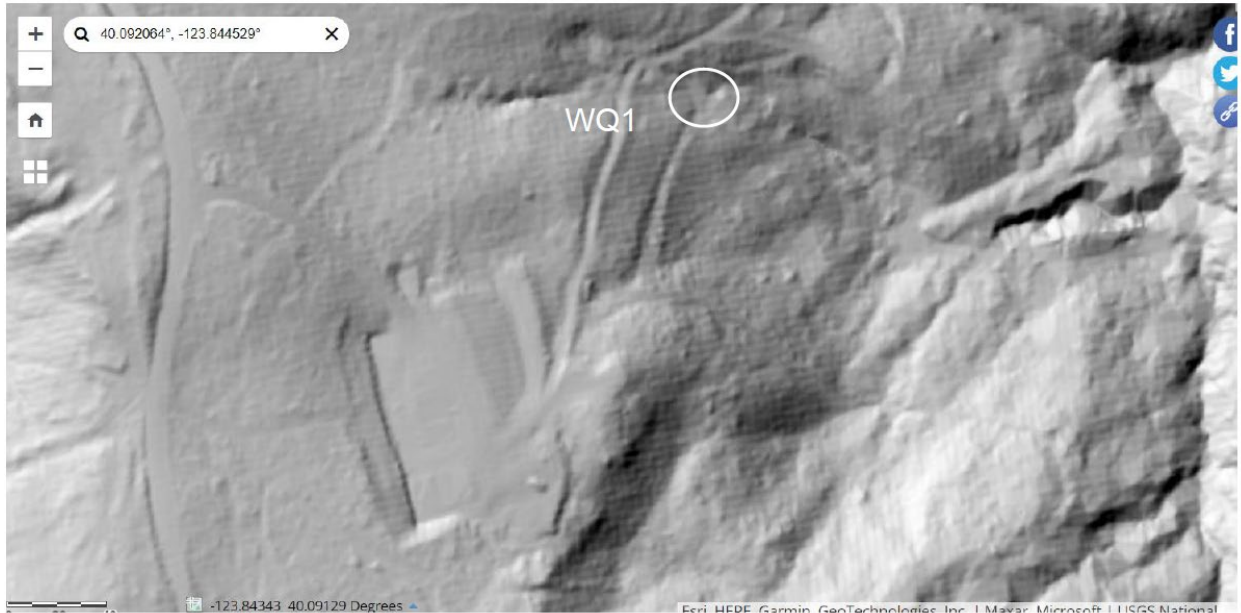
Figure 3. Terrain of Property, showing graded building landing and roads to onstream landing (shown as WQ1), associated with surface water diversion.

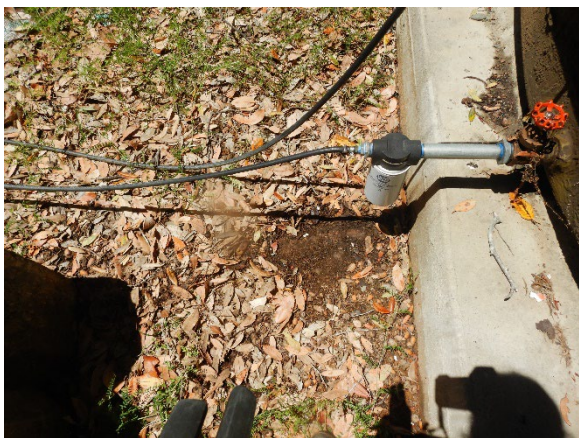
Figure 8. Fuel filter on fuel storage tank with stain on dirt at filter.

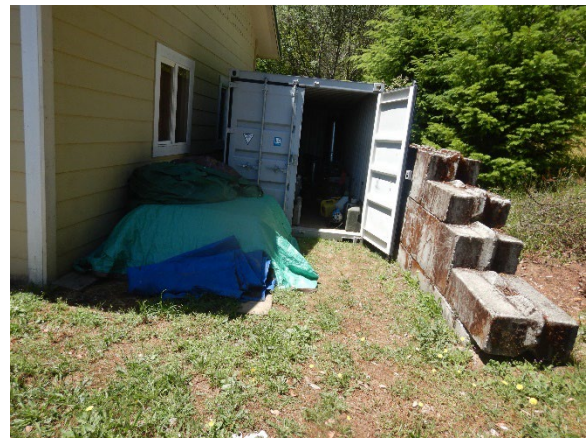
Figure 11. Shipping container, located next to garage, and used for storage.

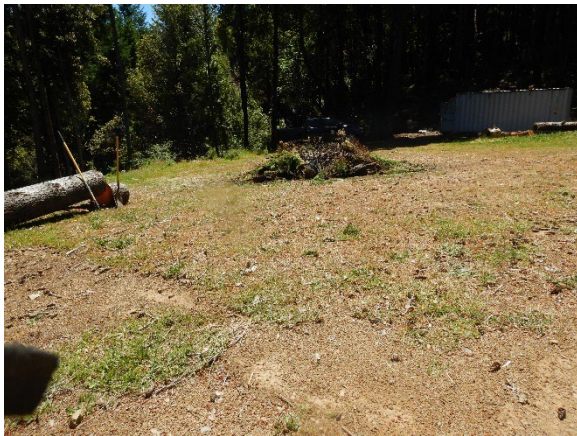
Figure 19. Active burn pile.

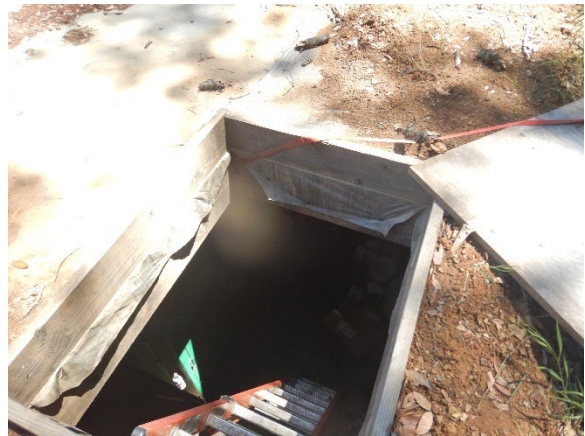
Figure 22. Buried shipping container is accessed from above via trap door.
