North Coast Regional Water Quality Control Board

Subject: Notice of Violation, Transmittal of Inspection Report for August 5, 2022, Inspection of Trinity County Assessor's Parcel No. 022-230-006-000

FACILITIES INSPECTION REPORT

Kettonpom Properties LLC Inspection Photo Log
Attachment C
Photos taken by Kate Hawken on August 5, 2022

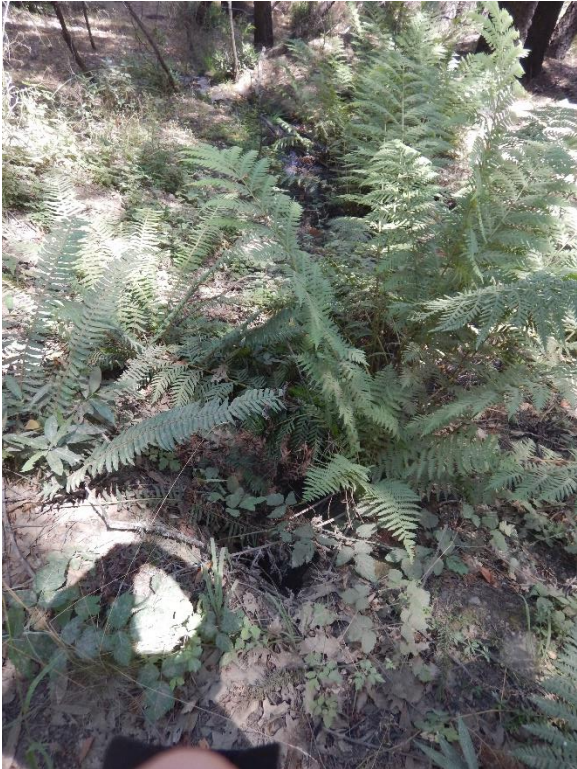
On the access road to the cultivation areas, I observed a watercourse crossing underneath a road through a buried culvert (Photo 1). At the first cultivation area I observed cannabis plants in grow bags surrounded by tarps, pots, and plant waste (Photo 2). I also observed cultivation related waste piled in the surrounding woods including large plastic tarps (Photo 3).

Photo 1: Buried culvert stream crossing on access road to cultivation areas

1. Regularly clean out culvert with hand tools to prevent blockage and sediment transport to receiving waters.
2. Retain a qualified professional to assess the culvert capacity to convey the 100-year flow event and associated debris.
3. If the owner and/or tenant plan to continue cultivating cannabis, enroll for coverage under the State Water Board's Order WQ 2019-0023-DWQ, General Waste Discharge Requirements and Waiver of Waste Discharge Requirements for Discharges of Waste Associated with Cannabis Cultivation Activities.
4. Contain and properly dispose of potting soil and other cultivation-related waste to prevent spillage and transport into receiving waters.

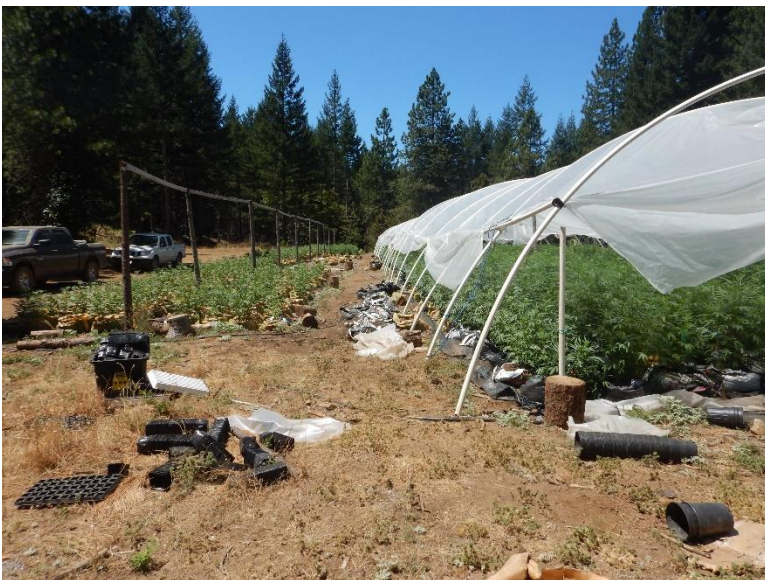
Photo 2: Outdoor cannabis cultivation area with plants in grow bags and cultivation related waste

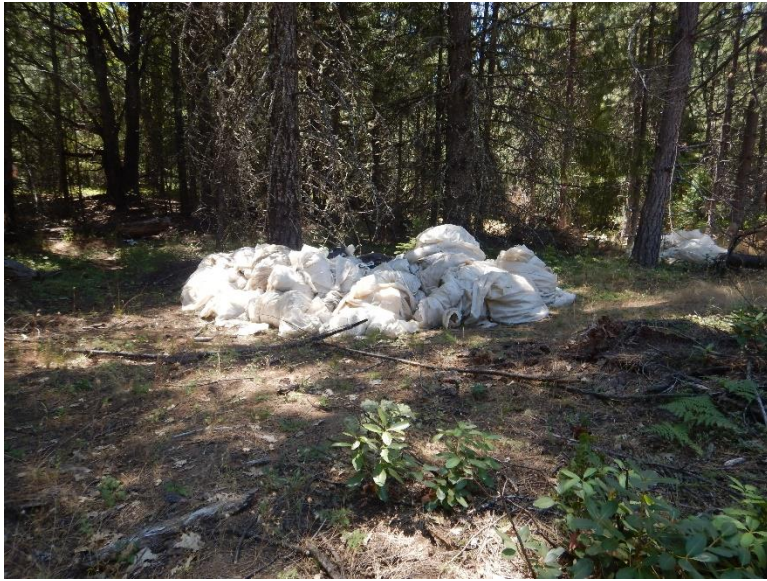
Photo 3: Cultivation related waste piled in woods

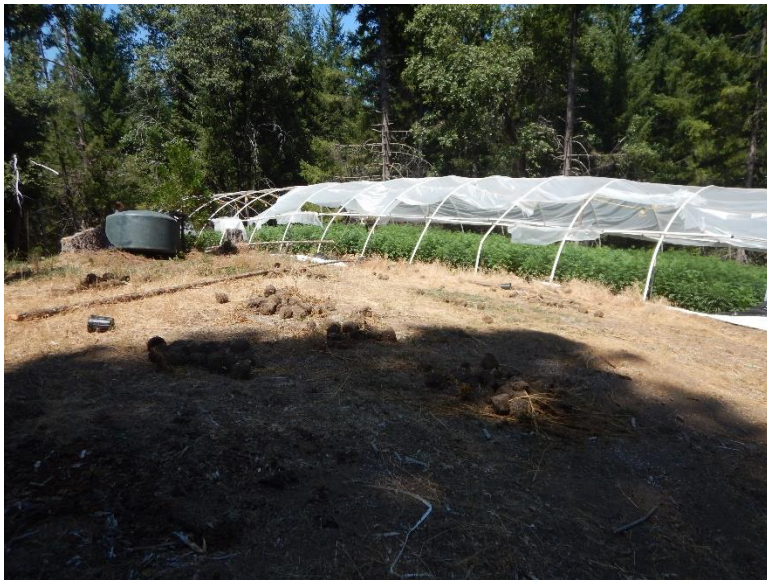
I observed another outdoor cannabis cultivation area; this area had a water storage tank and uncontained potting soil and plant waste near the active hoop house (Photo 4).

Photo 4: Outdoor cannabis cultivation area with plants in a hoop house, a water storage tank, and cultivation related waste
