Subject: **Notice of Violation** of North Coast Regional Water Quality Control Board Waste Discharge Requirements Order No. 85-79 and the Federal Clean Water Act Section 301 and Directive to Enroll in Order No. R1-2016-0002.

File: Manzana Products Company, 9141 Green Valley Rd.
Sebastopol, Sonoma County, WDID No. 1B781410SON

INSPECTION MEMO

Manzana Products Company, 9141 Green Valley Rd, Sebastopol, Sonoma County

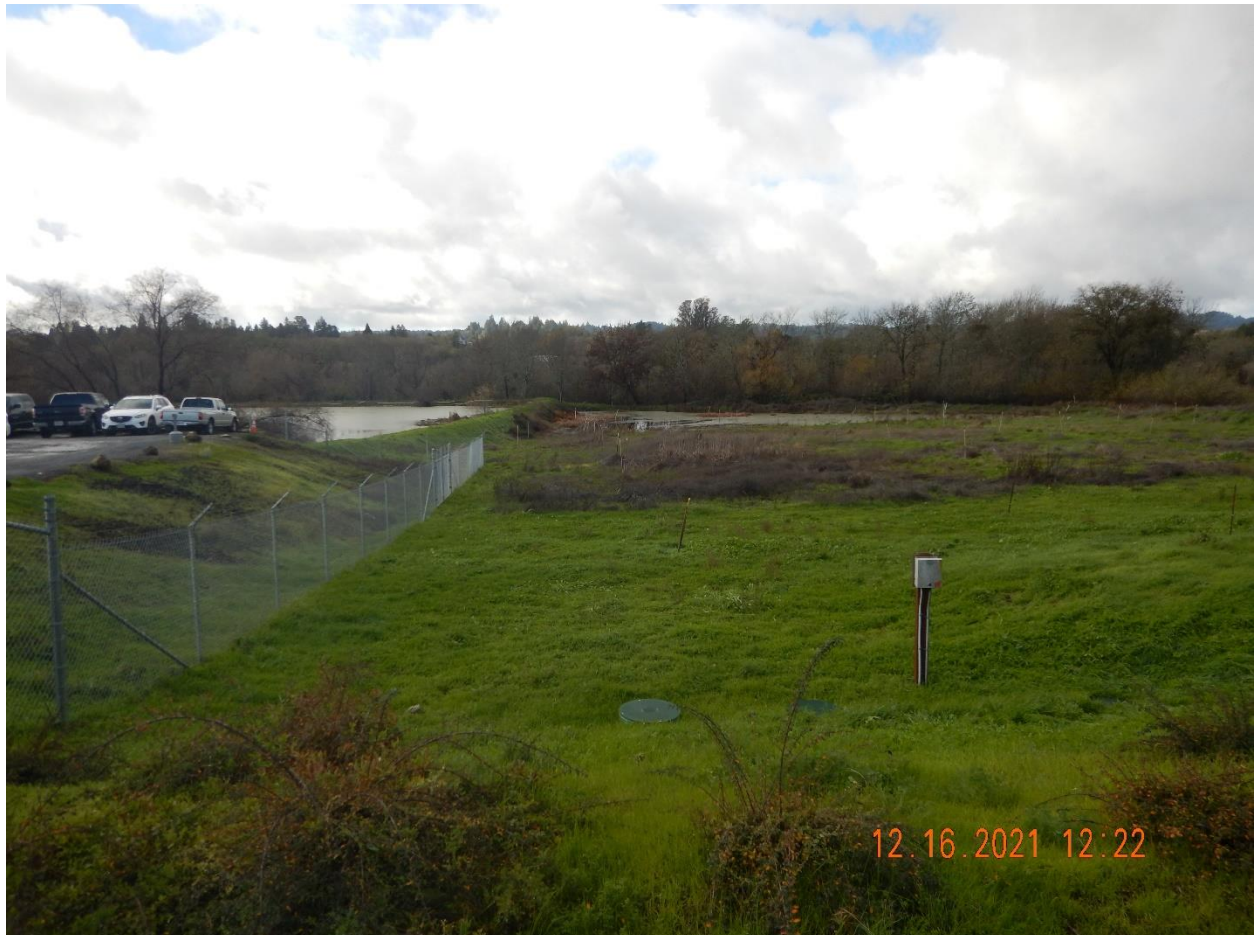
We began the inspection with an overview of the process wastewater system and the location of the wastewater ponds, irrigation fields and Atascadero Creek. Ponded water was observed in the north irrigation field (Photo 1) at the borders with Atascadero Creek and the north wall of the wastewater storage pond (Pond 3). Pond 3 was full during the inspection with approximately one to two feet of freeboard observed. The north irrigation field is sunken below the surrounding land area and slopes to the west. A Facility driveway and parking area are immediately east of the field and Green Valley Road is to the north (Photo 2). Several standing PVC pipes were arranged in a grid like pattern in the west half of the north irrigation field. Overhead irrigation sprinkler heads were attached to the standing pipes at approximately 4-5 feet above ground surface. Mr. Nelson stated that the irrigation fields need to be dry to satisfy Marin Sonoma Vector Control Agency requirements. A stormwater drop inlet with wood lid, was identified at the eastern border of the north irrigation field (Photo 3). Two green septic tank riser lids, an electrical panel and a mound were visible in the east portion of the north irrigation field (Photo 1 and 2). According to Mr. Nelson, the septic tank and mound system treat and dispose of Facility domestic waste.

Photo 1 – Process wastewater storage pond (Pond 3), north irrigation filed, septic tank riser, mound system electric panel, and portion of mound. Photo taken facing southwest.

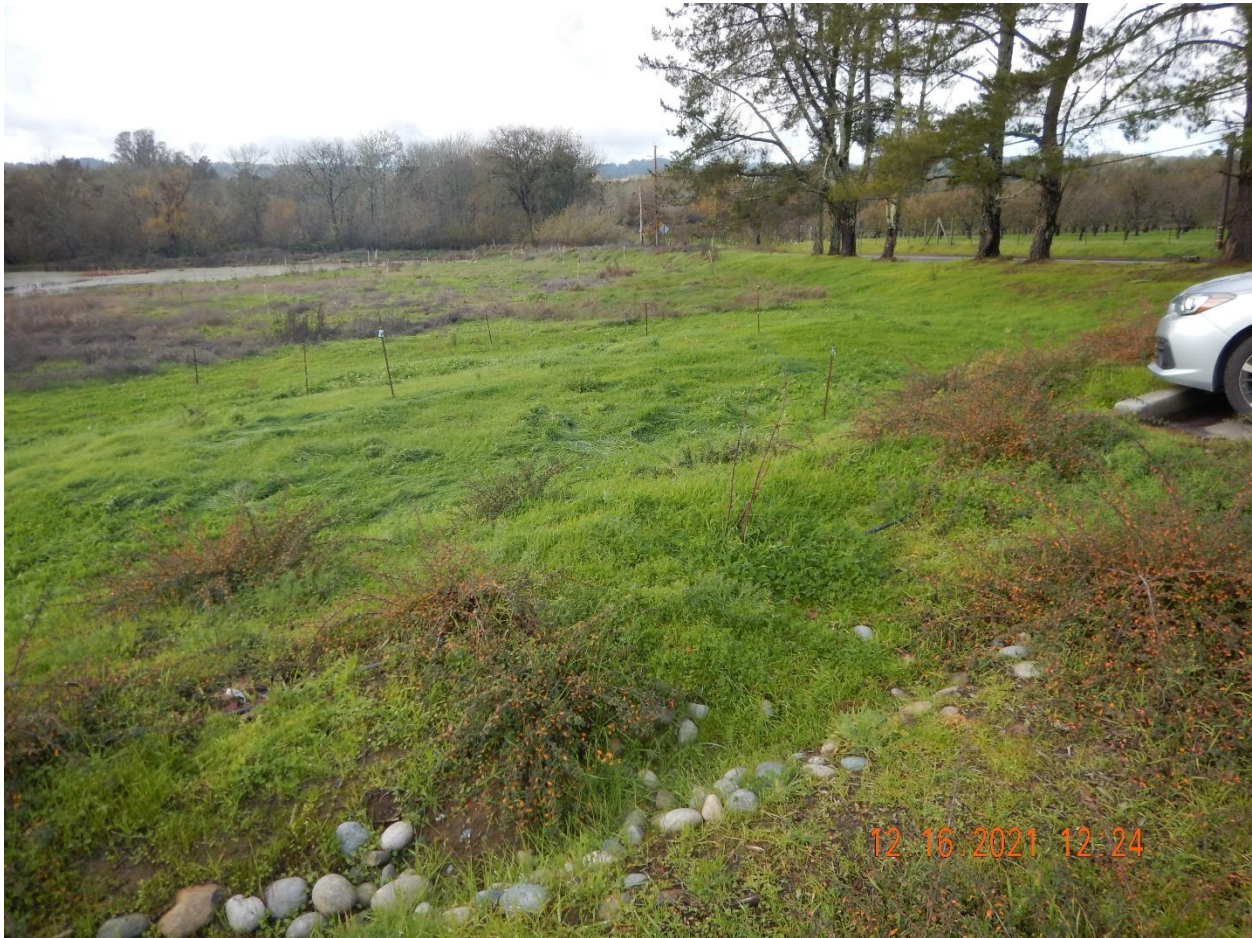
Photo 2 – North irrigation field and domestic waste mound system. Photo taken facing northwest.

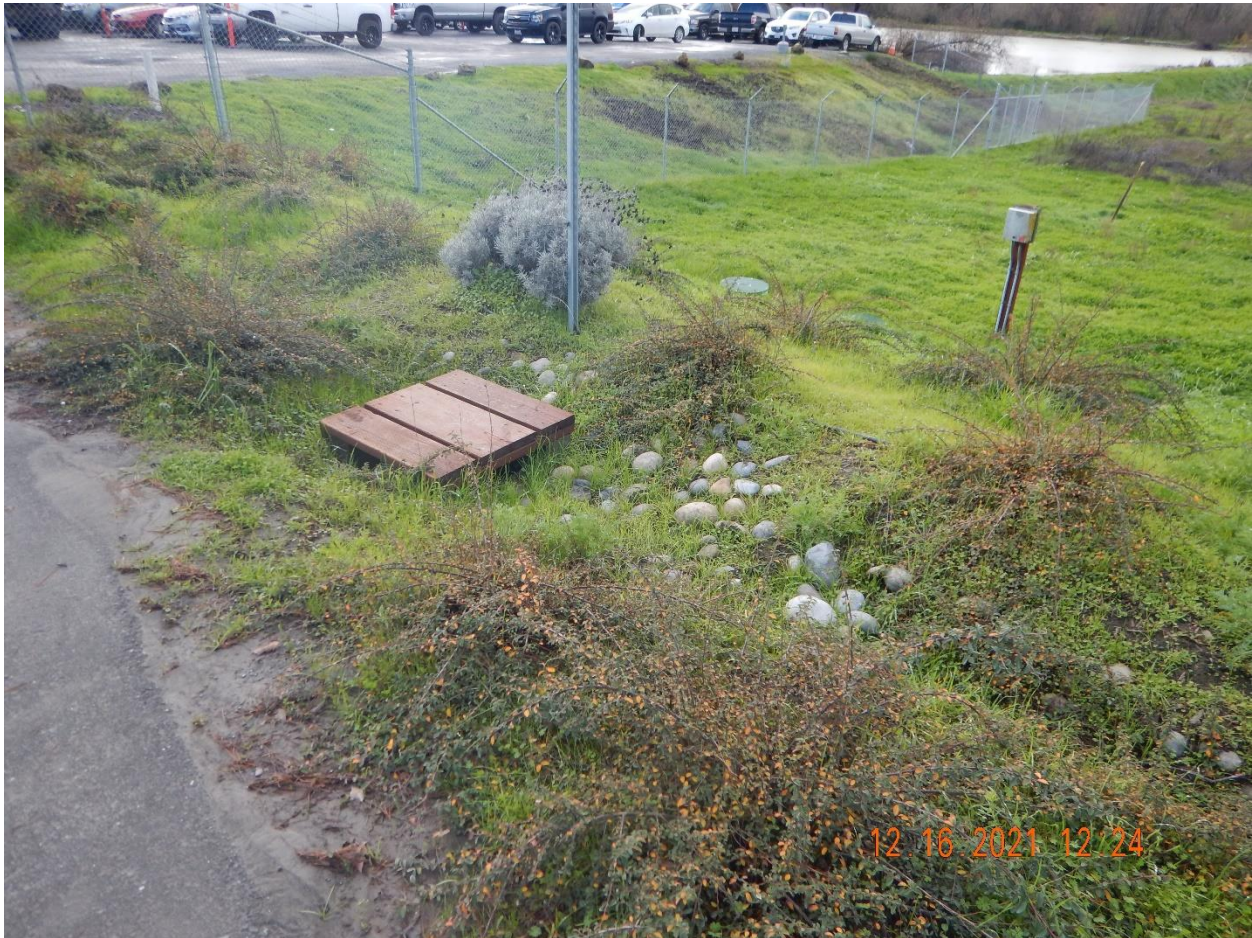
Photo 3 – Stormwater drop inlet with wood lid, at southeast corner of north irrigation field. Photo taken facing southwest.

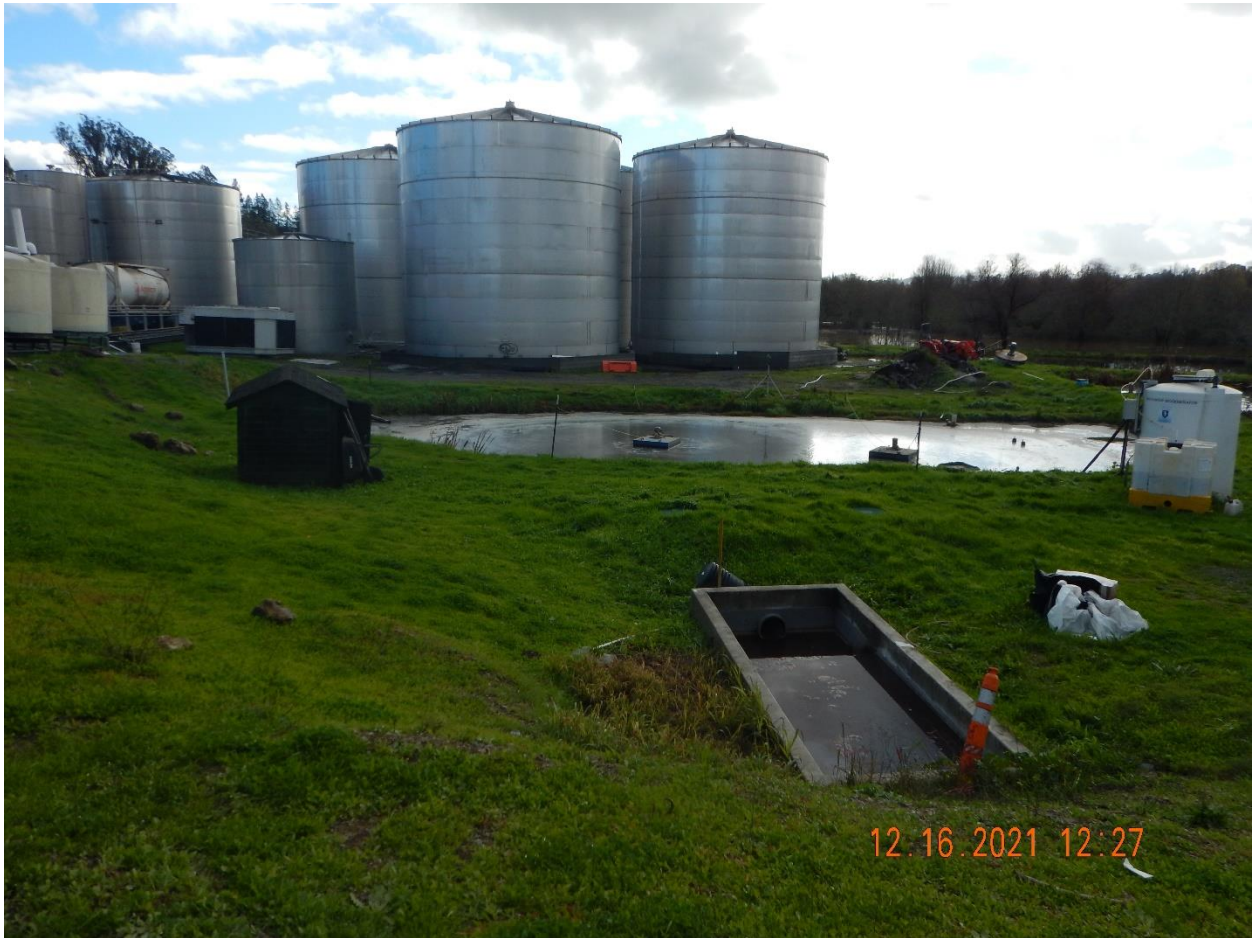
Process wastewater originating at the Facility is directed to an open concrete sump where it passes through and over a screen (Photo 4 and 5). Larger processing solids, such as whole apples are captured by the screen. Following the sump, wastewater passes through a septic tank where additional solids are settled out. The septic tank is located between the sump outlet and the initial treatment pond (Pond 1). Mr. Nelson confirmed that Pond 1 was historically larger. Outdoor stainless steel storage tanks were constructed on the historical southern portion of Pond 1 approximately five years ago. Two aerators were operating on Pond 1 during the inspection. When questioned Mr. Nelson said that the aboveground overhead sprinkler adjacent to Pond 1 was used to spray water from Pond 3 onto Pond 1 for odor control. He also confirmed that stormwater is directed to Pond 1 via pipes located in the bank of Pond 1. Two aboveground plastic tanks located adjacent to Pond 1 marked with Heritage Systems

Photo 4- Process wastewater sump, septic tank risers, Pond 1 and Heritage Systems additive tank. Photo taken facing south.

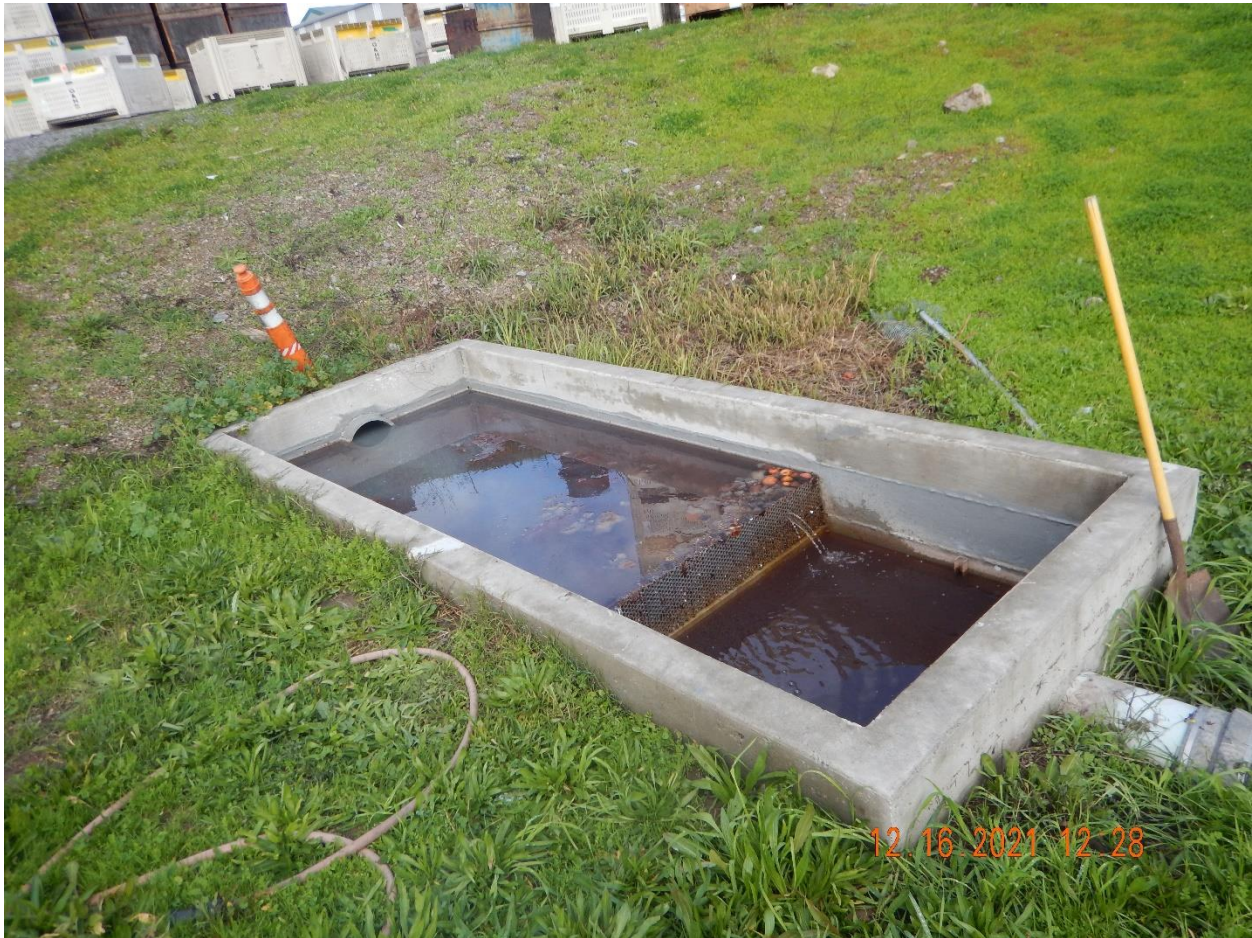
Photo 5- Concrete process wastewater sump with screen. Photo taken facing northeast.

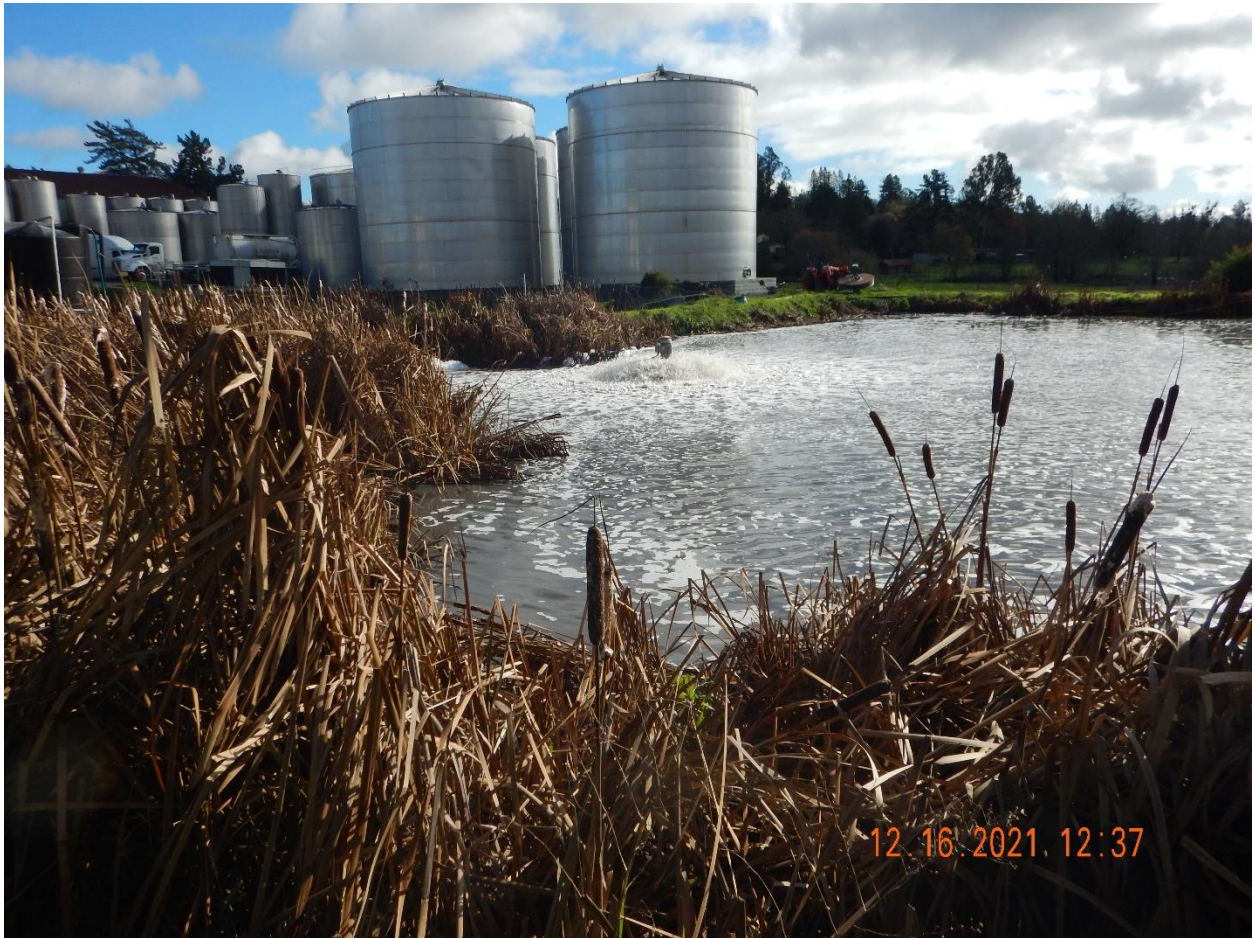
The second treatment pond in series (Pond 2), is located adjacent to the west of Pond 1. Effluent from Pond 1 gravity flows to Pond 2. Cattails surround the perimeter of Pond 2. One aerator was in operation on Pond 2 during the inspection (Photo 6 and 7). A second aerator, requiring repair, was located on the bank of Pond 2. A 4-inch PVC pipe gravity feeds wastewater from Pond 2 to Pond 3.

Photo 6- Second treatment pond (Pond 2) in series. Photo taken facing southeast.

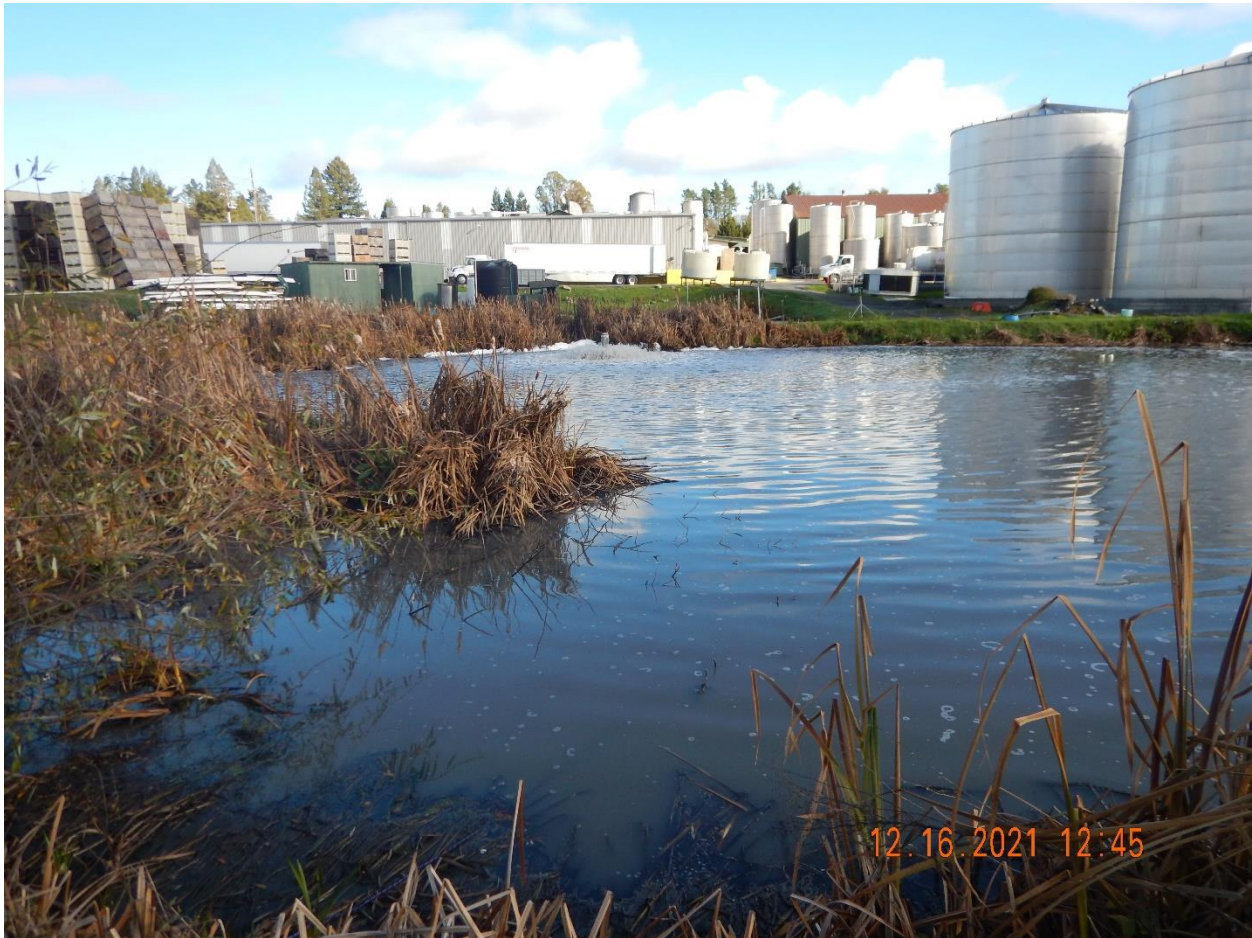
Photo 7- East wall of Pond 2, with Pond 1 in the background. Photo taken facing west.

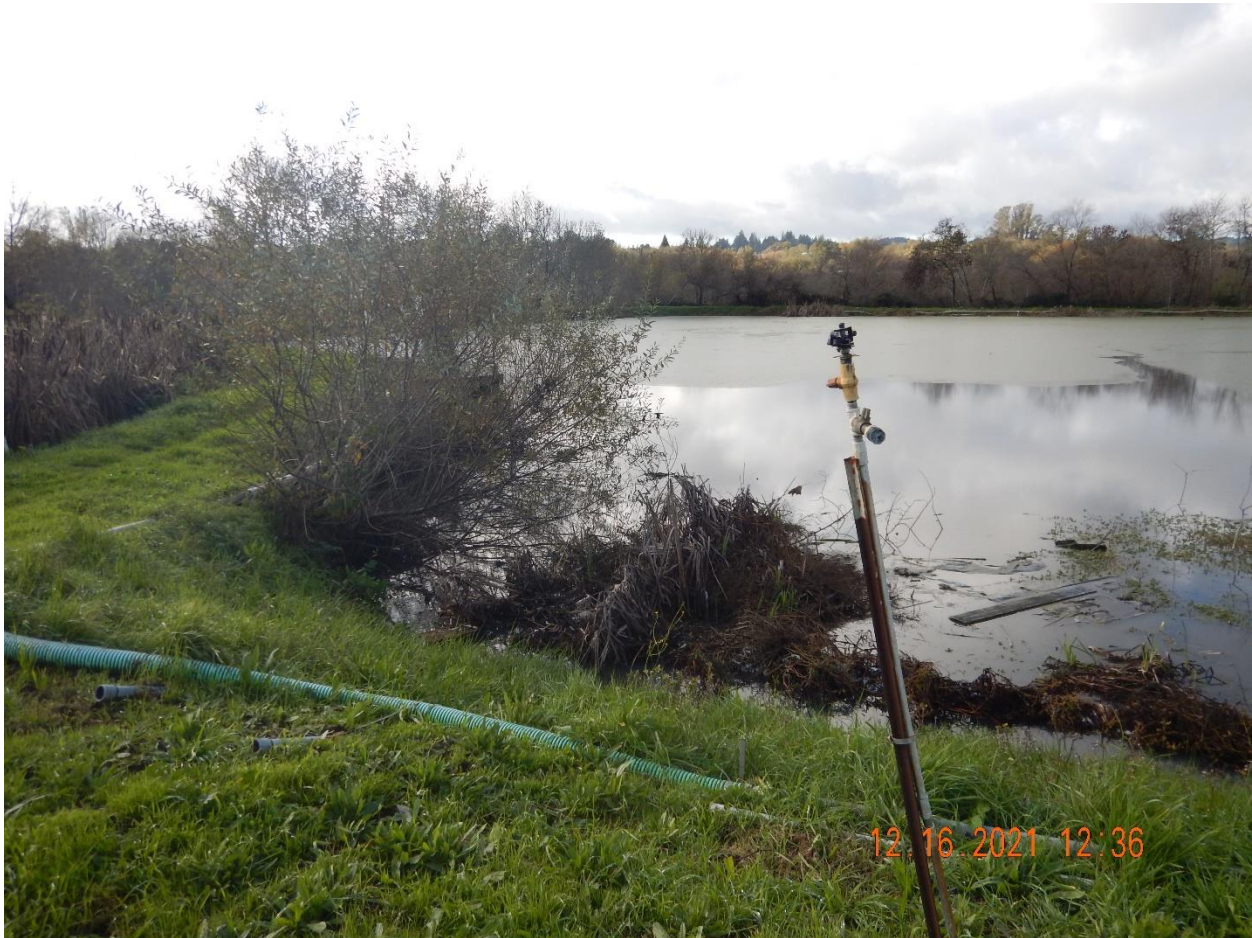
The third pond in the series, Pond 3, is the largest of the 3 ponds and is located west of Pond 2. Pond 3 is used for the storage of treated process wastewater prior to land application. Pond 3 was partially covered with duck weed and had areas where willows and other vegetation were established along the pond walls. Other vegetation and wooden debris was observed floating along the wall of Pond 3 (Photo 8). A wooden platform, with electrical panel is located midway along the berm between Pond 2 and Pond 3 (Photo 9). Mr. Nelson told us there was a depth gauge for Pond 3 but it was not visible during the inspection. A second wooden platform with electrical panel is located at the southeast corner of Pond 3 (Photo 10). There were several hoses and pipes running along the banks and berms of all the ponds. It was unclear which piping was currently in use and which had been abandoned. A flow meter connected to piping near the southeast platform was confirmed to be the meter used to monitor wastewater flow volumes reported in self-monitoring reports.

Photo 8- West wall of Pond 3, with willows, duckweed, floating vegetation and wood.
Photo taken facing west.

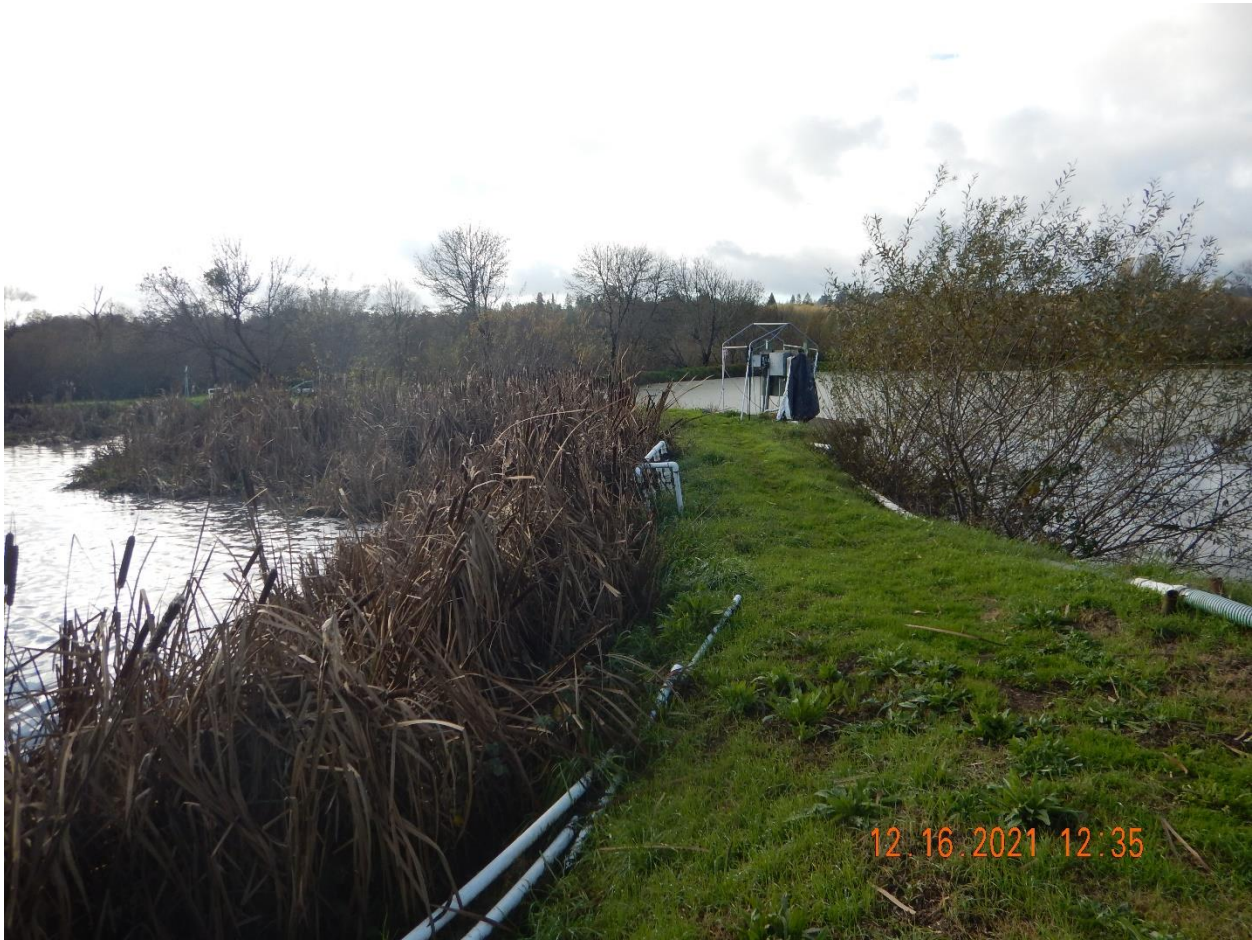
Photo 9- Berm between Pond 2 and Pond 3 with wooden platform. Photo taken facing southwest.

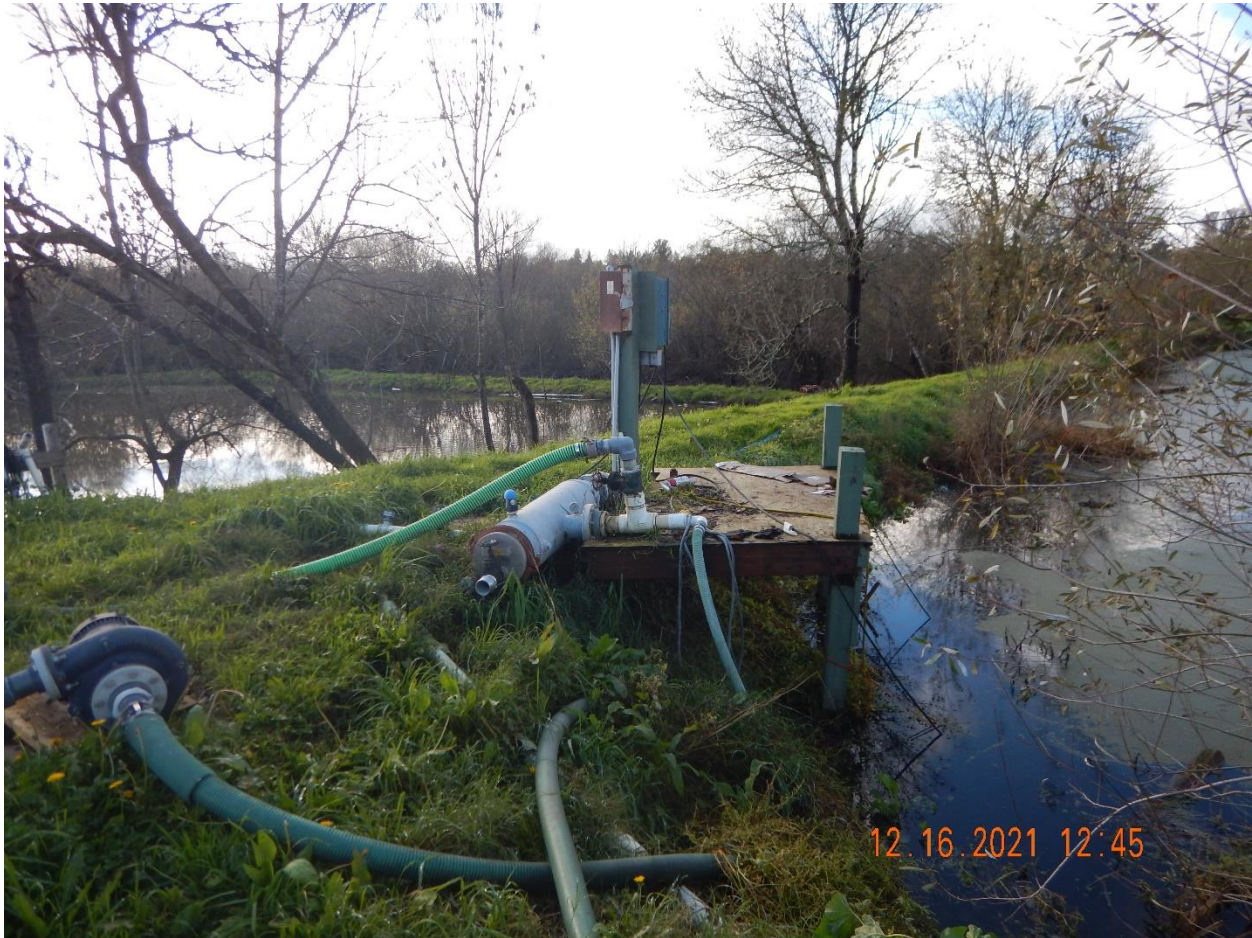
Photo 10- Southeast corner of Pond 3, wooden platform with electric panel and pump. Flooded south irrigation field in background. Flow meter area. Photo taken facing southwest.

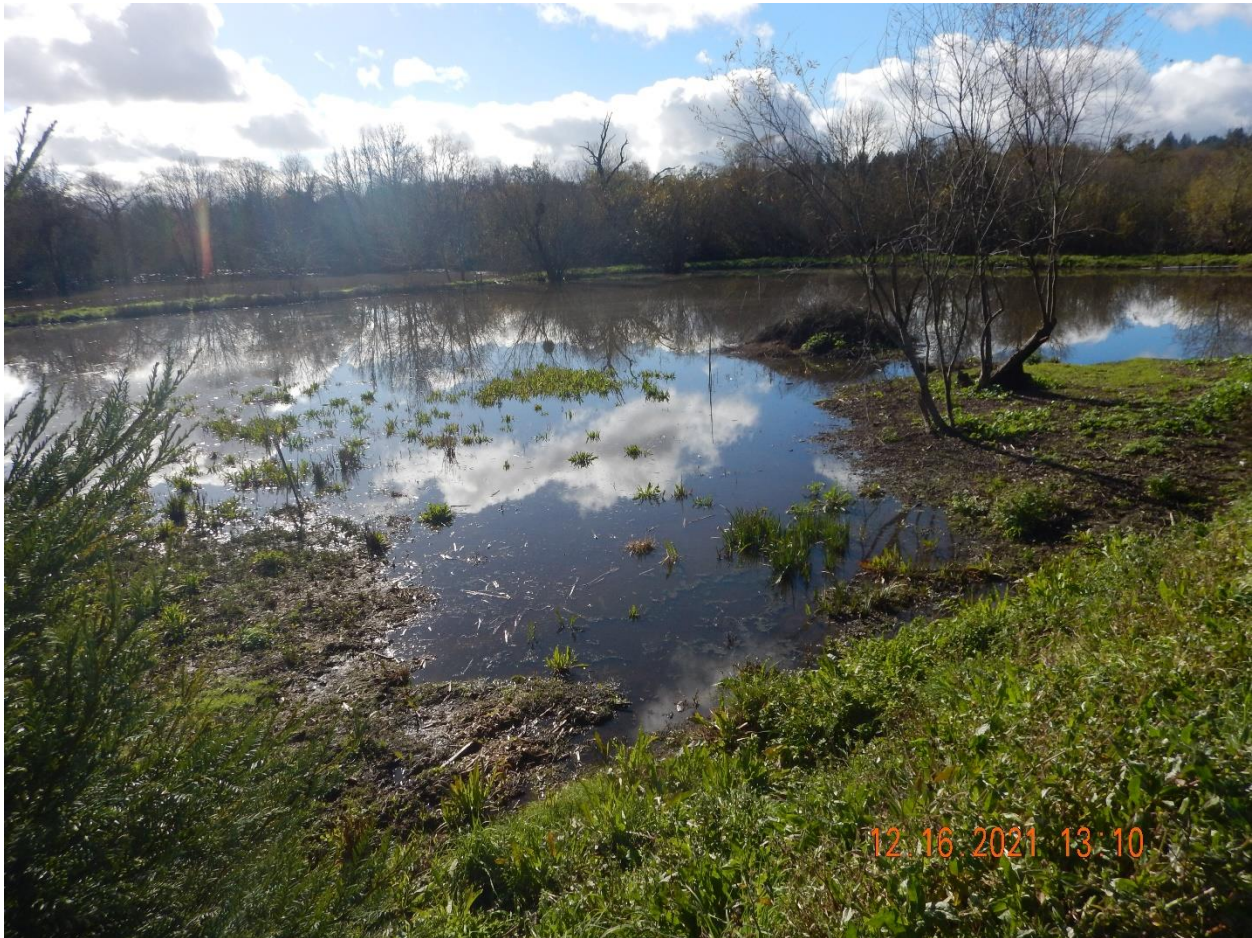
The south irrigation field is located adjacent to the south wall of Pond 3 and Pond 2. The irrigation field is bermed to the west and south within the flood plain of Atascadero Creek. At the time of the inspection the western portion of the south irrigation field was flooded with water (Photo 11). The southern berm of the irrigation field was breached and water from the flood plane was flowing into the field (Photo 12). Two portable, gasoline powered, pumps, and a plastic gasoline container were located along the west berm of the south irrigation field (Photo 13). An orange hose attached to the outlet of one of the pumps was on the other side of the berm, within the Atascadero Creek flood plain.

Photo 11- Flooded south irrigation field with breach of south berm in distance. Photo taken facing southwest from berm between irrigation field and Pond 2.

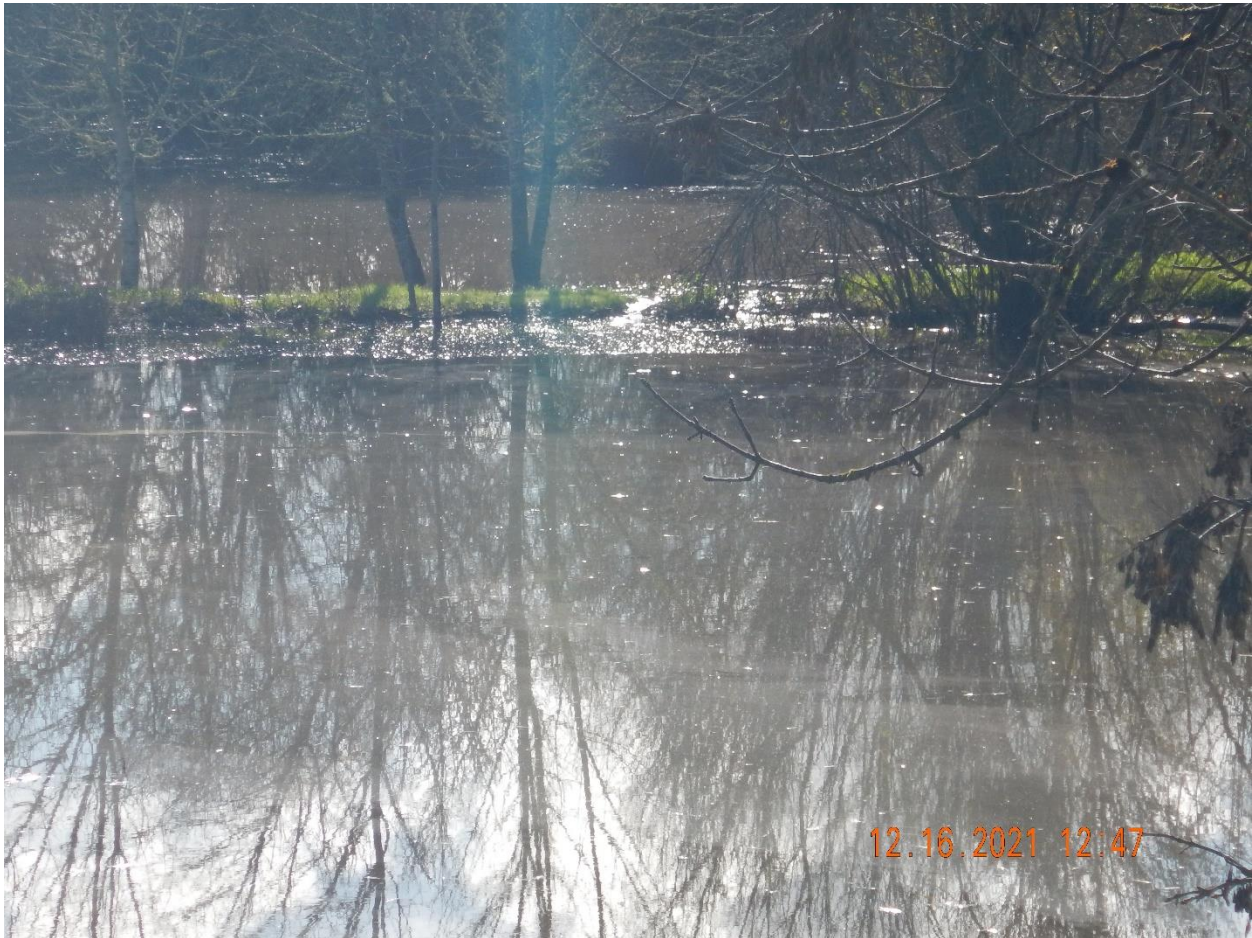
Photo 12- South berm of south irrigation field, with water flowing into field from Atascadero Creek. Photo taken facing south from berm between Pond 3 and south irrigation field.

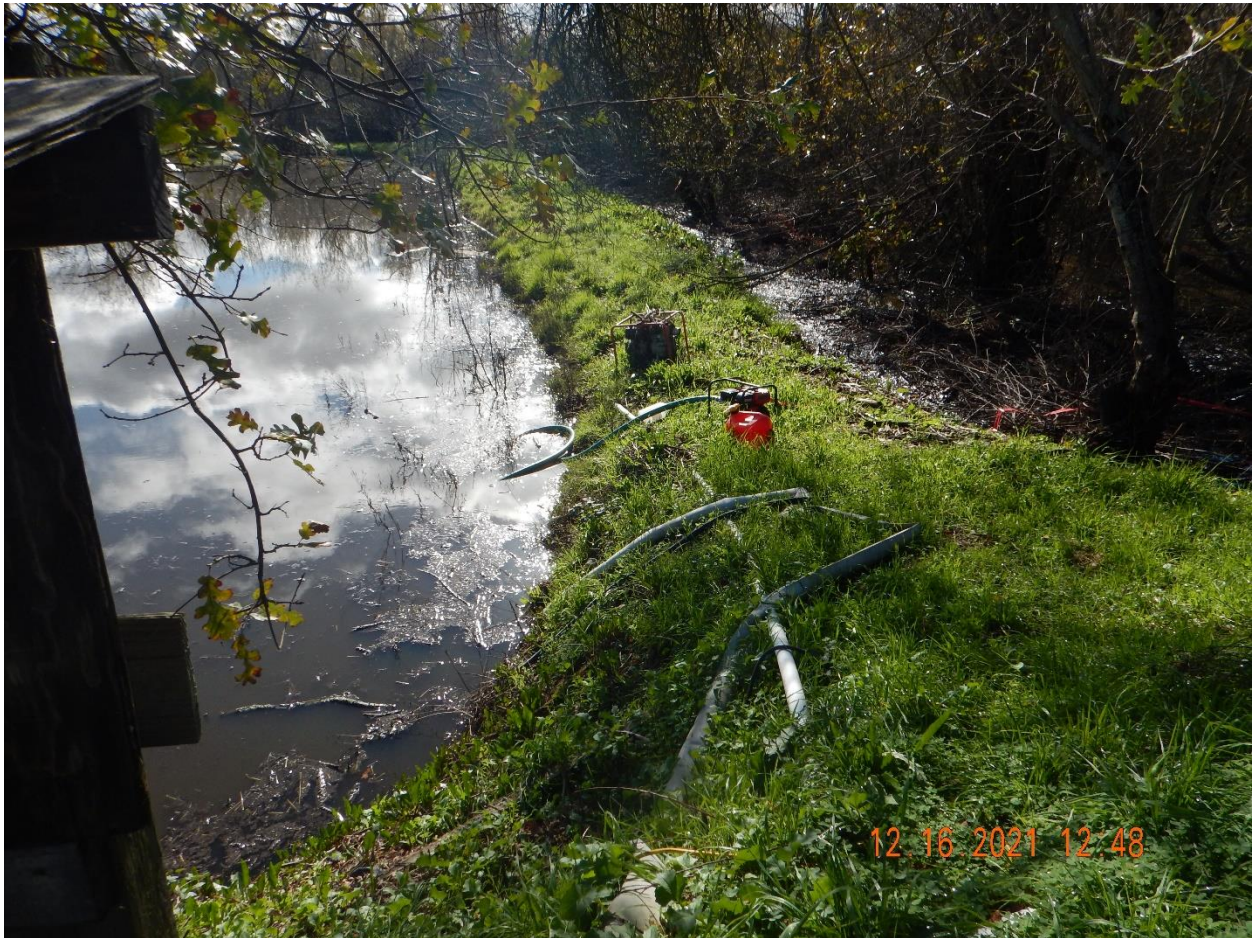
Photo 13- West berm of south irrigation field, with portable pumps, gas can, and orange discharge hose to Atascadero Creek. Photo taken facing south from berm between Pond 3 and south irrigation field.

Mr. Puget discussed the need to implement best management practices identified in the Facility's Stormwater Pollution Prevention Plan (SWPPP), such as the appropriate storage of gasoline, to limit or prevent impacts to water quality. Mr. Puget additionally explained that the Facility's coverage under the Industrial Stormwater General Permit was overseen by Regional Water Board staff, Farzad Kasmeh and that we would be informing Farzad of this inspection.

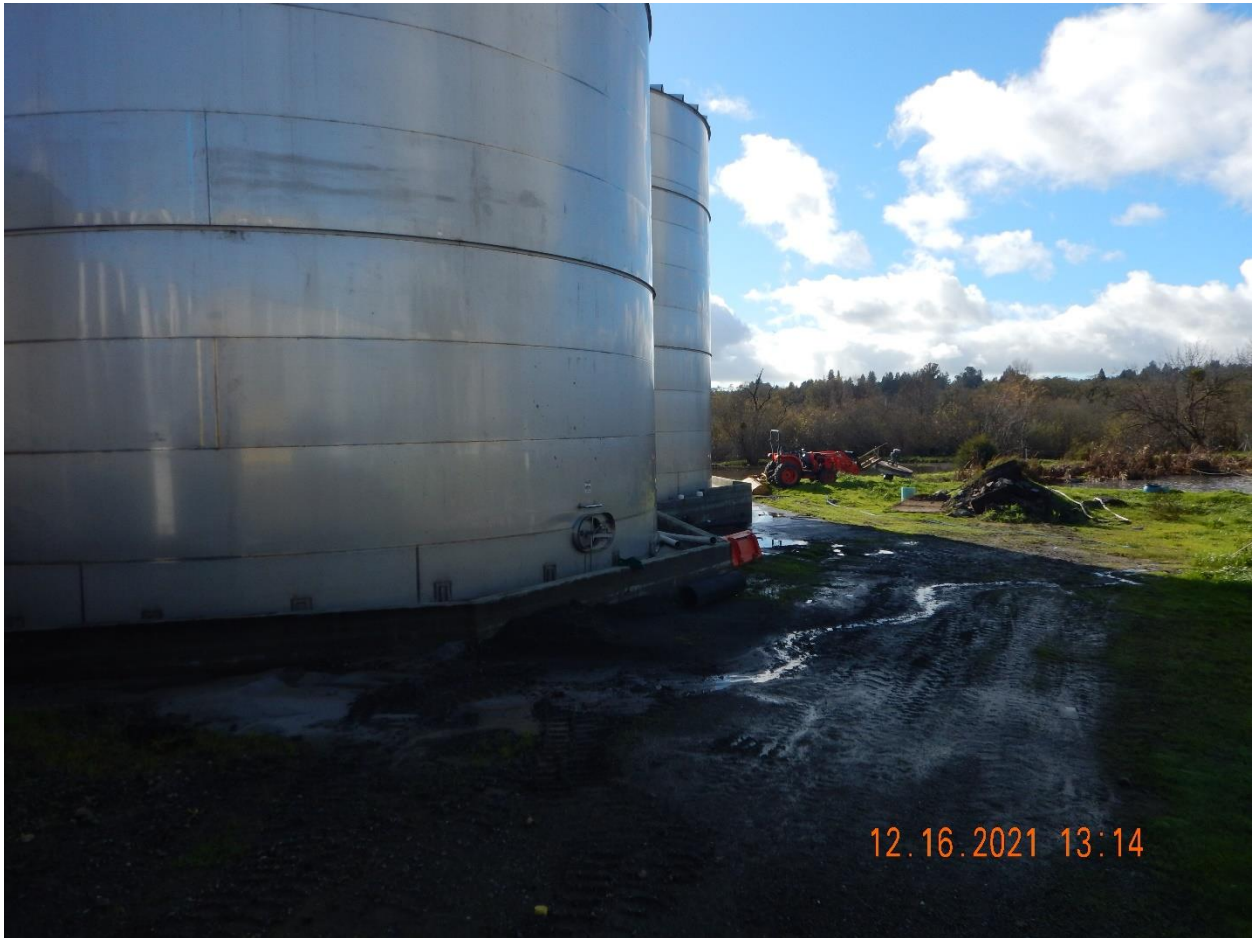
We walked back to the parking lot and driveway adjacent to the north irrigation field. Along the way we passed by the stainless-steel storage tanks constructed on the former footprint of Pond 1 (Photo 14). East of the tanks, we observed a stormwater drop inlet (Photo 15) which directed stormwater to Pond 1. Additional pipes conveying stormwater to Pond 1 were observed (Photo 16).

Photo 14 – Stainless steel storage tanks located in former footprint of Pond 1. Photo taken facing southeast from Pond 1.

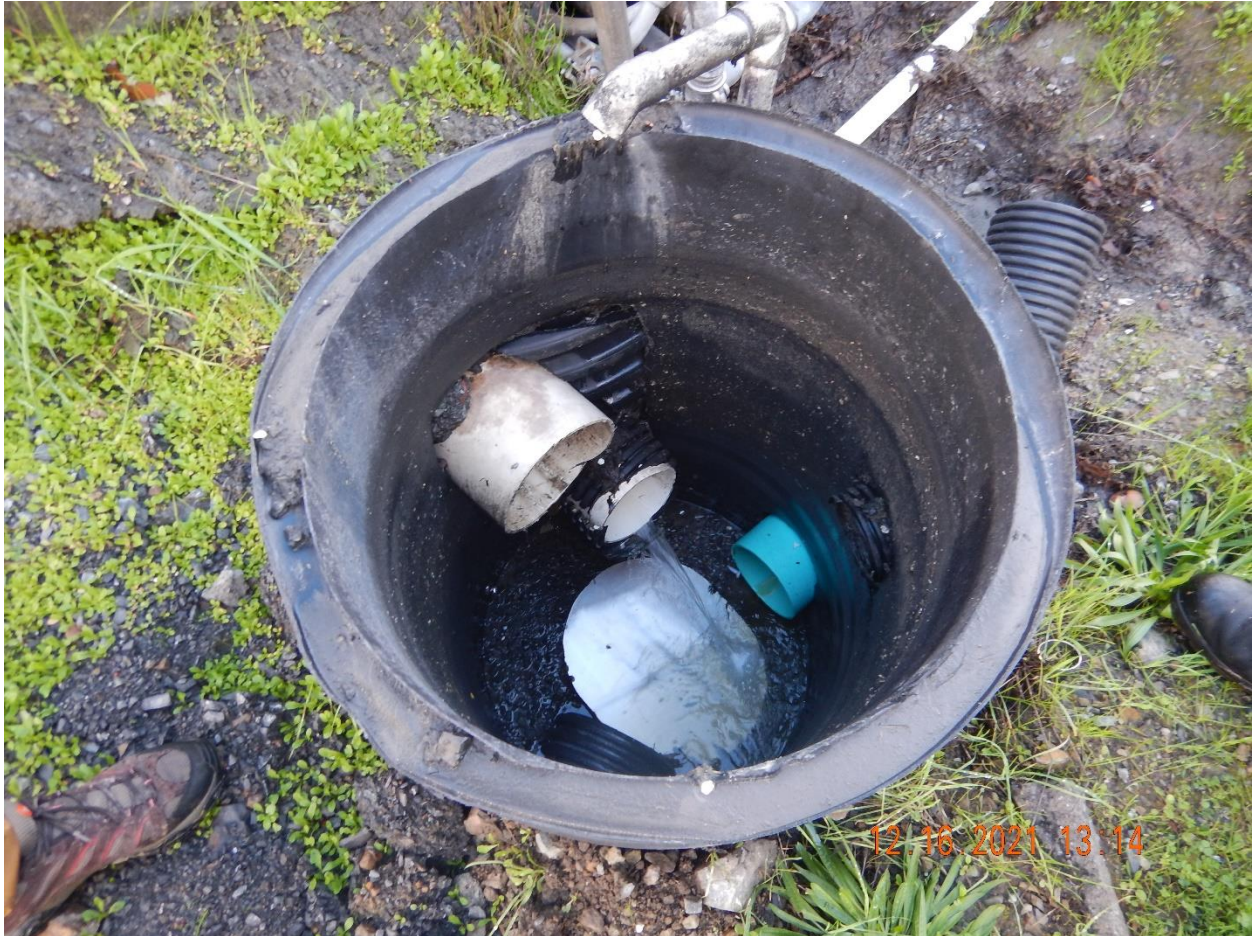
Photo 15 – Stormwater junction box east of stainless steel tanks adjacent to Pond 1.

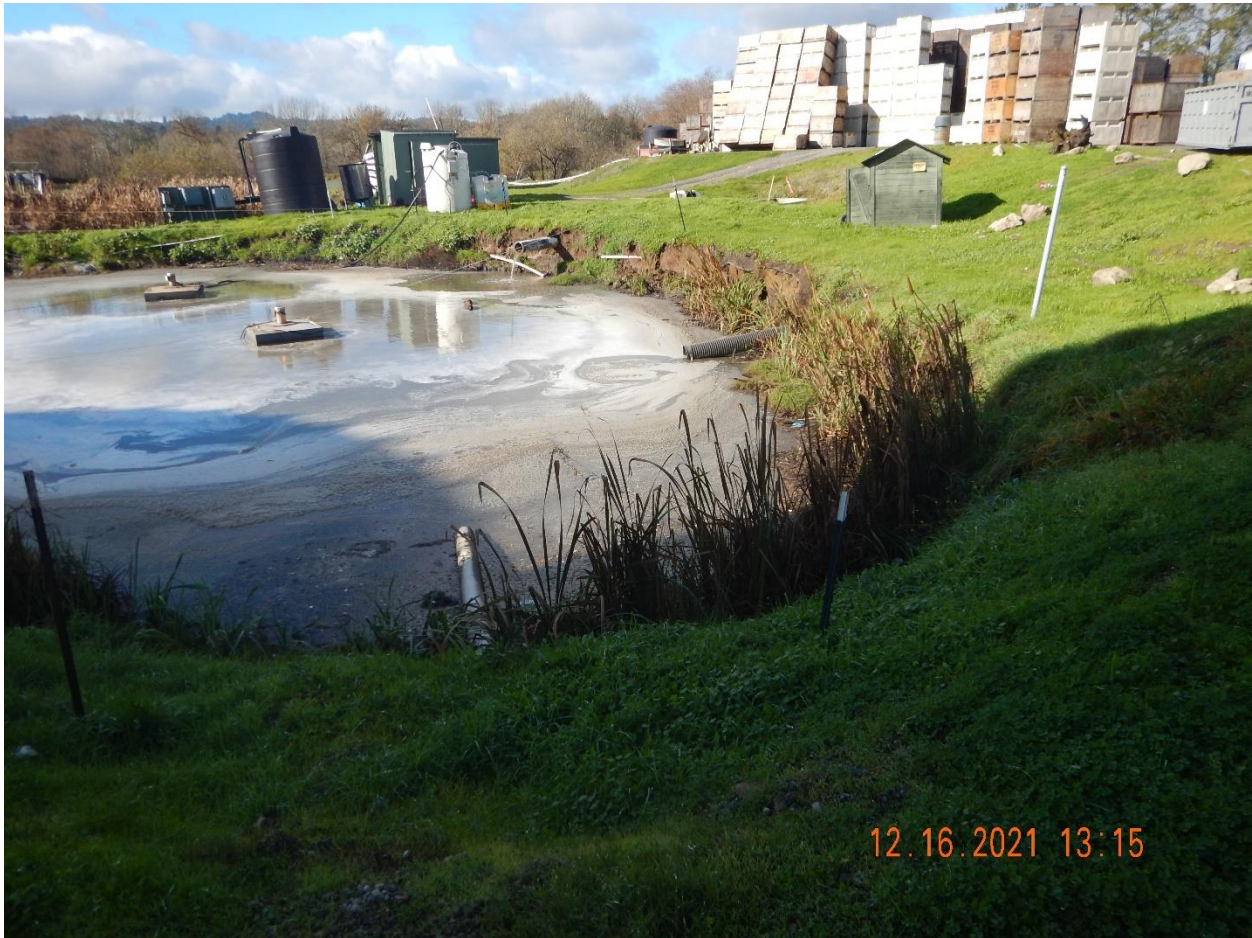
Photo 16 – Discharge pipes to Pond 1. Photo taken from southeast corner of Pond 1.

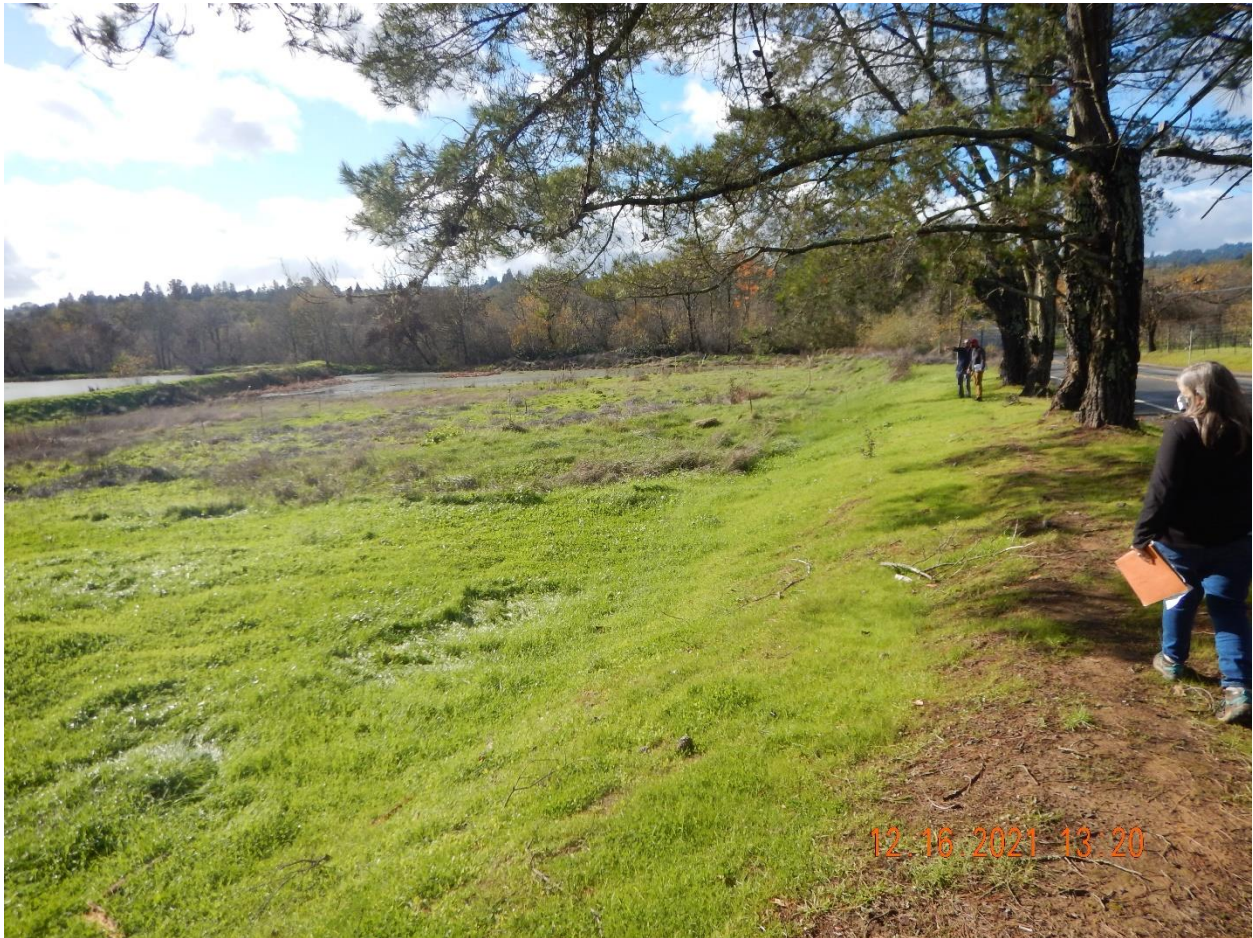
We then walked along the northern berm of the north irrigation field, adjacent to Green Valley Road to get to observe the stormwater outlet identified on the SWPPP map (Photo 17). Three pipes used to convey stormwater were located along the north berm of the north irrigation field (Photo 18). Several rocks were located near where the pipes discharged, making identification of the down gradient drainage channel difficult.

Photo 17 – North berm of north irrigation field, adjacent to Green Valley Road. Photo taken facing west.
