Subject: **Notice of Violation** of North Coast Regional Water Quality Control Board Waste Discharge Requirements Order No. 85-79 and the Federal Clean Water Act Section 301 and Directive to Enroll in Order No. R1-2016-0002.

File: Manzana Products Company, 9141 Green Valley Rd.
Sebastopol, Sonoma County, WDID No. 1B781410SON

INSPECTION MEMO

Manzana Products Company, 9141 Green Valley Rd, Sebastopol, Sonoma County

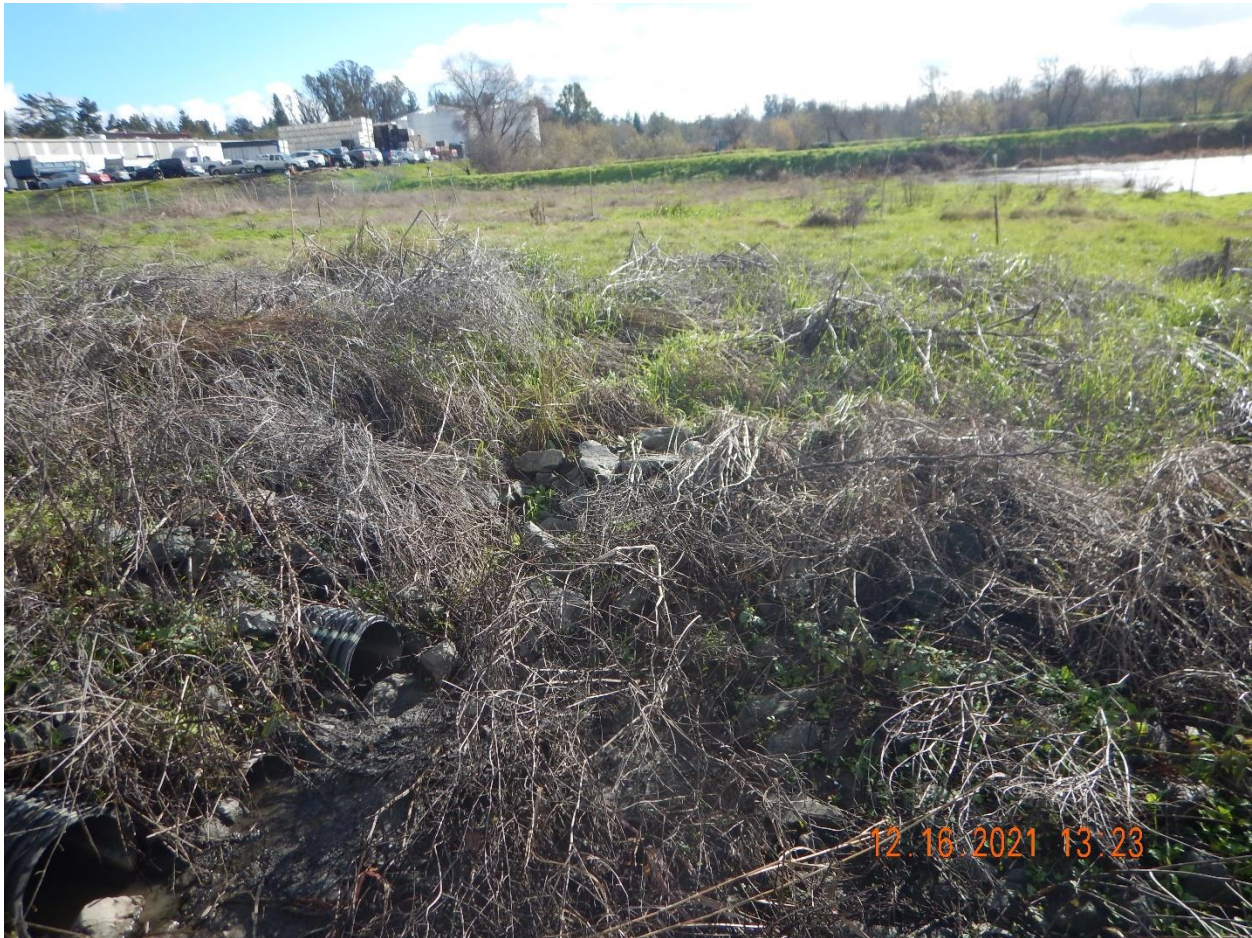
We then walked along the northern berm of the north irrigation field, adjacent to Green Valley Road to get to observe the stormwater outlet identified on the SWPPP map (Photo 17). Three pipes used to convey stormwater were located along the north berm of the north irrigation field (Photo 18). Several rocks were located near where the pipes discharged, making identification of the down gradient drainage channel difficult.

Photo 18 – Three stormwater culverts in north berm of north irrigation field, adjacent to Green Valley Road. Photo taken facing southeast.

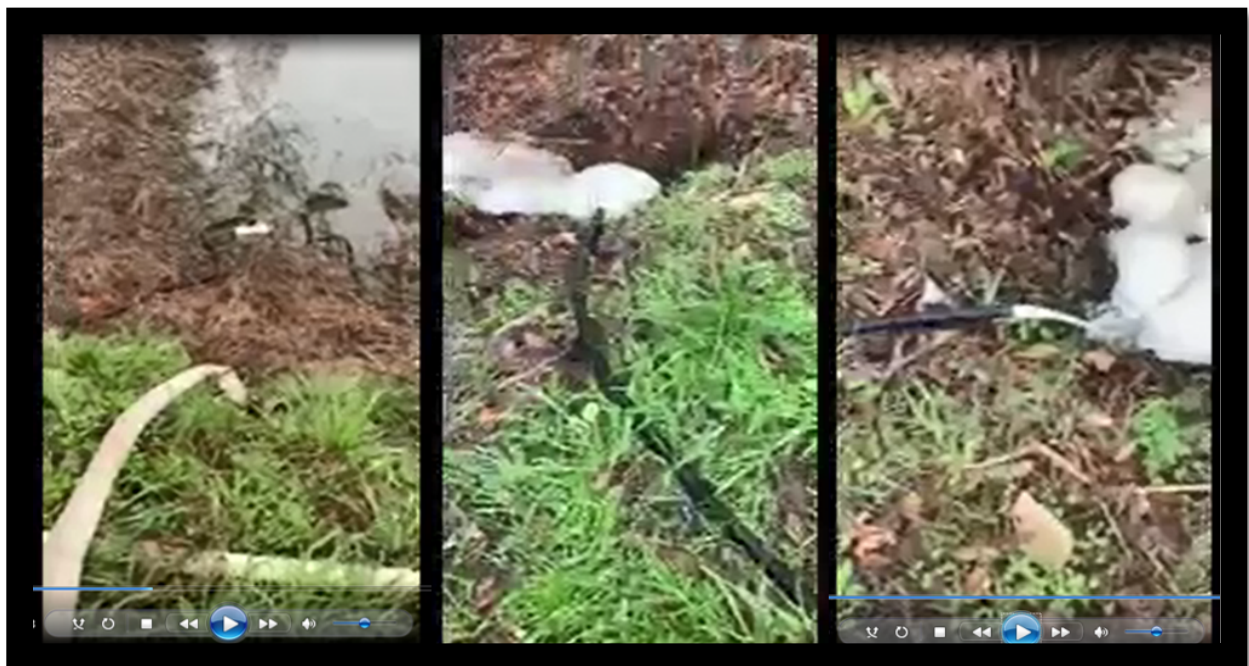
The Facility's discharge to Atascadero Creek was observed and video documented on December 3, 2021. The video shows a white, foam creating, liquid being pumped from the Facility south irrigation field over a berm wall to Atascadero Creek. Mr. Nelson confirmed with staff that water collected in the south irrigation field was pumped to Atascadero Creek.

Image A3. On the left is the sump pumping from hose in wastewater disposal area. The middle and right show the pump outlet into Atascadero Creek and white foam in the creek from the white colored discharge.
