North Coast Regional Water Quality Control Board

Subject: Notice of Violation, Transmittal of Report for August 8, 2022 Inspection of Mendocino County Assessor's Parcel Number (APN) 150-220-01-00

**Inspection Report for August 8, 2022 Warrant Inspection,
Mendocino County
Assessor's Parcel Number (APN) 150-220-01-00 (the "Property")**

File: Cannabis Program Inspections, Mendocino County, 2022, Scott,
CIWQS Place ID 882700

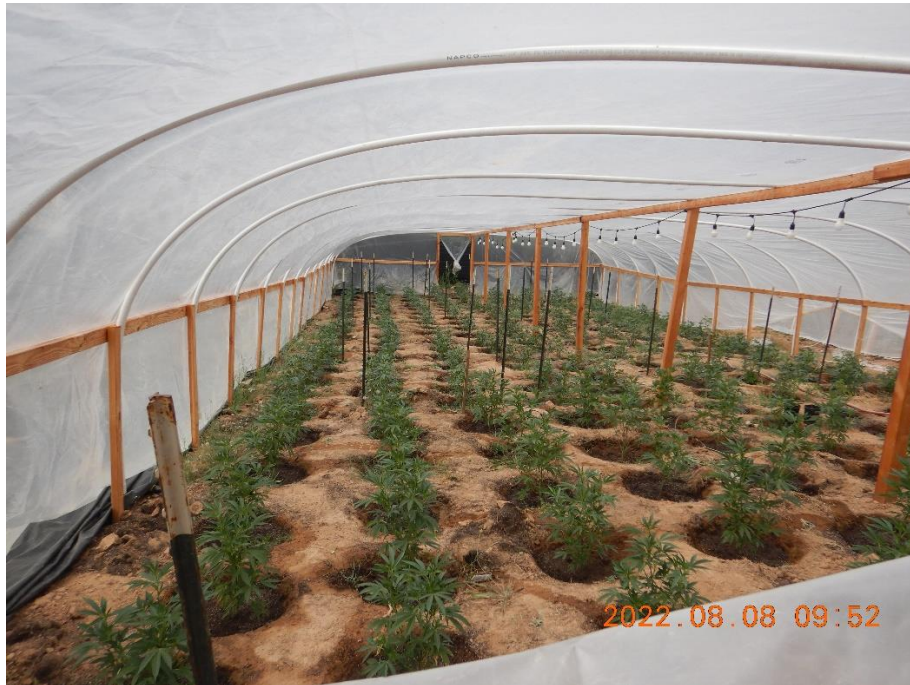
Photo1— Cannabis plants being grown in a hoop-type greenhouse in the vicinity of WQ1.

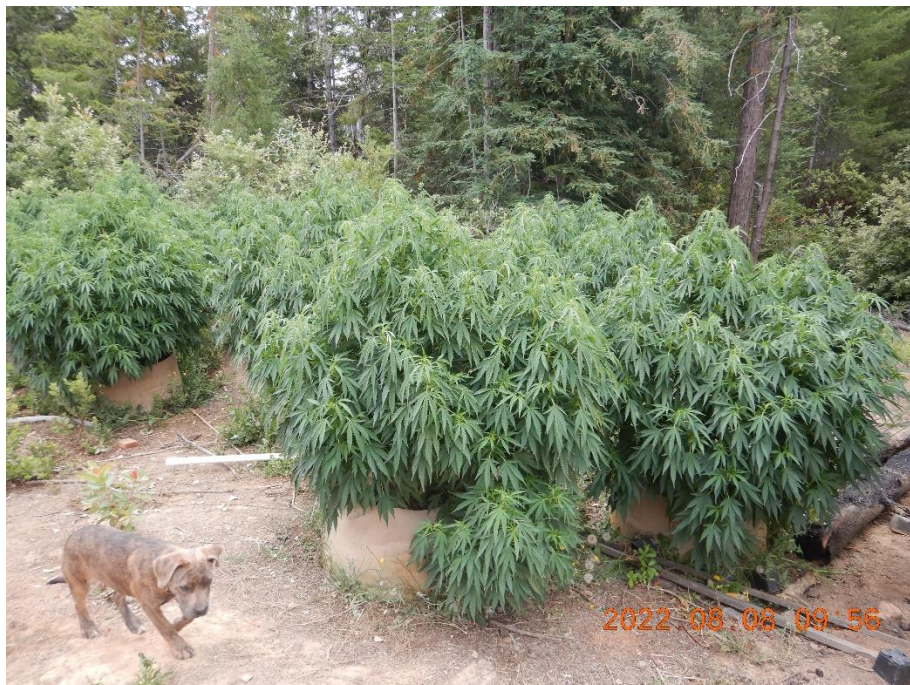
Photo 2— Cannabis plants outdoors in the vicinity of WQ1.

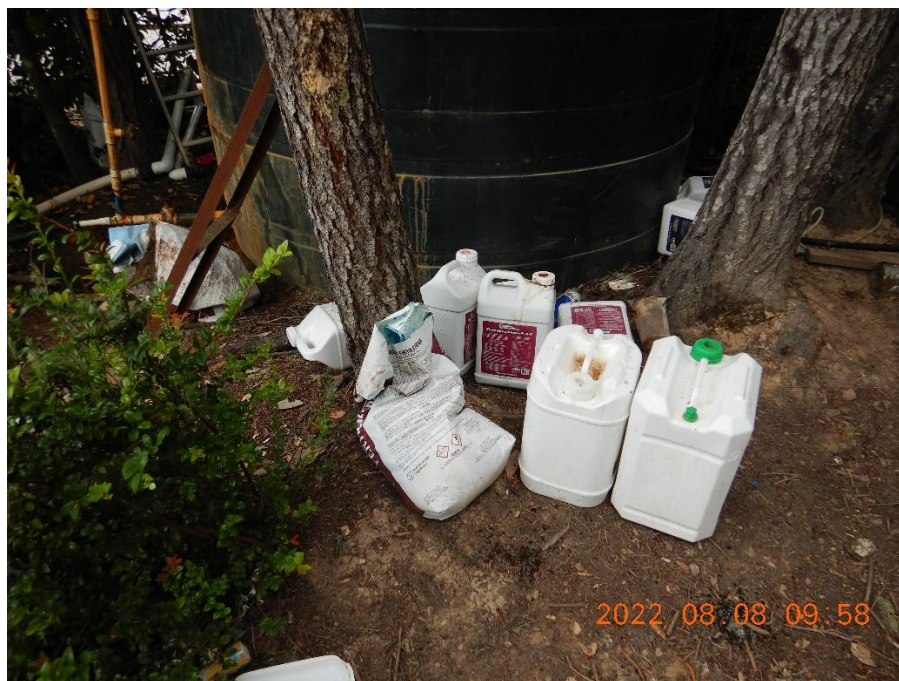
The inspection was associated with a criminal search warrant, and I viewed only portions of the Property. See the above Inspection Map and below Photo Appendix for locations and details about features of concern to water quality. I entered the northeast corner of the Property from the east and observed approximately 10,000 square feet of cannabis being cultivated outdoors and in hoop-type greenhouses at WQ1. I observed uncontained refuse and agricultural chemicals in the vicinity of WQ1.

Photo 3— Bags of potting soil and multiple containers of high-concentration liquid nutrient containers in the vicinity of WQ1.

1. Immediately collect all petroleum products, other chemicals, refuse and cannabis cultivation wastes on the Property which have discharged and/or threaten to discharge and properly dispose of these wastes at licensed waste collection facility.
2. Retain a licensed professional to investigate the extent of contaminated soil, surface water and groundwater associated with the spilled petroleum products and develop a workplan and schedule for cleaning up the spill.
3. Retain a licensed professional to inventory, assess, all aquatic resources including watercourses that are waters of the State of California on the Property, and to develop a workplan and schedule to implement measures to ensure that all developed features, roads and watercourse crossings throughout the Property are corrected, restored, and/or maintained in conditions that prevent or minimize

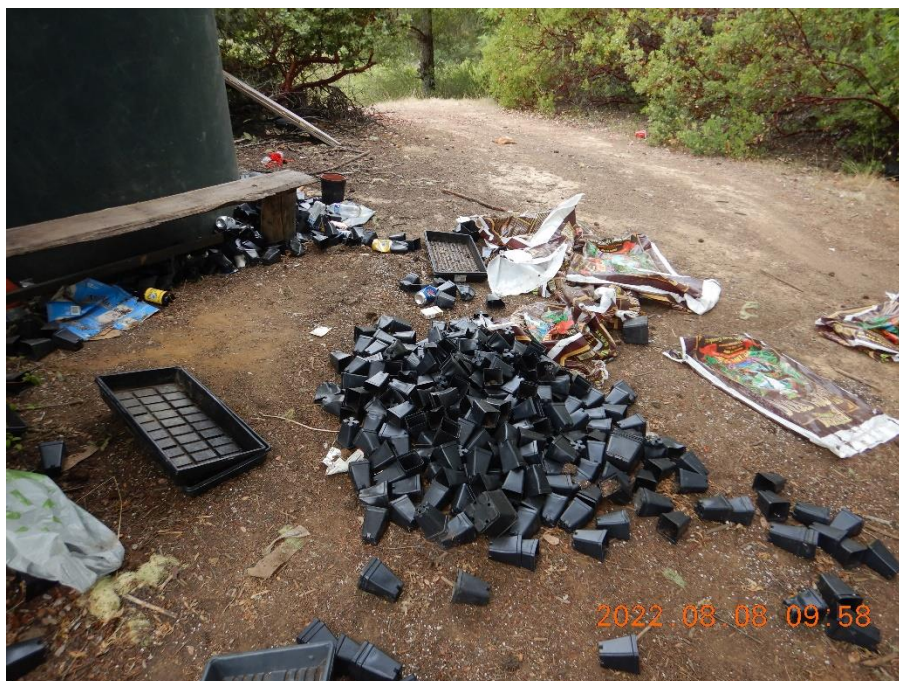
Photo 4— Empty plant containers, soil bags and other cannabis cultivation waste in the vicinity of WQ1.

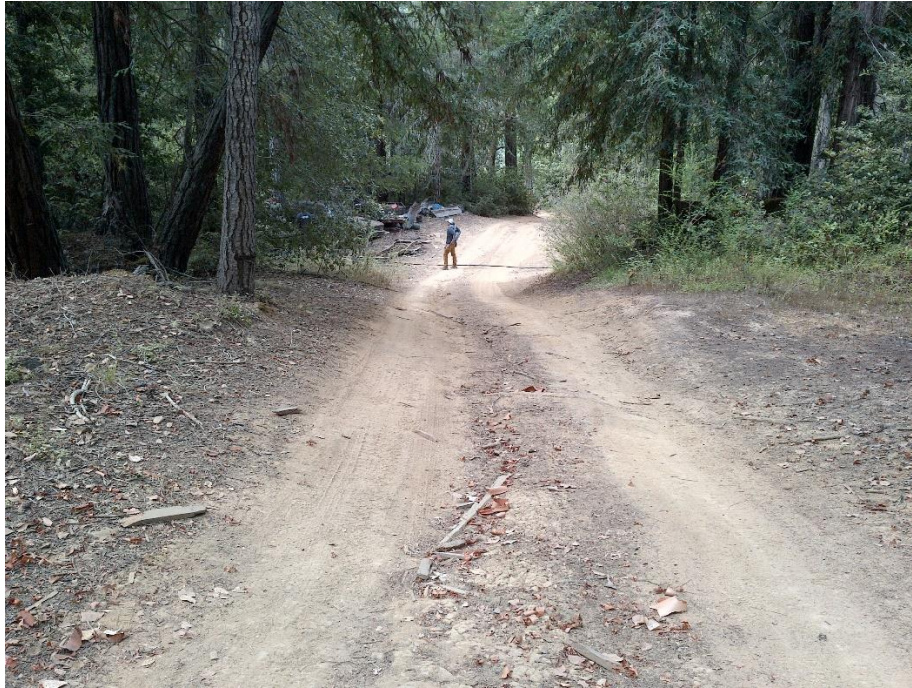
I drove south along a dirt road and observed scour marks on the road surface from where stormwater had concentrated. The road was shaped such that the concentrated stormwater would flow past parked vehicles in disrepair and toward a watercourse at WQ3. I observed another road segment fording a watercourse at WQ3. I continued south along the road from WQ2 and observed a dilapidated trailer at WQ4 with a watercourse to the east and cannabis cultivation area to the west. I walked northwest from WQ4 to WQ5 where I observed a road intersection at a watercourse.

Photo 5— Looking south along road in the vicinity of WQ2. A scour mark is visible in the middle of the road where stormwater had concentrated and flowed downslope and past vehicles pictured in the top left of the image.

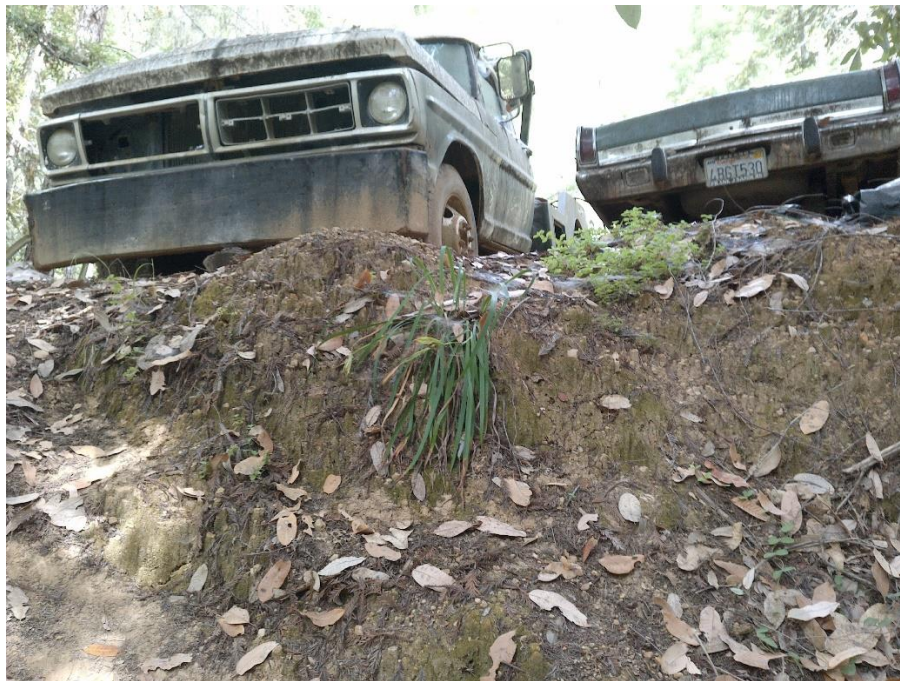
Photo 6—Looking west at Vehicles pictured in the top left of the previous image. Stormwater from the road will flow past the vehicles and to a watercourse to the back of the photographer at WQ3.

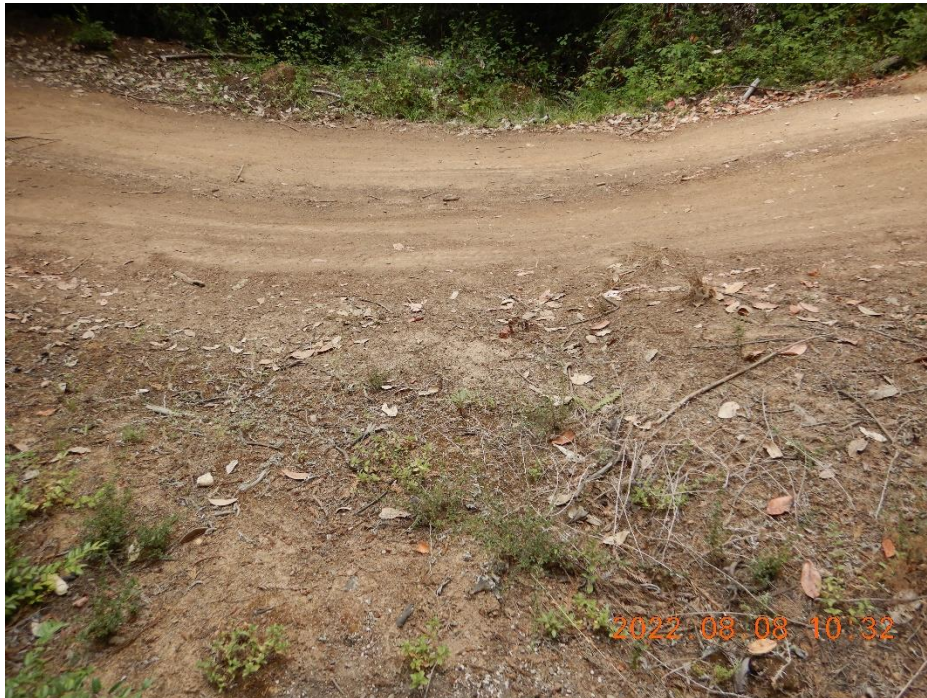
Photo 7—Looking south at a road fording a watercourse at WQ3. A channel scoured from concentrated stormwater is visible in the foreground of the image and the topographic form of a watercourse with a duff covered bed is visible below the road in the background of the image.

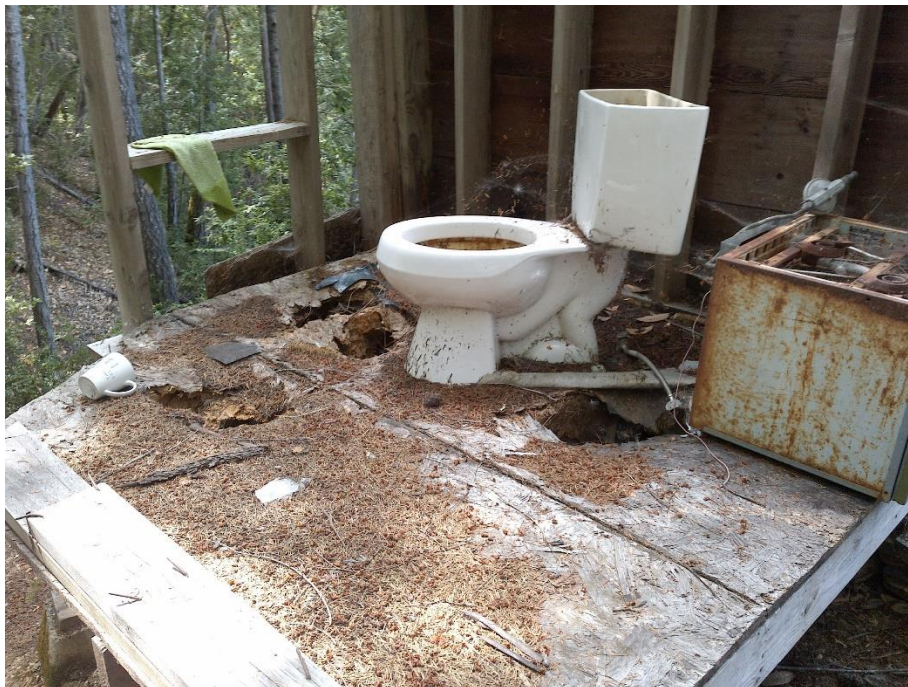
Photo 8—A flush toilet and waste from human habitation at WQ4. The topographic form of a watercourse is out of view behind the structure pictured in the image.

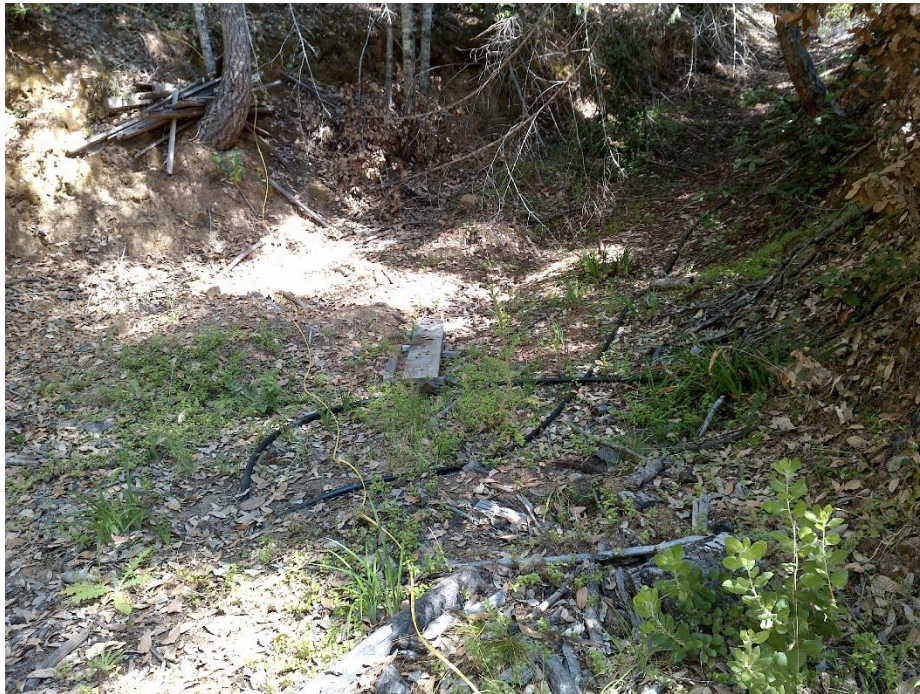
Photo 9—Looking north and upstream along a watercourse at WQ5.

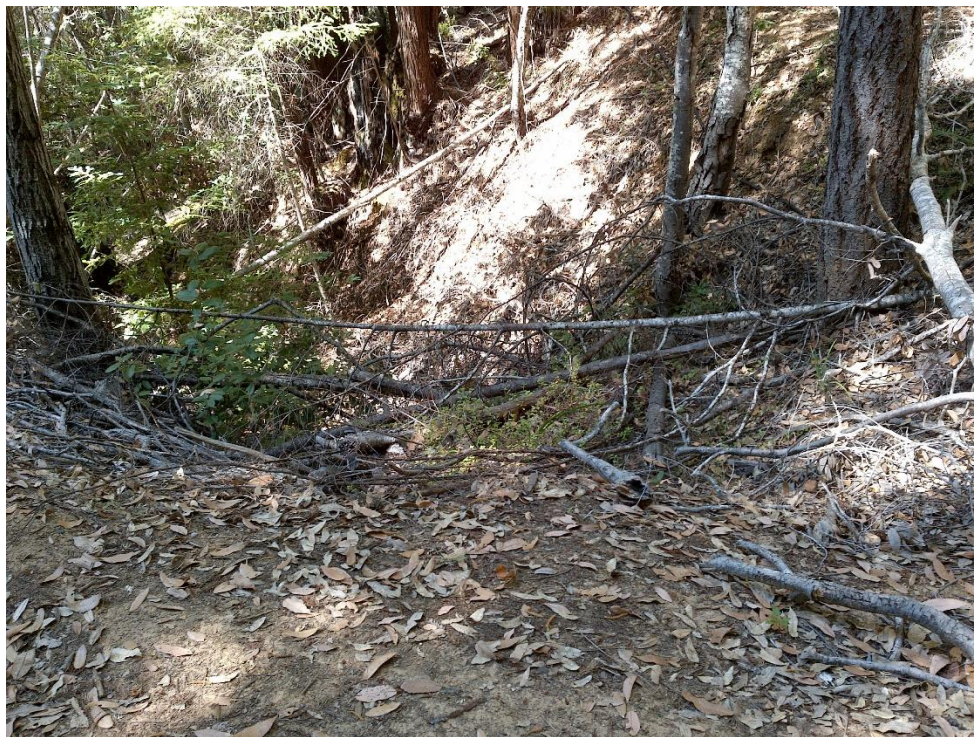
Photo 10—Looking west at WQ5, where the road fords the watercourse pictured in the previous image.

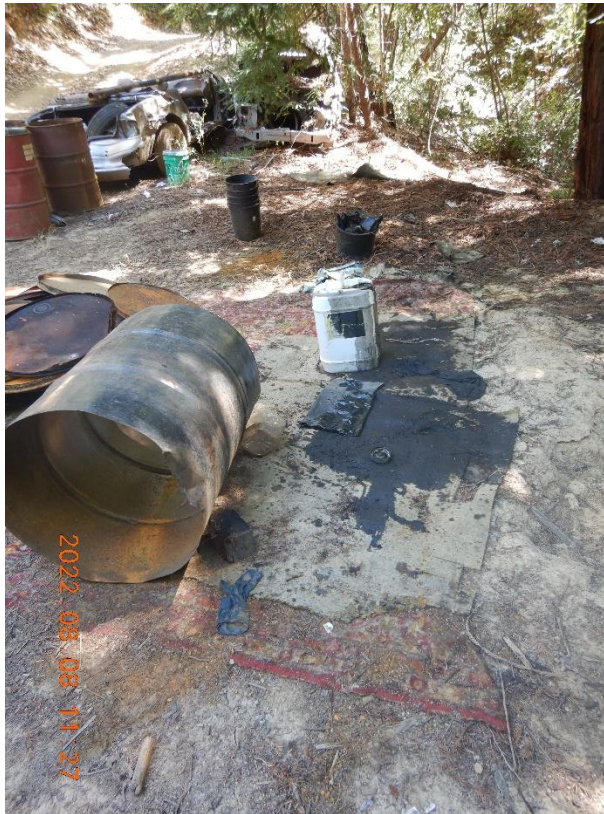
I then proceeded north to WQ6 where I observed several 55-gallon drums. Some of the drums were partially filled and petroleum products had been released to the ground from where they threaten to discharge to the neighboring watercourse at WQ7. I walked to WQ7 and observed that waste cannabis stalks had been disposed in the watercourse. I then walked west to WQ8 and observed more waste metal and an open 55-gallon drum that was more than half filled with a black oily fluid. These wastes threaten to discharge to another watercourse at WQ9.

Photo 11—Looking at an oil spill at WQ6. Several 55-gallon drums labeled with hydraulic fluid along with two damaged vehicles are visible in the back left of the image. A watercourse pictured in the following image is out of view to the back right.

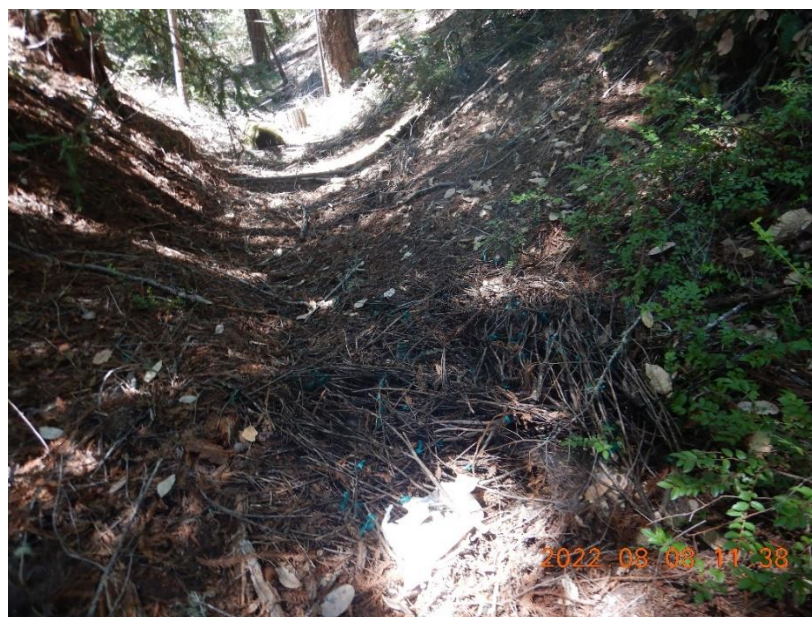
As documented in the report of the August 8, 2022 inspection, Staff observed: violations of the of the Basin Plan Section 4.2.1 Prohibition 2 at locations WQ2 through WQ5 and WQ10 for threatened discharge of sediment or construction related wastes to tributaries to the Little North Fork Navarro River; Staff observed large-scale cannabis cultivation and associated activities that were being conducted without first obtaining regulatory coverage for associated waste discharges, in violation of Water Code section 13260; Staff observed violations of the California Water Code section 13264 for unauthorized discharges of waste cannabis plants stalks into a tributary to the Little North Fork

Photo 12—Cannabis stalks in a watercourse at WQ7. The channel has the topographic form of a watercourse with a bed covered by duff and leaf-litter.

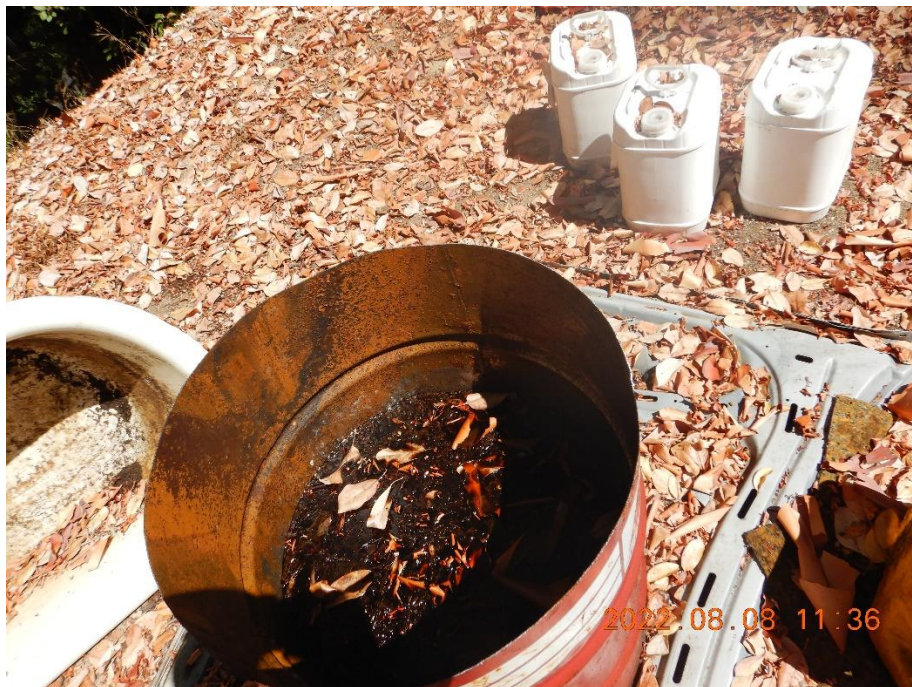
Photo 13—Uncovered 55-gallon drum containing an oily substance at WQ8.

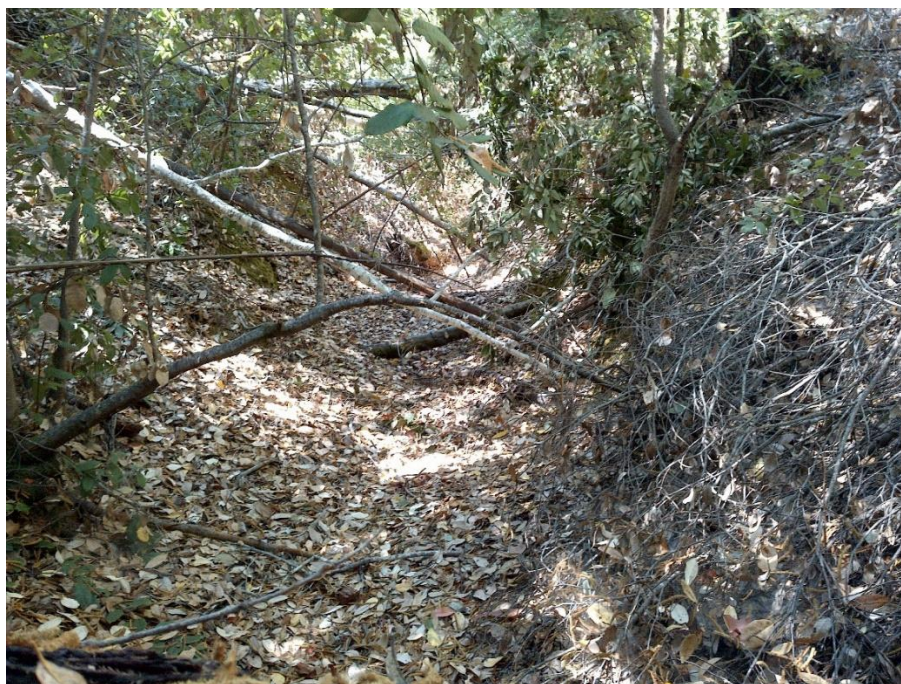
Photo 14—Looking south and downstream at watercourse at WQ9 located downslope from 55-gallon drum pictured in previous image

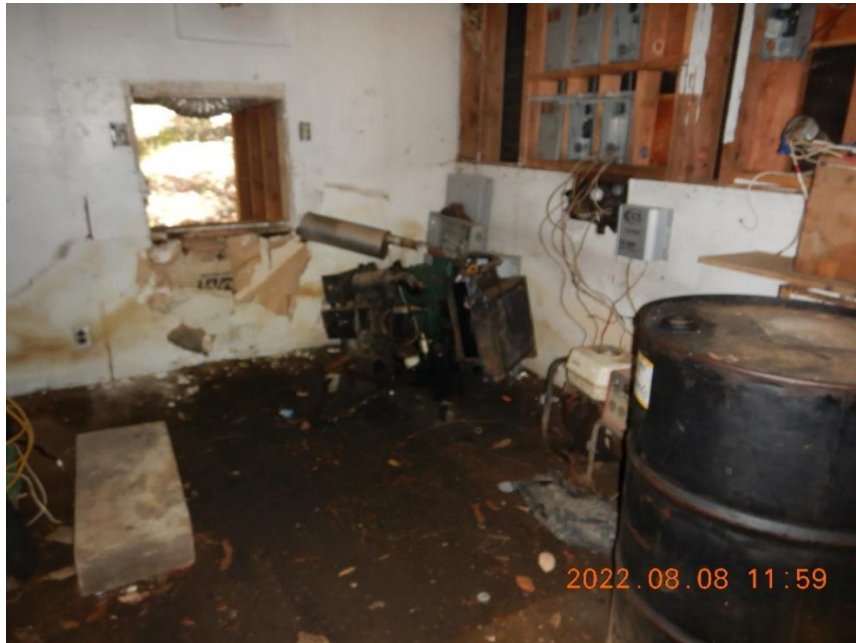
I then proceeded west to WQ10 where I observed a generator shed constructed above a watercourse. I observed petroleum products stored without adequate secondary containment and other wastes at the generator shed which threatened to discharge to the watercourse.

Photo 15—Looking inside generator shed located at WQ10. The wooden floor is stained with oil.

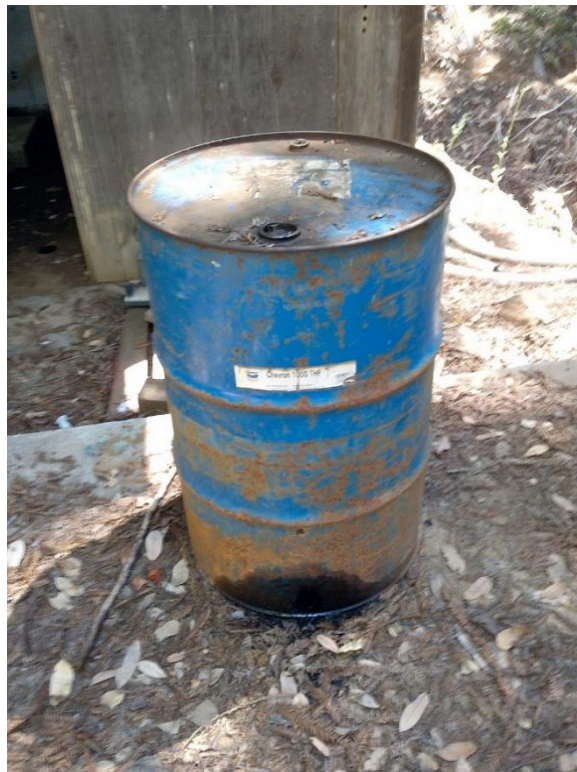
Photo 16—Looking east at a leaking 55-gallon drum outside of the generator shed at WQ10. The drum is on top of a piece of plywood and surrounded by leaf litter. Oil is visible on the ground at the bottom of the drum.

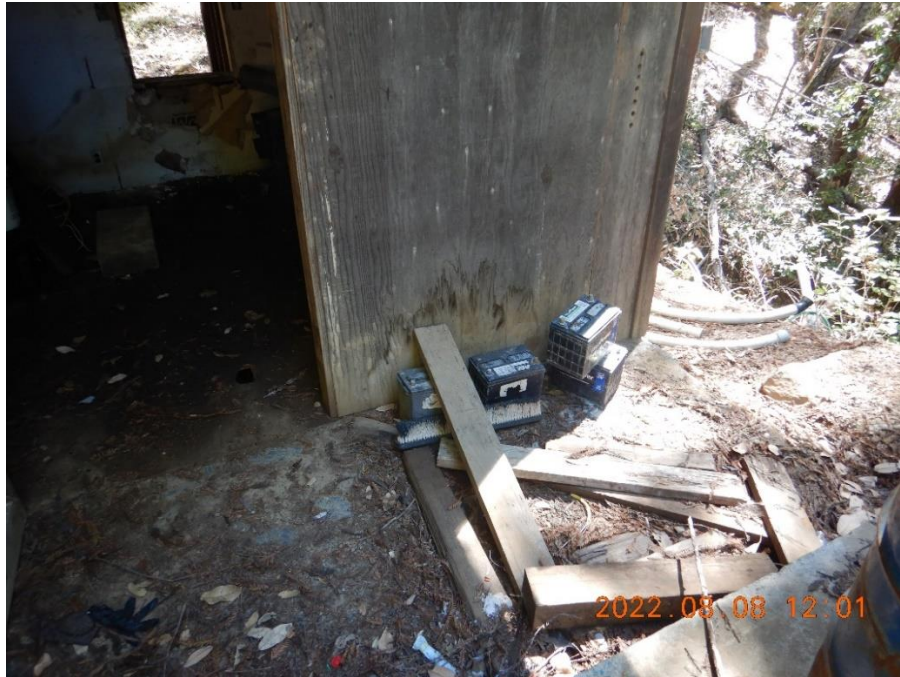
Photo 17—Looking at the area between the shed and drum pictured at WQ10 in the previous image. The drum is visible in the bottom right of the image and the receiving watercourse is visible in the top right.

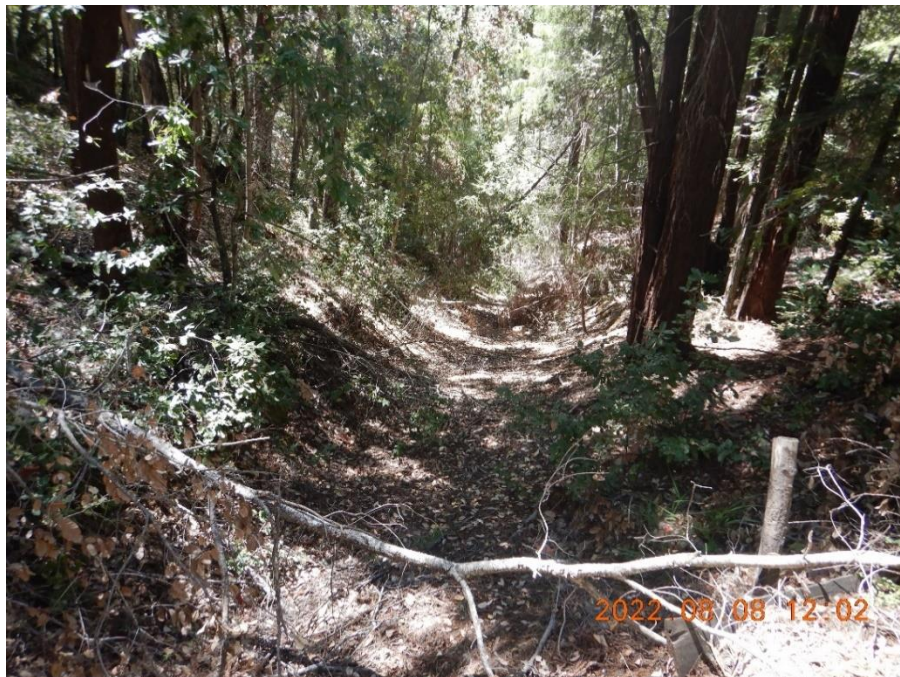
Photo 18—Looking south at watercourse at WQ10. The generator shed pictured in the previous three photos is behind the photographer.
