**Subject: Notice of Violation, Transmittal of Report for September 12, 2022
Inspection of Mendocino County Assessor's Parcel Numbers 038-121-12-00 and 038-121-14-00**

**Inspection Report for September 12, 2022 Warrant Inspection,
Mendocino County
Assessor's Parcel Numbers (APN) 038-121-12-00 and 038-121-14-00
(the "Property")**

File: Cannabis Program Inspections, Mendocino County, 2022, Tomes and Powers, CIWQS Place ID 883661

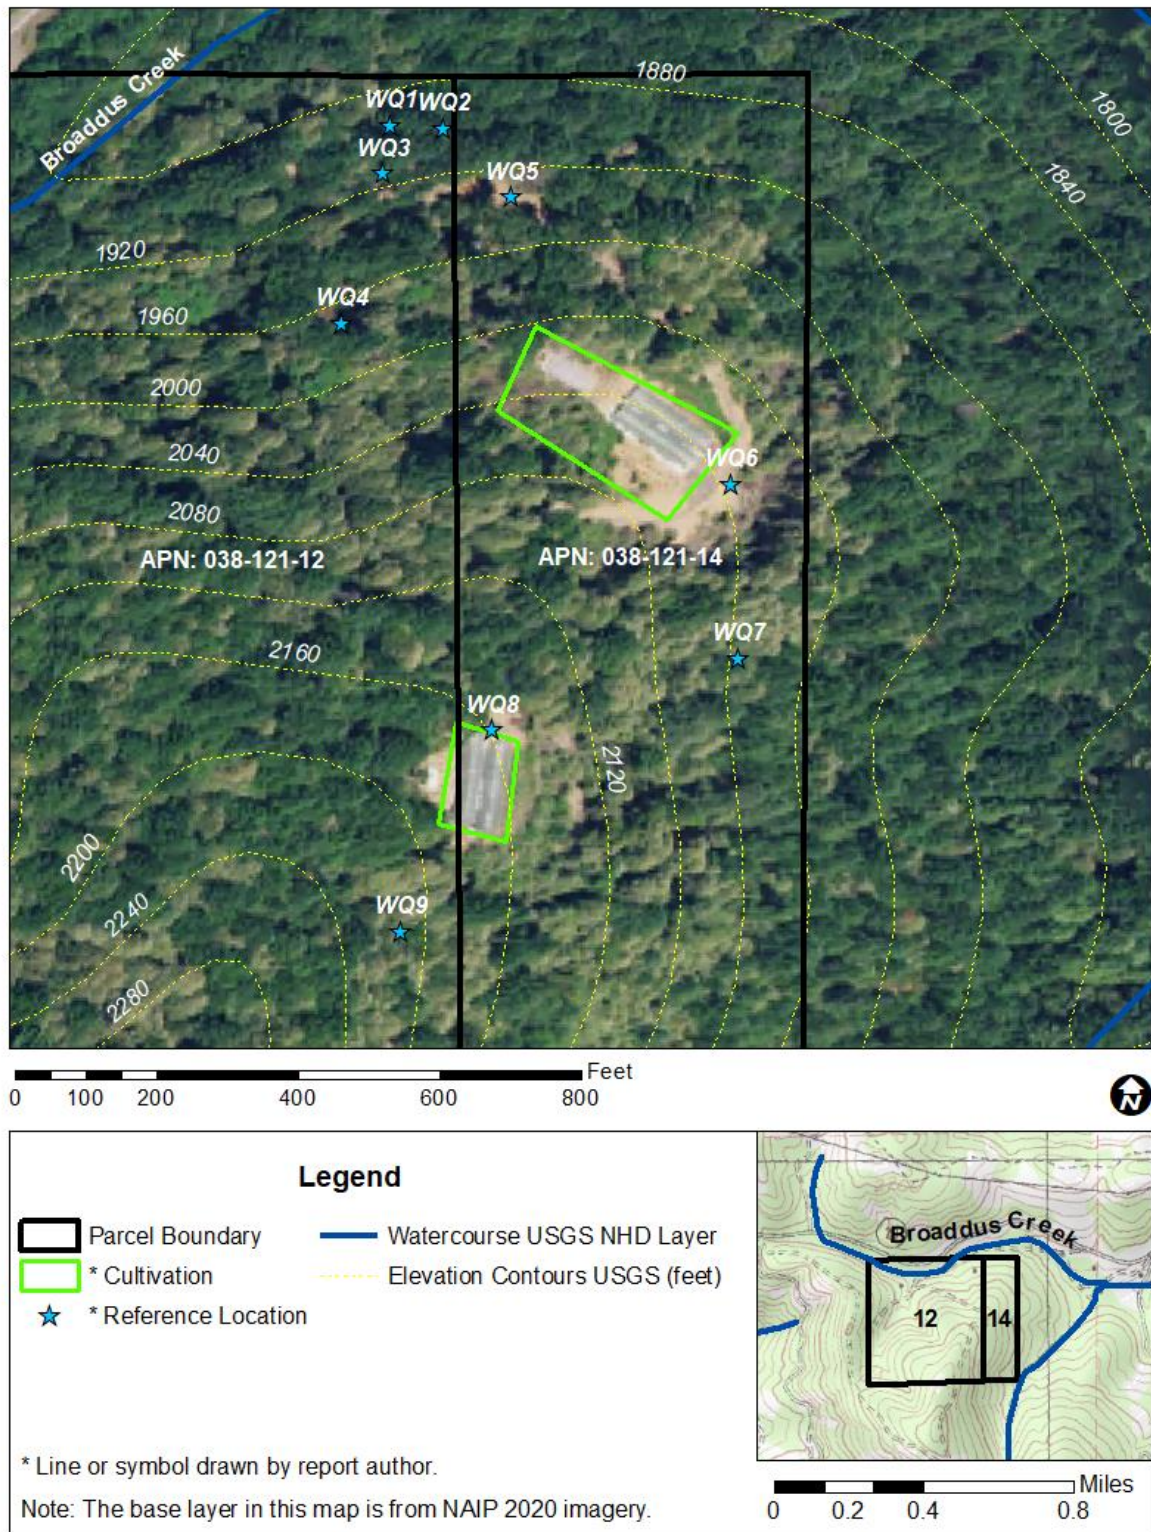
Figure 1: Aerial image/map showing inspection points discussed in this report.

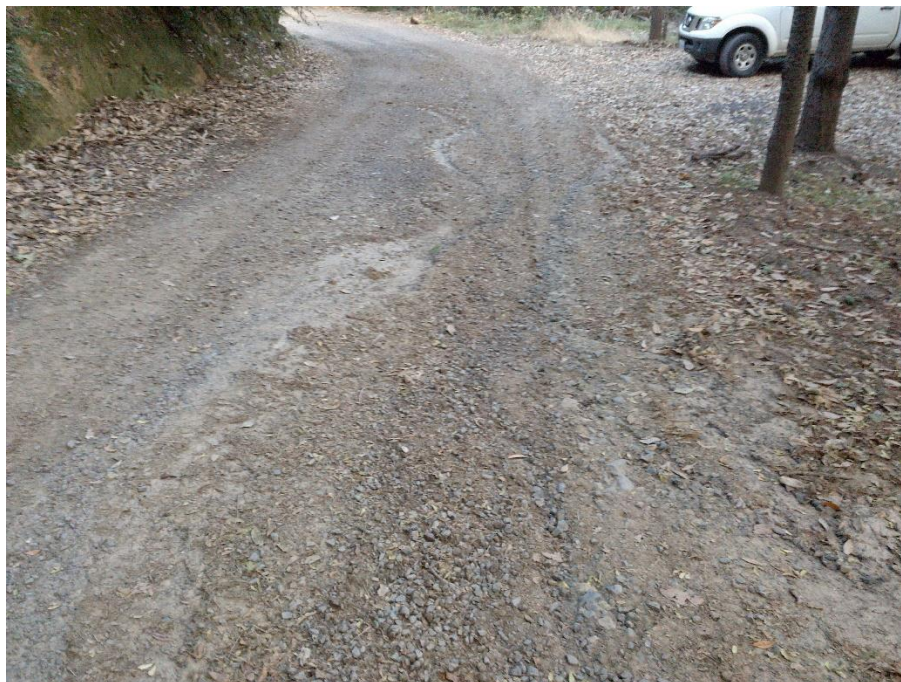
Photo 1—Looking north along the road accessing the property west of WQ1. Sinuous scour marks on the road surface are visible in the middle of the image.

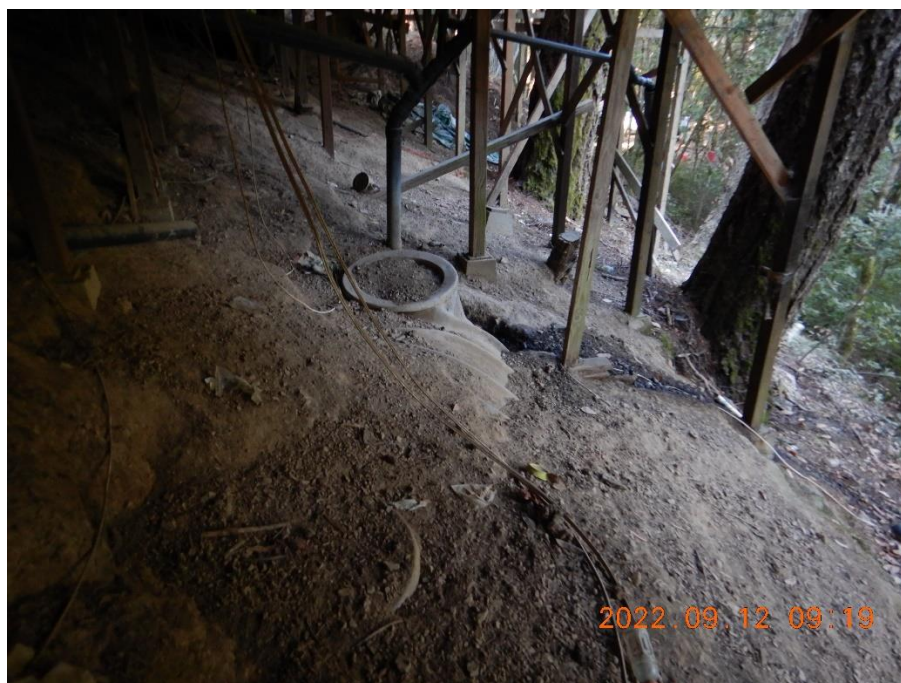
Photo 2—Looking west at WQ1. A partially buried septic tank is visible in the middle of the image.

1. Immediately cease the discharge of sewage to land, implement corrective actions, and obtain the appropriate county permit for the disposal of on-site wastewater (i.e., septic system permit).
2. Retain a licensed professional to investigate the extent of contaminated soil associated with the spilled petroleum products and develop a workplan and schedule for cleaning up the spill.
3. Immediately collect all refuse and wastes and properly dispose of these wastes at a licensed waste collection facility.
4. Retain a licensed professional to inventory, assess, and develop a workplan and schedule to implement measures to ensure that all developed features, roads, watercourse crossings, and cultivation areas throughout the Property are corrected,

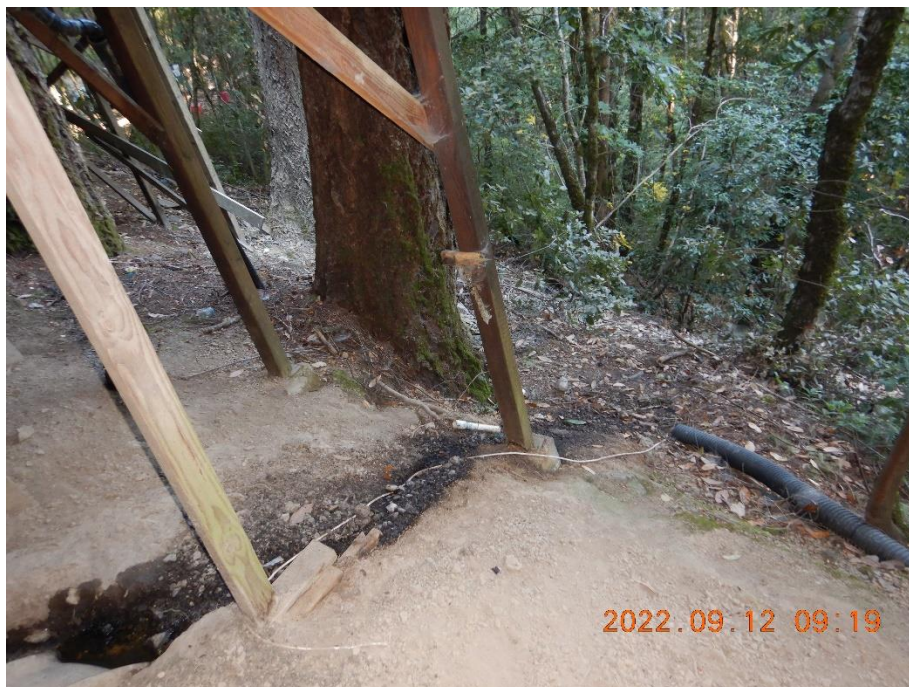
Photo 3—Looking north from WQ1. Sewage is visible leaking from the septic tank in the lower left of the image and flowing north toward Broaddus Creek which is out of view to the right of the image.

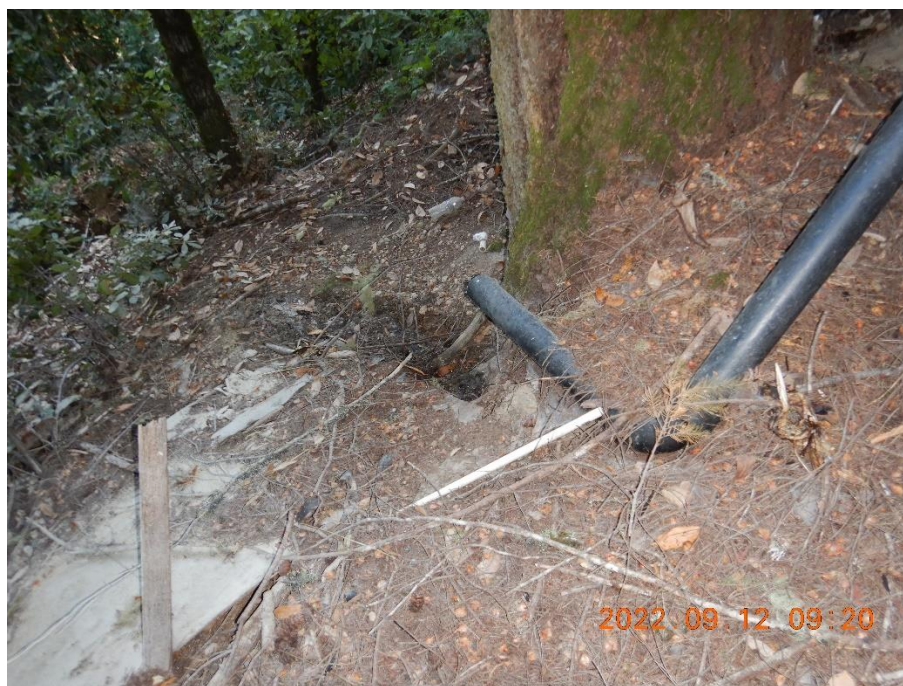
Photo 4—Looking north-east in the vicinity of WQ1. The leaf litter is darker in the middle of the image where a black pipe discharges waste water from the residence.

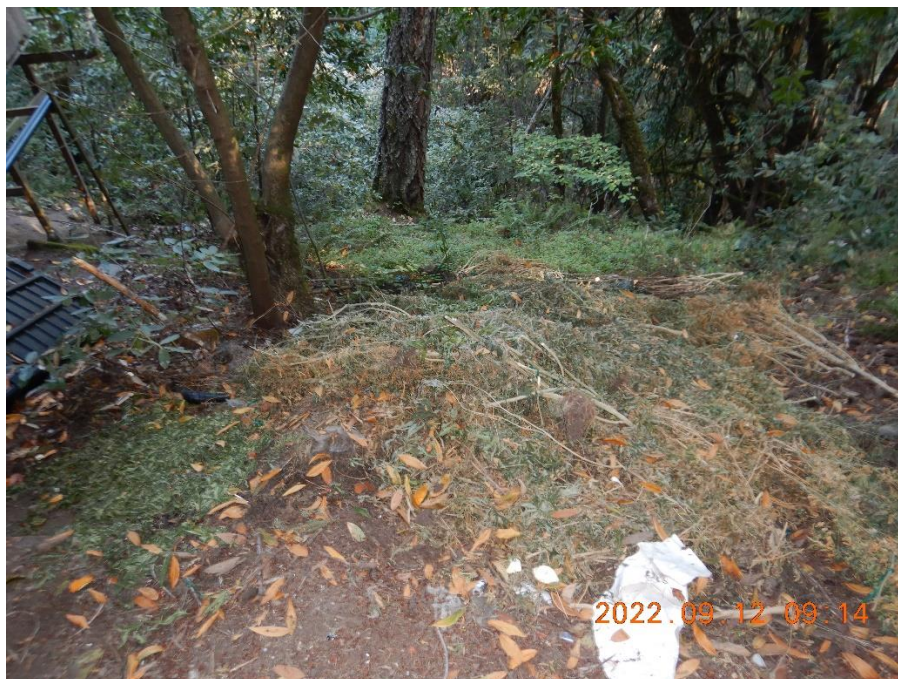
The inspection was associated with a criminal search warrant, and I viewed only portions of the Property. See the above Inspection Map and below Photo Appendix for locations and details about features of concern to water quality. I entered the northeastern portion of APN 038-121-12-00 from the north and observed scour marks on the road surface west of WQ1. I walked behind a residence in the vicinity of WQ1, detected the odor of sewage and observed a septic tank overflowing and discharging onto the hillslope to the north in the direction of Broaddus Creek. I observed trimmed cannabis waste east of the residence at WQ2.

Photo 5—Looking north in the vicinity of WQ2. A pile of cannabis cultivation waste, including plant stalks, covers a 10-foot by 16-foot area on the hillslope south of Broaddus Creek.

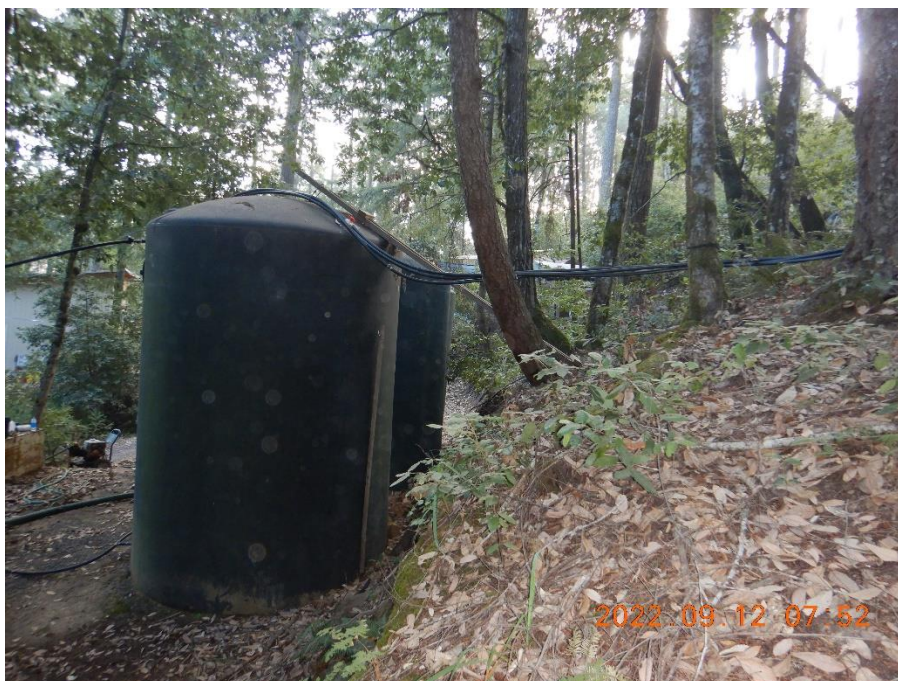
Photo 6—Looking east from WQ3. Water tanks with black water lines extending from the top of the tanks to the south, (right side of the image).

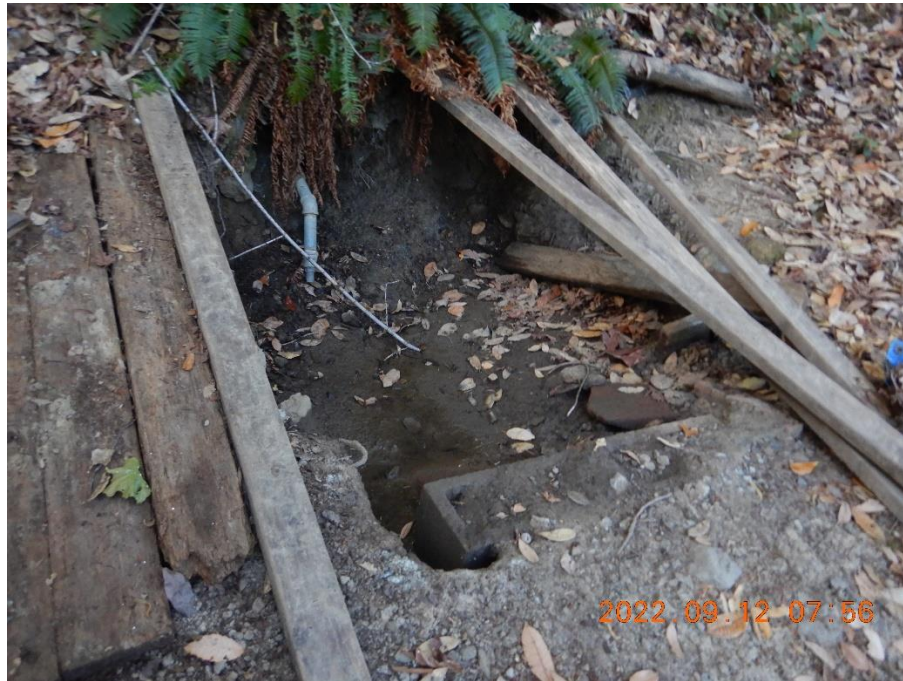
South of the residence at WQ3, I observed a pump and water tanks and followed a waterline that was connected to the top of the tanks south to WQ4. At WQ4 I observed the topography formed a gentle swale that hosted a higher concentration of ferns than the surrounding area. I observed three shallow pits that had been excavated in the saturated ground and had waterlines leading to WQ3.

Photo 7—Looking south at WQ4. One of several pits excavated to access shallow groundwater.

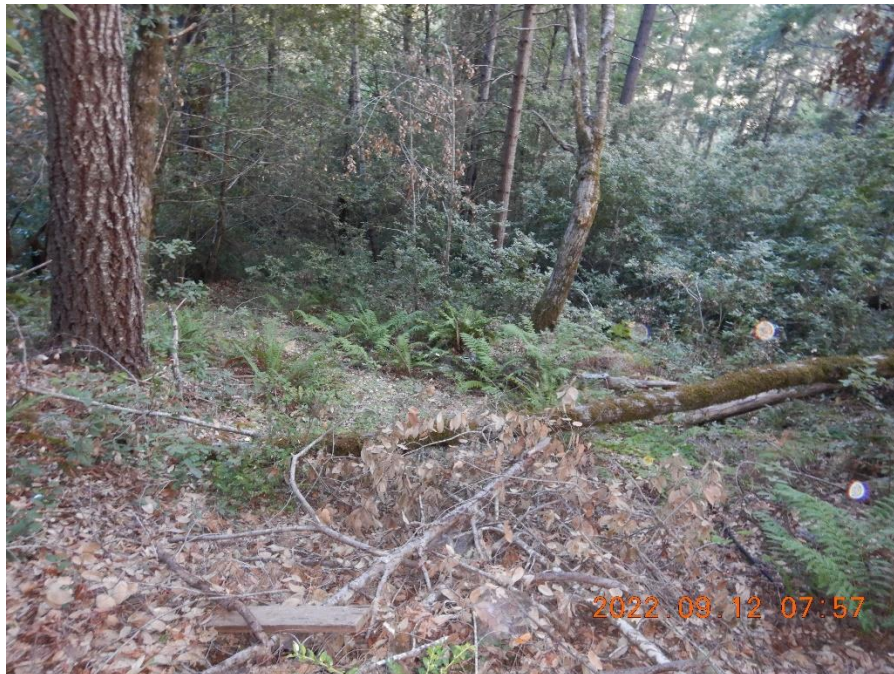
Photo 8—Looking north from WQ4. There is no surface water visible immediately downslope from the excavated pits that are behind the photographer.

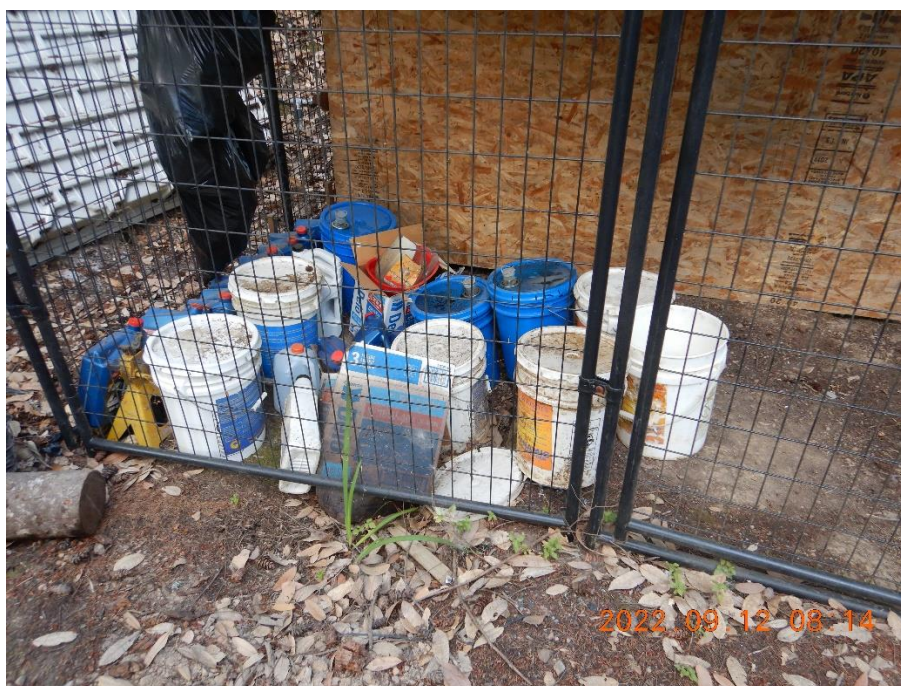
Photo 10—Closer view of the shed pictured in the previous image at WQ5. Petroleum products are being stored without secondary containment.

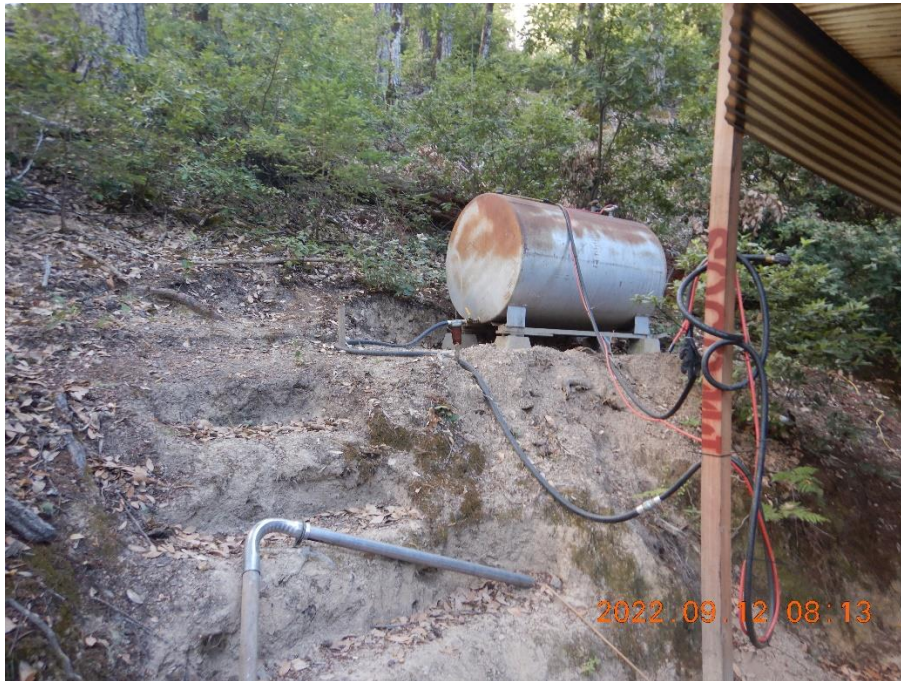
Photo 11—Looking south from WQ5 at a fuel storage tank.

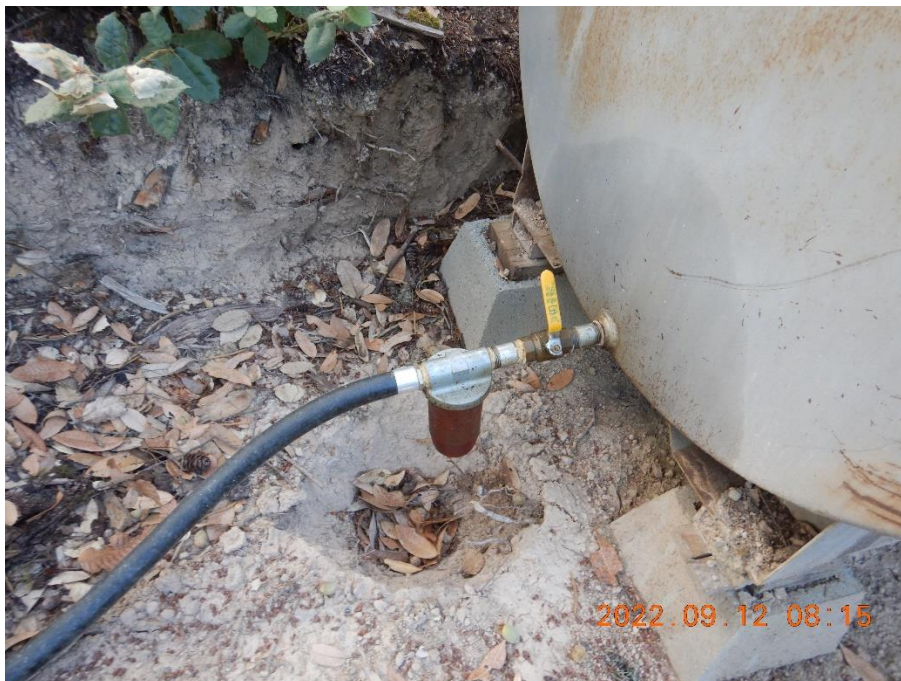
Photo 12—Fuel storage tank pictured in previous image. The fuel tank does not have secondary containment.

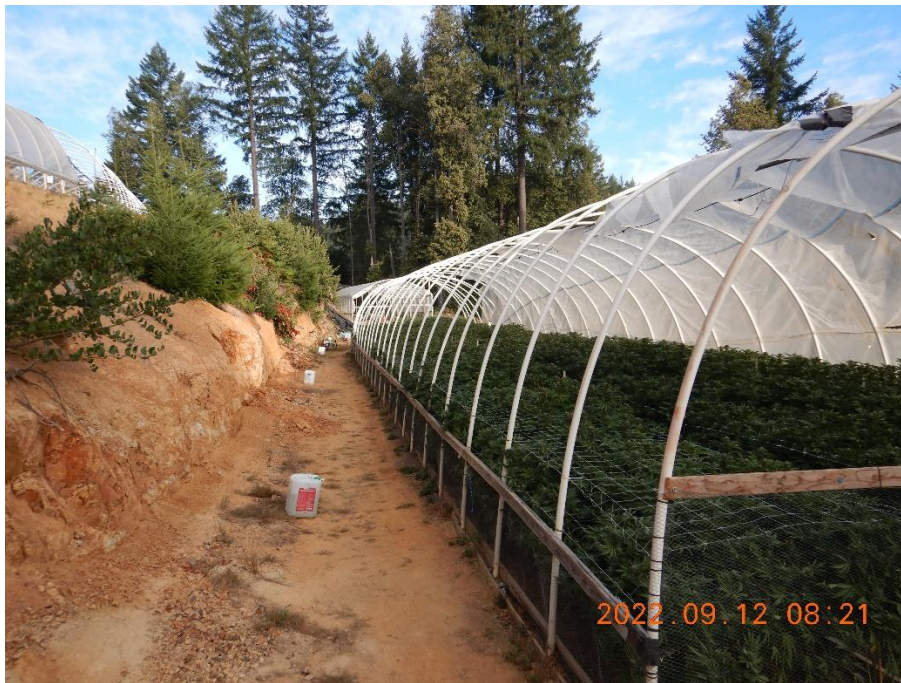
I followed the road to the south and observed terraced cultivation pads at WQ6 with hoop-type greenhouses covering an area exceeding 10,000 square feet. I observed wheel ruts on the dirt road in the vicinity of WQ6. I observed an area east of WQ6, between WQ6 and WQ7 where cultivation waste had been dumped. I continued following the road to the south and observed a pad with hoop-type greenhouses covering approximately 10,000 square feet at WQ8. I observed tension cracks and slope failures along the fill-slope's face of one of the pads. I observed water tanks and agricultural chemicals at WQ9 used to irrigate the cannabis cultivation at WQ8.

Photo 13—Looking west from WQ6 at terraced pads with cannabis hoop-type greenhouses.

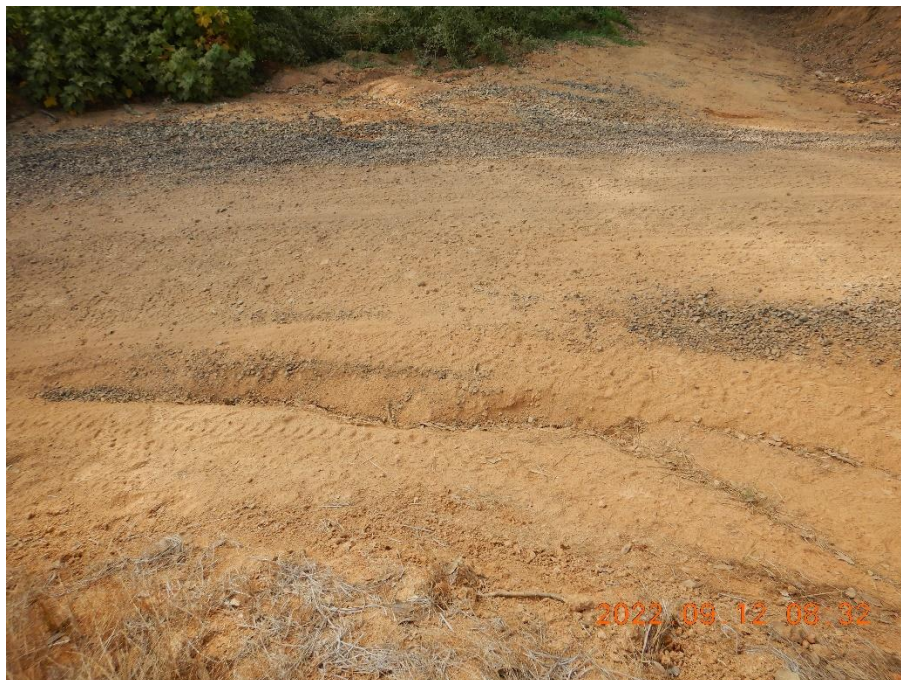
Photo 14—A road in the vicinity of WQ6. Ruts are visible on the road surface.

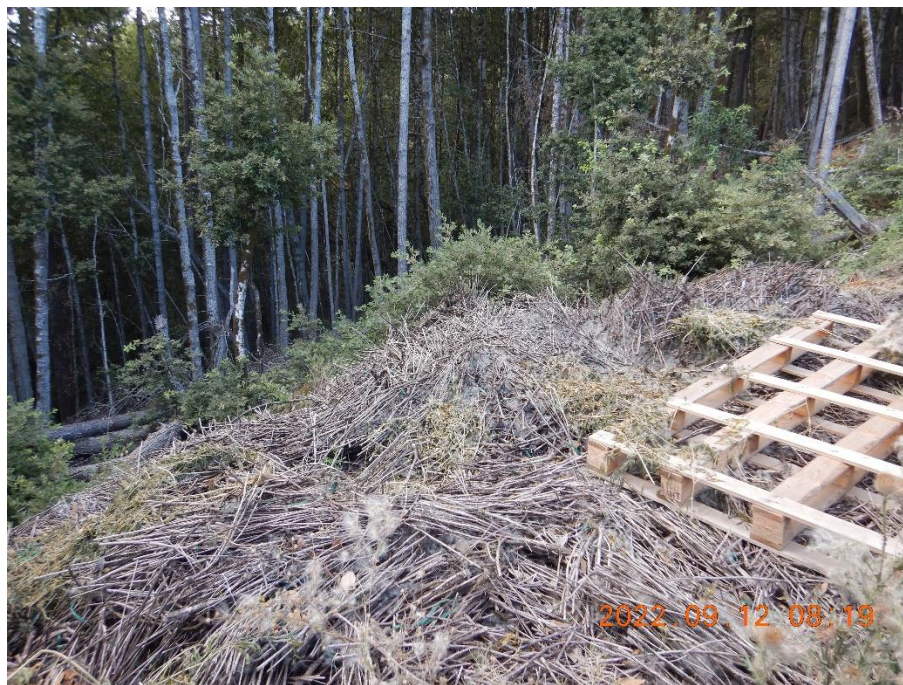
Photo 15—Waste cannabis stalks on the hillside east of the road in the vicinity of WQ6.

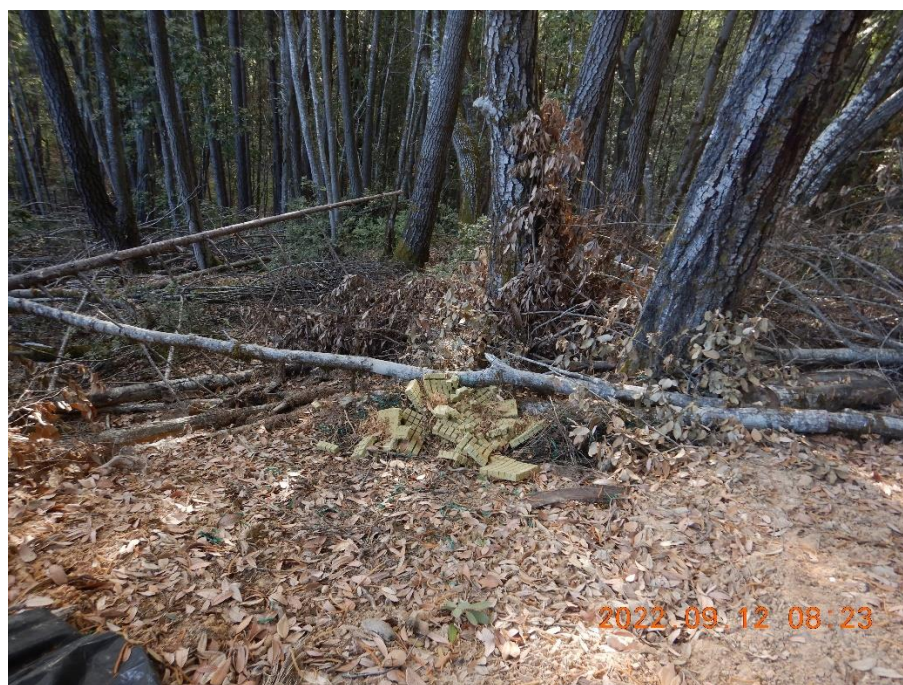
Photo 16—Cannabis cultivation waste, including plant growth media between WQ6 and WQ7.

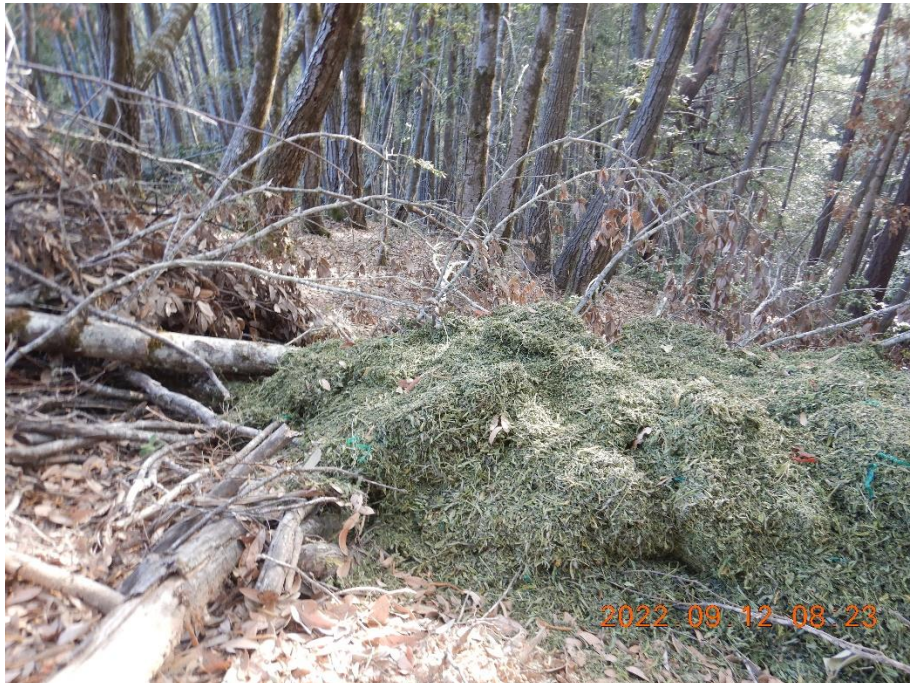
Photo 17—Cannabis cultivation waste between WQ6 and WQ7.

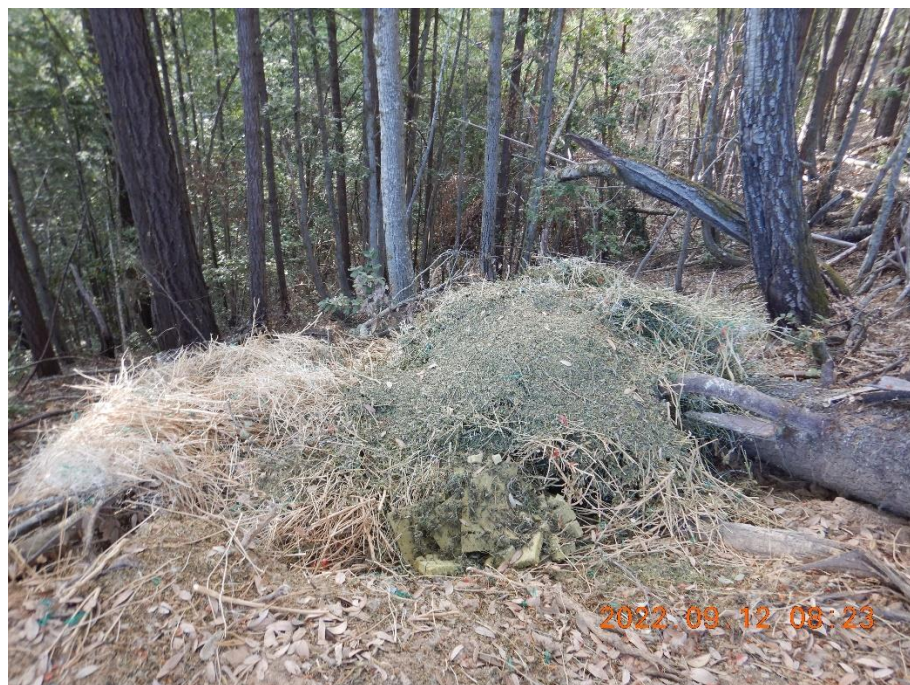
Photo 18—Cannabis cultivation waste between WQ6 and WQ7.

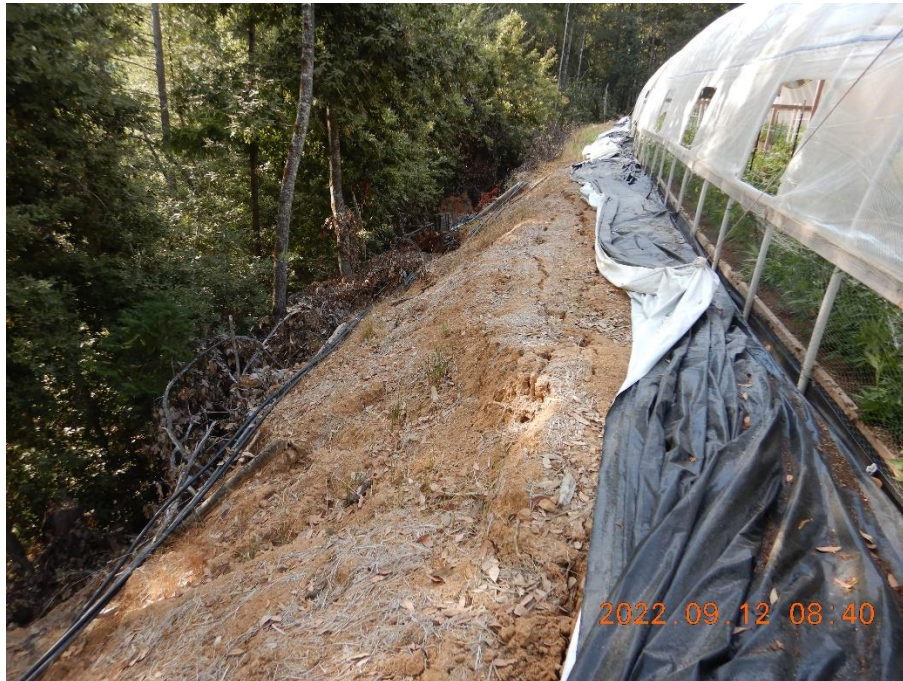
Photo 19—Looking south along the eastern edge of a terraced pad at WQ8. Tension cracks are visible along the top of the slope face and the area of the slope face visible in the bottom middle of the image displays a concave-up shape resulting from a previous slope failure.

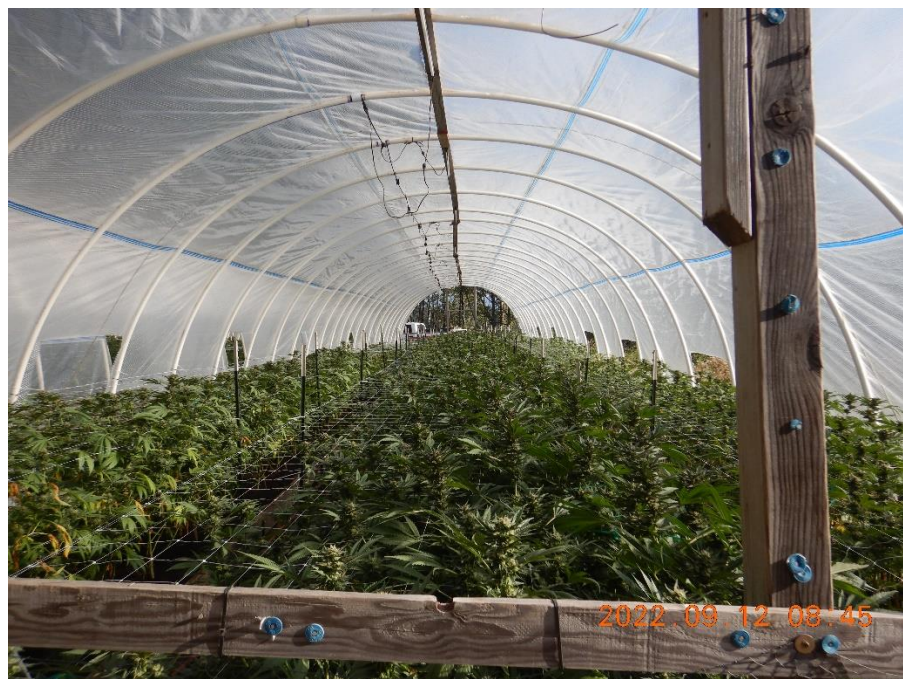
Photo 20—Cannabis plants growing in a hoop-type greenhouse at WQ8.

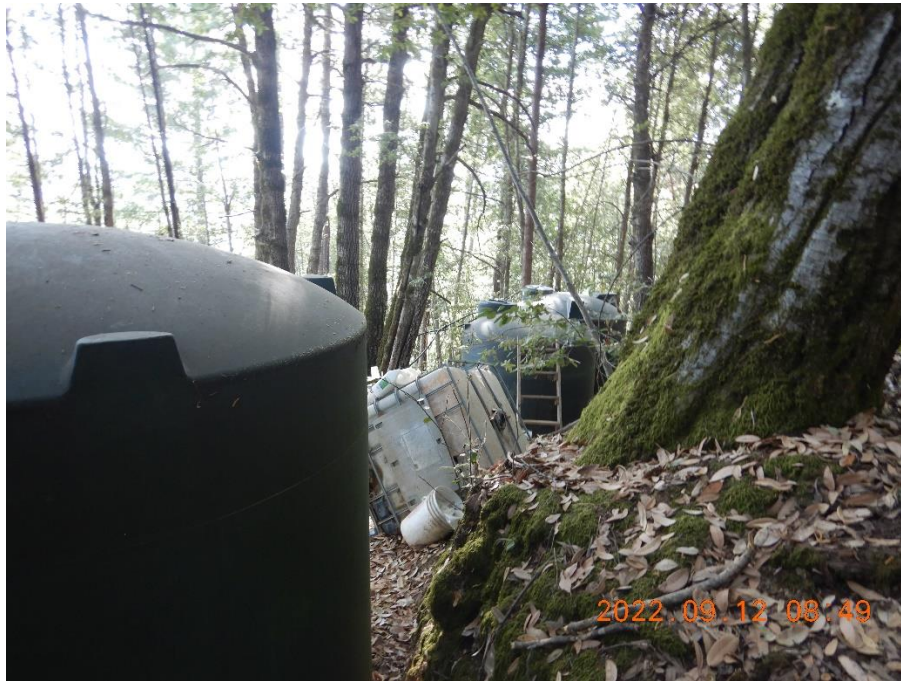
Photo 21—Water tanks located at WQ9.

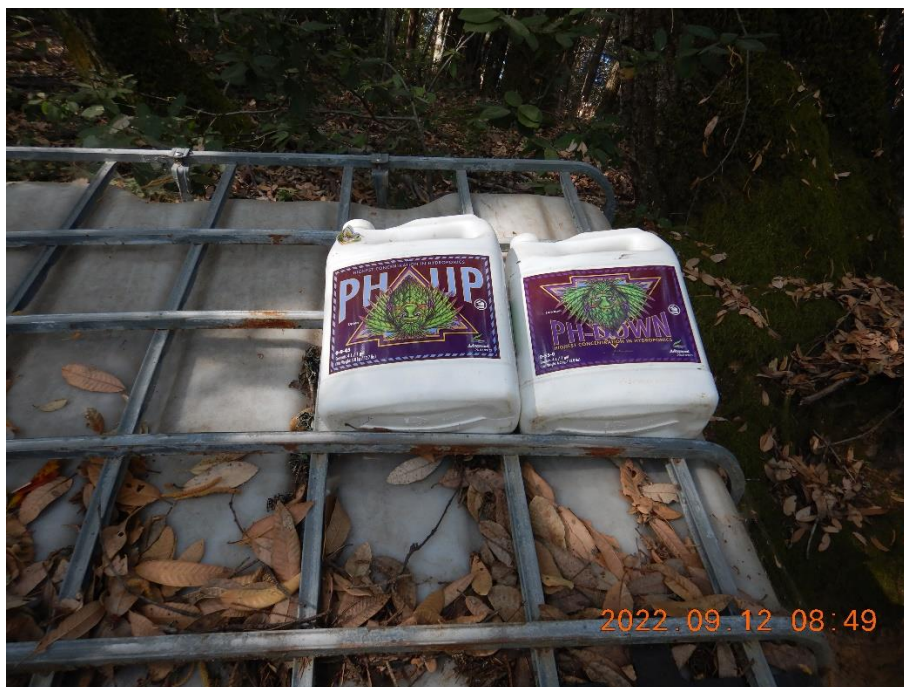
Photo 22—Agricultural chemicals at WQ9.
