**Subject: Notice of Violation, Directive to Obtain Regulatory Coverage for discharges to waters of the state, and transmittal of Site Inspection Memo, Wills Property, 4898 Fickle Hill Road, Arcata, CA.**

### Inspection Memo

**Subject:** October 4, 2022, inspection of Assessor's Parcel Number (APN) 502-091-013-000

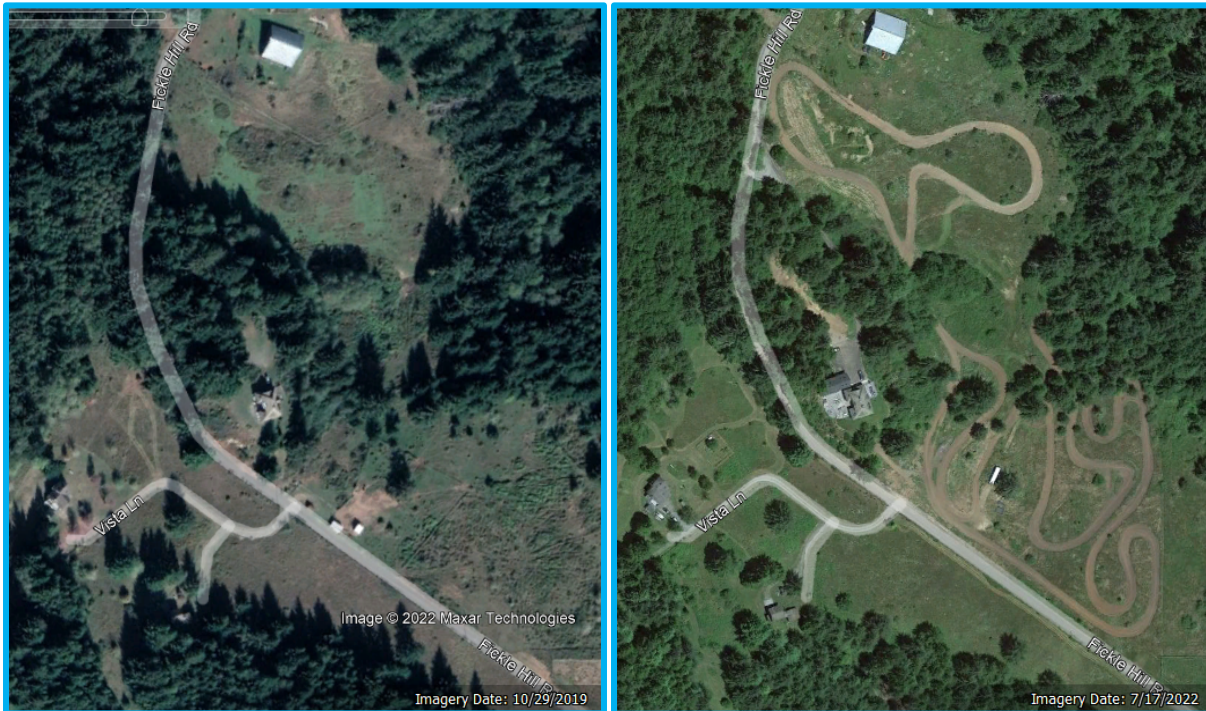
Review of historic imagery available on Google Earth shows road development on the property (Figures 2a and 2b). Road appears to have been installed in 2022 after property sale.

Figures 2a and 2b. Google Earth imagery from 2019 and 2022 showing extent of road development on property. Figure 2a from October 29, 2019, and Figure 2b from July 17, 2022.

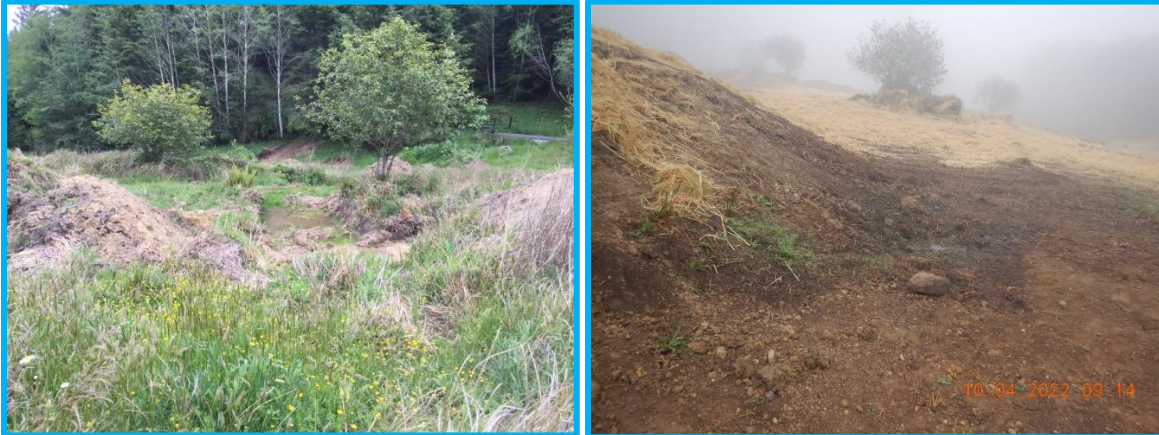
permit. Additionally, after comparing CDFW's photographs taken during their May 27, 2022 site visit with current on-site conditions, it appears earth moving activities have continued and expanded in area and extent (Photographs 1a and 1b). Straw was spread over much of the northern slope to provide erosion control.

Photographs 1a and 1b. Photographs showing ongoing and increased extent of ground disturbance on northern slopes. Photograph 1a taken May 27, 2022 by Kalyn Bocast, CDFW and Photograph 1b taken during October 4, 2022 site visit by Amanda Piscitelli. Note fill adjacent to standing water and possible wetland vegetation in 1a and seep and sedges at base of jump in 1b. Both photographs taken in same general location.

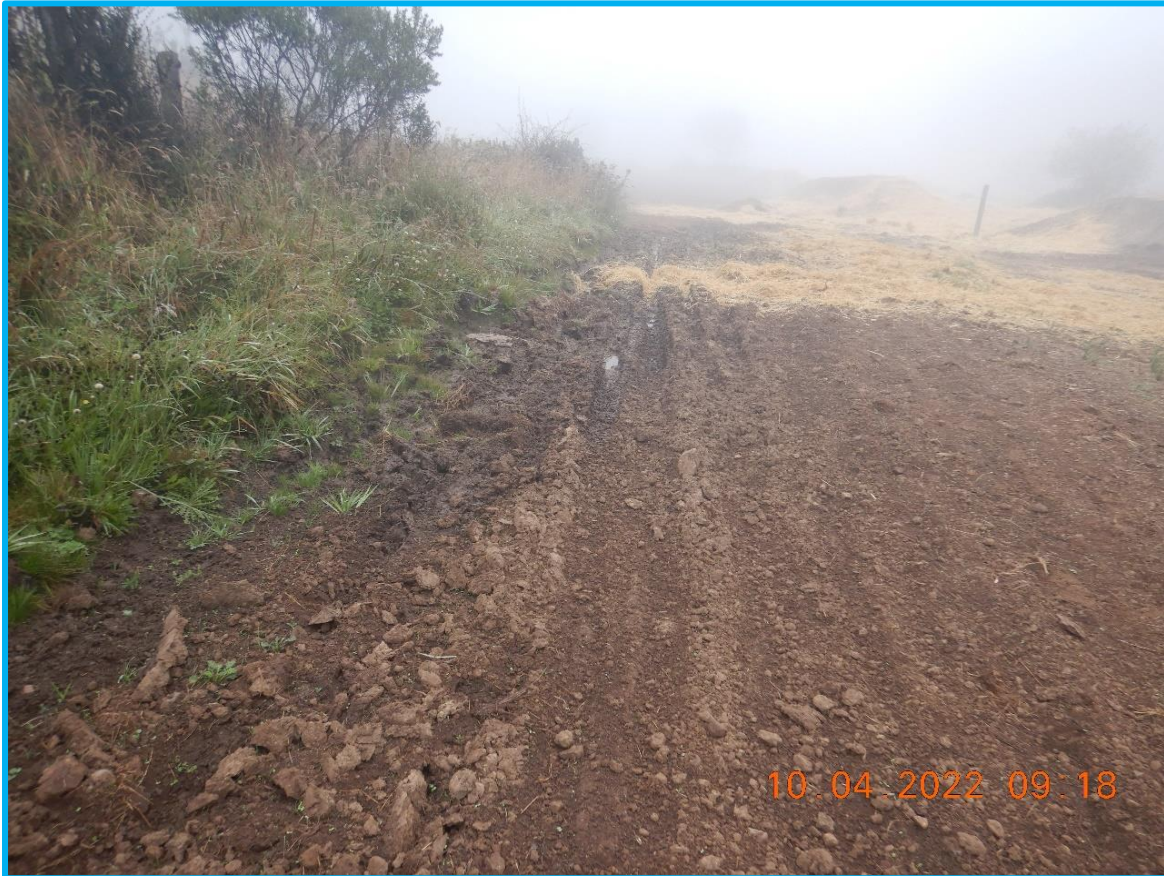
While assessing the dirt track, I observed heavy equipment tracks on portions of its surface. The surface was loose and unstable (Photograph 2). Mr. Wills informed the group the dirt tracks are tilled regularly, often as frequently as prior to each use because the loosened earthen material creates a more desirable running surface that improves the overall riding experience. The Mad River and its tributaries are Clean Water Act Section 303(d) listed as impaired for excess sediment. Fine sediment also negatively impacts wetlands. Tilling loosens the track's earthen surface and generates fine sediment. Portions of the dirt track matrix are hydrologically connected to possible wetlands and Puter Creek. During rainfall events, the freshly tilled track surface will erode, and fine sediment will likely discharge into adjacent waters of the State.

Photograph 2. Recently tilled dirt track. Note seep, ponded water, small sedges and rushes along track's edge. Note also graded jumps in background. Photographed by Amanda Piscitelli.

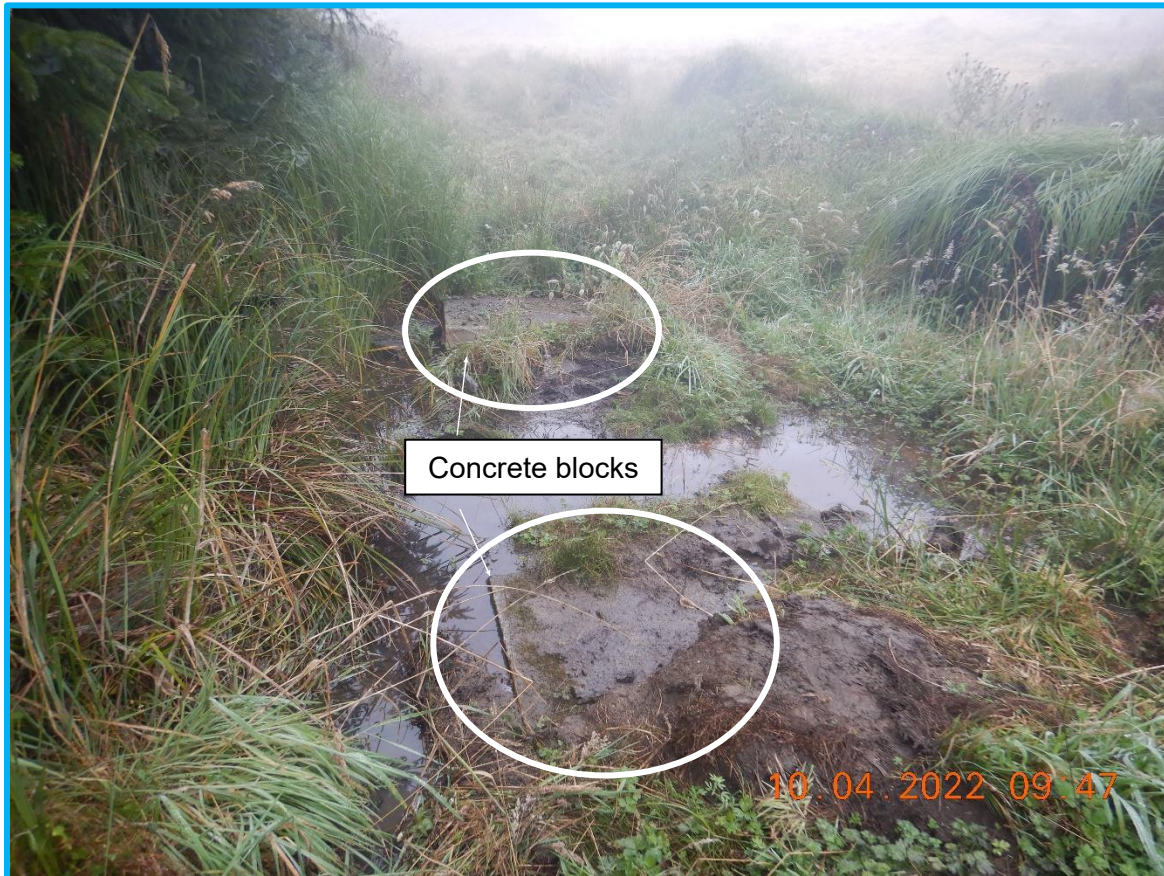
During the site visit I inspected an unpermitted wet crossing located at the upper reaches (headwaters) of Puter Creek. The trail leading to the crossing is not well maintained and partially vegetated. Mr. Wills informed the group the crossing was installed by the previous landowner, but that it is not currently used as a motorcycle crossing. While no distinct bed, bank or channel was identifiable at the crossing, the area was saturated and standing water was present. I observed approximately four concrete slabs in the wetted area intended to create a crossing. Each slab appeared to be approximately 4 feet by 5 feet (Photograph 3). Vegetation at the site included sedges (*Carex spp.*), rushes (*Juncus spp.*) and red alders (*Alnus rubra*). Overall site conditions indicate the likely presence of wetlands. Concrete has the capacity to alter the pH of downstream waters and negatively impact beneficial uses of water. Regional Water Board does not typically permit projects authorizing placement of concrete blocks in a wetted channel as a crossing. The debris should be removed from waters of the state during the 2023 construction season.

Photograph 3. Concrete slab pieces used for crossing in Puter Creek headwaters. The headwaters flow downstream to the right. Photographed by Amanda Piscitelli.

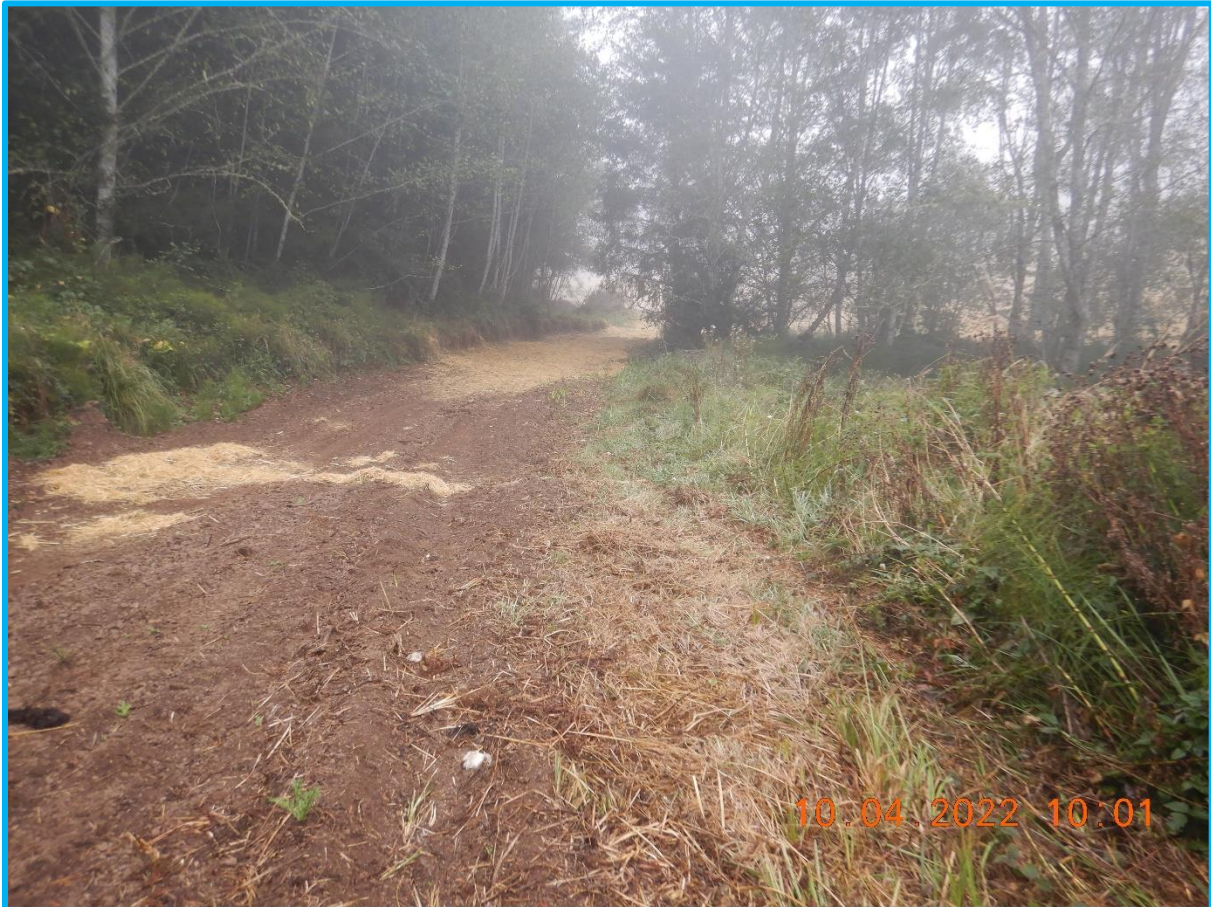
At the upstream end of the headwaters of Puter Creek is a dirt road approximately 20 feet wide. I observed sedges, rushes, horsetail (*Equisetum spp.*), and red alders on either side of the road suggesting the likely presence of wetlands. It appears portions of the road are also hydrologically connected to Puter Creek headwaters. During the site visit, Mr. Wills stated this was an existing road that he re-opened. The road appeared freshly graded/tilled. Portions of its surface were partially covered with straw to prevent erosion. The recently graded road surface is likely to erode during rain events. Because portions of the road are hydrologically connected, erosion will likely discharge eroded fine sediment into waters of the State, including possible wetlands and Puter Creek. It does not appear this rural road is being maintained to current acceptable standards.

Photograph 4. The track/road upslope of Puter Creek headwaters. Note vegetation indicating possible wetlands. Note also straw partially covering road's surface. Photographed by Amanda Piscitelli.

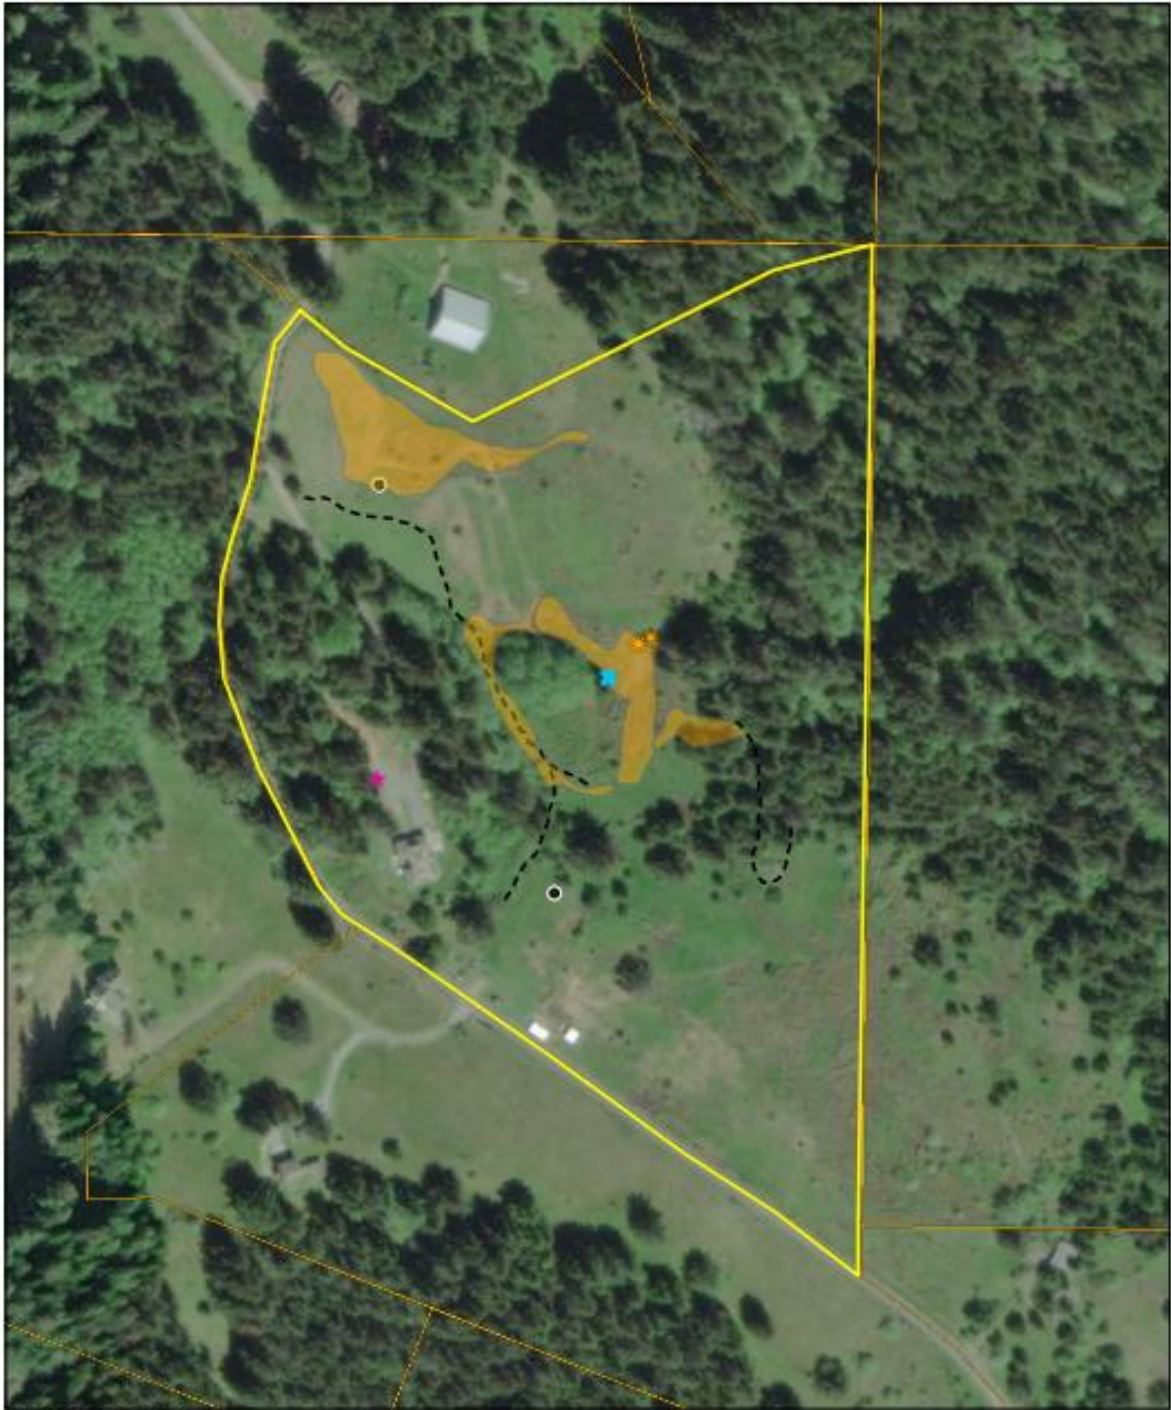
Please see the site map (Figure 1.) that includes graded wet areas (yellow polygon), a portion of the newly graded road (black hashed line), unpermitted stream crossing (blue x), and species observations (yellow star). Photographs of site observations have also been included for your reference.

Figure 1: Map of parcel with field observations (identified areas of disturbance).

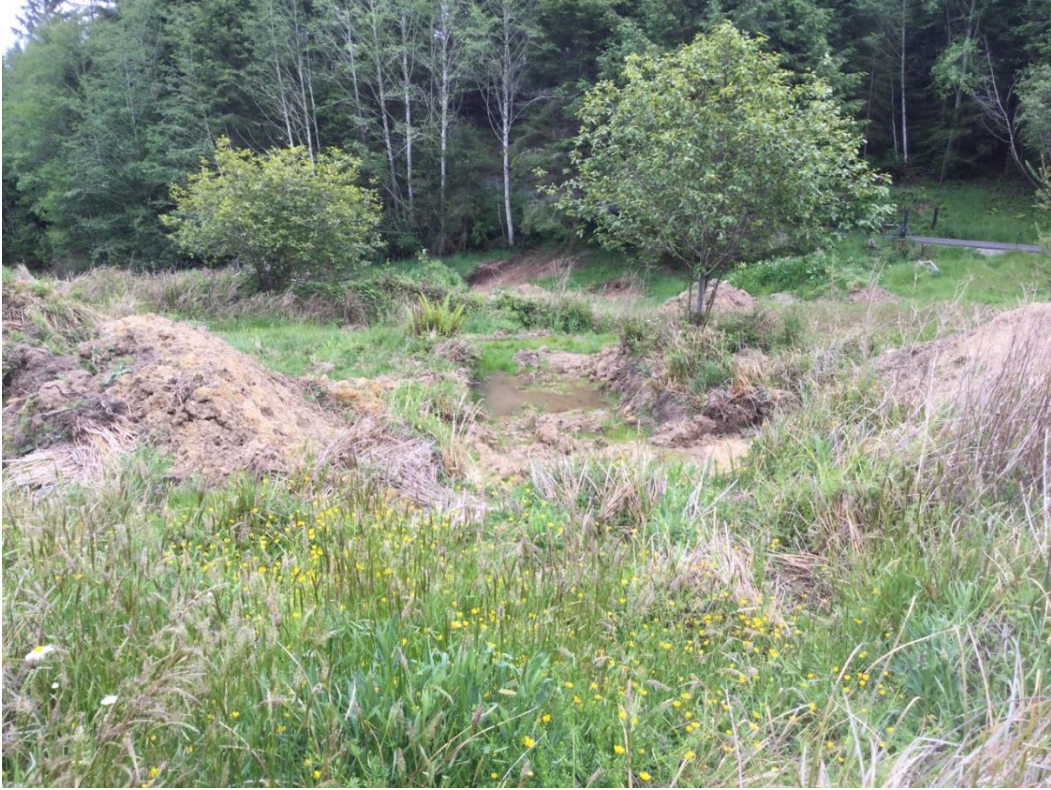
Figure 2. Graded wetland.

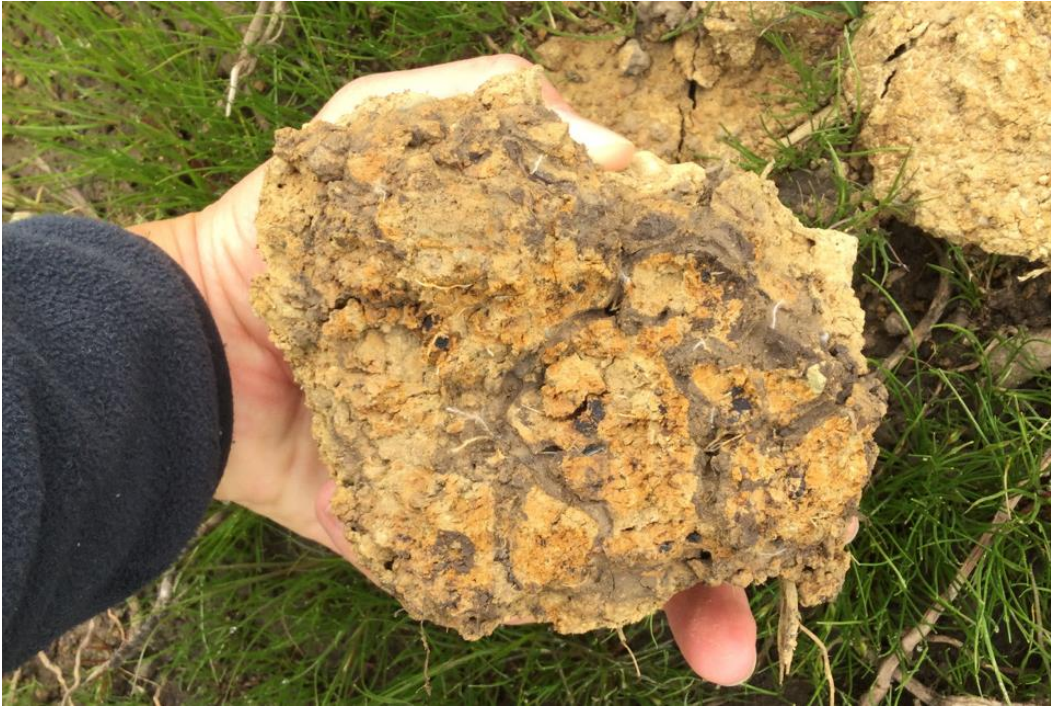
Figure 3. Redox soil observed in areas of disturbance.

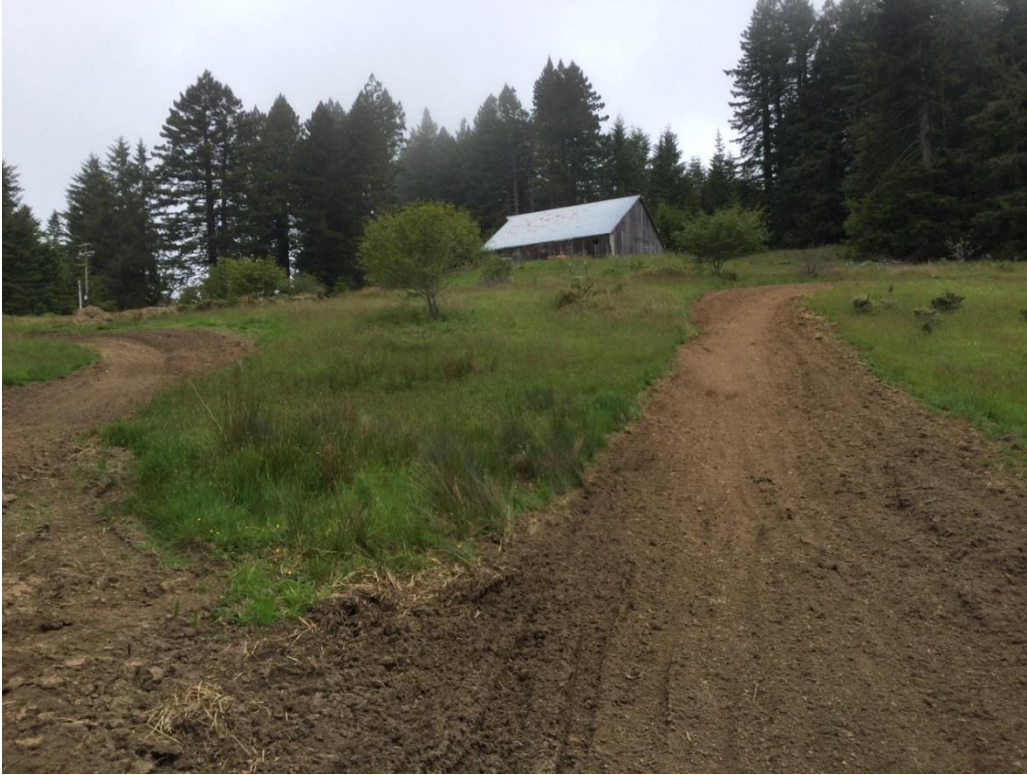
Figure 4. A portion of the >0.6 miles of unpermitted road located on parcel.

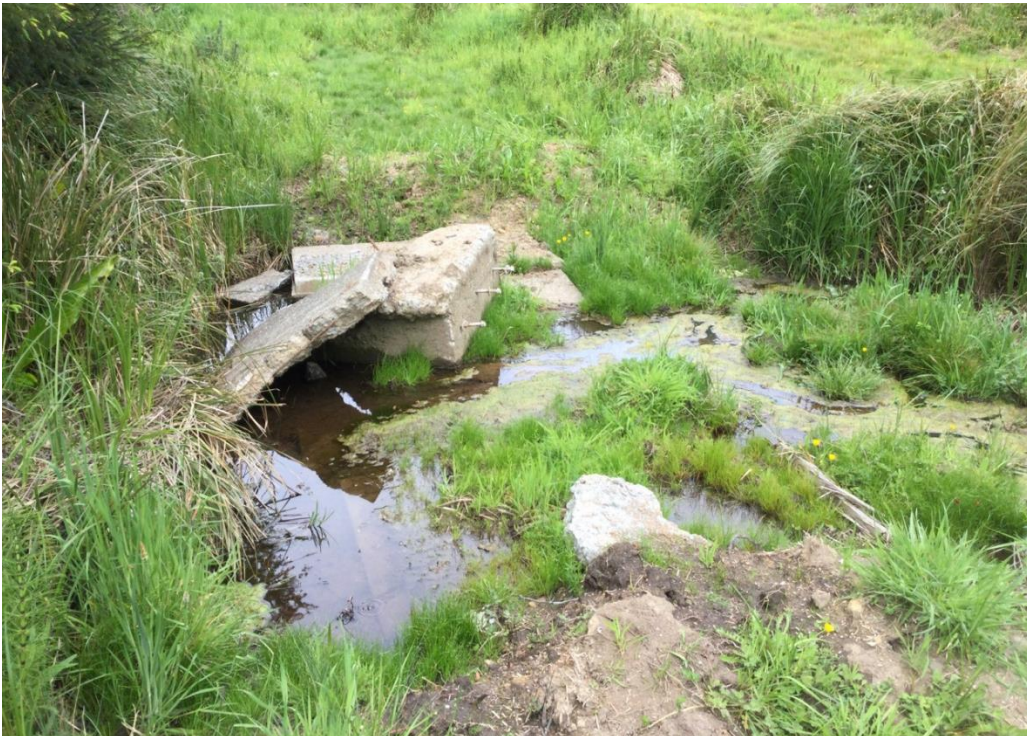
Figure 5. Unpermitted stream crossing with concrete fill. Northern red-legged frog (*Rana aurora*), a State Species of Special Concern, observed in this location.

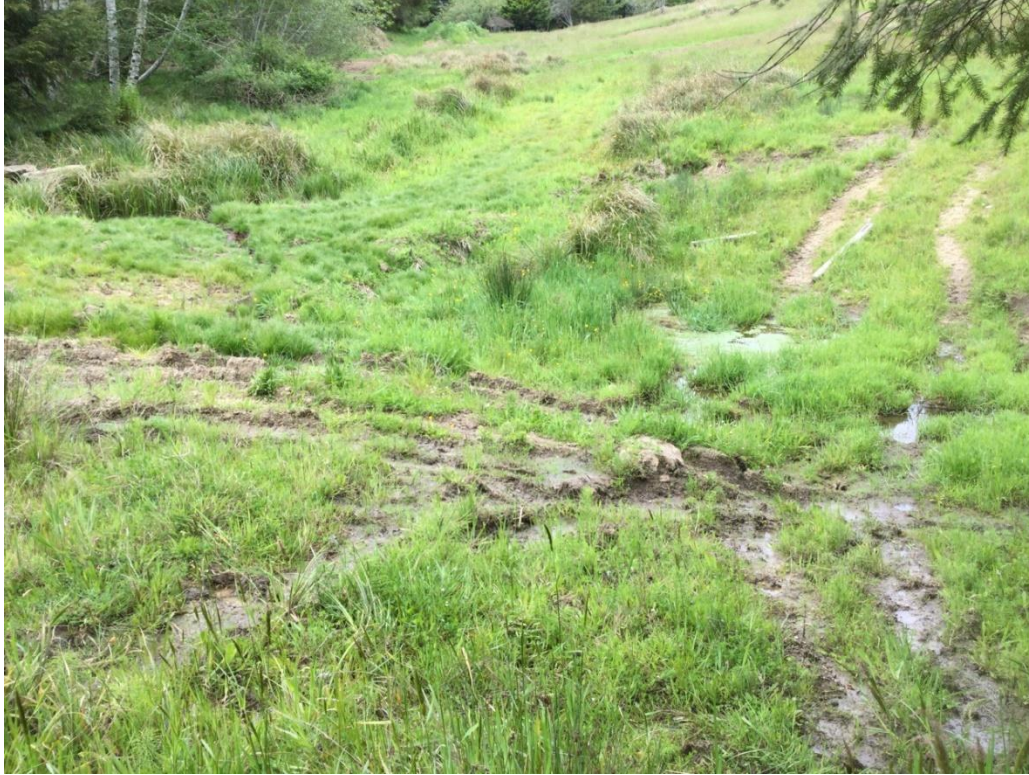
Figure 6. Unpermitted stream crossing resulting in water pollution and substantial alteration to the stream. Northern red-legged frog (*Rana aurora*), a CDFW Species of Special Concern, observed in this location.

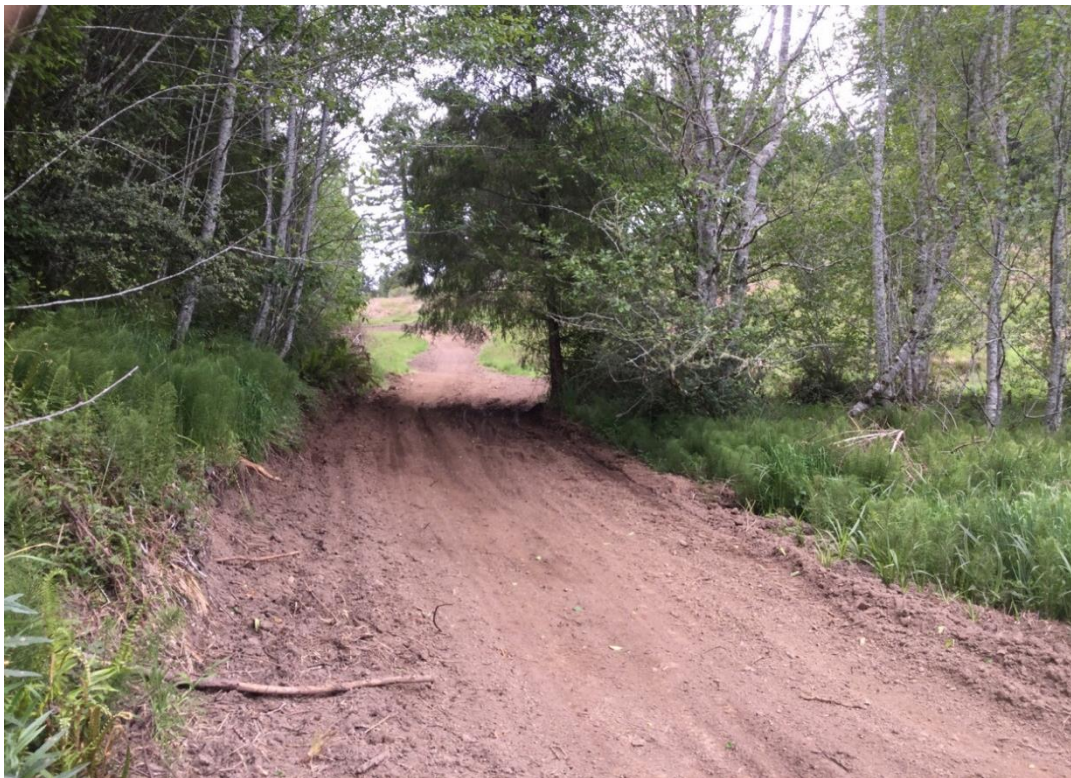
Figure 7. Grading in the headwaters of a stream/wetland complex.
