North Coast Regional Water Quality Control Board

October 27, 2022

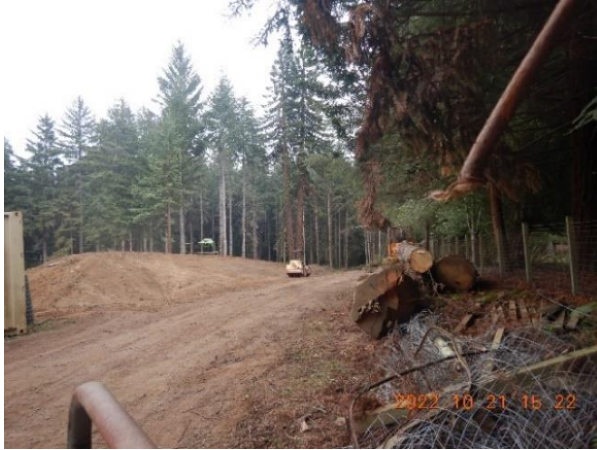
*Figure 4. View from gate of upper mound and access road that parallels the southern parcel boundary to the watercourse. The mound was larger than I observed last inspection. Mr. Gutierrez claims that the slash is buried in the mound.*

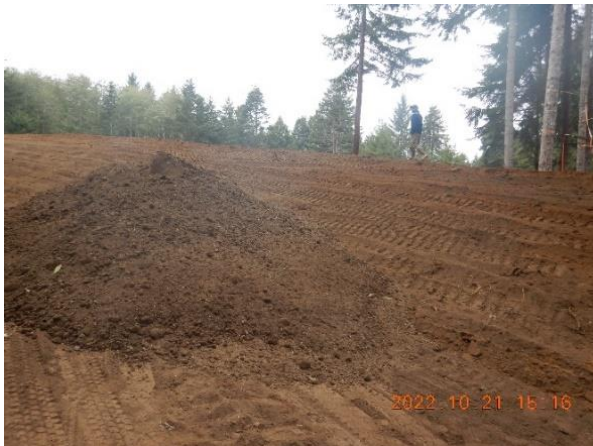
*Figure 5. View of upper mound and fresh fill pile. Mr. Gutierrez claimed that no material besides the mulch had been delivered.*

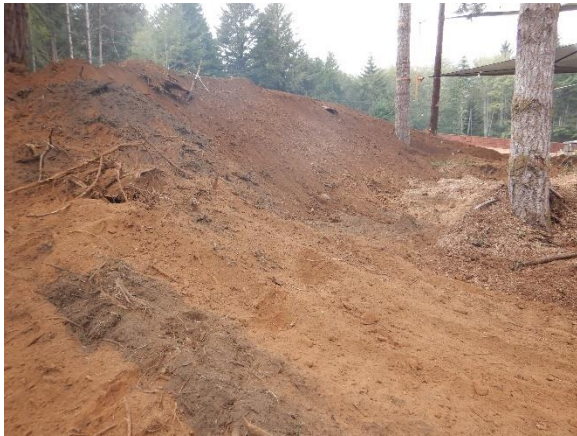
*Figure 8. Loose material on north side of upper mound. Photo by Jordan Filak on October 21, 2022.*

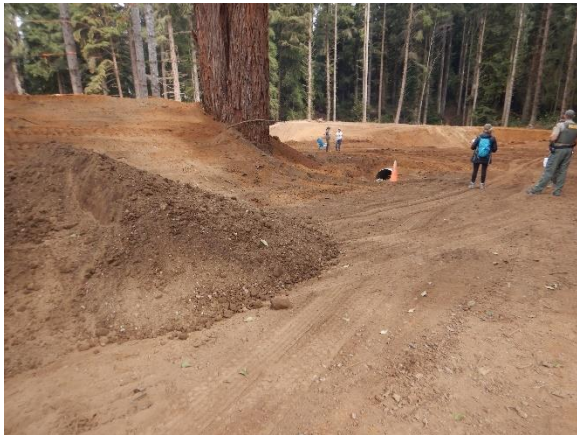
*Figure 9. View of base of upper mound on left, pond inlet at cone, pond berm between people on right, and lower mound beyond people on left. Photo by Jordan Filak on October 21, 2022.*
