Subject **Notice of Violation, Transmittal of Inspection Report of July 19, 2023
Inspection of Mendocino County Assessor's Parcel Numbers 056-
060-24-00, 056-060-25-1 and 056-060-28-00**

**North Coast Regional Water Quality Control Board
Attachment B**

**Cannabis Water Quality Inspection Report
Brenda Kershenbaum Property, Mendocino County APNs 056-060-28-00,
056-060-24-00 and 056-060-25-01, WDID No. 1_23MJ000380**

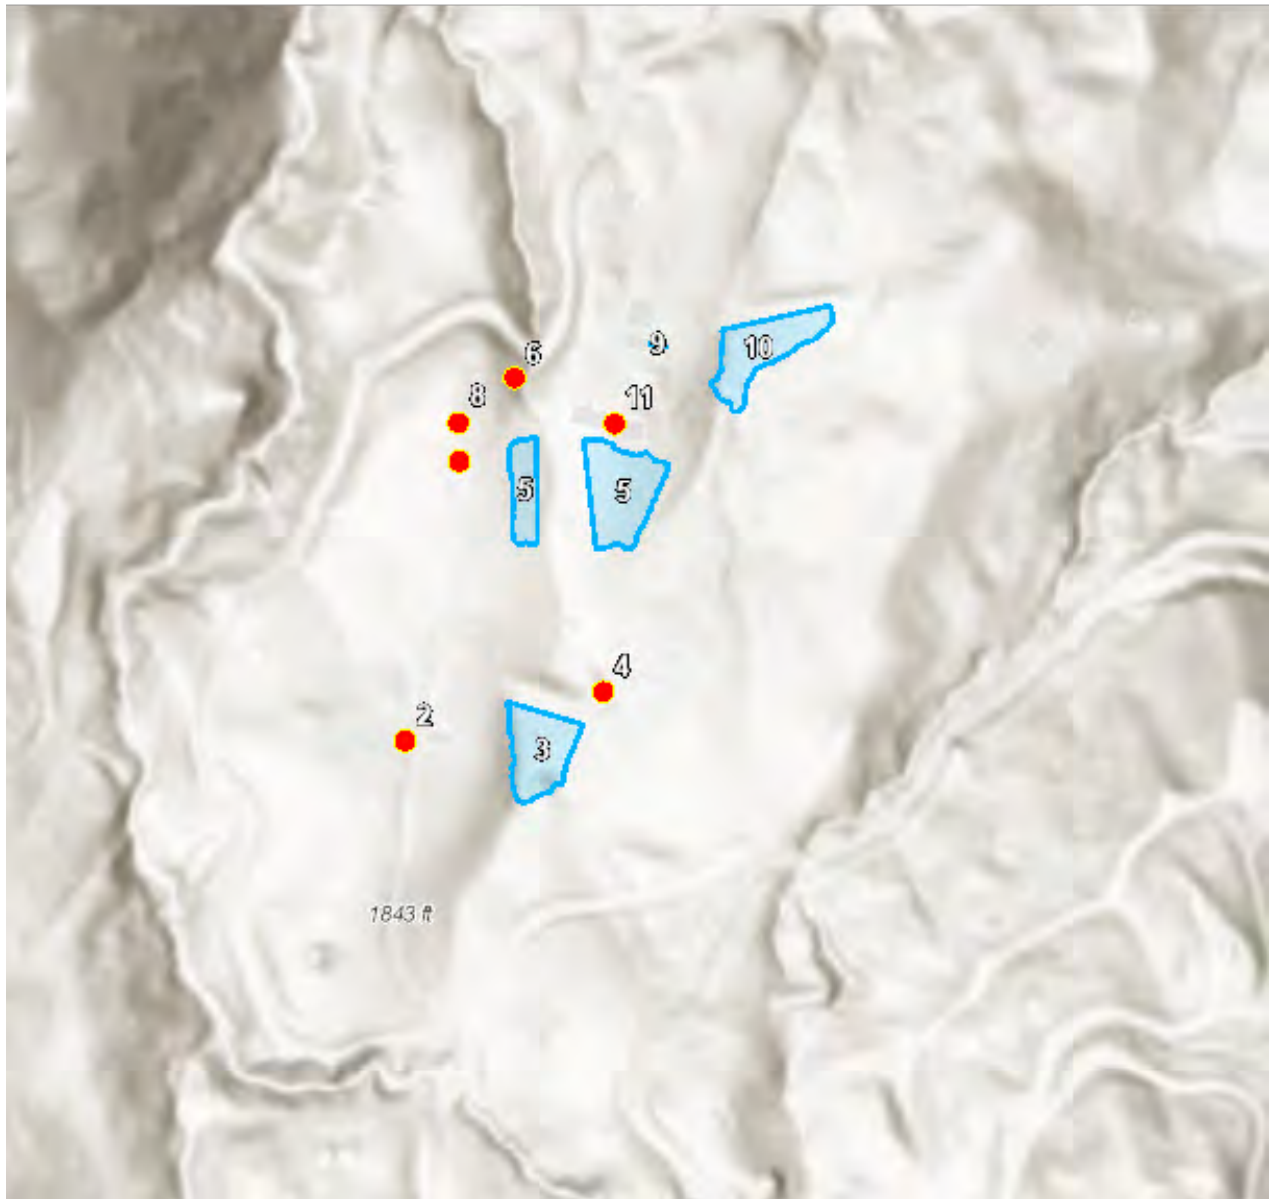
Figure 3 Inspection map with aerial imagery showing the point, line, and polygon feature locations of interest are described in the text.

The inspection map is shown in Figure 2 and includes the locations referenced at the following features of concern to water quality.

Polygon Feature 3: An older onstream, unlined pond with an earthen berm is located at confluence with two Class III watercourses entering and one Class II watercourse exiting the impoundment. The slopes are moderate. I did not observe cracks in the berm.

Polygon Feature 10: An older onstream, unlined pond with an earthen berm has a Class III watercourse channel entering. The outlet is comprised of a corrugated pipe. I did not observe cracks or obvious signs of instability. We observed bullfrogs in the pond.

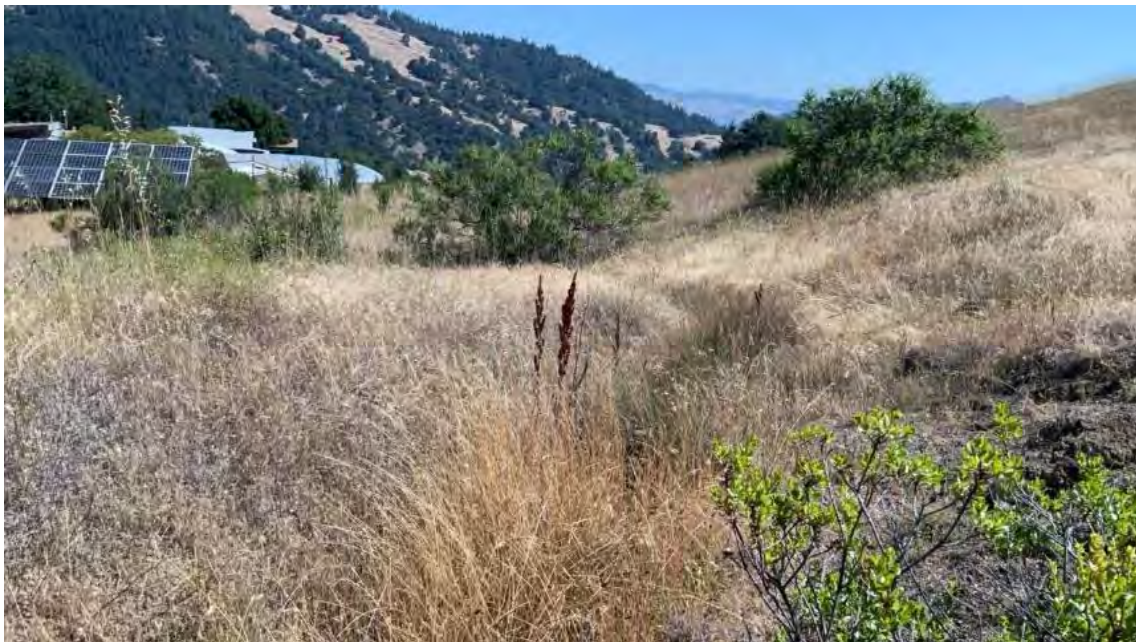
Figure 5. Polygon Feature 3 – onstream pond, view of downstream channel.

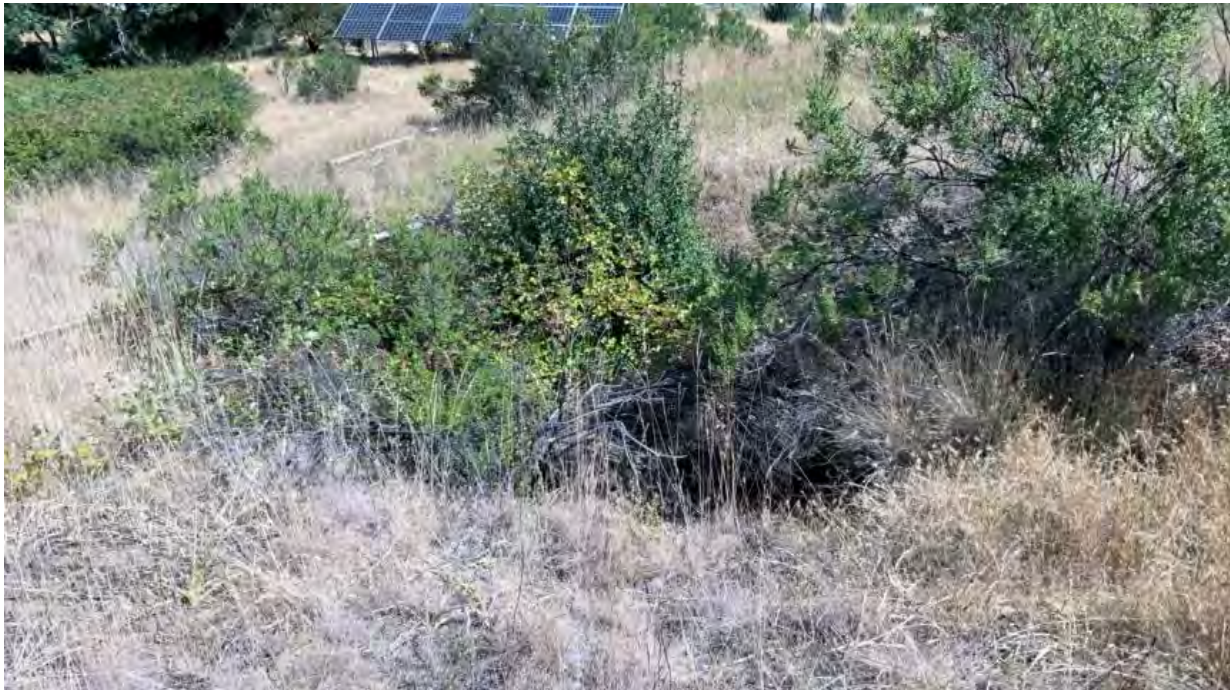
Point Feature 4: The pond outlet has an erosional void due to a headcut and is a threatened discharge of sediment to the stream.

Figure 6. Point Feature 4 – erosional void associated with an older head-cut of the downstream channel.

5. Cleanup potting soil and properly contain and cover or remove and dispose of at a legal disposal facility.
6. Hire a qualified professional to assess the Property, including but not limited to the features described in this report, to develop a treatment plan to guide that the cleanup and remediation of the assessed features that ensures that will no longer pose a threat of discharge or impacts to the quality of waters of the state. Submit the plan for approval and implement cleanup and restoration work.

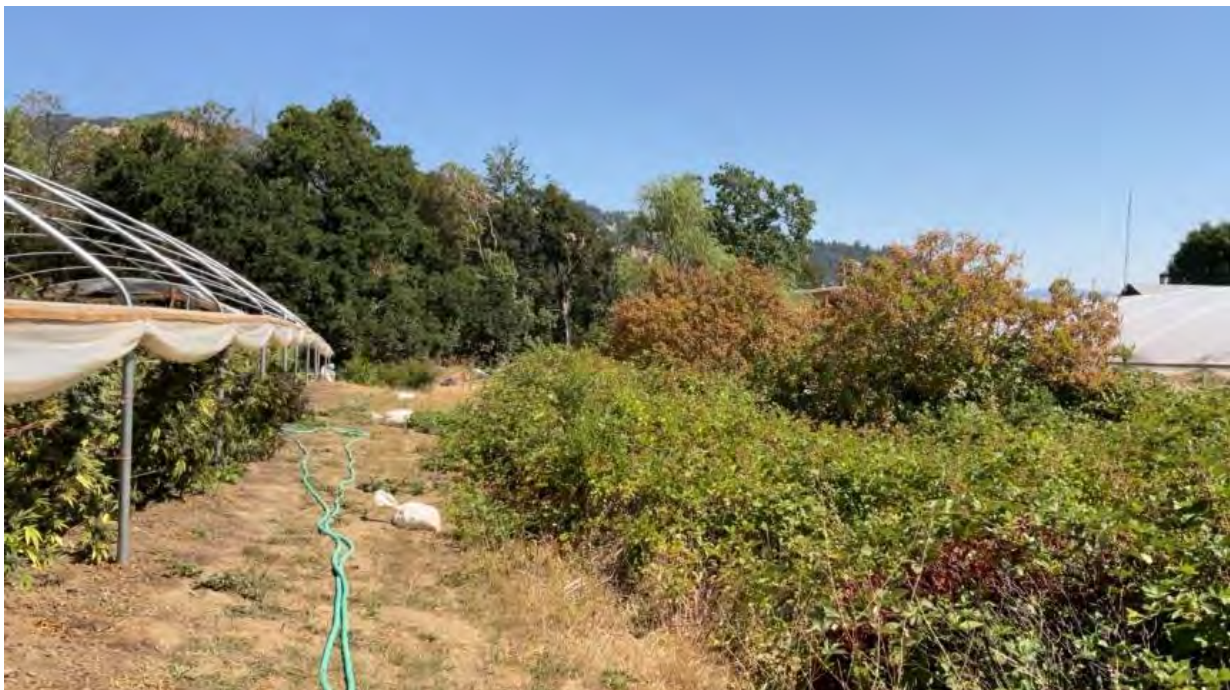
Polygon Feature 5: Active cultivation in four greenhouses on the west side of the Class II stream described above, and on greenhouse on the east side of the stream.

Figure 7. Polygon Feature 5 – Greenhouse cultivation areas. Along one stream reach, a greenhouse is located within fifteen feet of the stream bank.

4. Remove greenhouses within one hundred feet of the watercourse. Remove cultivation materials and properly dispose of waste including but not limited to trash, fertilizer, pesticide and petroleum containers, plastic tarps and sheeting at a legal facility.

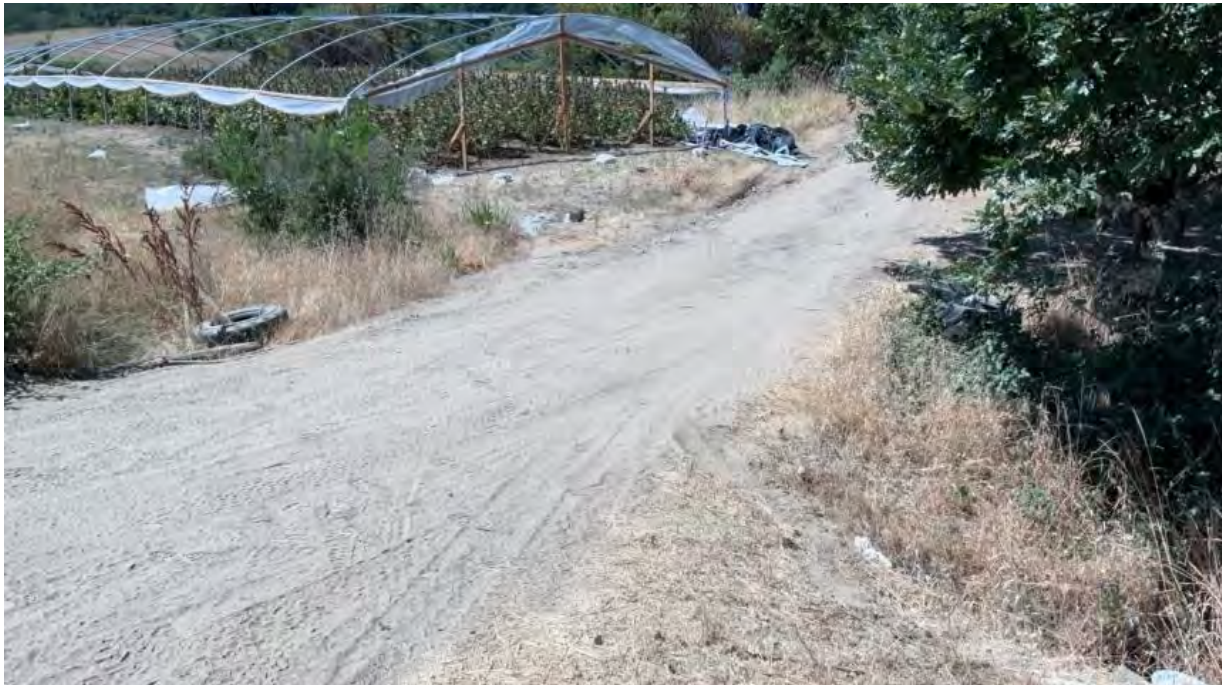
As document in the inspection report, staff observed evidence of fine sediment delivery to the Class II watercourse at Point Location 6, in violation of the Basin Plan section 4.2.1 Prohibition 1 and posing a threat the quality of waters of the state in violation of Water Code section 13264.

Point Feature 6: Stream crossing over Class II is undersized, receives runoff from the hydrologically connected roadway, refuse piled nearby.

Figure 8. Point Feature 6 – the stream crossing over the Class II watercourse is located on the main access driveway to the residence, just downslope from the cultivation greenhouses. The stream flows left to right in the photo.

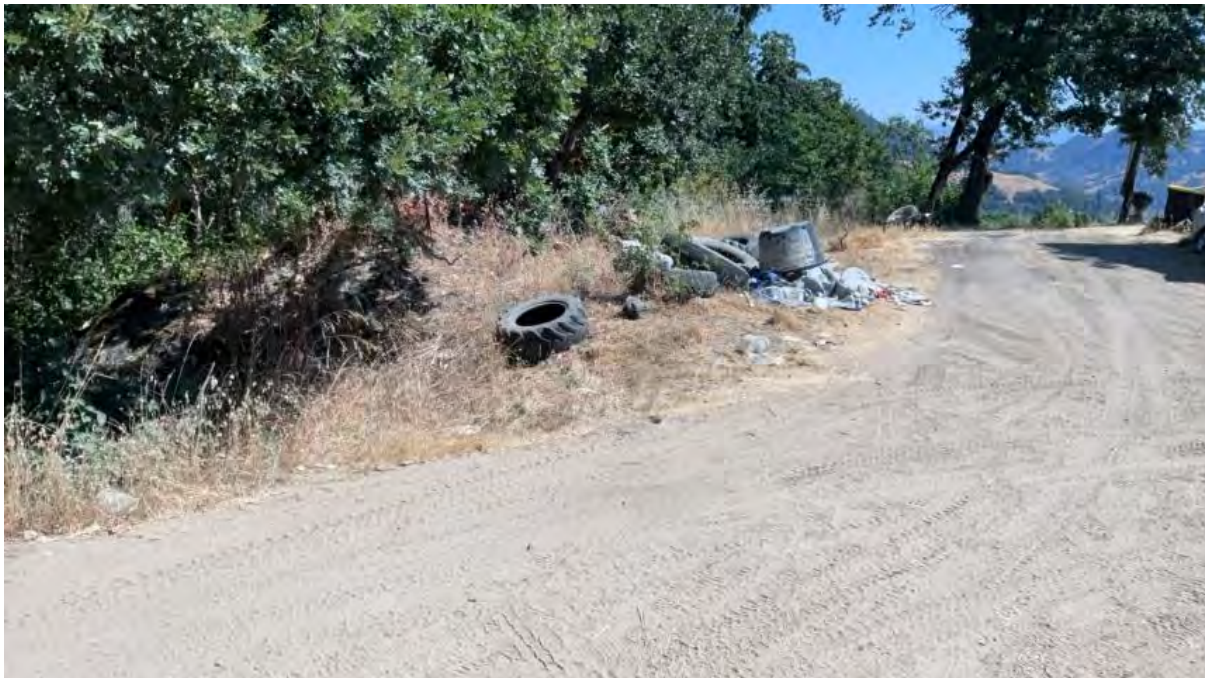
Figure 9. Point Feature 6 – refuse is piled on near the outlet of the culvert. Outlet is on left of photo in shadow. The stream flows right to left in the photo. The residence is to the right of the photo.

1. Cease unauthorized cannabis cultivation.
2. Cease land disposal of household and cultivation-related trash and properly dispose all refuse at a legal disposal facility.
3. Cleanup fertilizer containers and prevent discharge of nutrients in a manner that threatens water quality. Properly dispose of pesticides and fertilizers at a legal disposal facility. Maintain storage areas and ensure discharges to lands and waters of the state are prevented.

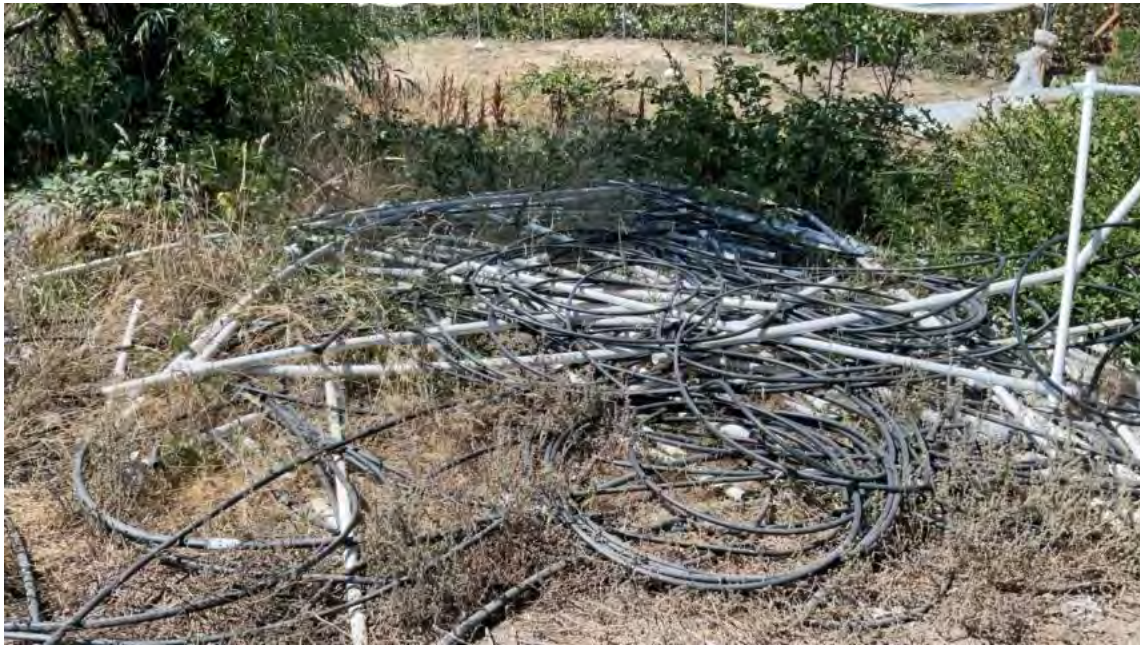
Figure 10. Point Feature 6 – waterline stockpile located near stream crossing.

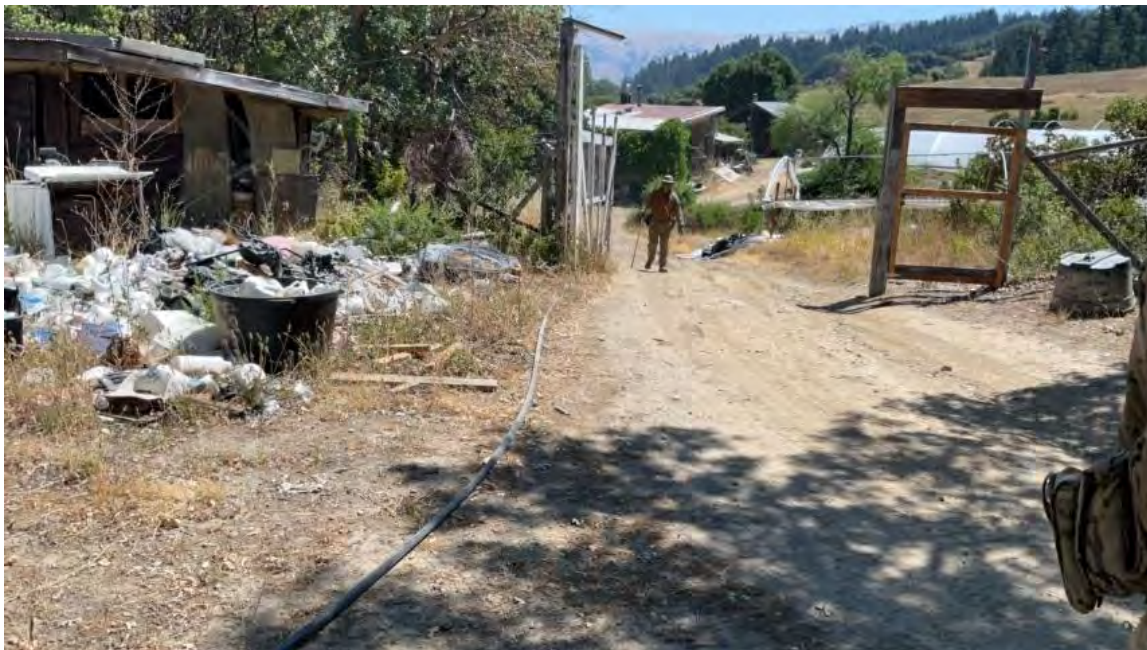
Figure 11. Point Feature 6 – the access driveway to the residence slopes down to the stream crossing and approximately three hundred feet of roadway is hydrologically connected to the stream crossing. The road is rilled and has deep dust. The road condition is threatened discharge of sediment to the stream at the crossing. At the top of the grade, plastic refuse is dumped and is not contained and could blow into the watercourse or other areas of the landscape.

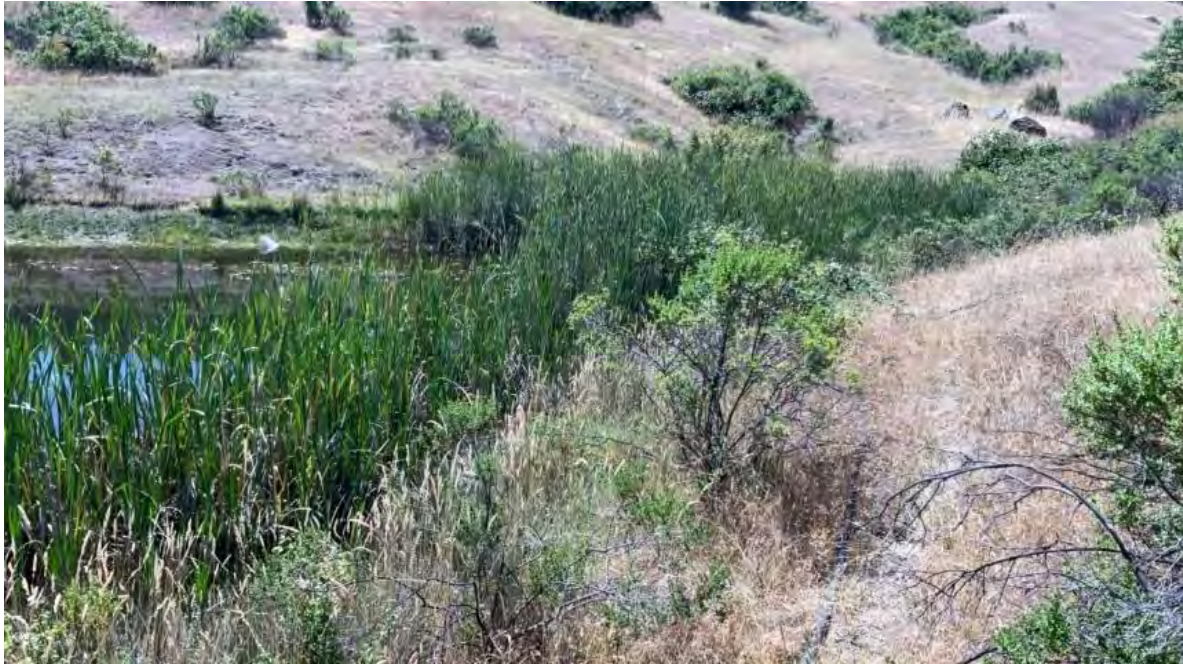
Figure 12. Polygon Feature 10 - Channel entering the pond from the right of photo.

As documented in the inspection report, the features at Point Locations 9, 10 and 13 are located instream and must be decommissioned to comply with the Basin Plan, which will require a water quality certification prior to conducting instream work.

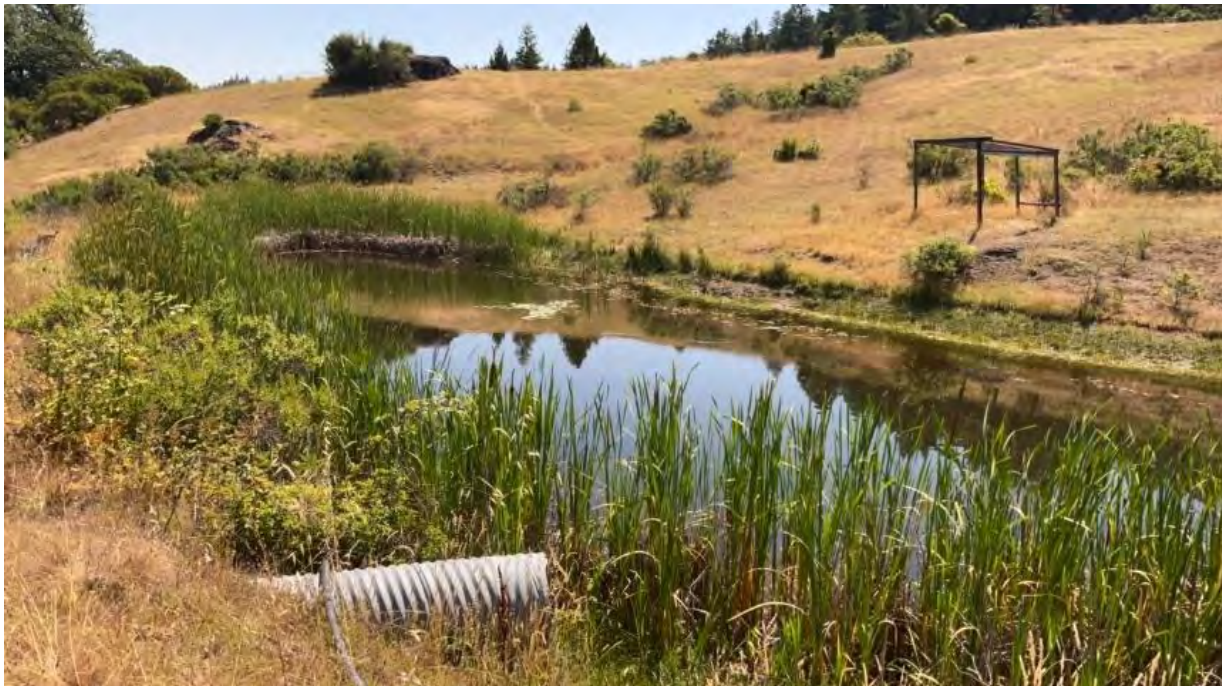
Figure 13. Polygon Feature 10 – onstream pond with piped outlet with approximately two feet of free-board at the berm.

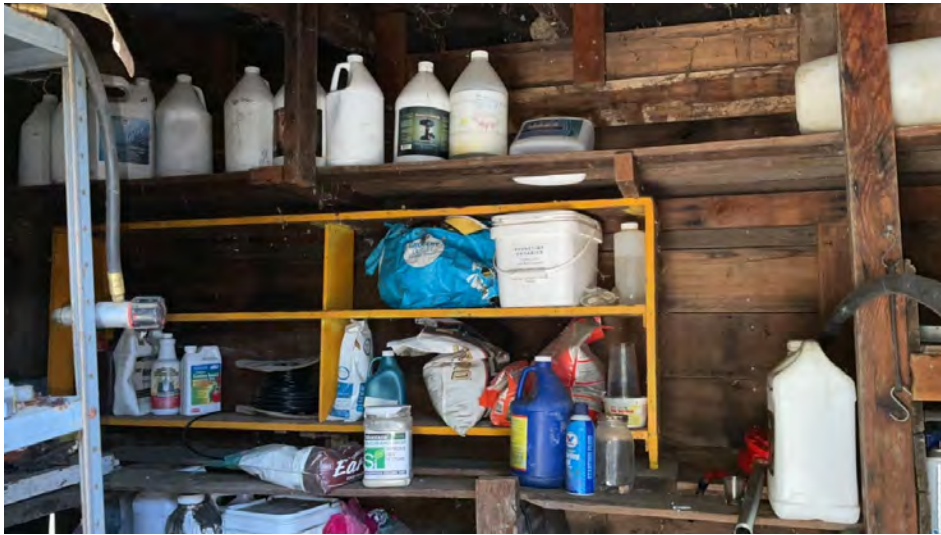
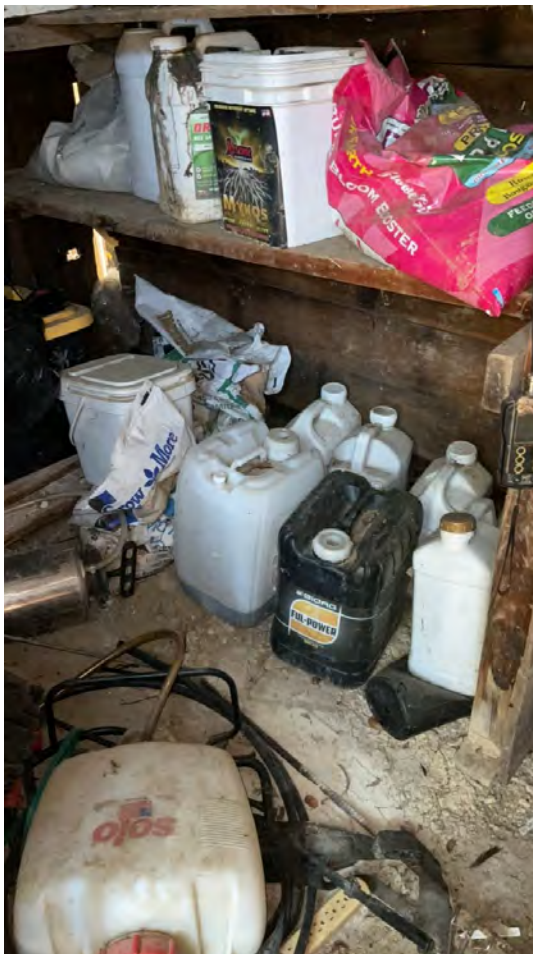
Figure 14. Point Feature 11 – shed with storage of fertilizers.

Figure 15. Point Feature 11 – shed with storage of fertilizers.
