**North Coast Regional Water Quality Control Board
Attachment B**

**Cannabis Water Quality Inspection Report, Lee Site,
Siskiyou County APN 011-120-010, WDID No 1_47MJ00370**

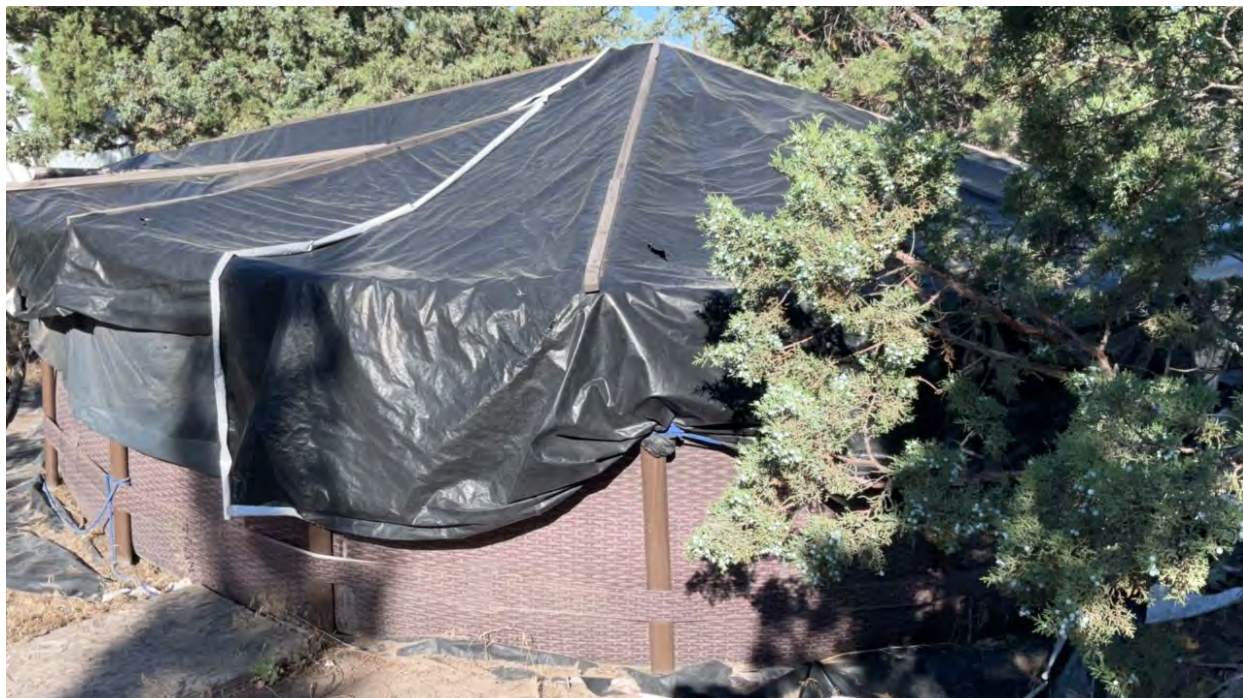
Figure 5. At location 2, water storage is in above ground swimming pool, 22 ft diameter and 4 ft deep. Style is consistent with those observed at other sites in the neighborhood.

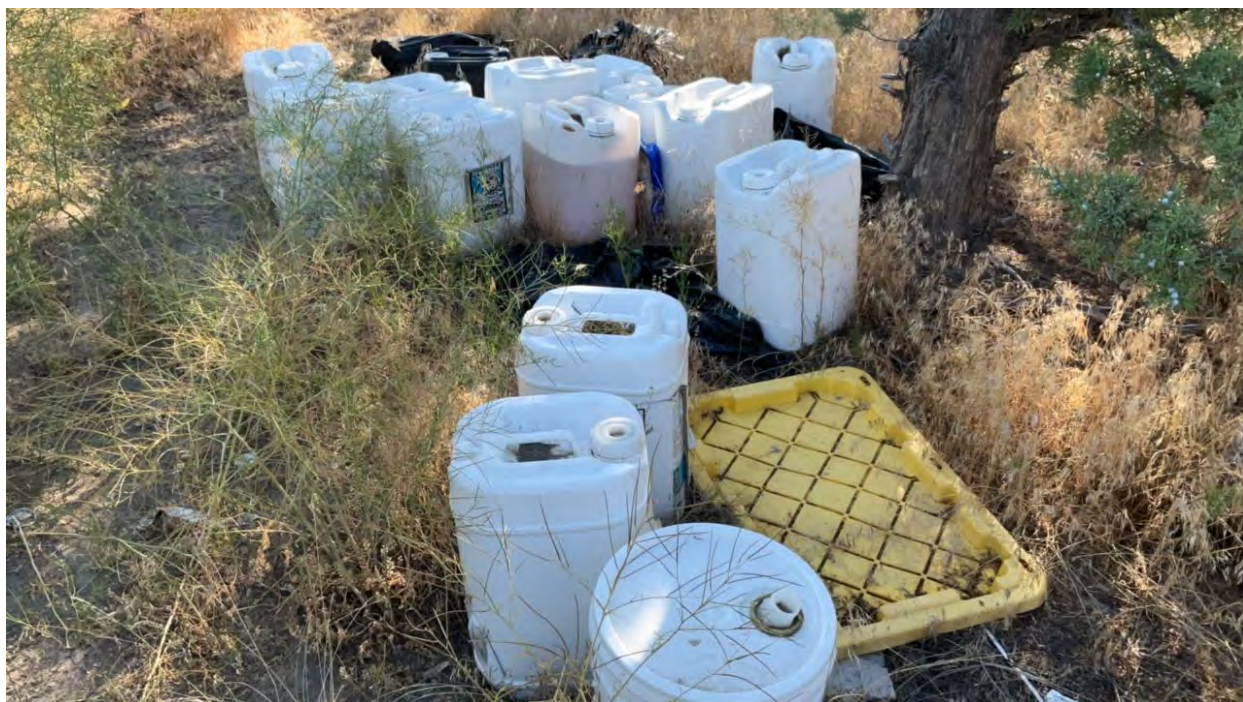
Figure 6. Fertilizers stored uncontained at location 3.

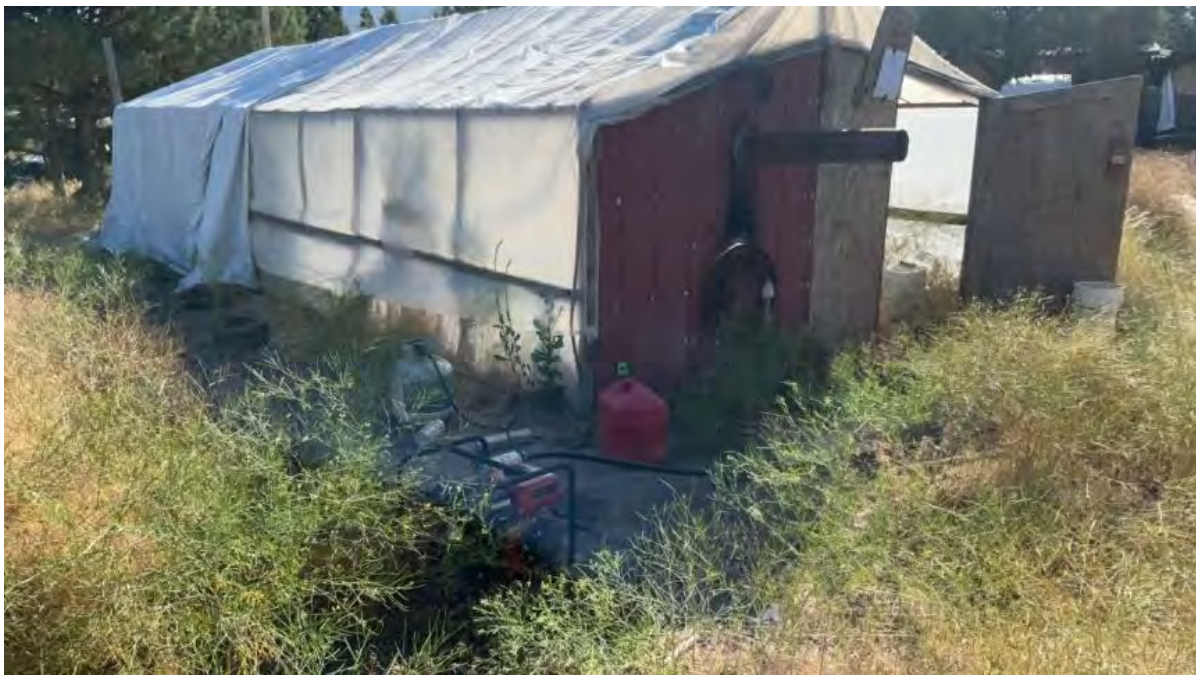
Figure 12. Gas pump leaking water near old greenhouse.

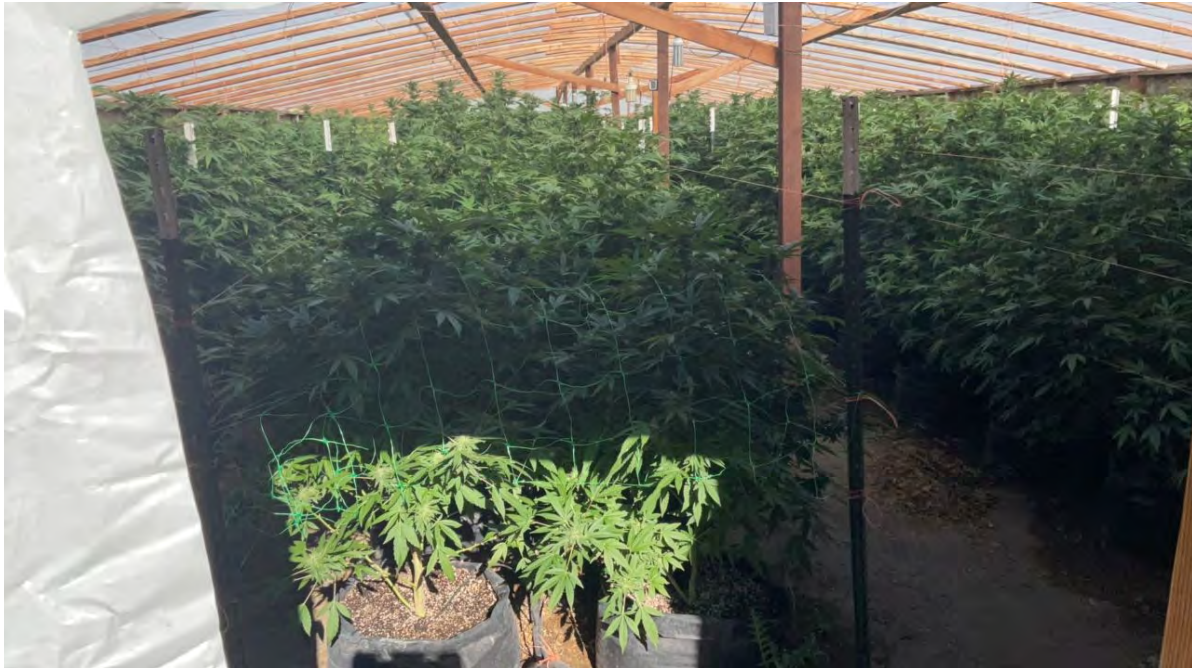
Figure 13. Greenhouse cultivation at location 8.

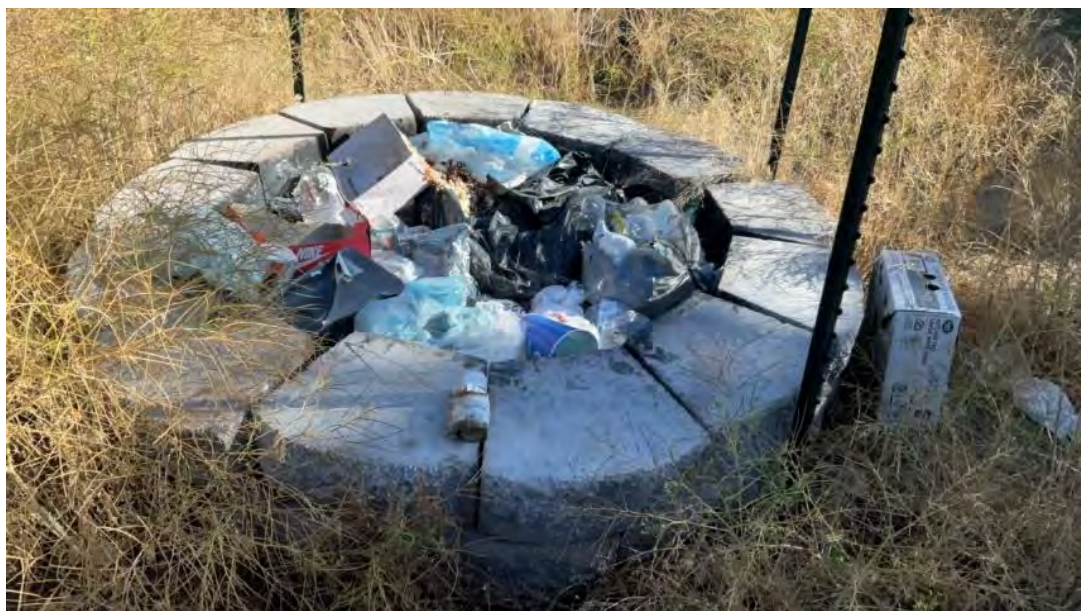
Figure 17. Location 10 is a trash burn pit and includes plastic and pyrethrum fumigating bomb container.

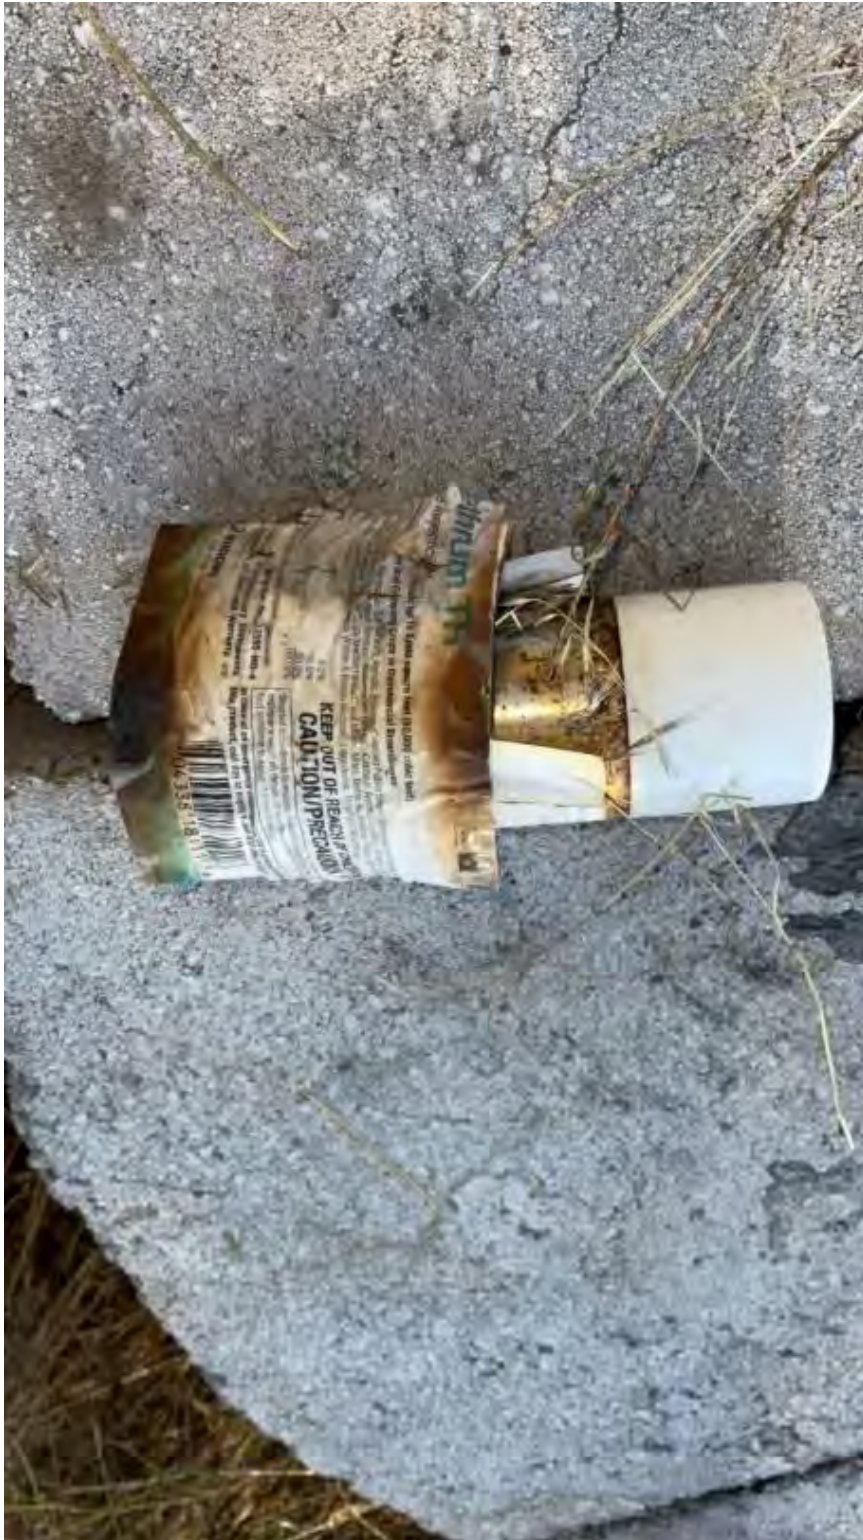
Figure 18. Burned pyrethrum bomb location 10.

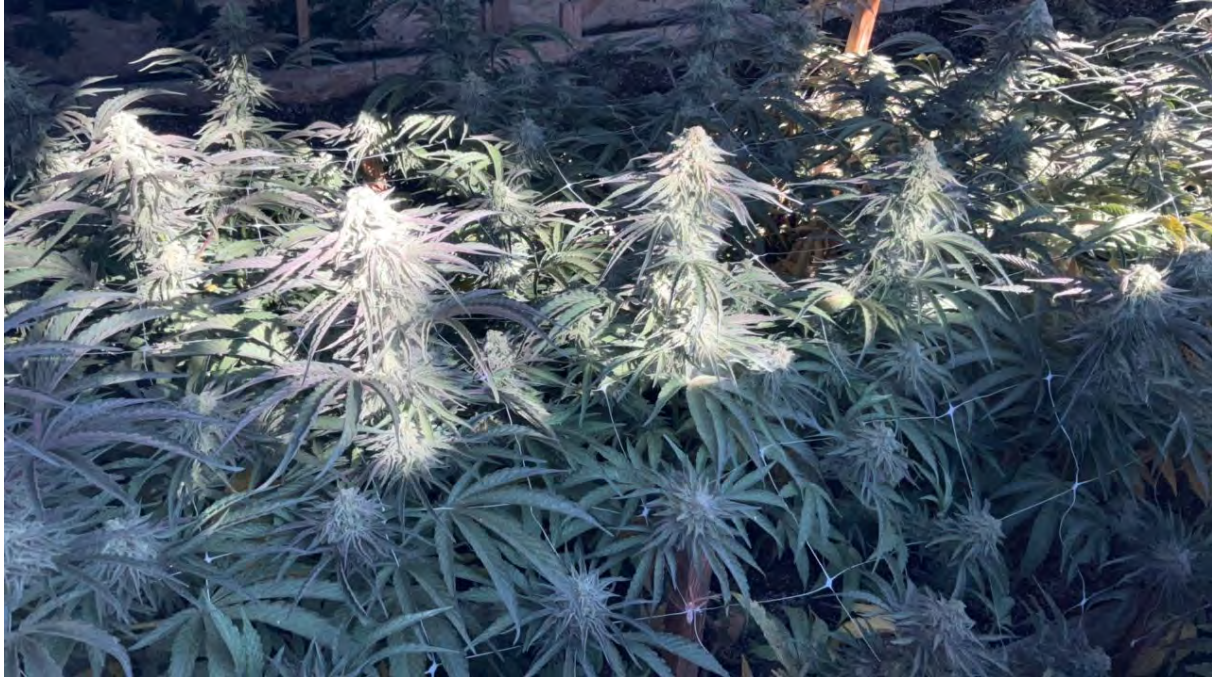
Figure 19. Greenhouse cultivation at location 11.

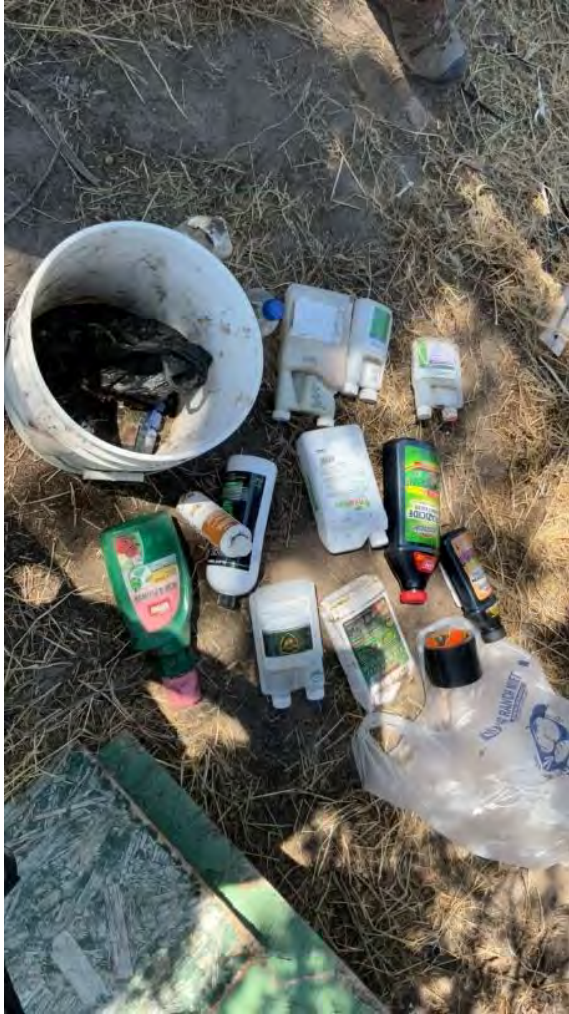
Figure 33. At location 3 I observed numerous bottles pesticides, including Avid, Happy Spray, Malathion, Aza Mix, and an unlabeled bottle with brown liquid.

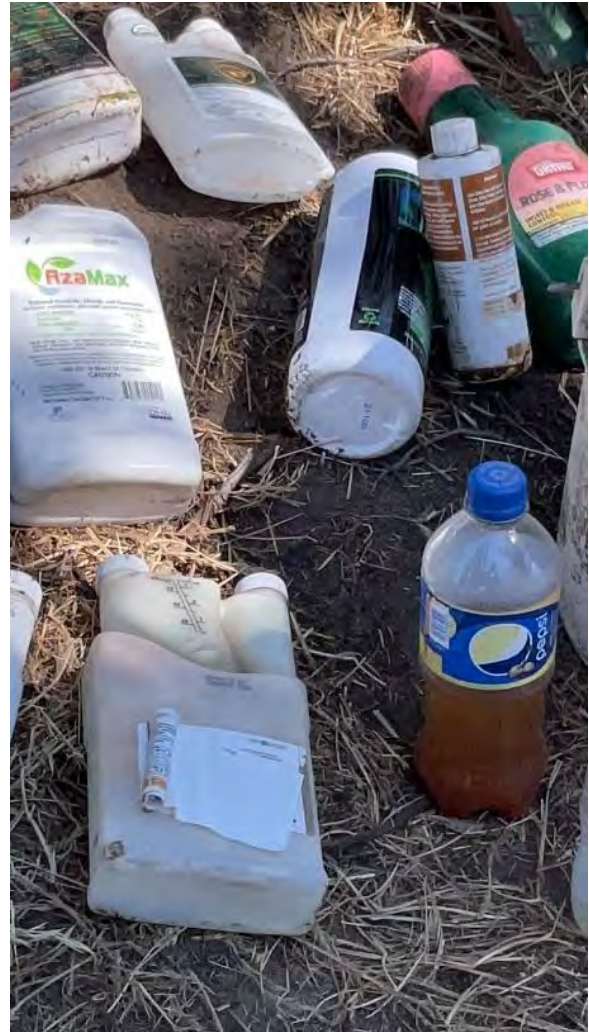
Figure 34. Pesticide bottles at location 3.

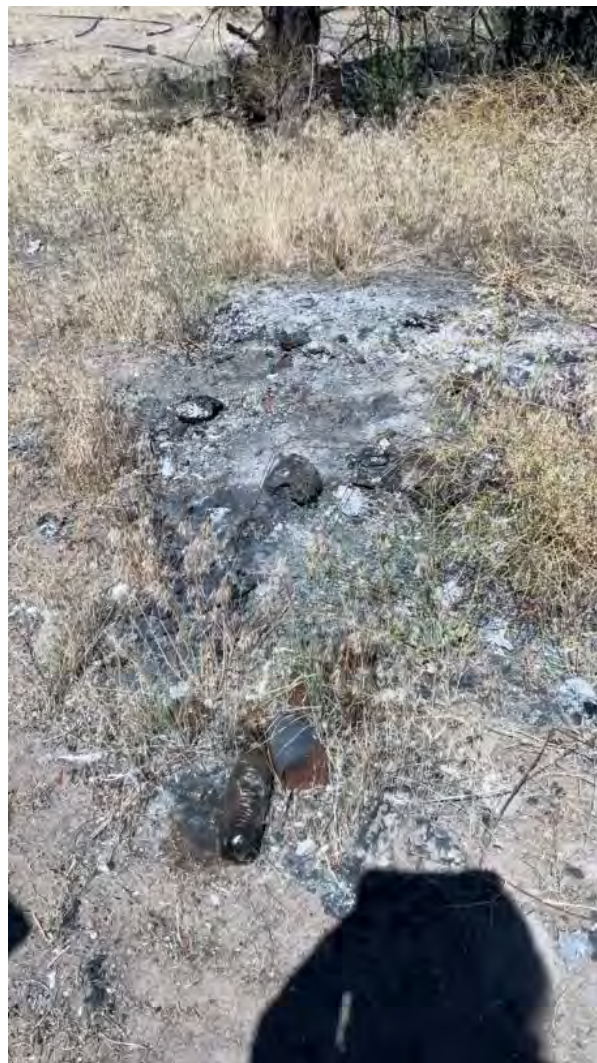
Figure 42. Evidence of a burned trash at location 10, along with a bottle of oil.

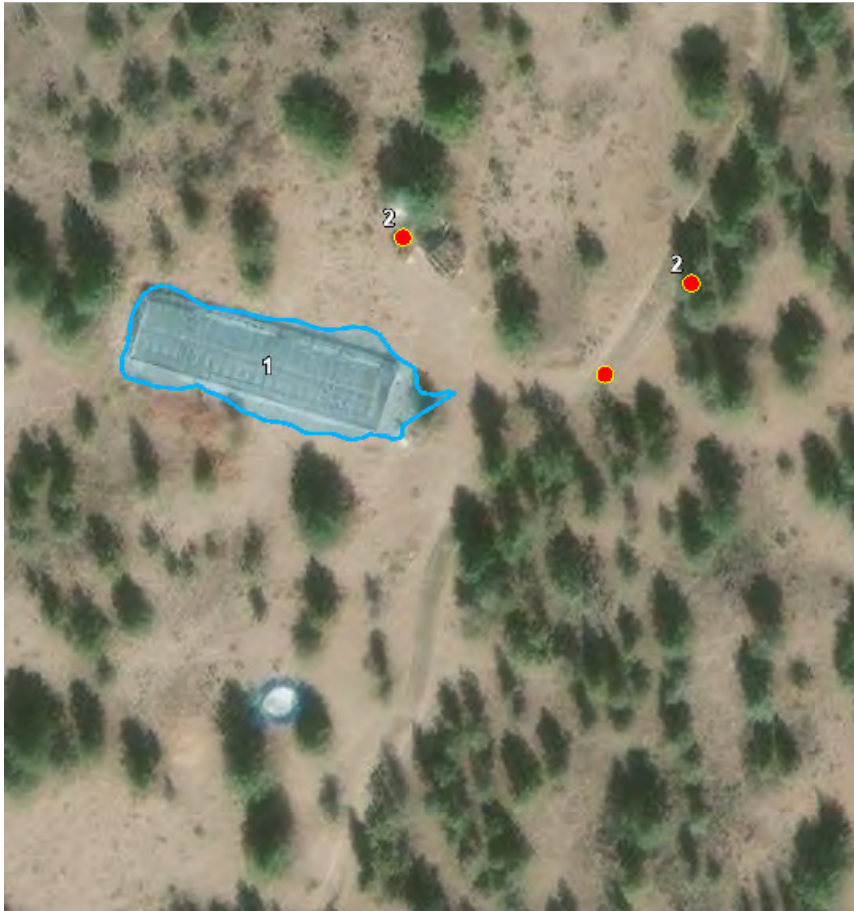
Figure 43. Area C inspection map with Locations of interest marked and discussed in the text.

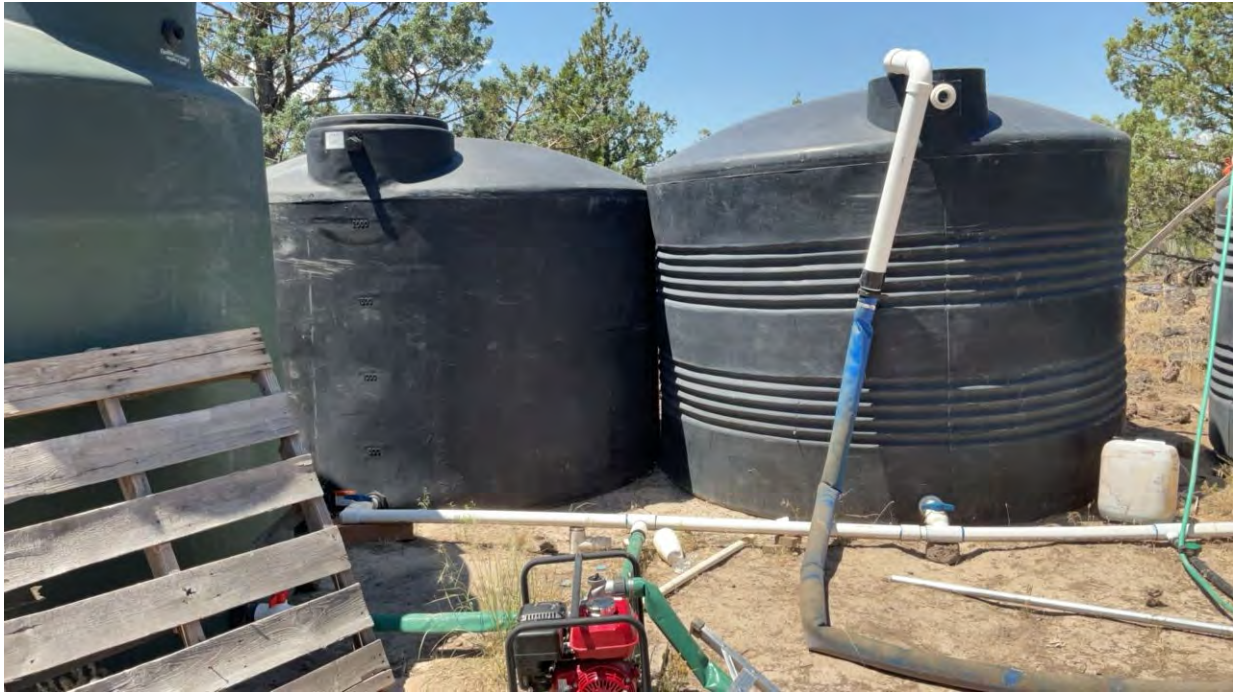
Figure 65. Water storage tanks and pump at location 2, similar to those observed at previous locations.

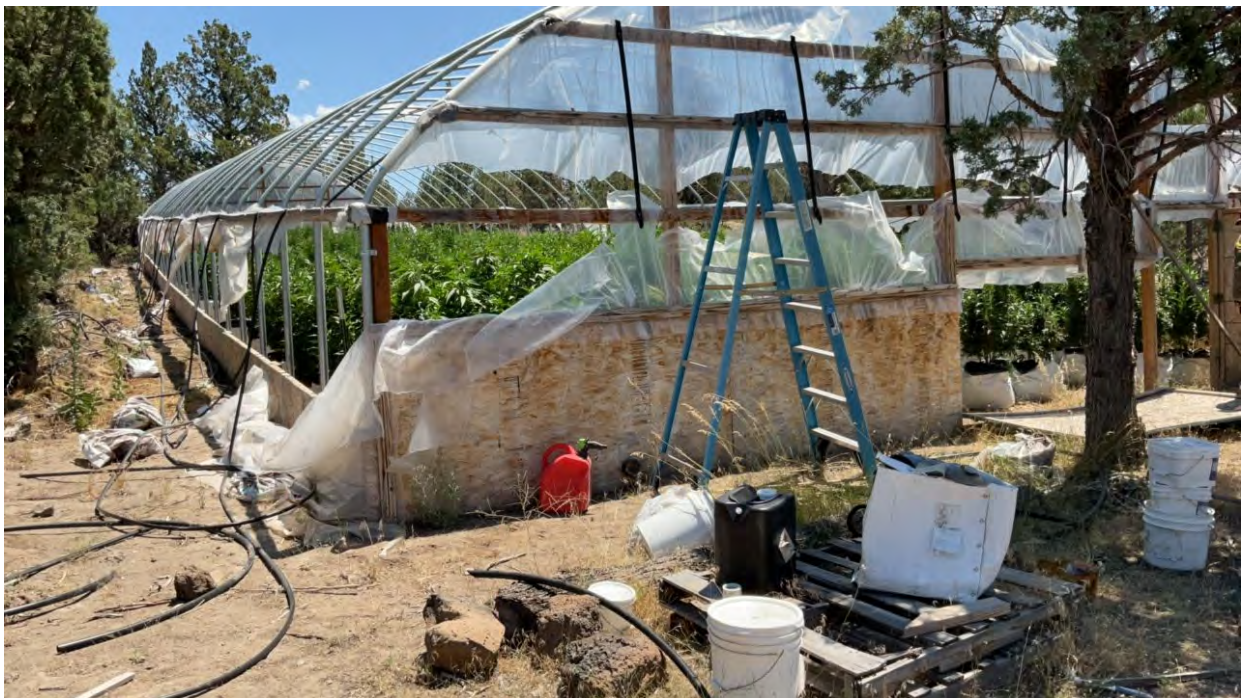
Figure 66. Greenhouse cultivation at location 3.

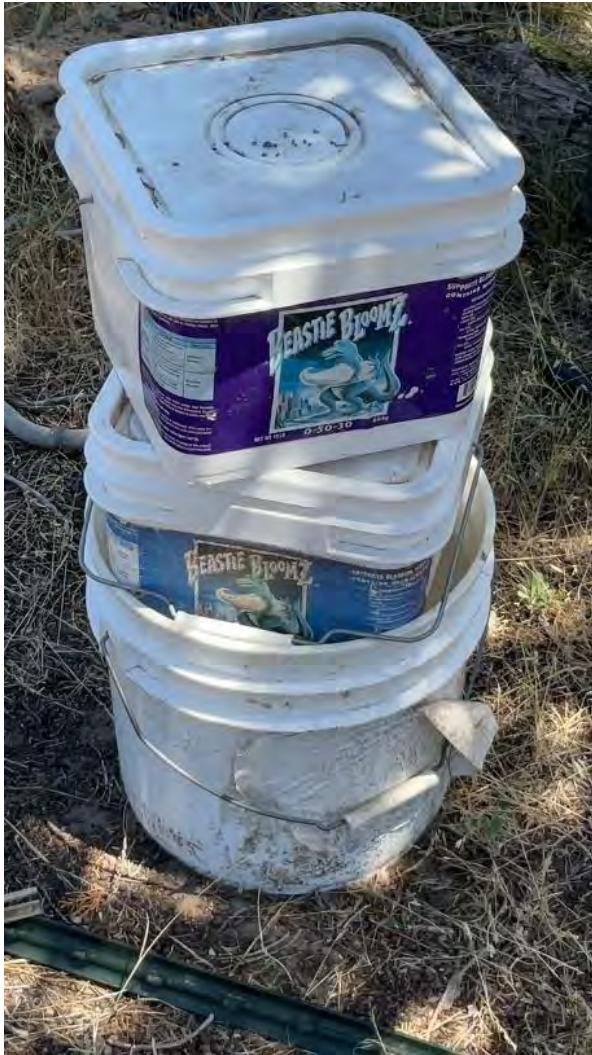
Figure 69. Fertilizer at location 3.

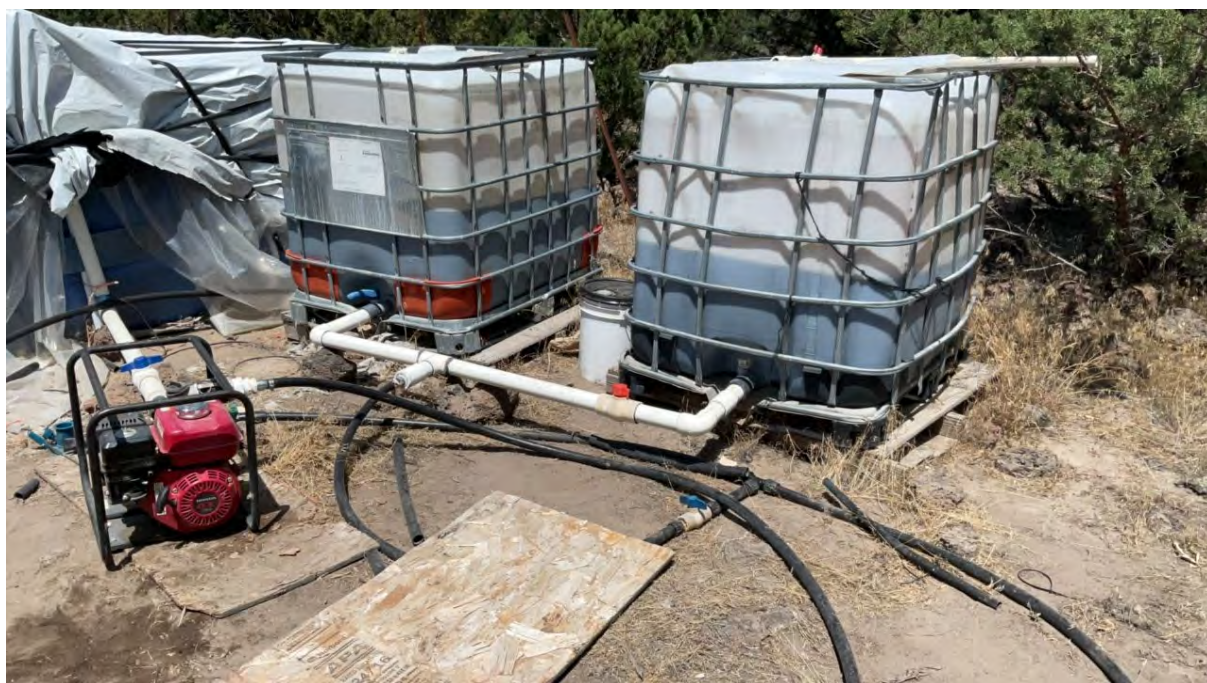
Figure 76. Feed tanks and pump at location 4 with petroleum stains on the ground.

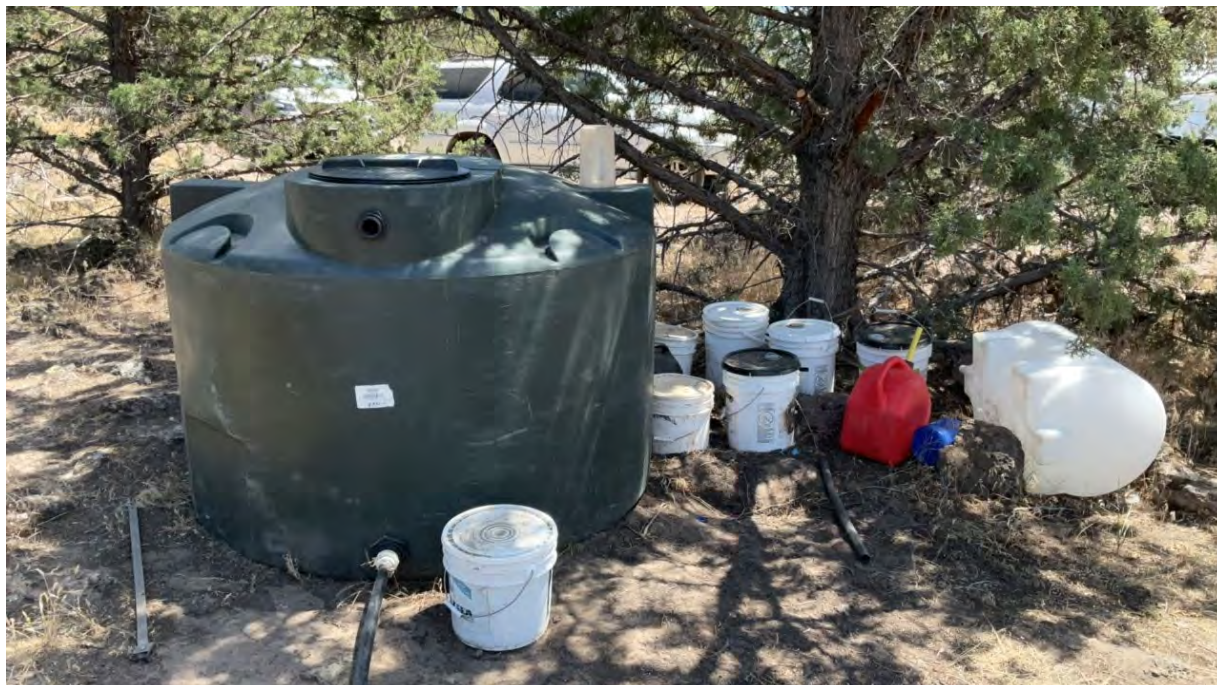
Figure 77. Fertilizer at location 4.

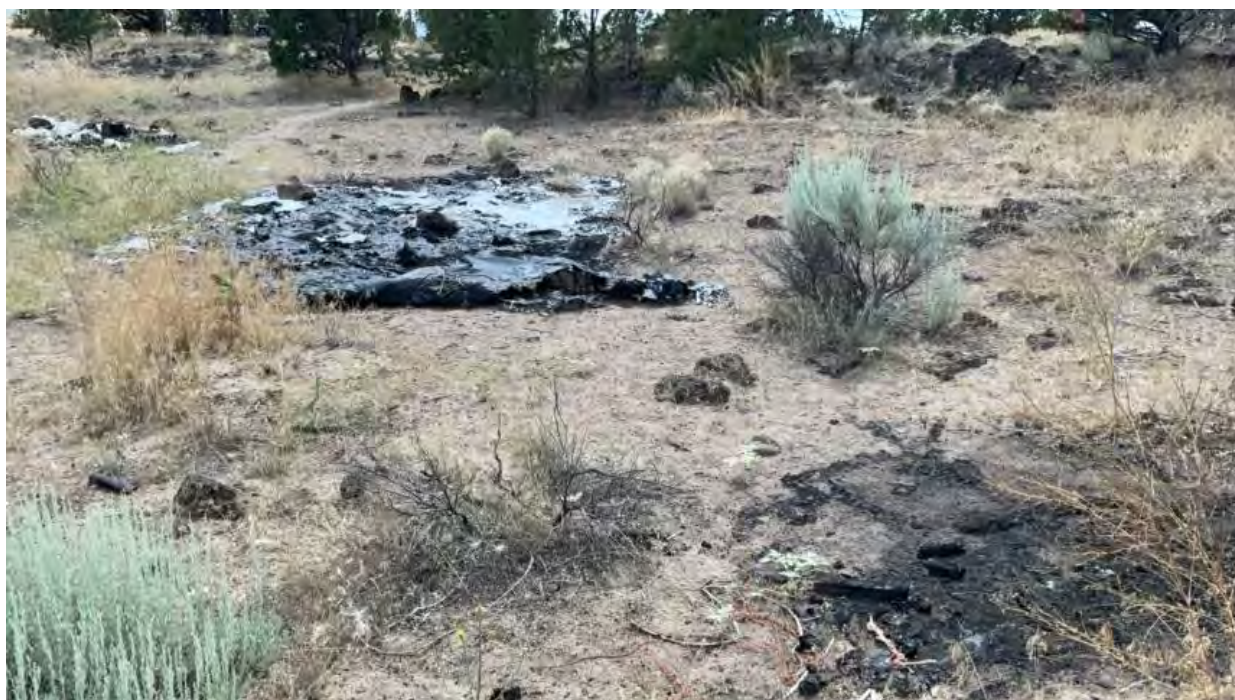
Figure 83. At location 2, I observed at least 4 areas where light deprivation tarps had been burned.

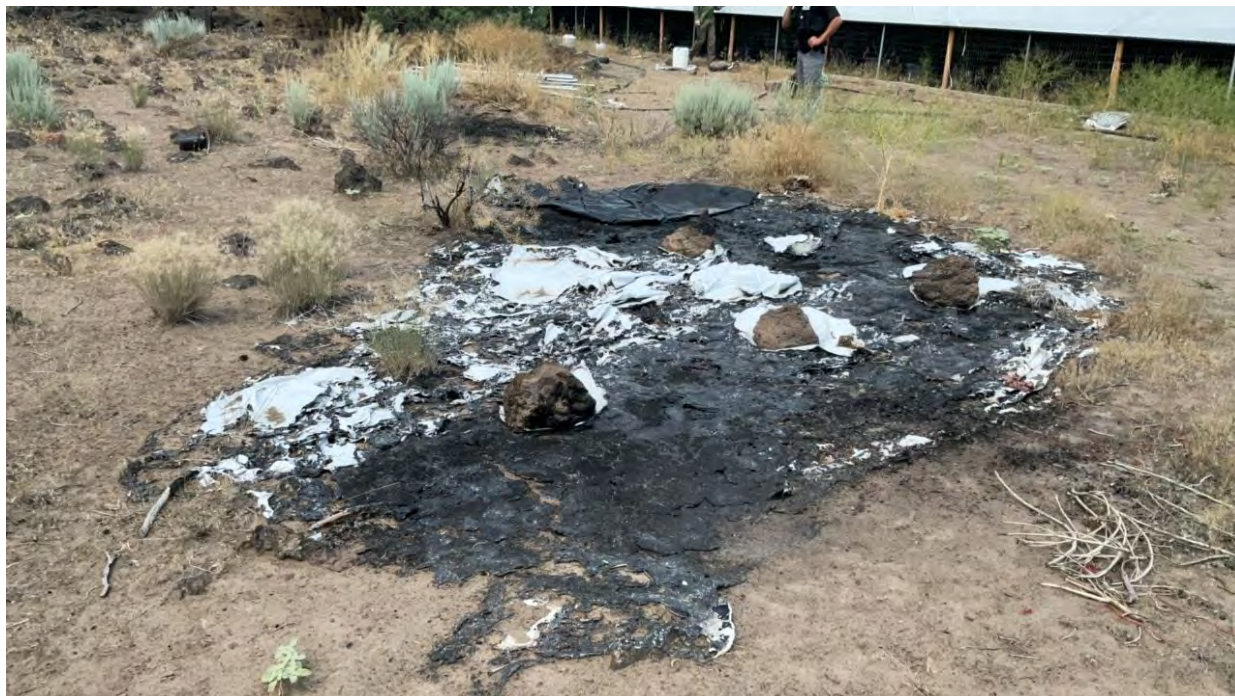
Figure 84. Location 2 burned tarp.

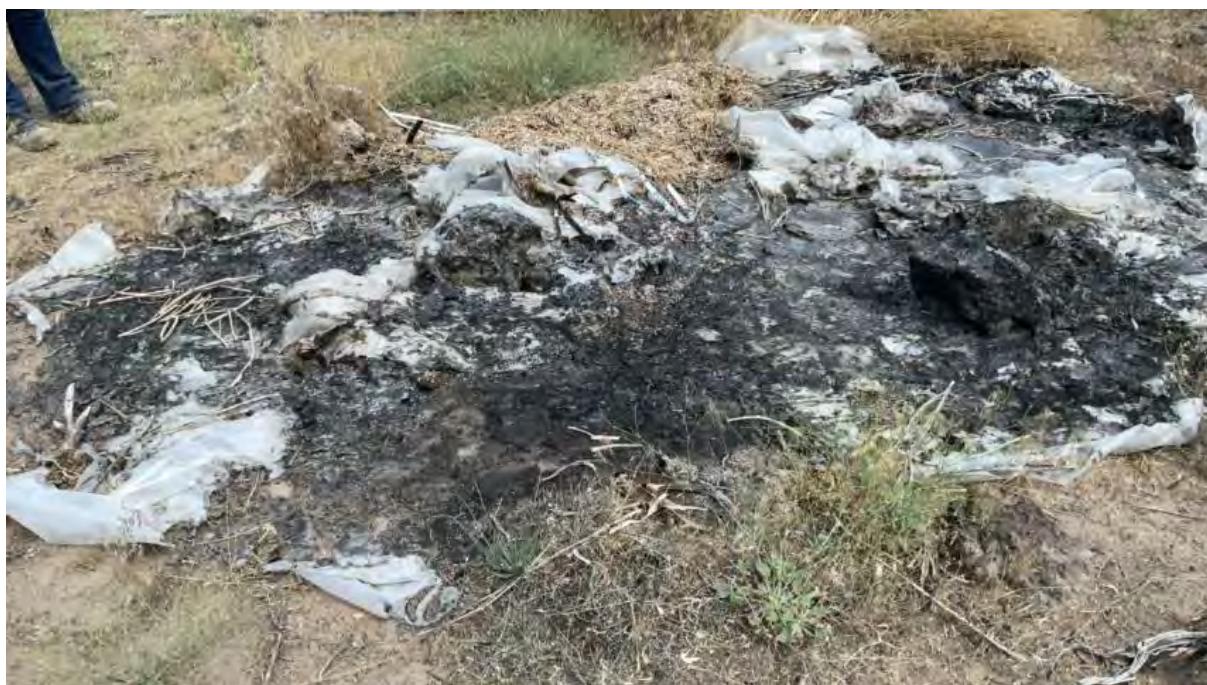
Figure 85. Location 2 burned tarp.

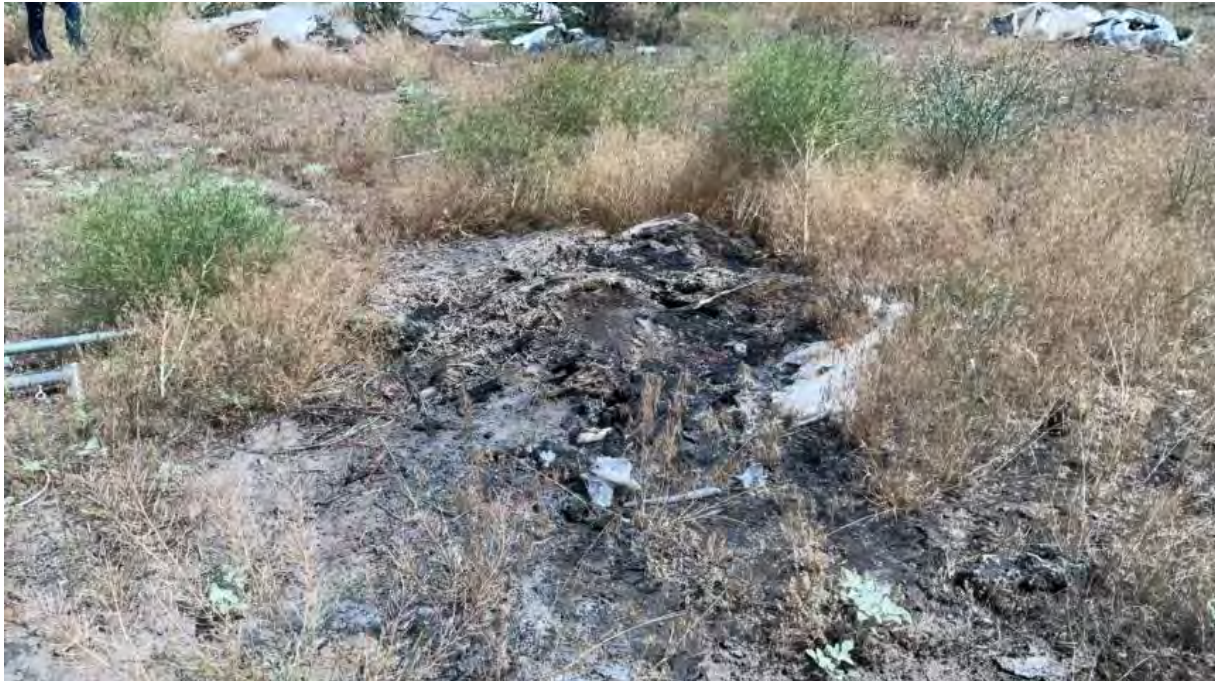
Figure 86. Location 2 burned tarp.

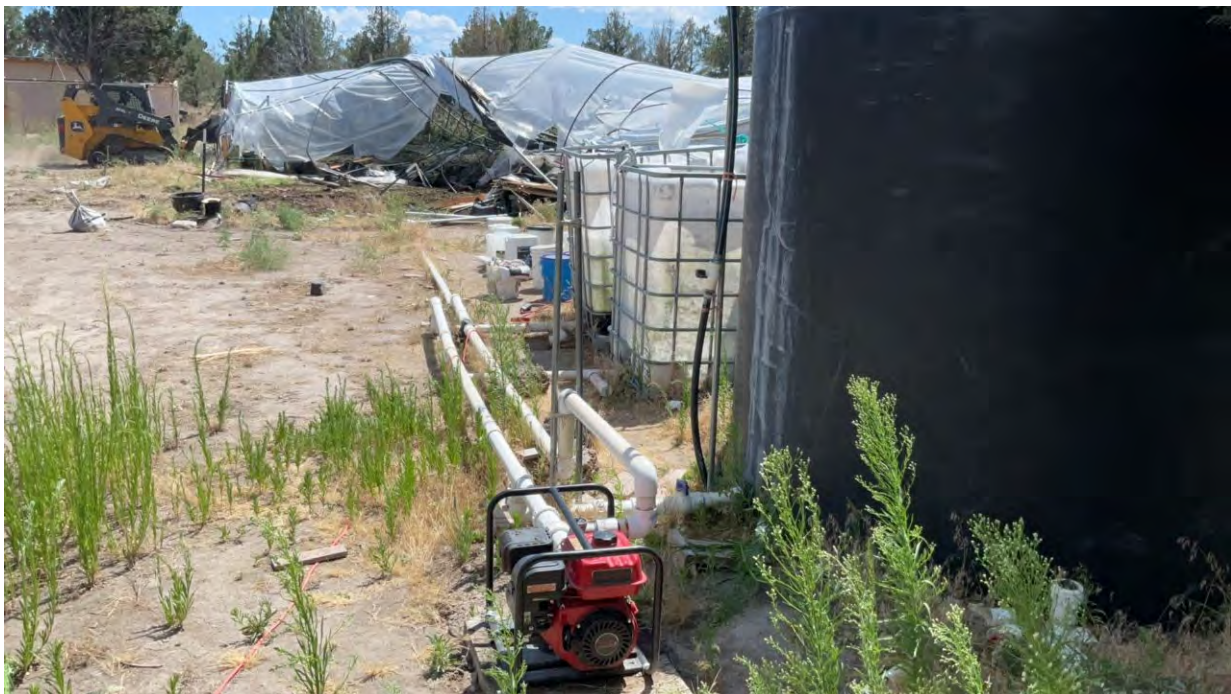
Figure 87. Feed tanks, pump, and fertilizers and pesticides are at location 3.

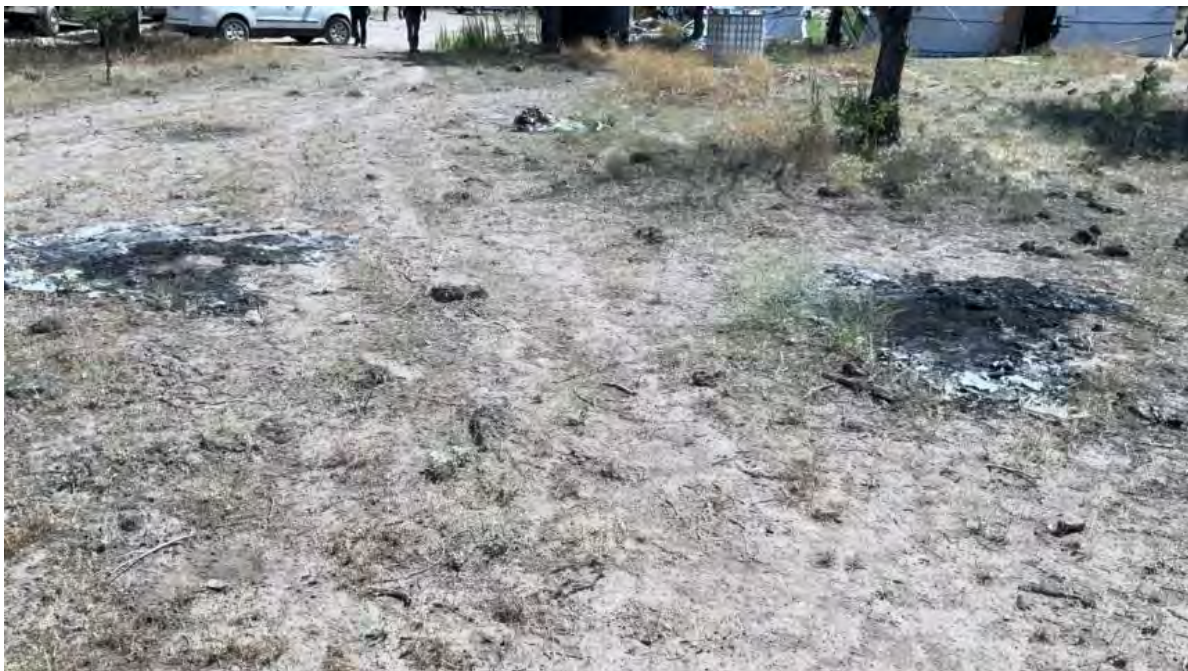
Figure 91. Burned tarps at location 4.

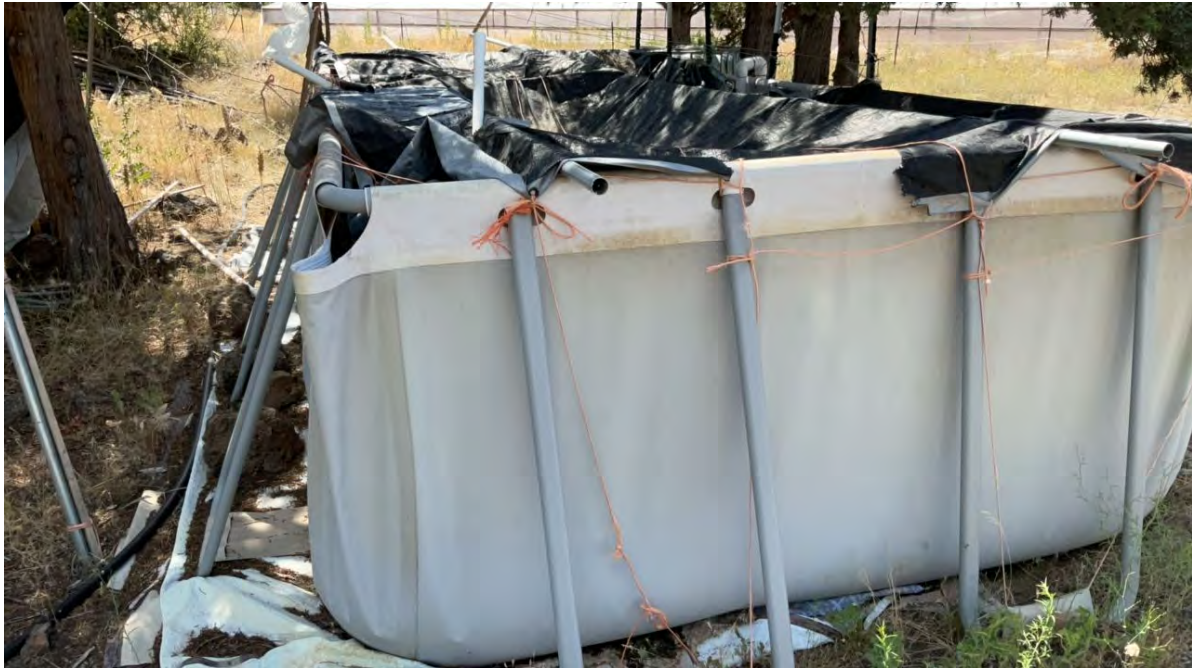
Figure 92. Water storage pool at location 5.

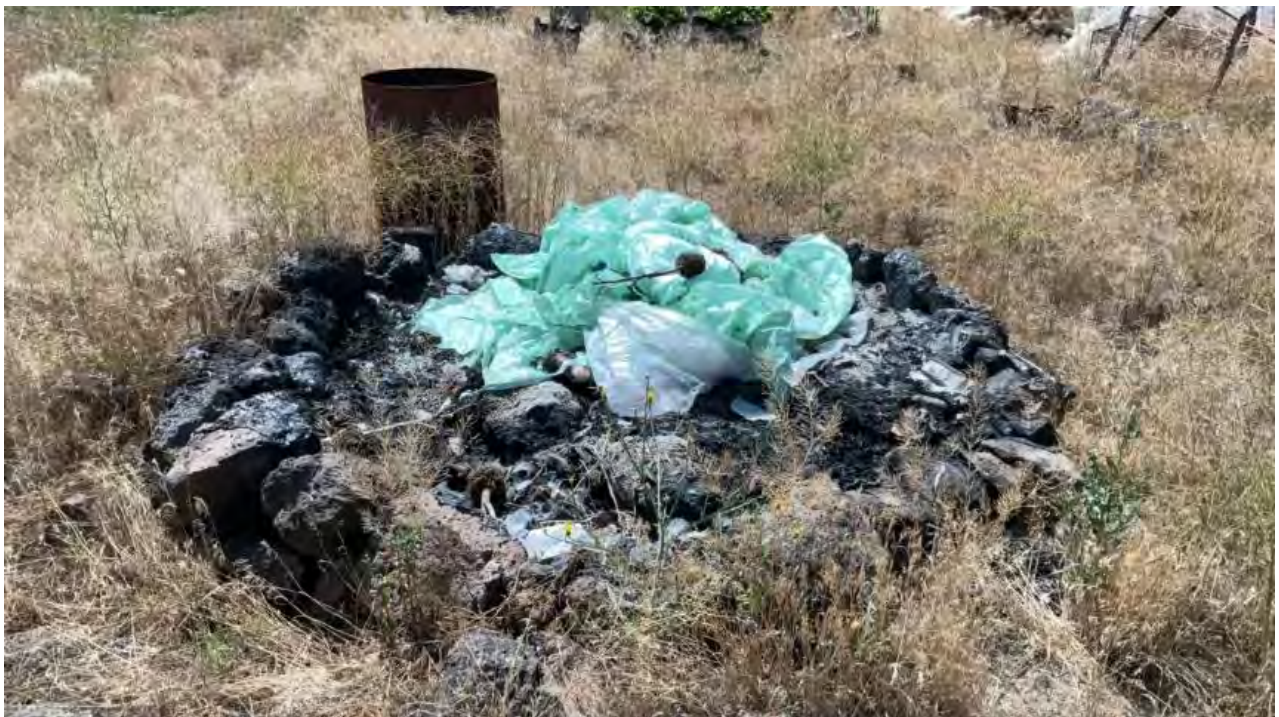
Figure 95. Burn ring with plastic melted on rocks at location 9.

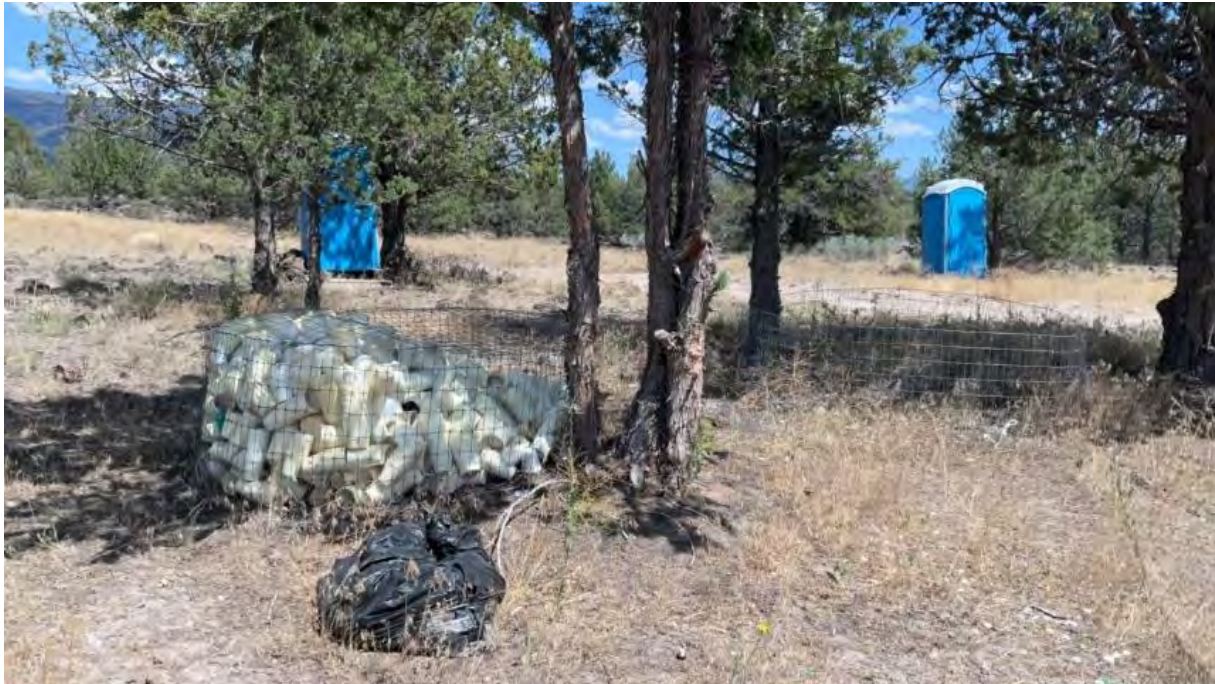
Figure 96. Porto potties at location 10.

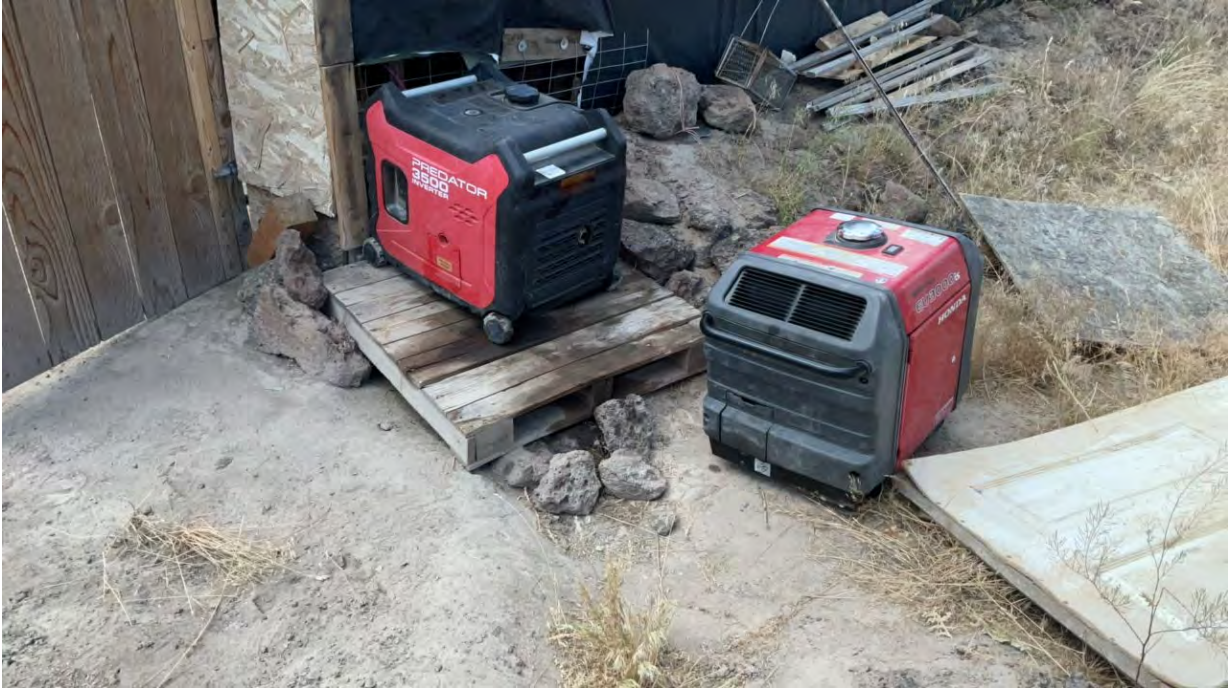
Figure 100. Generator with petroleum stains on ground at location 2.

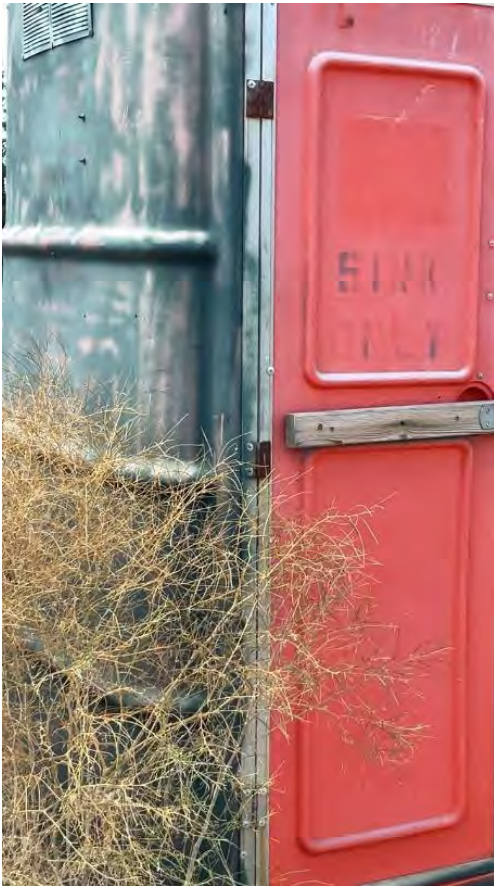
Figure 101. Porto potty at location 1.

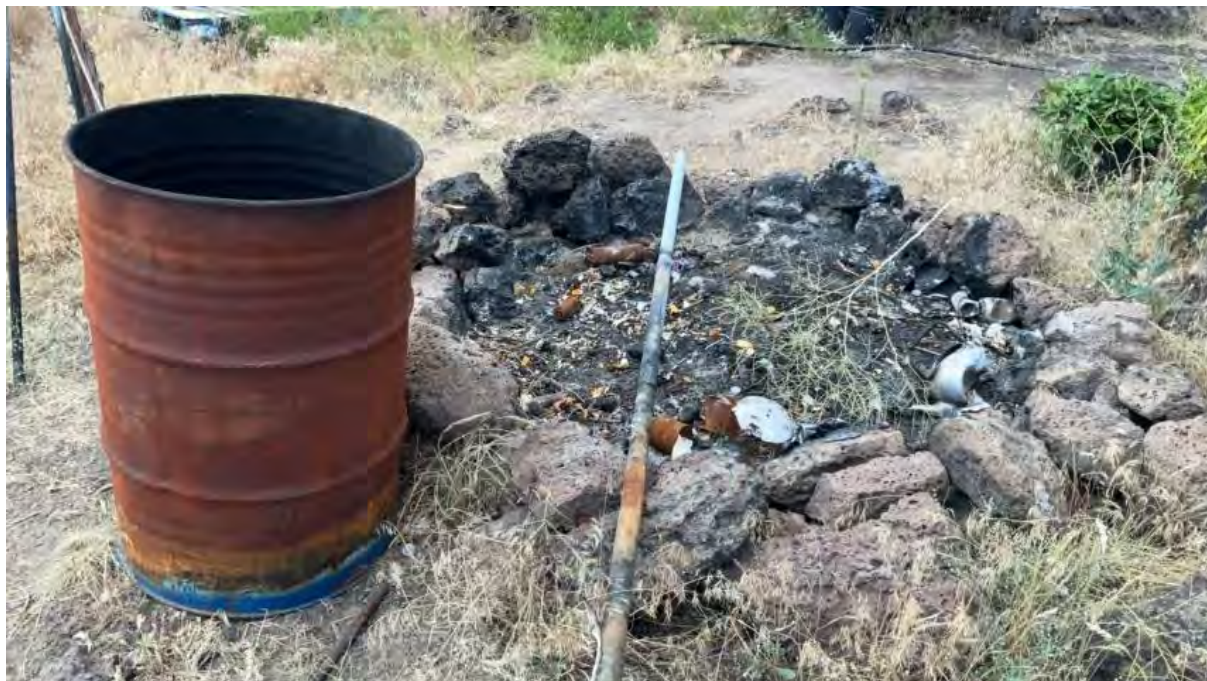
Figure 109. Burn ring at location 9 with metal and containers.
