**North Coast Regional Water Quality Control Board
Attachment B**

**Cannabis Water Quality Inspection Report, Lee Site,
Siskiyou County APN 011-120-010, WDID No 1_47MJ00370**

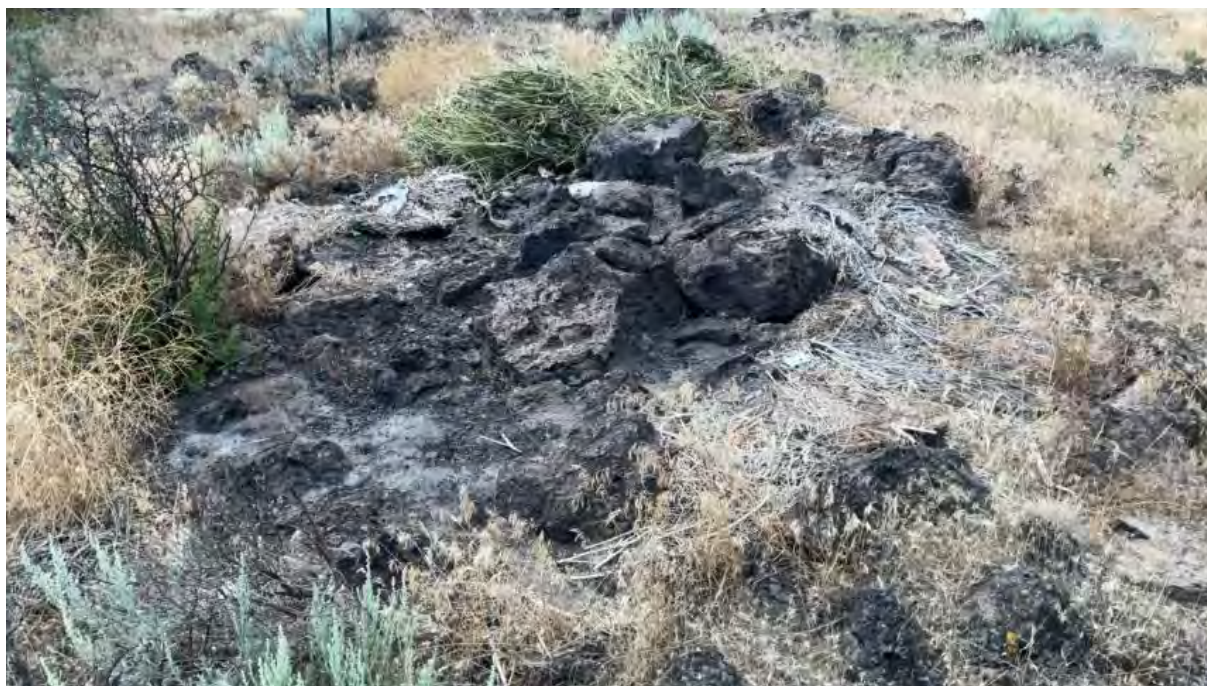
Figure 110. Burn ring at location 10 with cultivation waste and plastic.

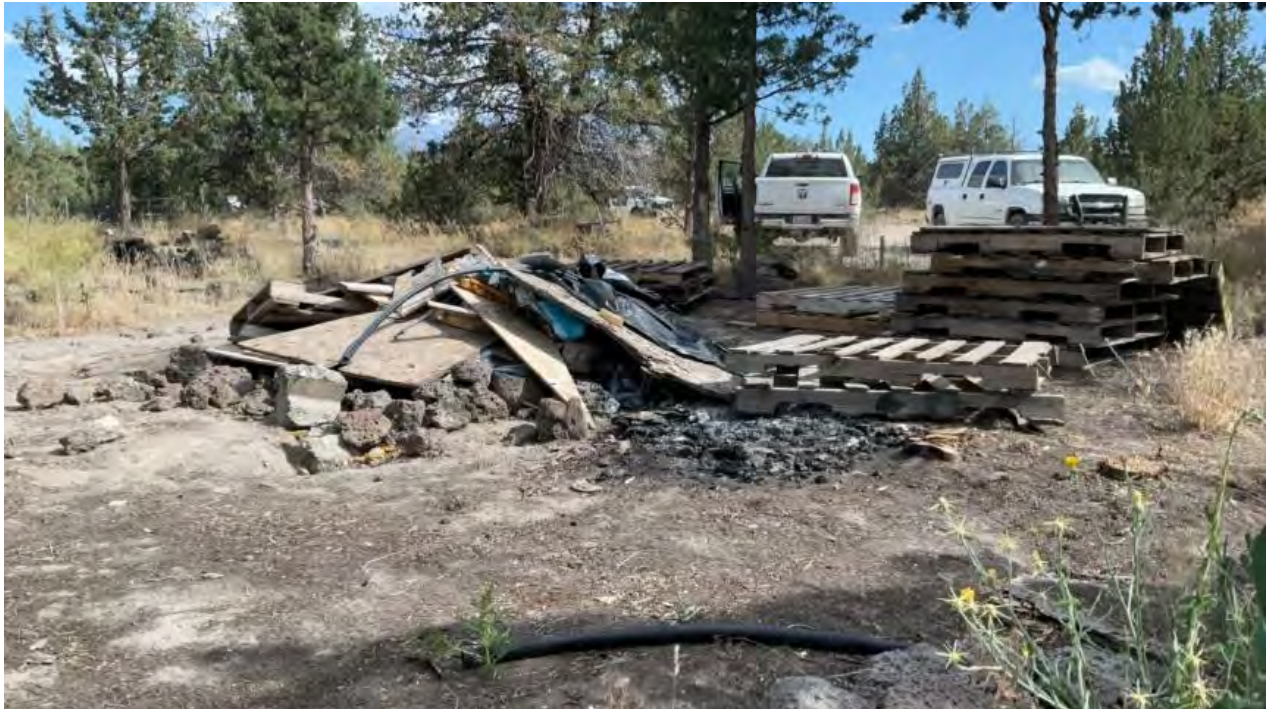
Figure 114. Burned trash including plastic at location 3.

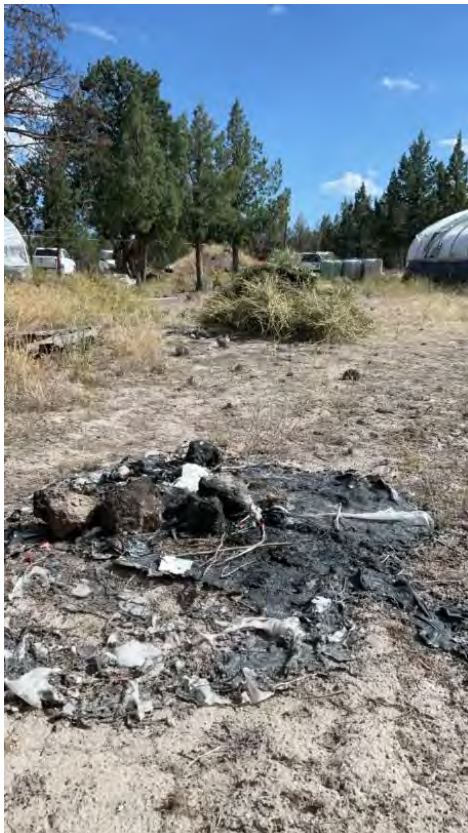
Figure 115. Burned plastic at location 4.

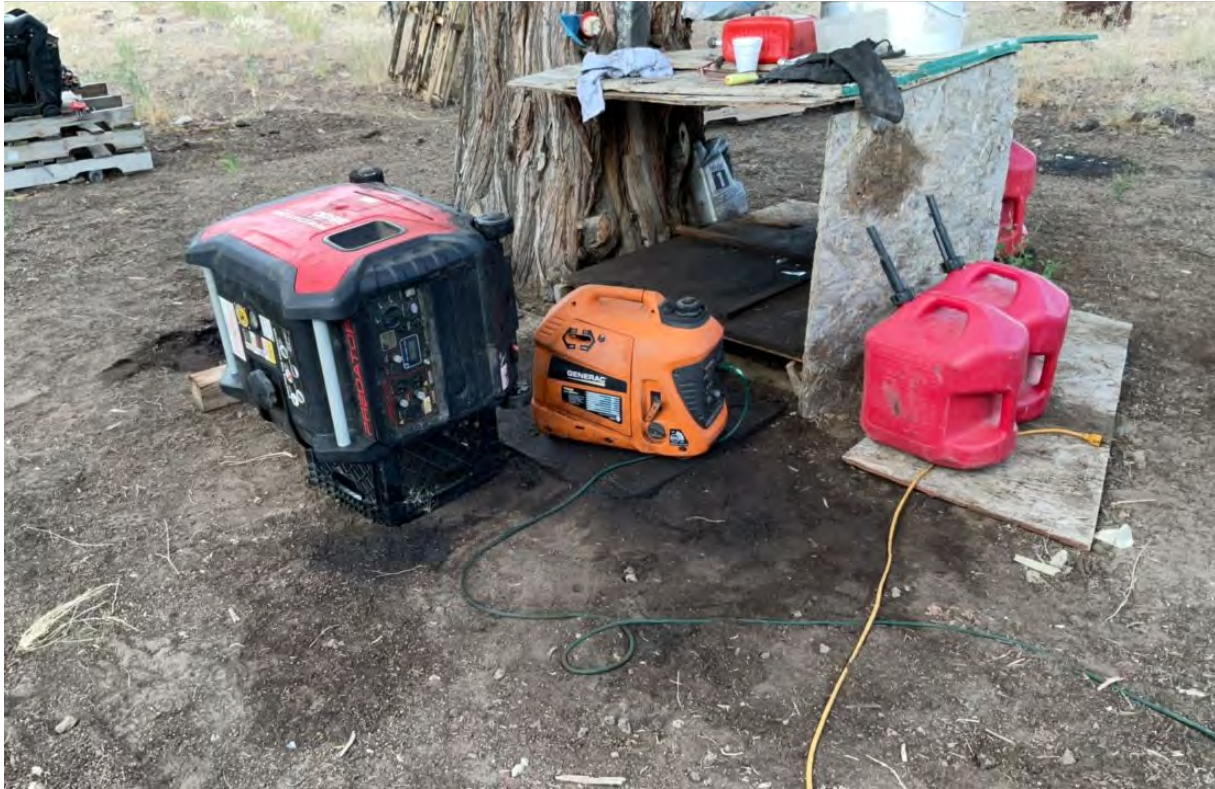
Figure 123. Generator at location 5 with stained ground from spill.

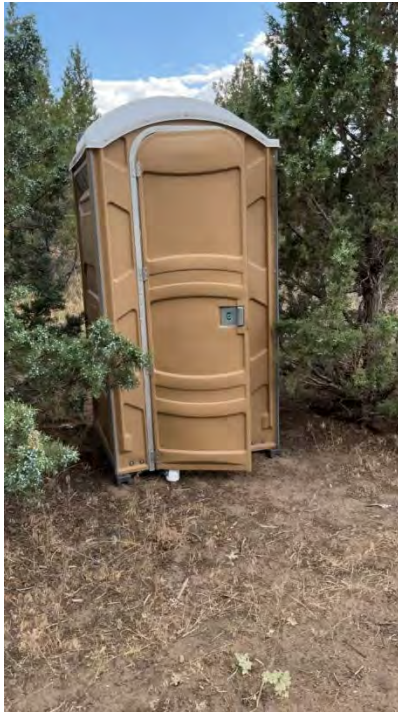
Figure 124. Porto Potty at location 7.
