## North Coast Regional Water Quality Control Board

**Subject: Notice of Violation, Transmittal of Inspection Report of July 19, 2023  
Inspection of Mendocino County Assessor's Parcel Number 056-050-11**

**Cannabis Water Quality Inspection Report  
Burge and Williams Property**

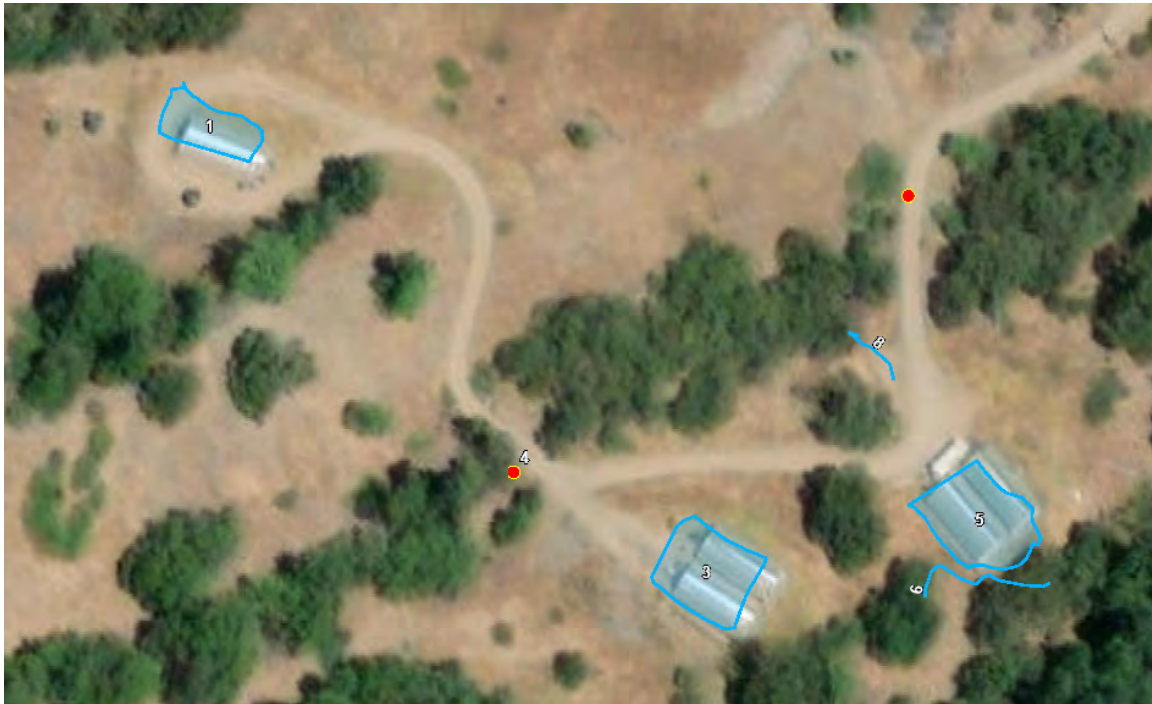
The inspection map is shown in Figures 3 and 4 and includes the locations referenced at the following features that could be of concern to water quality.

Figure 3. Inspection map with aerial imagery showing the point, line, and polygon feature locations of interest described in the text.

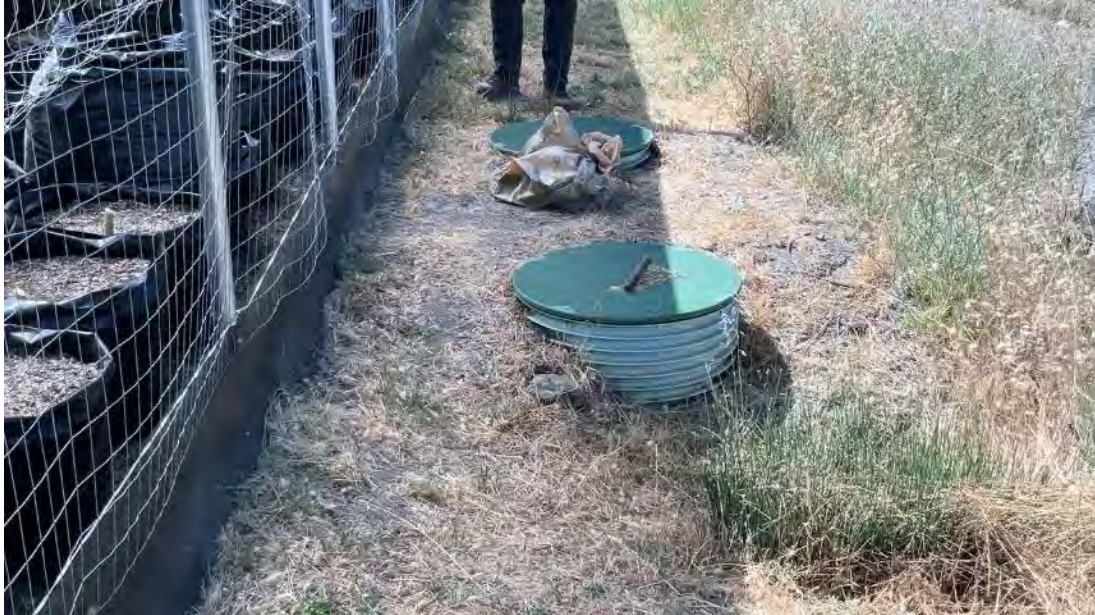
Polygon 1: Greenhouse cultivation area. Water tank with line for truck fill. Ditch from cultivation with a gullied path.

*Figure 5. Polygon 1 cultivation area.*

Remove cultivation infrastructure and properly dispose of waste including but not limited to trash, fertilizer, pesticide and petroleum containers, plastic tarps and sheeting at a legal disposal facility.

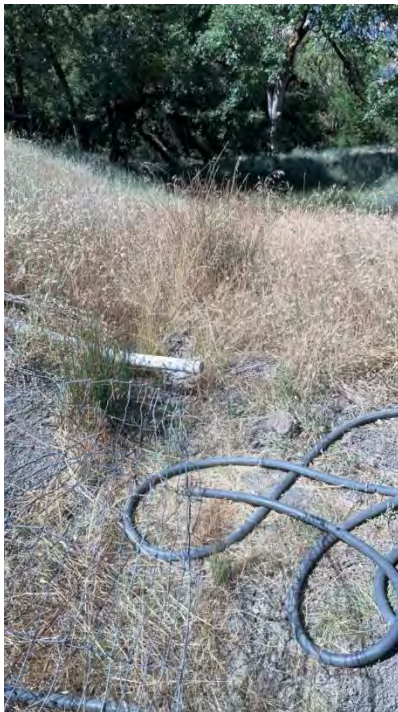
*Figure 6. Ditch from cultivation area at Polygon 1 is gullied.*

6. Hire a qualified professional to assess the Property, including but not limited to the features described in this report, to develop a treatment plan to guide that the cleanup and remediation of the assessed features that ensures that will no longer pose a threat of discharge or impacts to the quality of waters of the state. Submit the plan for approval and implement cleanup and restoration work.

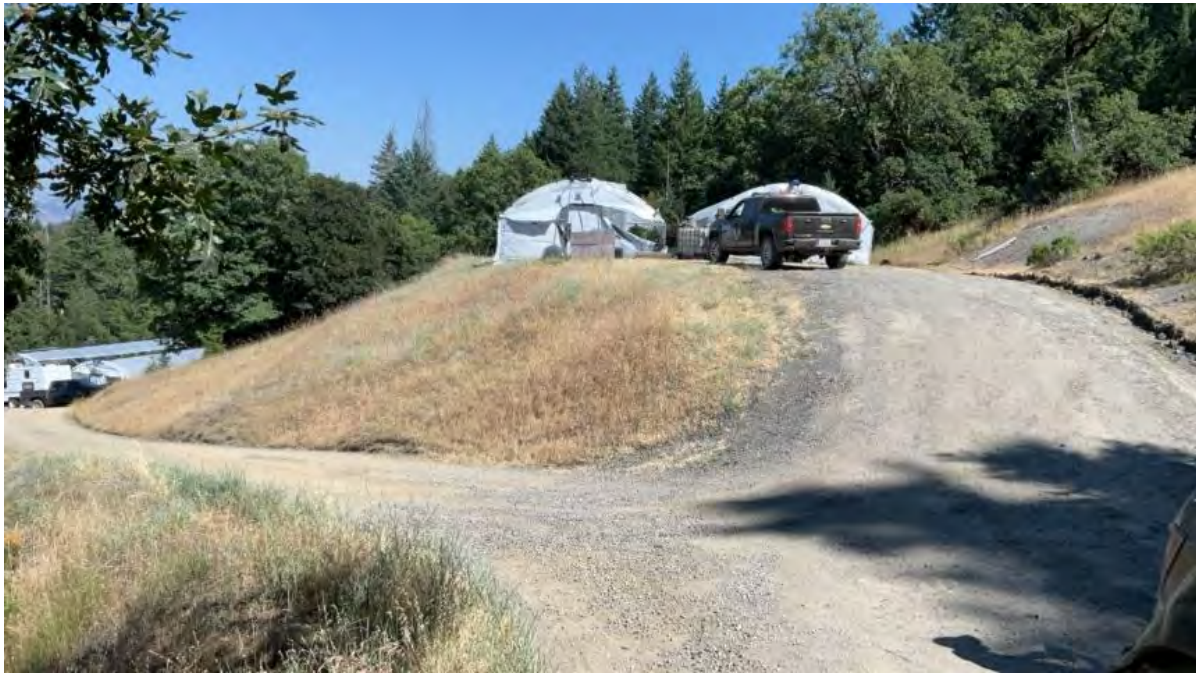
Polygon 3: Greenhouse cultivation area.

*Figure 7. Polygon 3 Cultivation area with feed tank.*

3. Cleanup fertilizer containers and feed tanks and prevent discharge of nutrients to land in a manner that threatens water quality. Properly dispose of all pesticides and fertilizers at a legal disposal facility.
4. Cleanup potting soil and properly locate and stabilize or remove and dispose of at a legal disposal facility.

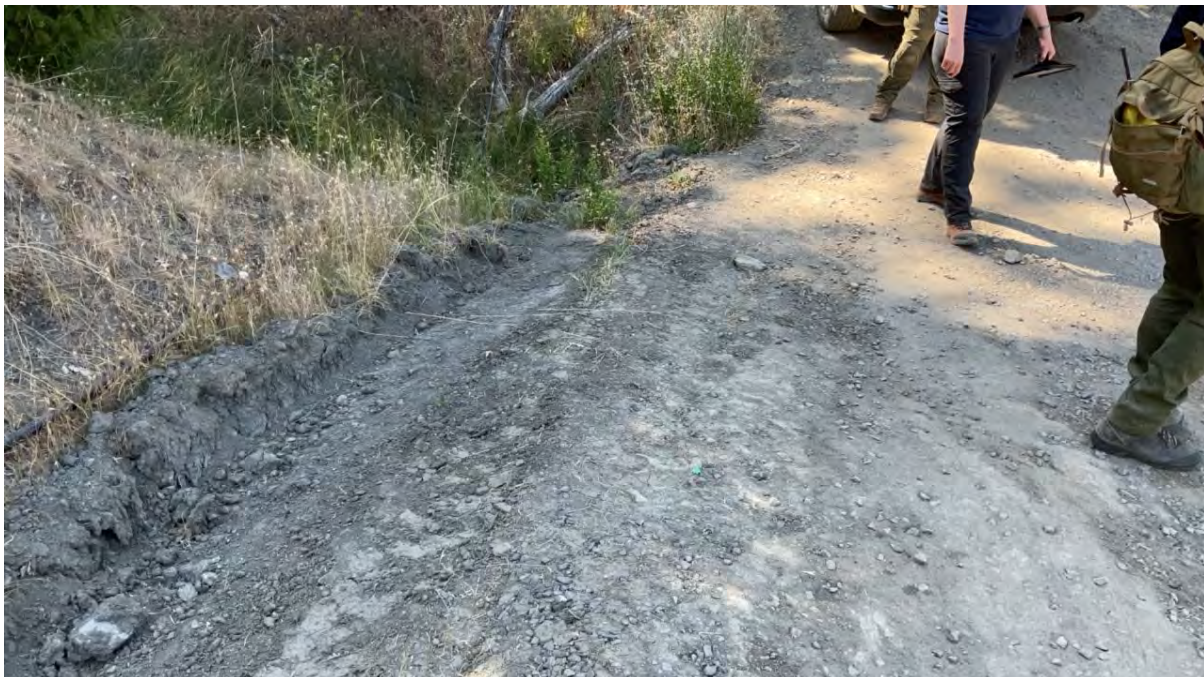
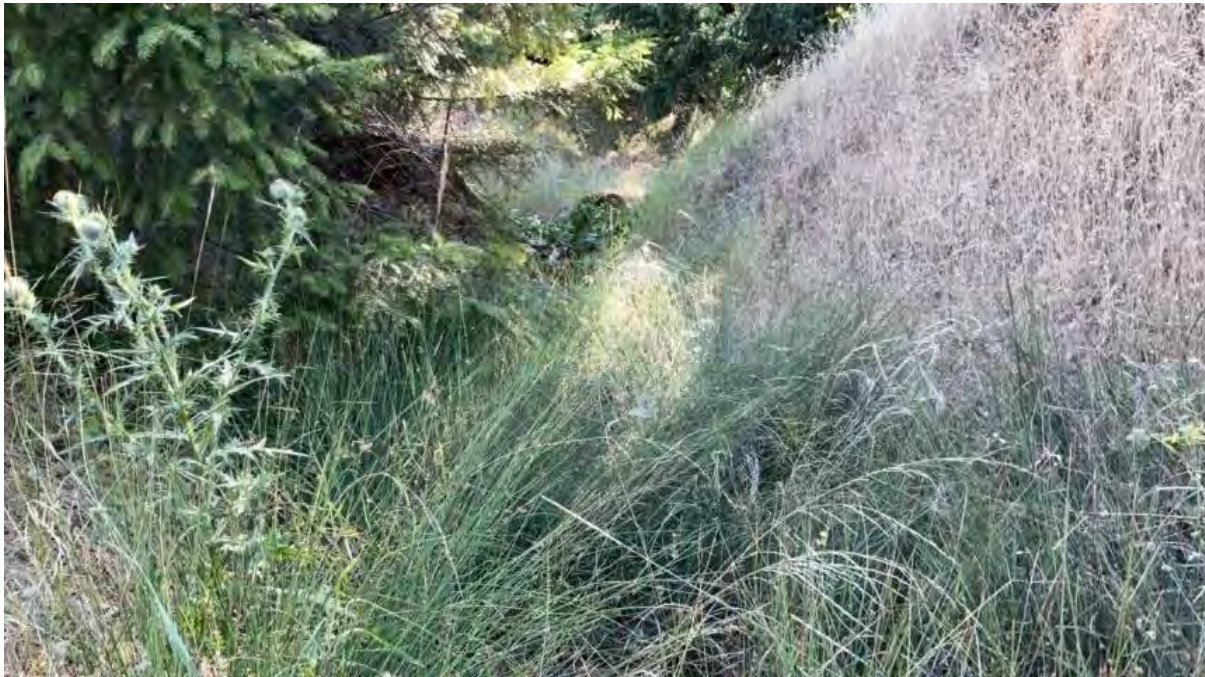
Point 4: Watercourse crossing comprised of an 18" corrugated metal pipe (CMP). There is potential for erosion around the pipe and road ditch delivery, resulting in threats of sediment discharge to the watercourse.

*Figure 8. Point 4 watercourse crossing.*

*Figure 9. Point 4 watercourse crossing.*

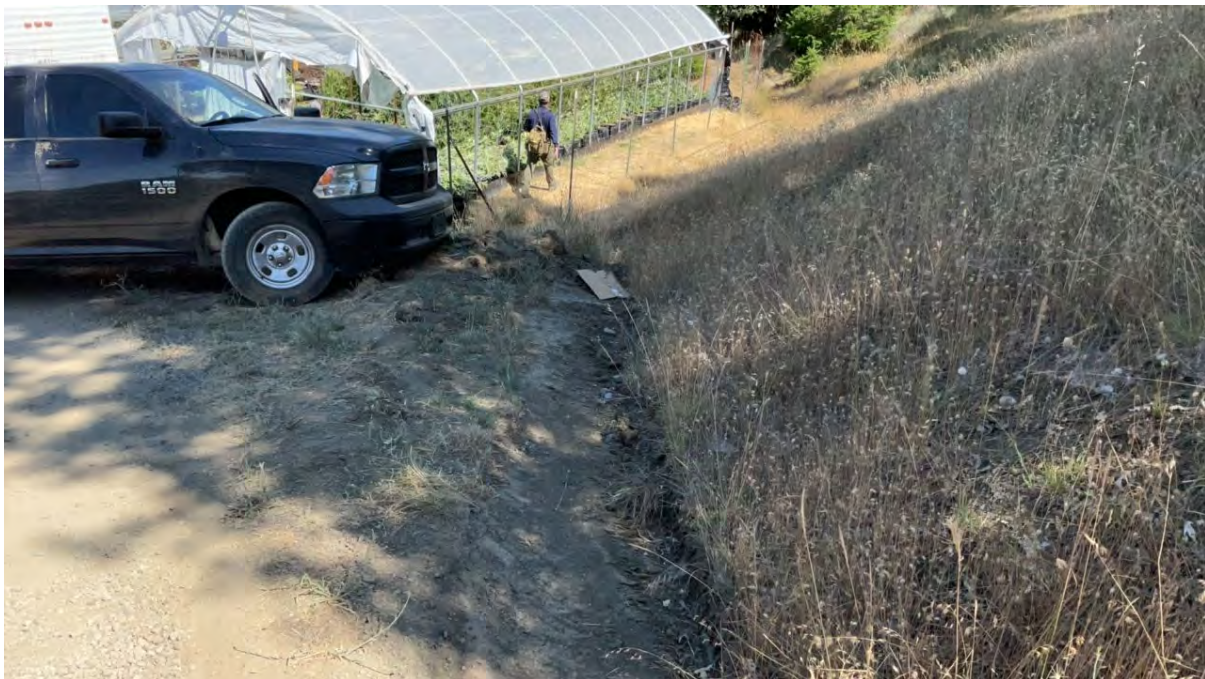
Polygon 5: Greenhouse cultivation area. Road ditch directs runoff into cultivation area, resulting in a threat of sediment and nutrient discharge.

*Figure 10. Polygon 5 is an area with active greenhouse cultivation. A road ditch directs road runoff to cultivation area.*

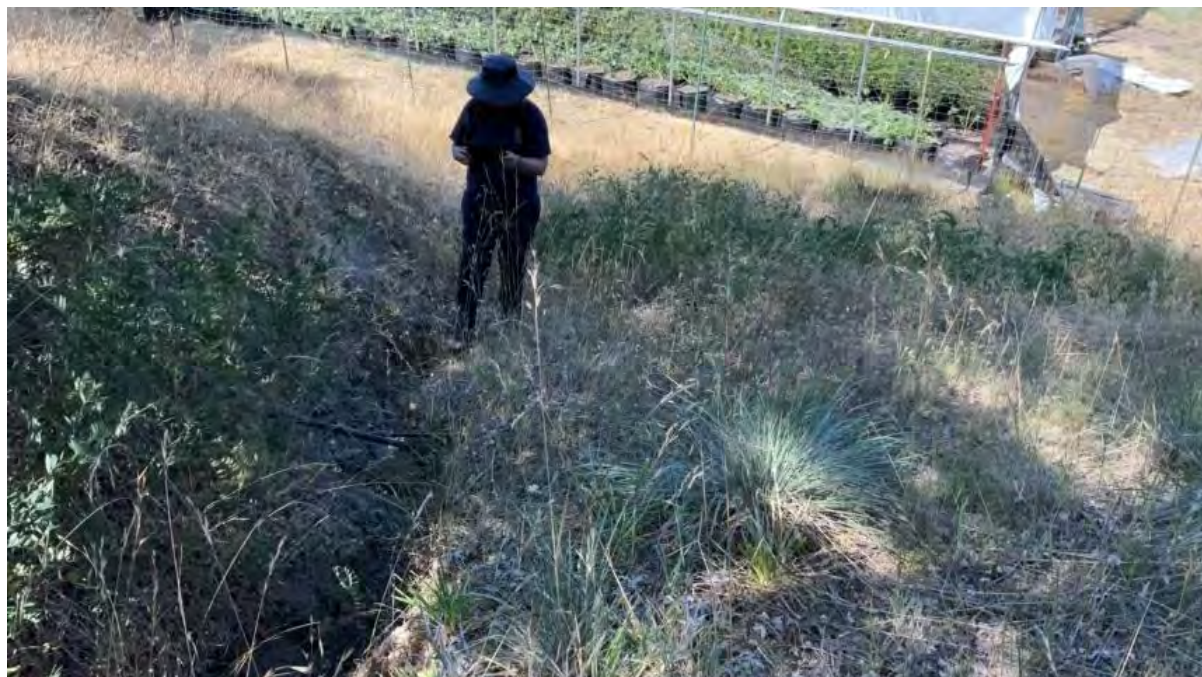
Line 6: A Class III watercourse, draining the slope above the greenhouse, is diverted across the slope and around the cultivation area and delivers to the next watercourse to the east with actual and threatened discharge of sediment.

*Figure 11. Line 6 represents a watercourse draining the area above the Polygon 5 cultivation area cut bank that is diverted around cultivation area to the next drainage over. Along the rerouted flow path sediment was eroded, transported, and delivered to the receiving watercourse.*

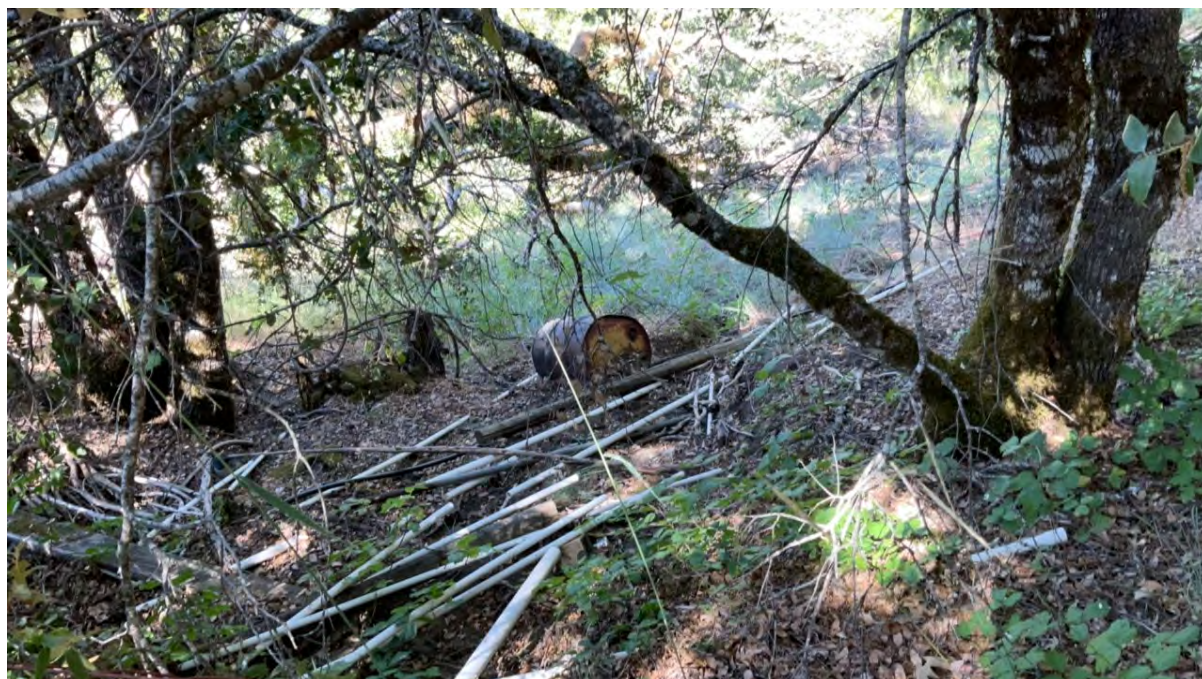
*Figure 12. Line 6. Trash is placed in the flow path of the diverted watercourse.*

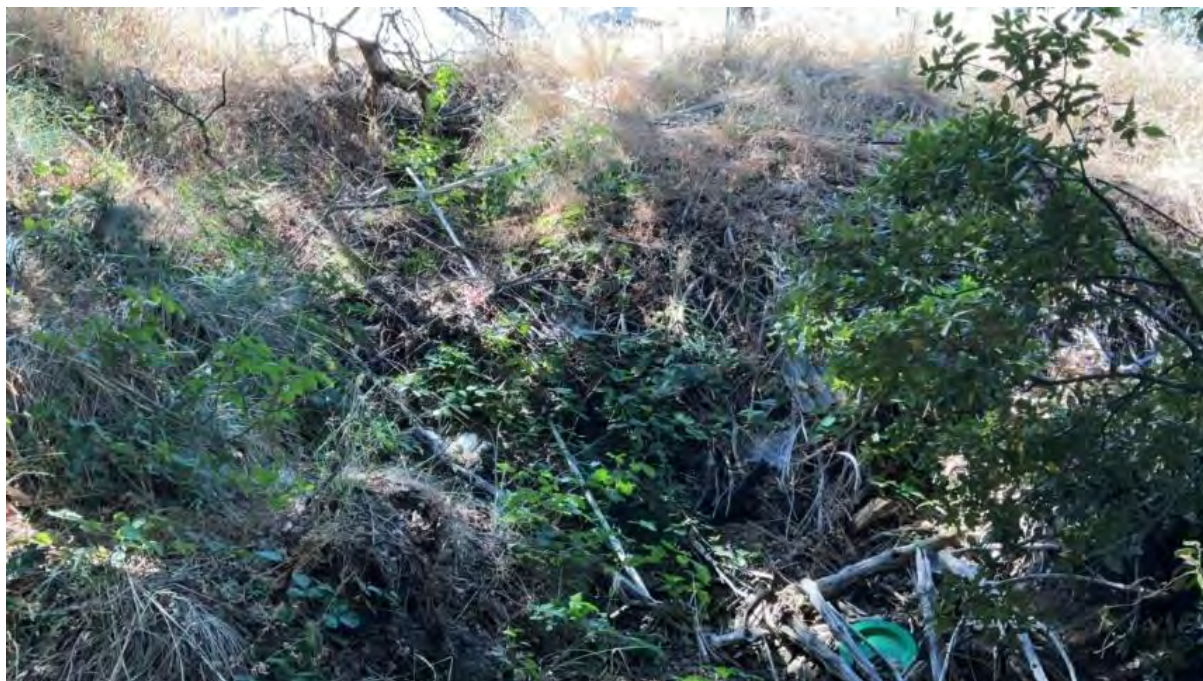
*Figure 13. Line 6. Diverted watercourse delivers to a Class III watercourse in next drainage to east. There is a threat of additional sediment delivery along this new flow path.*

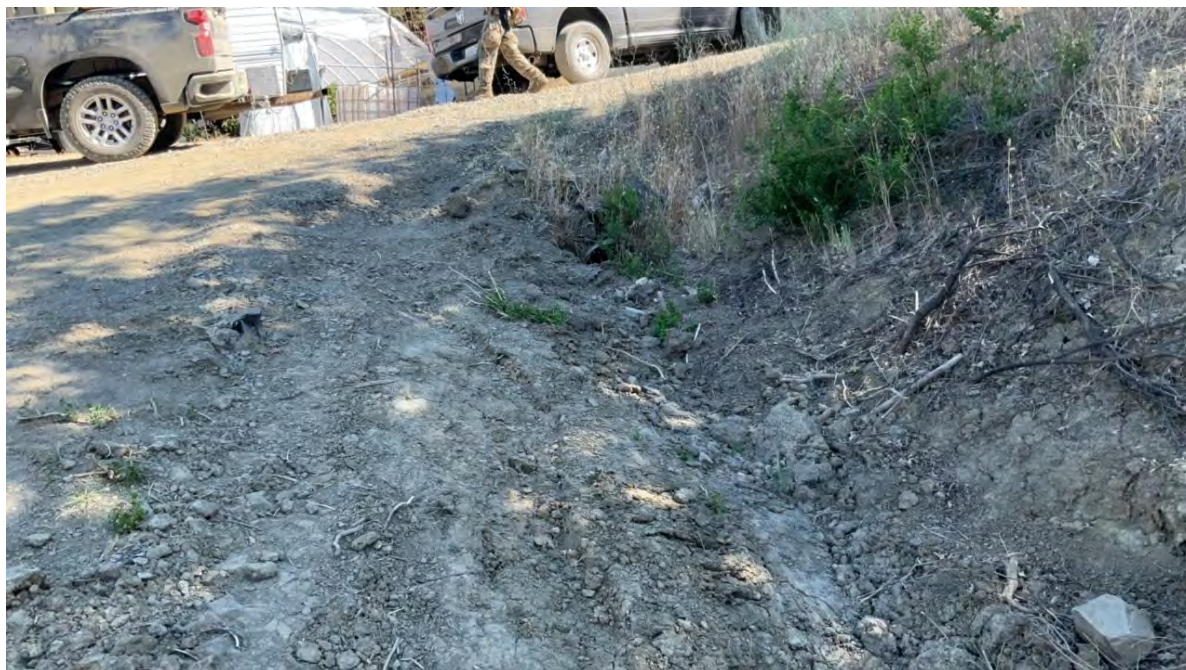
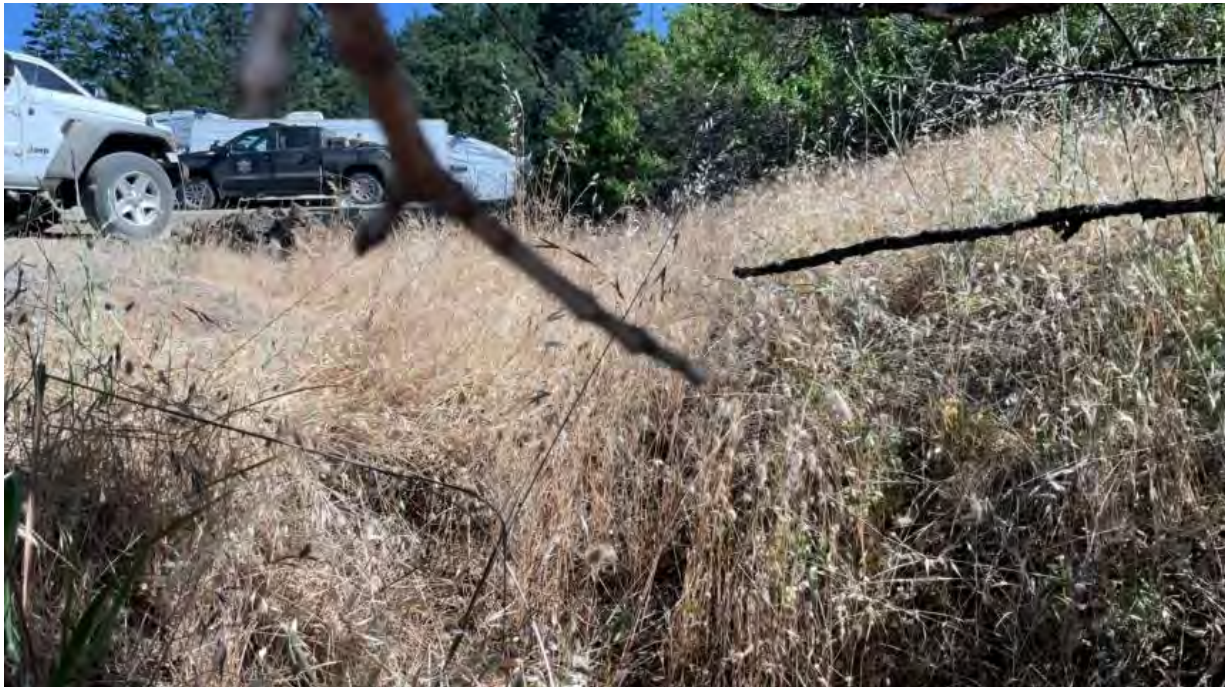
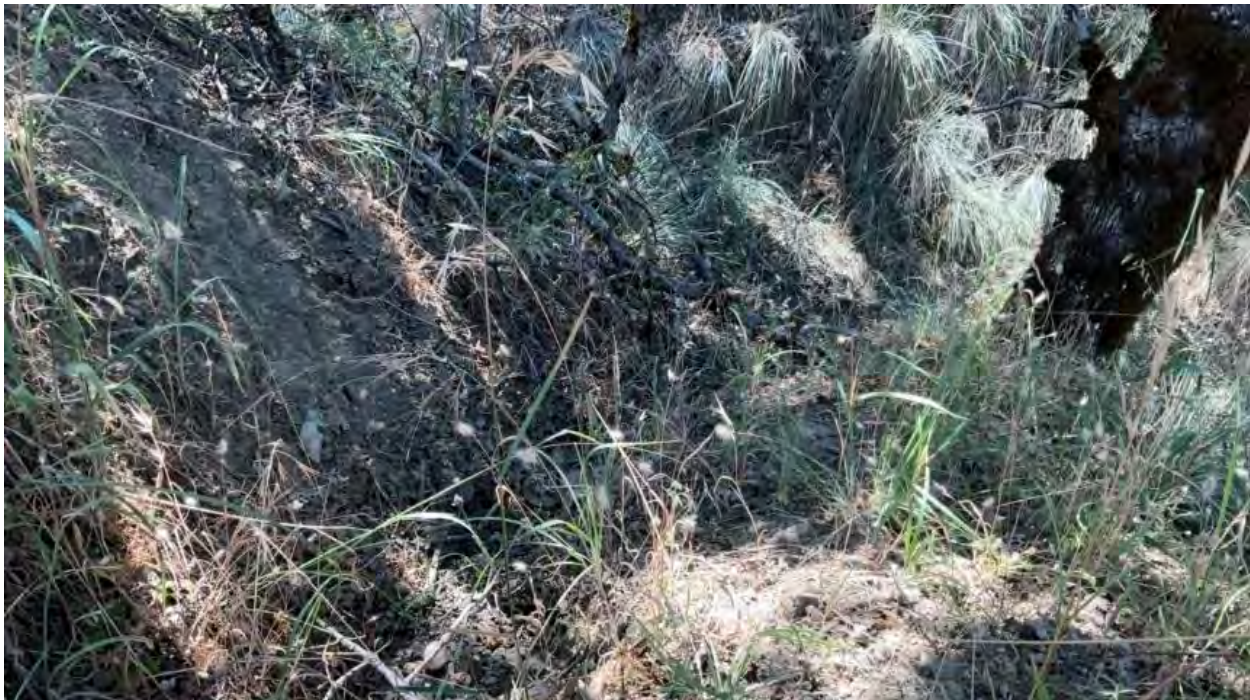
Line 8: Road runoff directed to a watercourse with threat of sediment discharge.

*Figure 14. Line 8. Road-runoff delivers to a Class III watercourse.*

*Figure 15. Line 8. Road-runoff delivers to a Class III watercourse.*

*Figure 16. Line 8. Road-runoff delivers to a Class III watercourse.*
