**Subject Notice of Violation, Transmittal of Inspection Report of July 13, 2023
Inspection of Siskiyou County Assessor's Parcel Number 019-021-420**

**Cannabis Water Quality Inspection Report
George Griset Property, Siskiyou County APN 019-021-420, WDID No.
1_47MJ000373**

Inspection Details
Inspection Date & Time	July 13, 2023; 07:20 to 09:06
Address/Location	unknown address, Eagle Road, Montague, CA
County	Siskiyou
Assessor's Parcel Number (APN)	019-021-420
Watershed	Shasta HA/Klamath HU
Property Owner's Legal Name and Company	George Griset
Mailing Address	PO Box 367, Gustine, CA 95322
Agency Responsible for Warrant	California Department of Fish and Wildlife (CDFW)
Person Responsible for Warrant	Joseph Laugesen
Warrant Date	July 13, 2023
Warrant Type	Criminal Search
Lead Inspector Name	Adona White, PE, Water Resources Control Engineer
Office/Regional Board	North Coast Regional Water Quality Control Board
Other Personnel Onsite	Representatives from CDFW, California Department of Cannabis Control, California Department of Tax and Fee Administration, California Department of Toxic Substances Control, the Siskiyou County Sheriff's Office, the Siskiyou County Department of Environme

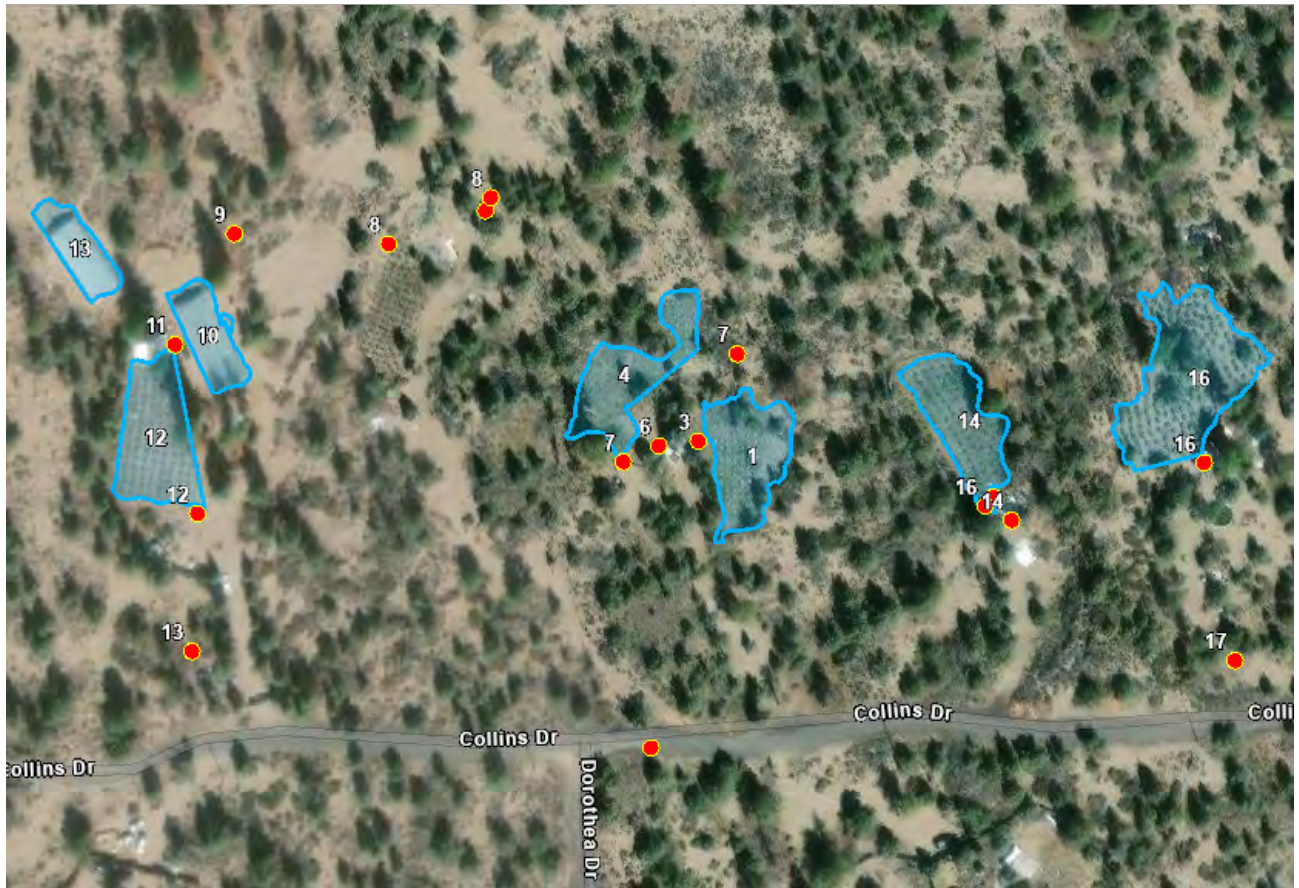
Figure 2. Inspection map.

The inspection map is shown in Figure 2 and includes the locations referenced at the following features of concern to water quality.

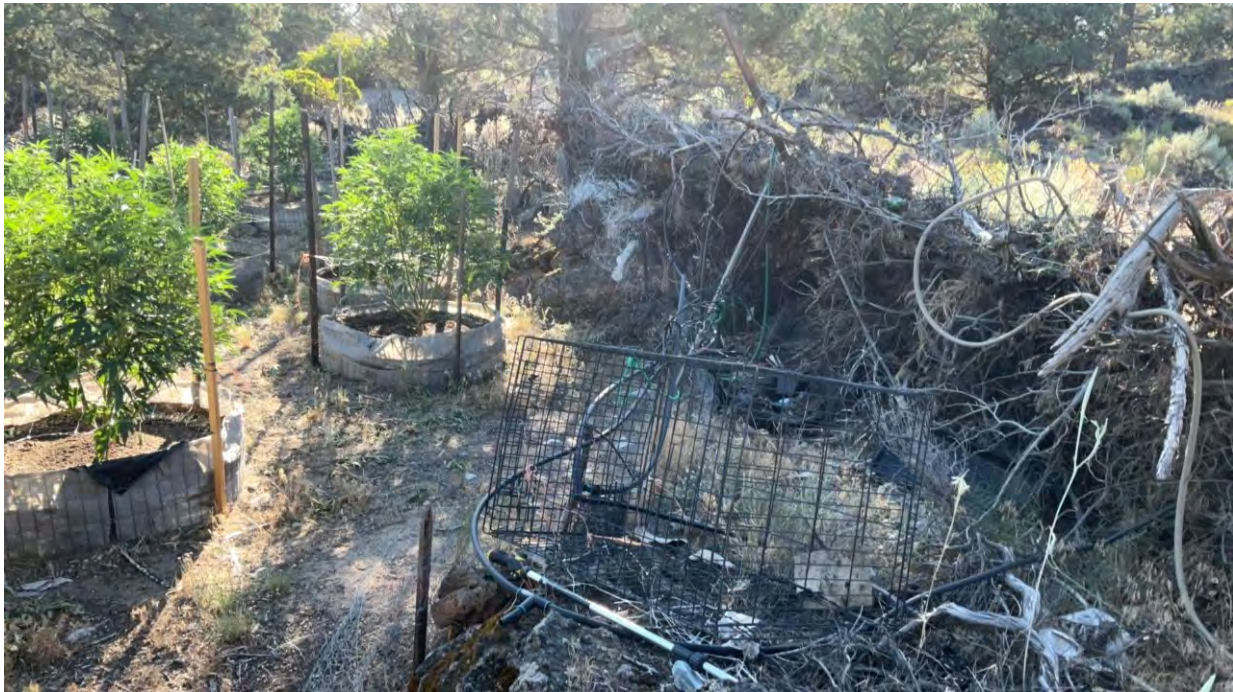
Polygon Feature 1: Approximately 7,800 square feet of active outdoor cultivation. Cultivation-related plastic waste is co-mingled with cleared brush pushed around the perimeter of the cultivation area.

Figure 3. Perimeter of cultivation area at Polygon Feature 1.

3. Remove cultivation infrastructure and properly dispose of cultivation-related and household refuse including but not limited to trash, fertilizer, pesticide and petroleum containers, plastic tarps and sheeting at a legal facility.

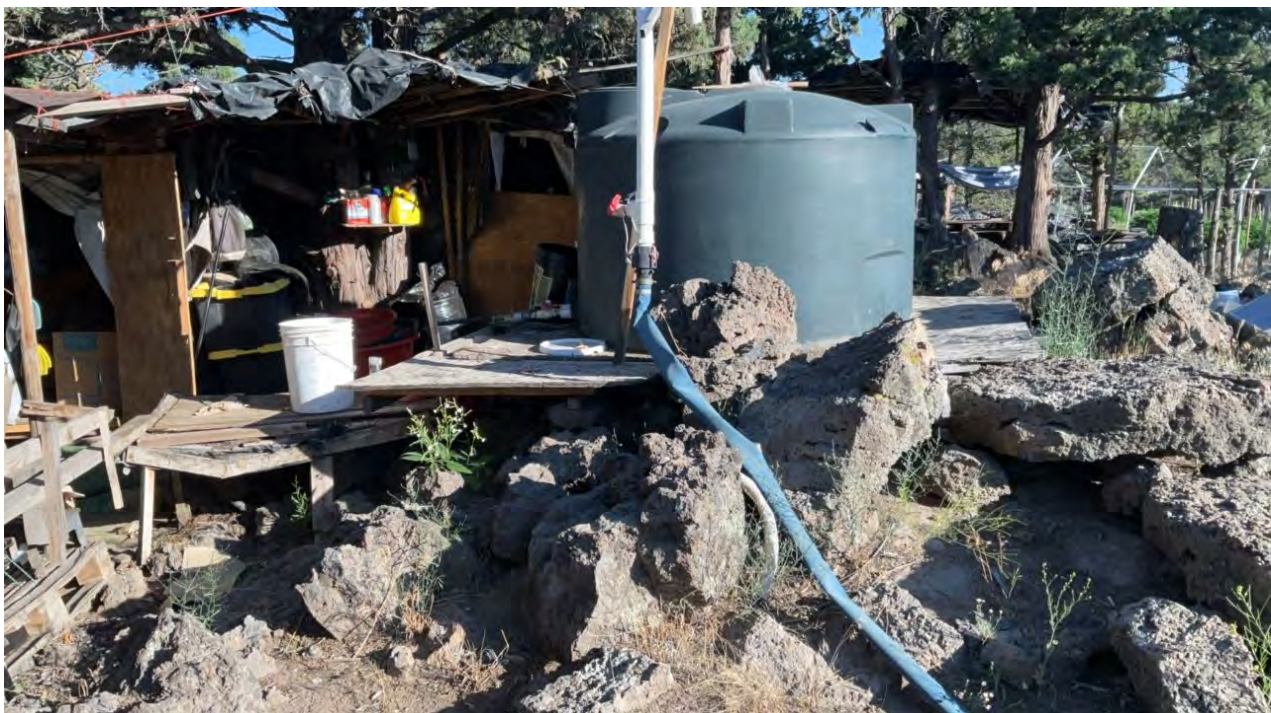
Point Feature 3: Water tank with hookup for water truck deliveries.

Figure 4. Tank and hookup for truck delivery is located at Point Feature 3.

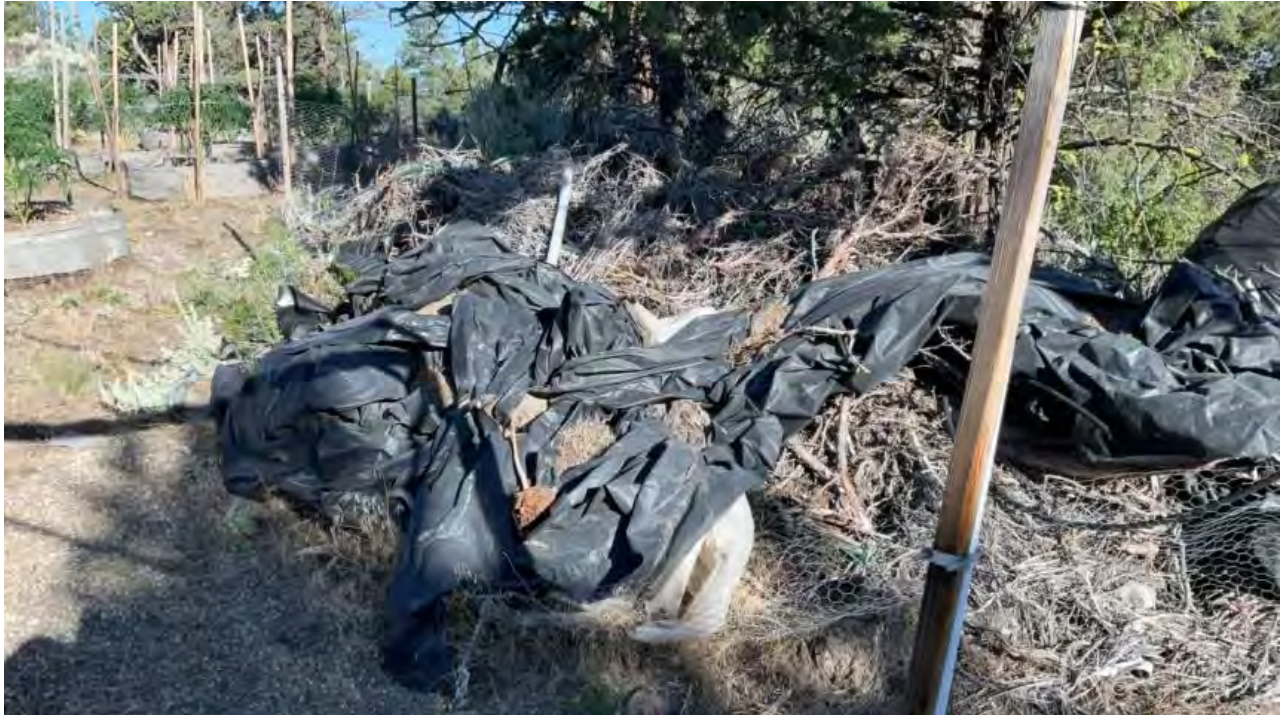
Polygon Feature 4: Approximately 7,000 square feet of active outdoor cultivation. Cleared brush at the perimeter of the associated disturbed area is comingled with plastic cultivation-related waste.

Figure 5. Cultivation-related refuse is comingled with cleared brush around the perimeter of the outdoor grow at Polygon Feature 4.

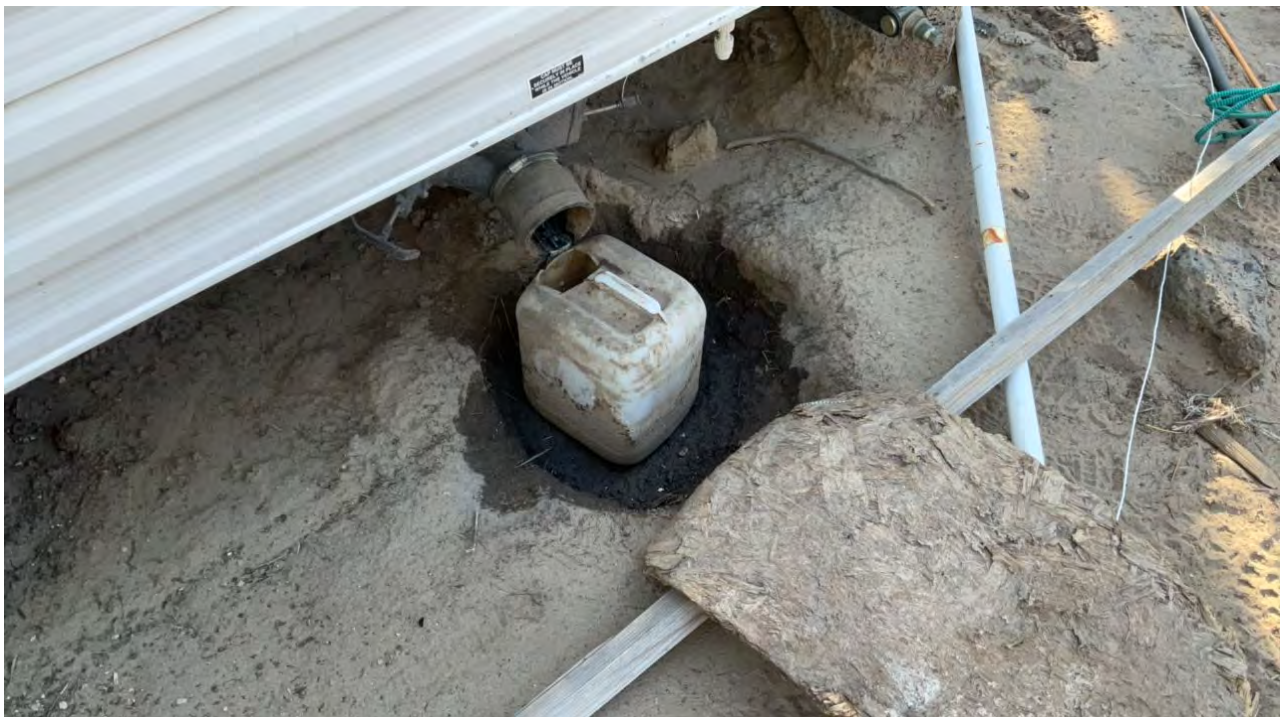
Point Feature 6: RV used as a residence with a jug placed to capture liquid waste from an effluent pipe. The ground is wet.

Figure 6. RV effluent with discharge to land at Point Feature 6.

6. Cease discharge of human and domestic waste to land. Work with Siskiyou County to obtain the necessary permits and ensure adequate domestic waste treatment systems.

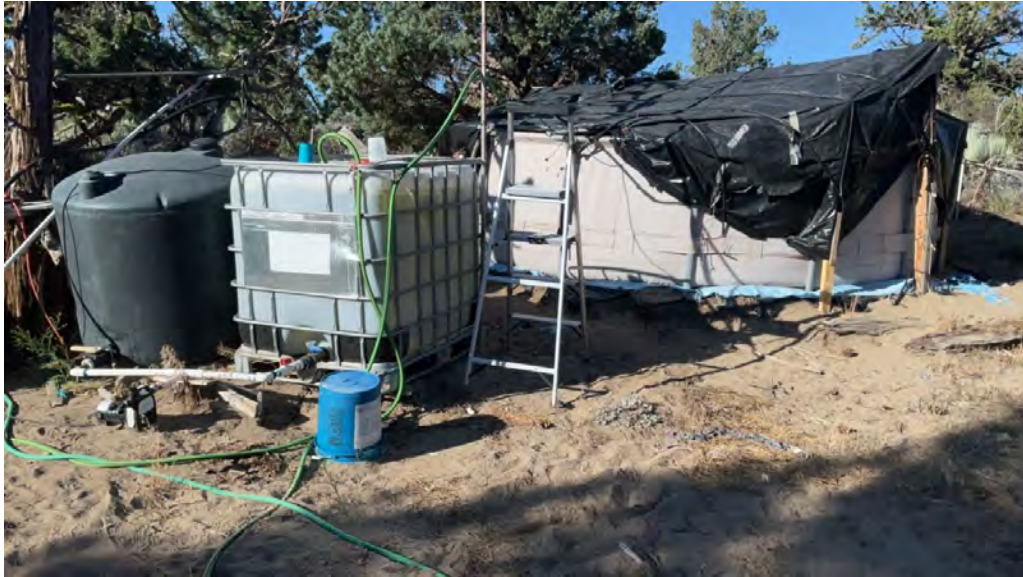
Point Feature 7: Water storage pool with fill hose from the driveway, feed tank, and uncontained fertilizer containers.

Figure 7. Water storage pool with fill hose from the driveway, feed tanks, and uncontained fertilizer containers are located at Point Feature 7.

1. Cease unauthorized cannabis cultivation.
2. Cleanup fertilizer containers and feed tanks and prevent further discharge of feed water to land in a manner that threatened water quality.

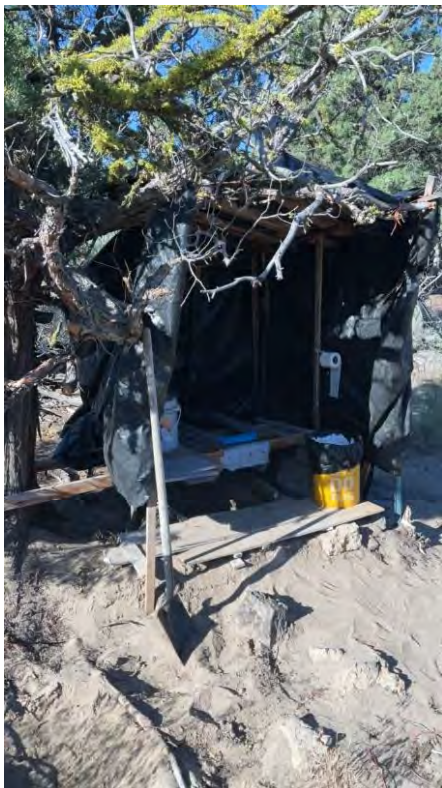
As document in the inspection report, Staff observed pit privies with human waste discharge to land, threatening the quality of waters of the state in violation of Water Code section 13264.

Point Feature 7: Pit privy with discharge of human waste to land.

Figure 8. To the north of Polygon Feature 1 cultivation area is a pit privy located at Point Feature 7, with human waste discharge to land.

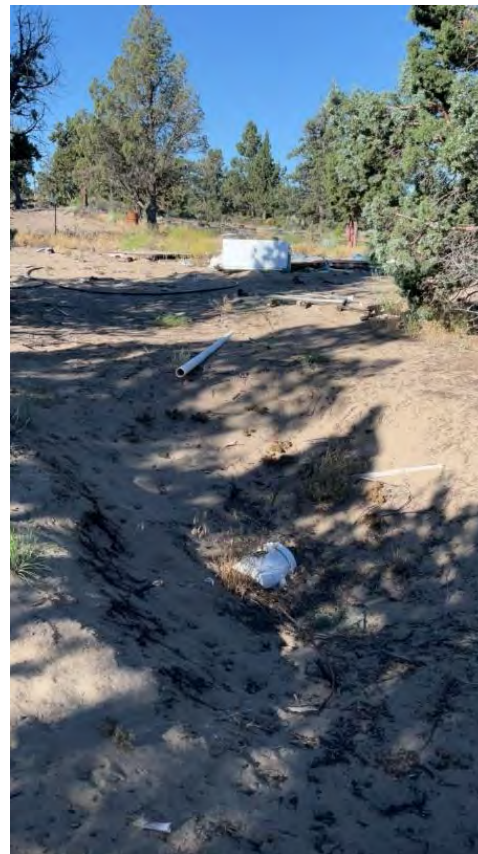
Point Feature 8: Inactive cultivation area with potting soil remaining, along with refuse and a pipe associated with a former RV site.

Figure 9. Refuse and pipe at Point Feature 8.

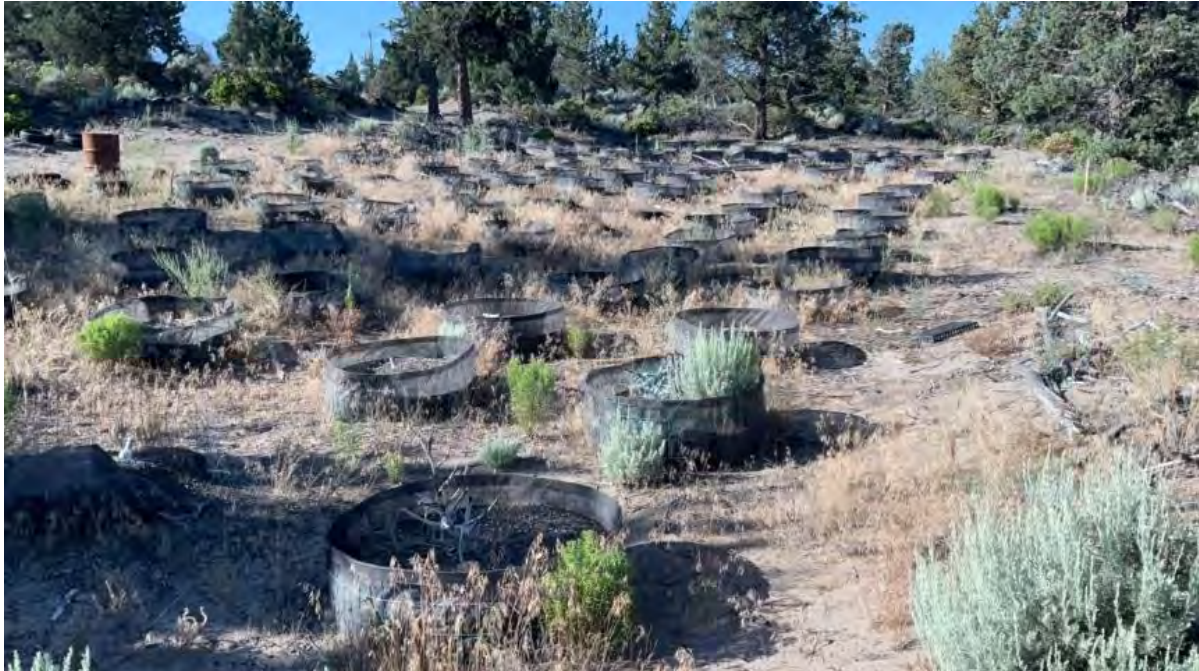
Figure 10. Soil associated with inactive cultivation area at Point Feature 8.

4. Properly dispose of all pesticides and fertilizers at a legal disposal facility.
5. Cleanup potting soil and properly contain and cover or remove and dispose of at a legal disposal facility.

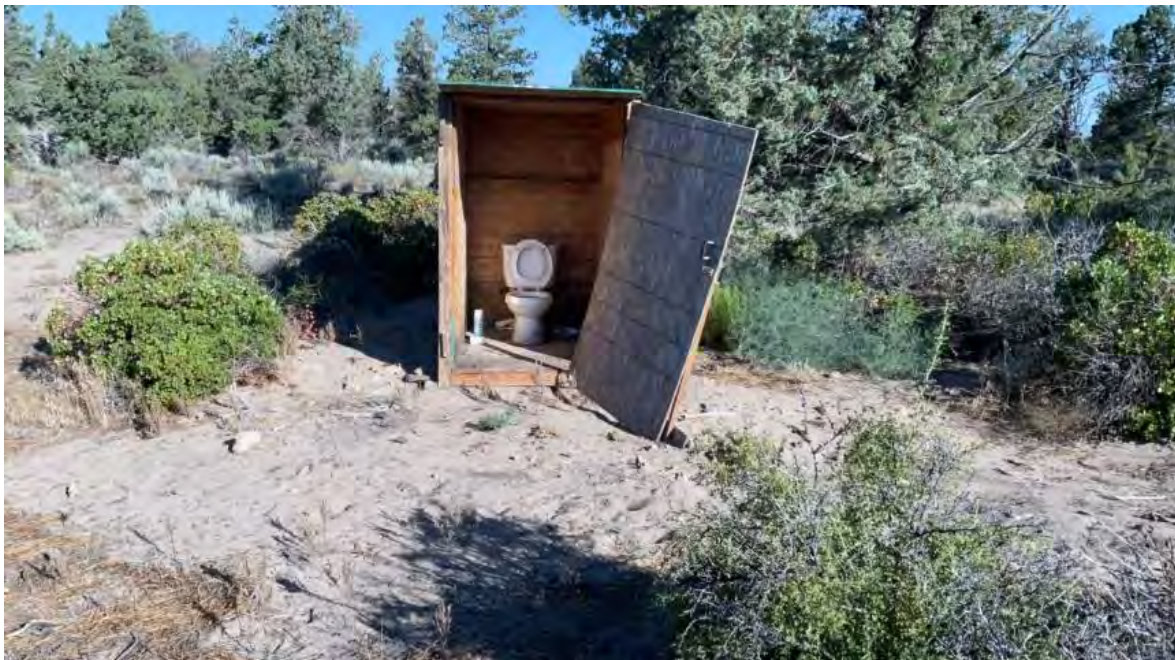
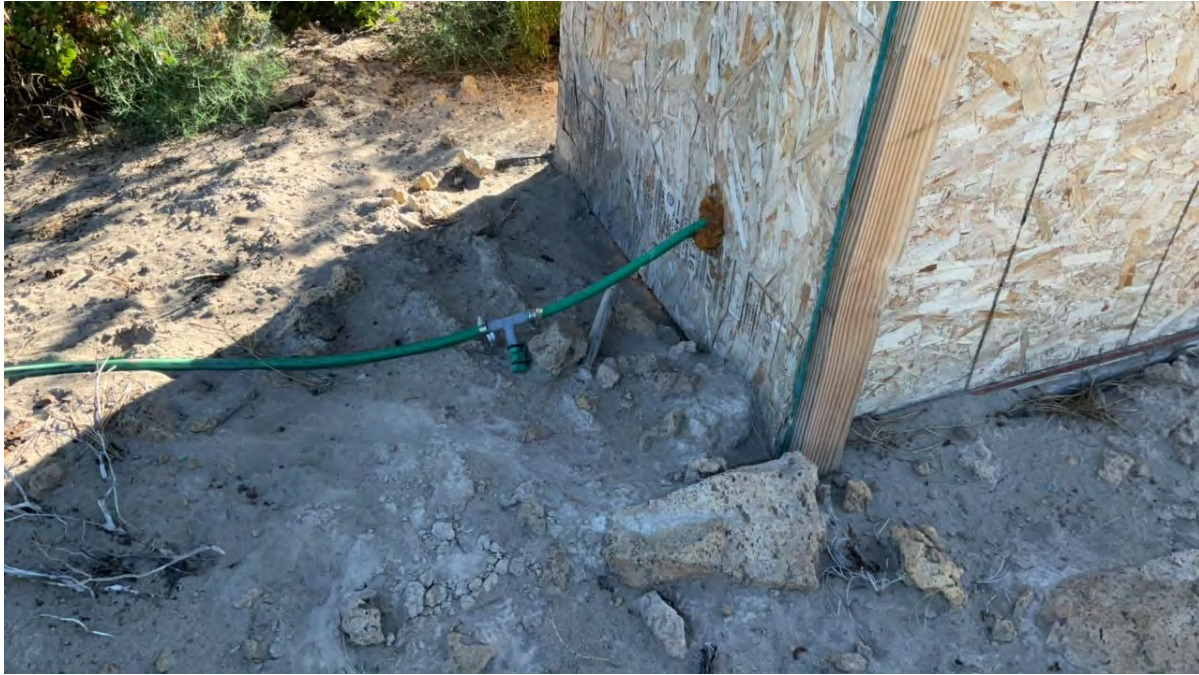
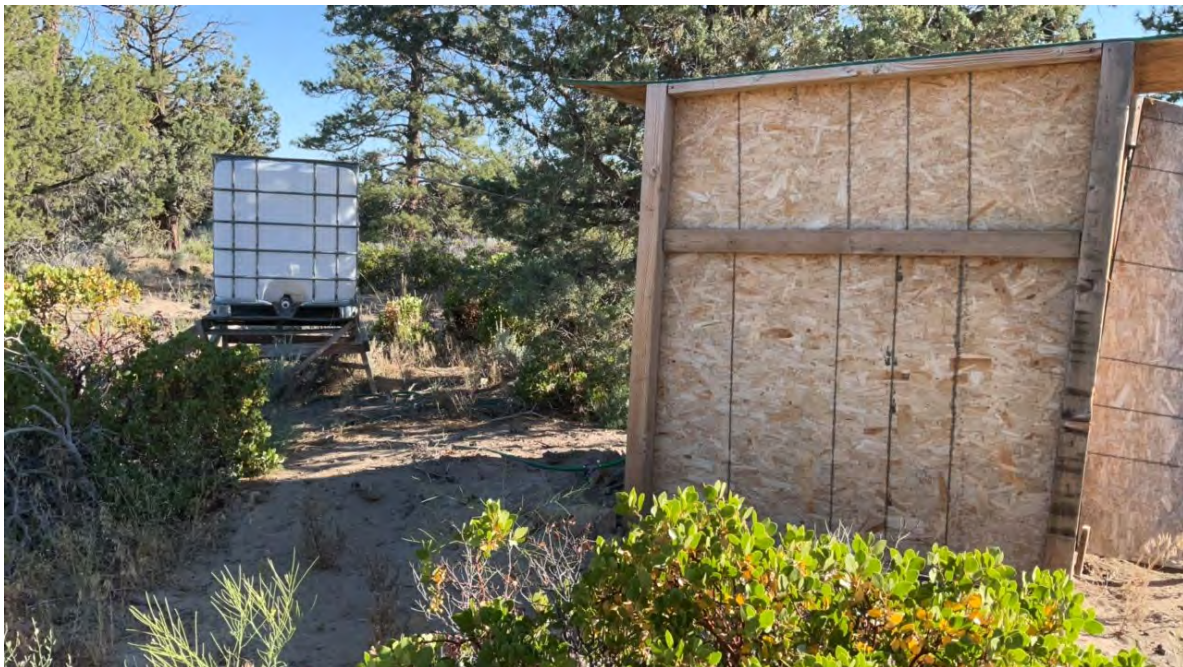
Point Feature 9: Shed with toilet connected to water tank via hose with human waste discharge to land.

Figure 11. Shed with toilet connected to water tank via hose with human waste discharge to land at Point Feature 9.

Figure 12. Shed with toilet connected to water tank via hose with human waste discharge to land at Point Feature 9.

Figure 13. Shed with toilet connected to water tank via hose with human waste discharge to land at Point Feature 9.

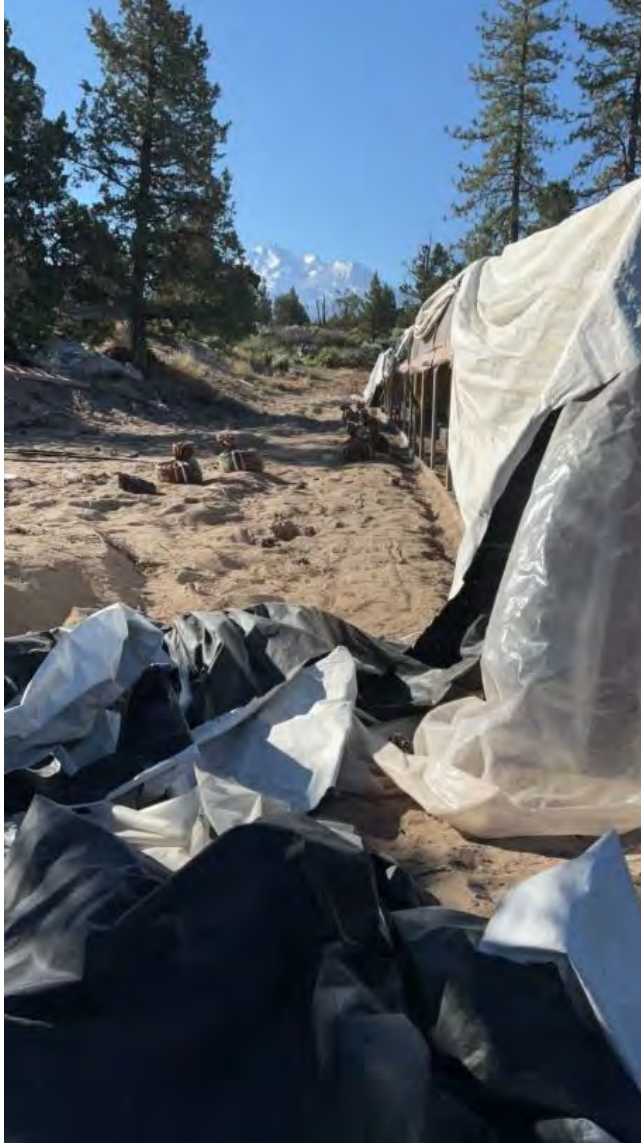
Polygon Feature 10: Approximately 4,000 square feet of active greenhouse cultivation.

Figure 14. Disturbed area associated with active greenhouse cultivation at Polygon Feature 10.

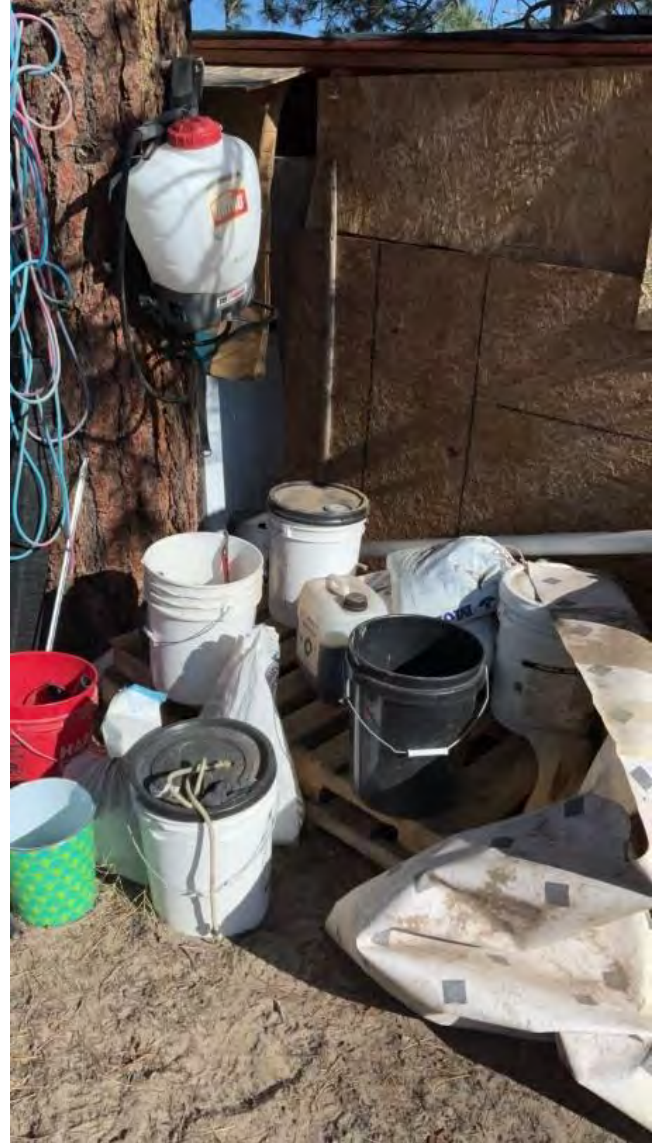
Figure 15. Spray pack located at residential building at Point Feature 11.

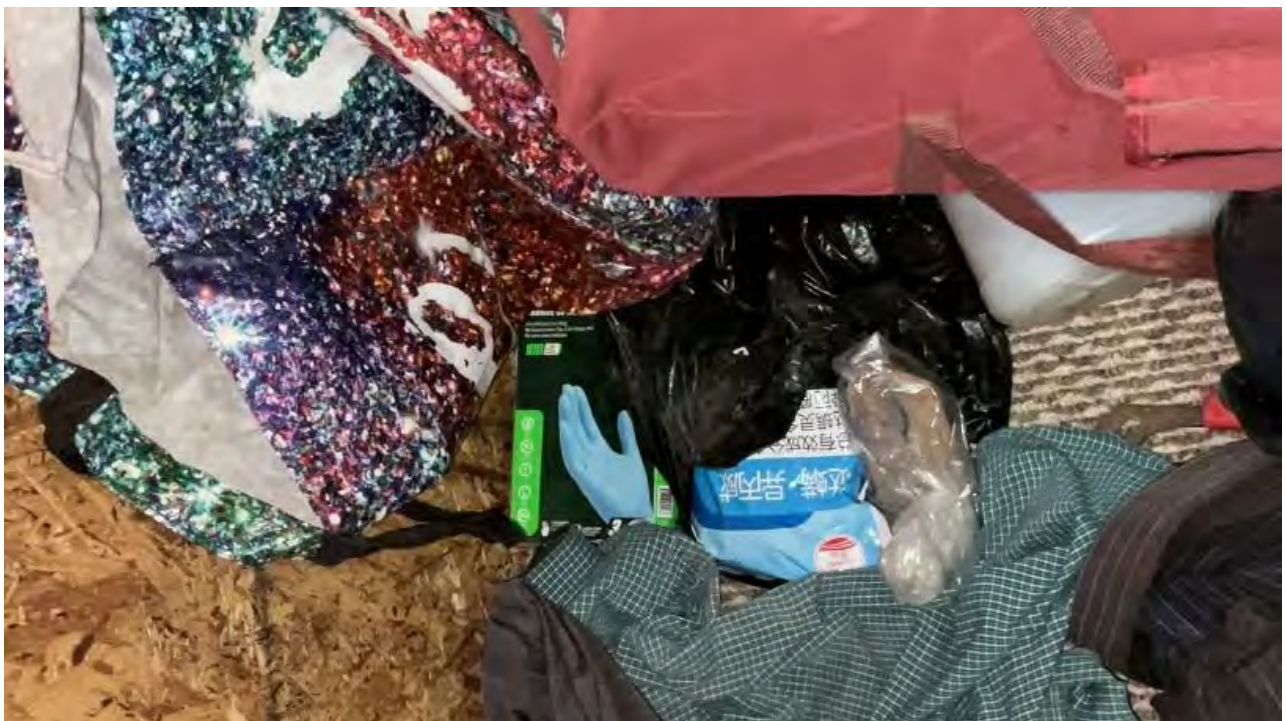
Figure 17. Illegal, imported pesticides located at residence at Point Feature 11.

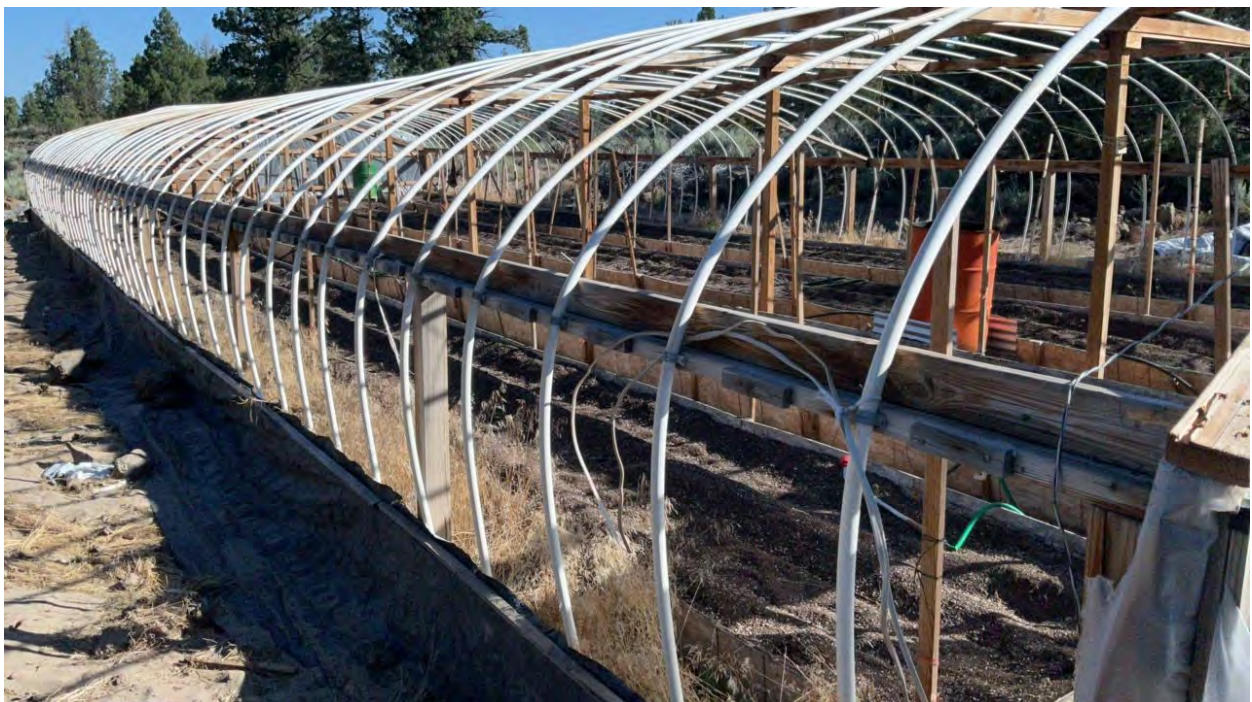
Polygon Feature 13: Greenhouse being prepped for cultivation. Refuse accumulation.

Figure 19. Empty greenhouse at Polygon Feature 13.

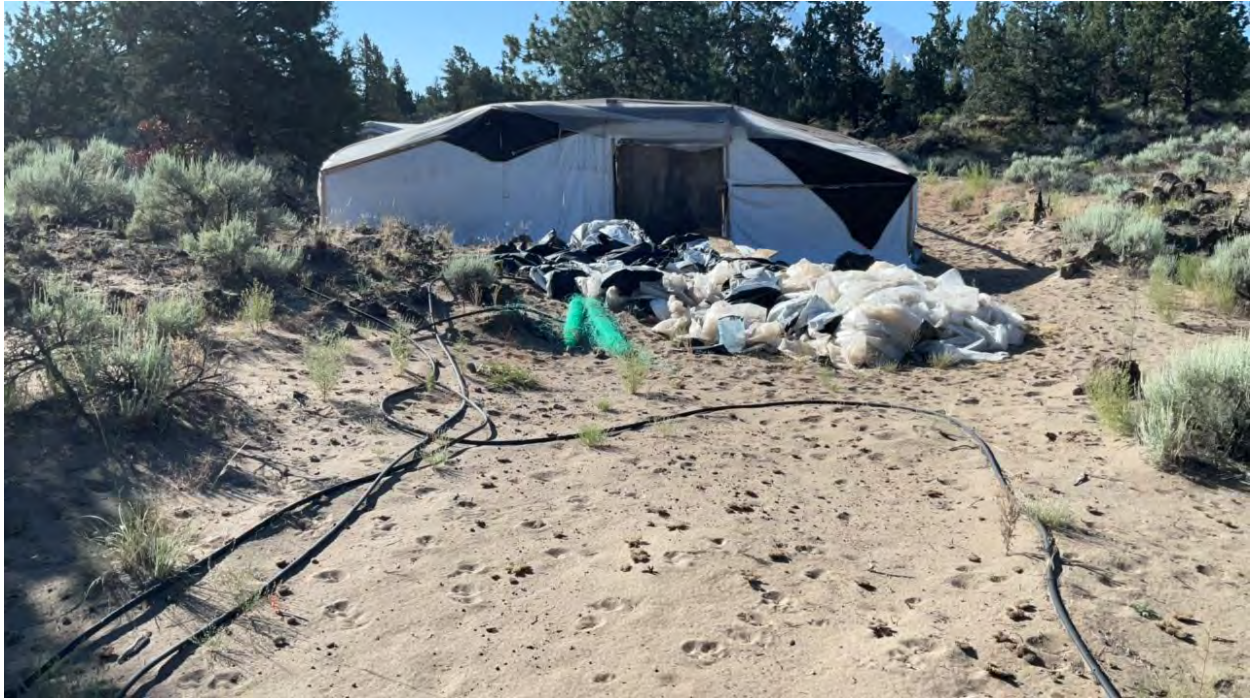
Figure 20. Refuse accumulation near Polygon Feature 13.

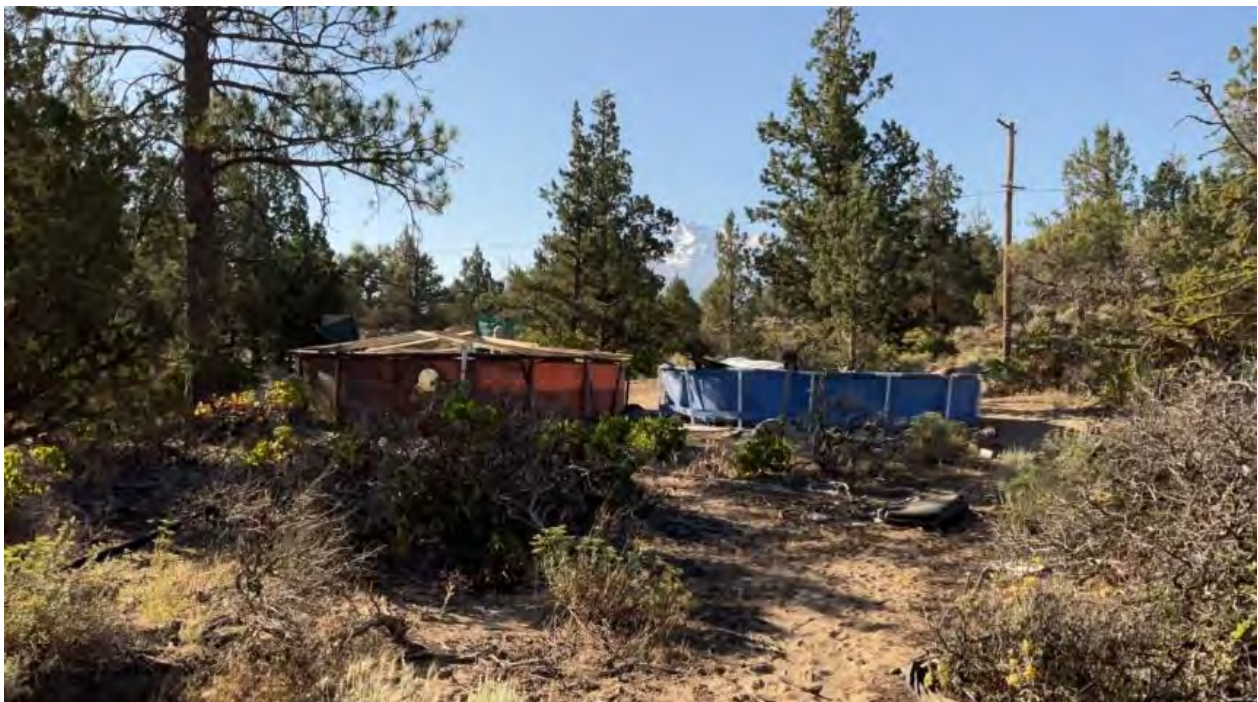
Point Feature 13: Near gated driveway are two pools with water truck hookup hose.

Figure 21. Water storage pools at Point Feature 13.

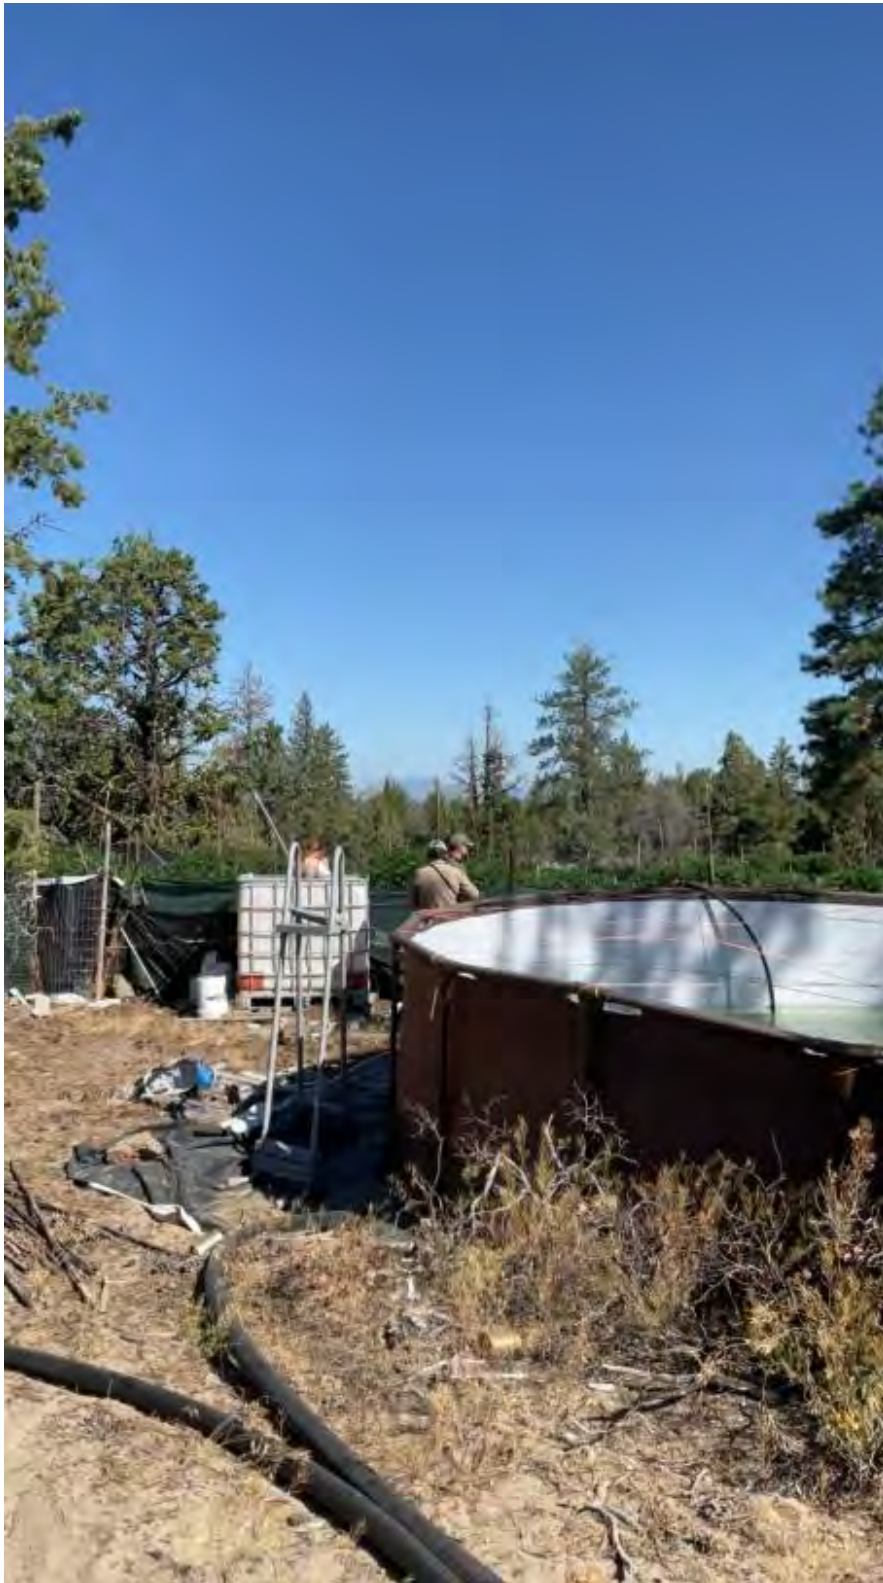
Polygon Feature 14: Outdoor cultivation with water storage pool, feed tanks and fertilizers.

Figure 23. Outdoor cultivation, pool, feed tanks and fertilizers at Polygon Feature 14.

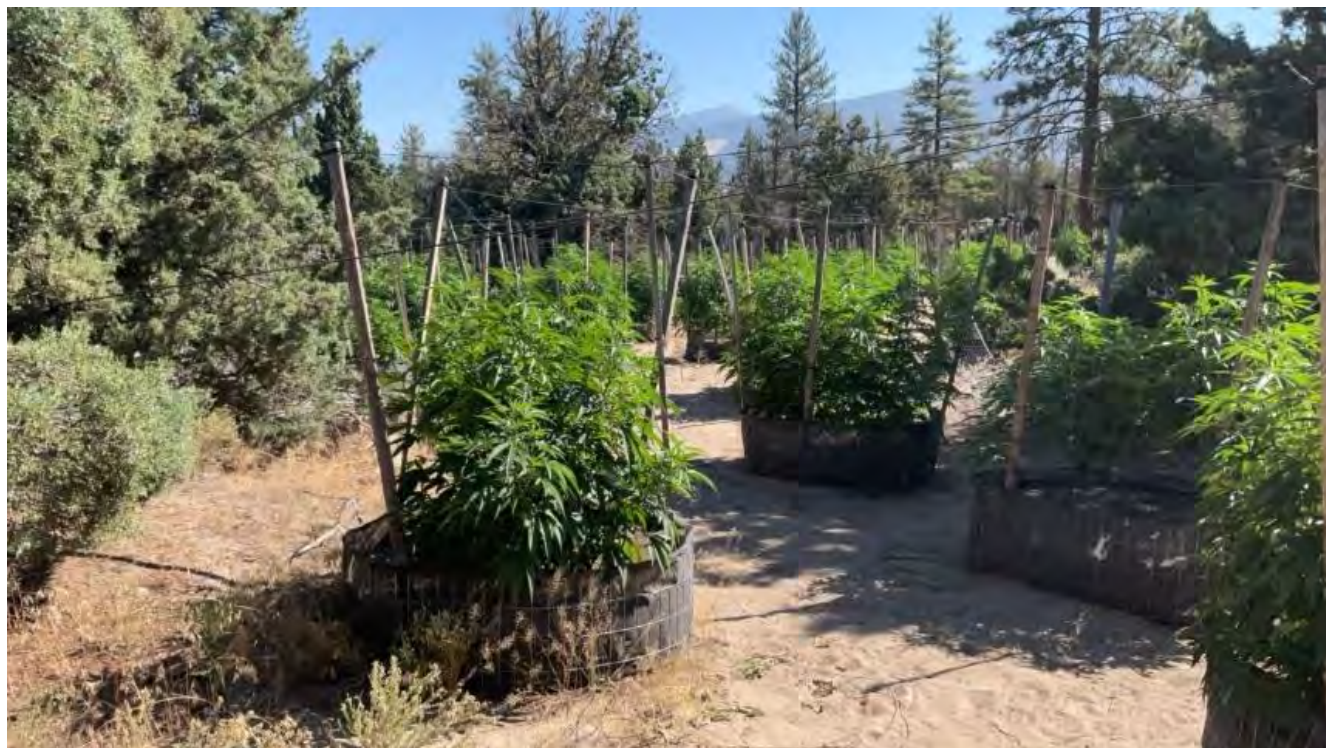
Polygon Feature 16: Approximately 15,000 square feet of outdoor cultivation, water storage pool and pump, with line to Point Feature 17 for water delivery. Trash accumulation

Figure 24. Outdoor cultivation at Polygon Feature 16.

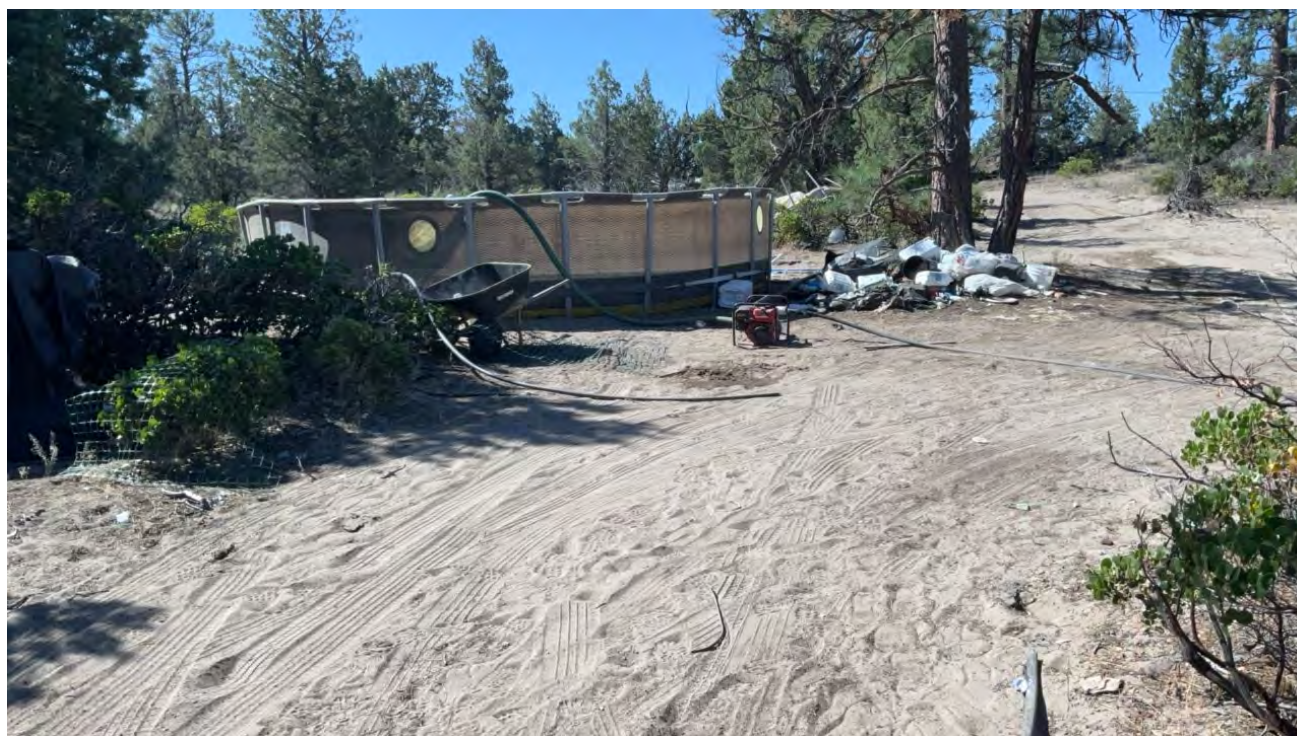
Figure 25. Water storage pool and trash at edge of cultivation area at Polygon Feature 16. A fill hose extends out the driveway to Collins Drive for water truck deliveries.
