North Coast Regional Water Quality Control Board

**Subject: Notice of Violation, Transmittal of Inspection Report of July 26, 2023
Inspection of Trinity County Assessor's Parcel Number 011-120-014**

Cannabis Water Quality Inspection Report

Evan Henshaw-Plath, Trinity County APN 011-120-014

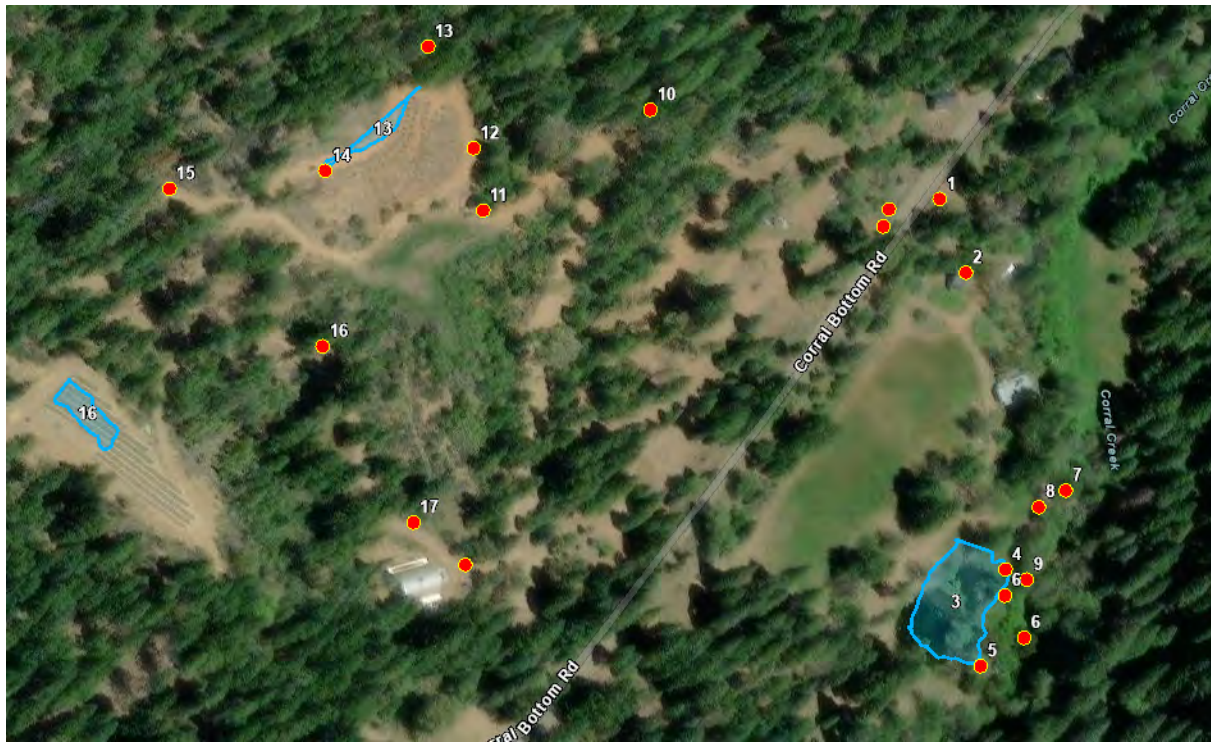
Figure 2. Inspection map with aerial imagery showing the point, line, and polygon feature locations of interest described in the text.

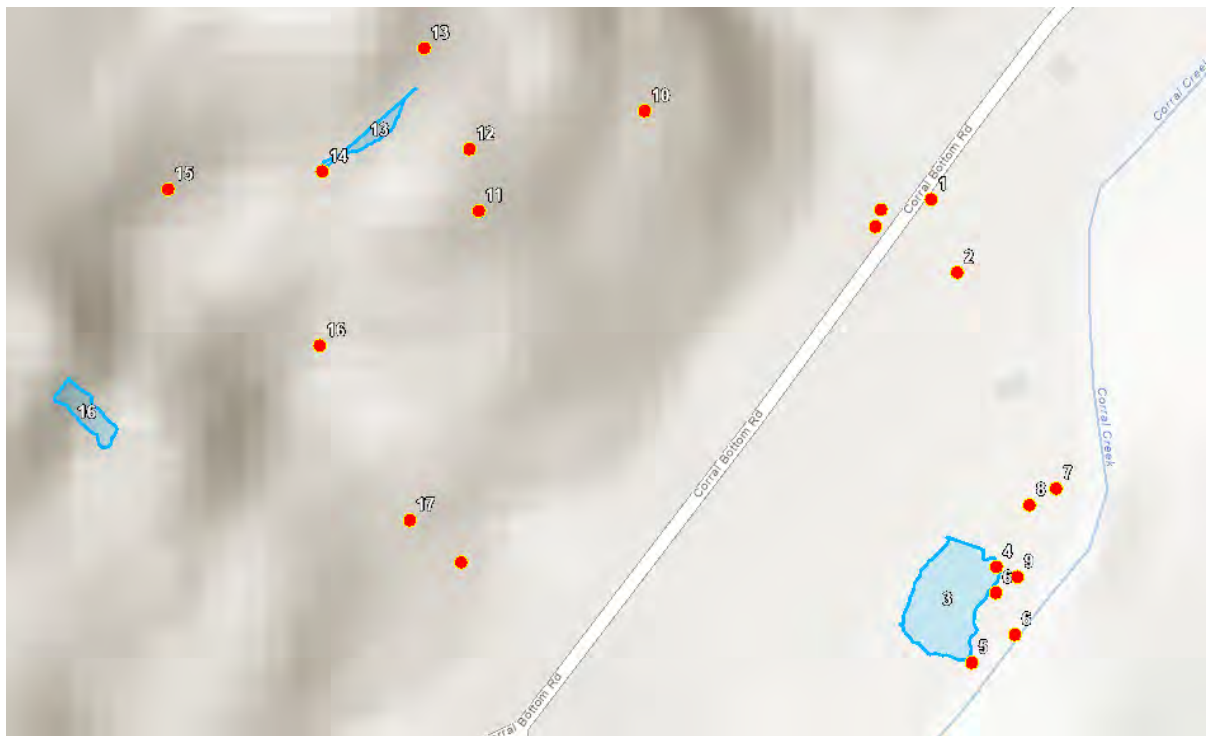
Figure 3 Inspection map with terrain showing features of interest described in the text.

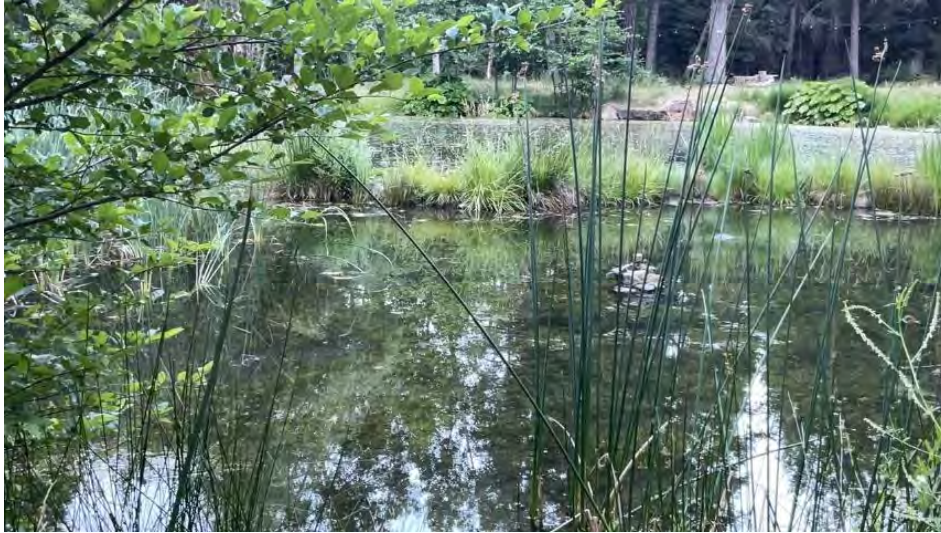
Polygon Feature 3: Pond located next to Corral Creek. Approximately 10,000 square feet of surface area.

Figure 4. Polygon Feature 3 – pond located next to Corral Creek, with inflow and outflow structures from Corral Creek and a berm along the edge of Corral Creek

1. Hire a qualified professional to:
 - a. Assess the Property, including, at a minimum the pond (Polygon Feature 3), the footbridge (Point Feature 7) the converted areas and steep access road used for cultivation-related activities.

10. If instream work is proposed as part of the proposed cleanup and remediation, including at the pond (Polygon Feature 3) and the footbridge (Point Feature 7), submit an application for instream work describing plans to ensure the work is in conformance with the Basin Plan, the Water Code, and the federal Clean Water Act.

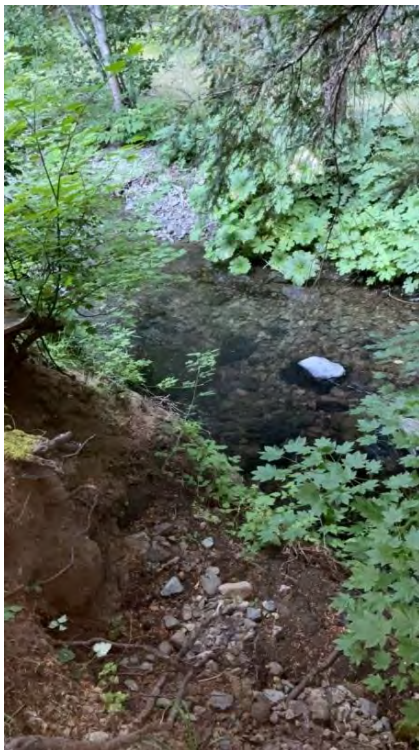
Figure 5. Corral Creek next to pond.

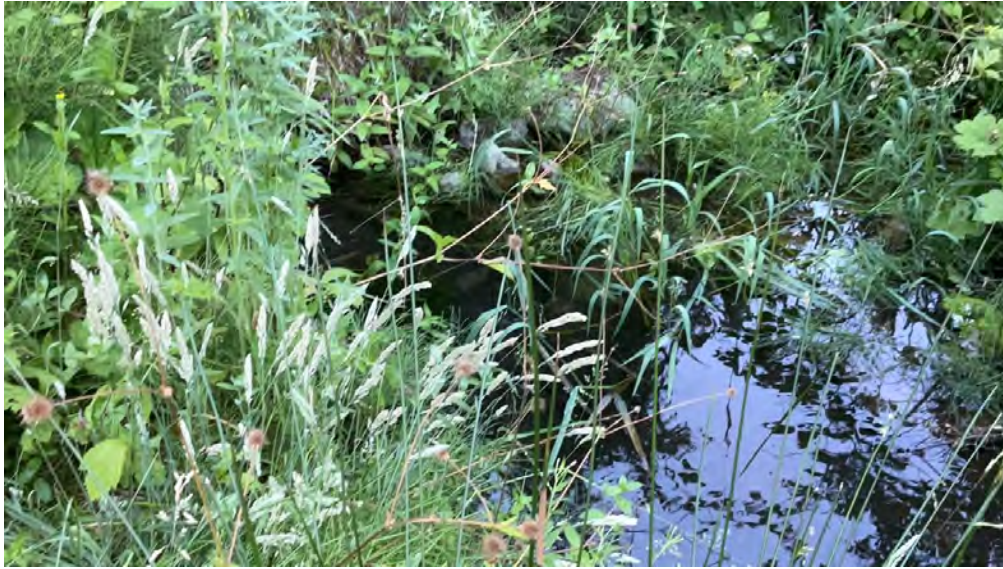
Point Feature 4: Inflow channel to pond from Corral Creek.

Figure 6. Point Feature 4 - Inlet channel from Corral Creek.

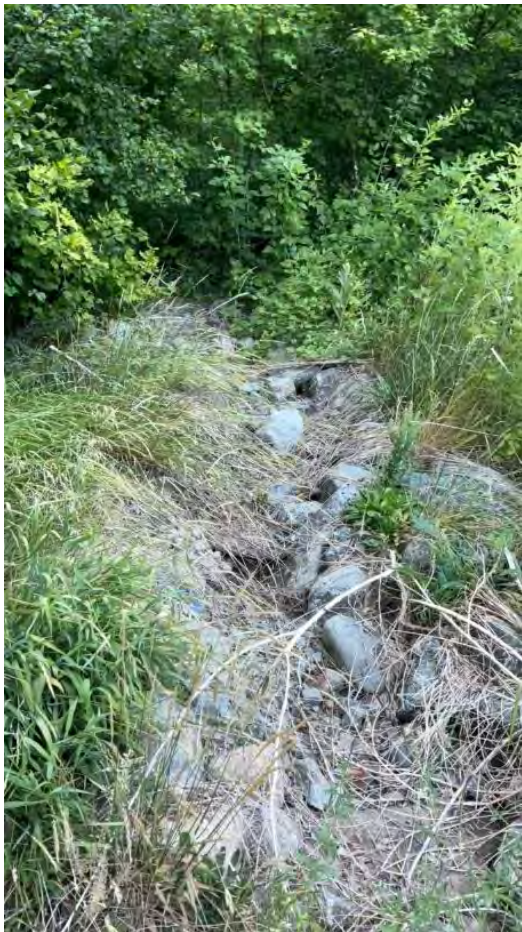
Figure 7. Point Feature 6 - Constructed channel to pond from Corral Creek.

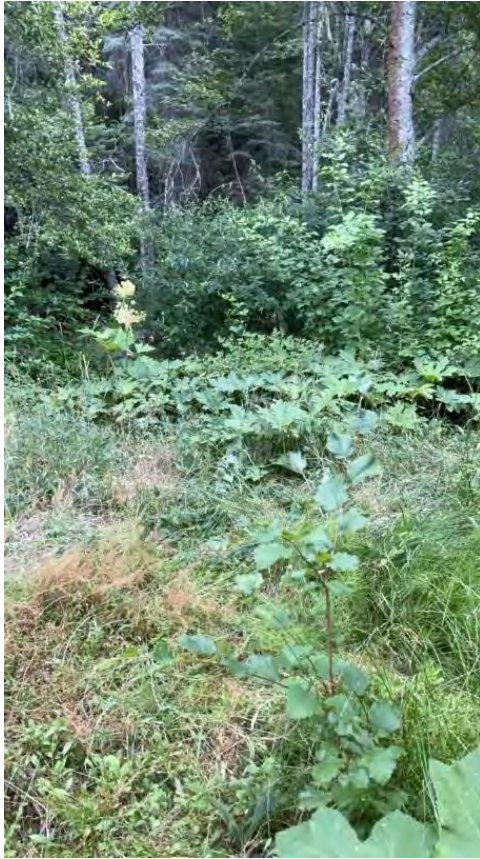
Point Feature 9: Pond berm is constructed within the stream gravels. The placed material poses a threat of erosion and discharge and an impediment to the free flow of Corral Creek.

Figure 8. Point Feature 9 – Pond berm along Corral Creek.

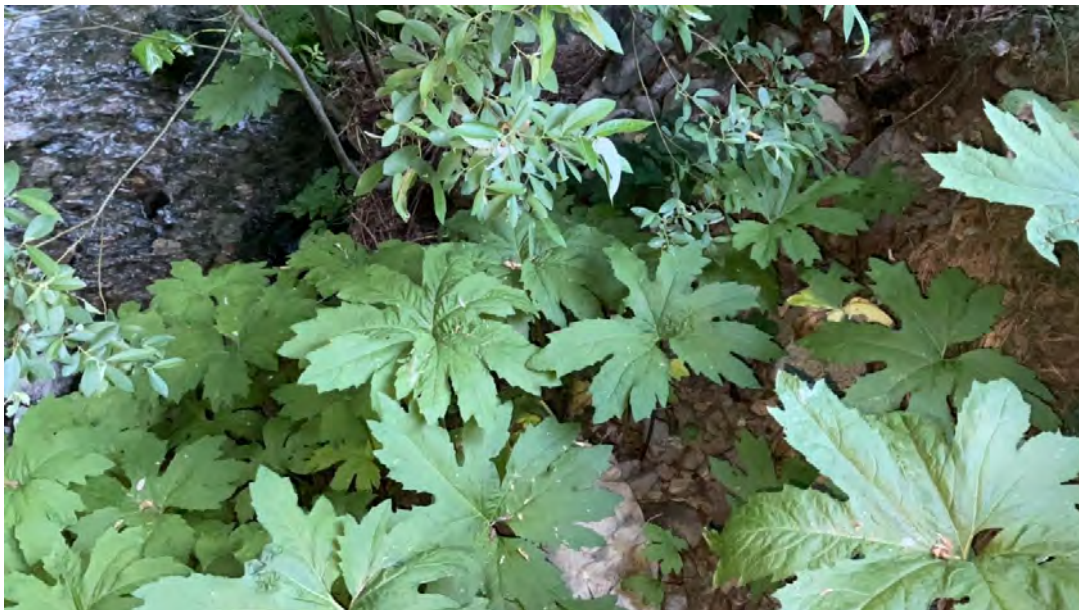
Figure 9. Point Feature 9: Toe of pond berm located next to wet channel of Corral Creek.

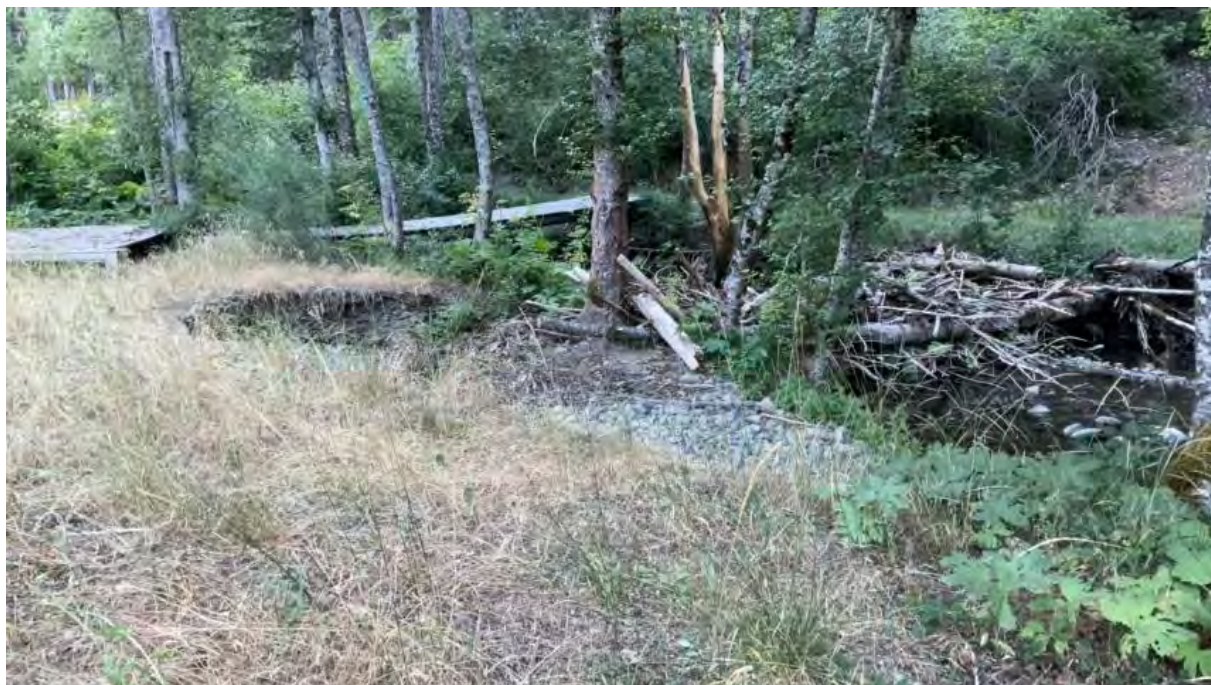
Point Feature 7: Foot bridge over Corral Creek. I observed some debris racking on nearby trees; voids are on both banks. It appears that the bridge deck is approximately at the elevation of bankfull stage. Sand deposits were evident at the right bank bridge abutment. May be an impediment to the free flow of Corral Creek and pose a threat of sediment discharge.

Figure 10. Point Feature 7 - Looking upstream at footbridge over Corral Creek. Debris is raked in nearby trees. Erosional voids are evident on both banks.

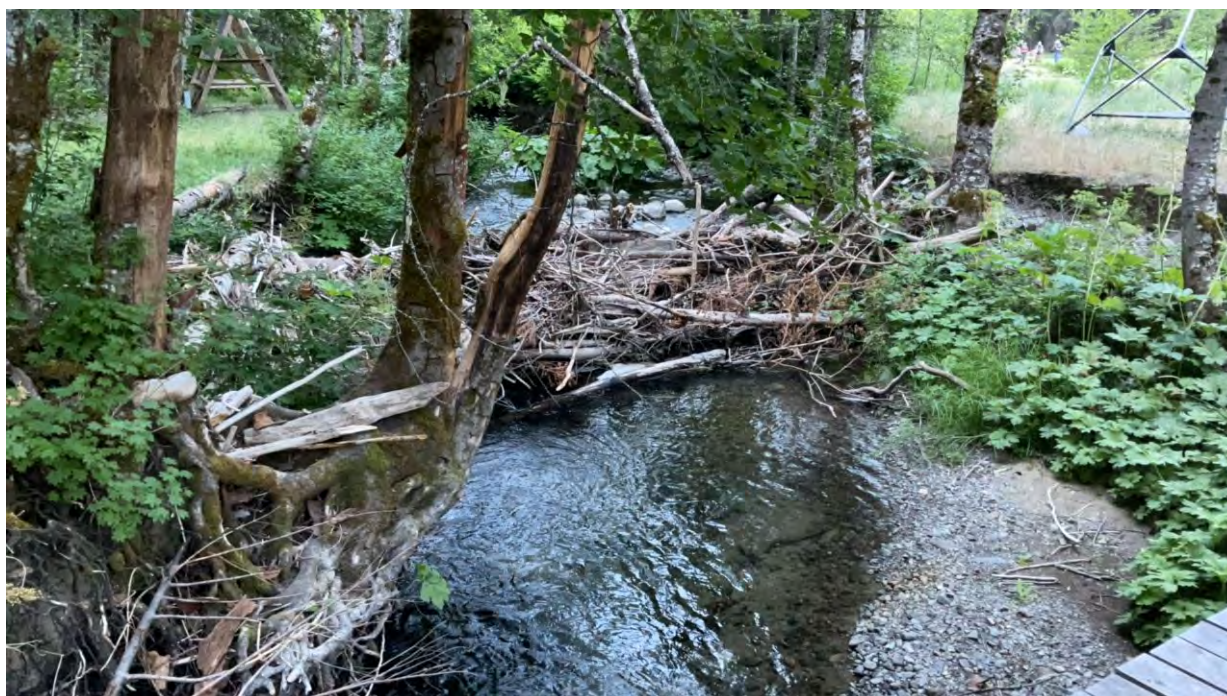
Figure 11. Point Feature 7 - Looking downstream from footbridge.

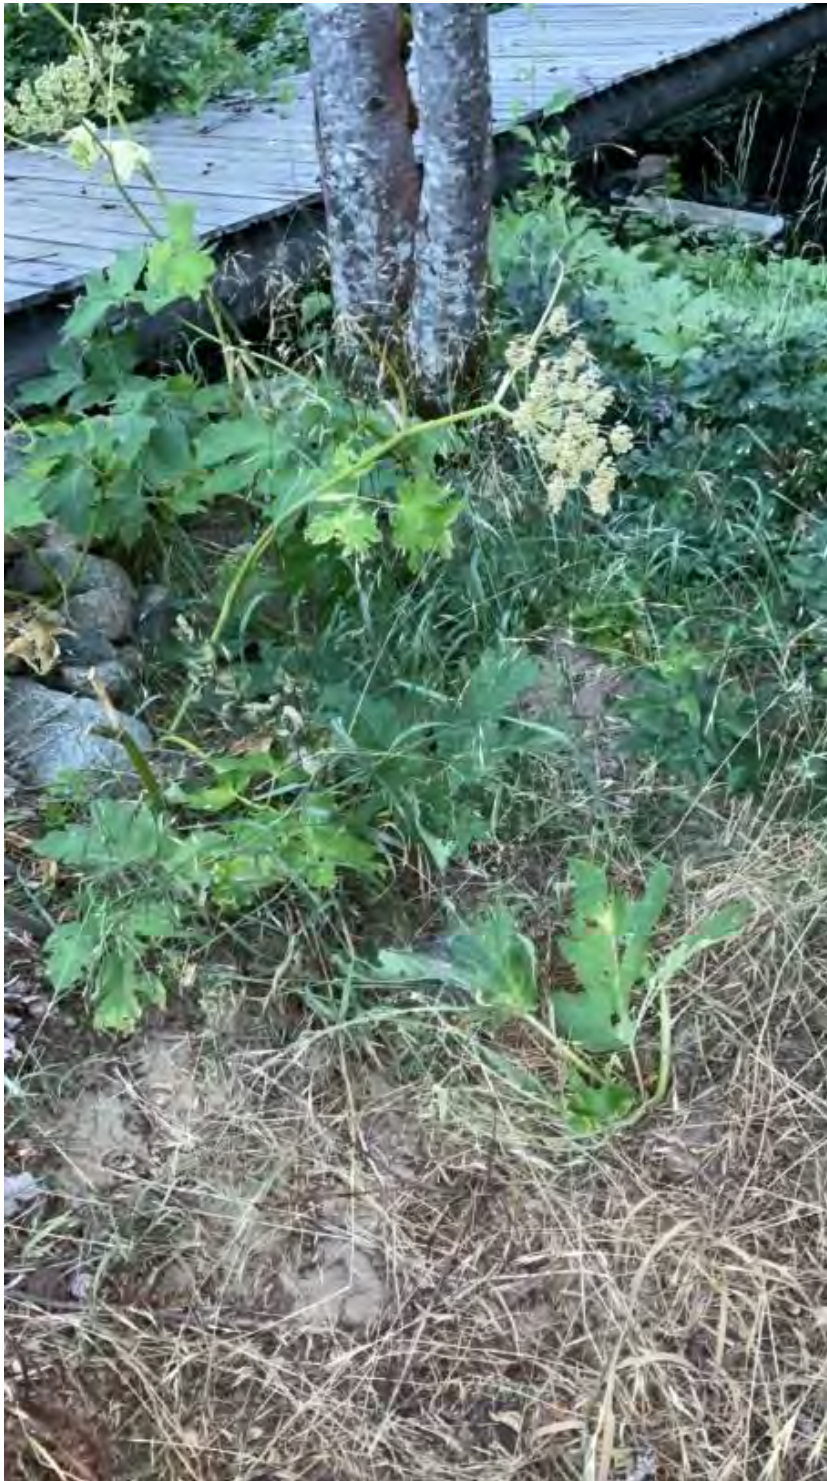
Figure 12. Point Feature 7 – Recent sand deposits on ground surface next to downstream side of right bank abutment, close in elevation to the bottom of the footbridge deck.

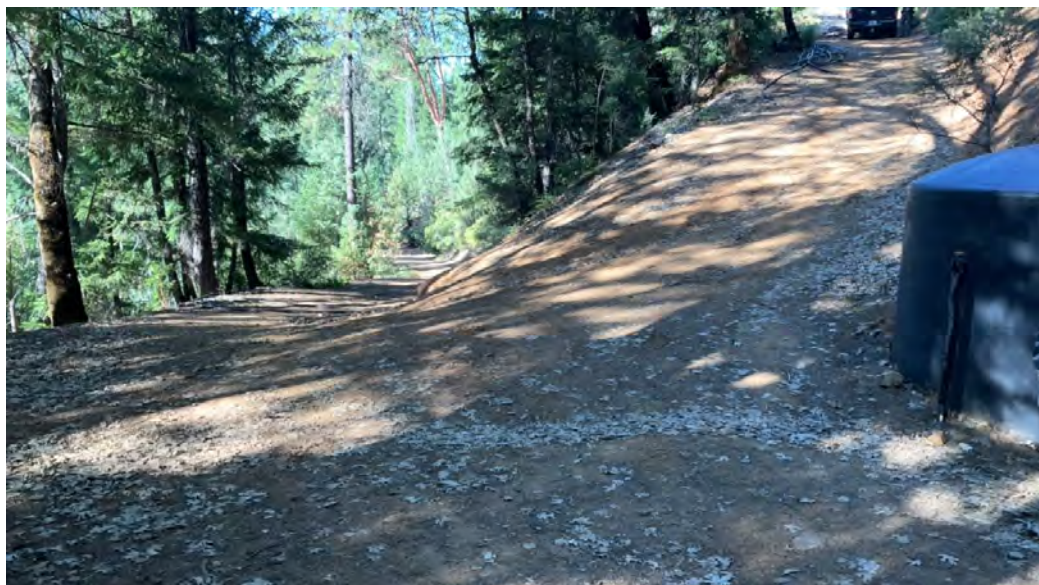
Point Feature 10: Water storage tanks located on a landing at the road switch back.

Figure 13. Point Feature 10 - Switchback in steep road to converted areas being used for cultivation-related activities.

4. Stabilize the disturbed area associated within the disturbed areas to prevent erosion and threats to waters of the state.
5. Maintain roads to prevent erosion, transport, and threat of sediment delivery to waters of the state. To minimize concentrated runoff on the road surface,

maintain drainage breaks at adequate spacing to prevent surface rills. Avoid discharge to fill or swales.

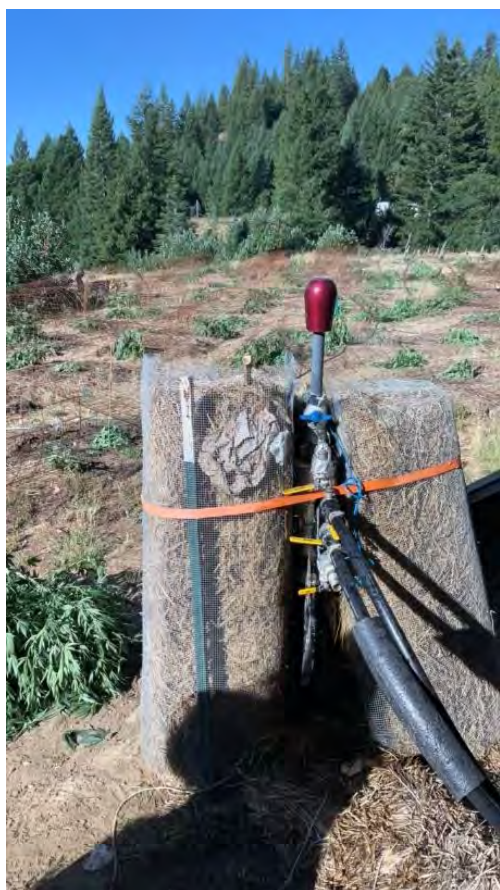
Point Feature 11: Well located at the edge of outdoor cultivation area.

Figure 14. Point Feature 11 – well next to outdoor cultivation area.

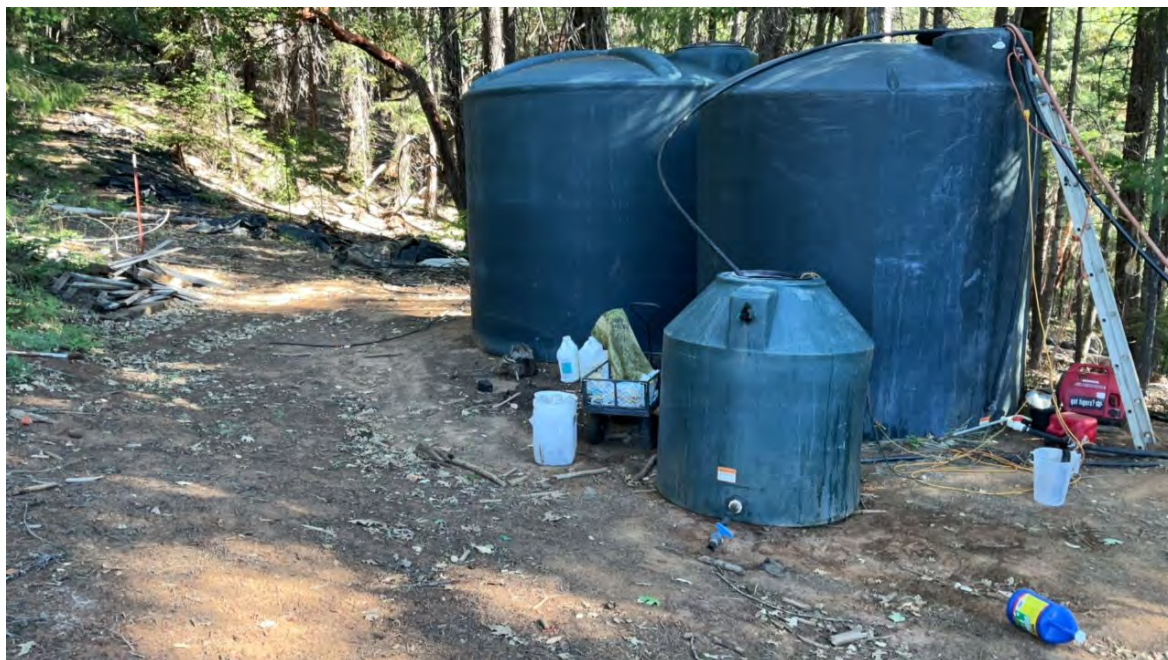
Point Feature 13: water storage and feed tanks with fertilizer containers and gas powered pump.

Figure 15. Point Feature 13 – water storage and feed tanks with gas powered generator for pump and fertilizers.

6. Cleanup fertilizer containers and feed tanks and prevent further discharge of feed water to land in a manner that threatens water quality.
7. Properly dispose of waste including but not limited to trash, fertilizer, pesticide and petroleum containers, plastic tarps and sheeting at a legal facility.

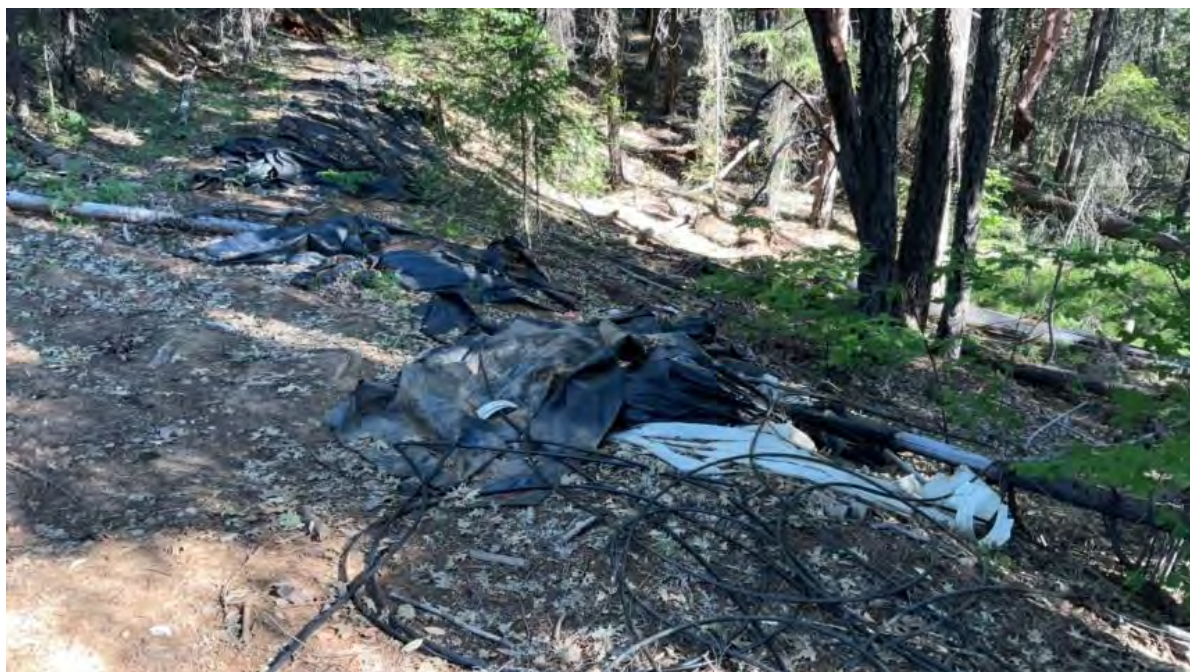
Figure 16. Point Feature 13 - Cultivation-related refuse.

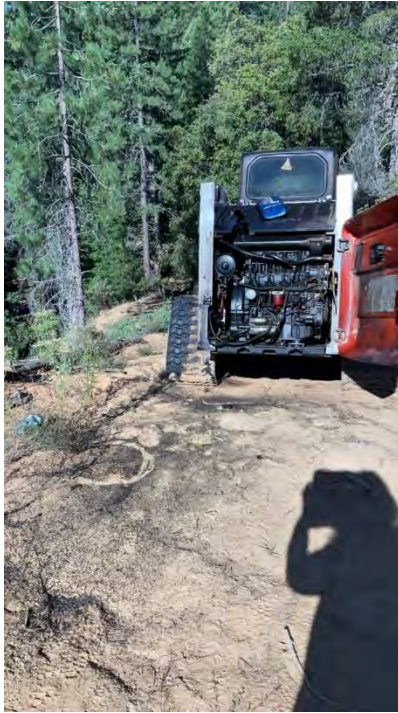
Point Feature 14: skid steer with stains from spray of petroleum products on ground.

Figure 17. Point Feature 14 – skid steer with spray of dark fluid on ground.

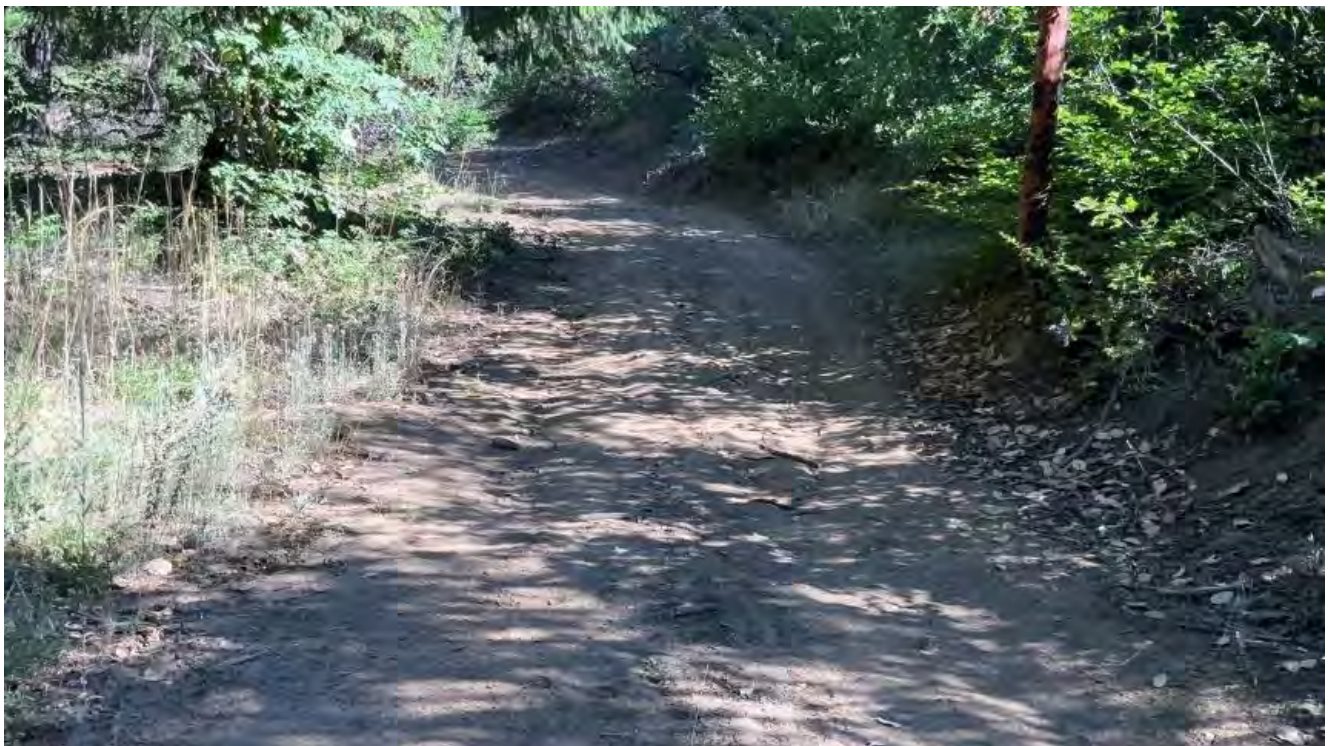
Point Feature 16: Rilled road surface through the outdoor cultivation area.

Figure 18. Point Feature 16 – rilled road surface.

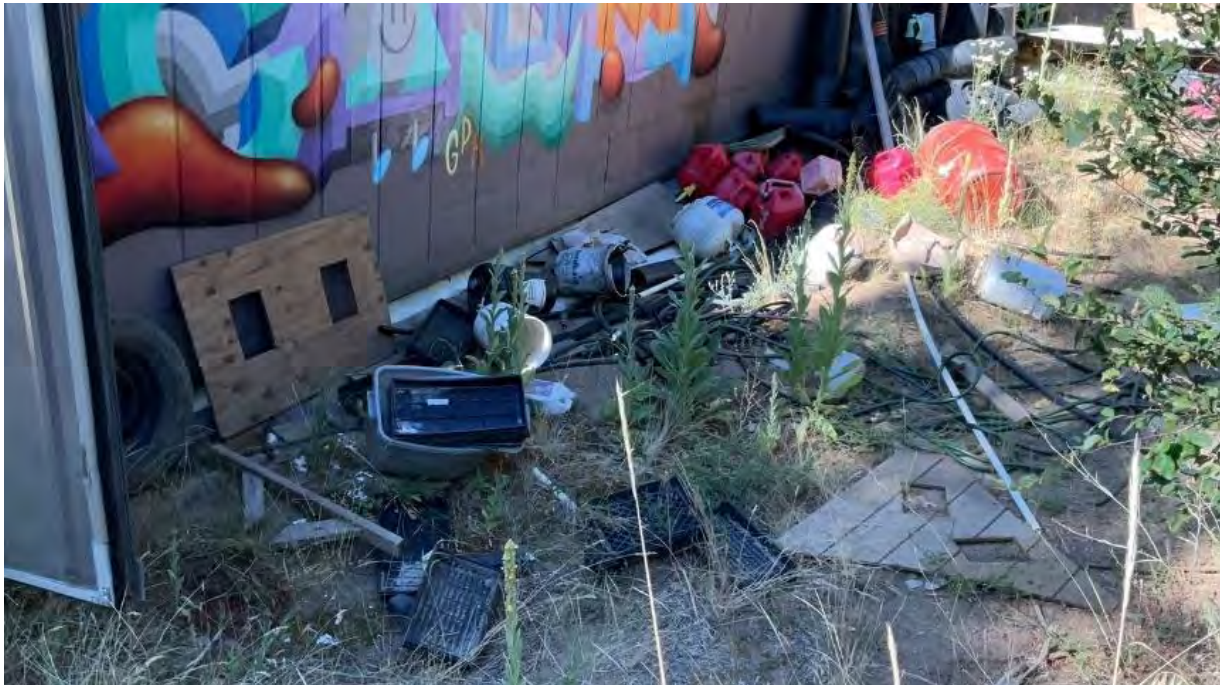
Figure 19. Point Feature 17 – building with refuse.

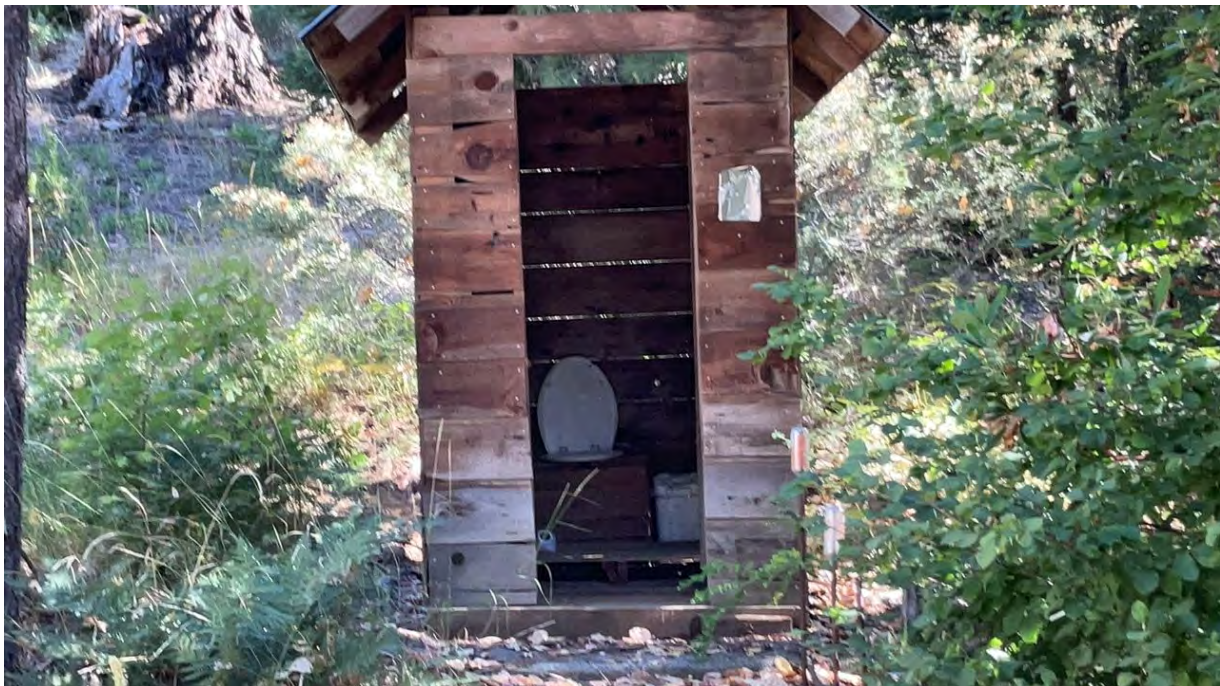
Point Feature 17: building and pit privy.

Figure 20. Point Feature 17 - Pit privy

8. Work with Trinity County to ensure that domestic waste is handled in a manner that is protective of water quality and in conformance with the State Water Board Onsite Waste Treatment Policy.
