North Coast Regional Water Quality Control Board

Subject: Notice of Violation, Transmittal of Inspection Report for September 7, 2023, Inspection of Humboldt County Assessor's Parcel Number 107-054-036-000, and Requirement to Respond within 30 days

North Coast Regional Water Quality Control Board
Cannabis Water Quality Inspection Report
 APN(s): 107-054-036-000

Inspection Date and Time			
Inspection Date		September 7, 2023	
Inspection Start Time:	07:30	Inspection End Time:	10:30
Site Location			
Address/Location		47730 Mattole Road, Honeydew, CA 95545	
County		Humboldt	
Assessor's Parcel Number(s) (APN(s))		107-054-036-000	
Watershed		Upper North Fork Mattole River	
Property Owner Contact Information			
Property Owner		Evan Kouchalakos	
Mailing Address		74 Amherst Road, Merrimack, NH 03054	
Warrant Information			
Agency Responsible for Warrant		CDFW	
Person Responsible for Warrant		Josh Zulliger	
Warrant Date		September 7, 2023	
Lead Inspector, Team Members, Other Agencies and Personnel Onsite			
Lead Inspector Name		Katherine Hawken	
Lead Inspector's Credentials		Water Resource Control Engineer	
Office/Regional Board		North Coast Regional Water Quality Control Board	
Author of

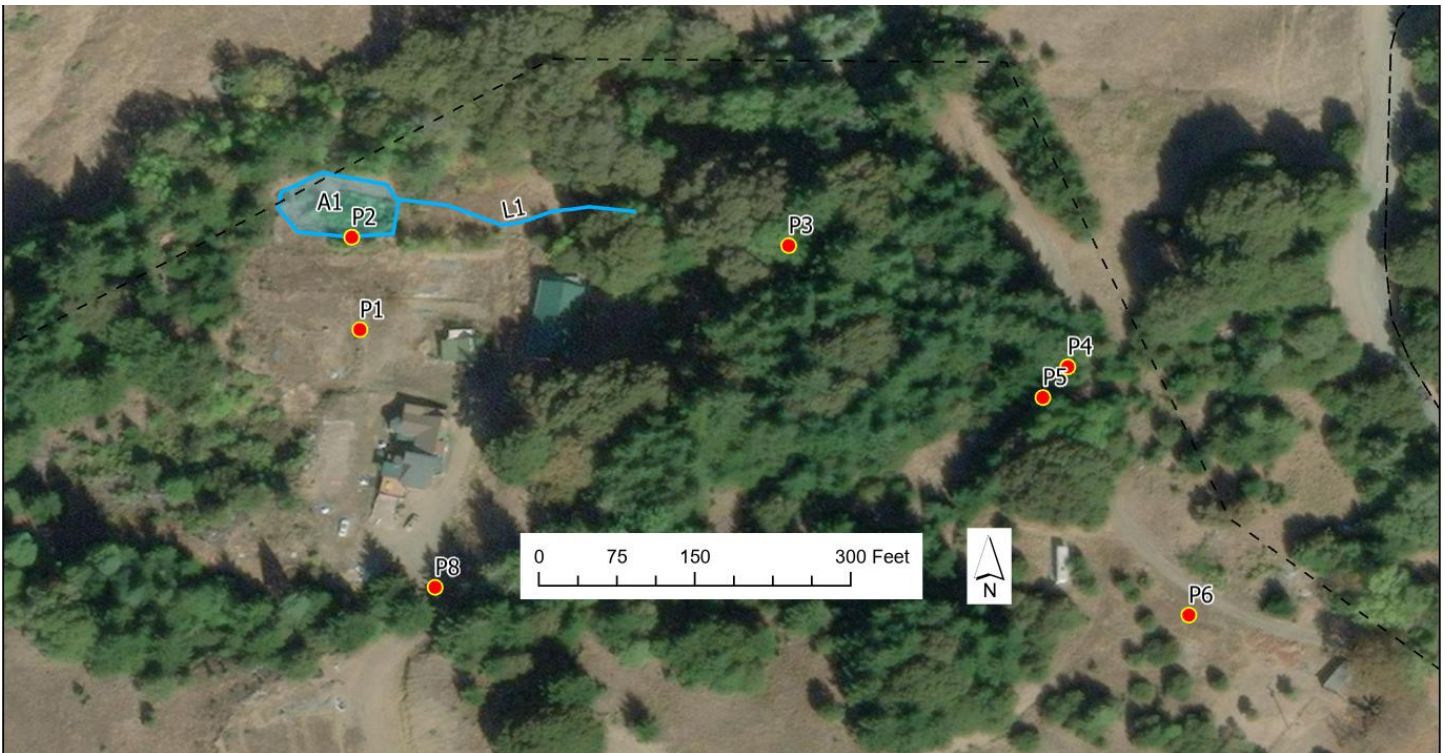
Points (P), line (L), and area (A) of interest are displayed in the map Figure 1 and photographed in the SITE FEATURES table below.

Figure 1: Site Map with dashed parcel boundaries and points (P), line (L), and area (A) of interest. P7 was determined to be off parcel and is not included in this map or report.

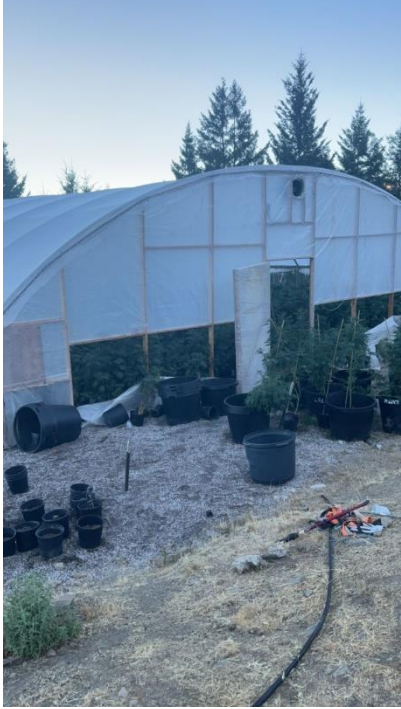
P1: I observed two hoop houses with plastic flooring, and cannabis plants in pots. I observed a pile of potting soil in front of the hoop houses. I left a field notice on the property with the warrant.

P1	
Category: Cultivation Area (CA)	
Description: Two hoop houses with plastic tarp floors and cannabis plants in pots.

Photo Number: 1
	Photo Description: Front of hoop house with cannabis plants and pile of potting soil.
	Facing North

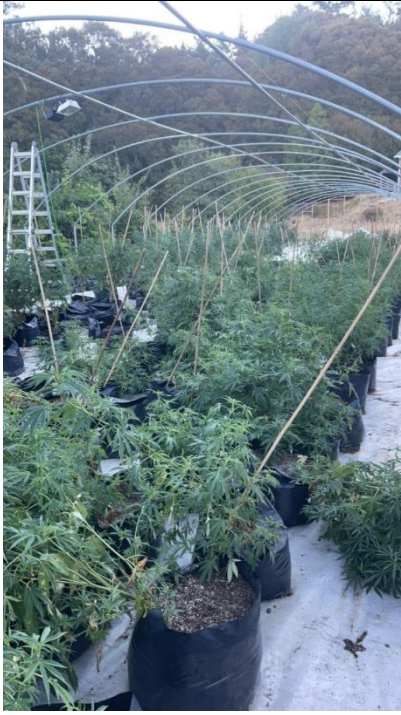
Photo Number: 2
	Photo Description: Inside view of second hoop house.
	Facing Northeast

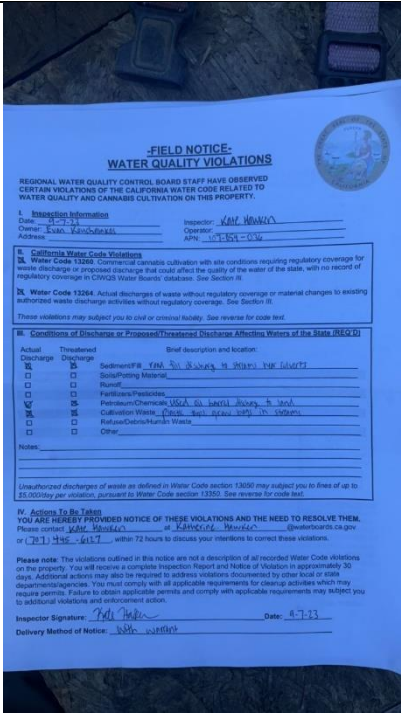
<p>Photo Number: 3</p>
	<p>Photo Description: I left a field notice with the warrant.</p>
	<p>Facing Southwest</p>

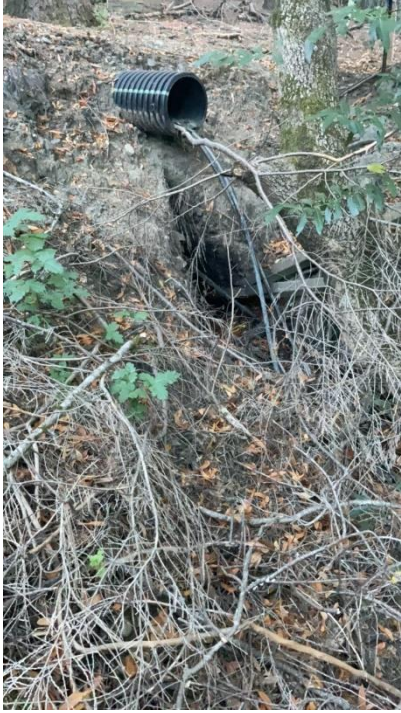
P3: I observed a 16-inch diameter plastic culvert stream crossing with ponding at its inlet. I observed a clogged metal culvert left in the road prism, and evidence of the stream overtopping the road. I observed a road ditch discharging to the stream at the culvert inlet.

P3	
Category: Watercourse Crossings (WC)	
Description: Plastic culvert stream crossing.

Photo Number: 1
	Photo Description: Culvert outlet perched 4 feet above stream channel.
	Facing Southeast

4. Retain a qualified professional to assess the culvert stream crossings for capacity to convey a 100-year flow event and associated debris, disconnect road ditches from watercourses, and recontour roads to prevent discharge to receiving waters.
5. Apply for a 401 water quality certification prior to work instream to replace culverts.
6. Work with the State Water Board Division of Water Rights and the California Department of Fish and Wildlife to obtain necessary permits to divert and store water.
7. Do not use water storage bladders unless the bladder is safely contained within a secondary containment system with sufficient capacity to capture 110 percent of a bladder's maximum possible contents in the event of bladder failure.

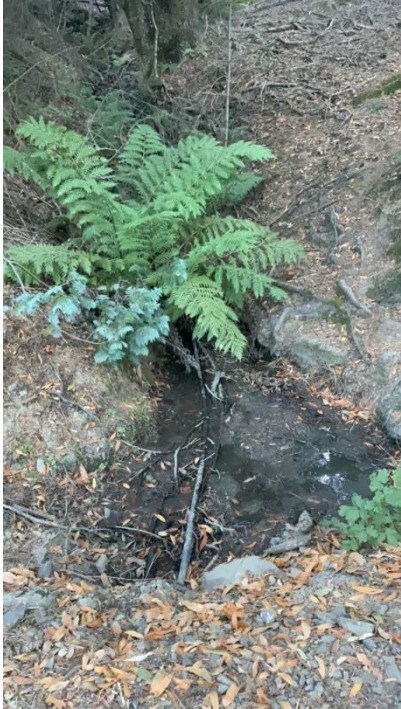
Photo Number: 2
	Photo Description: Ponding at undersized culvert inlet.
	Facing East

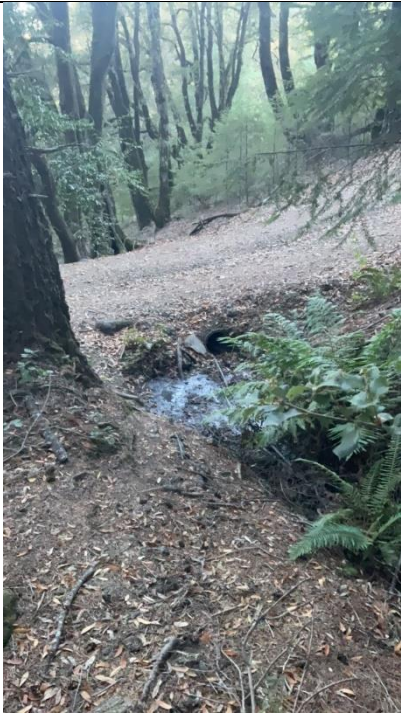
<p>Photo Number: 3</p> <p>Photo Description: View from uphill of culvert inlet.</p> <p>Facing Northwest</p>
 	<p>Photo Number: 4</p> <p>Photo Description: Road ditch discharging into inlet of culvert.</p> <p>Facing North</p>

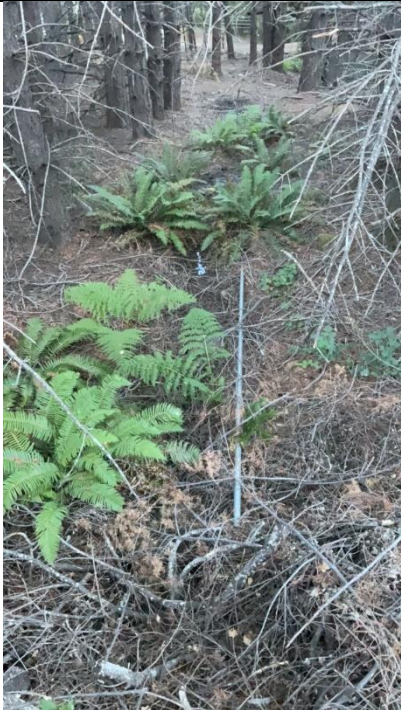
P4: I observed a spring with an approximately 50-foot wet area below it. I observed electrical conduit in the spring channel.

Description: Spring with wet area extending 50 feet below.

Photo Number: 1
	Photo Description: Surface water spring.
	Facing West

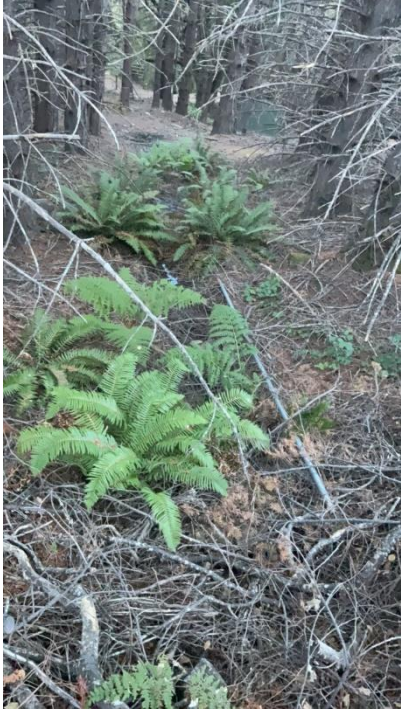
Photo Number: 2
		Photo Description: Electrical conduit in spring channel.
		Facing West

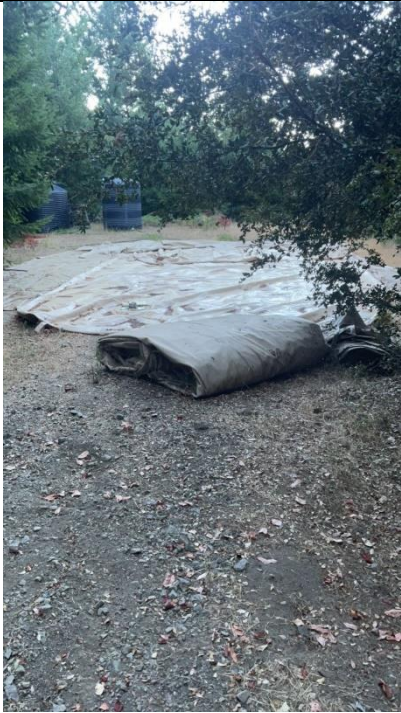
P5: I observed inactive water storage bladders, and water storage tanks on a flat.

Description: Water storage bladders and tanks.

Photo Number: 1
		Photo Description: Water bladders and tanks on flat.
		Facing Southwest

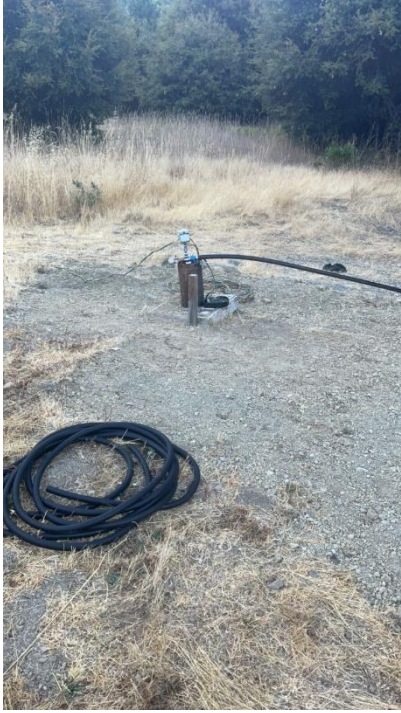
P6: I observed a groundwater well in an upland area. The well did not appear to be connected to the cultivation area.

Photo Number: 1
	Photo Description: Groundwater well. Facing South
P8	
Category: Surface Water Diversion (WD)	
Description: Culvert stream crossing and diversion point.

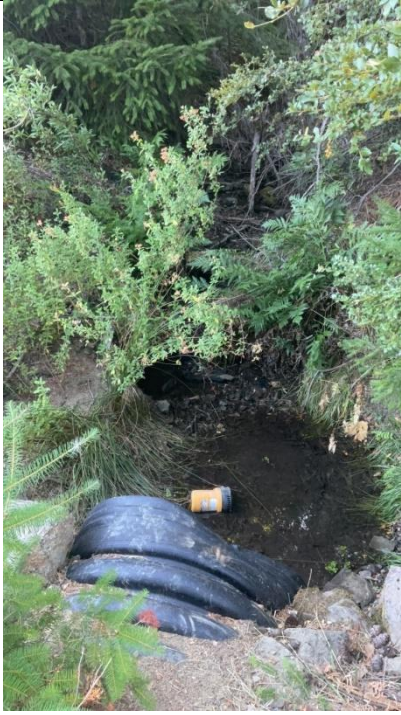
P8: I observed a plastic culvert stream crossing with ponding at its inlet. I observed a disconnected submersible pump in the ponded area. I observed a road ditch discharging to the stream at the culvert inlet. I observed trash at the culvert outlet, and the road prism eroding into the stream.

Photo Number: 1
	Photo Description: Culvert inlet with ponding, and submersible pump. Facing Northeast

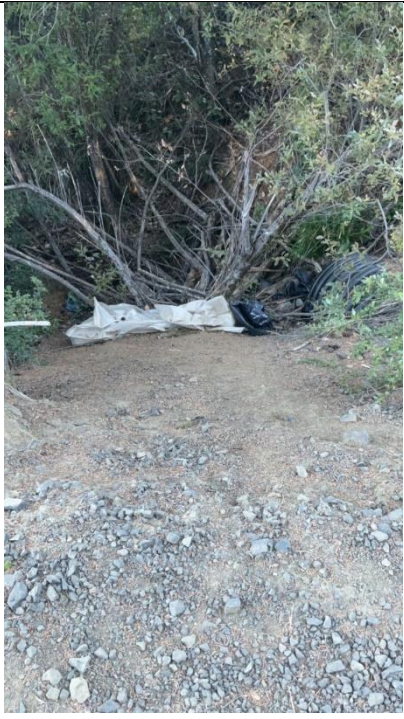
<p>Photo Number: 2</p> <p>Photo Description: Dirt road prism eroding into stream at culvert outlet. Trash in stream.</p> <p>Facing West</p>

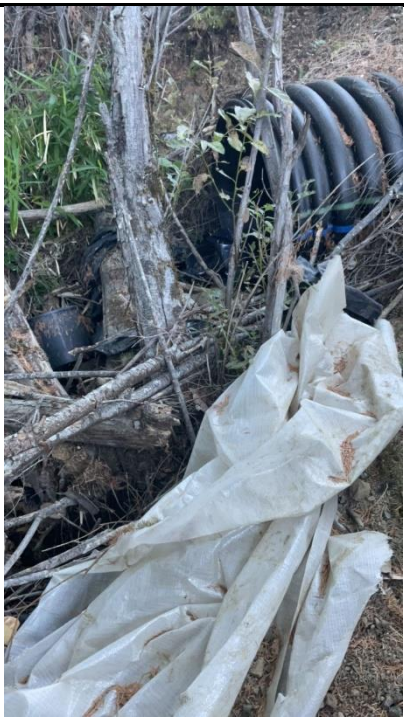
<p>Photo Number: 3</p> <p>Photo Description: Trash at culvert outlet.</p> <p>Facing North</p>

1. If you and/or your tenant(s) plan to continue commercial cannabis cultivation, enroll for coverage under the State Water Board's Order WQ 2019-0023-DWQ, General Waste Discharge Requirements and Waiver of Waste Discharge Requirements for Discharges of Waste Associated with Cannabis Cultivation Activities.
2. Relocate all cannabis cultivation activities, supplies, and trash outside of the riparian setbacks (50 feet from Class III, 100 feet from Class II, 150 feet from Class I).
3. Regularly contain and dispose of all waste/ trash, including used motor oil, at a licensed transfer site. Remove cultivation related waste from surface waters.

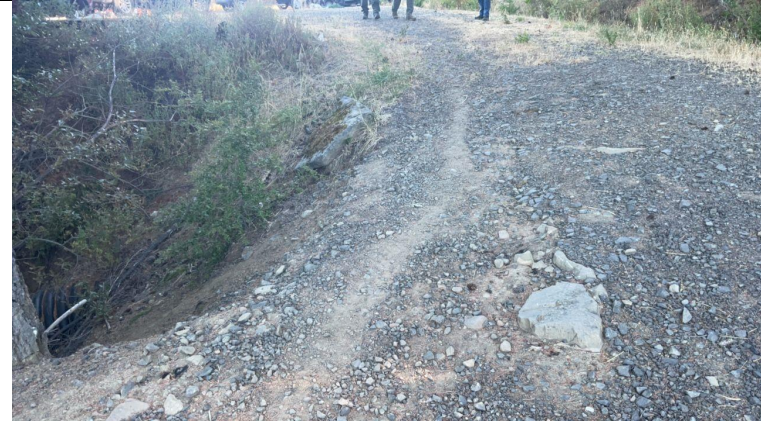
Photo Number: 4
Photo Description: Eroding dirt road prism.
Facing West

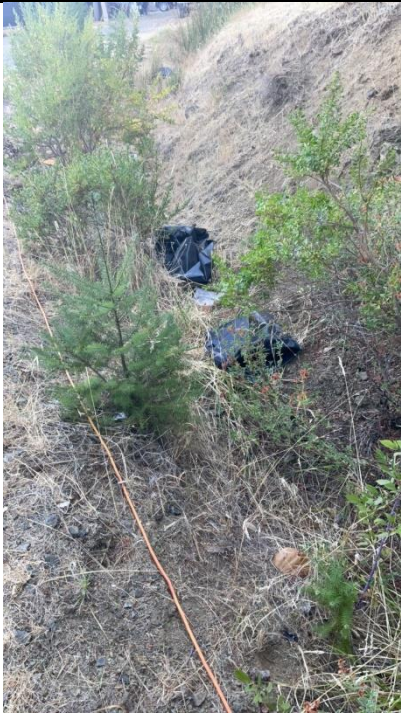
Photo Number: 5
Photo Description: Road ditch with trash leading to culvert inlet.
Facing North

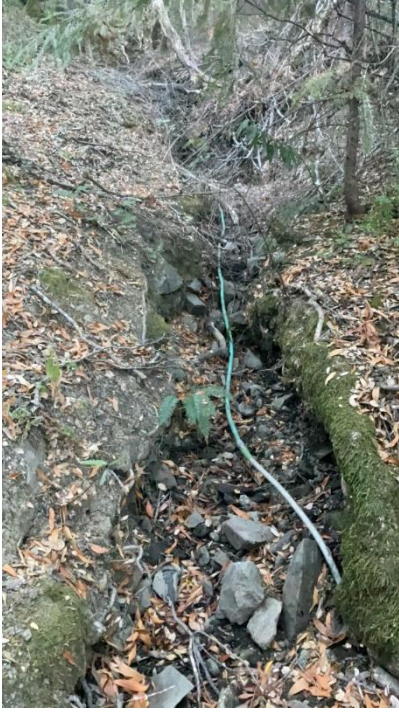
L1: I observed a watercourse channel with portions of cobble substrate, and dirt substrate. I observed cultivation related waste in the stream. I observed the stream discharges to a pond/ wetland feature.

L1	
Category: Riparian Areas (RA)	
Description: Watercourse discharging into wetland/ pond feature.

Photo Number: 1
	Photo Description: View of watercourse channel with cobble.
	Facing East

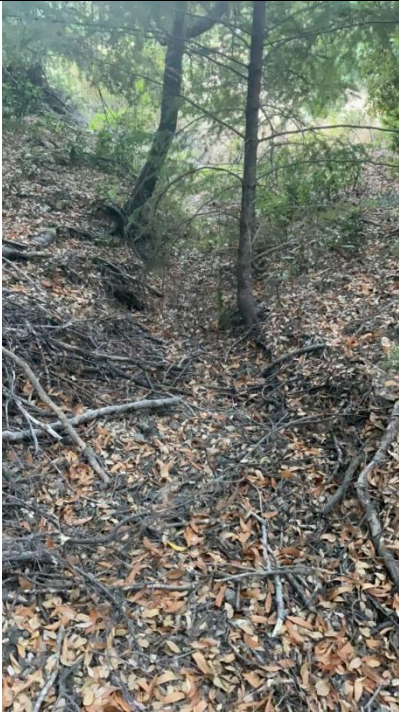
Photo Number: 2
	Photo Description: View of watercourse channel with reduced slope approaching wetland/ pond area.
	Facing West

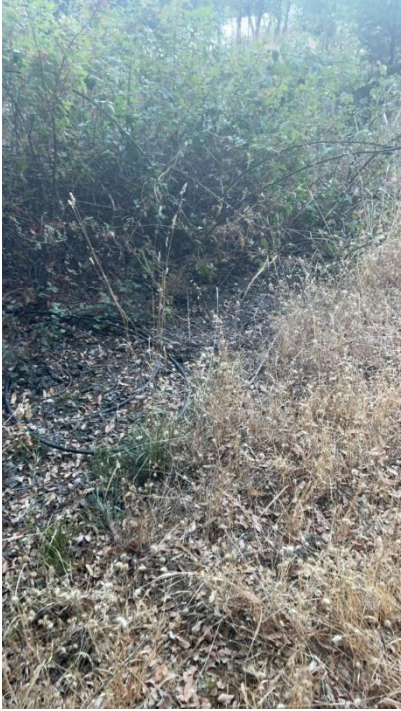
Photo Number: 3
	Photo Description: Trash in wetland/ pond.
	Facing Southwest

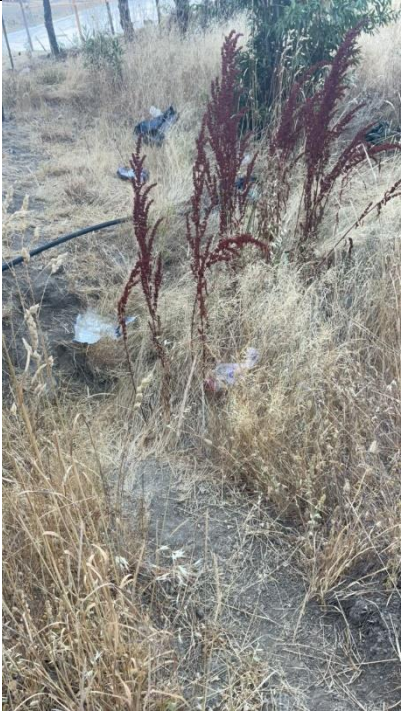
Photo Number: 4
	Photo Description: Trash in watercourse.
	Facing Southwest

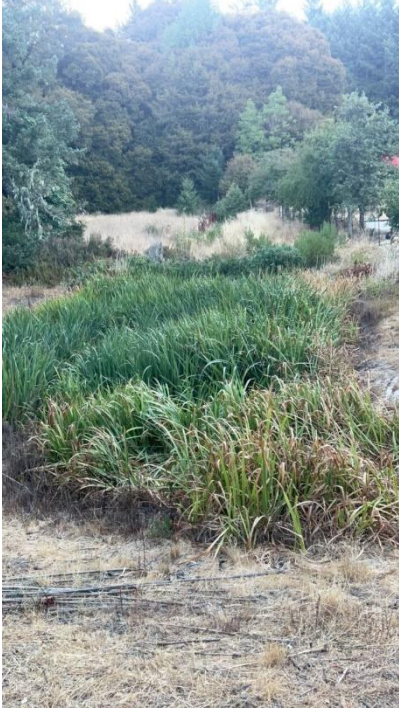
A1: I observed a pond/ wetland feature with hydrophytic plants including rushes, willows, penny royal, and grasses. I observed cultivation related waste in the pond/ wetland. I observed a metal culvert connecting the wetland/ pond at high flows to an adjacent watercourse running along the northwest parcel boundary. I observed the wetland/ pond feature was approximately 20 feet from the cultivation area P1 at the closest edge.

A1	
Category: Riparian Areas (RA)	
Description: Wetland/ pond feature with hydrophytic plants adjacent cultivation area.

Photo Number: 1
	Photo Description: Wetland feature with rushes, willows, penny royal, and grasses.
	Facing East

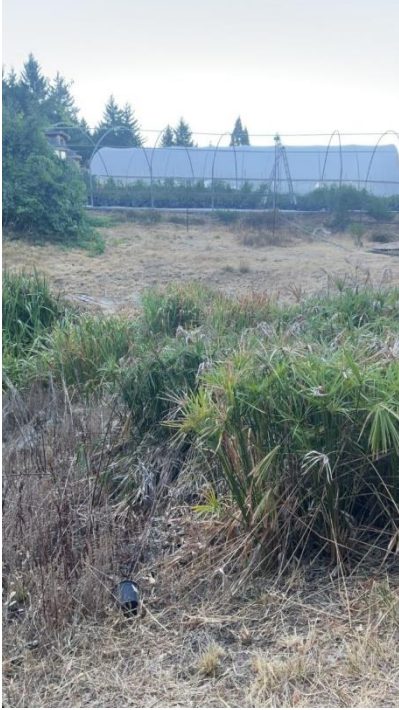
Photo Number: 2
	Photo Description: View of cultivation area proximity to wetland/ pond.
	Facing South

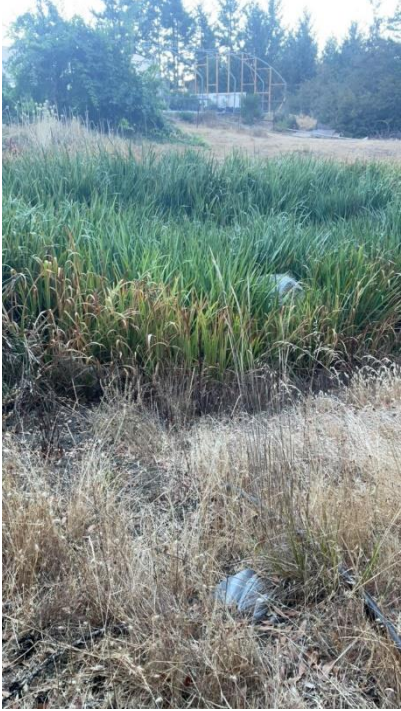
Photo Number: 3
	Photo Description: Metal culvert on wetland/ pond side. Plastic tarps and grow bag in wetland/ pond.
	Facing Southwest

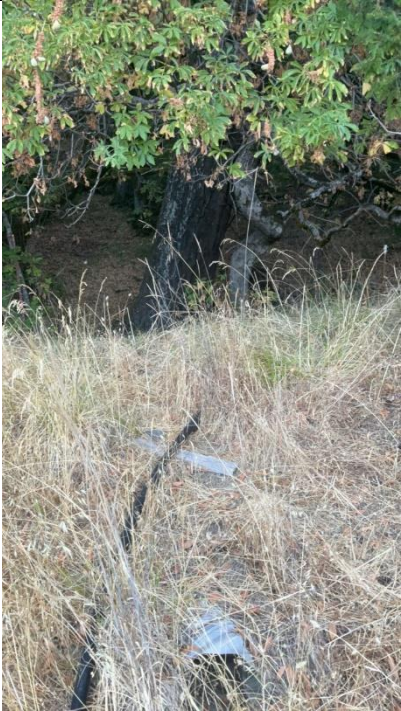
Photo Number: 4
	Photo Description: View of metal culvert inlet from wetland/ pond side and 20 foot berm to adjacent watercourse on parcel boundary.
	Facing North

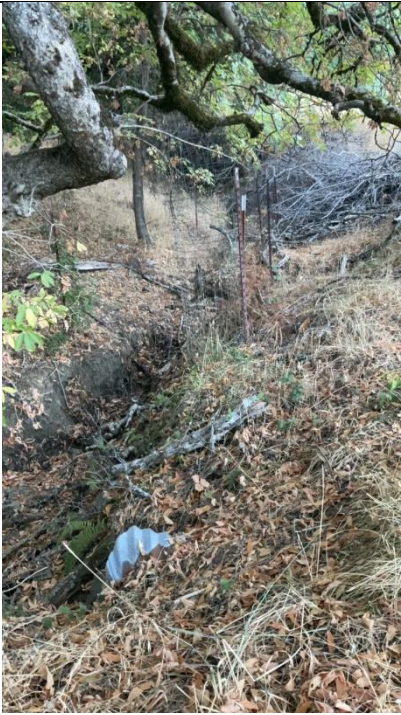
Photo Number: 5
	Photo Description: Culvert on watercourse side. Metal plant cages, metal stakes, and slash in stream.
	Facing East

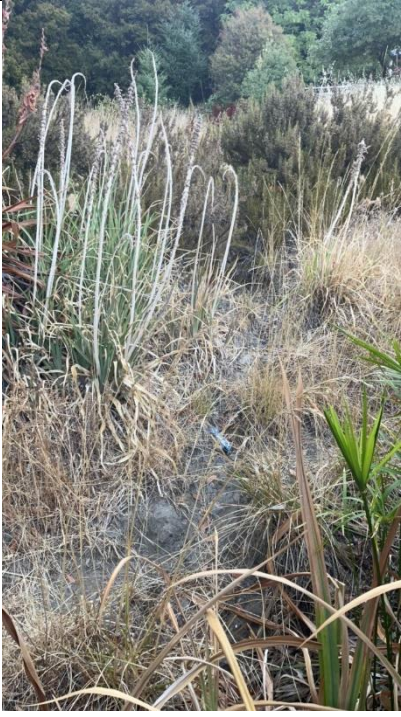
Photo Number: 6
	Photo Description: Watercourse coming into wetland/ pond feature.
	Facing East

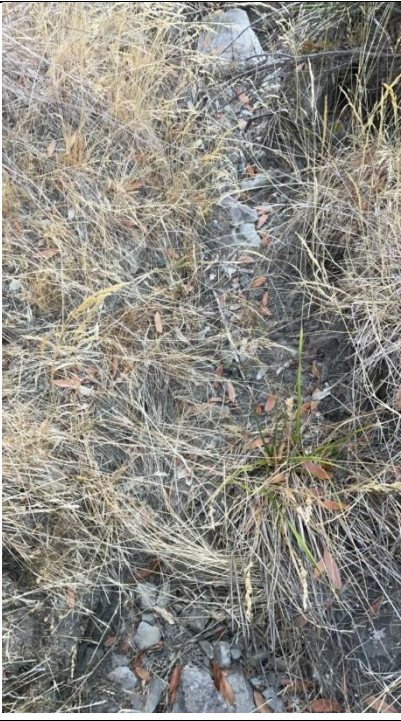
Photo Number: 7
	Photo Description: Watercourse channel approximately 20 feet from cultivation area.
	Facing East
