North Coast Regional Water Quality Control Board

**Subject      Notice of Violation, Transmittal of Inspection Report of July 19, 2023  
Inspection of Mendocino County Assessor's Parcel Number 056-050-  
12-00**

**Cannabis Water Quality Inspection Report  
Martin Taribio Property, Mendocino County APN 056-050-12-00, WDID No.  
1\_23MJ000383**

Inspection Details
Inspection Date & Time	July 19, 2023; 16:50
Address/Location	58150 Registered Guest Road, Laytonville, CA 95454
County	Mendocino
Assessor's Parcel Number (APN)	056-050-12-00
Watershed	Blue Rock Creek, Middle Mainstem Eel Hydrologic Area, Eel River Hydrologic Unit
Property Owner's Legal Name and Company	Martin Toribio
Mailing Address	P.O. Box 2, Talmage, CA 95481
Agency Responsible for Warrant	California Department of Fish and Wildlife (CDFW)
Person Responsible for Warrant	Warden Kyle Perdue
Warrant Date	July 19, 2023
Warrant Type	Criminal Search
Lead Inspector Name	Adona White, PE, Water Resources Control Engineer
Office/Regional Board	North Coast Regional Water Quality Control Board
Other Personnel Onsite	Representatives from CDFW and State Water Resources Control Board Division of Water Rights
Author of Report	Adona Whi

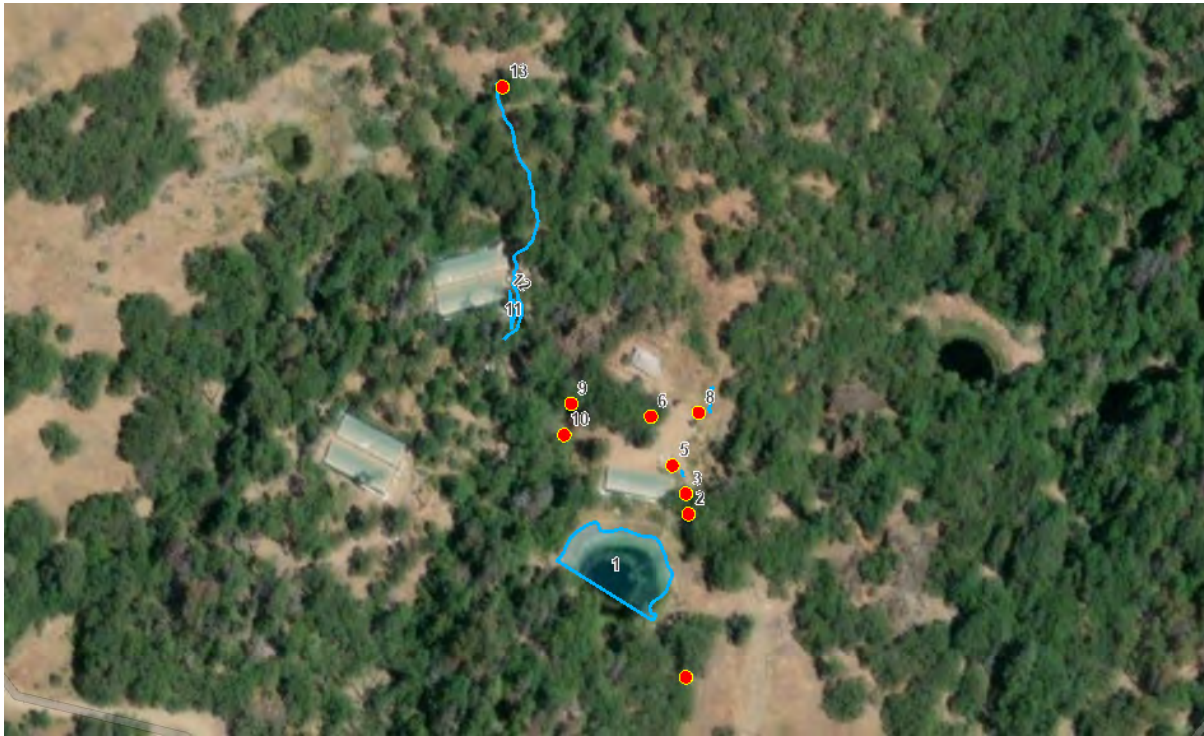
Figure 2. Inspection map with aerial imagery showing the point, line, and polygon feature locations of interest are described in the text.

The inspection map is shown in Figure 2 and includes the locations referenced at the following features of concern to water quality.

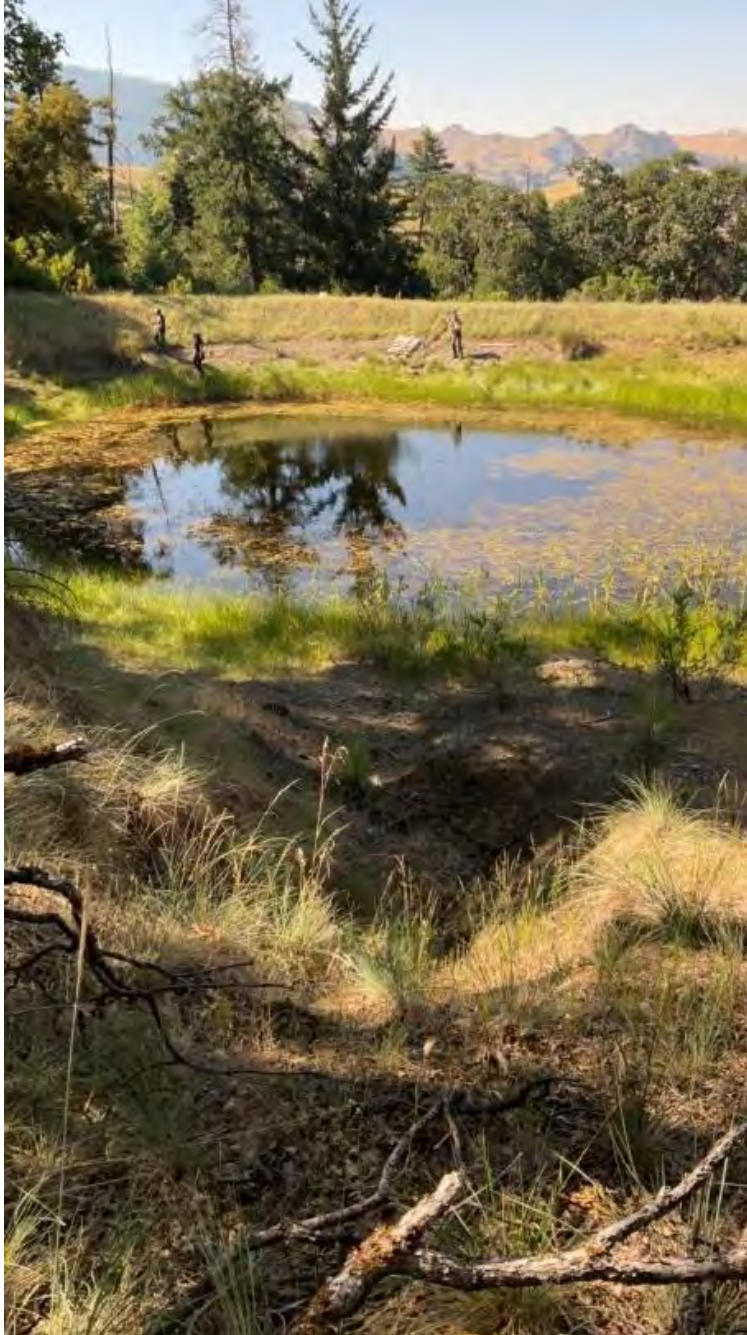
Polygon Location 1: Pond with surface water channel entering. An unscreened two-inch intake and gas pump transfer water to cultivation areas. Bullfrogs are present in the pond.

*Figure 4. Pond at Polygon Location 1 has a channel entering from the upslope area.*

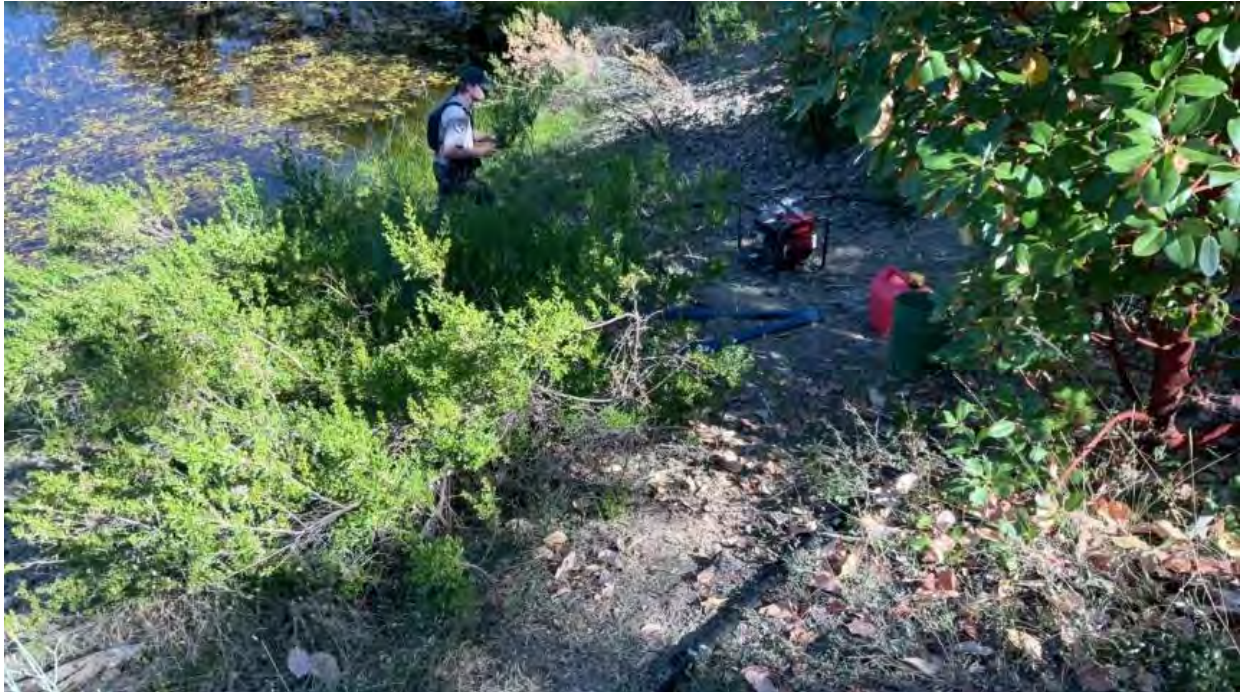
*Figure 5. Gas pump located on the berm of the pond at Polygon Location 1; I did not observe measures to ensure petroleum is prevented from discharge to land and to the pond.*

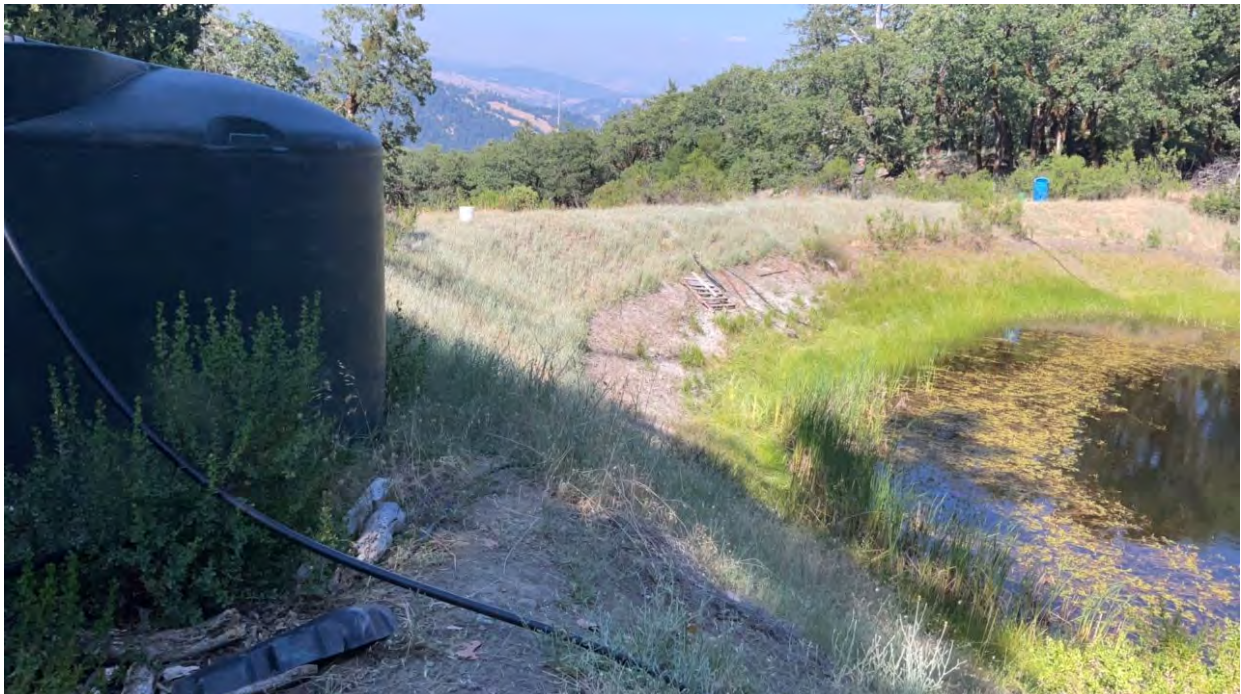
*Figure 6. Earthen berm and water tank on the pond at Polygon Location 1.*

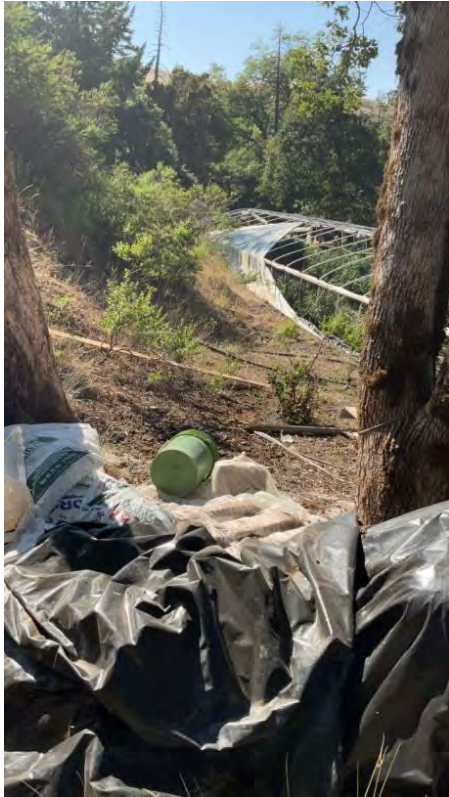
Point Location 2: Fertilizers on the ground.

*Figure 7. Fertilizer and trash on the ground at Point Location 2.*

1. Cease unauthorized cannabis cultivation.
2. Cleanup fertilizer containers and feed tanks and prevent further discharge of feed water to land in a manner that threatens water quality.

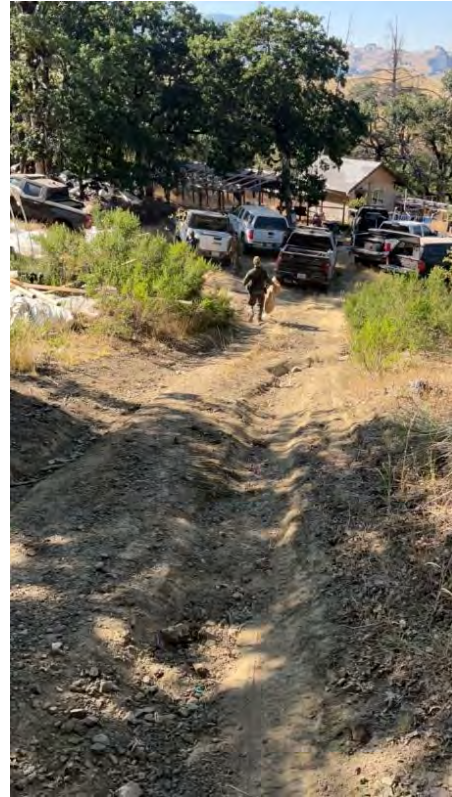
Point Location 3: Steep access driveway with extensively rilled surface indicating concentrated stormwater, erosion and sediment transport downslope.

*Figure 8. Road rills down the steep access driveway, aligned with Point Location 3, indicated concentrated stormwater runoff, erosion, and sediment transport downslope. The road lacked adequate drainage or surfacing.*

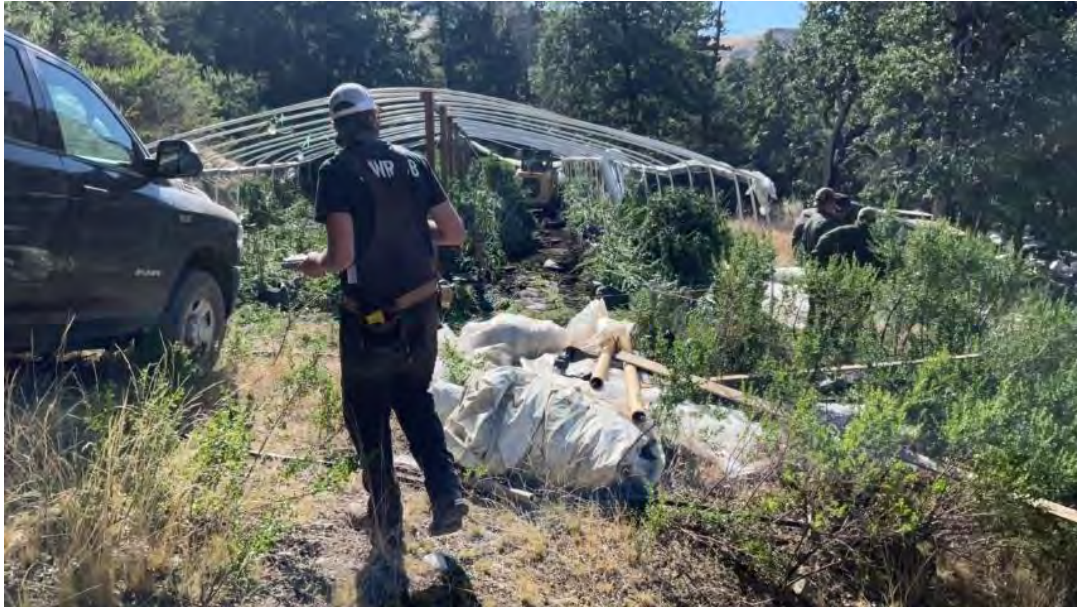
Polygon Location 4: Active cultivation in one greenhouse.

*Figure 9. Active cultivation in two greenhouses as Polygon Location 4.*

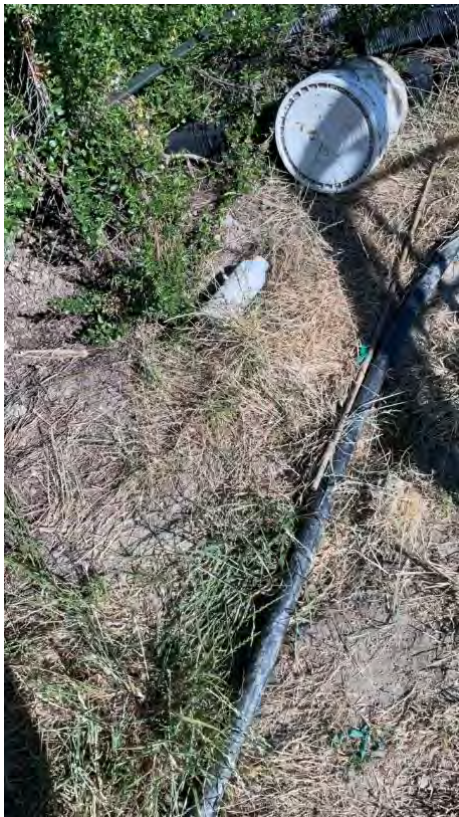
Point Location 5: Bottle of carbofuran at cultivation area.

*Figure 10. Bottle of suspected carbofuran on ground at greenhouse cultivation area at Point Location 5.*

3. Properly dispose of all pesticides and fertilizers at a legal disposal facility.
4. Remove cultivation infrastructure and properly dispose of waste including but not limited to trash, fertilizer, pesticide and petroleum containers, plastic tarps and sheeting at a legal facility.

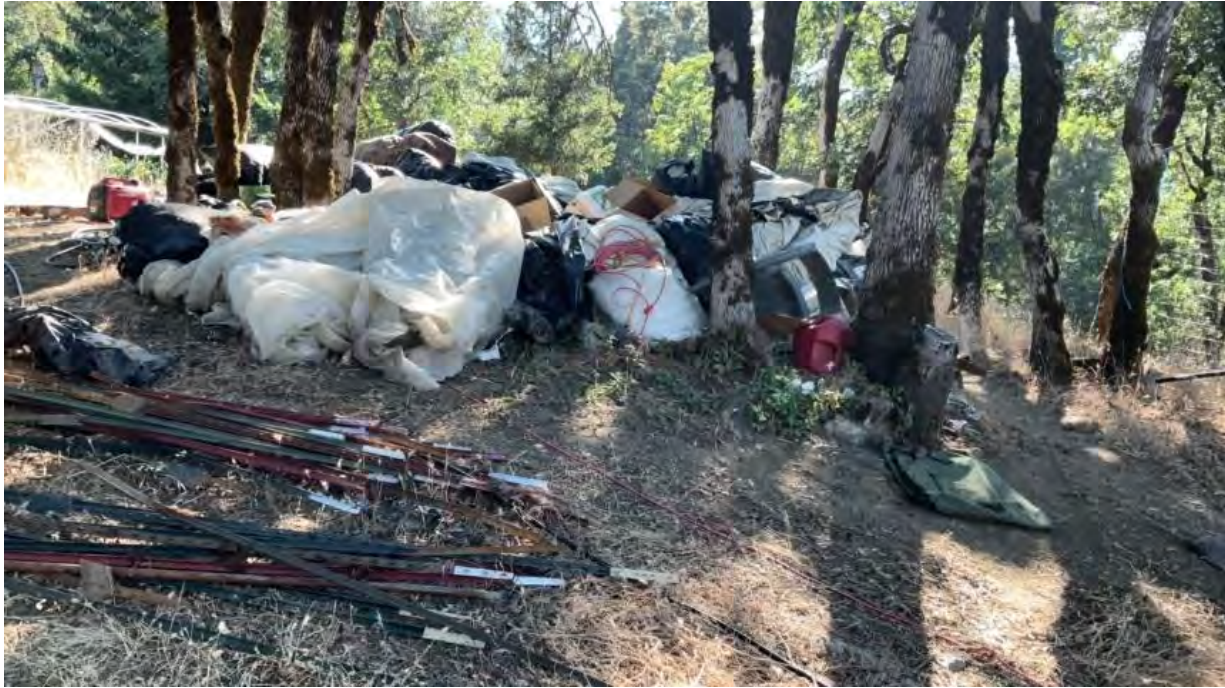
Point Location 6: Pile of cultivation-related refuse.

*Figure 11. Pile of refuse, including petroleum containers and plastic cultivation-related refuse, at Point Location 6.*

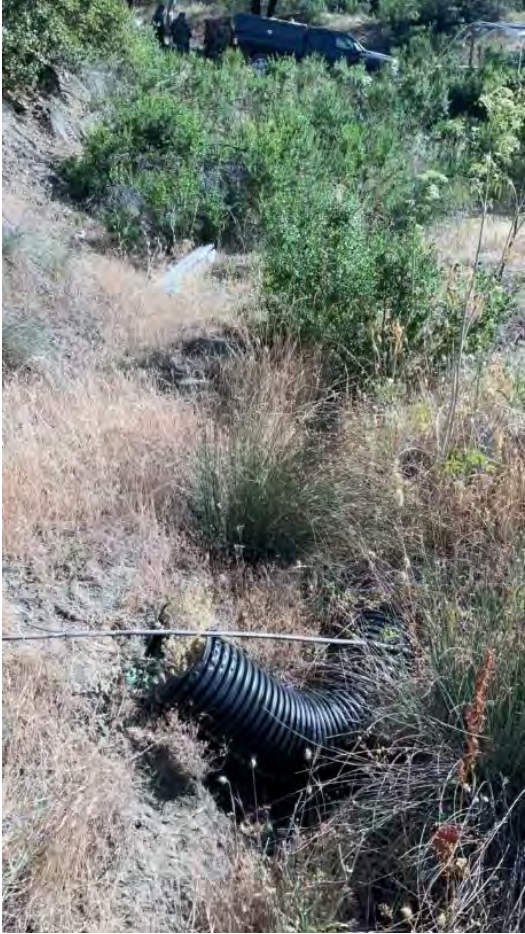
Line Feature 7: A flexipipe was installed to capture and carry the driveway runoff down slope. The pipe is separated.

*Figure 12. The road rills described at Point Location 3 connect to a drainage feature with a defunct flexipipe installed from the road edge downslope along Line Location 7. Photo is view looking upslope along feature to access driveway.*

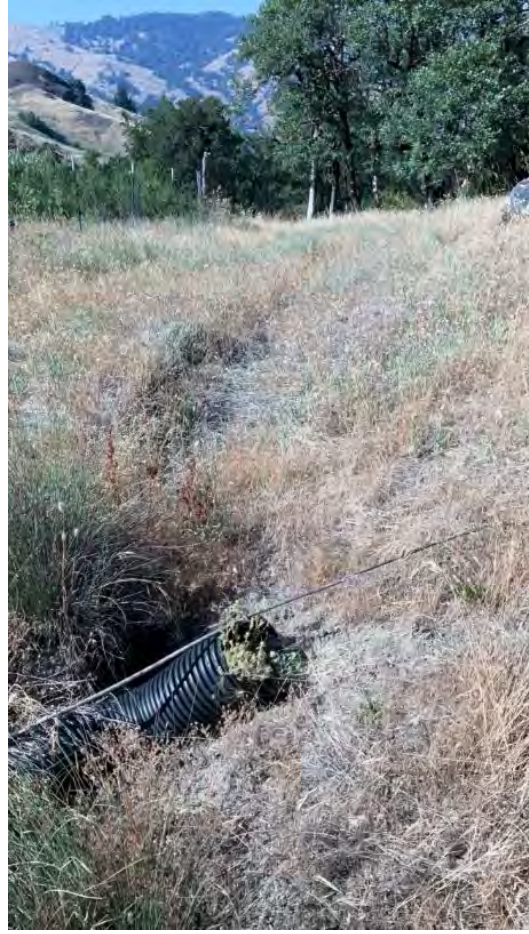
*Figure 13. Looking downslope from Line Feature 7 along the flowpath that can carry concentrated stormwater, sediment and other contaminants downslope.*

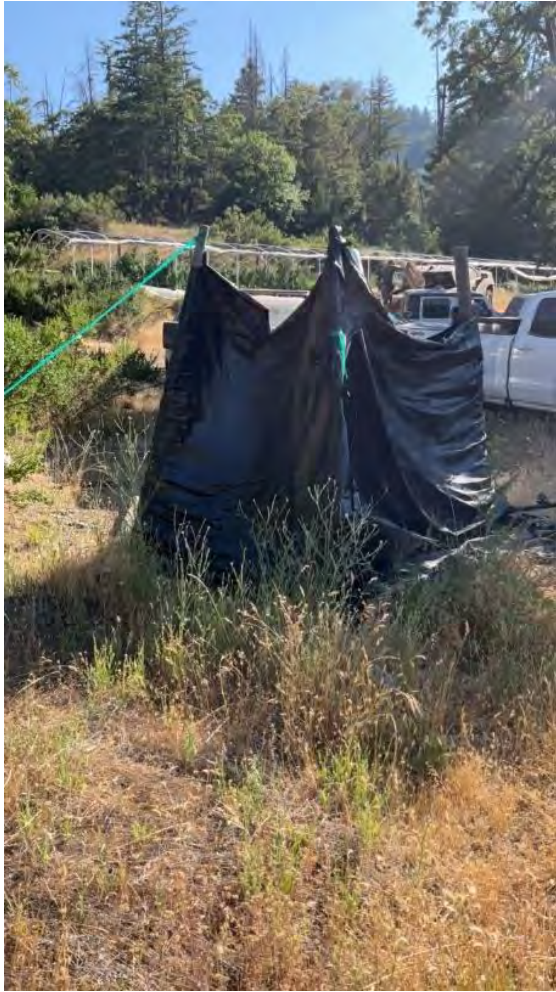
As document in the inspection report, staff observed a pit privy with discharge to land at Point Location 8, threatening the quality of waters of the state in violation of Water Code section 13264. The dredge and fill in the blue line stream at Point Location 10 for unauthorized surface water diversion, the dredge of fill to install the foot bridge, and the sediment delivery to a blue line stream caused by the unauthorized placement of an undersized culvert at Point Location 13 resulted in unauthorized discharge of sediment to the streams, in violation of Water Code 13264, the Basin Plan section 4.2.1 Prohibitions 1 and 2, and Federal Clean Water Act section 301.

Point Location 8: Pit privy.

*Figure 14. Pit privy with domestic waste discharge to ground is at Point Location 8.*

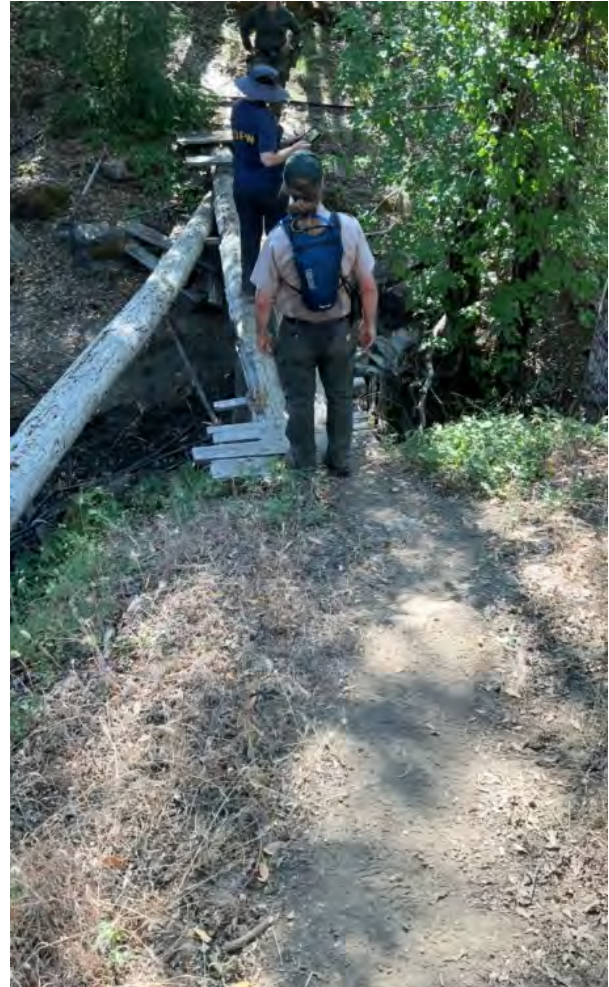
Point Location 9: Foot bridge over large watercourse constructed with piles driven into channel bed; obstructs flow and woody material transport.

*Figure 15. Watercourse crossing at Point Location 9 is a footbridge constructed with poles driven into the bed of a blue line stream. The piles impede free flow and woody material transport downstream.*

As documented in the inspection report, the features at Point Locations 9, 10 and 13 are located instream and must be decommissioned to comply with the Basin Plan, which will require a water quality certification prior to conducting instream work.

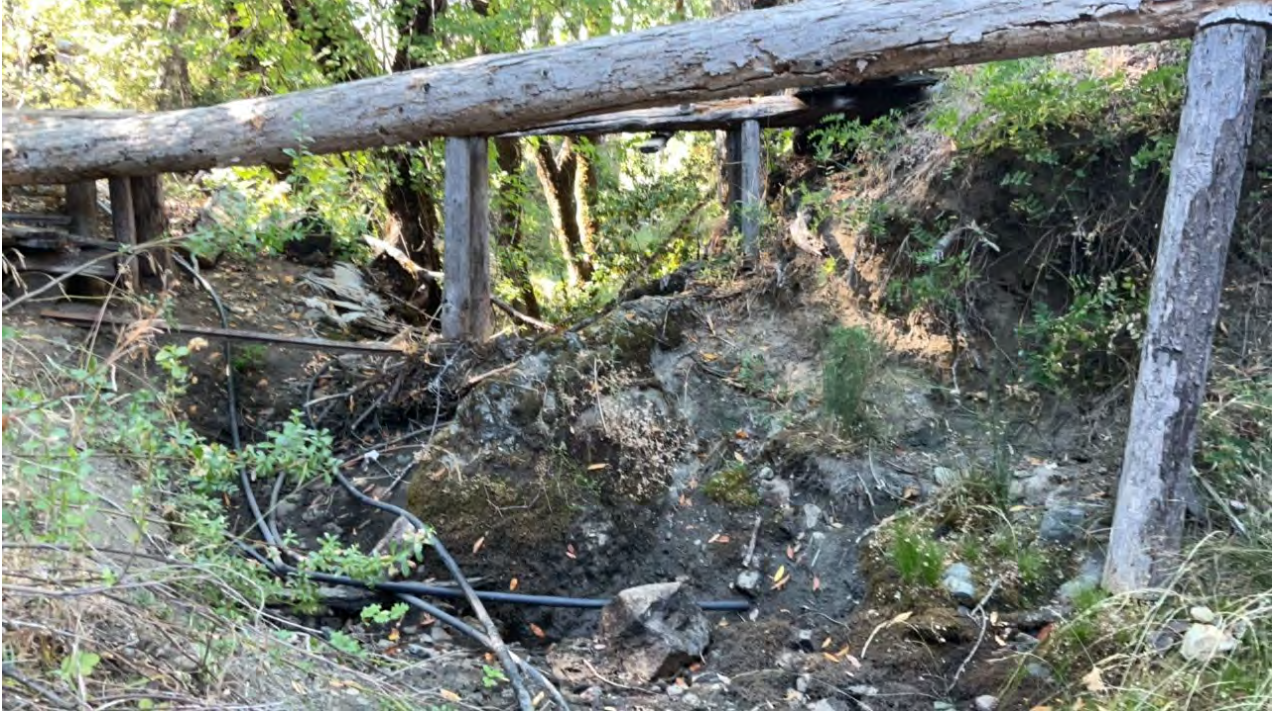
*Figure 16. Bridge at Point Location 9, looking downstream from the stream bed at the piles.*

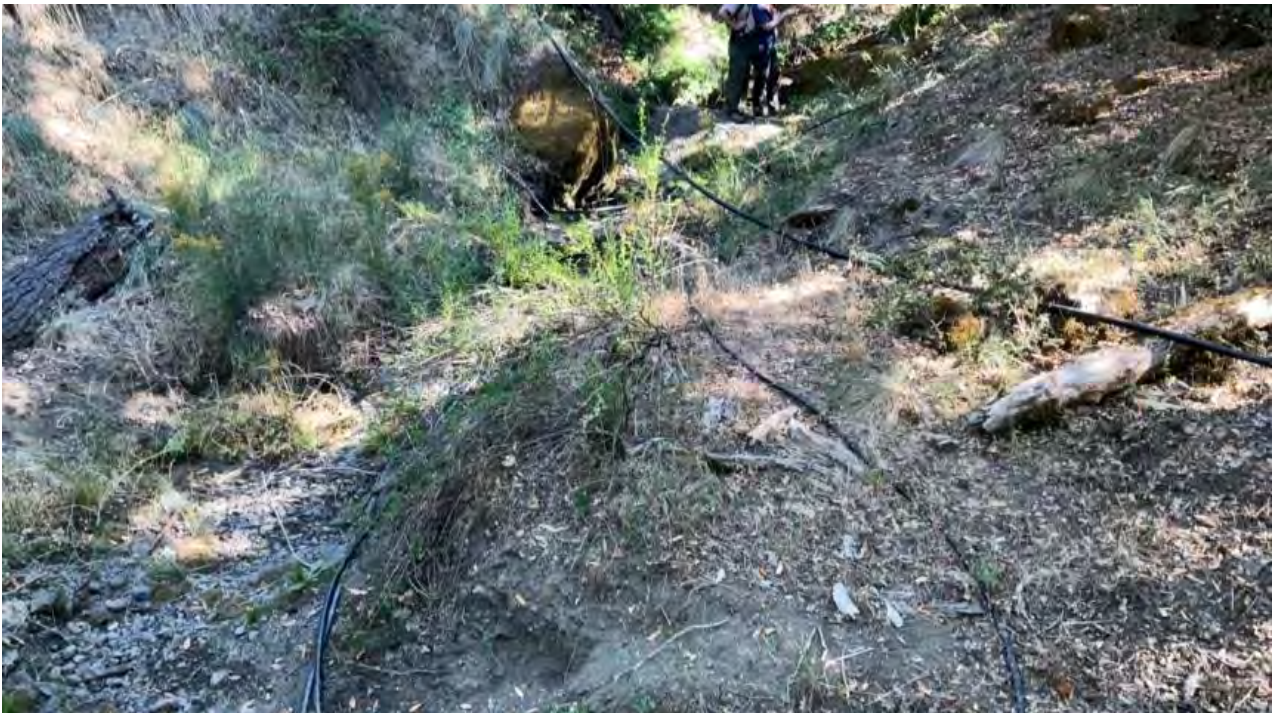
Point Location 10: Unauthorized dredge and fill in a blue line watercourse. The channel bed was excavated with a shovel and the material was used to construct and berm across the channel to capture and divert surface water without authorization. The feature is five feet long, eight feet wide, and one foot deep. I observed surface flow upstream and a dry channel downstream. Lots of black poly water line is in the channel.

*Figure 17. Just upstream of the bridge, is an in-stream excavation and berm construction at Point Location 10. Multiple lines of black plastic poly pipe are in the watercourse.*

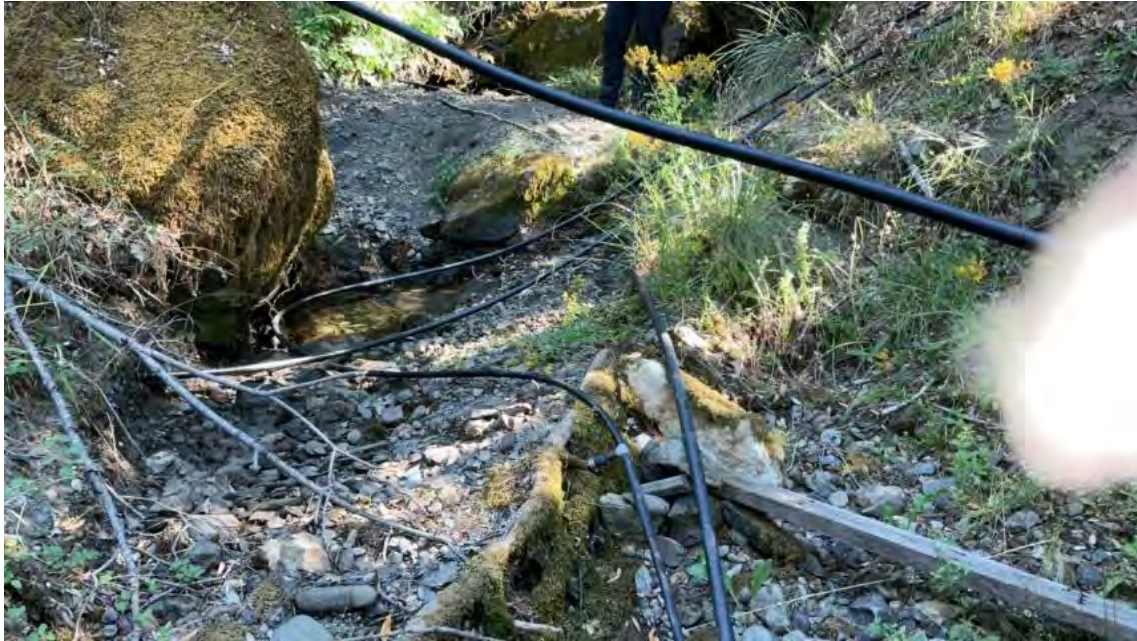
*Figure 18. The berm at Point Location 10 is constructed across a narrow portion of the channel to impede one hundred percent of the surface stream flow and is comprised of gravel substrate that appears to be dug from the channel with a shovel. Surface flow is disconnected downstream of the berm.*

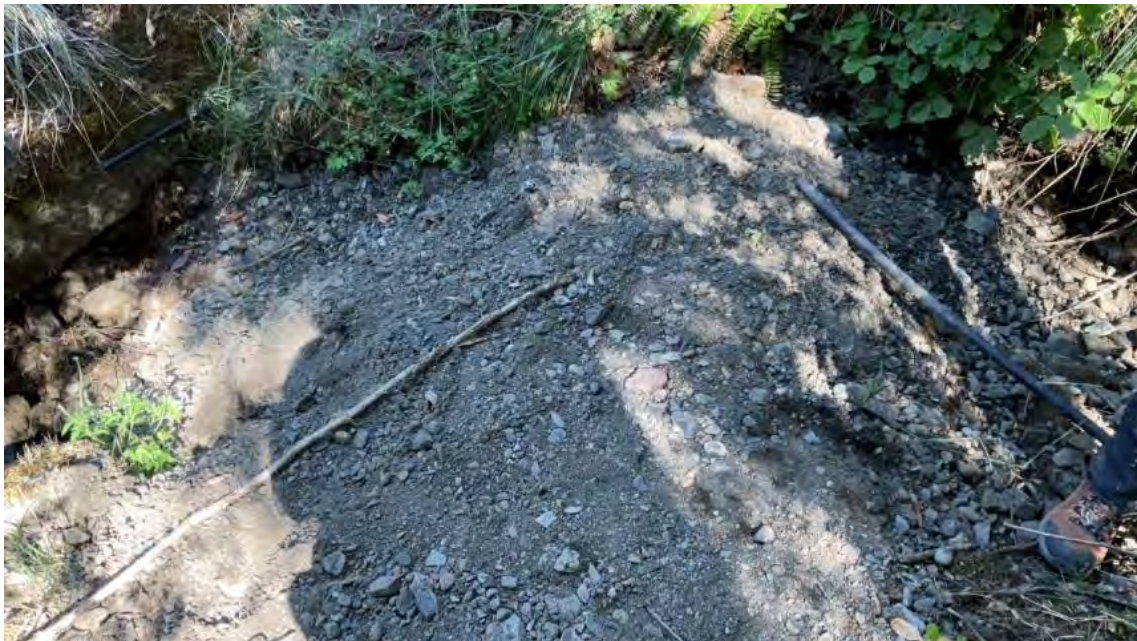
*Figure 19. The berm at Point Location 10 is approximately eight feet wide, five feet long, and one foot deep.*

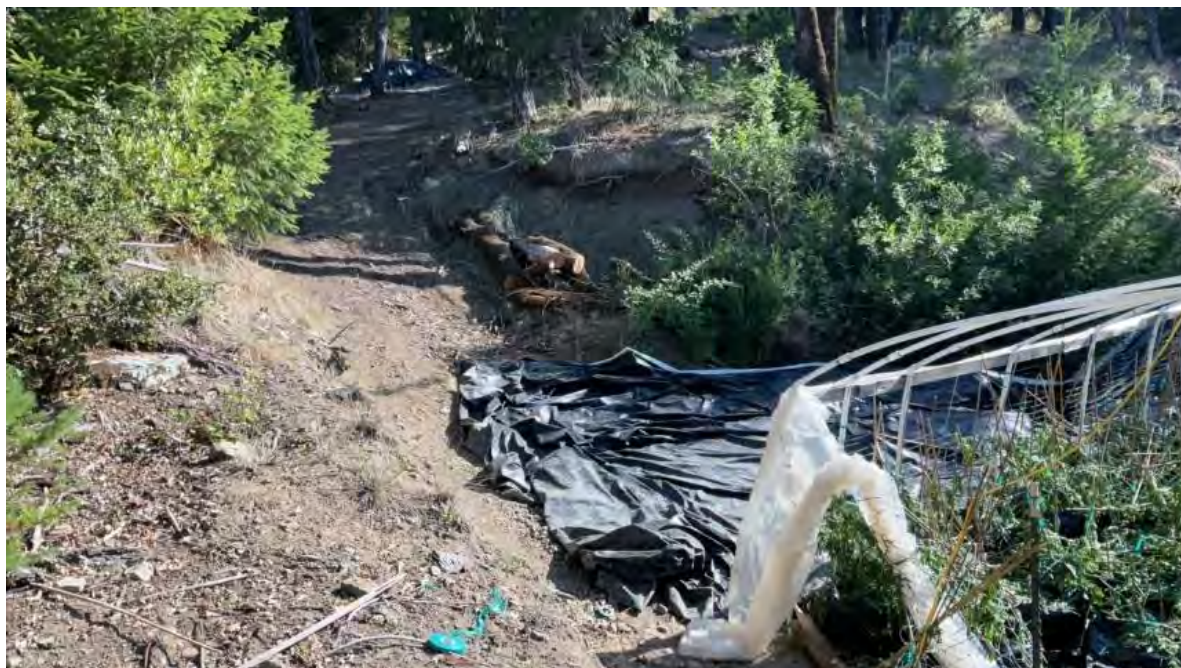
Polygon Location 11: Two greenhouses with active cultivation. The graded flat cutbank has been used as a road, causing concentrated runoff to deliver into the cultivation area at the feed tanks and carry nutrient laden water downslope.

*Figure 20. An active greenhouse cultivation area at Polygon Location 11 is constructed on a cut and fill graded flat. The cut bank is used as a quad trail to access the cultivation area. Runoff from upslope concentrates down the cut bank and enters the cultivation area.*

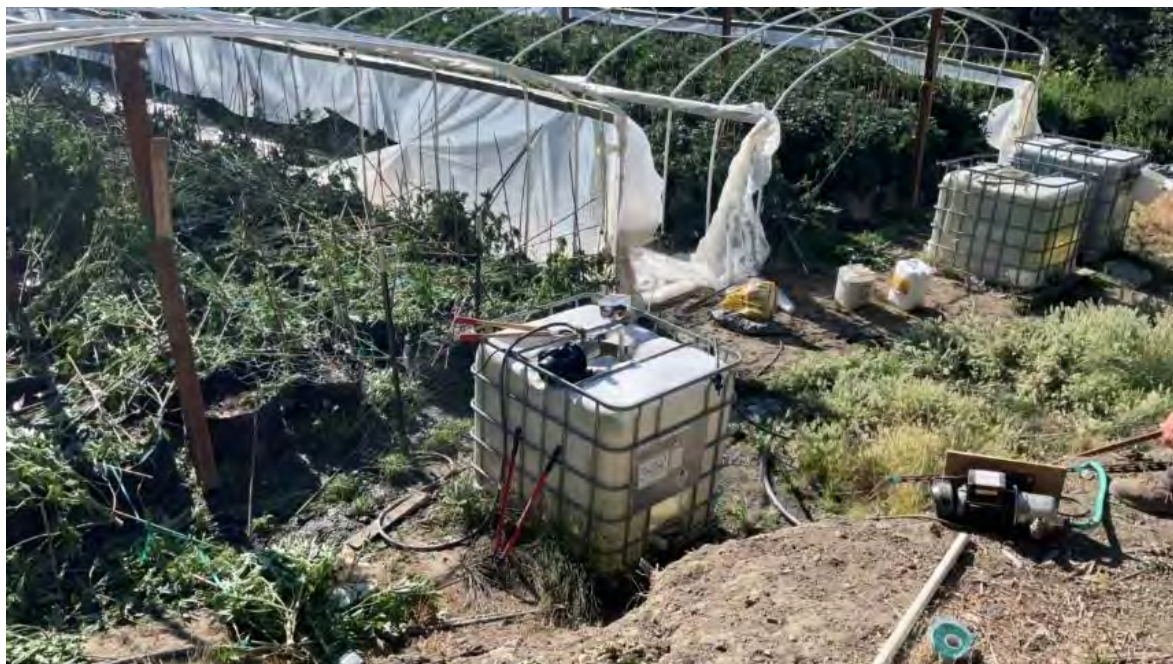
*Figure 21. Open feed tanks are located in the flow path from the cutbank at Polygon Location 11. Uncontained fertilizer containers are on the ground.*

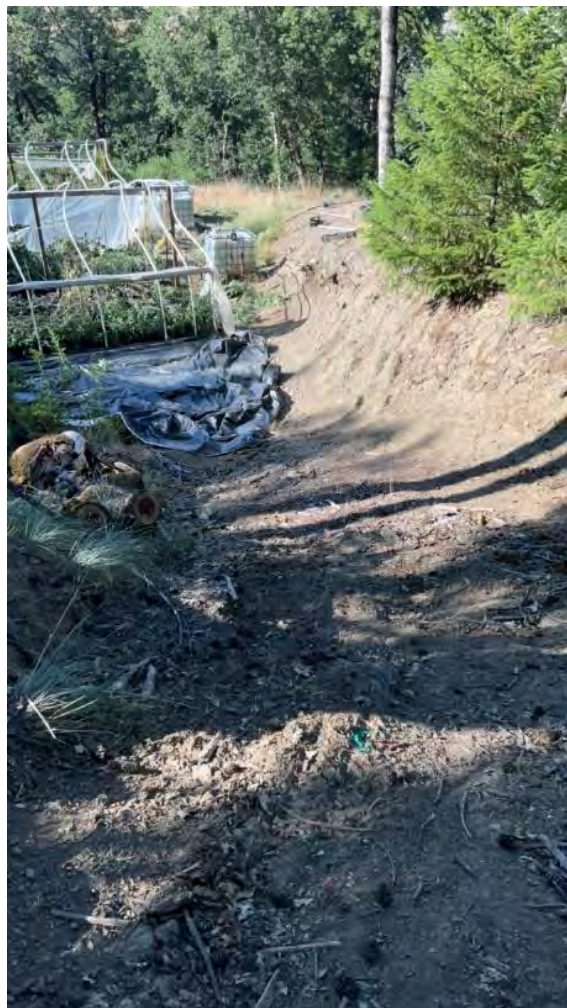
*Figure 22. The flow path down the cut bank, through the cultivation area, past the feed tanks and down the access road.*

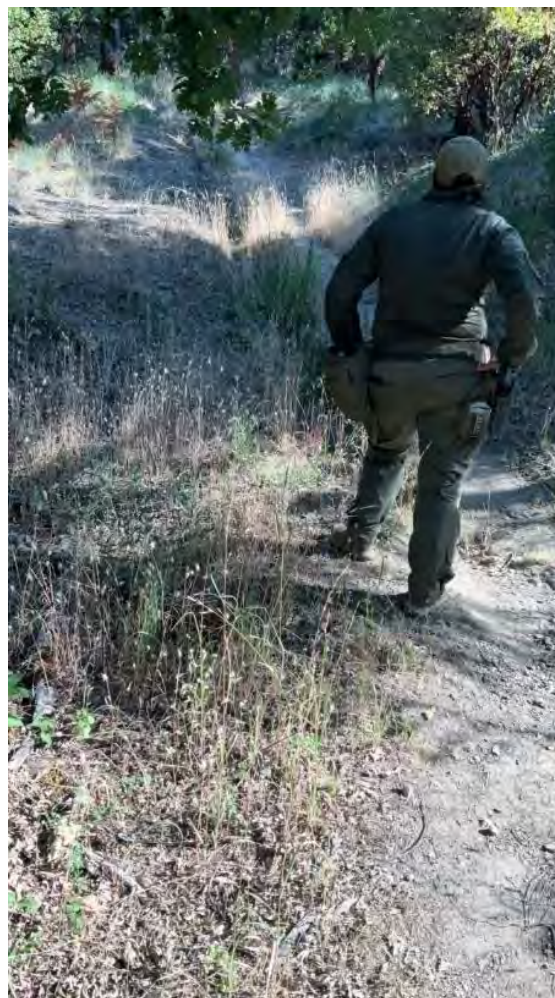
Line Location 12: Concentrated runoff from the cultivation area at Poly Location 11 has scoured a path downslope for a distance of three hundred feet and delivers to a stream at Point Location 13, threatening surface water quality with the discharge of sediment and nutrient laden water to a blue line stream.

*Figure 23. Concentrated runoff from the cultivation area at Polygon Location 11 continues down the access road, along Line Location 12, where it is hydrologically connected and delivers to a watercourse at Point Location 13.*

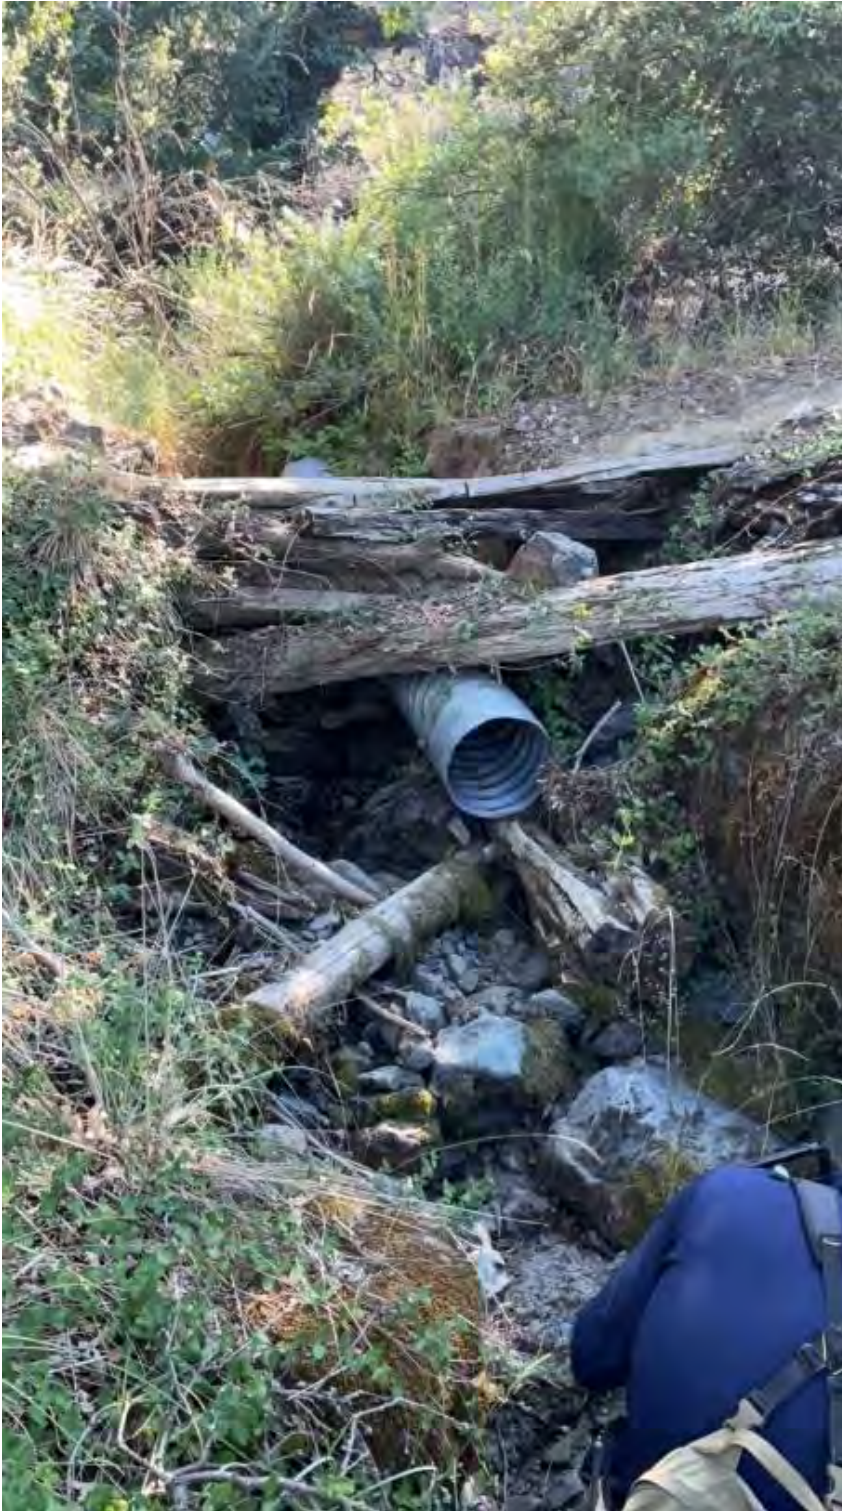
Point Location 13: An eroded watercourse crossing on a blue line stream consisting of twelve-inch diameter and ten-foot-long single walled corrugated metal pipe. The crossing fill has been eroded from around the pipe resulting in an erosional void that is five feet wide, five feet deep, and ten feet long and an eroded the left bank (facing

downstream) with an estimated five cubic yard void. The erosion resulted in one hundred percent delivery to the stream.

*Figure 24. Stream crossing at Point Location 13 is an eroded, twelve-inch diameter, ten-foot-long corrugated metal pipe. The channel is comprised of cobble. The stream crossing was not of sufficient size to pass the 100-year flow plus debris.*

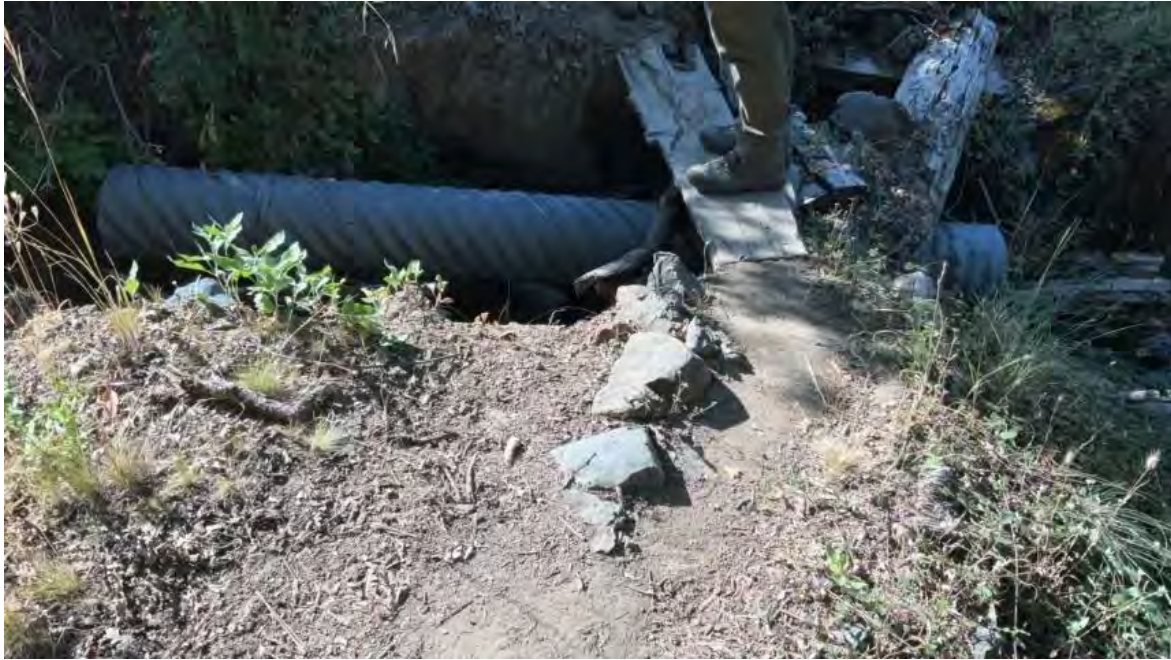
*Figure 25 . The erosional void of the stream crossing fill prism at Point Location 13 is approximately five-feet deep, five-feet wide, and ten-feet long (approximately nine cubic yards of sediment delivery to a blue line stream. Immediately downstream of the crossing on the left bank is an erosion void of approximately five cubic yards of sediment delivery to a blue line stream.*
