Subject: **Notice of Violation, Transmittal of Inspection Report of August 17, 2023 Inspection of Humboldt County Assessor's Parcel Number 212-033-006**

**North Coast Regional Water Quality Control Board
Attachment B**

**Cannabis Water Quality Inspection Report
Medrano Property**

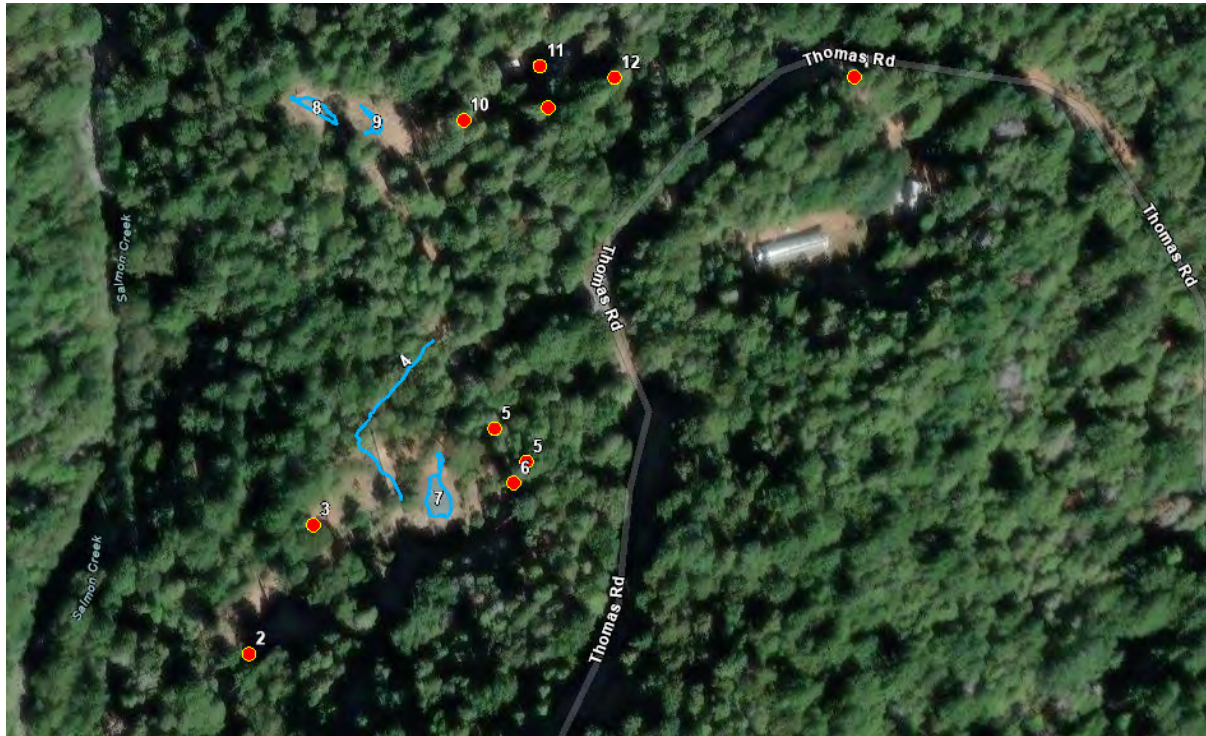
Figure 2. Inspection map with aerial imagery showing the point, line, and polygon feature locations of interest shown in the following photos.

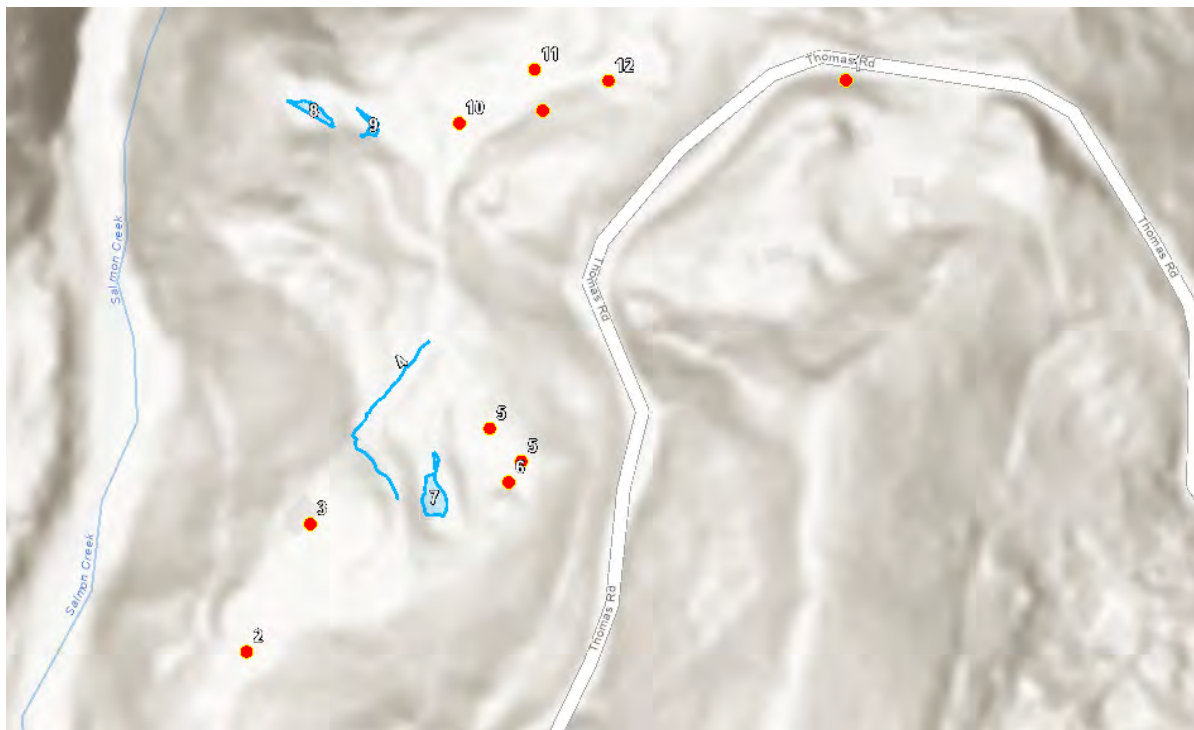
Figure 3 Inspection map with terrain showing features of interest shown in the following photos.

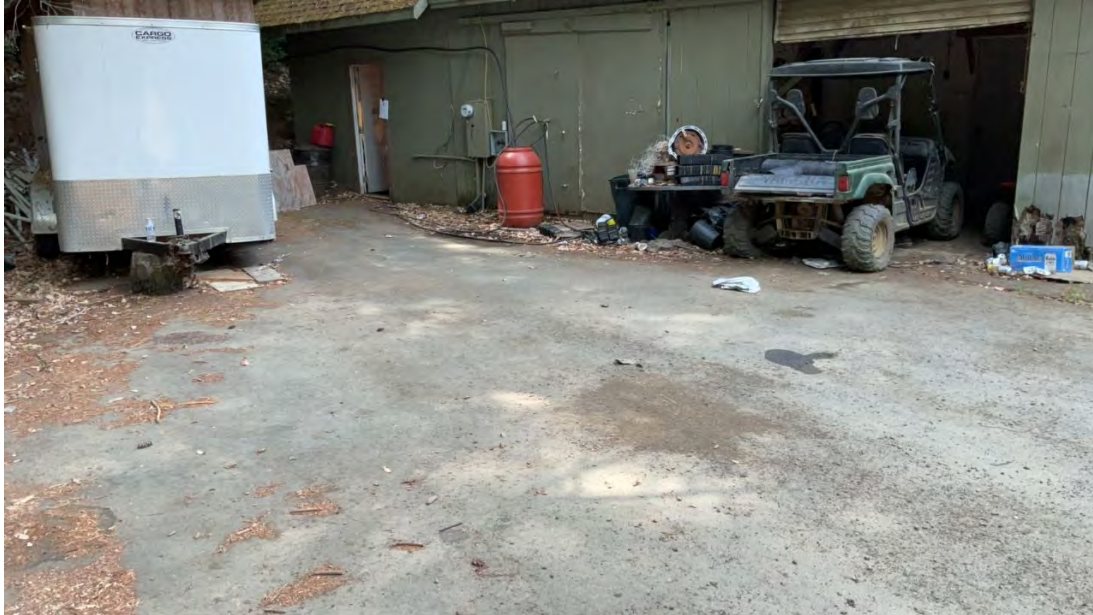
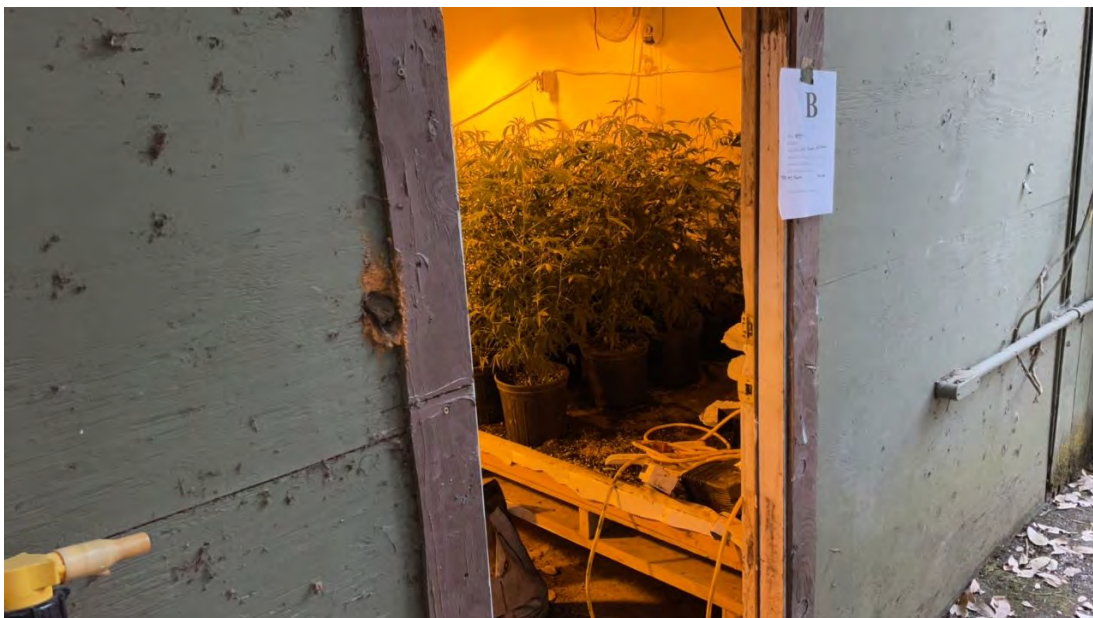
Point 1: Structure with small indoor.

Figure 4. Point 1. Structure with small indoor.

Figure 5. Point 1. Structure with small indoor.

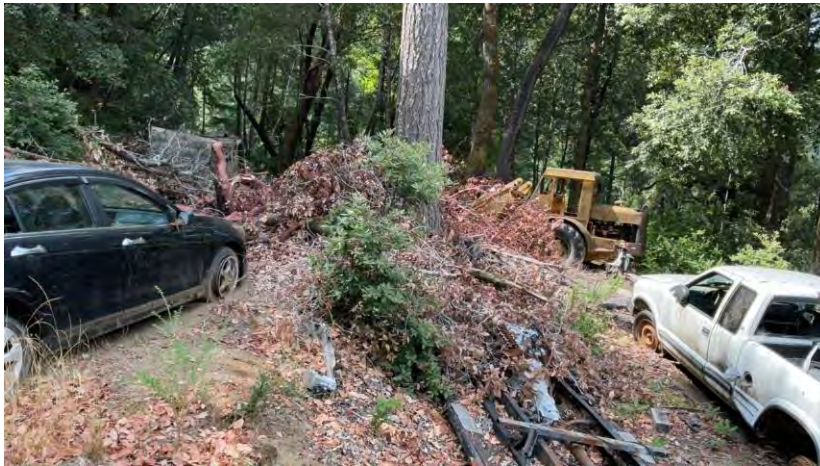
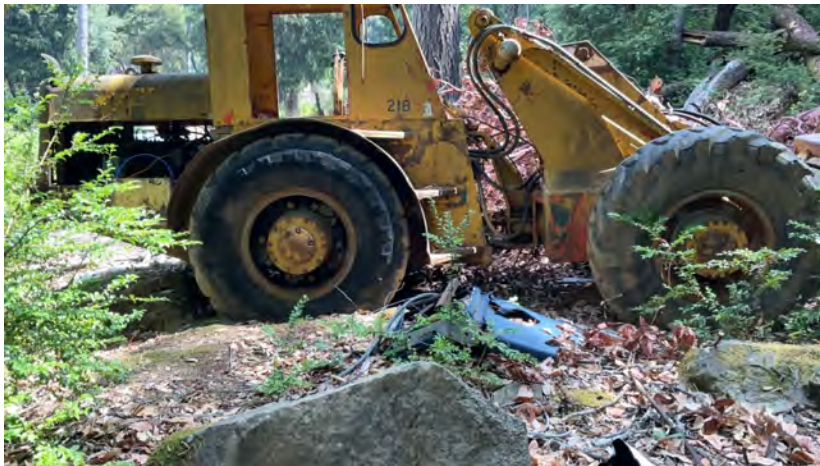
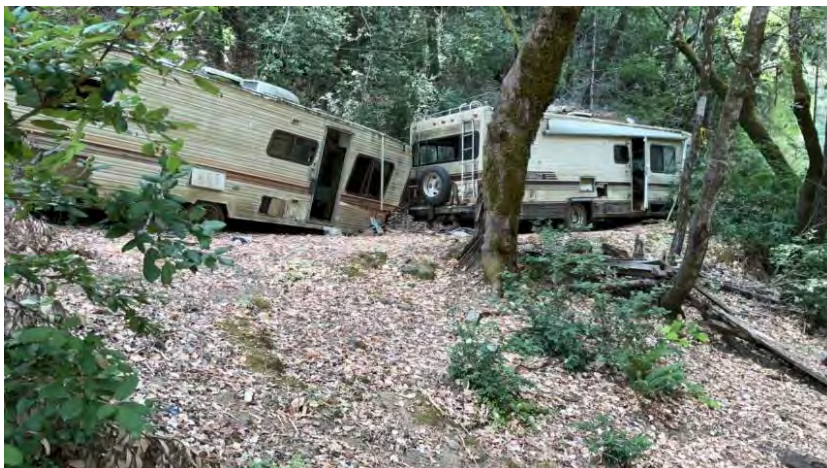
Point 2: Junked vehicles and RVs.

Figure 6. Point 2. Junked vehicles.

Figure 7. Point 2. Tractor.

Figure 8. Point 2. RVs.

4. Cleanup potting soil and properly locate and stabilize or remove and dispose at a legal disposal facility.
5. Cleanup refuse and junk vehicles and properly dispose at a legal disposal facility.
6. Prior to cultivating cannabis or developing a property for cannabis cultivation, ensure cannabis cultivation activities are in conformance with state and local requirements. Enroll for coverage under the Cannabis General Order. Details about enrolling in the Cannabis General Order can be found at: <https://public2.waterboards.ca.gov/mt/Home/Index>
7. Ensure the Property is cleaned up and winter-ready as soon as possible prior to the onset of winter wet weather with increased threat of impacts to waters of the state. Please document in your submissions evidence of completion of the cleanup work as soon as possible prior to October 15, 2023.

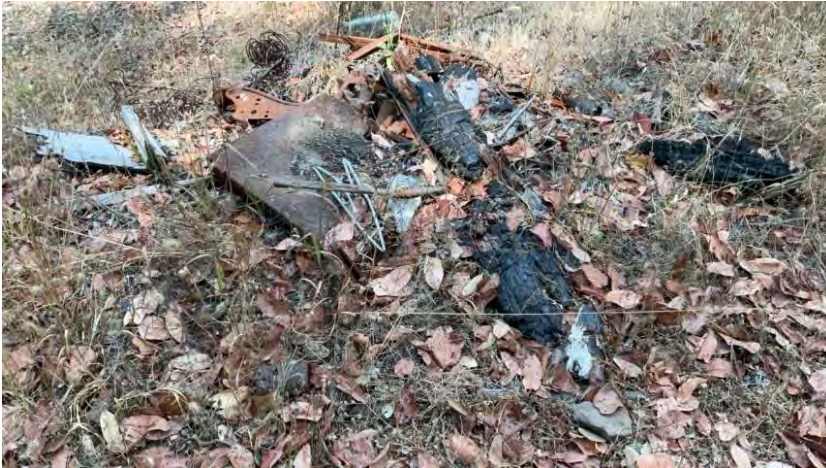
Burned trash.

Figure 9. Burn pile with metal.

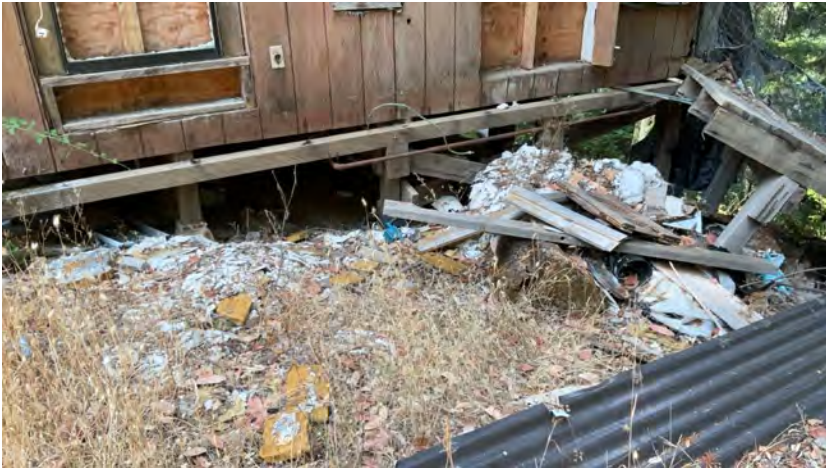
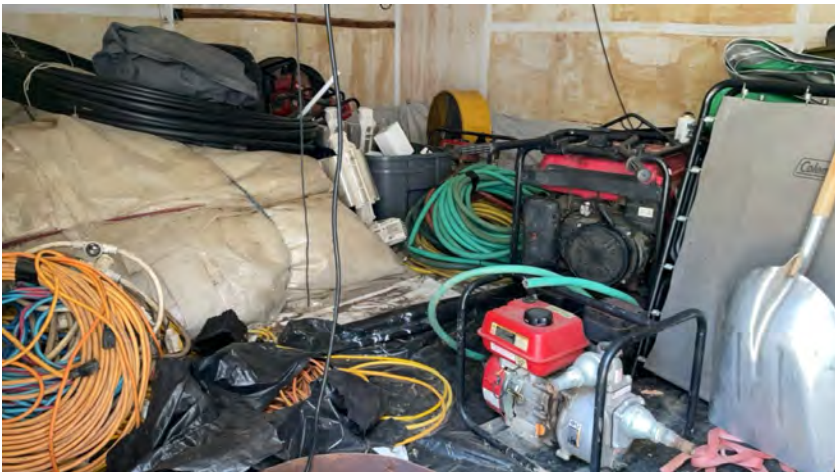
Point 3: Structure with trash outside.

Figure 10. Point 3. Structure.

Figure 11. Point 3. Generators and equipment within structure.

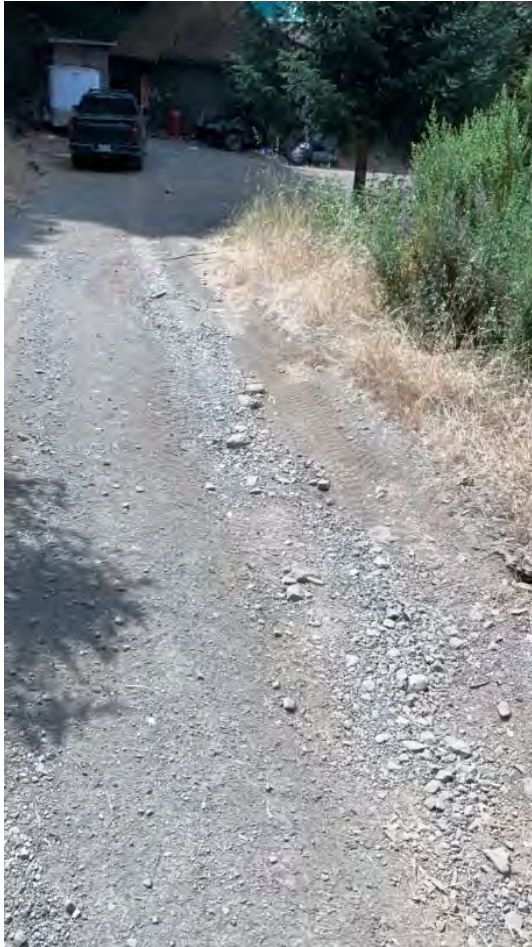
Line 4: Rilled road surface.

Figure 12. Line 4. Rilled road surface.

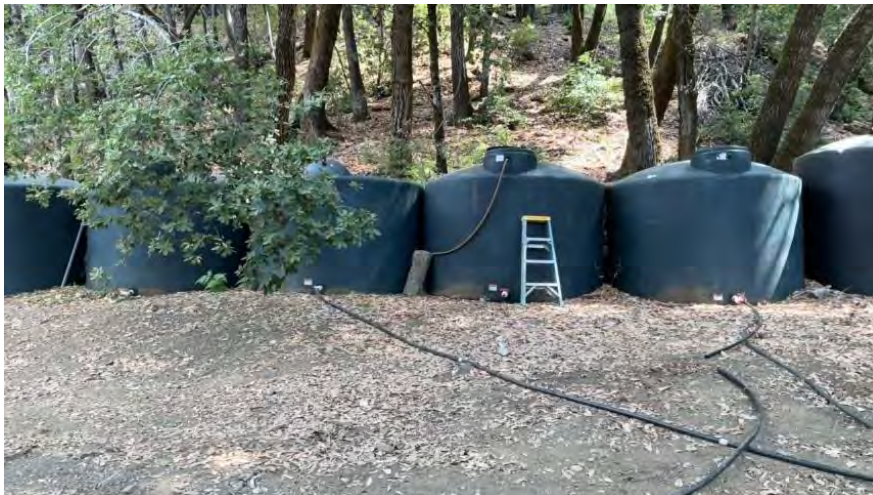
Figure 13. Point 5. Water storage tanks.

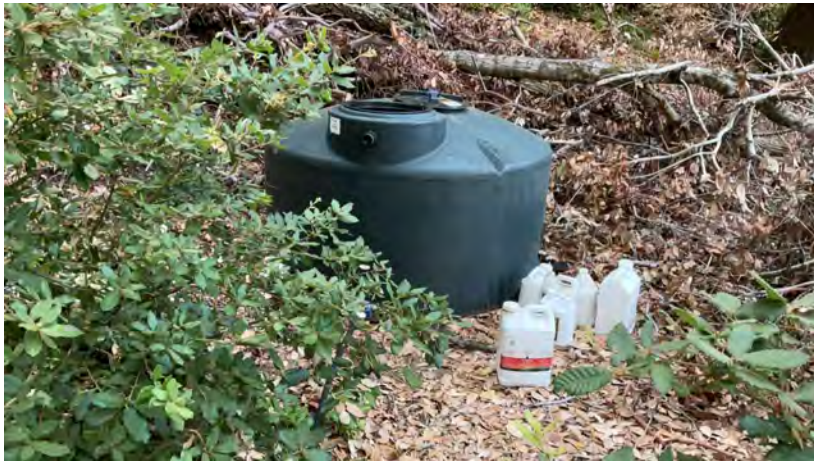
Point 5: Feed tank with open top and uncontained fertilizer jugs, located in swale.

Figure 14. Point 5. Feed tank with open top and uncontained fertilizer jugs, located in swale.

1. Immediately cease unauthorized cannabis cultivation.
2. Remove cultivation infrastructure and properly dispose of waste including but not limited to trash, fertilizer, pesticide and petroleum containers, plastic tarps and sheeting at a legal disposal facility.
3. Cleanup fertilizer containers and feed tanks and prevent discharge of nutrients to land in a manner that threatens water quality. Properly dispose of all pesticides

and fertilizers at a legal disposal facility.

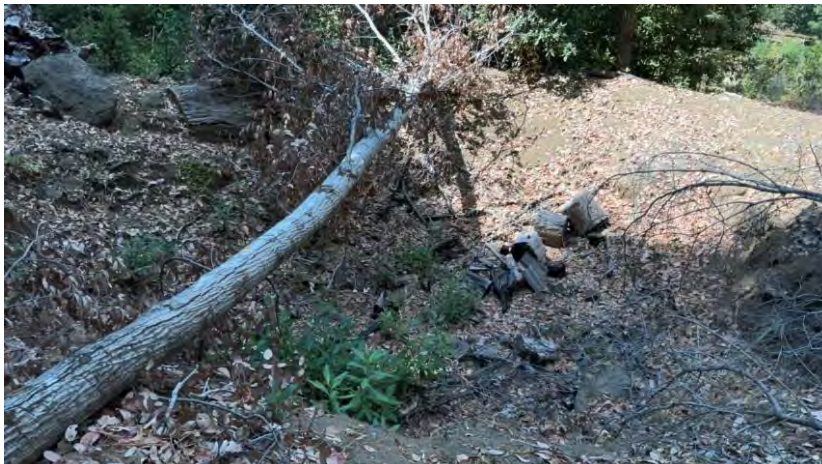
Point 6: Excavated pit.

Figure 15. Point 6. Pit.

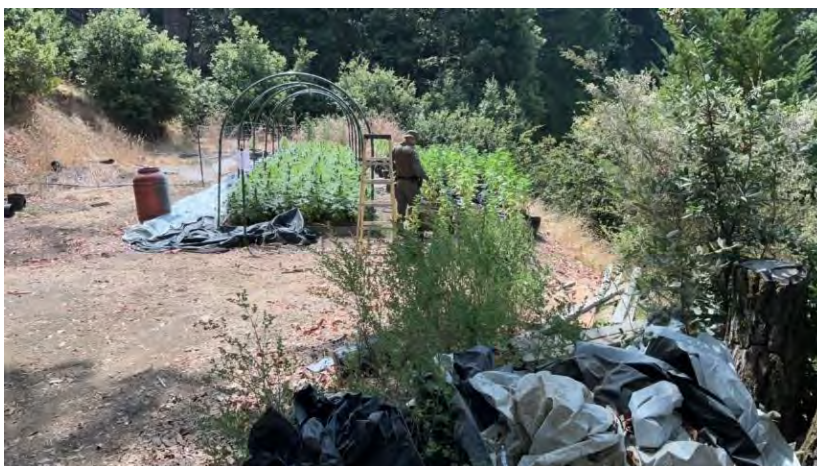
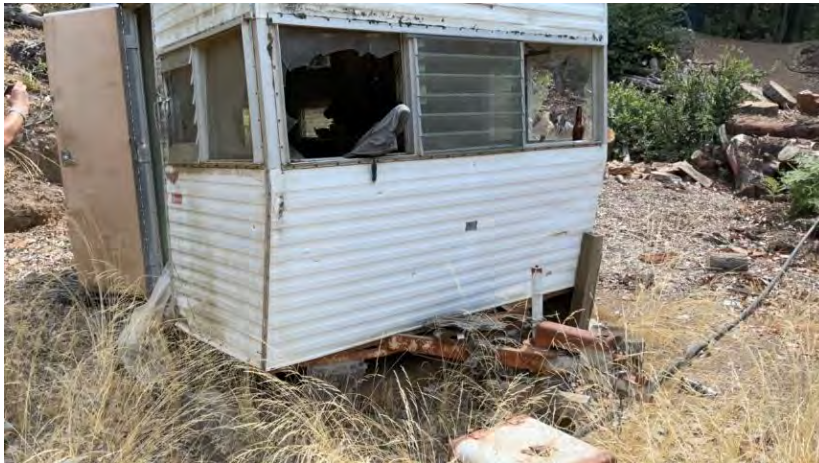
Polygon 7: Cultivation area (CA1) and trailer.

Figure 16. Polygon 7. Cultivation area (CA1).

Figure 17. Trailer at CA1.

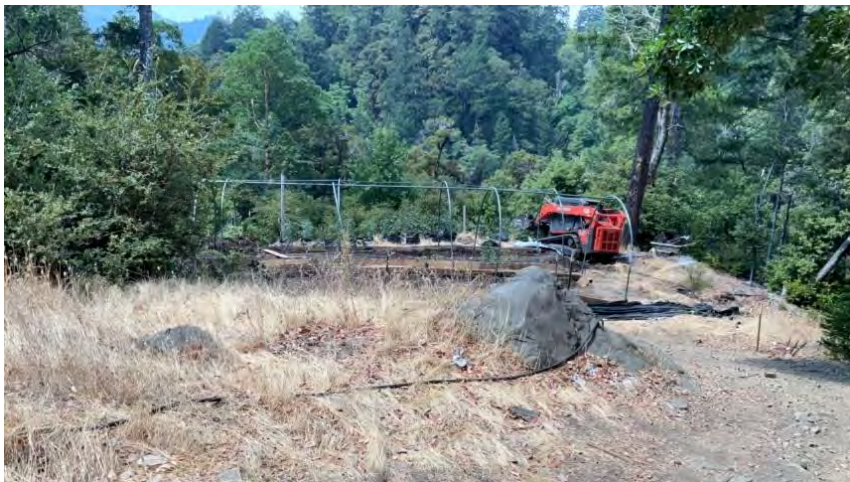
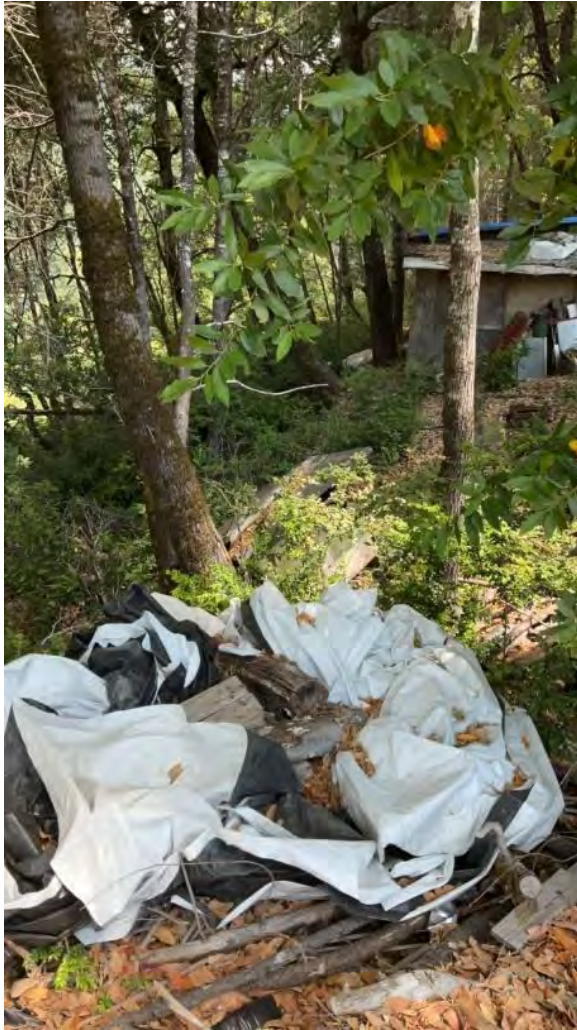
Polygon 8. Cultivation area CA2 with plastic tarps over slope.

Figure 18. Polygon 8. Cultivation area CA2.

Figure 19. Plastic refuse over slope from CA2.

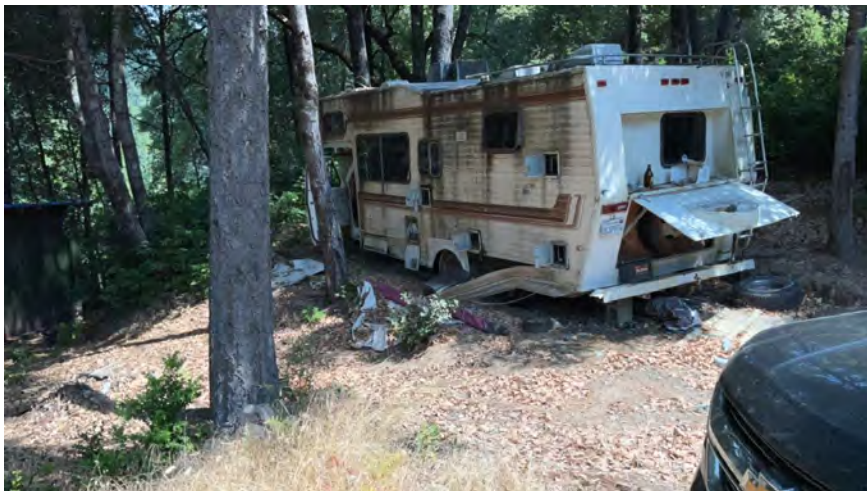
Polygon 9. Cultivation area CA3 and RV.

Figure 20. Polygon 9. RV at cultivation area CA3.

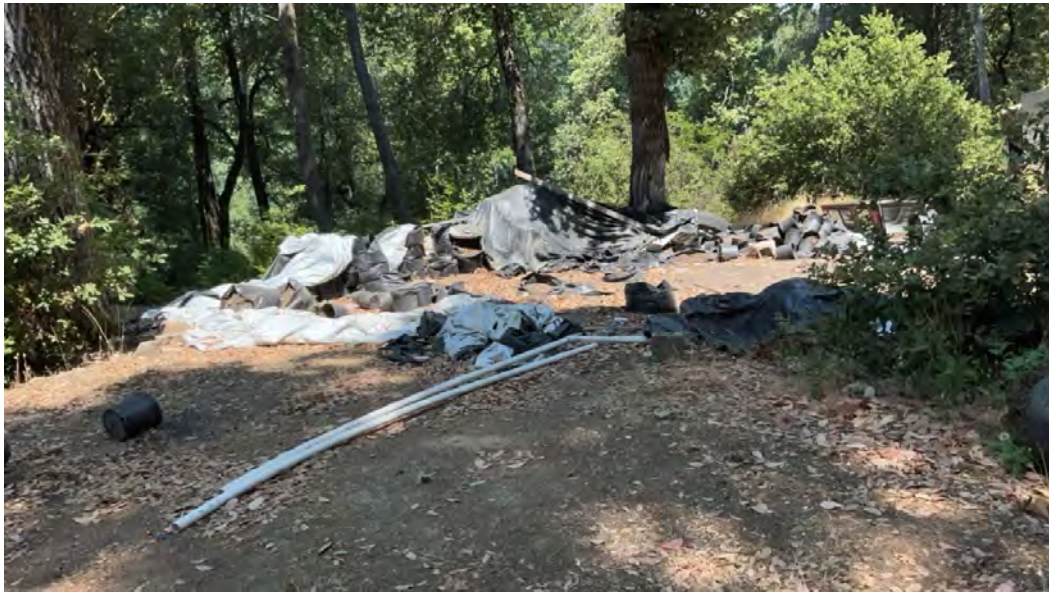
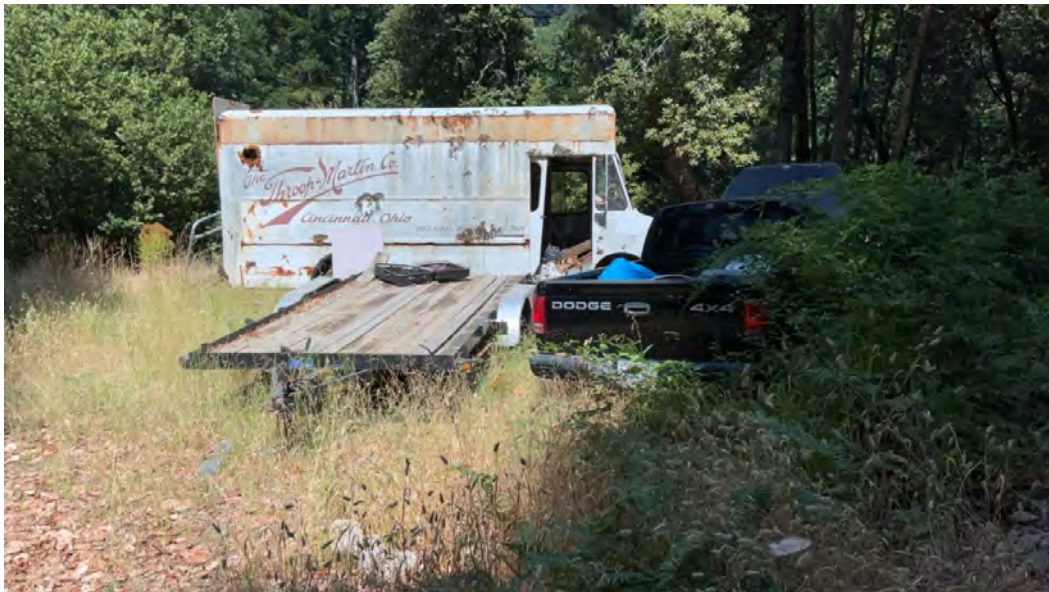
Point 10: Cultivation-related refuse and junked vehicles.

Figure 21. Point 10. Cultivation-related refuse.

Figure 22. Point 10. Vehicles.

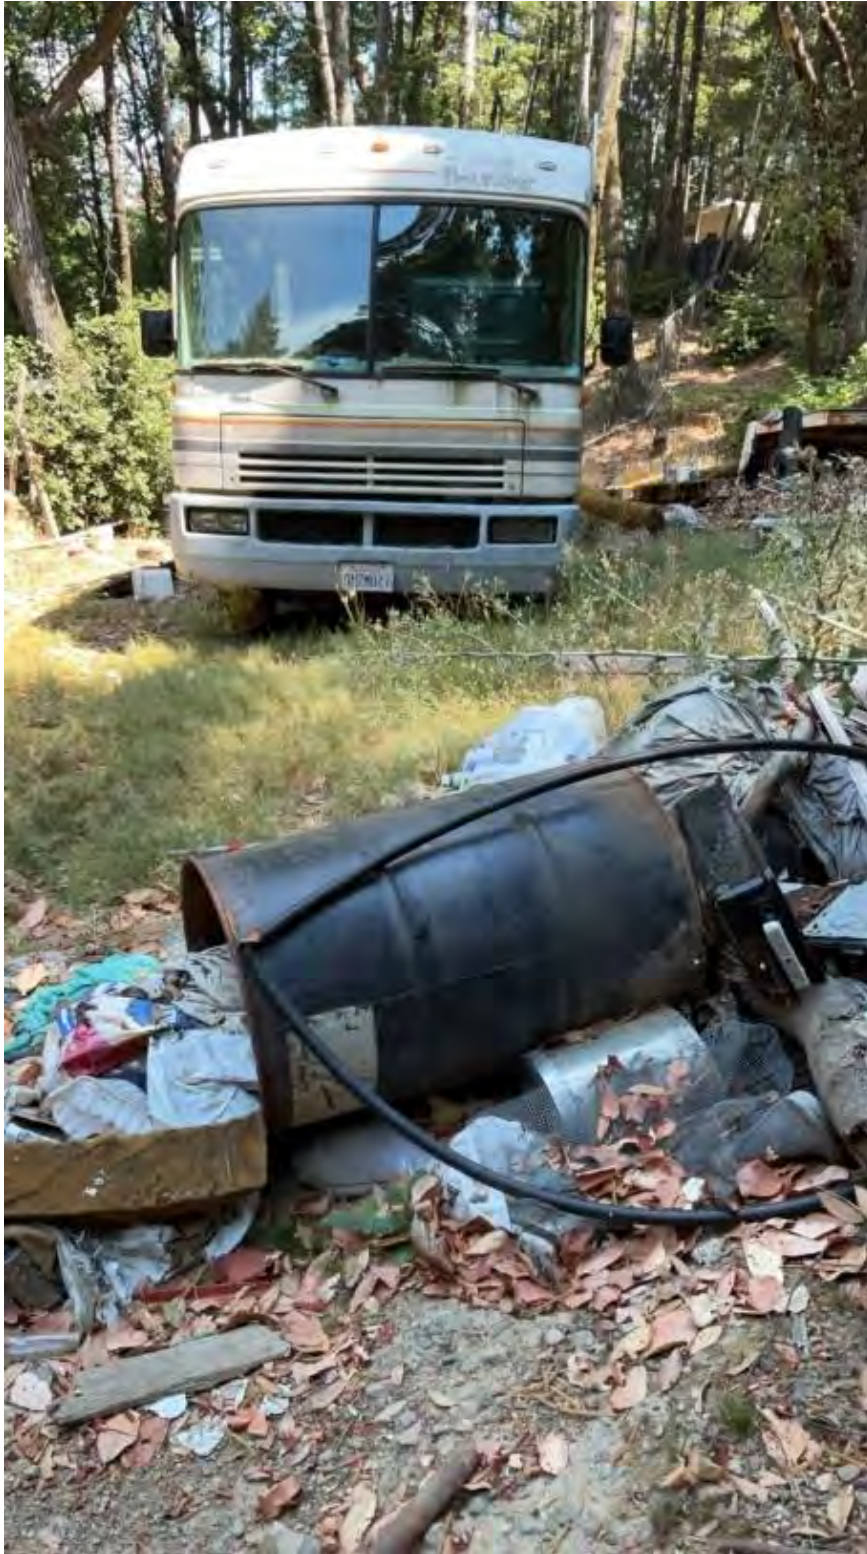
Point 11: Trash and RV.

Figure 23. Point 11. Trash and RV.

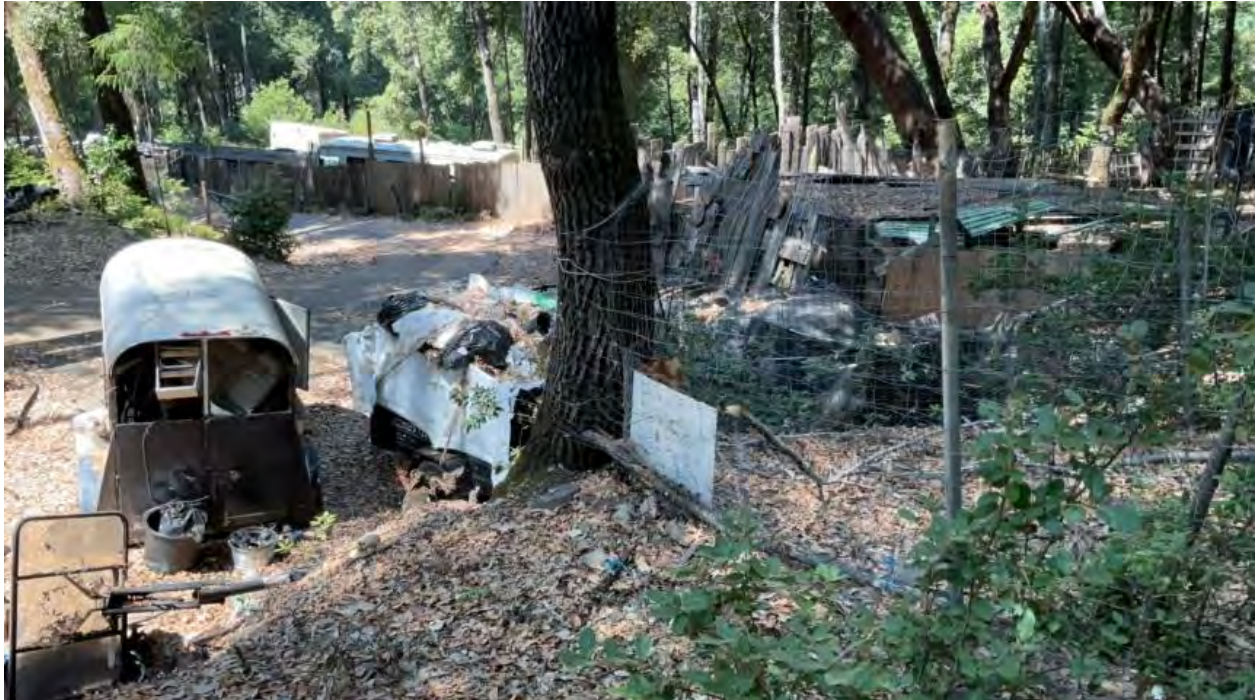
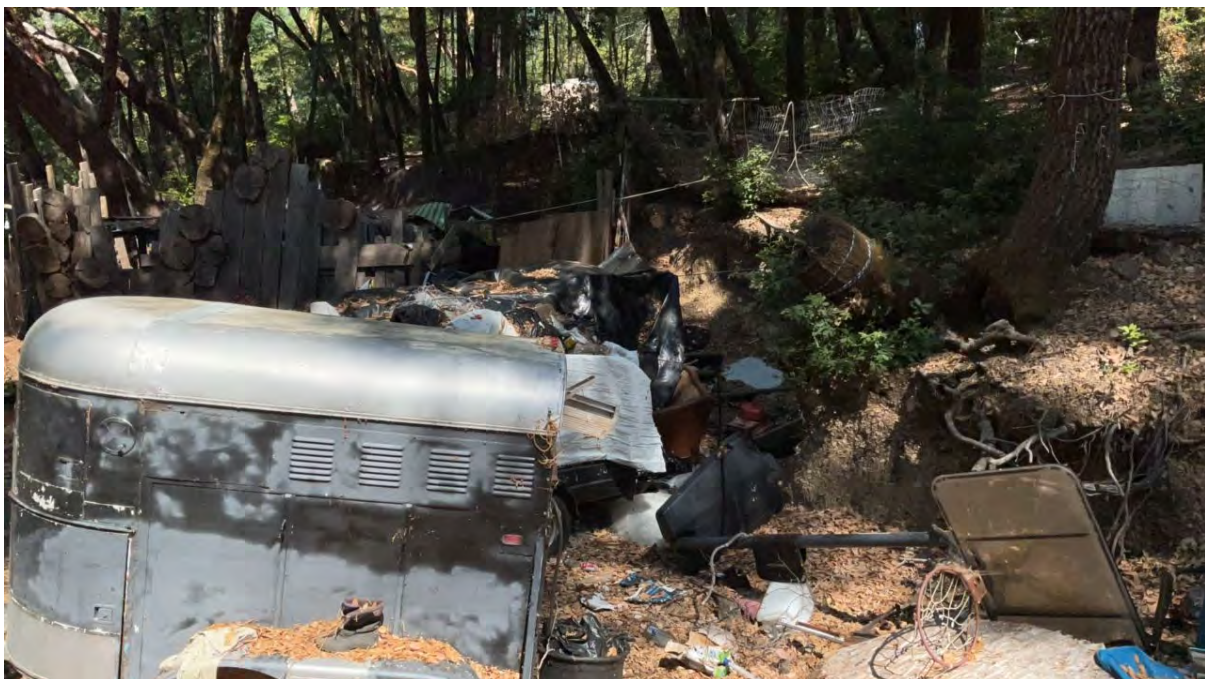
Point 12: Refuse accumulation.

Figure 24. Point 12. Refuse accumulation.

Figure 25. Point 12. Refuse accumulation.
