Subject **Notice of Violation, Transmittal of Inspection Report of July 11, 2023
Inspection of Siskiyou County Assessor's Parcel Number 100-451-080**

**North Coast Regional Water Quality Control Board
Attachment B**

**Cannabis Water Quality Inspection Report
Meng Lor Property, Siskiyou APN 100-451-080, WDID 1_47MJ000366**

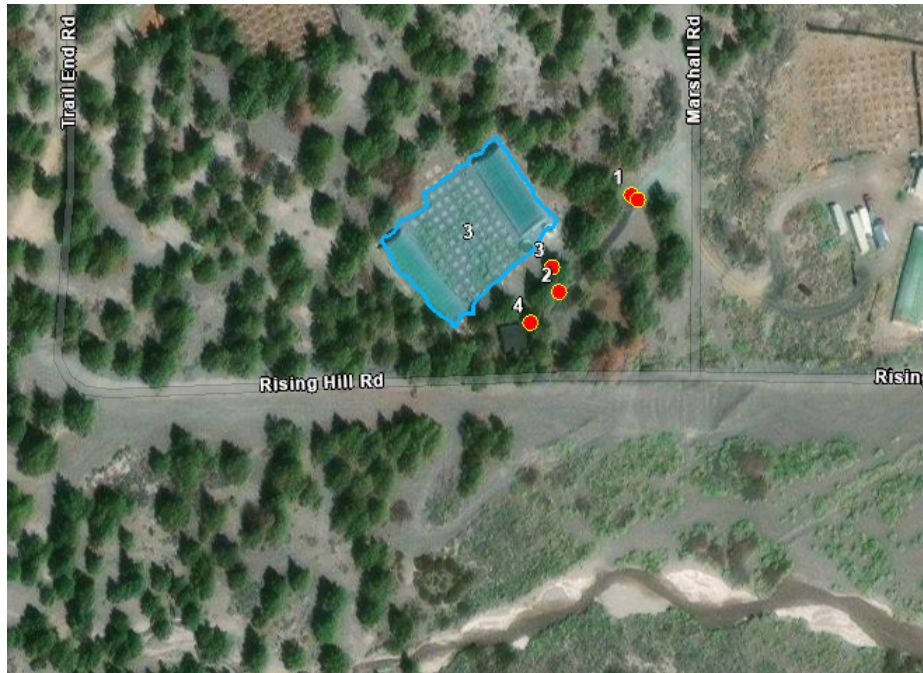
Figure 2. Inspection map with location markers discussed in text. The Property is located adjacent to Whitney Creek, which is fed by runoff from Whitney Glacier located on the north side of Mount Shasta. In the area of the Property, I observed that Whitney Creek has sand substrate and a broad channel migration area which numerous braided channels. Shifts in the historic flow paths of the braided channels appear to have resulted from channel migration and the construction of the subdivision and earthen berms along the southern boundary.

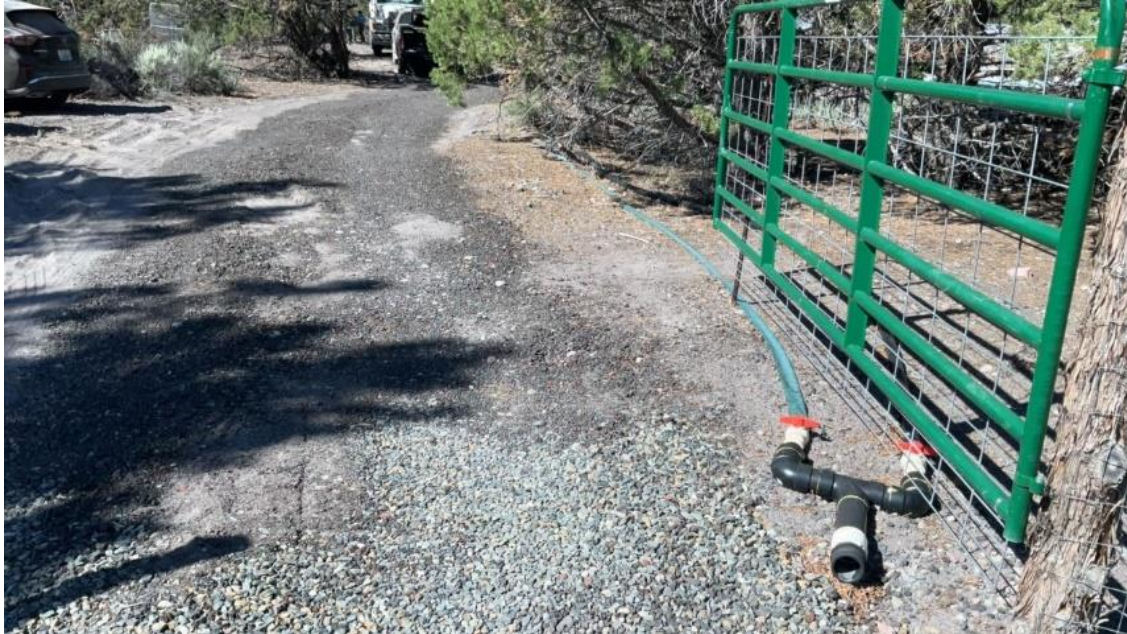
Location 1: Water truck delivery hookup at driveway gate to Property.

Figure 3. At the gate entrance to the Property (Location 1) there was a hookup for a water truck to delivery water.

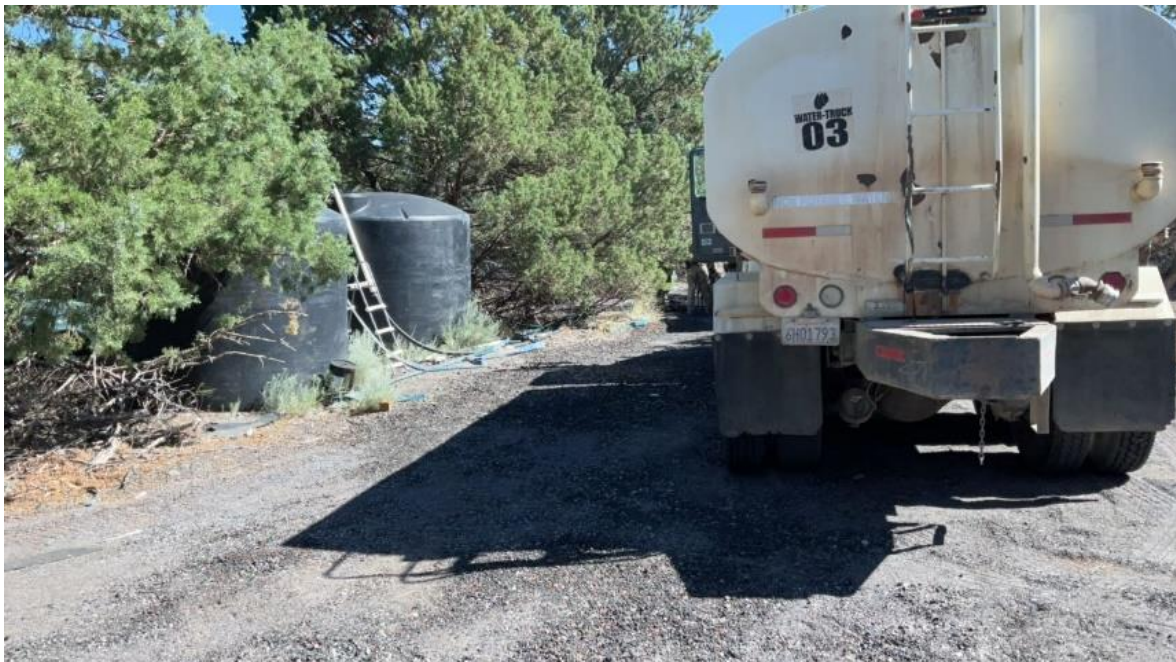
Location 2: Two water tanks and a water truck.

Figure 4. At Location 2 there were two water storage tanks and a water truck.

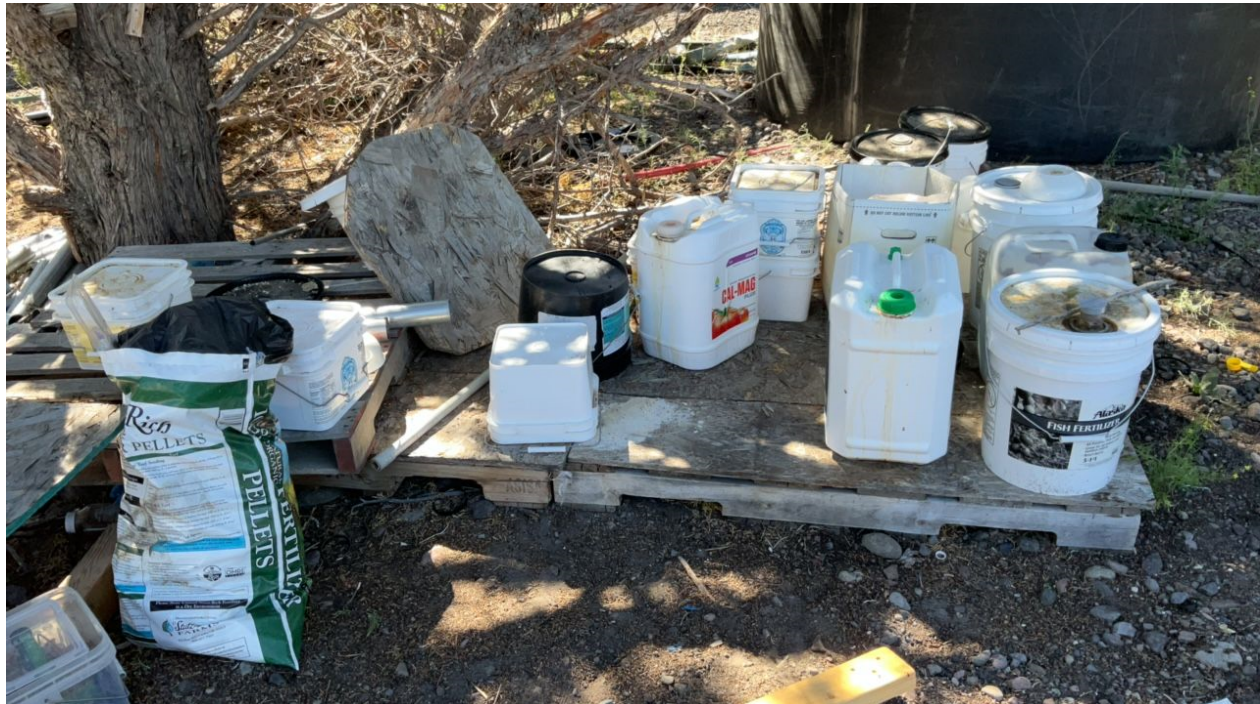
Point Location 3: Fertilizer and pesticides containers stored without adequate containment.

Figure 5. Fertilizers stored next to water tank without adequate containment were located at Point Location 3.

1. Cease unauthorized cannabis cultivation.
2. Cease use of pesticides and chemical that are not authorized for use in this country.
3. Remove cultivation infrastructure and properly dispose of waste including but not limited to trash, fertilizer, pesticide and petroleum containers, plastic tarps and sheeting at a legal facility.
4. Properly dispose of all pesticides and fertilizers at a legal disposal facility.
5. Cleanup and remediate the Property to ensure that additional discharges and threats of discharges of fertilizers, petroleum, chemicals and other deleterious materials are prevented during rain events and at times of elevated surface water flow.
6. Contact me at Adona.White@waterboards.ca.gov or 707-576-2672 to discuss your plans to cleanup and remediate the site conditions that threaten water quality.

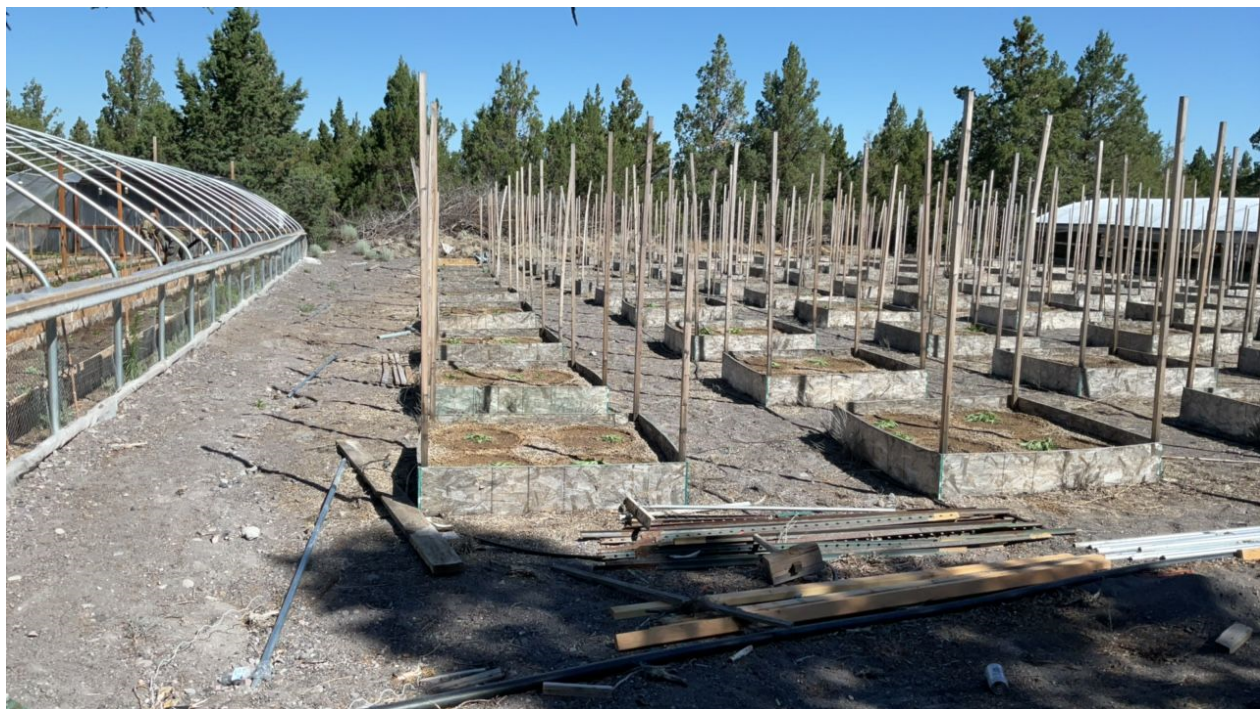
Polygon Location 3: Cultivation area with recently planted outdoor and greenhouse areas. Fertilizer containers were open on ground.

Figure 6. Cultivation area at Polygon Location 4 had recently been planted in small plants.

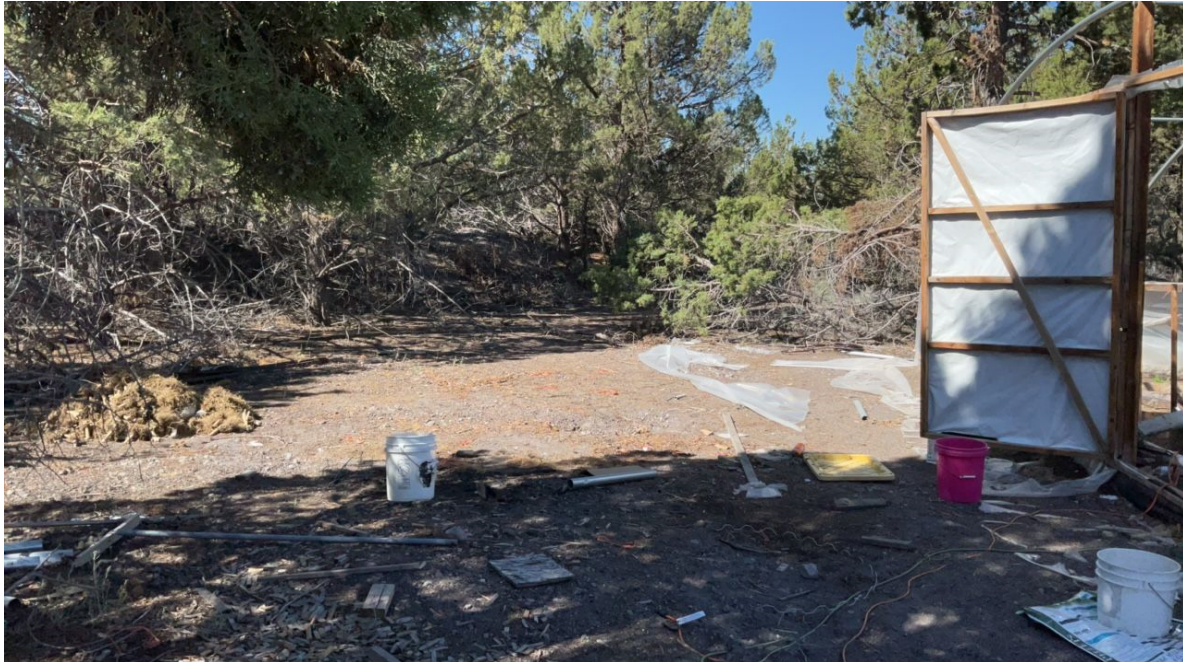
Figure 7. Fertilizer containers and disturbed soil area at cultivation area at Polygon Location 4.

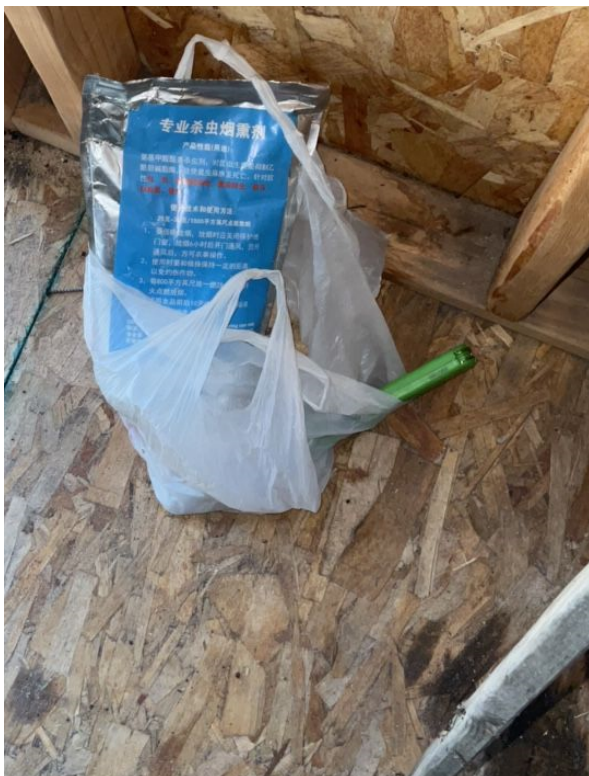
Location 4: Imported pesticides not approved for use in the country were located in a foil bag.

Figure 8. Imported pesticides not approved for use in the United States were observed at Point Location 4.
