North Coast Regional Water Quality Control Board

Subject: Inspection Report for August 2, 2023, Warrant Inspection of Trinity County Assessor's Parcel Number 019-490-027

File: Cannabis Program Inspections, Trinity County, Pa Vang, CIWQS Place ID 889923

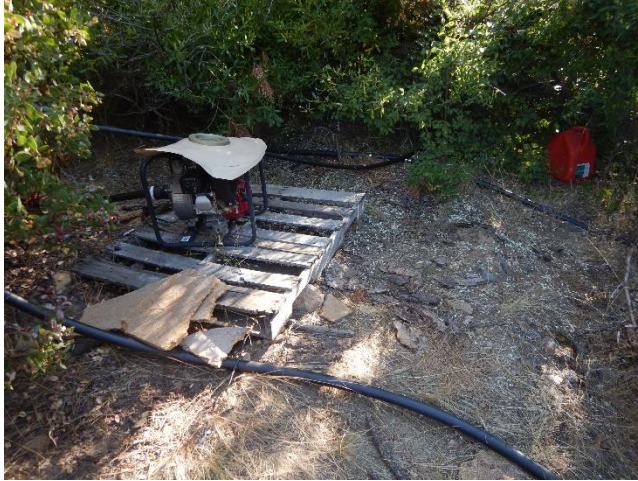
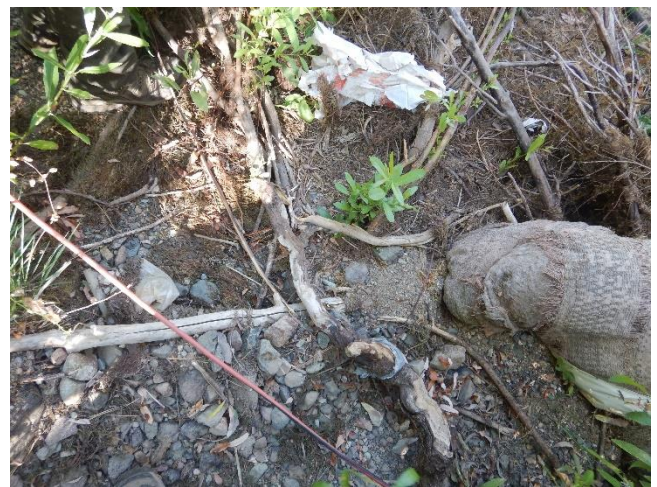
WQ1: I observed a generator and gas within the riparian setbacks to Post Creek (Photo 1). I observed plastic waste and couch cushions in the creek (Photo 2).

3. Riparian and wetland protection and management: I observed cannabis plants and trash in the setbacks to Post Creek and its tributary.

Photos 1 and 2: Generator, gas can, and trash in Post Creek.

3. Relocate all cannabis cultivation activities, supplies, and trash outside of the riparian setbacks (50 feet from Class III, 100 feet from Class II, 150 feet from Class I).

5. Store and contain all chemicals, including fertilizers, pesticides, and petroleum products, properly to prevent spillage and potential for migration/transport into receiving waters. Store generator in an area with secondary containment.

6. Discontinue burning of trash. Regularly contain and dispose of all waste/ trash at a licensed transfer site. Remove trash from creek.
7. Adhere to the California Department of Pesticide Regulation guidance on appropriate pesticide use for cannabis cultivation.

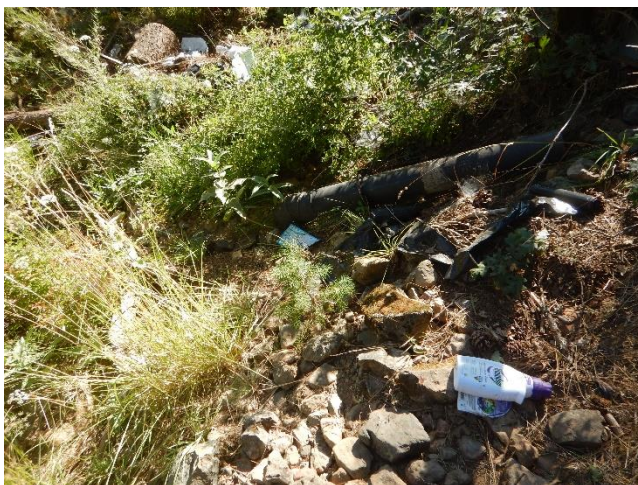
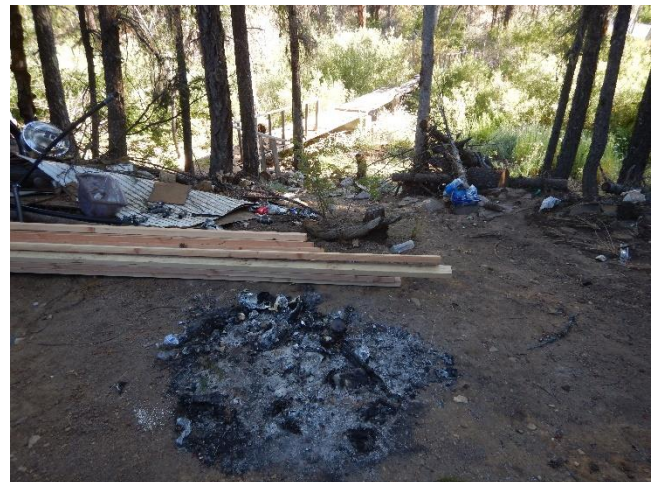
WQ2: I observed cultivation and domestic waste in Post Creek and on the bank, including the pesticide RoundUp and a burn pile (Photos 3 and 4).

7. Fertilizers and soil amendments: I observed a leaking bag of fertilizer.
8. Pesticides: I observed RoundUp stored where it may discharge to Post Creek.
9. Petroleum products and other chemicals: I observed a generator stored without adequate secondary containment.
10. Cultivation-related wastes: I observed waste in and adjacent to Post Creek and its tributary.
11. Refuse and human waste: I observed burnt trash. I observed a toilet with a black pipe discharging human waste to land, and potentially reaching nearby Post Creek.

Photos 3 and 4: RoundUp and trash in creek (left). Burn pile and trash perched above creek (right).

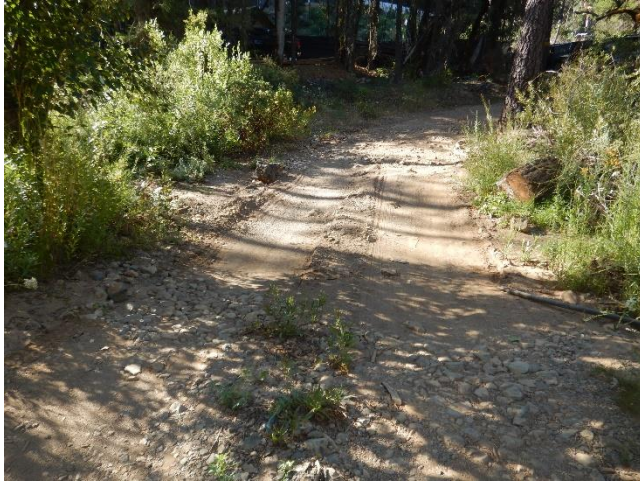
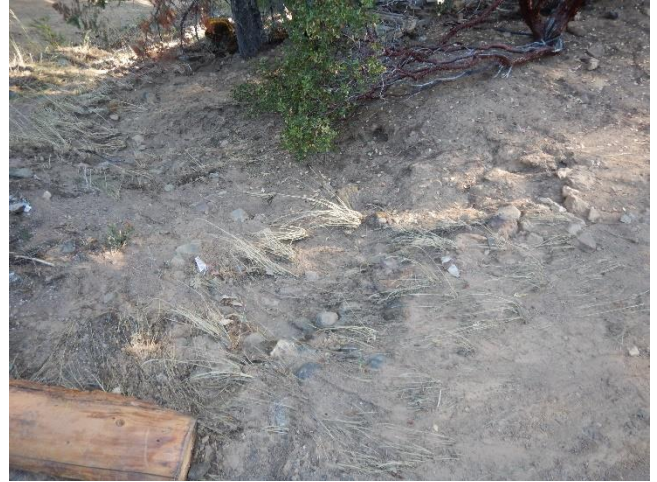
WQ3: I observed a dirt ford on Post Creek with approximate dimensions of 15 feet by 120 feet (Photo 5). I observed road runoff discharging to the creek (Photo 6).

1. Site maintenance, erosion control and drainage features: I observed an access road hydrologically connected to Post Creek, and a tributary diverted down the road.

2. Stream crossing maintenance and improvement: I observed dirt fords on Post Creek and on a tributary to Post Creek.

Photos 5 and 6: Dirt ford on Post Creek (left). Road runoff discharging to creek (right).

2. Hydrologically disconnect access road from receiving waters. Improve road surfacing to minimize sediment delivery. Install management practices like water bars and rolling dips to dissipate runoff.

4. Retain a qualified professional to design watercourse crossings to replace the dirt fords and apply for a 401 Water Quality Certification prior to work in stream.

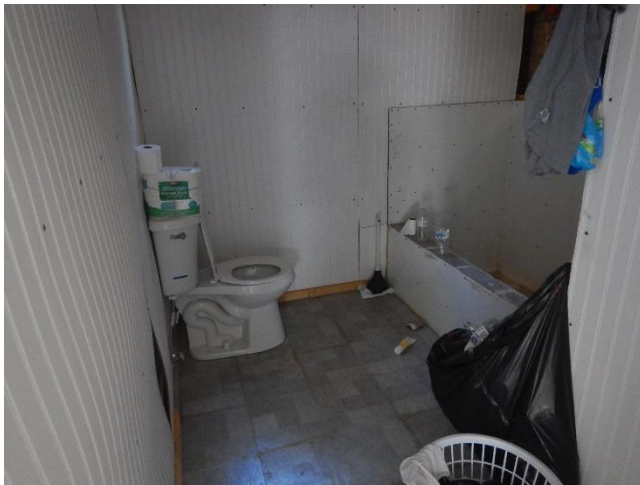
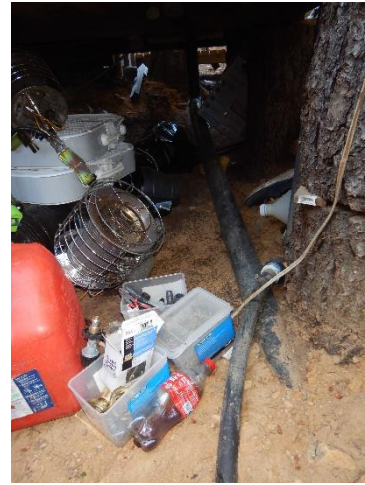
WQ4: I observed a toilet and bath, with a black discharge pipe beneath pointed in the direction of the creek with the outlet buried (Photos 7 and 8). I observed a well and water storage tank, adjacent terraces with cannabis plants in grow bags (Photos 9 and 10). I observed a bag of Grow More fertilizer leaking (Photo 11).

Photos 7 and 8: Toilet and bath with discharge pipe pointing towards creek.

8. Discontinue use of outhouse discharging to land. Adhere to Trinity County regulations on human waste management.

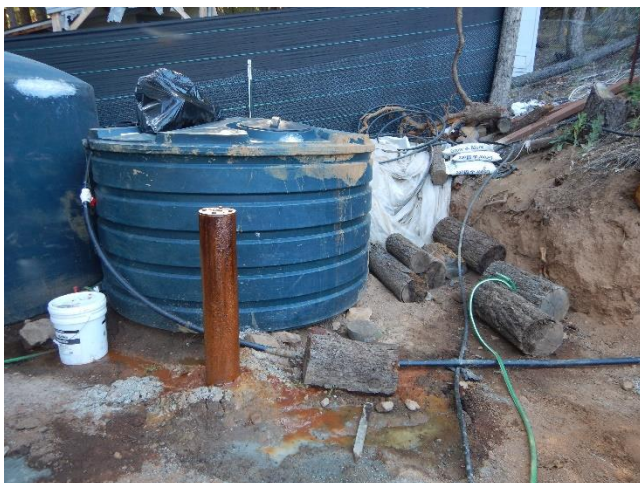
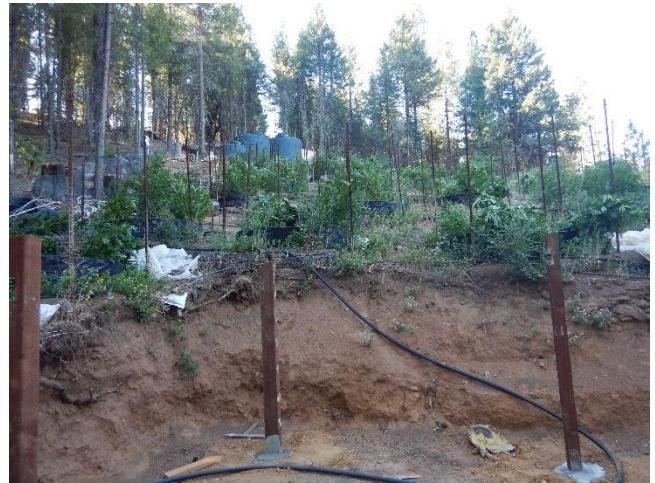
Photos 9 and 10: Well and water tanks (left). Cannabis plants on terraces (right).

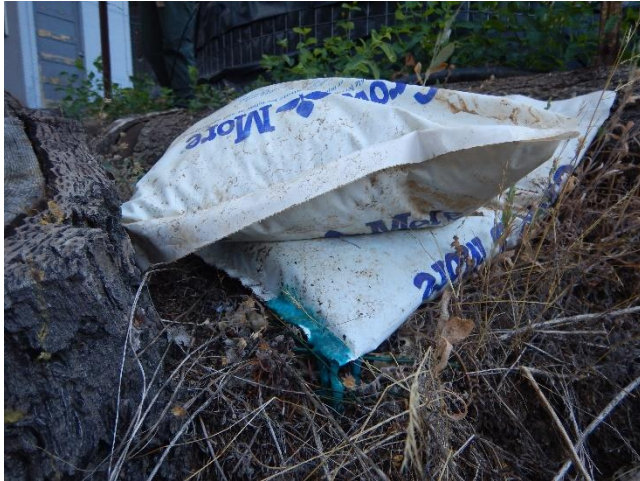
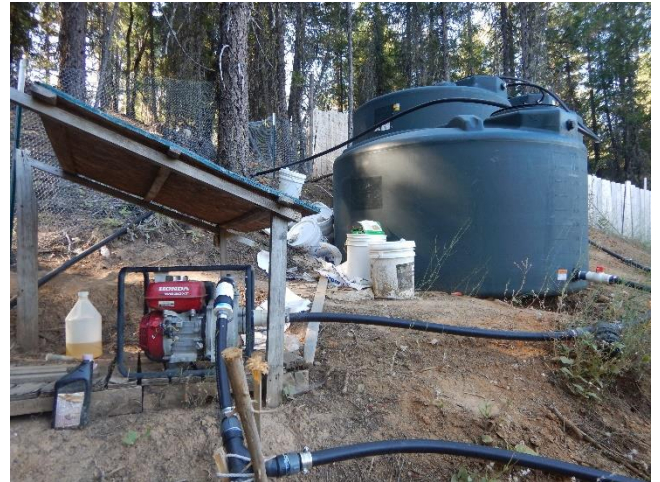
WQ5: At the top of the property, I observed a generator, oil container, fertilizer containers, and three water storage tanks (Photo 12).

Photos 11 and 12: Leaking bag of fertilizer (left). Generator, oil, and fertilizers (right).

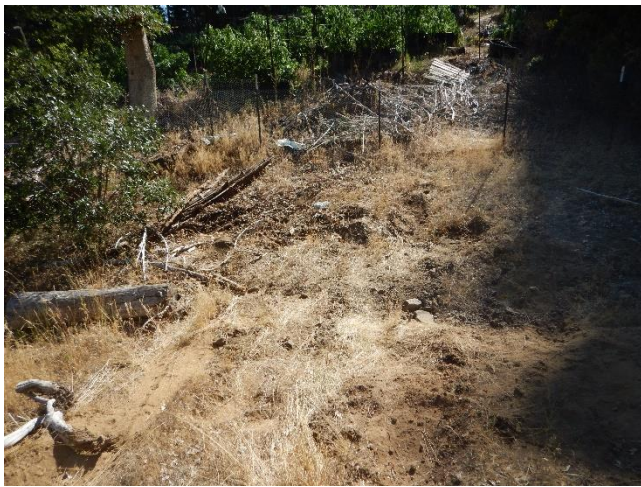
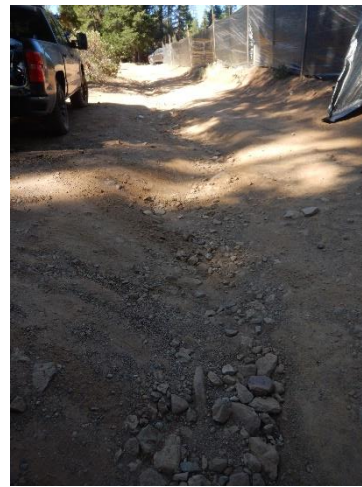
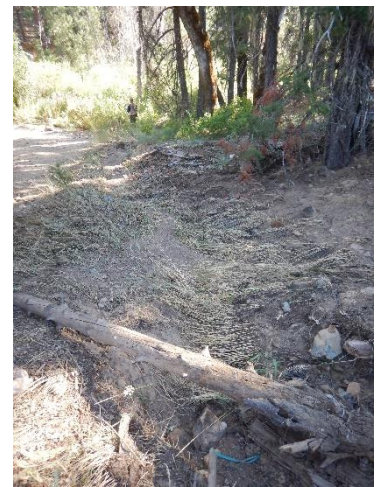
WQ6: I observed a small stream running along the south edge of the property (Photo 13). I observed tire marks through the stream, and cultivation related waste. I observed the stream flows down the access road and connects with Post Creek (Photos 14 and 15).

Photos 13, 14, and 15: Tire marks through tributary stream (left). Stream path down access road (middle). Tributary connecting to Post Creek (right).
